Inspection Photos
Paul Heinze #1 Flowline
Spill ID 479232 (AC)

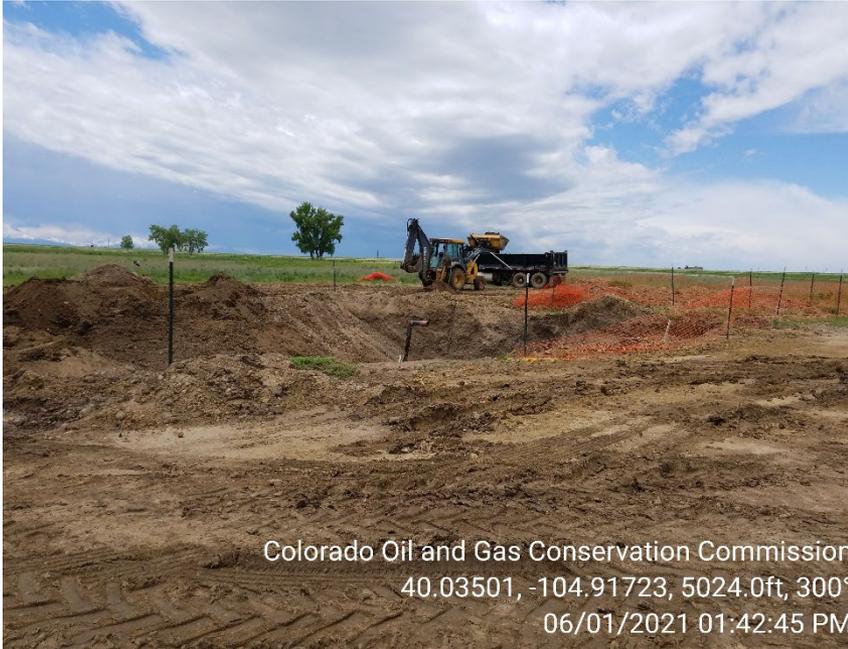
Photo 1 – Spill area. Additional excavation has occurred since last inspection. Soils previously stored on location have been removed.

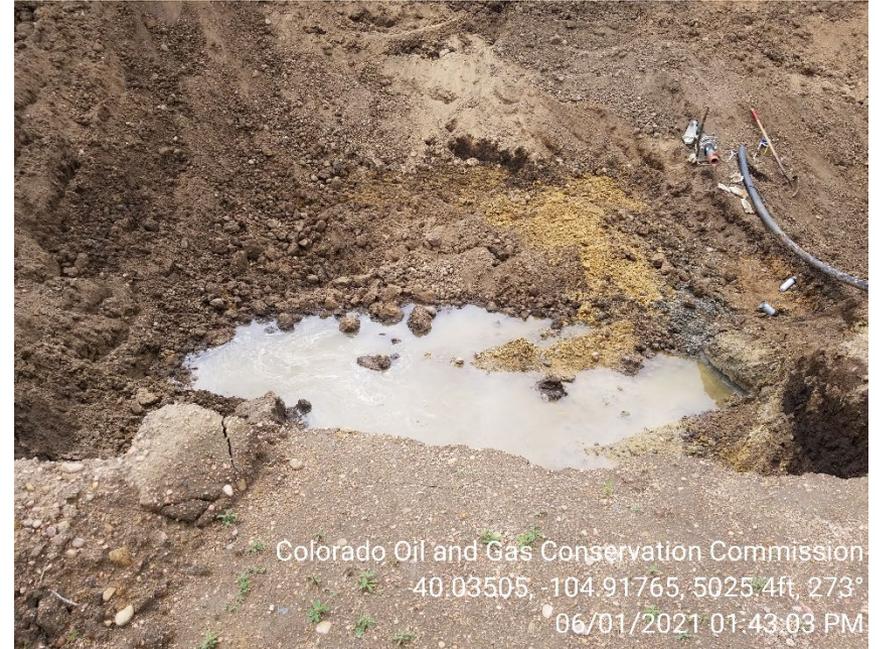
Photo 2 – Expanded area of investigation. Groundwater with hydrocarbon sheen observed. Impacts remain in situ.

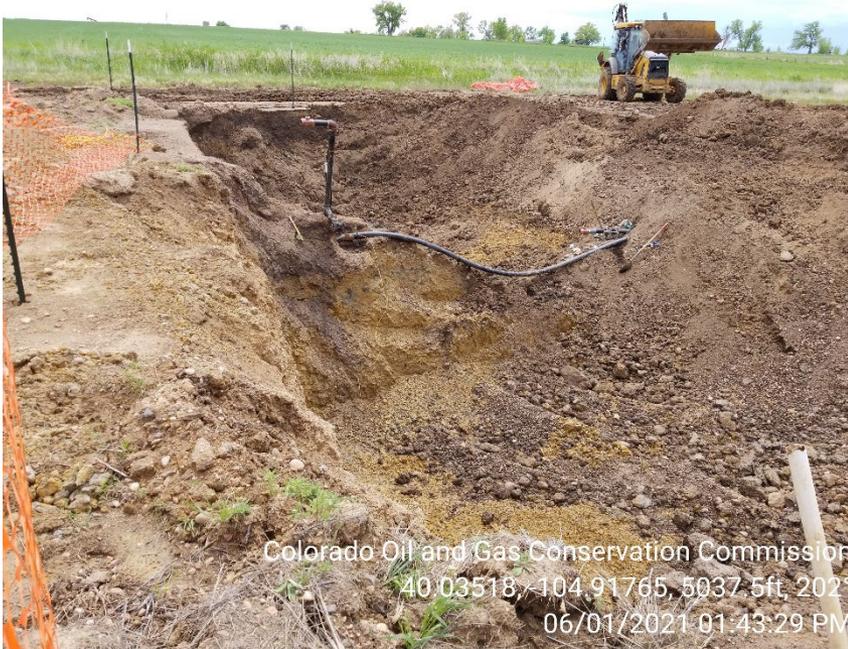
Photo 3 – Open excavation. Area where free product was previously observed appears to have been partially backfilled. Impacts remain in situ.

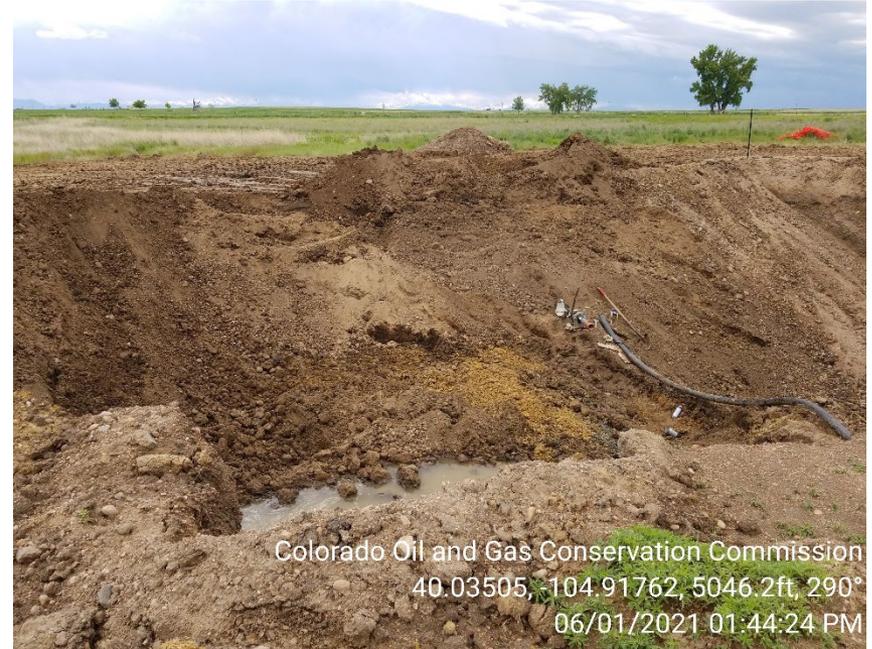
Photo 4 – Open excavation. Impacts remain in situ.

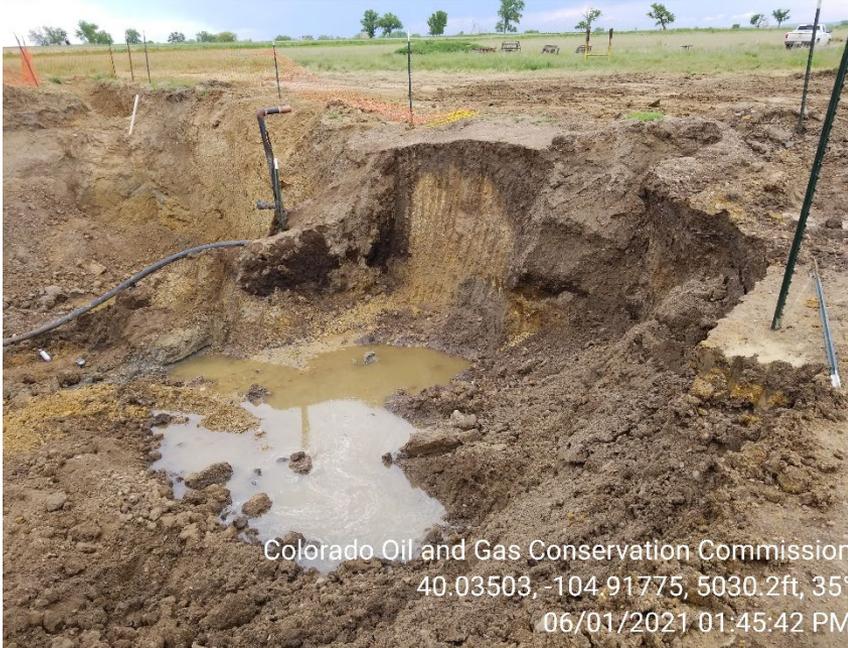
**Photo 5 – Open excavation. Impacts remain in situ.
Sheen observed on groundwater.**

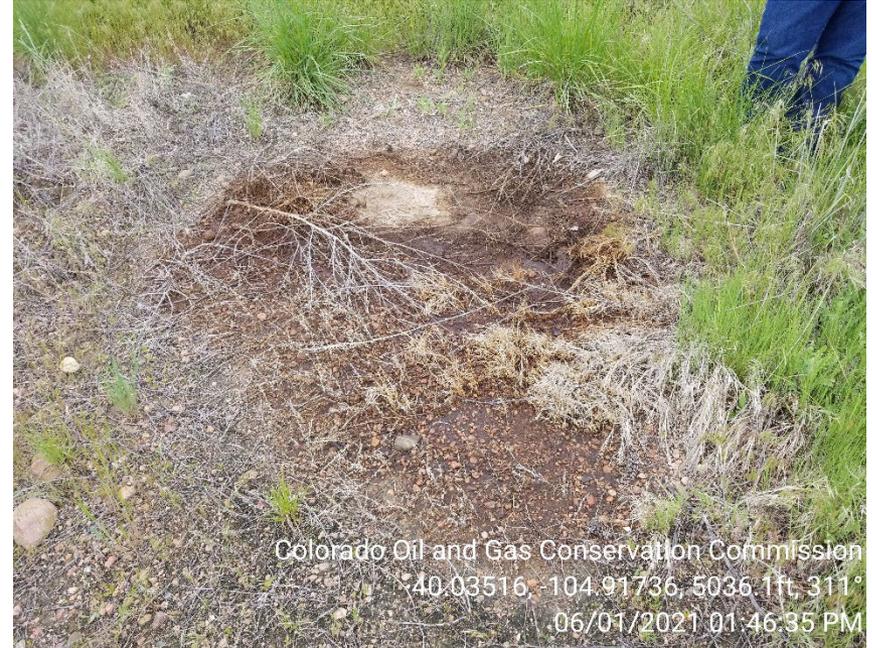
**Photo 6 – New Spill observed ~75' east of open
excavation.**

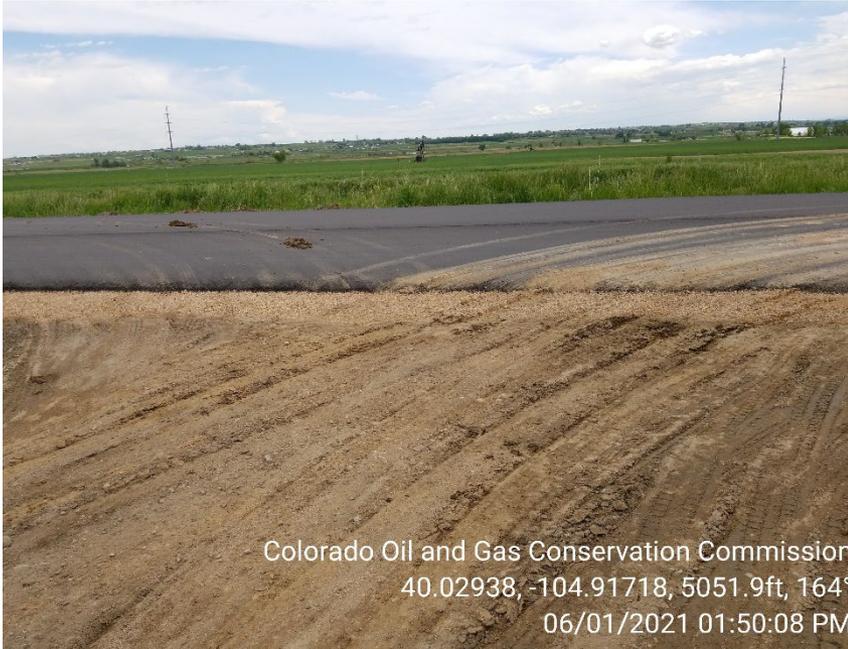
Photo 7 – Dirt being tracked off location onto county road.

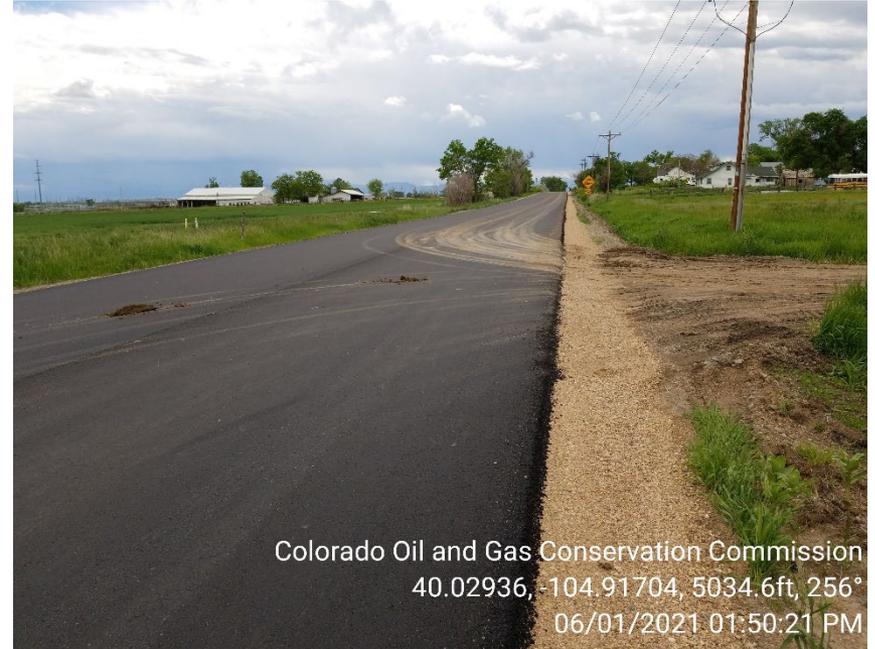
Photo 8 – Dirt being tracked off location onto county road.
