Inspection Photos  
Operator: Simcoe  
API: 067-09061  
Date: 5/28/2021

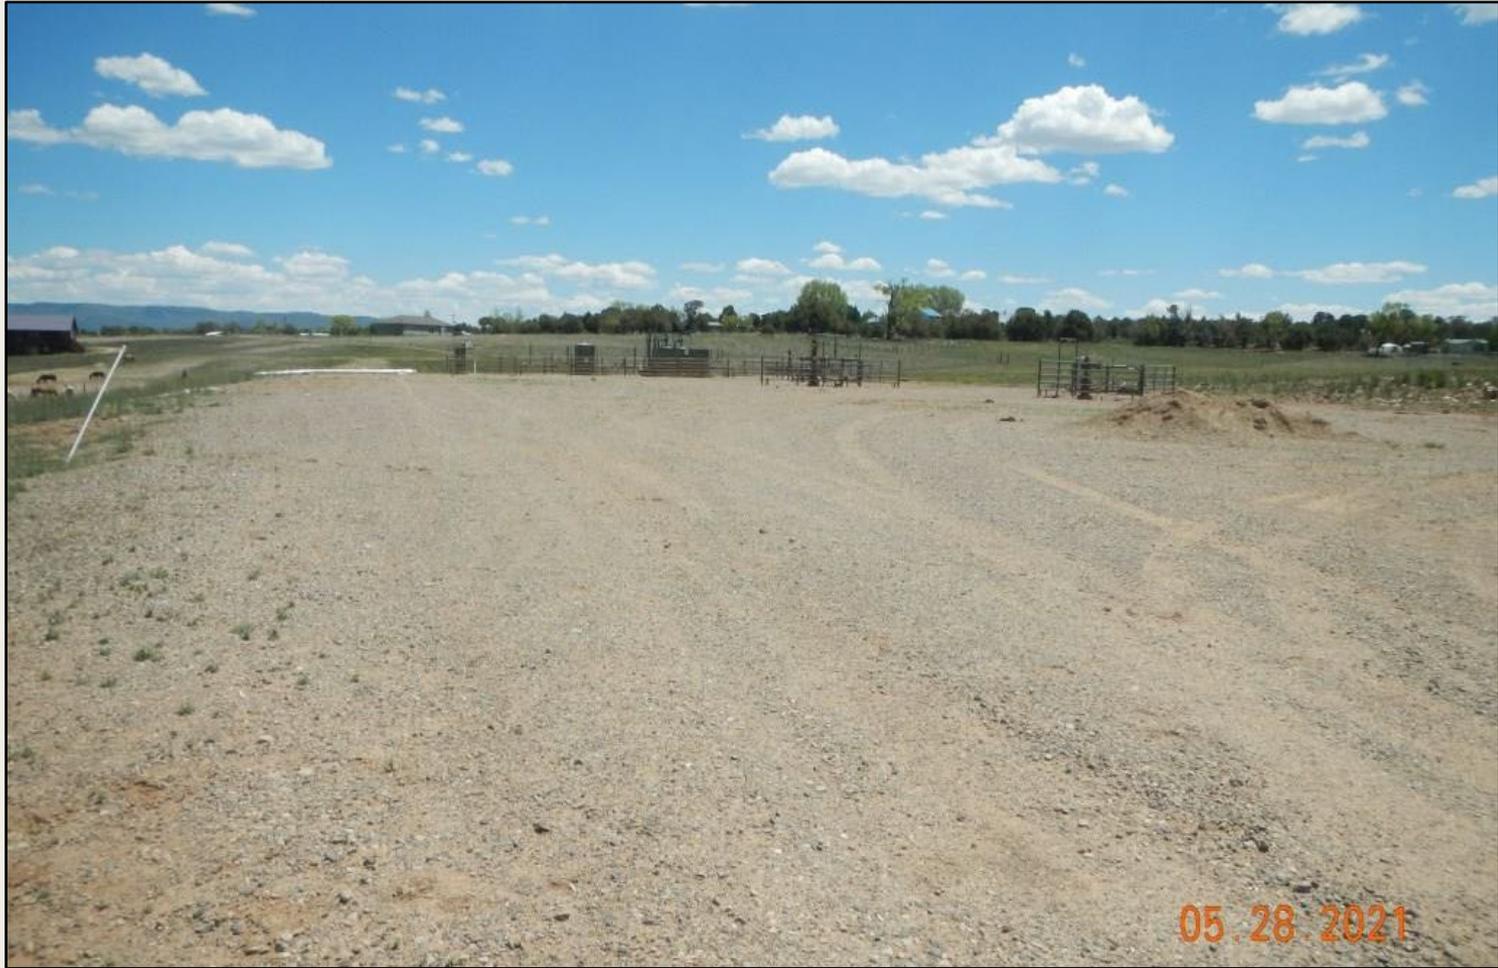
Photo 1. View of project area from the well pad entrance facing center.

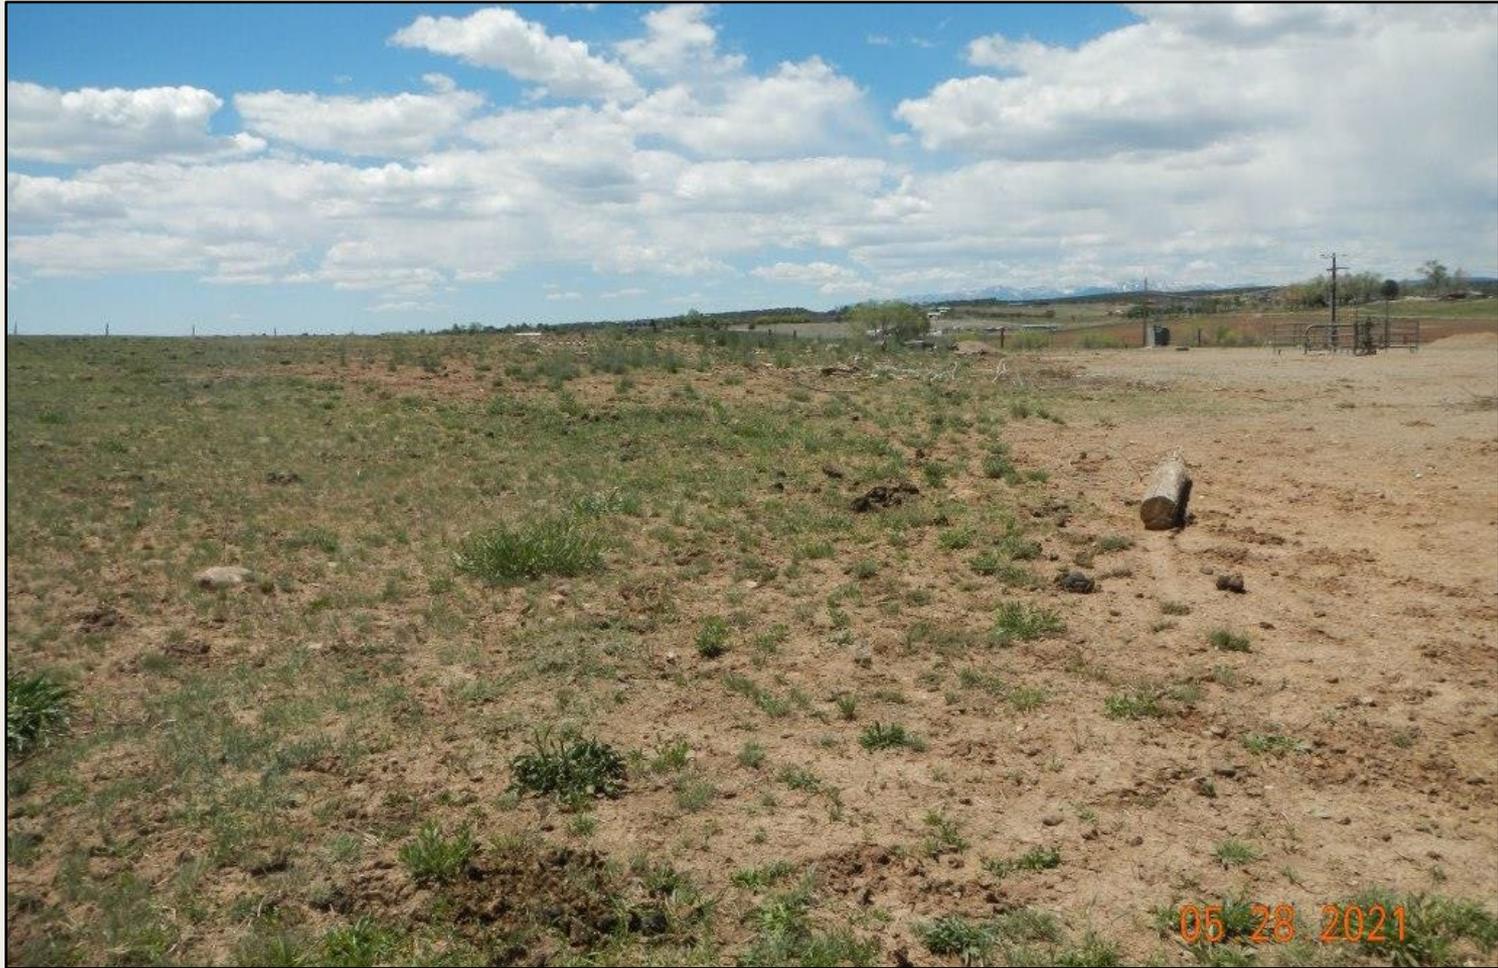
Photo 2. View of the southern project area from the southeastern corner facing westward. Revegetation is progressing with western wheatgrass and crested wheatgrass.

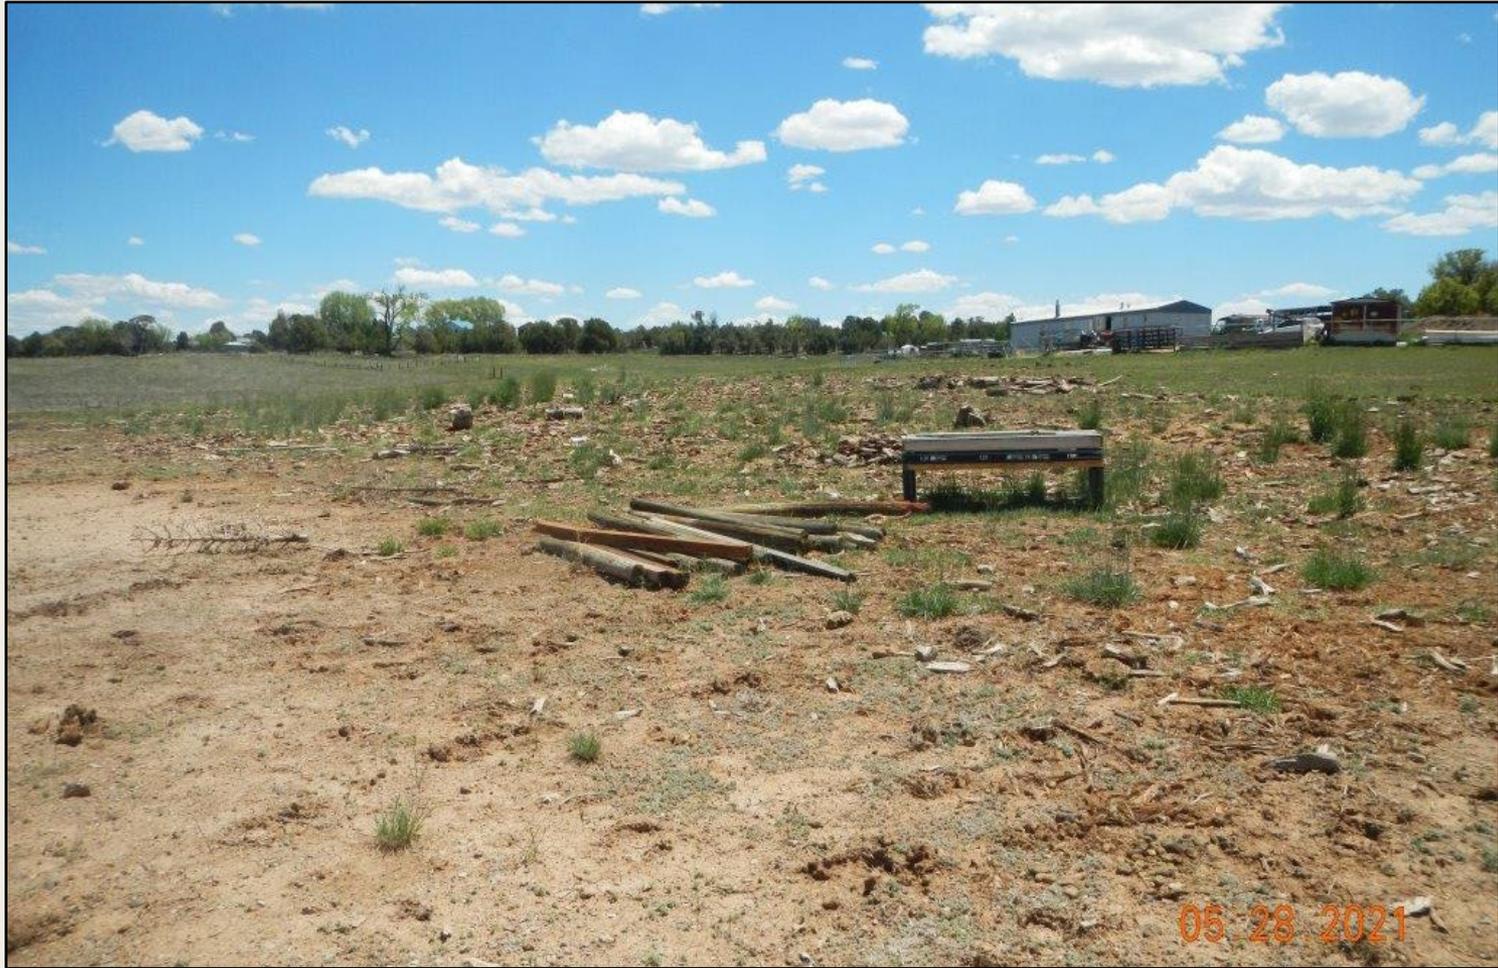
Photos 3. View of wood debris and other equipment/materials within the southern project area.

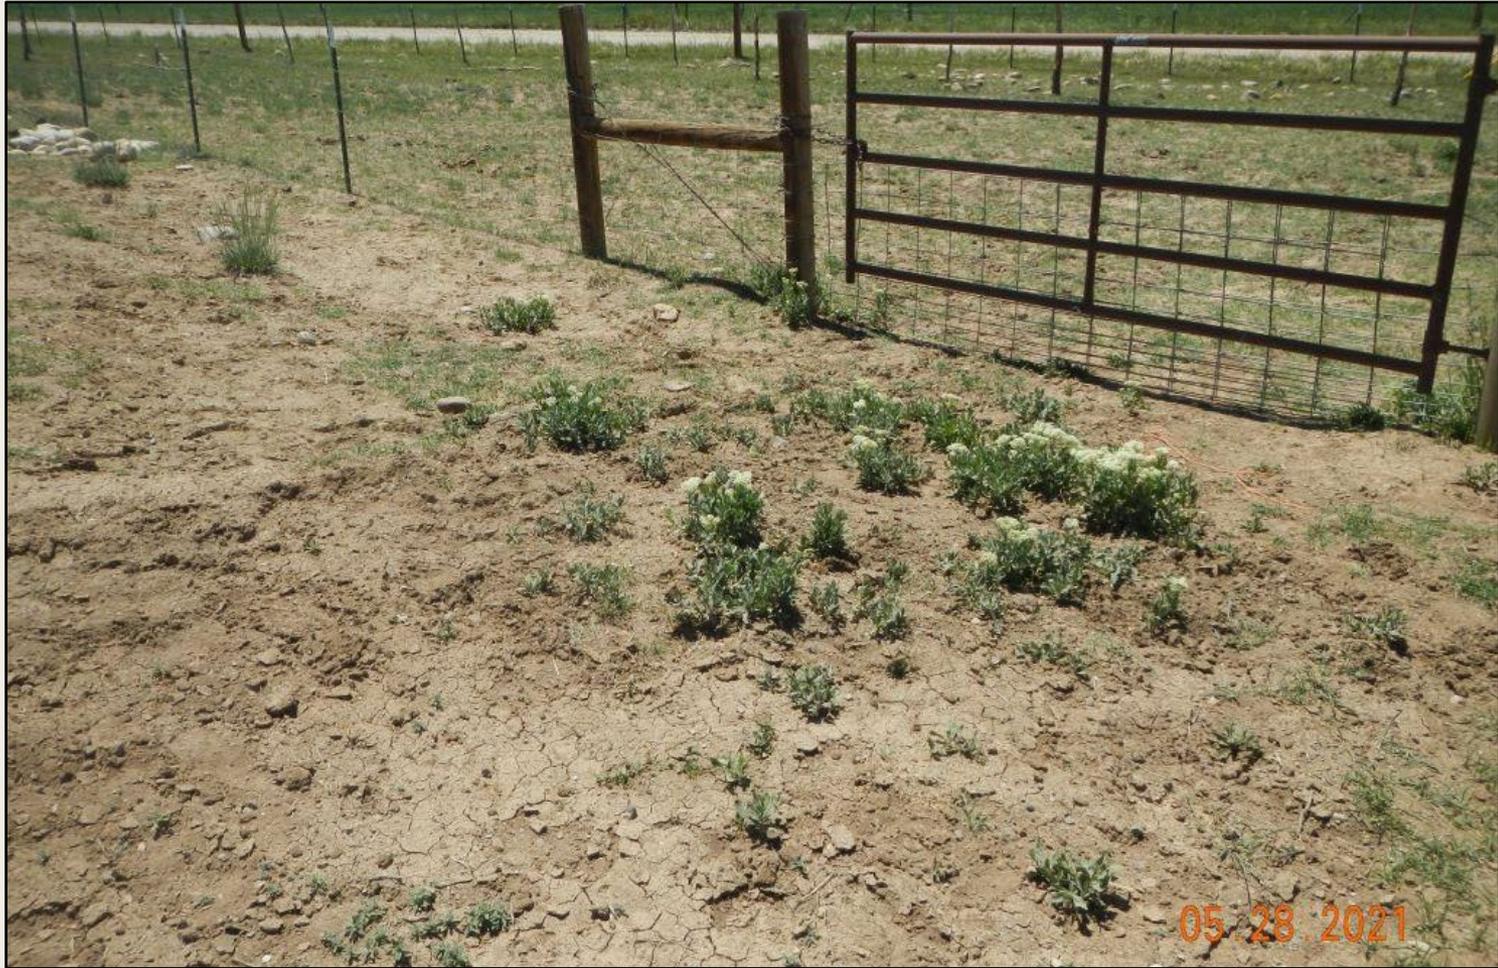
Photos 4. View of hoary cress within the western project area. Approximately 100 individuals observed.

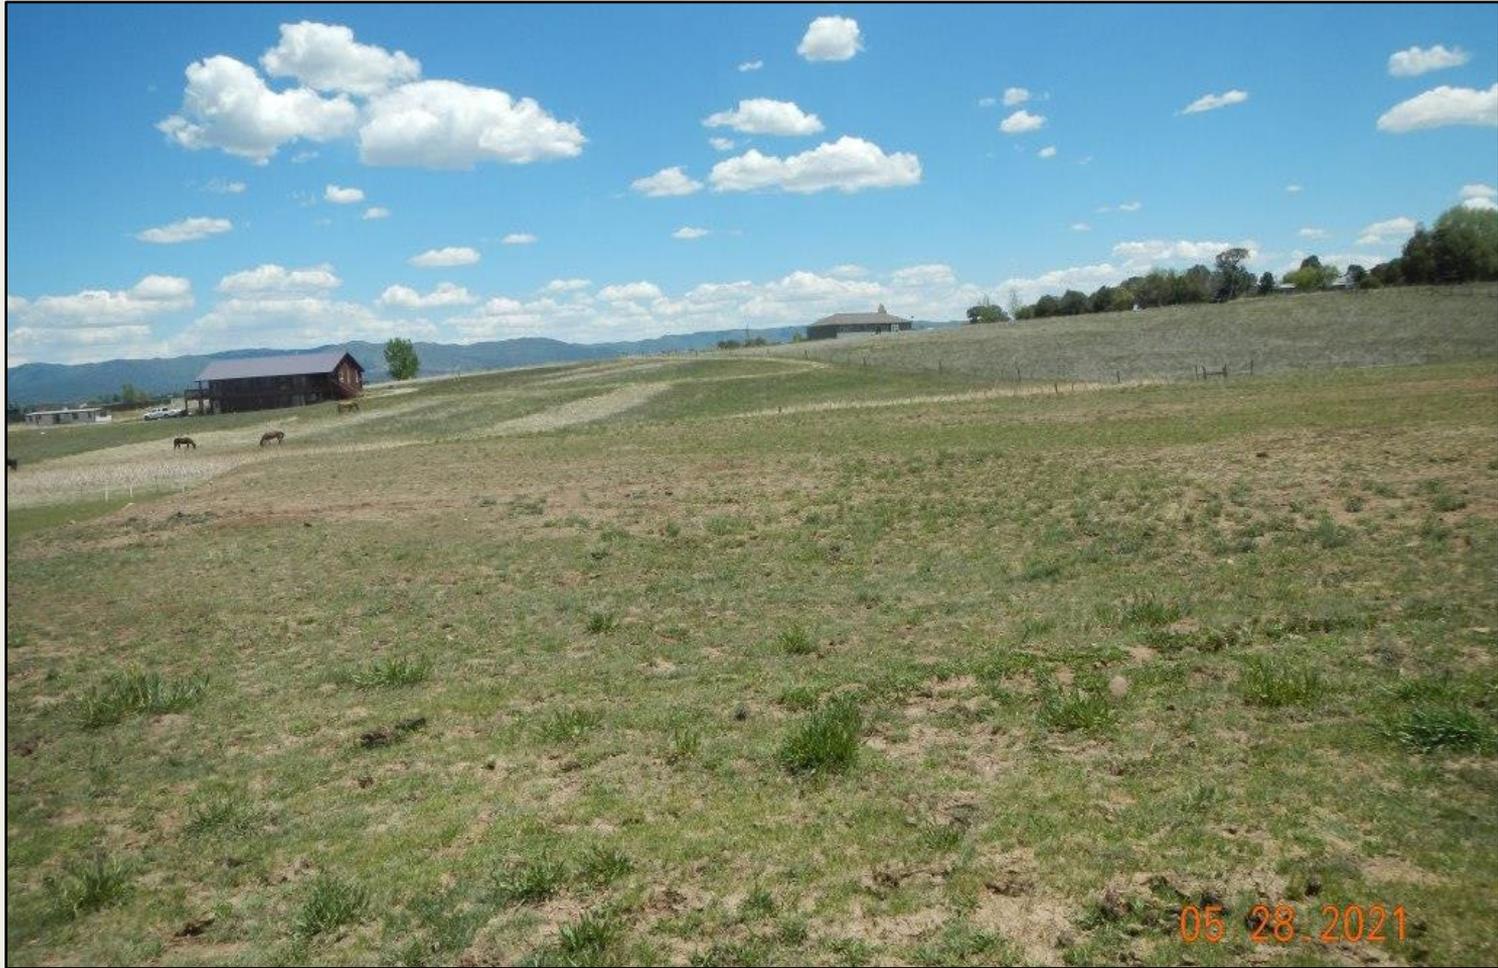
Photo 5. View of reference area, comprised of grass field currently grazed with western wheatgrass and forbs such as gumweed and bindweed.

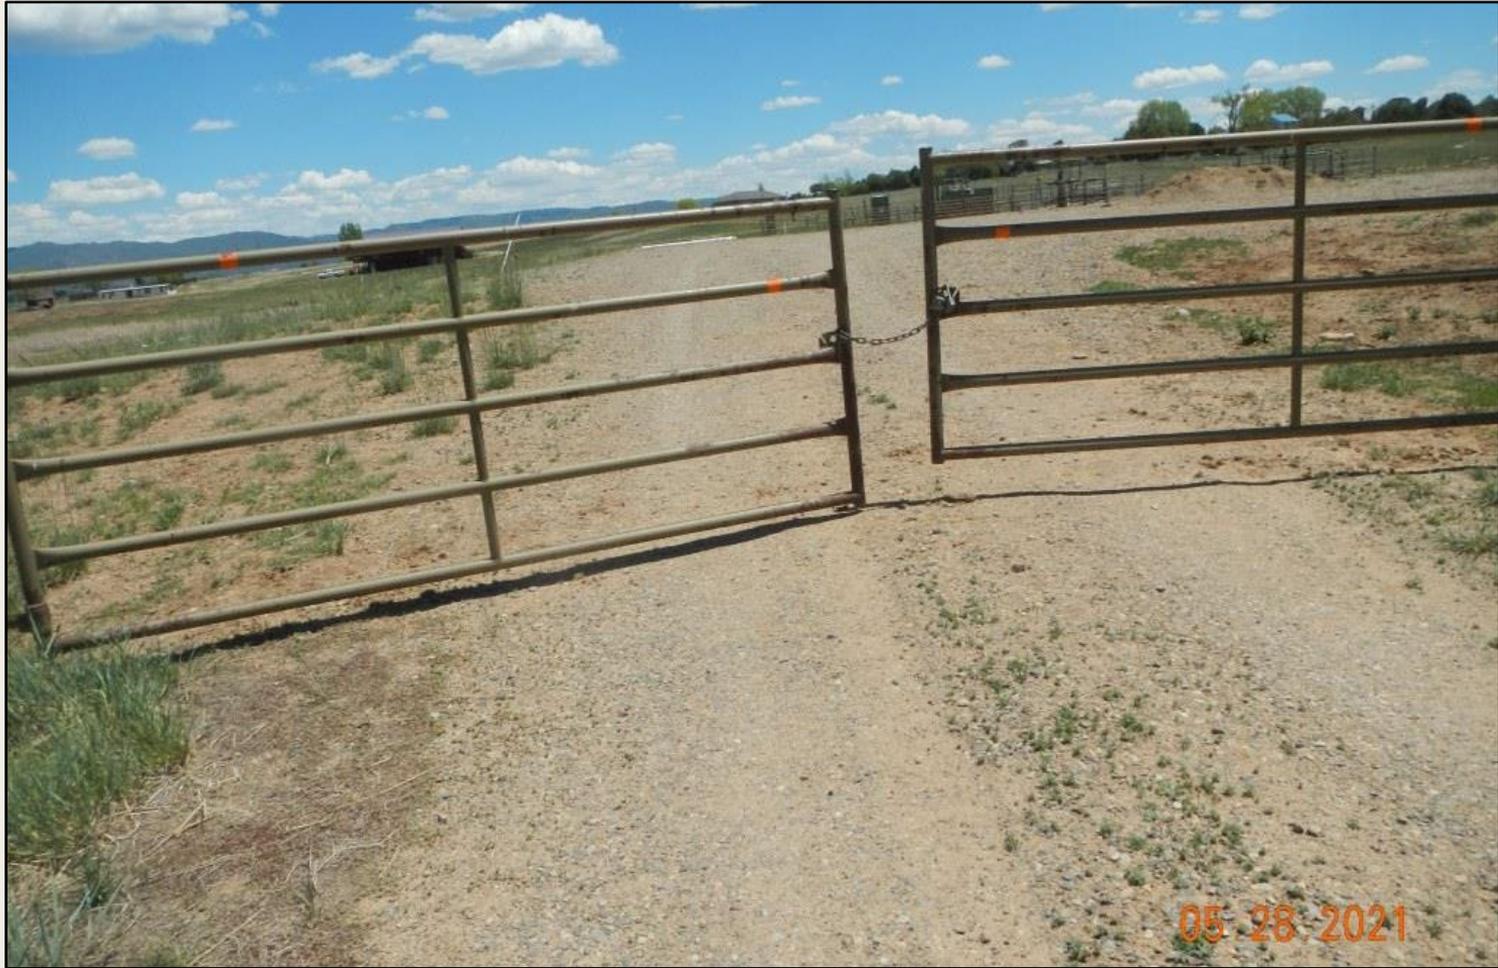
Photos 6. View of closed gate after leaving location.
