Inspection Photos
Operator: Hilcorp
API: 067-07548
Date: 5/28/2021

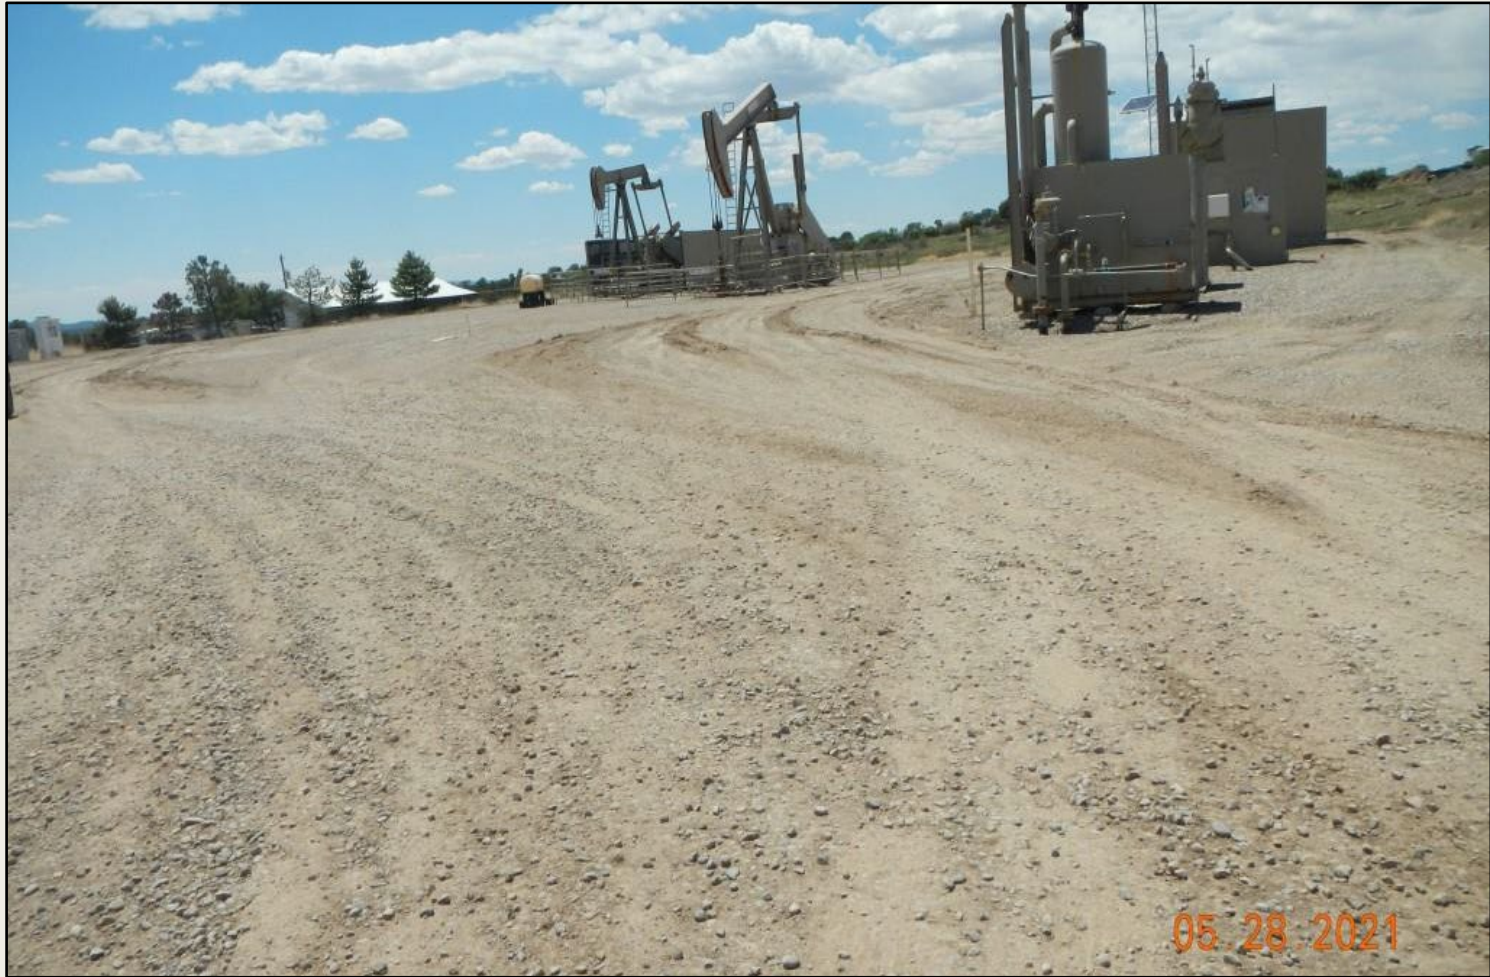
Photo 1. View of project area from the well pad entrance facing center.

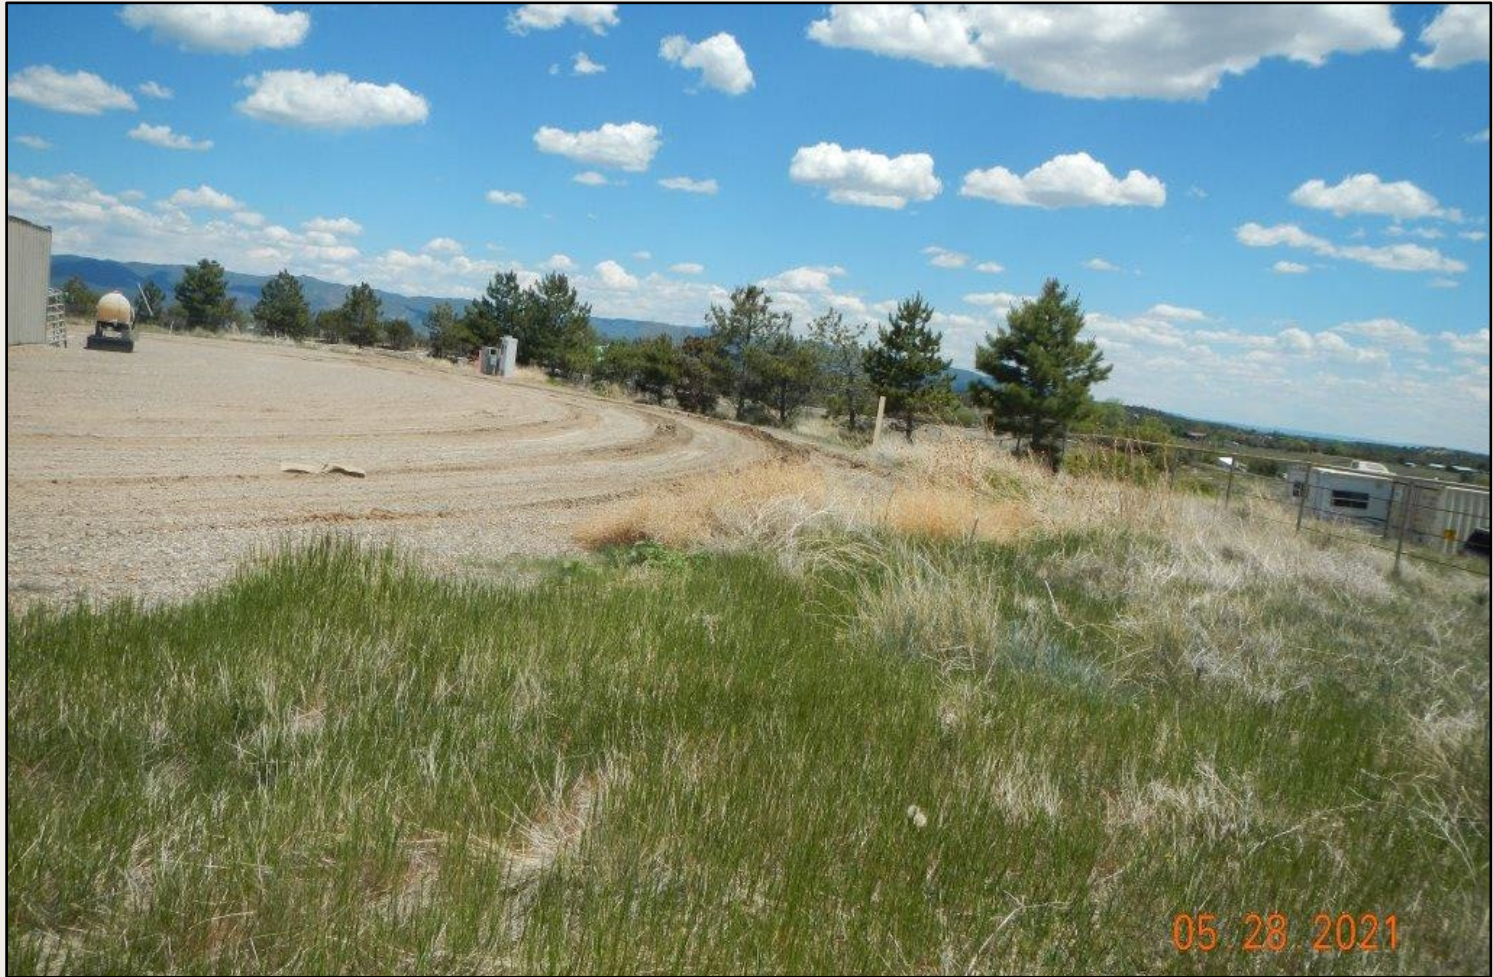
Photo 2. View of the southern project area from the southwestern corner facing eastward. Revegetation is progressing with western wheatgrass and crested wheatgrass.

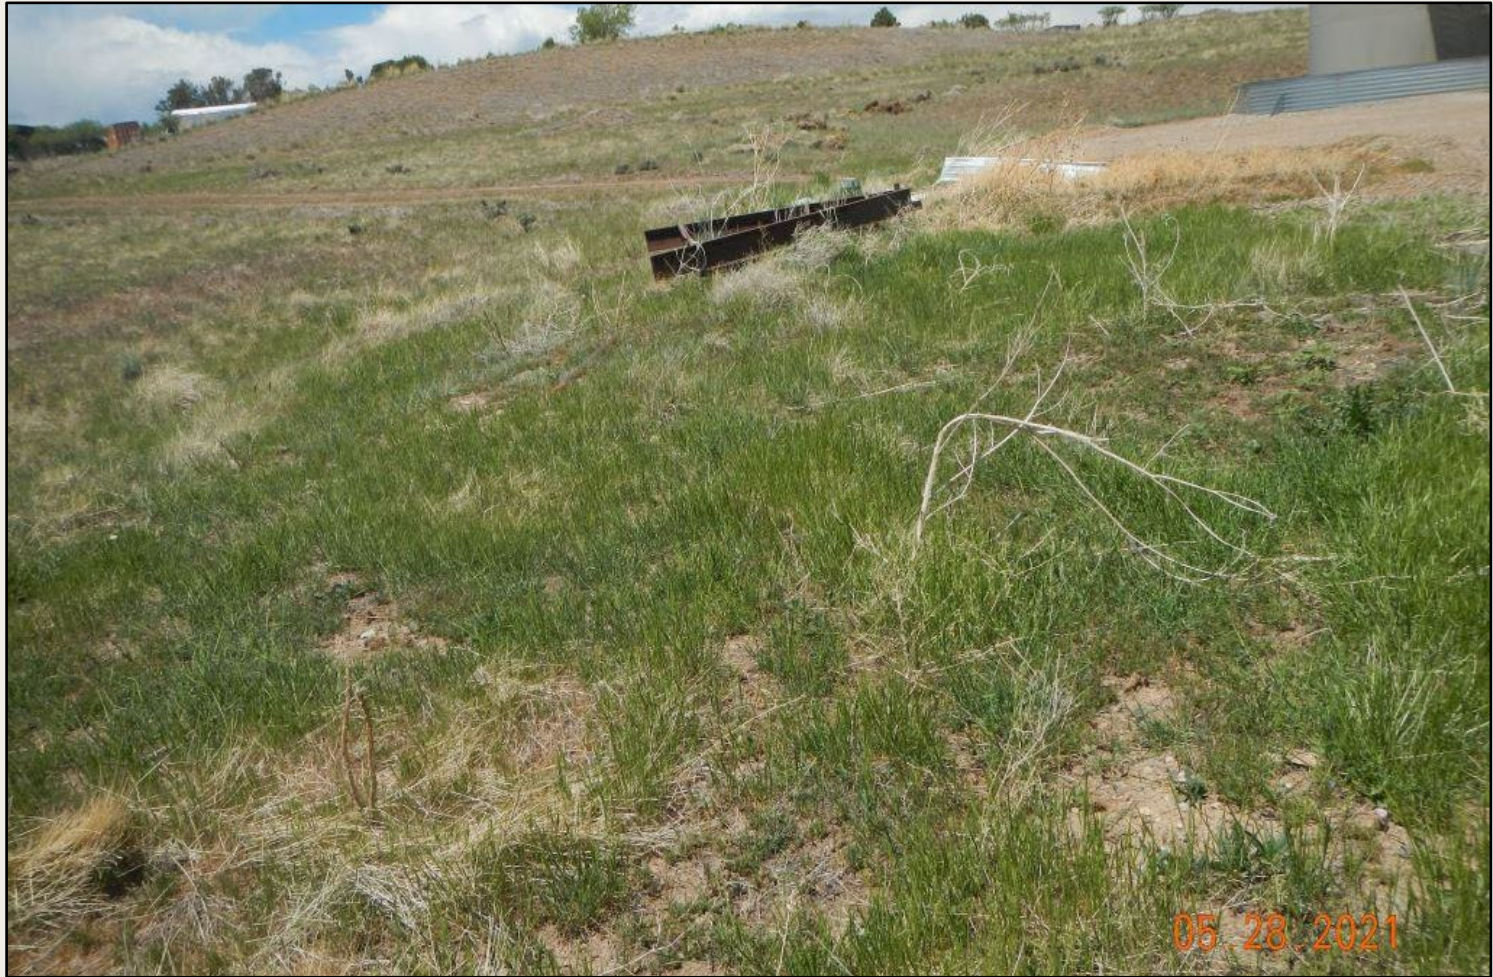
Photos 3. View of the western project area from the southwestern corner facing northward.

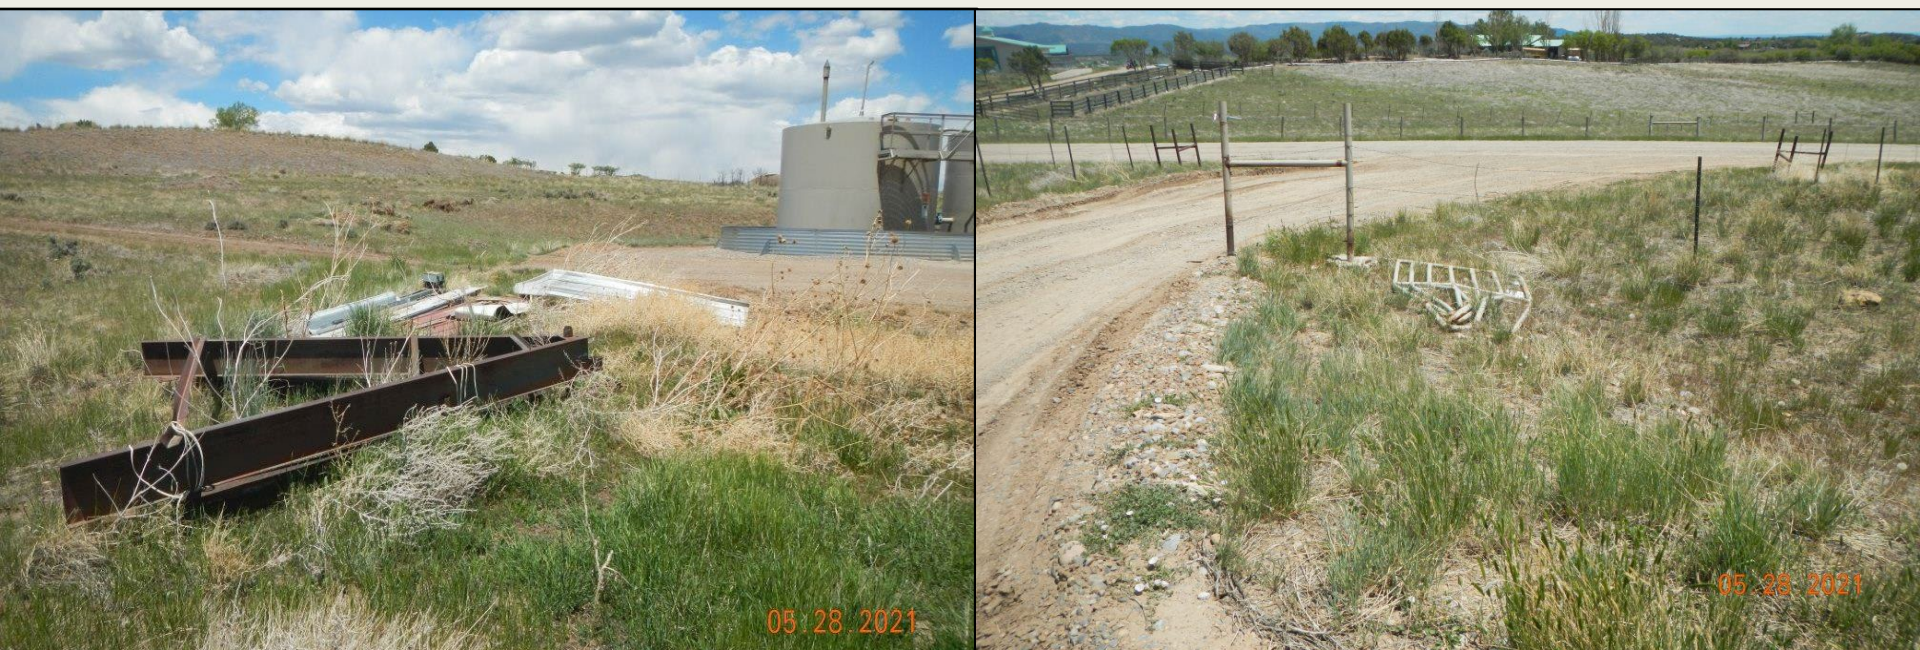
Photos 4/5. View of debris stored at the well pad entrance and along the southwestern edge of the working area.

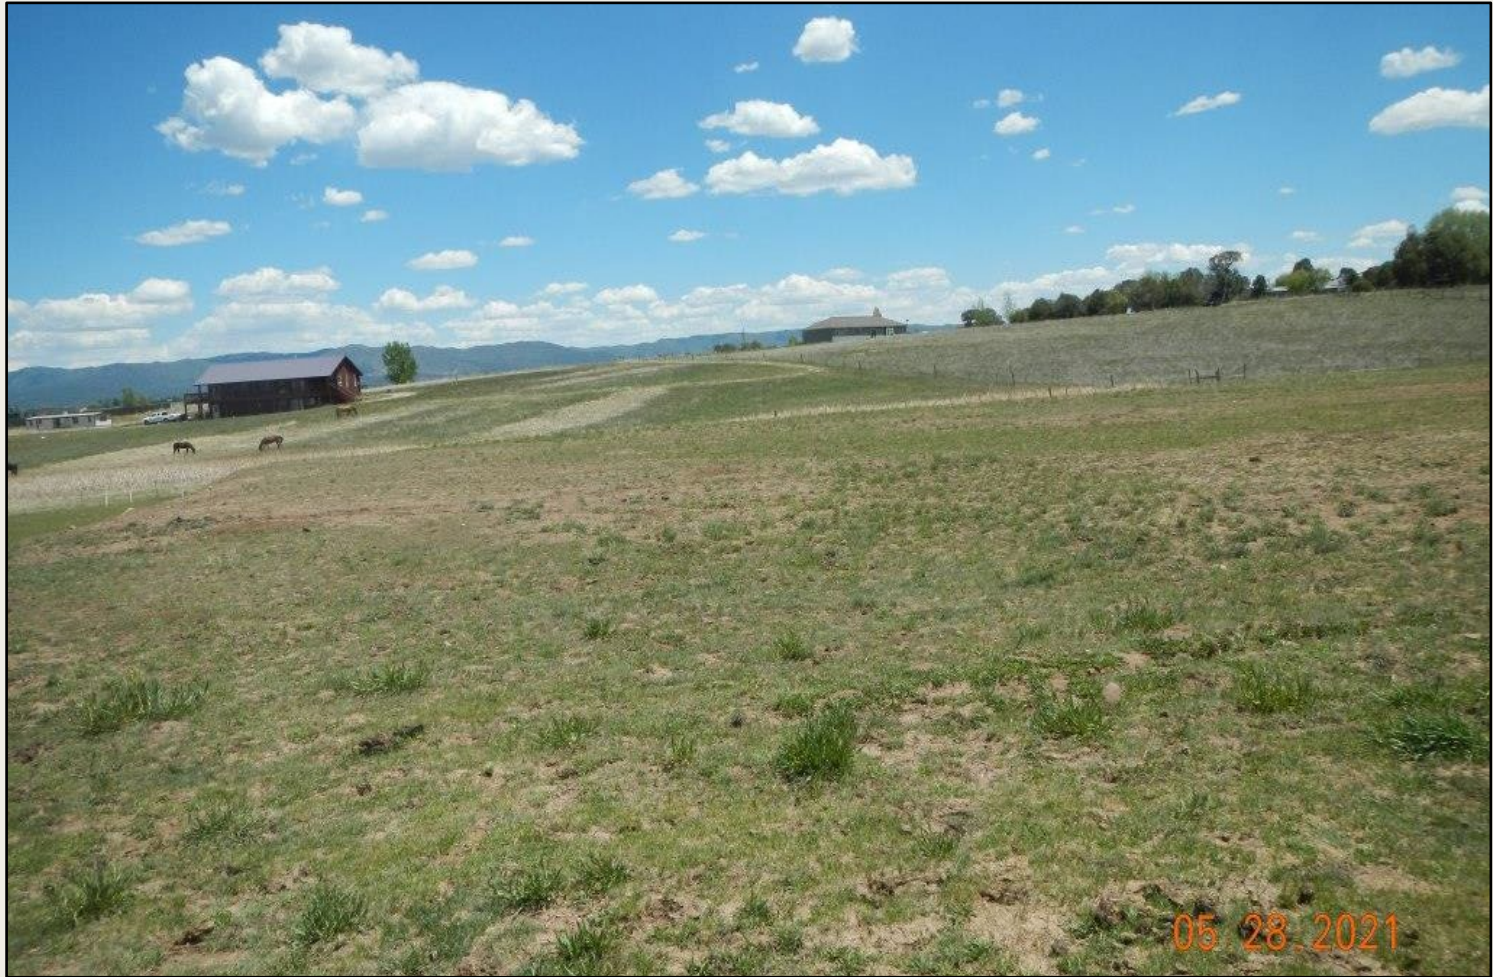
Photos 6. View of reference area comprised of open grass field with native and introduced grasses such as smooth brome and crested wheatgrass.
