Inspection Photos
H. Huett Consolidation Release
Spill ID 478005 (AC)

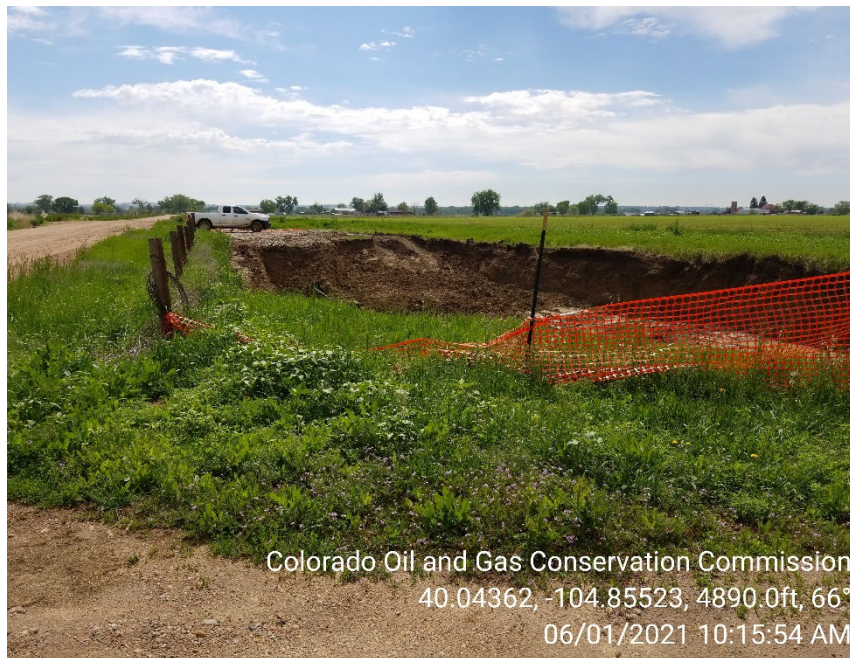
Photo 1 –Fencing down around open excavation.

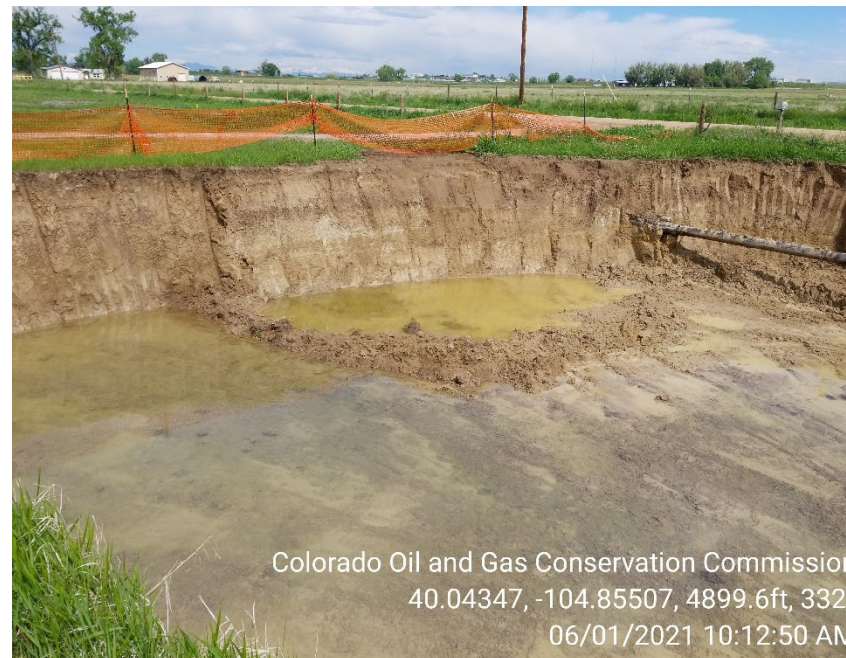
Photo 2 – Spill excavation. Groundwater with hydrocarbon sheen observed in open excavation.

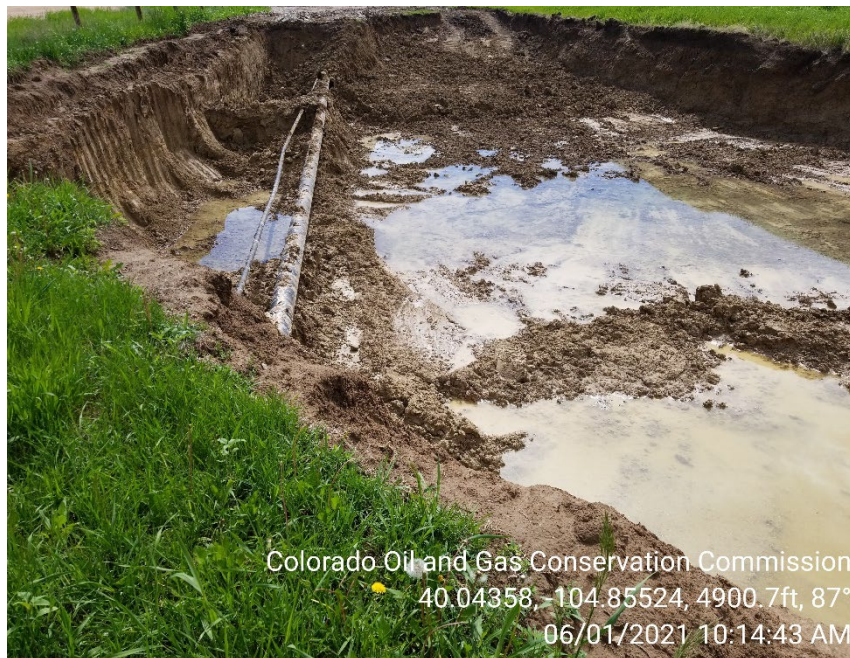
Photo 3 – Spill excavation. Hydrocarbons observed on groundwater in open excavation.

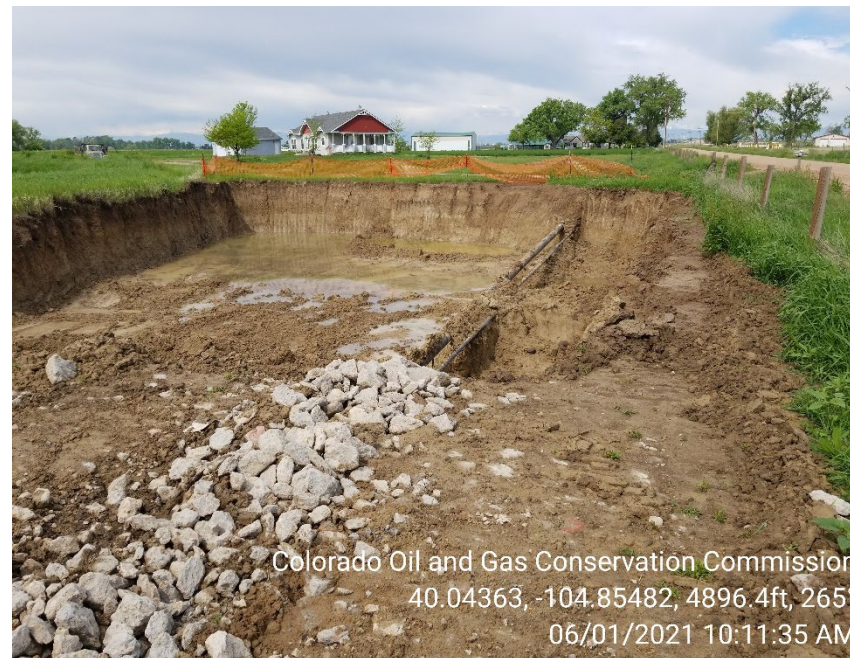
Photo 4 – Exposed flowline in open excavation.

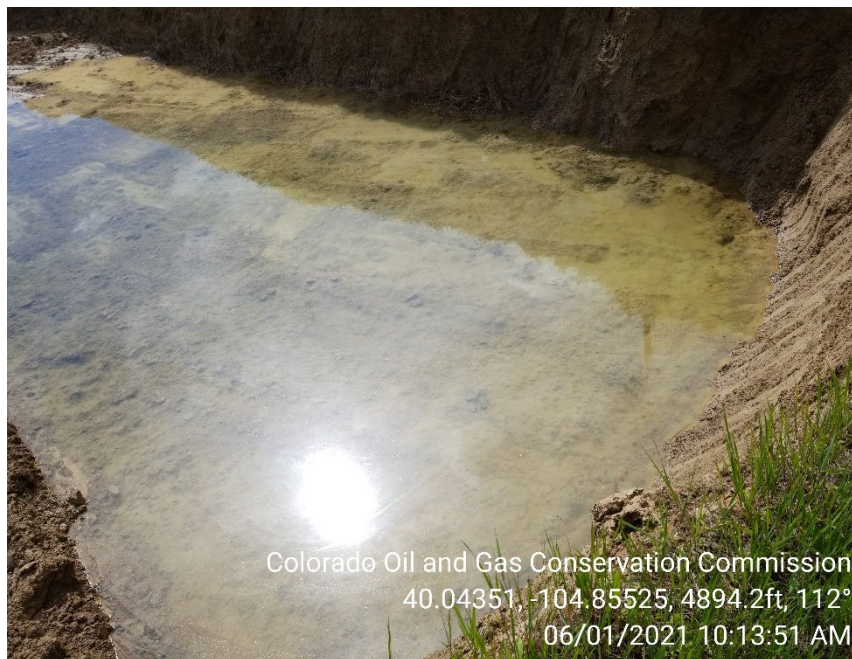
Photo 5 – Spill excavation. Hydrocarbons sheen observed on groundwater in open excavation.
