## Stormwater Inspection Report

<b>Operator:</b>	Laramie Energy, LLC
<b>Project:</b>	Cascade Creek
<b>Location:</b>	CC 610-22-43 Pad
<b>Date:</b>	Thursday, June 3, 2021
<b>Weather:</b>	Clear, Light Wind, 92°, Lo 54°

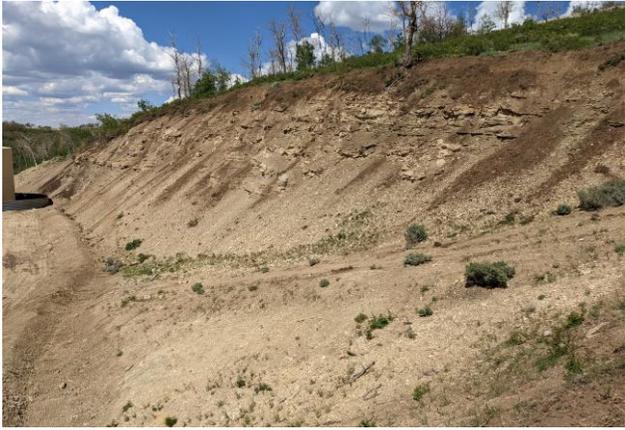
**Photo 1**

*Containment Berm Installed below CC 610-22-43 Cut Slope*

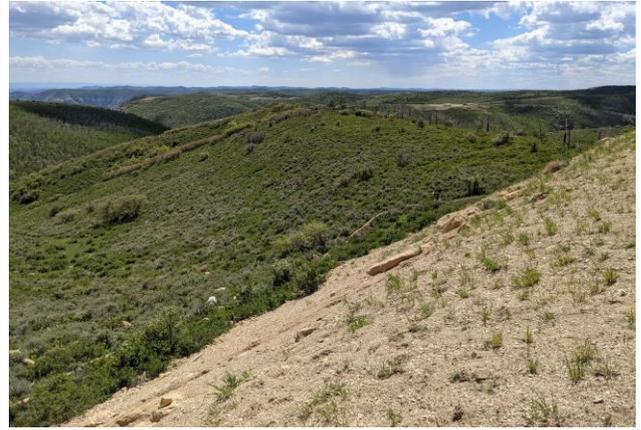
**Photo 2**

*Wattle Installed below CC 610-22-43 Fill Slope*

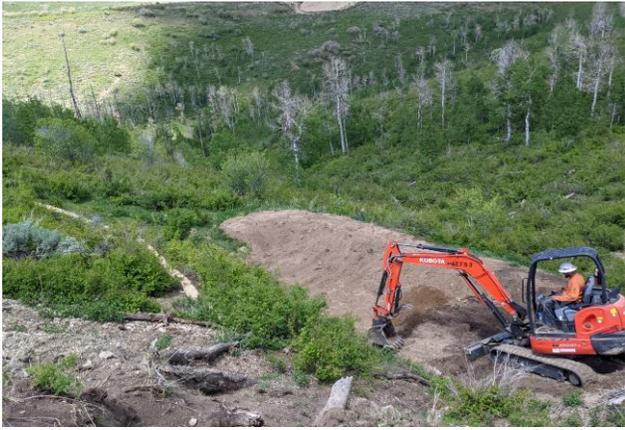
**Photo 3**

*Maintaining Sediment Trap near the Pad Entrance*

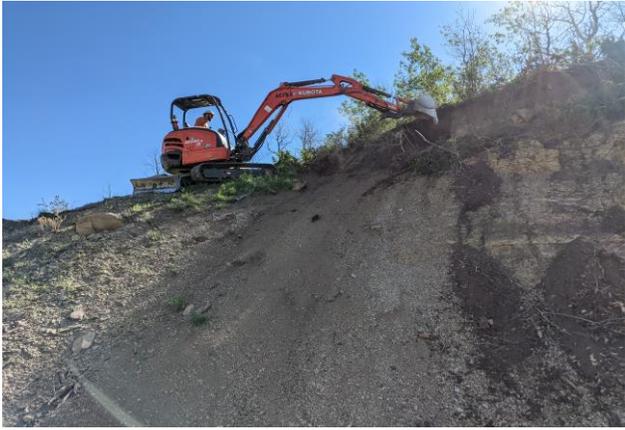
**Photo 1**

*Shaping Vertical Cut above Cut Slope*

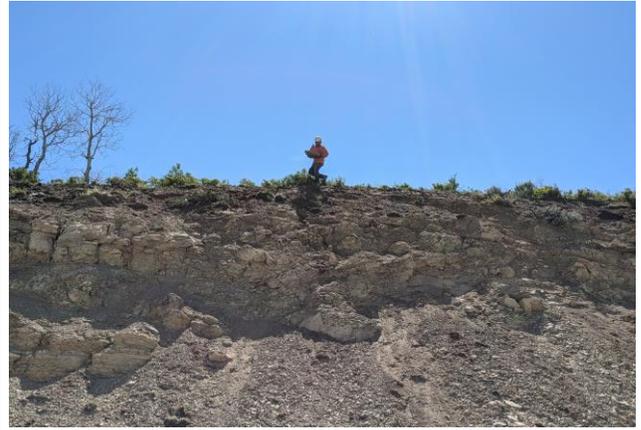
**Photo 2**

*Broadcast Seeding Cut Slope on CC 610-22-43*

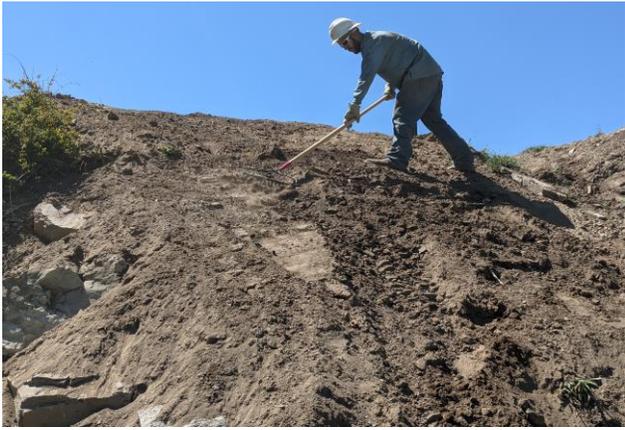
**Photo 3**

*Hand Raking Seed to Incorporate into Soil*

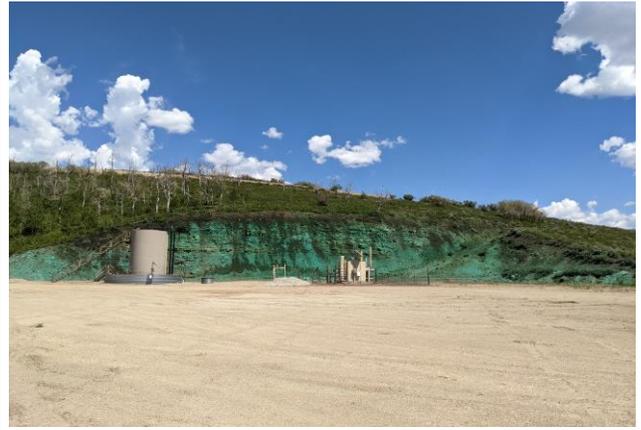
**Photo 4**

*Location after Treating Cut Slope with Liquid Amenities and Nutrients*
