Well Name : LTJ Partnership (OWP) 13-28

API # : 123-11243

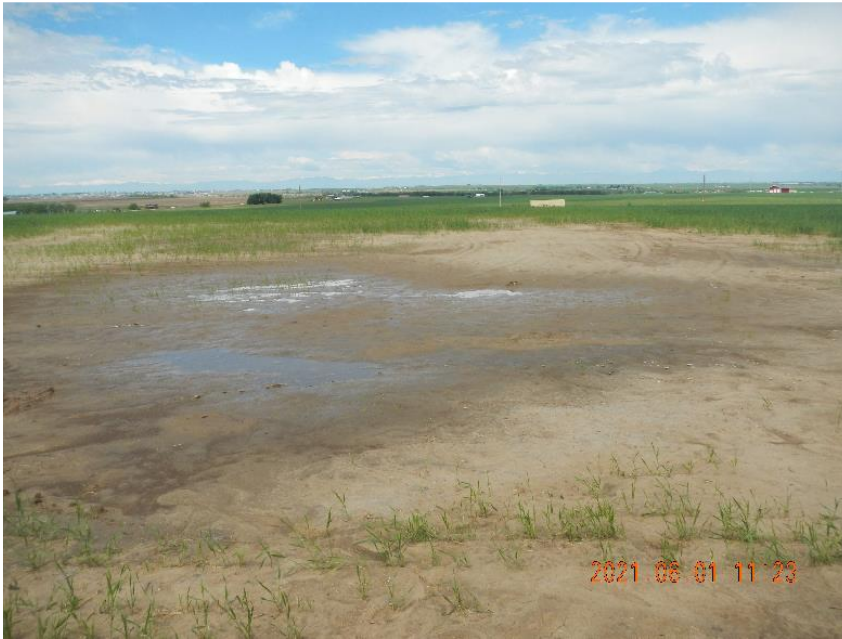
Photo 1: Storm water pooling at the top of the rise where P&A well site is located.

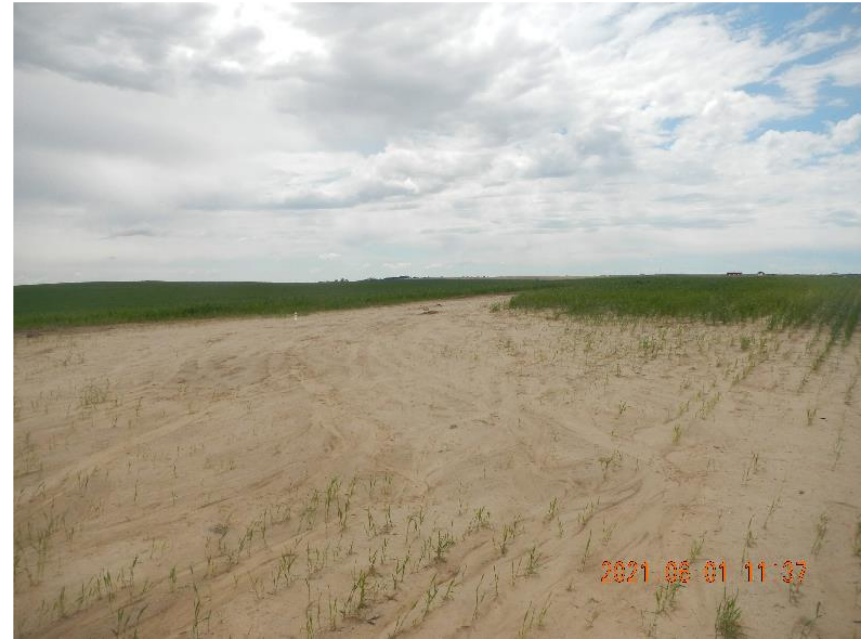
Photo 2: Access road entry point onto well site.

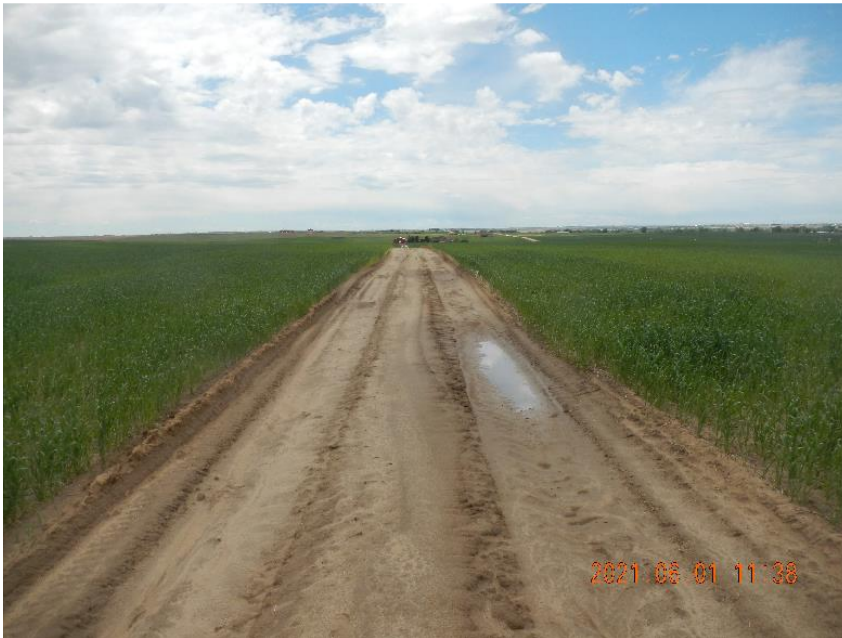
Photo 3: View from entry point looking downslope towards CR.

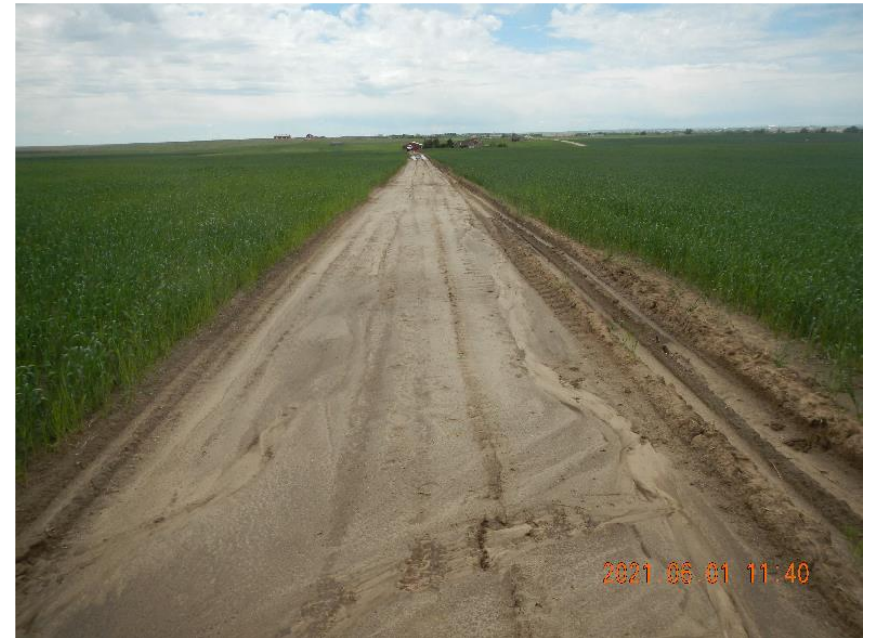
Photo 4: Additional view looking down slope towards CR showing water flow on access road.

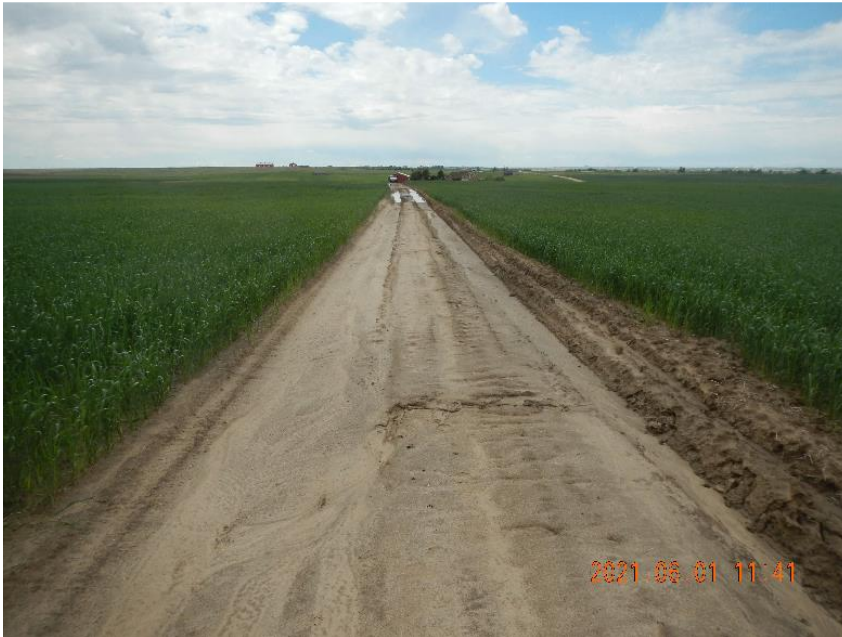
Photo 5: Additional view looking down slope towards CR showing water flow on access road. Standing water visible.

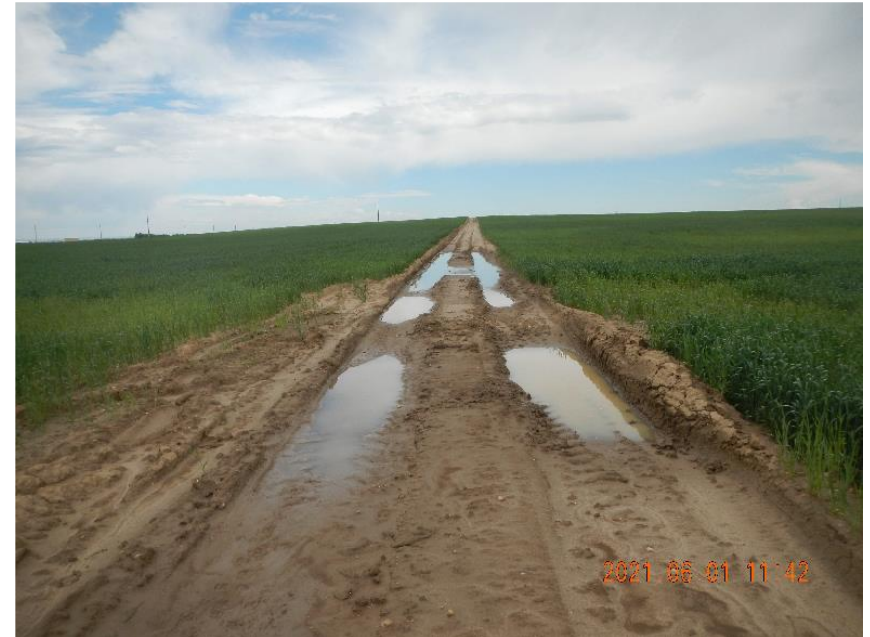
Photo 6: Looking upslope towards well site.

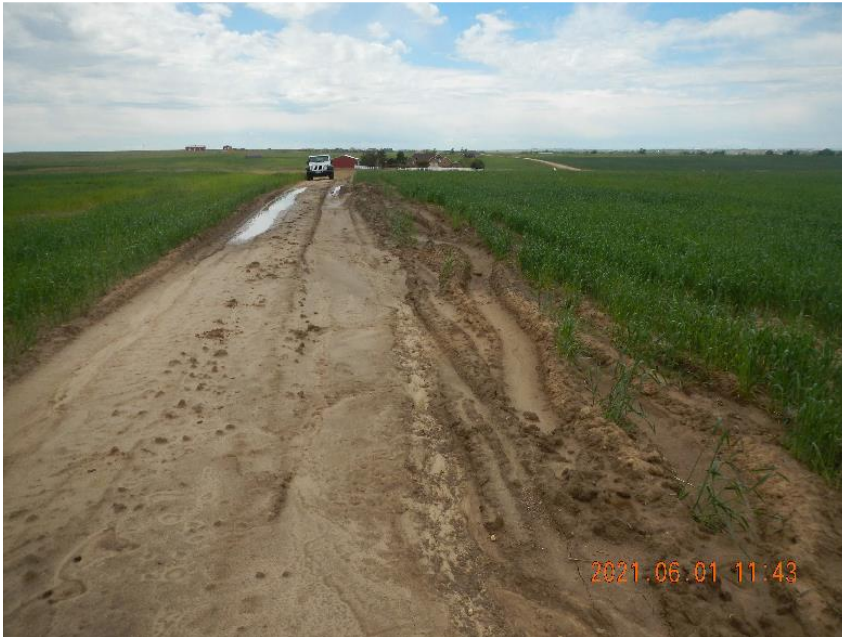
Photo 7: Same position looking down slope towards CR.

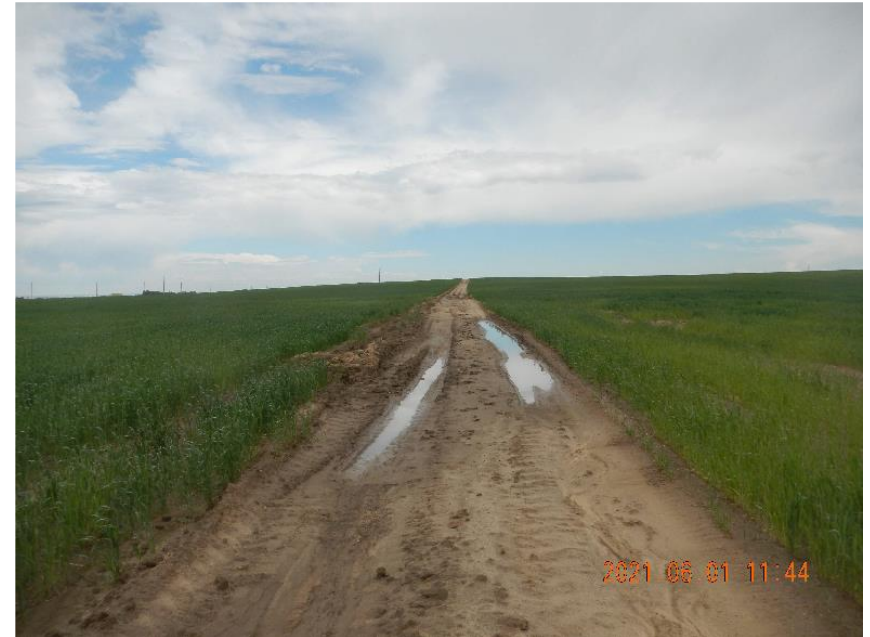
Photo 8: Additional view looking upslope past previous photo of water standing in ruts.

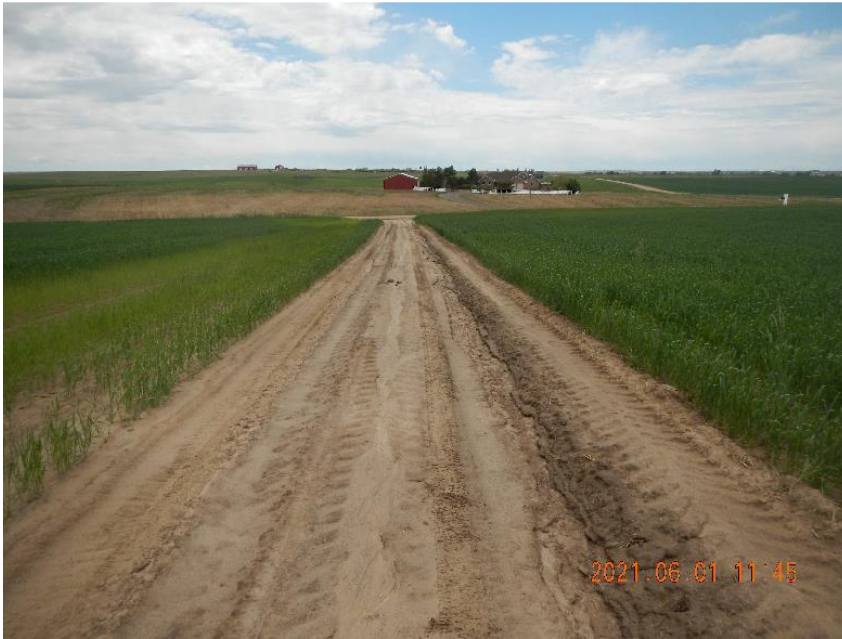
Photo 9: View with CR visible at end of access road.

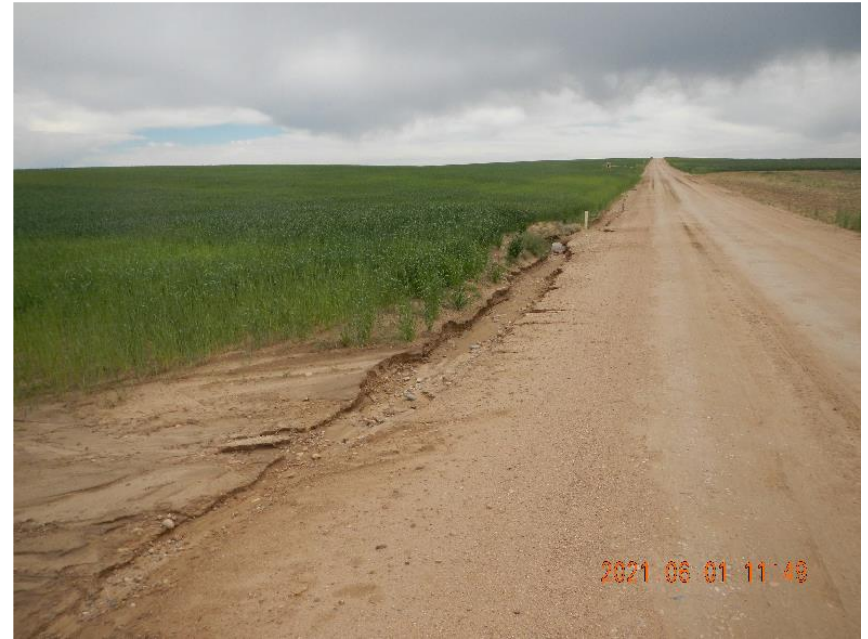
Photo 10: View looking upslope at edge of CR.

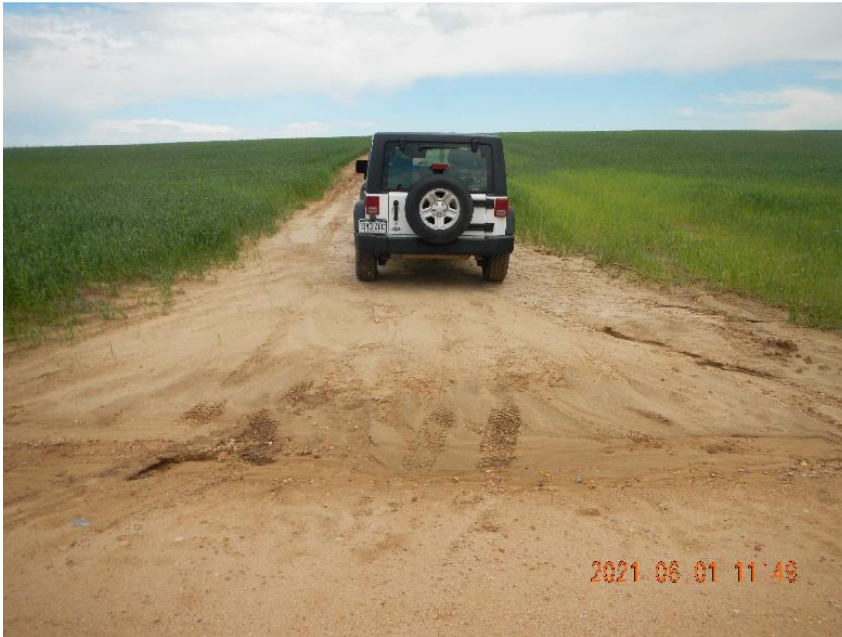
Photo 11: View at CR and access road intersection.

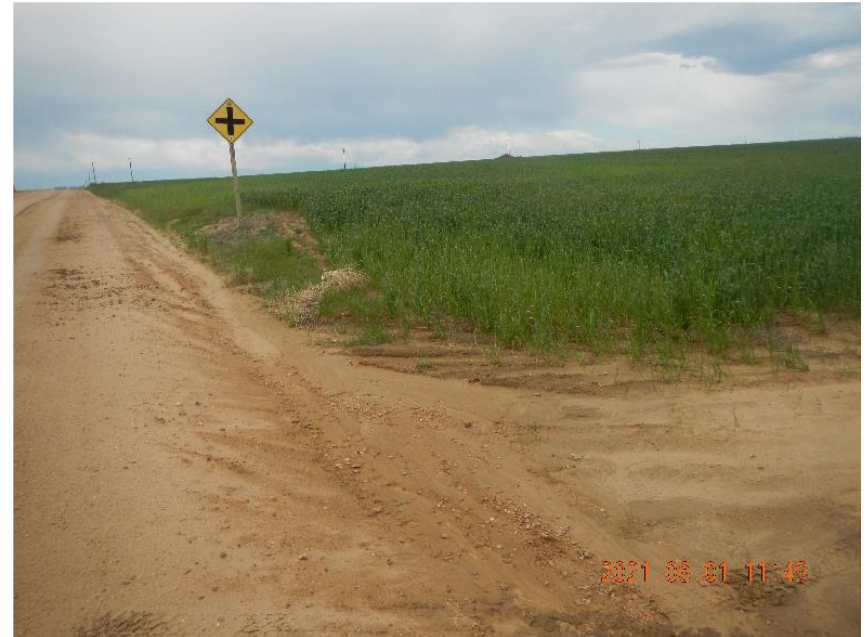
Photo 12: View looking upslope at CR and access road intersection.

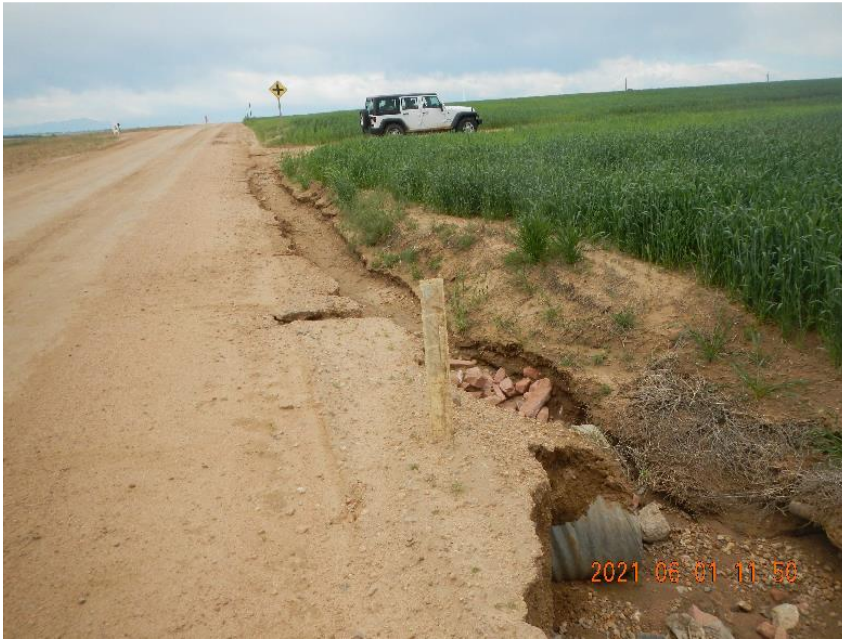
Photo 13: View below culvert looking upslope at bar ditch erosion.

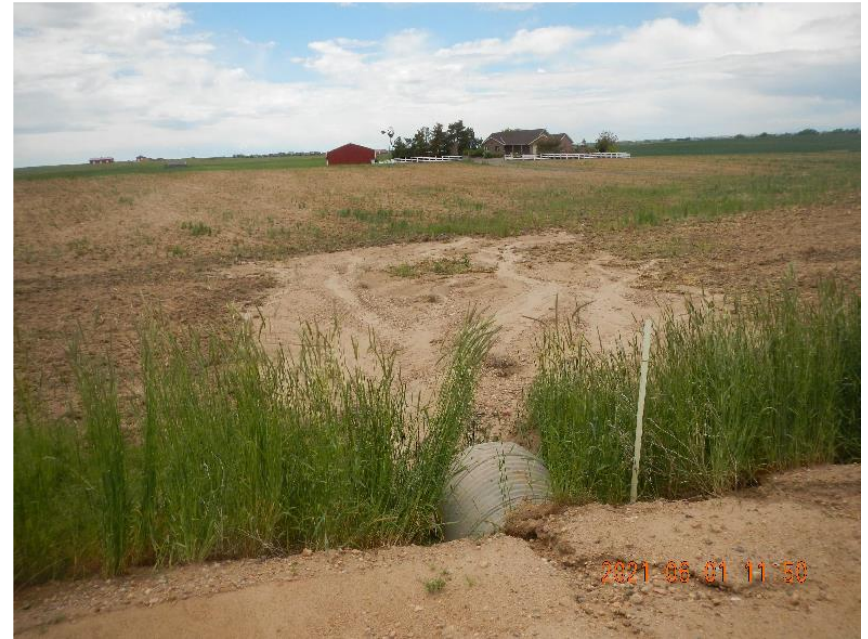
Photo 14: View of sediment plumb out of culvert into adjacent field.
