Inspection Photos

API: 073-06129

Operator: CITATION OIL & GAS CORP

Inspection Date: 6/2/2021

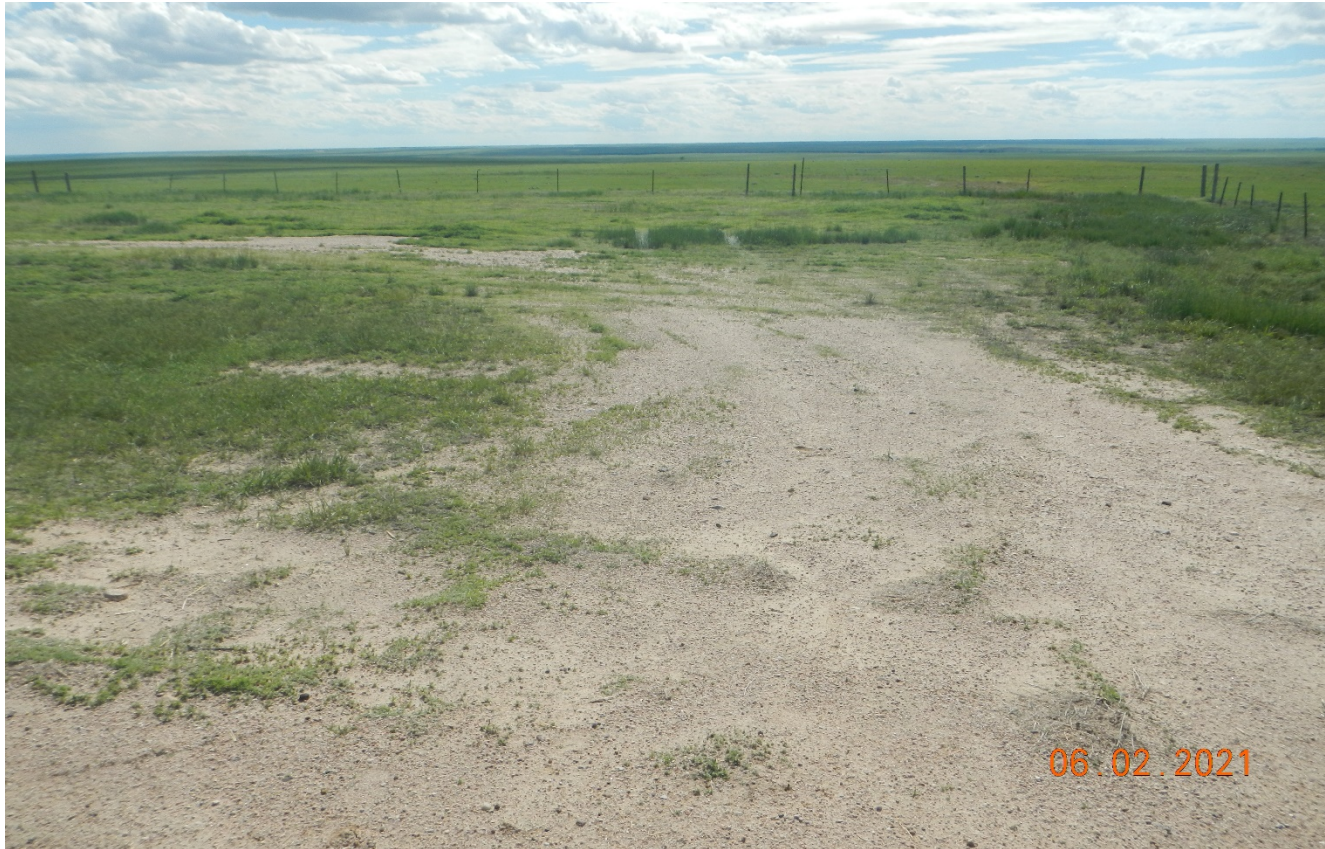
Photo 1. Facing southwest toward the access road from the County Road has not been reclaimed. There is two access points into the abandoned facility.

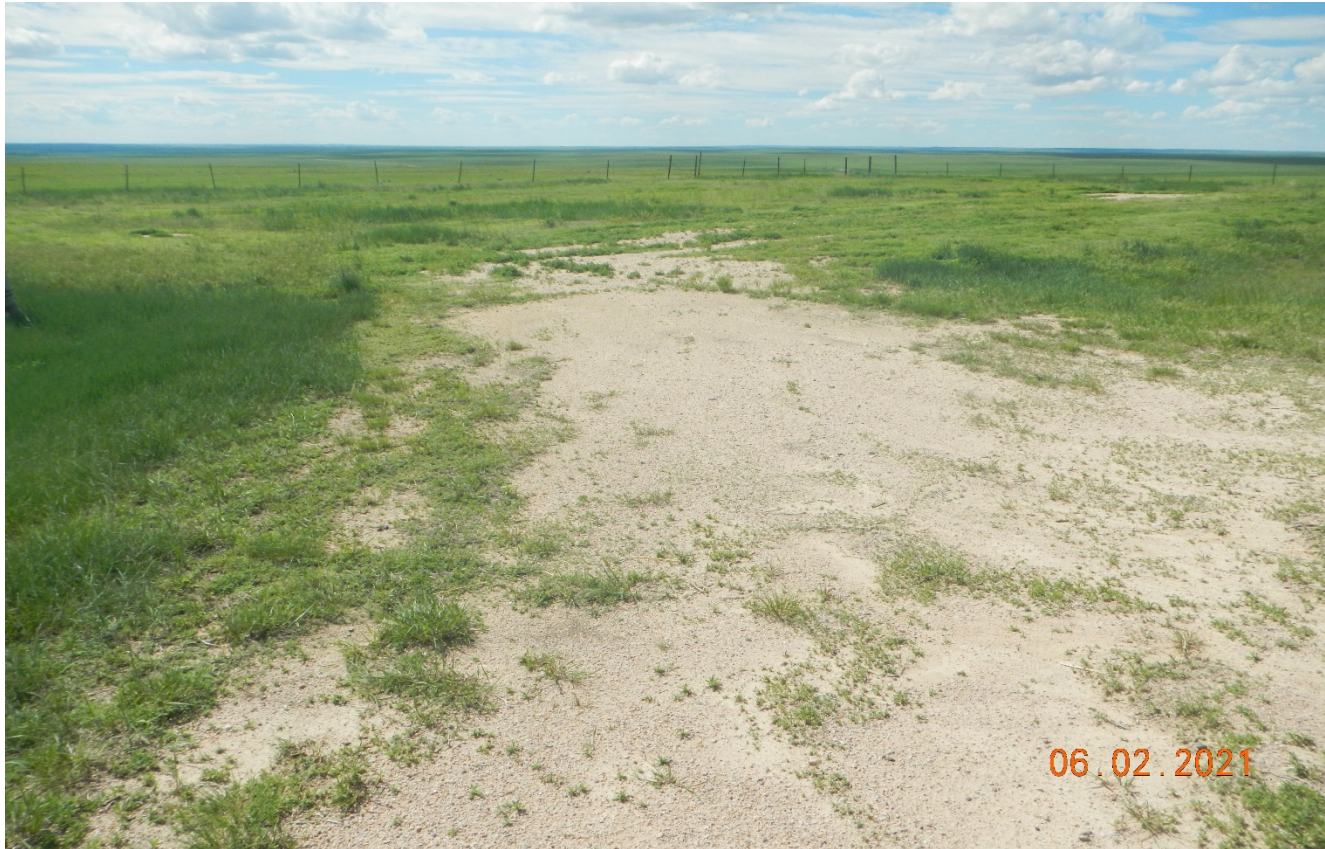
Photo 2. Facing northwest toward the access road from the County Road has not been reclaimed. There is two access points into the abandoned facility.

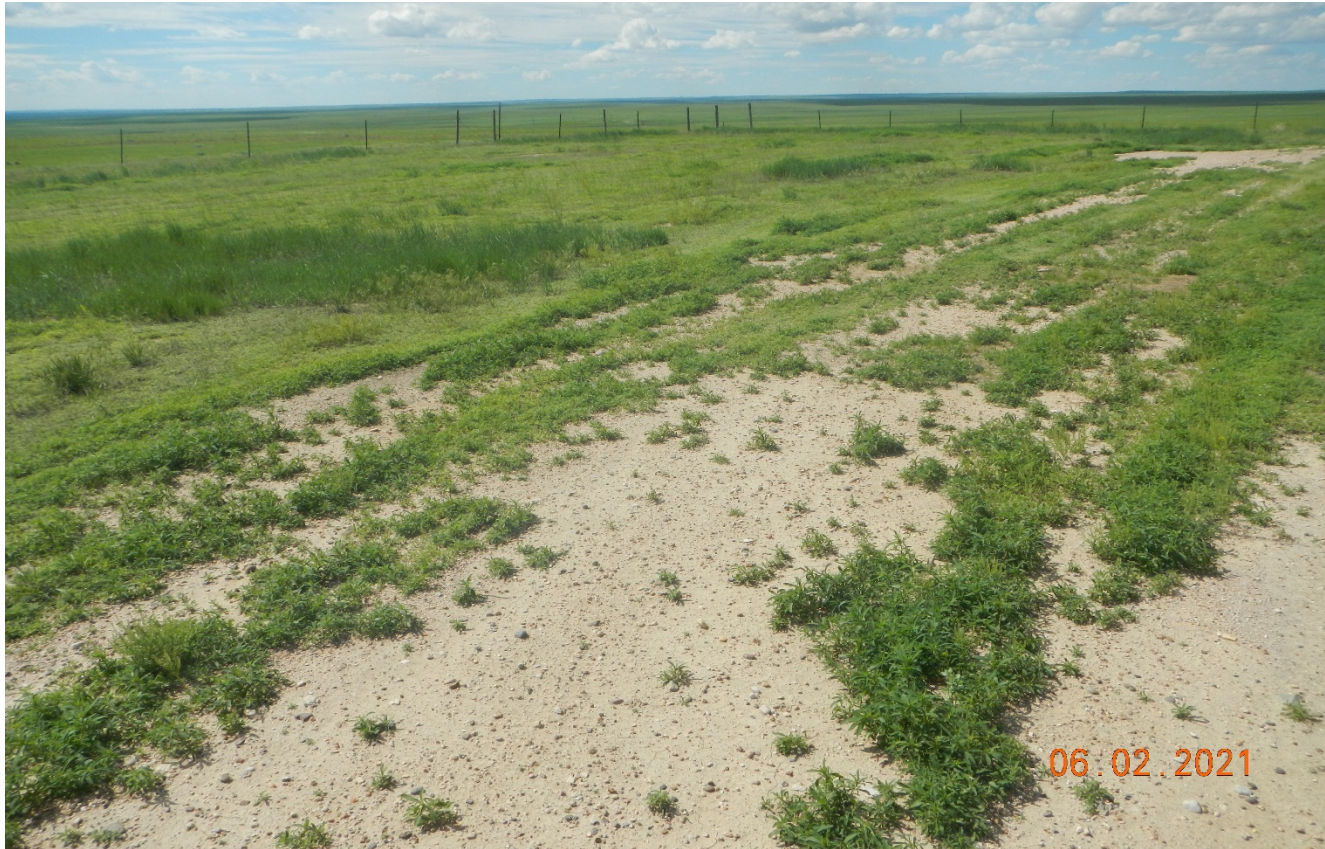
Photo 3. Facing northwest at the abandoned tank battery facility. The facility area consists predominately of undesirable weeds which has to be controlled. The facility has not re-established a desirable vegetation cover.

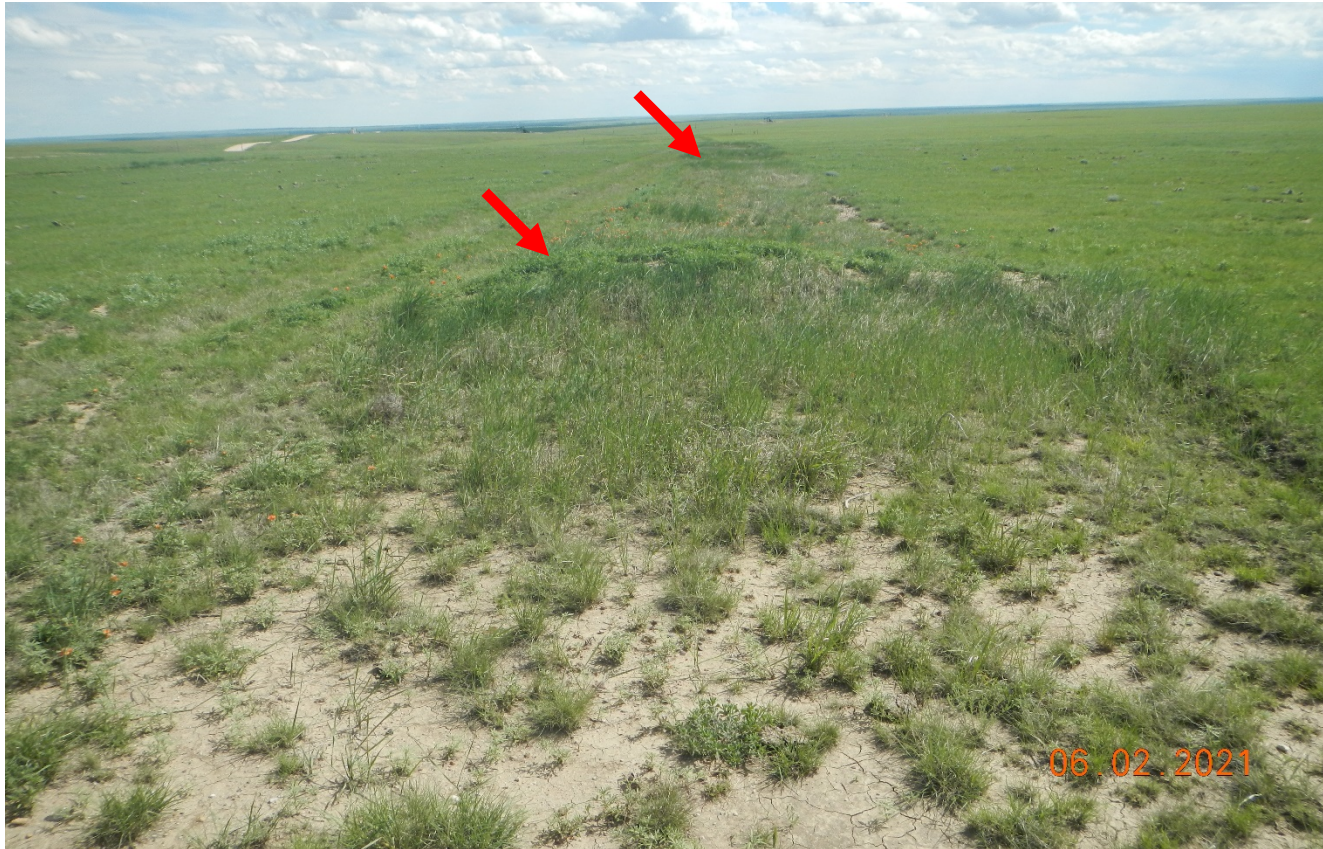
Photo 4. Facing south along the former access road. There are multiple berms along the former road that need to be leveled and reclaimed.

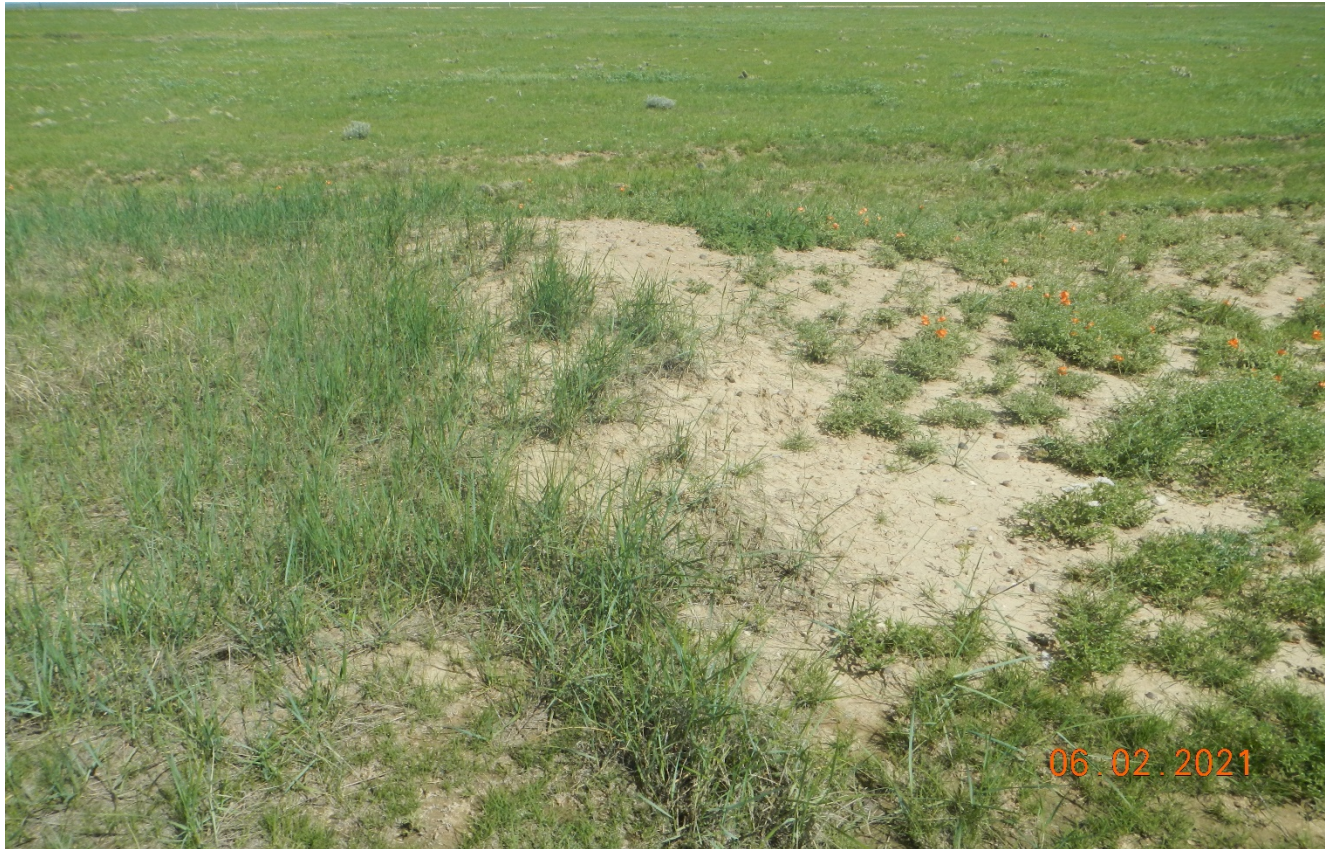
Photo 5. There are multiple berms along the former road that need to be leveled and reclaimed.

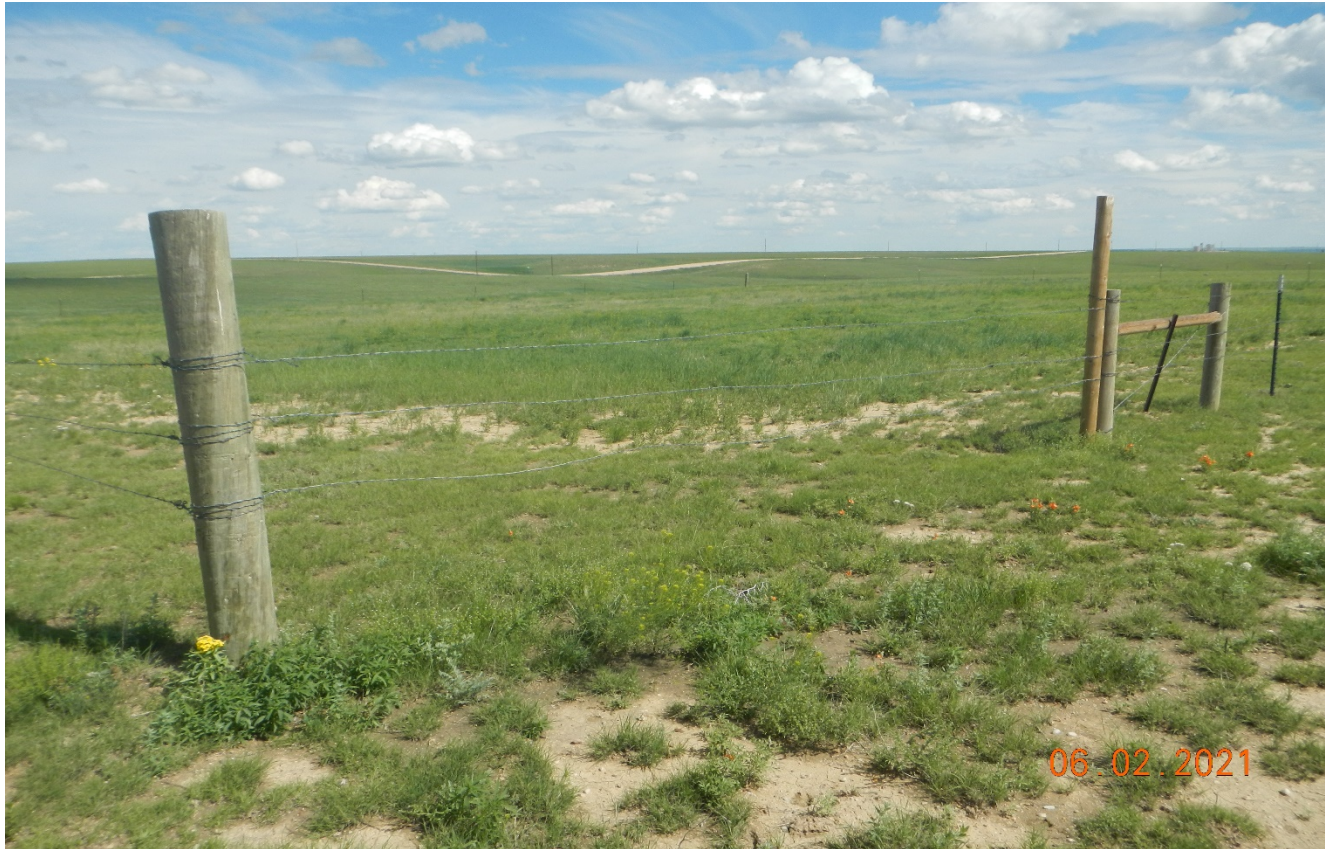
Photo 6. Facing southeast at the location. The perimeter of the location is fenced and maintenance is needed on the fence.

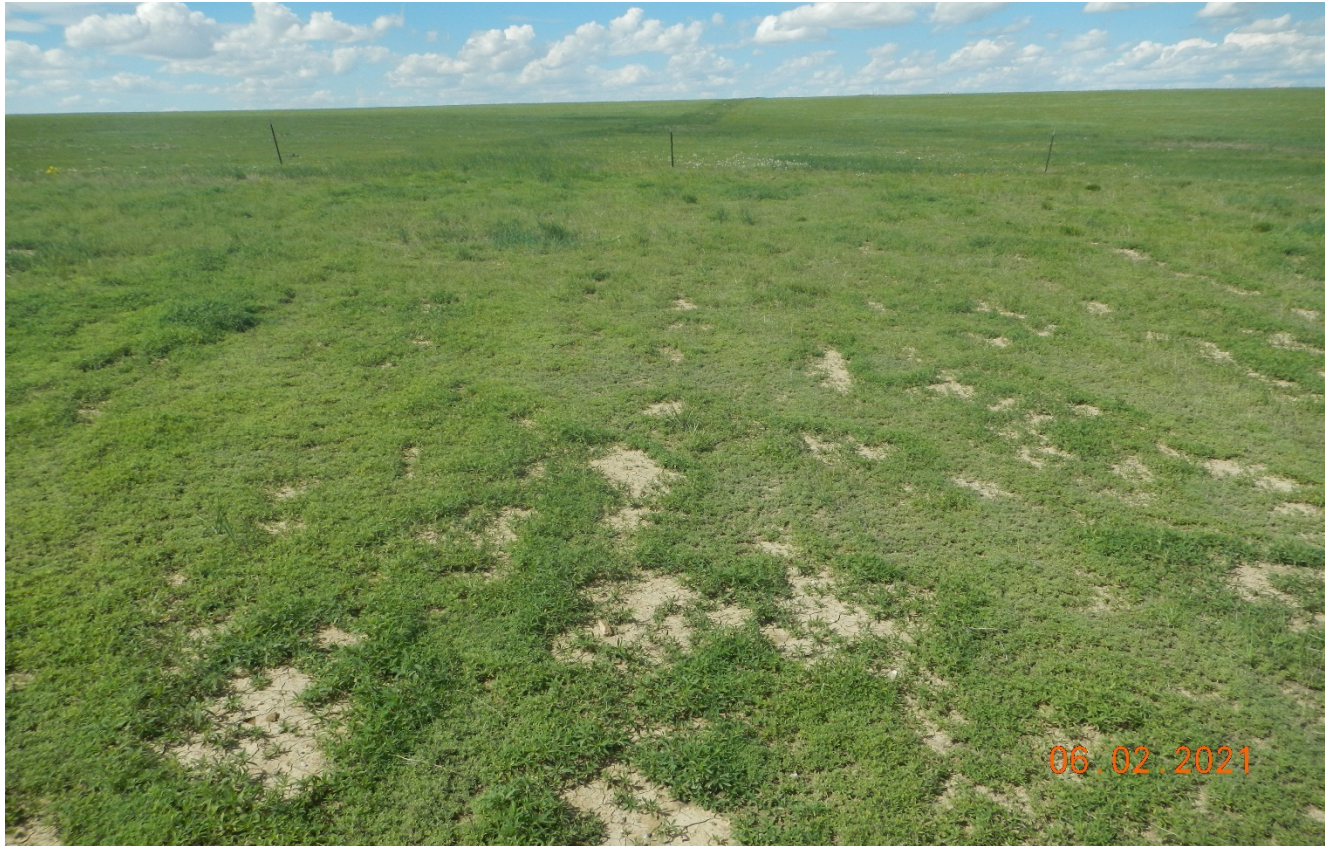
Photo 7. Facing north at the center of the location. The location consists predominately of undesirable weeds which must be controlled. The location has not re-established a desirable vegetation cover.

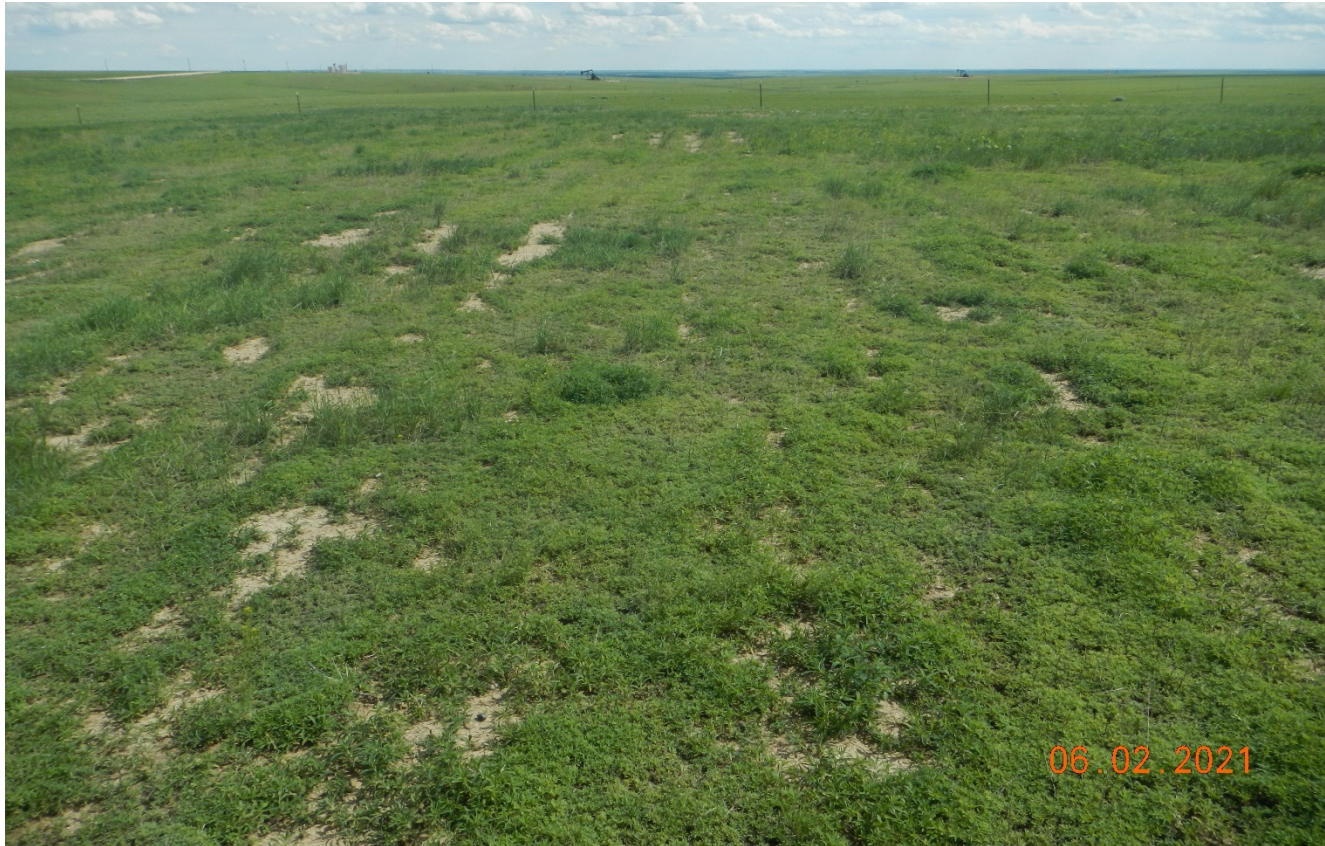
Photo 8. Facing south at the center of the location. The location consists predominately of undesirable weeds which must be controlled. The location has not re-established a desirable vegetation cover.

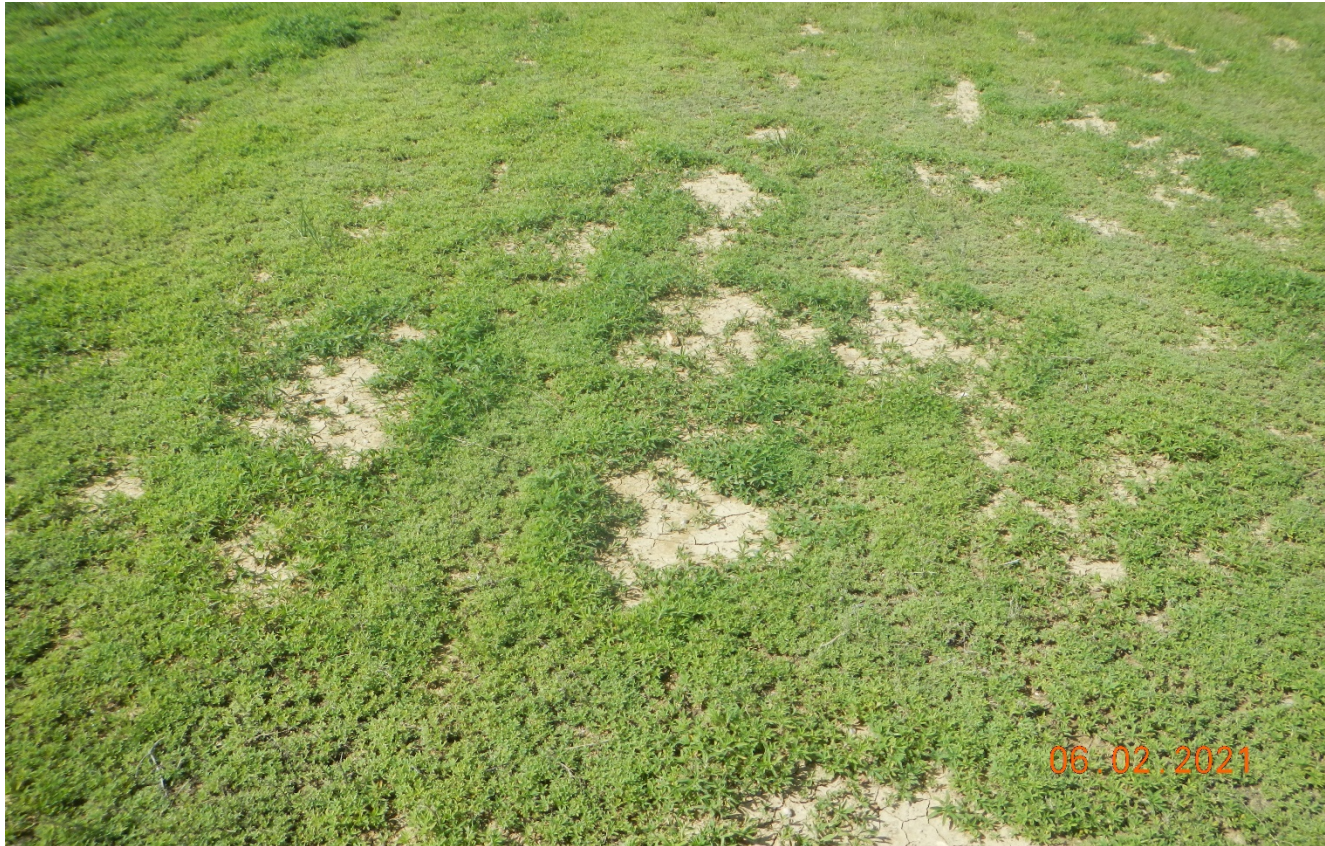
Photo 9. View of ground cover shows undesirable weeds (Kochia sp.) which was observed throughout the location.

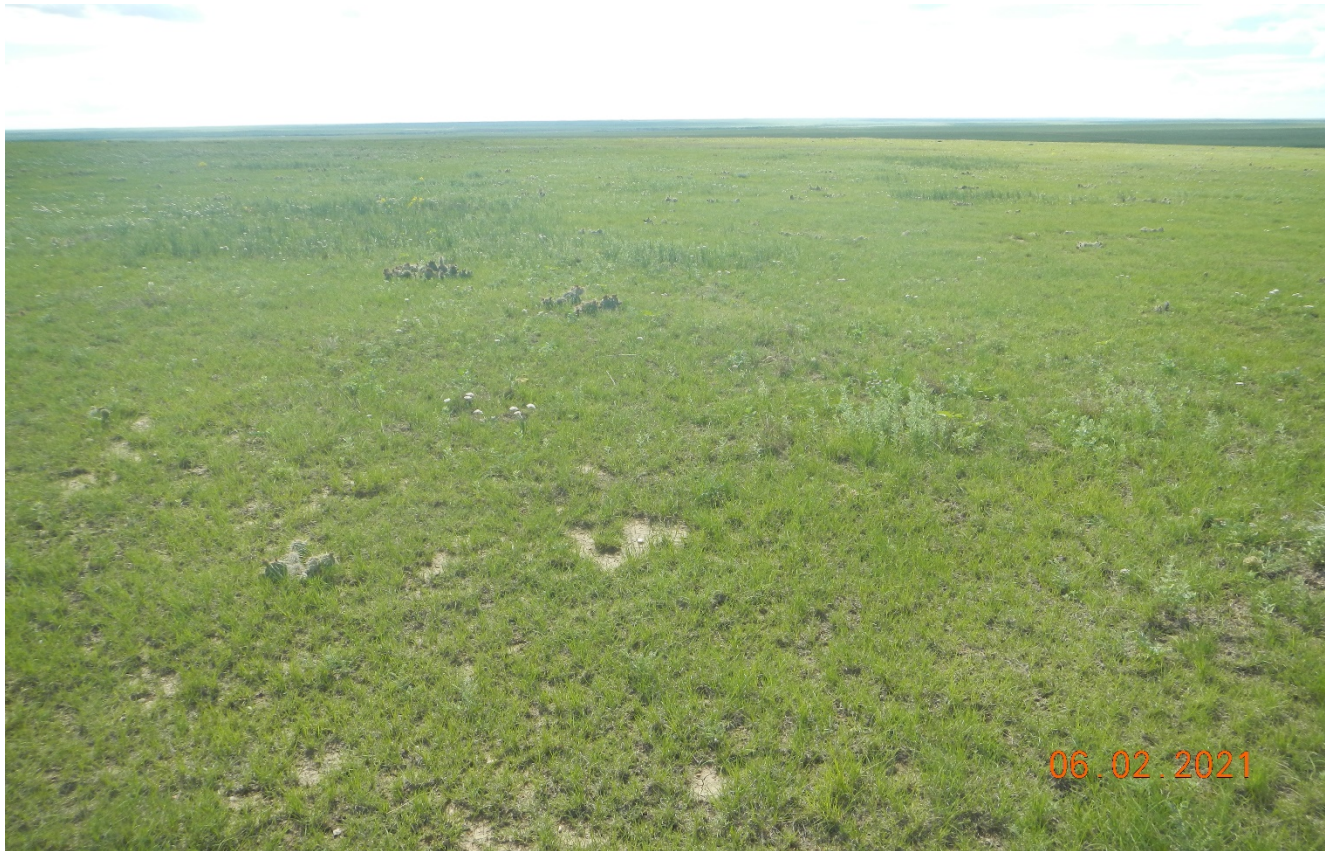
Photo 10. Facing west toward the undisturbed surrounding rangeland which consists of Blue grama, Sand dropseed among other native vegetation.
