Inspection Photos

API: 073-06209

Operator: CITATION OIL & GAS CORP

Inspection Date: 6/2/2021

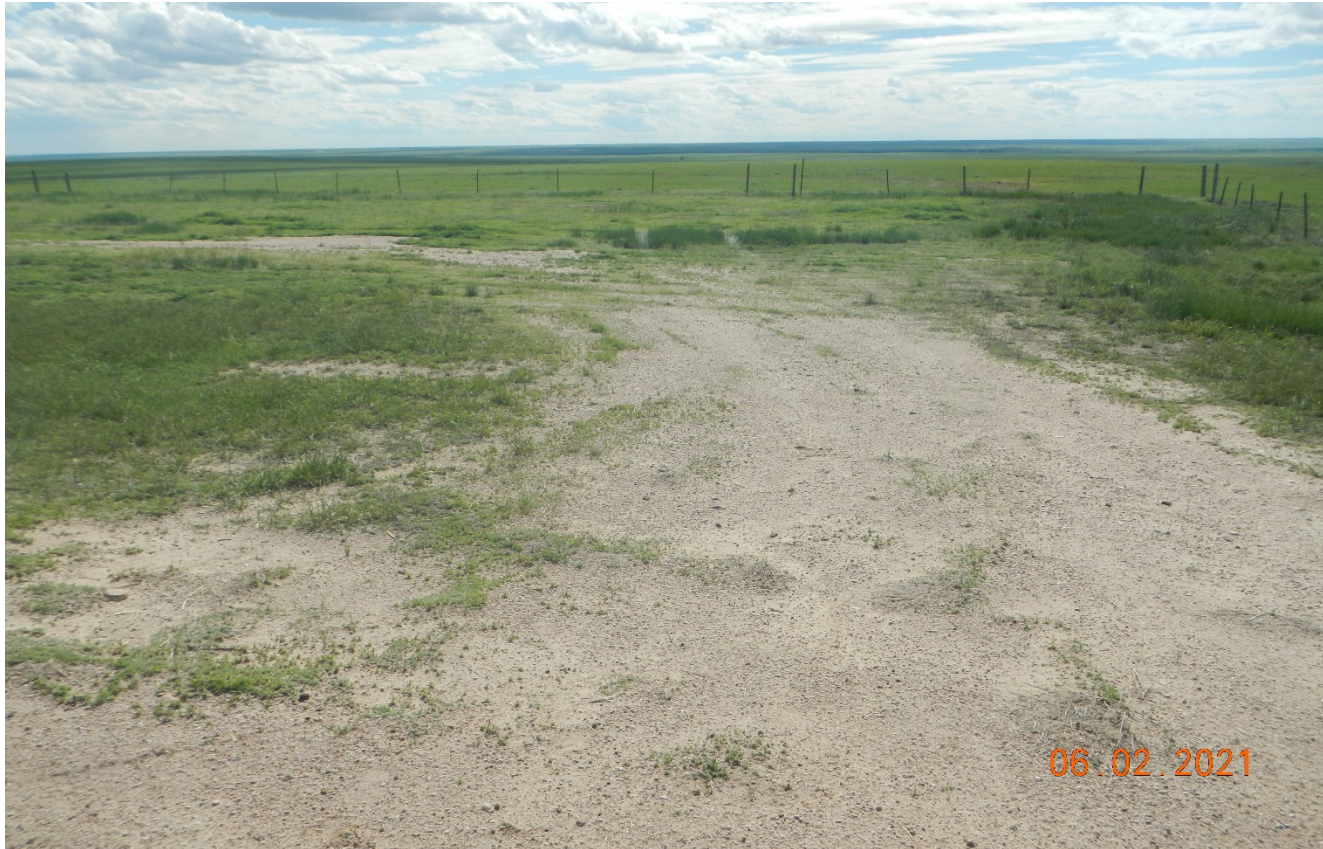
Photo 1. Facing southwest toward the access road from the County Road has not been reclaimed. There is two access points into the abandoned facility.

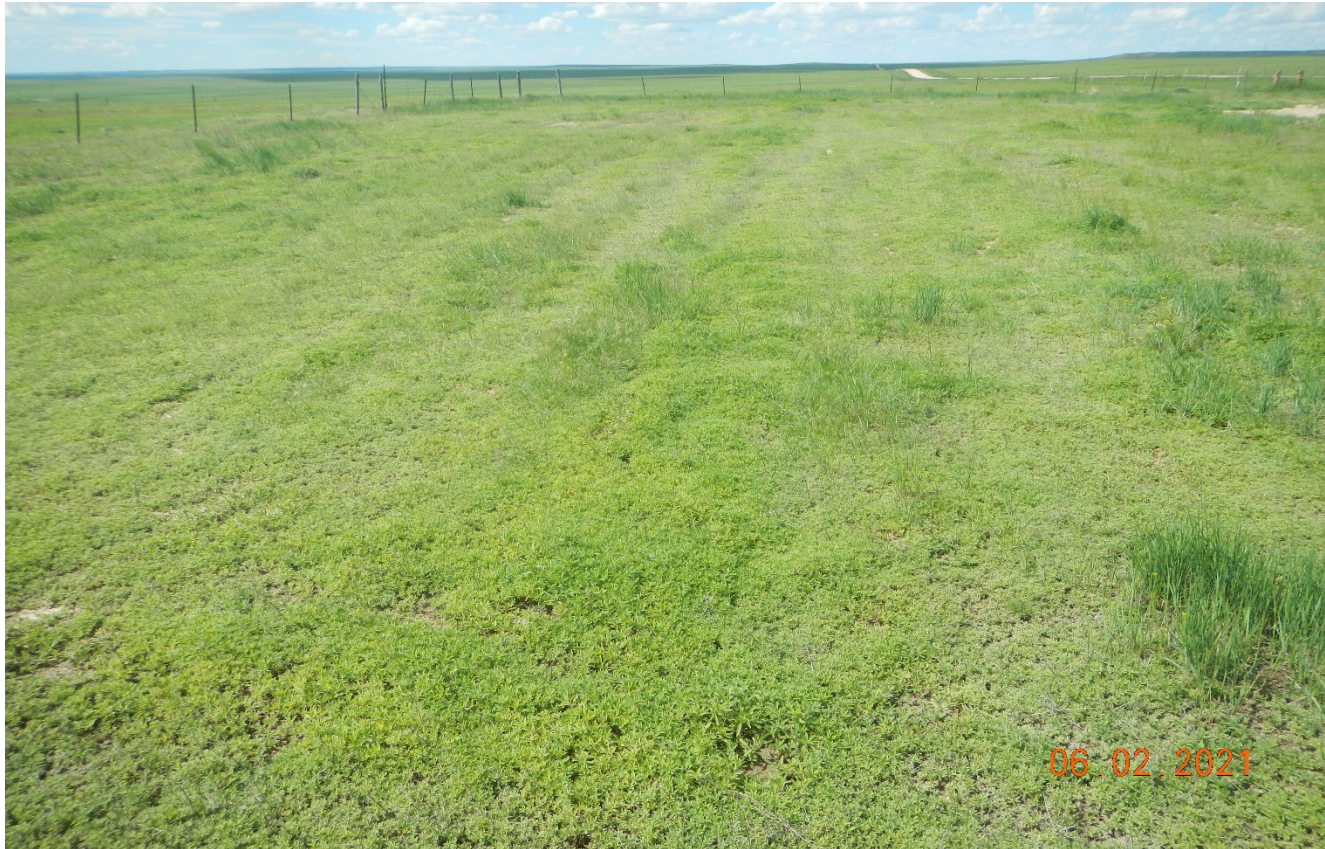
Photo 4. Facing north at the abandoned tank battery facility. The facility area consists predominately of undesirable weeds which has to be controlled. The facility has not re-established a desirable vegetation cover.

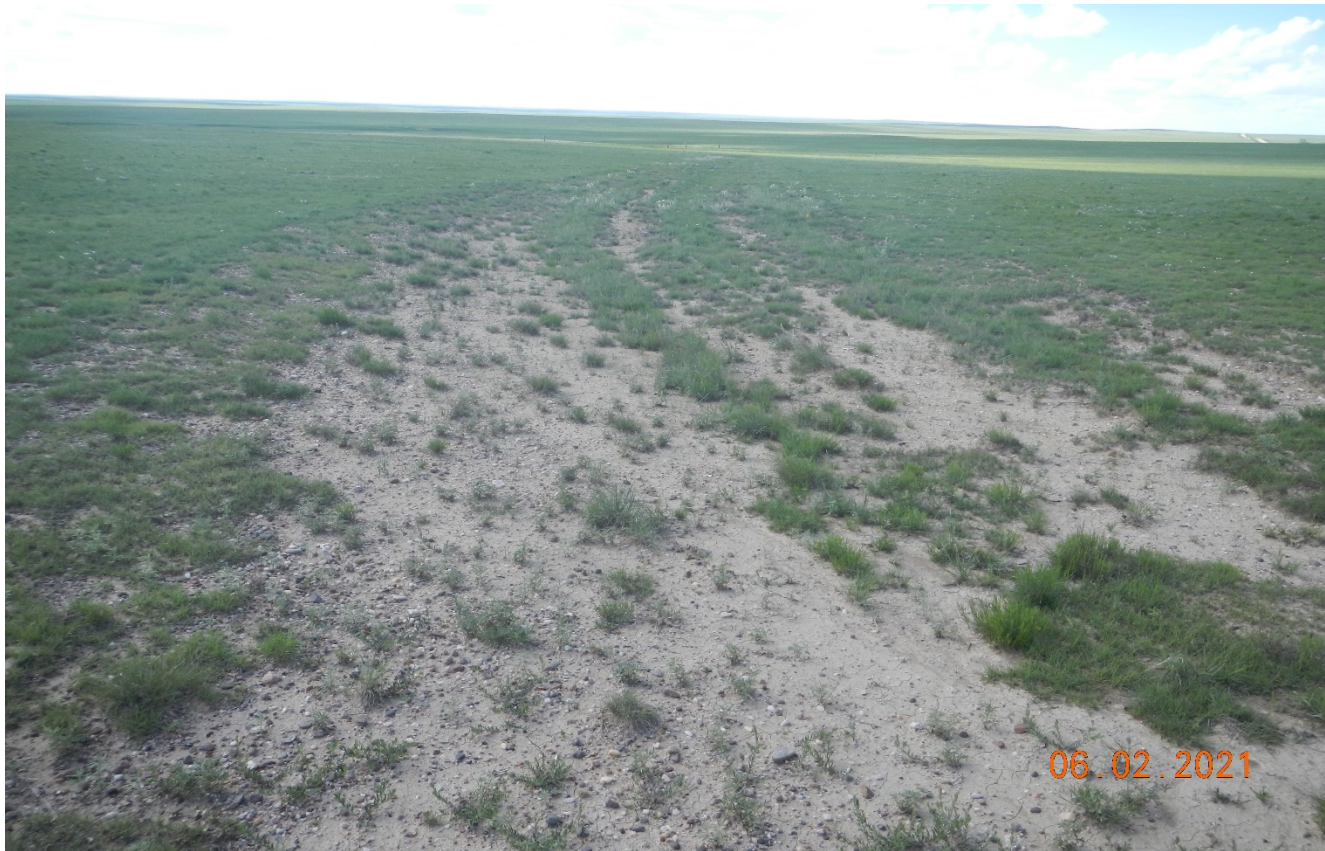
Photo 5. Facing northwest along the former access road. The majority of the road has re-established vegetation. The area where the road turns has bare areas that will needed addition reclamation.

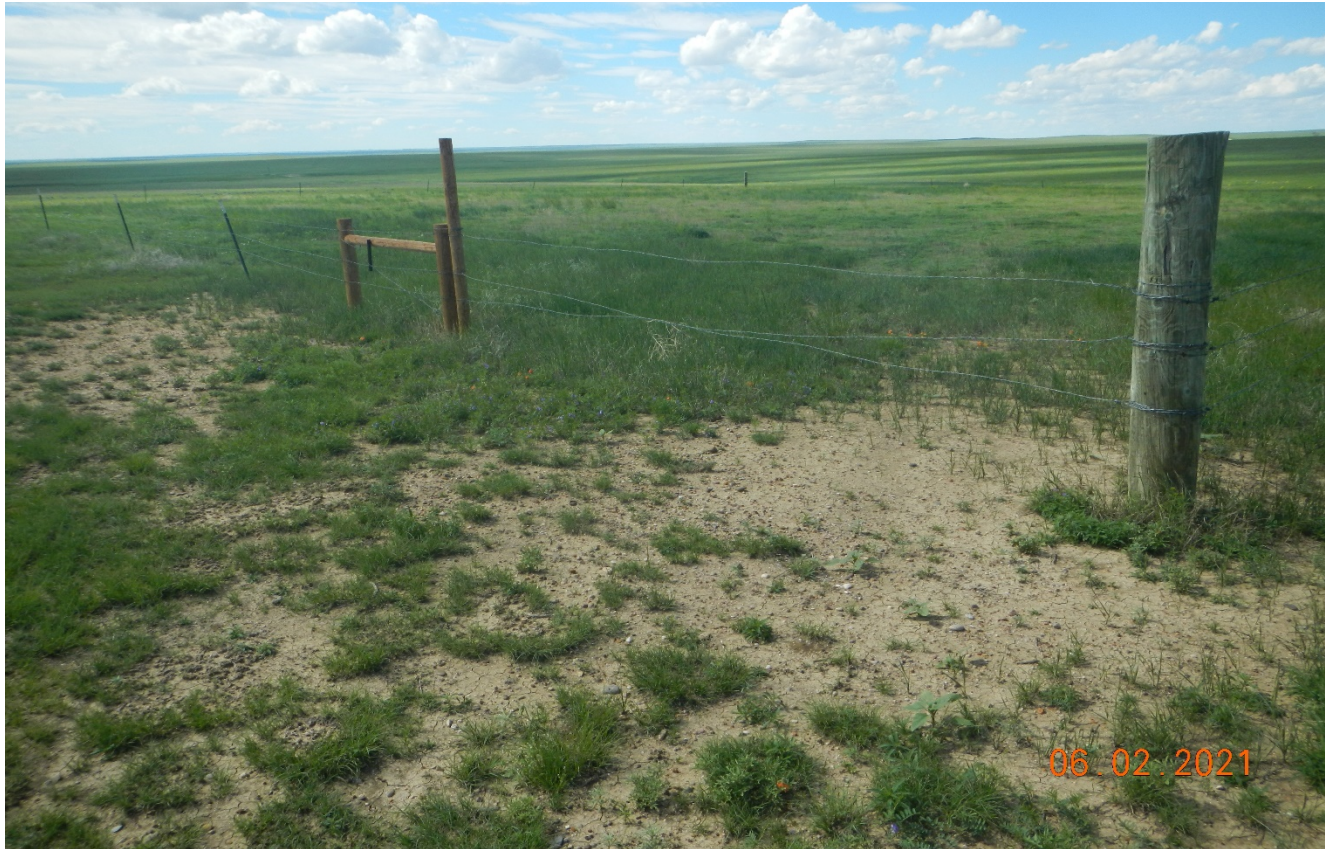
Photo 6. Facing northwest at the location. The perimeter of the location is fenced and maintenance is needed on the fence.

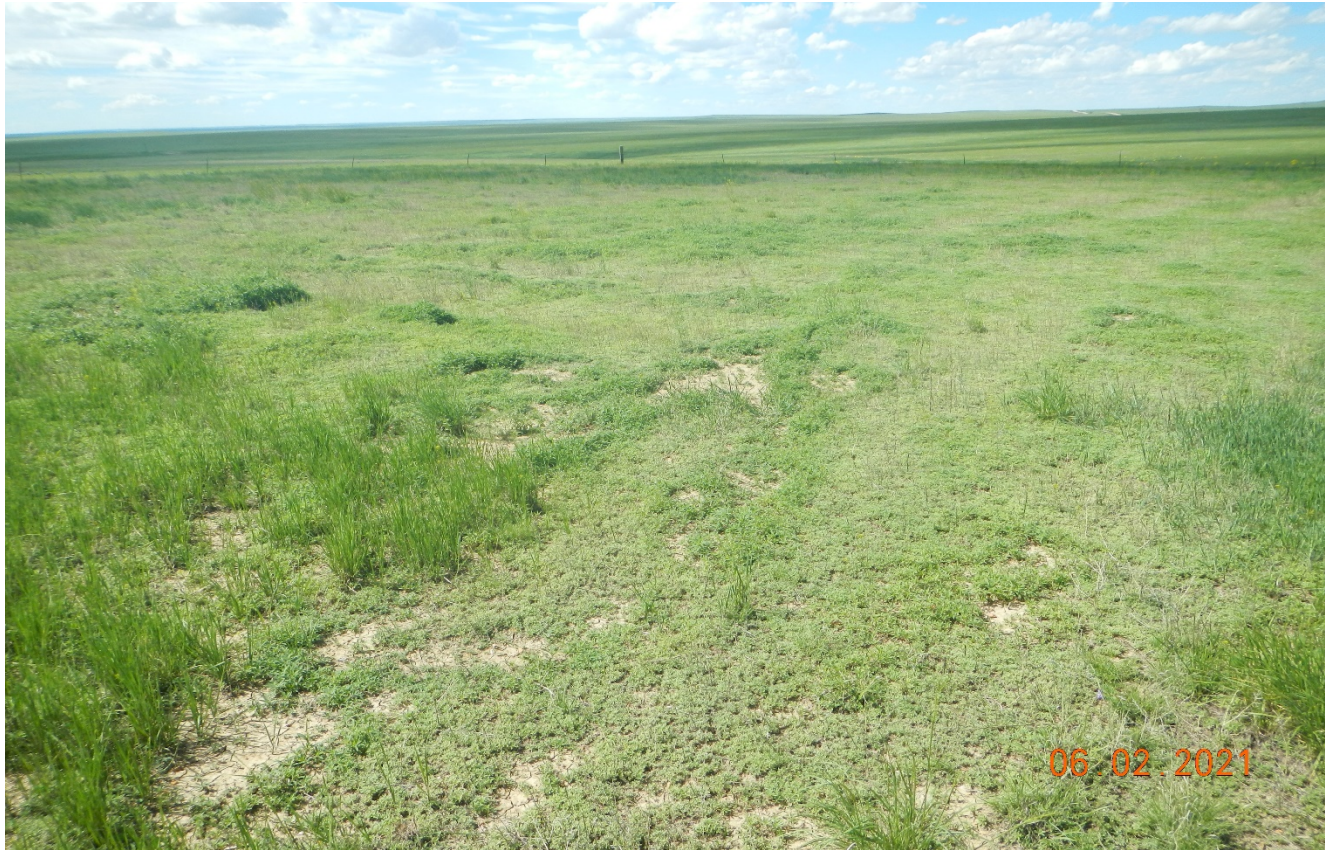
Photo 7. Facing northwest at the location. The location consists predominately of undesirable weeds which has to be controlled. The location has not re-established a desirable vegetation cover.

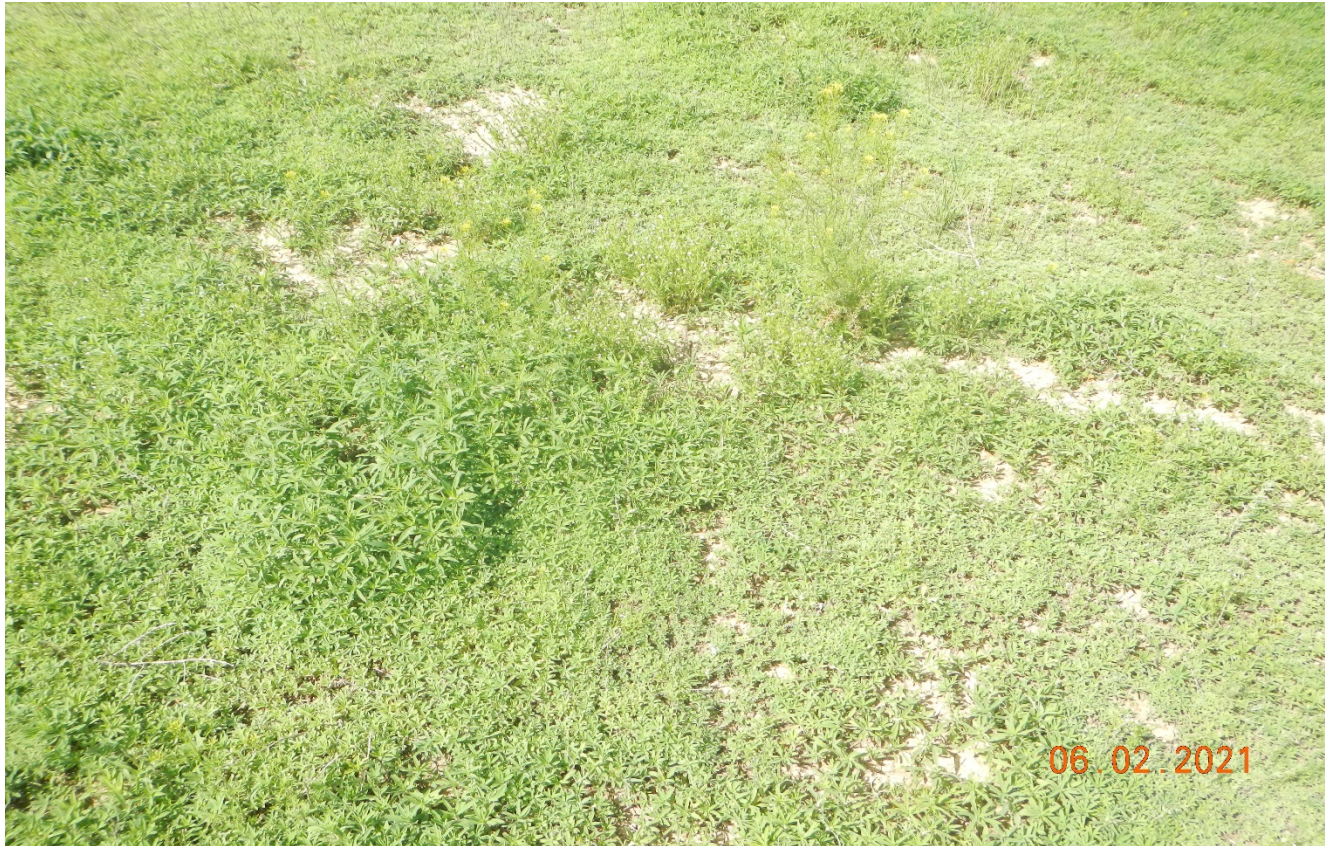
Photo 8. View of ground cover shows undesirable weeds (Kochia sp.) which was observed throughout the location.
