Inspection Photos

Operator: Catamount Energy
API: 067-09380
Date: 6/3/2021

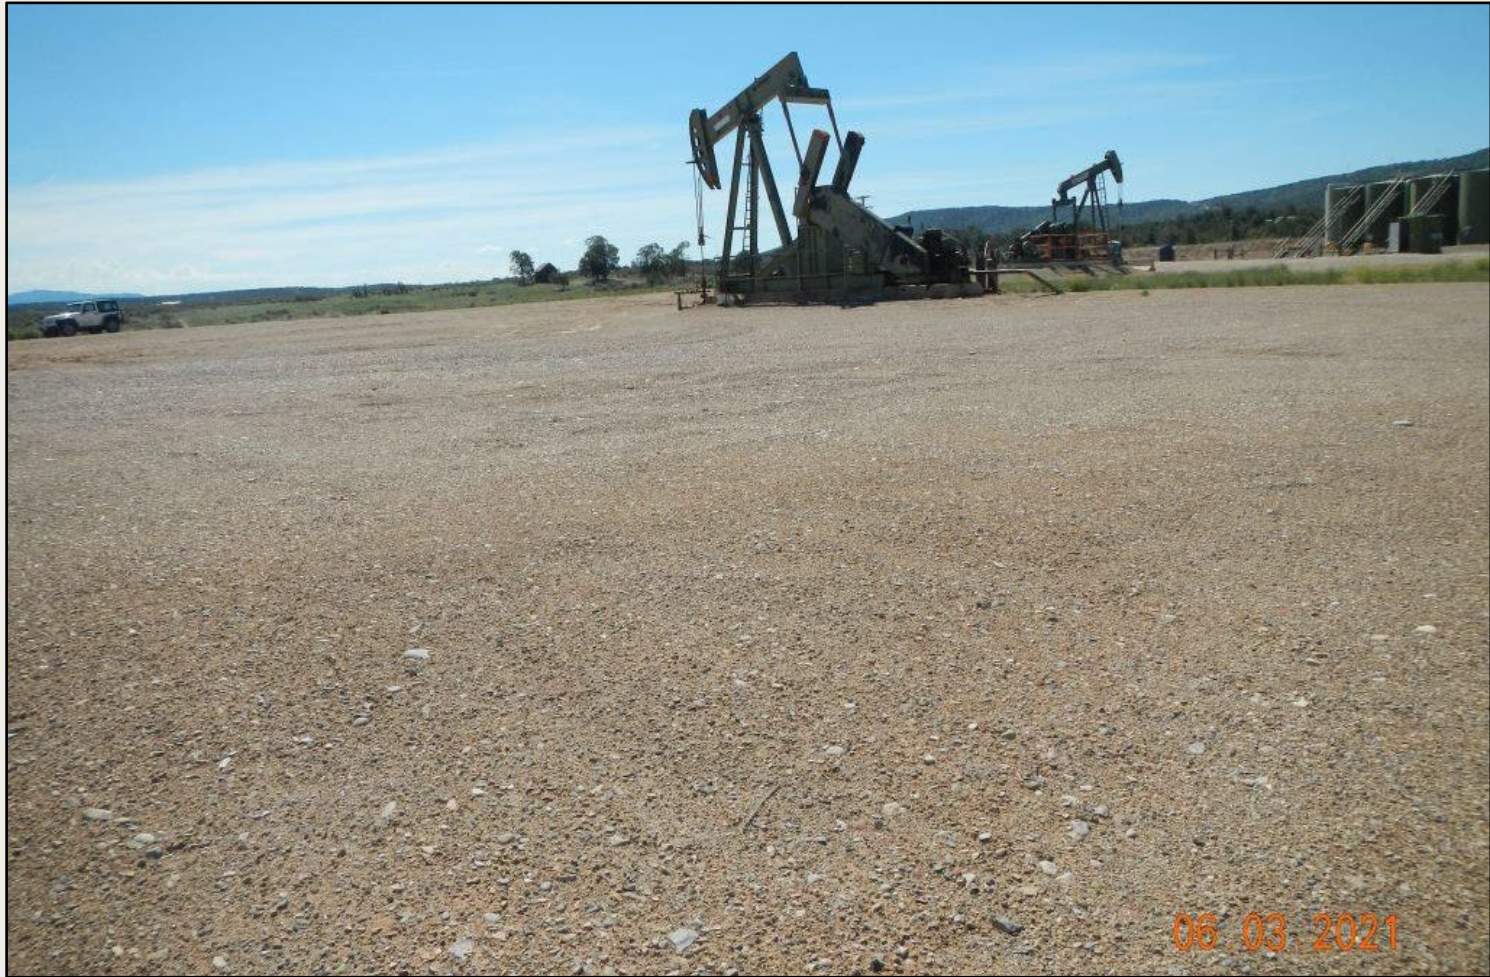
Photo 1. View of project area from the northeastern corner facing center.

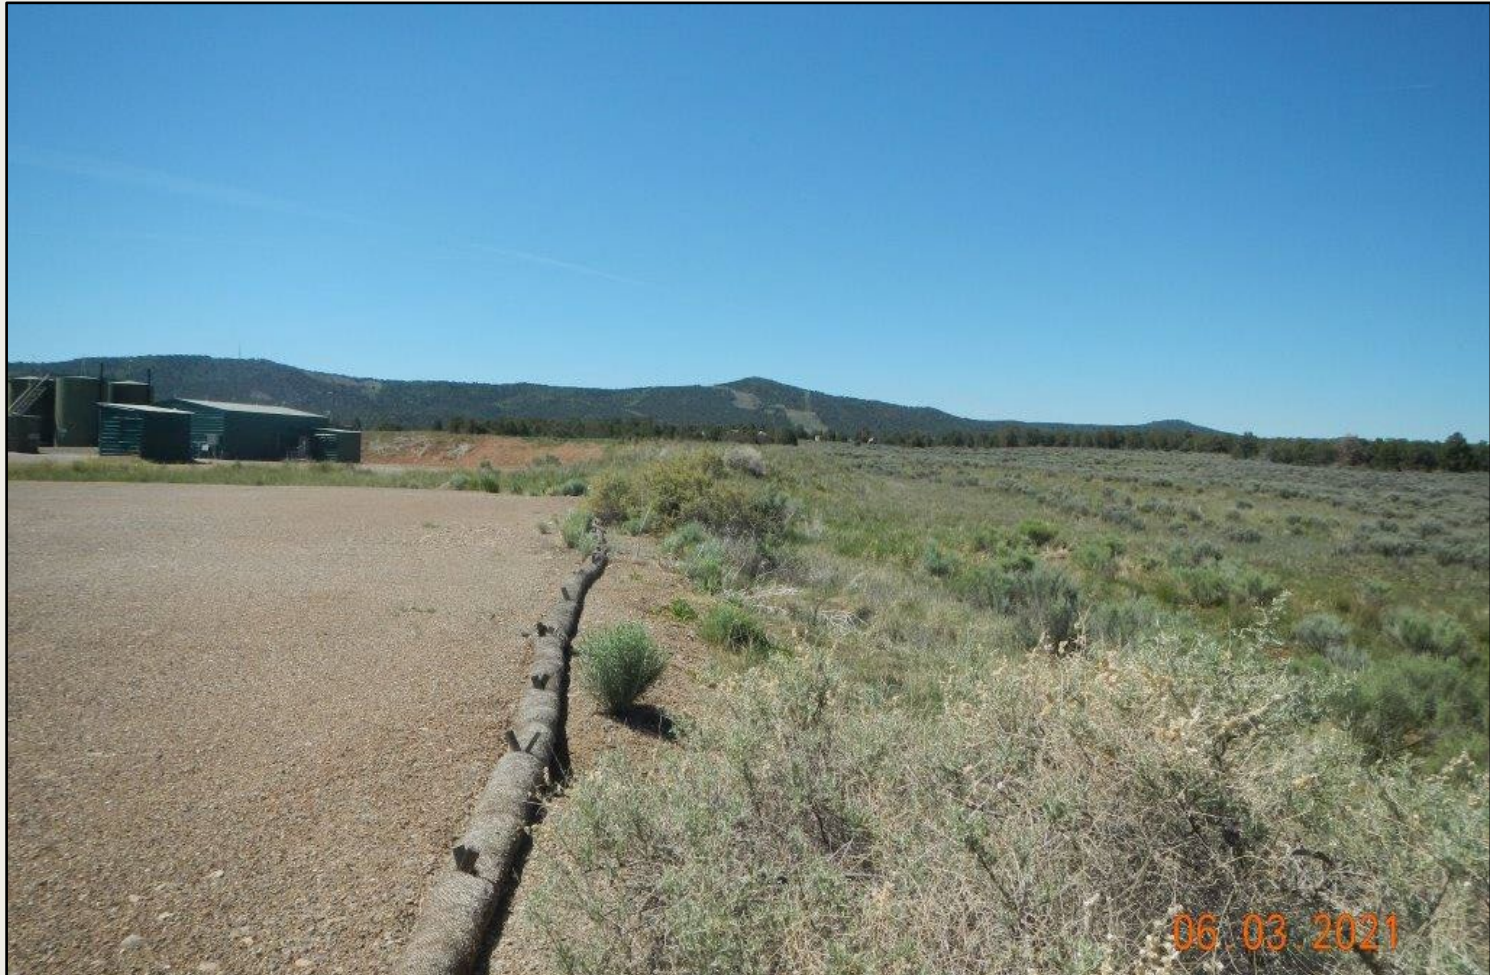
Photo 2. View of the eastern project area from the northeastern corner facing southward. Revegetation is progressing with western wheatgrass, fourwing saltbush, crested wheatgrass, smooth brome, and rubber rabbitbrush.

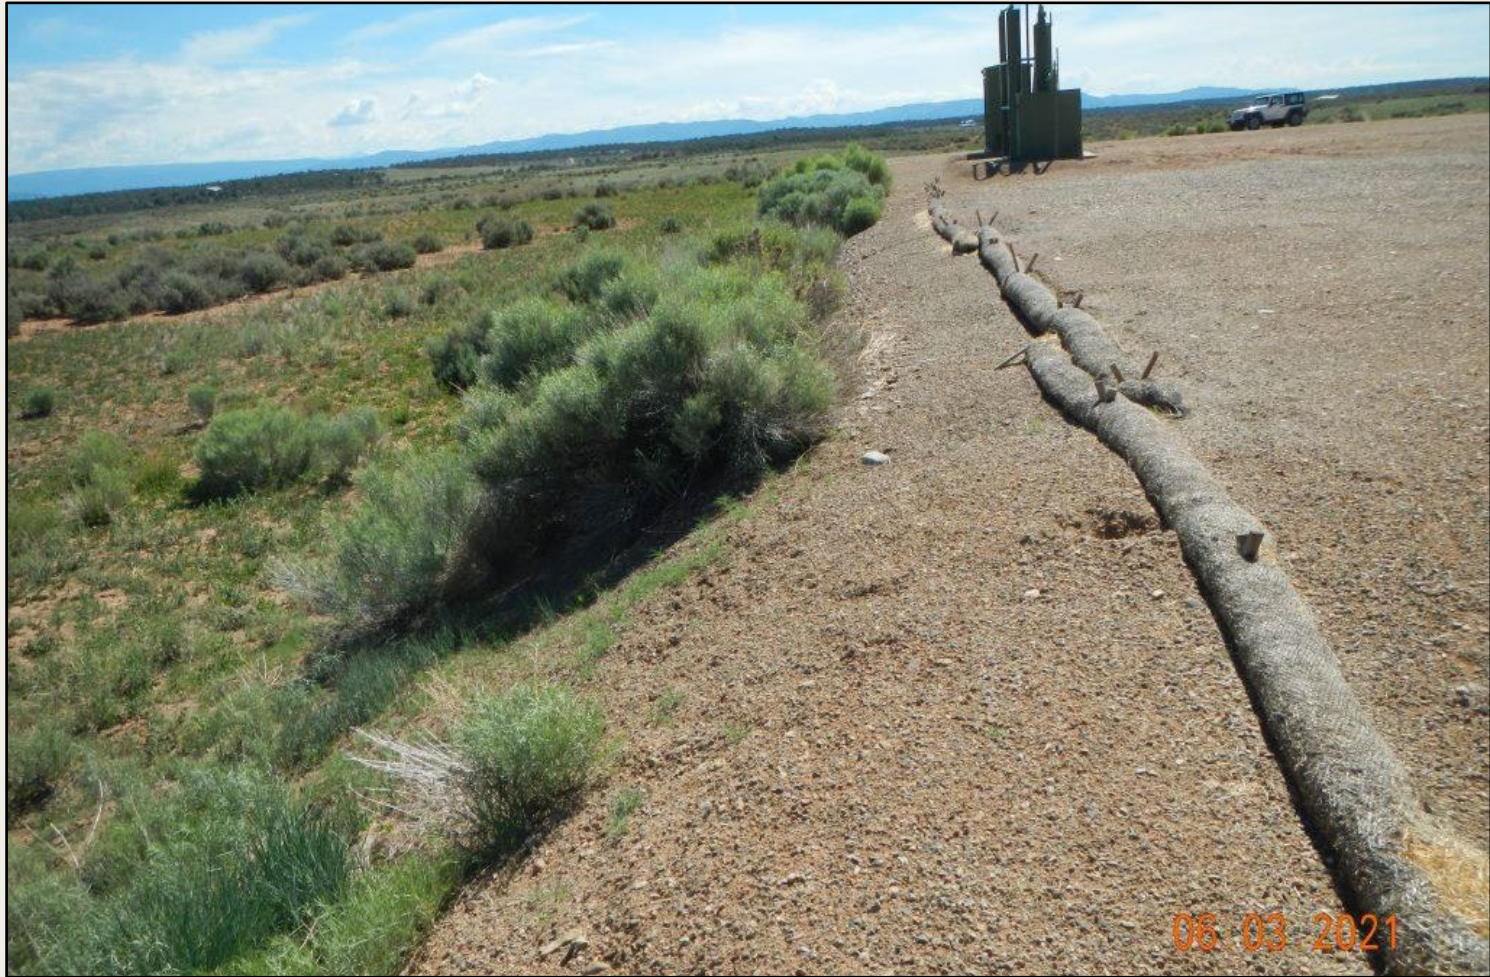
Photos 3. View of the northern project area from the northeastern corner facing westward.

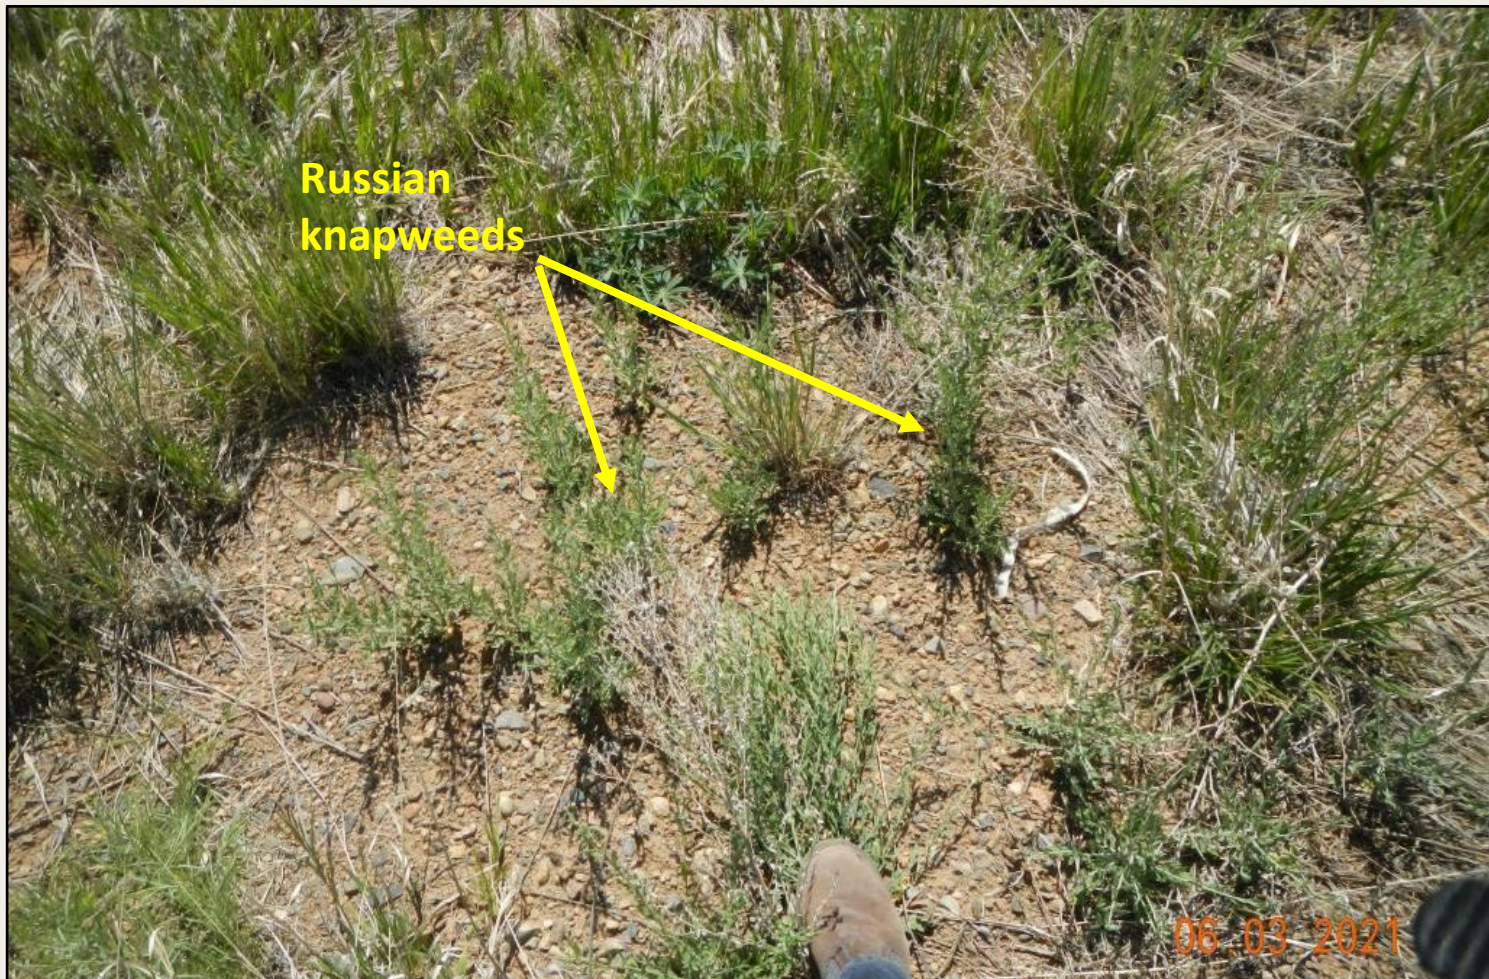
Photos 4. View of Russian knapweeds within the eastern project area. Approximately 1000 individuals observed.

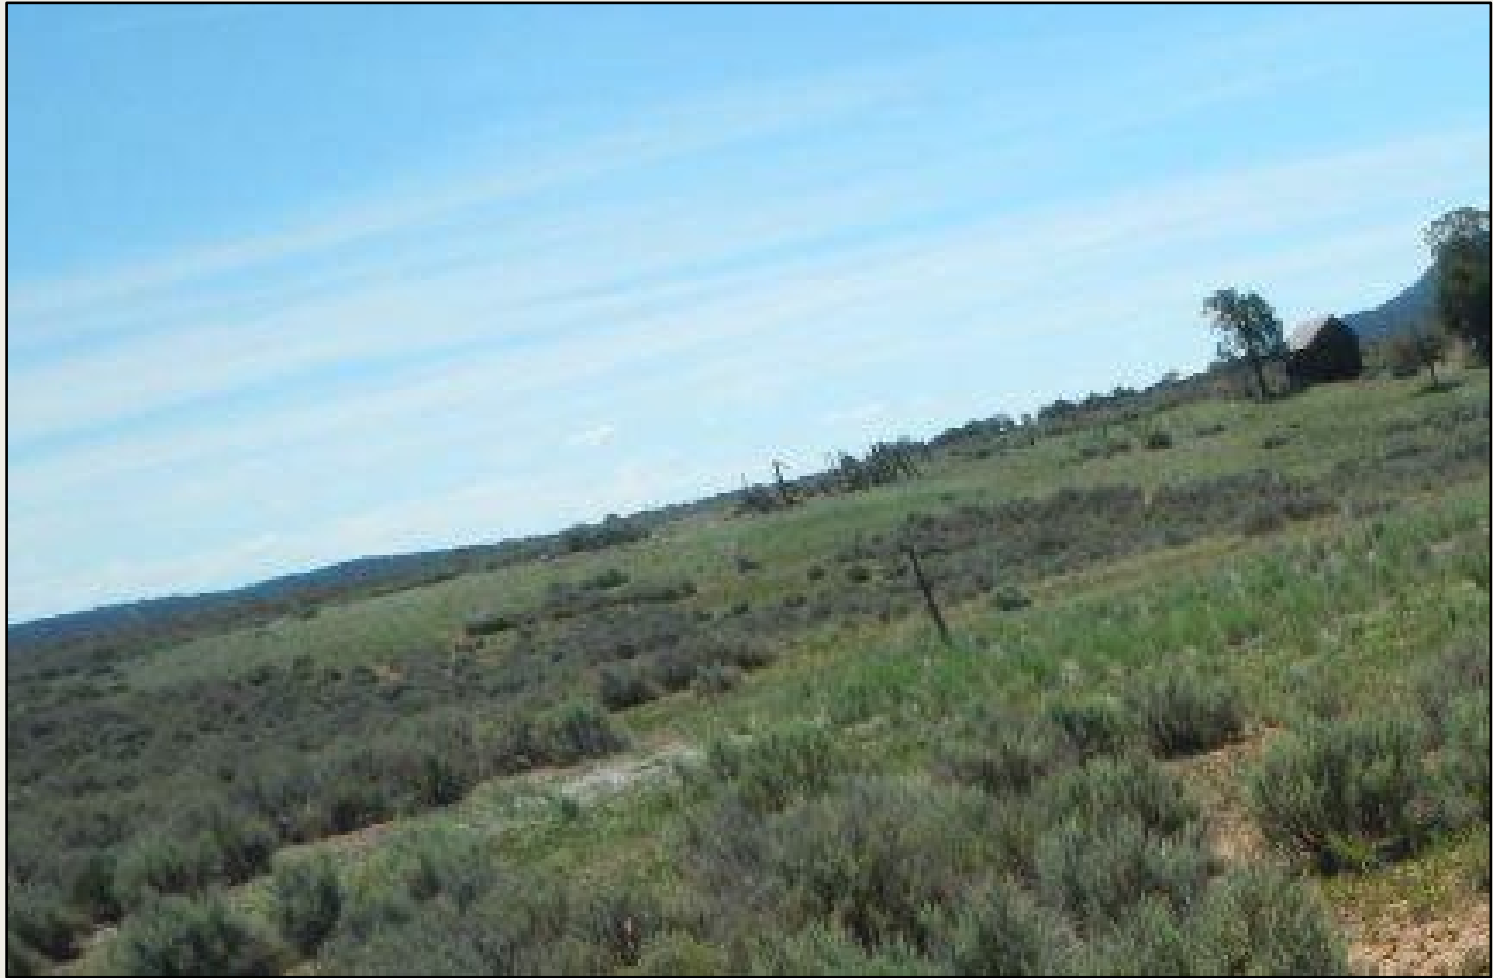
Photos 5. View of reference area comprised of big sagebrush and black sagebrush shrubland with mosaic of western wheatgrass, squirreltail, and phlox.
