Inspection Photos
Operator: Catamount Energy
API: 067-08184
Date: 6/3/2021

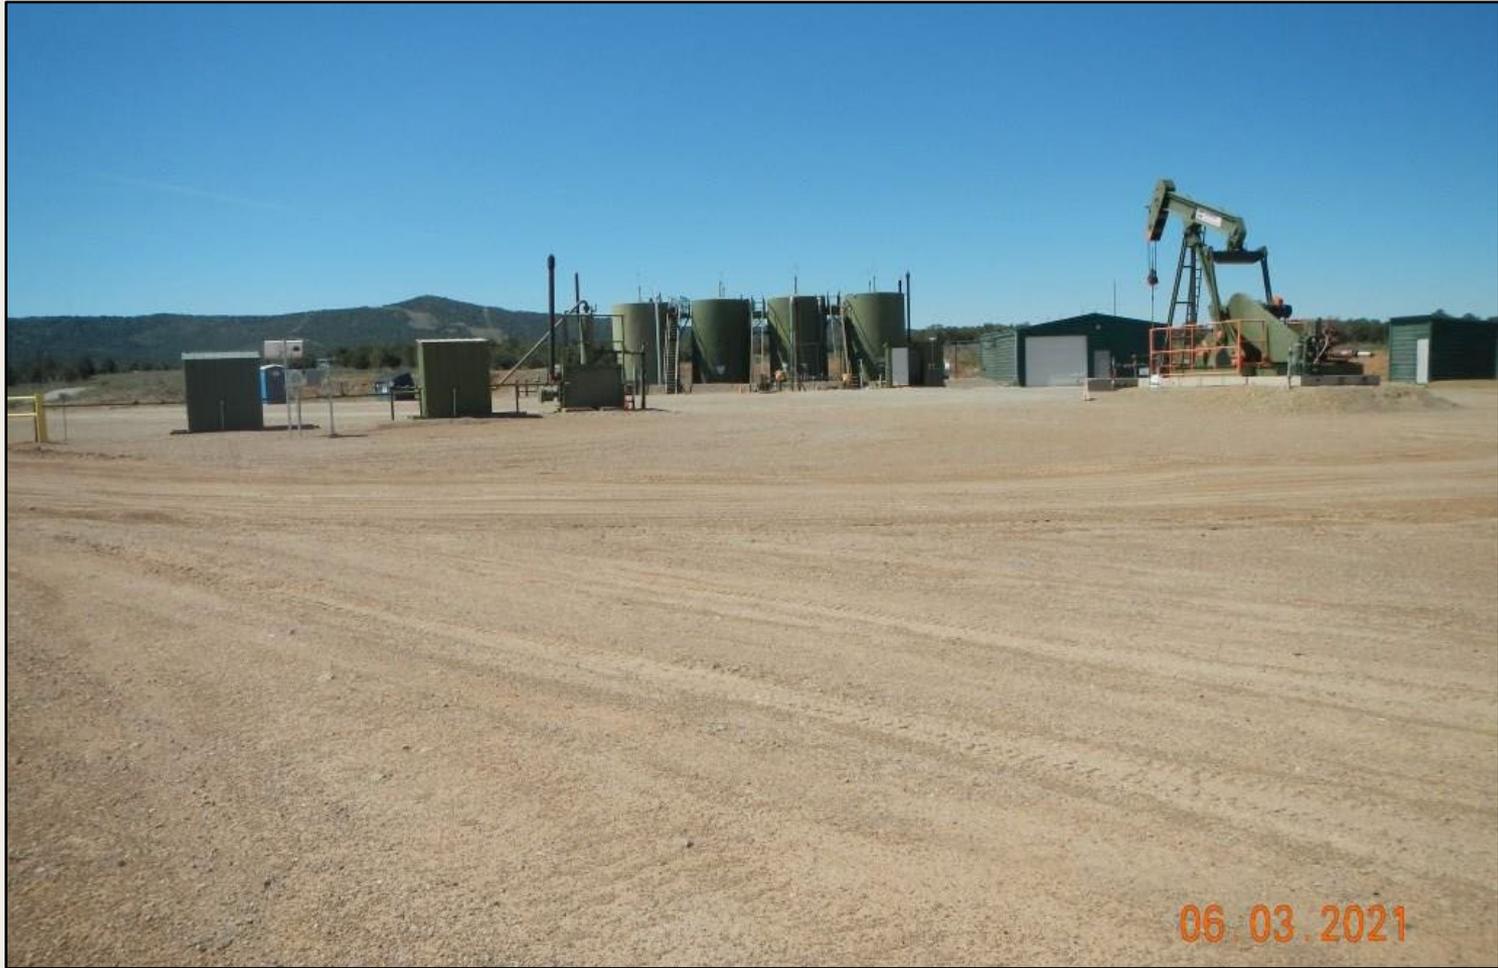
Photo 1. View of project area from the northeastern corner facing center.

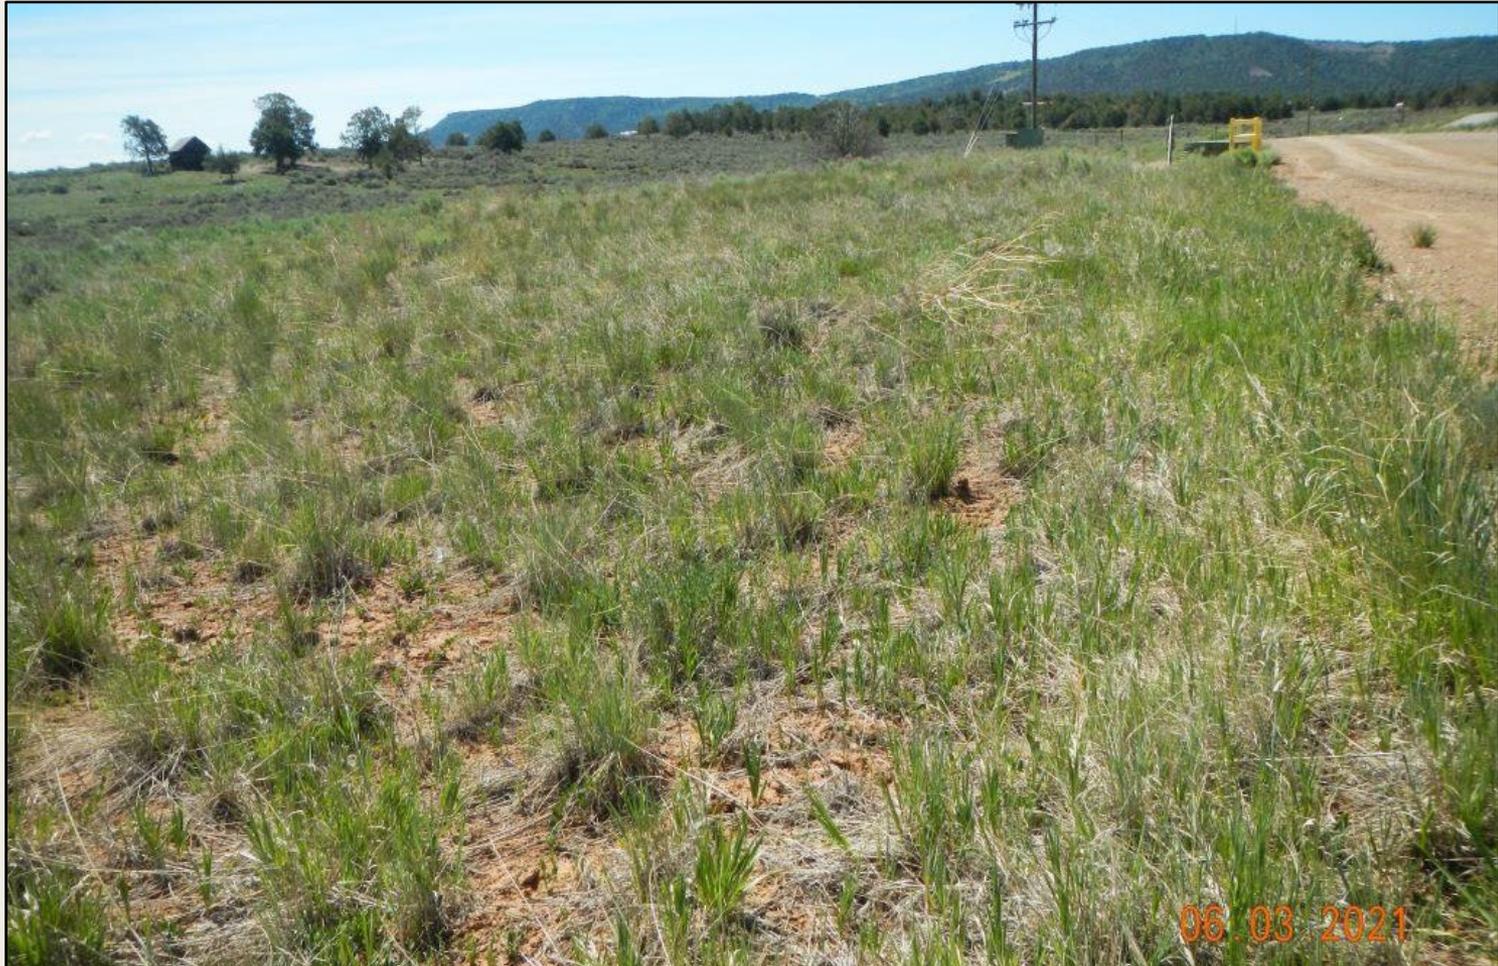
Photo 2. View of the eastern project area from the northeastern corner facing southward. Revegetation is progressing with western wheatgrass, crested wheatgrass, smooth brome, and rubber rabbitbrush.

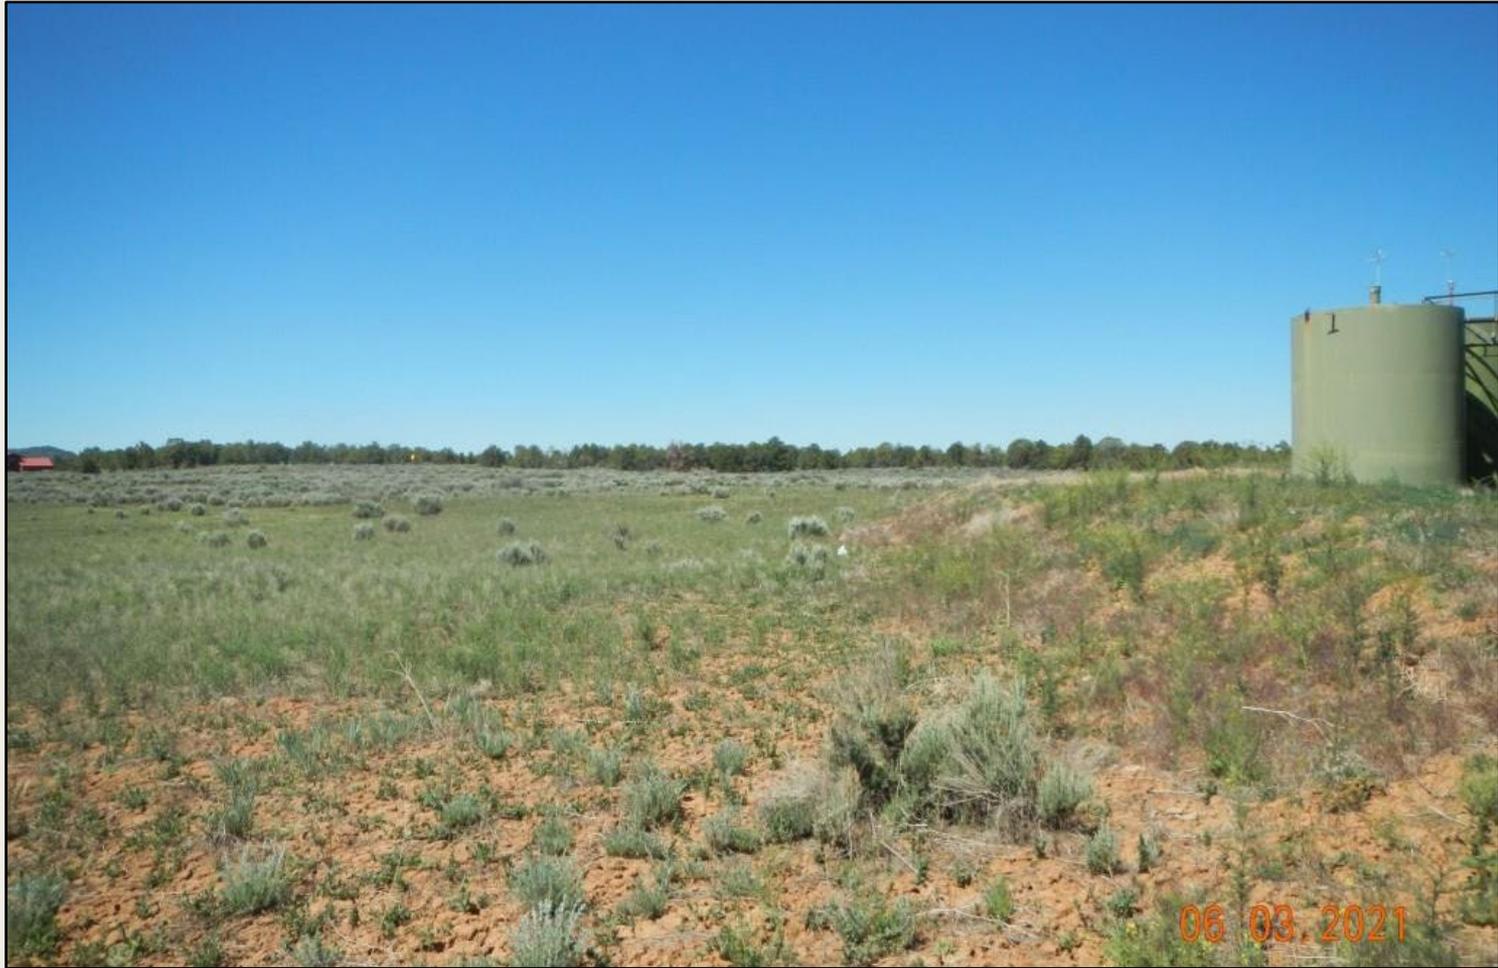
Photos 3. View of the southern project area from the southeastern corner facing westward.

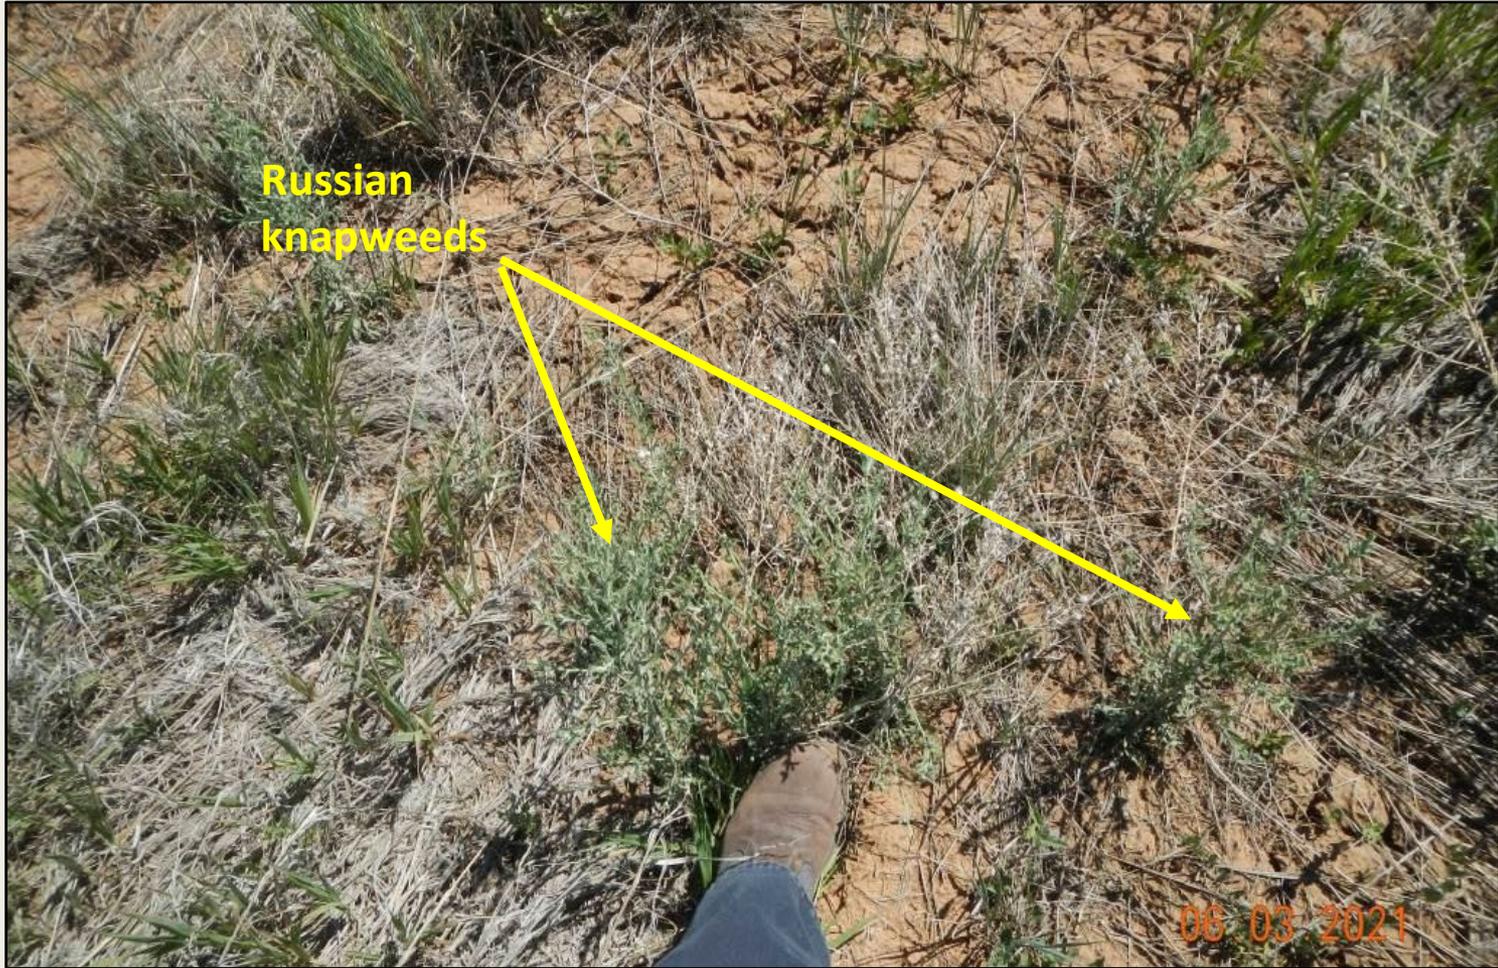
Photos 4. View of Russian knapweeds within the eastern project area. Approximately 1000 individuals observed.

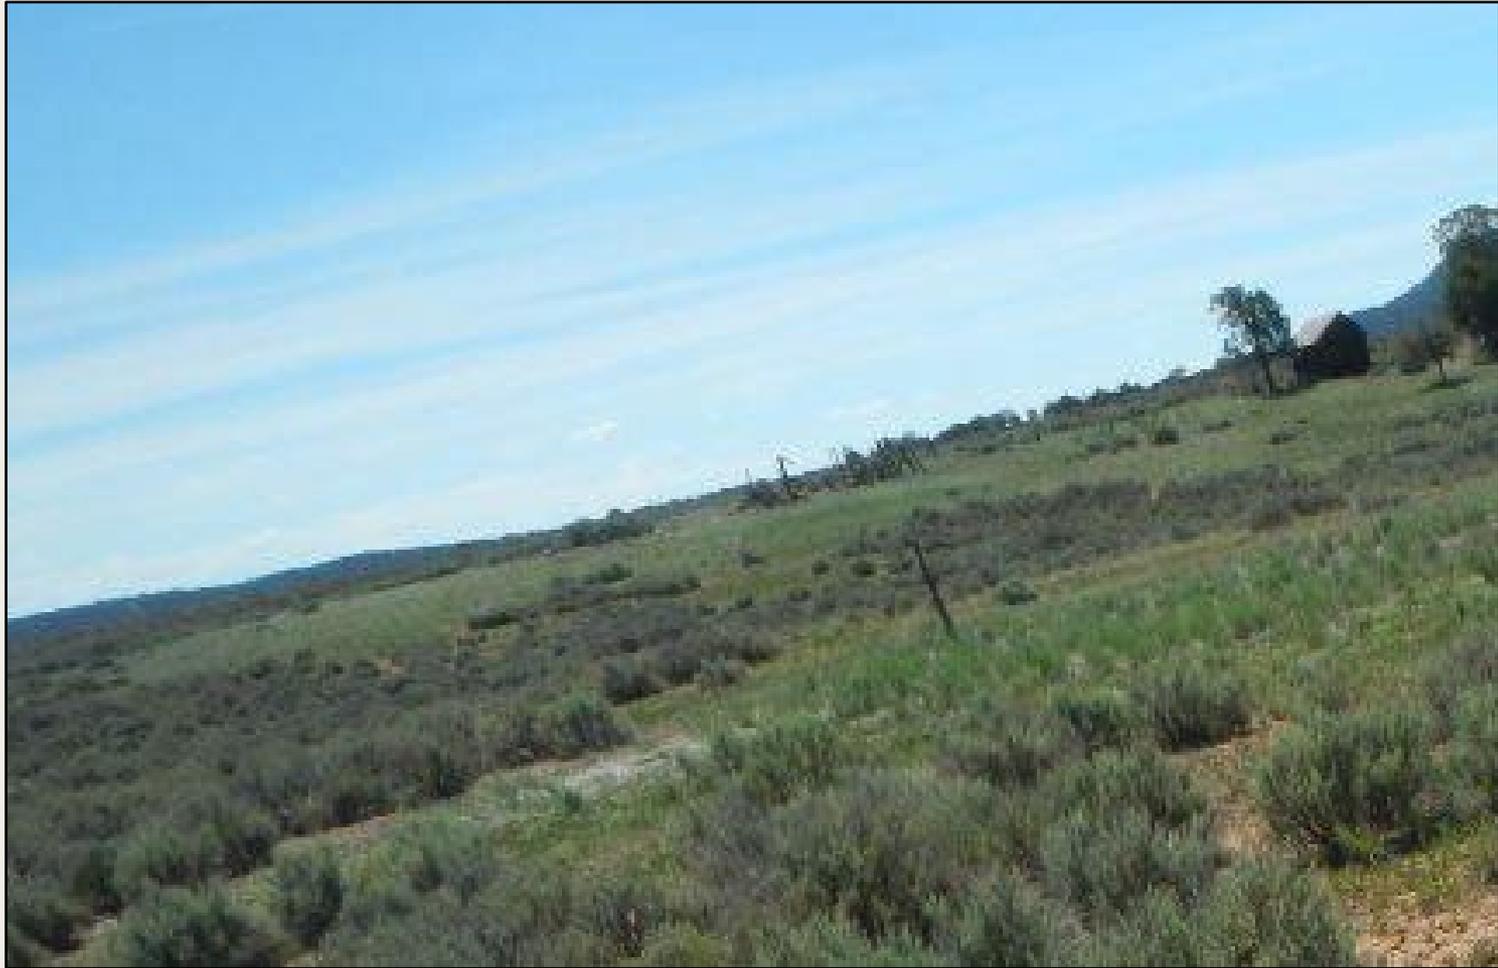
Photos 5. View of reference area comprised of big sagebrush and black sagebrush shrubland with mosaic of western wheatgrass, squirreltail, and phlox.
