Inspection Photos
Operator: Catamount
API: 067-07882
Date: 6/3/2021

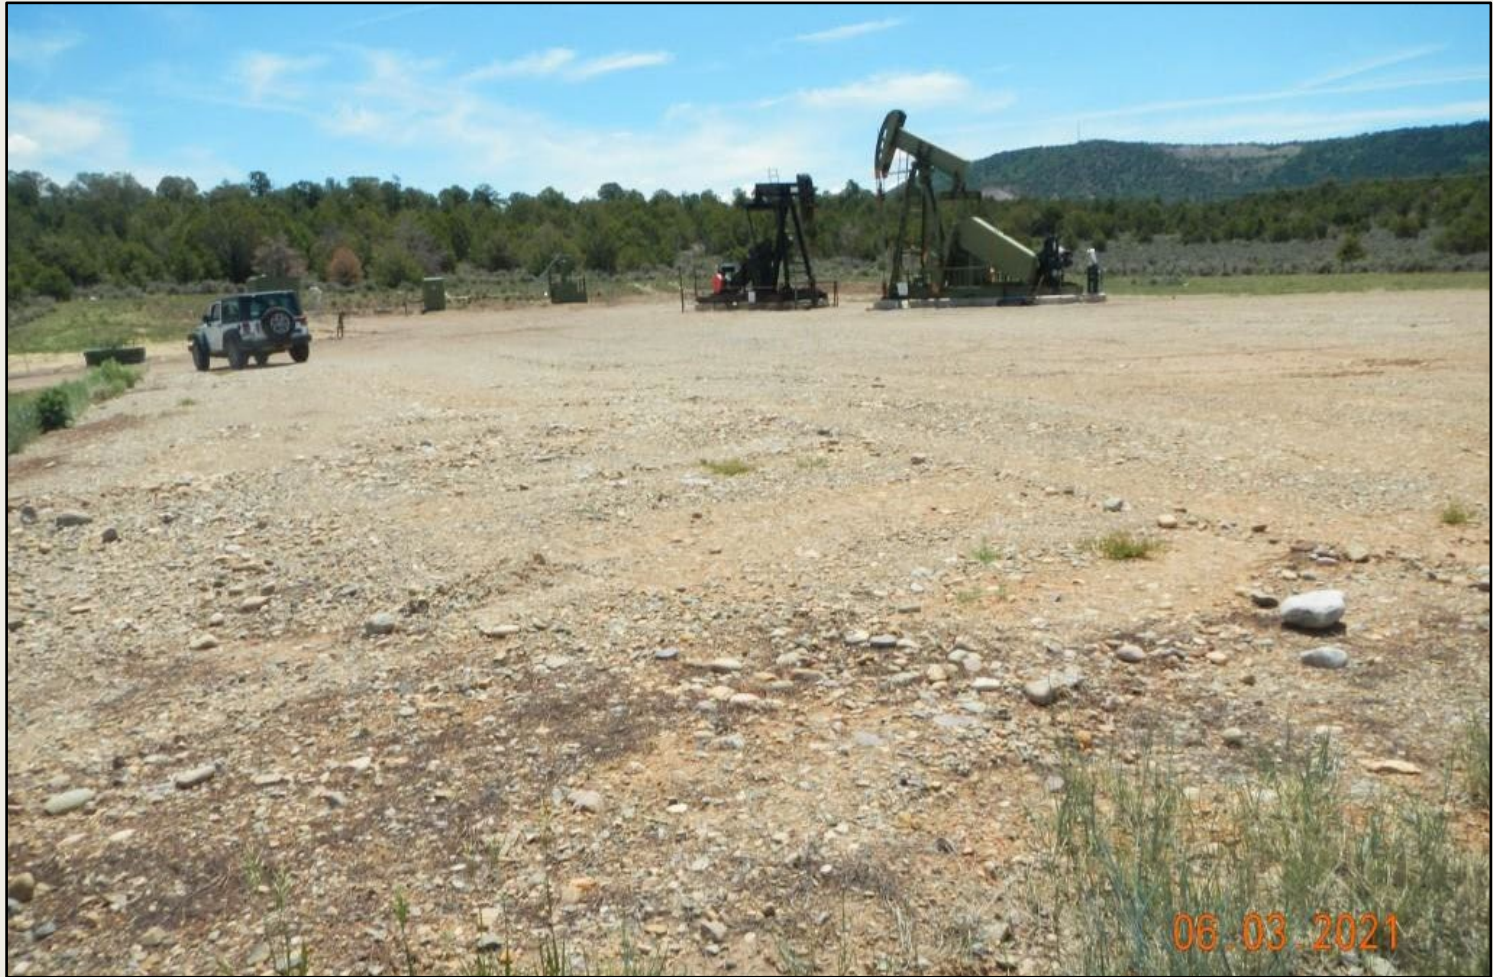
Photo 1. View of project area from the northwestern corner facing center.

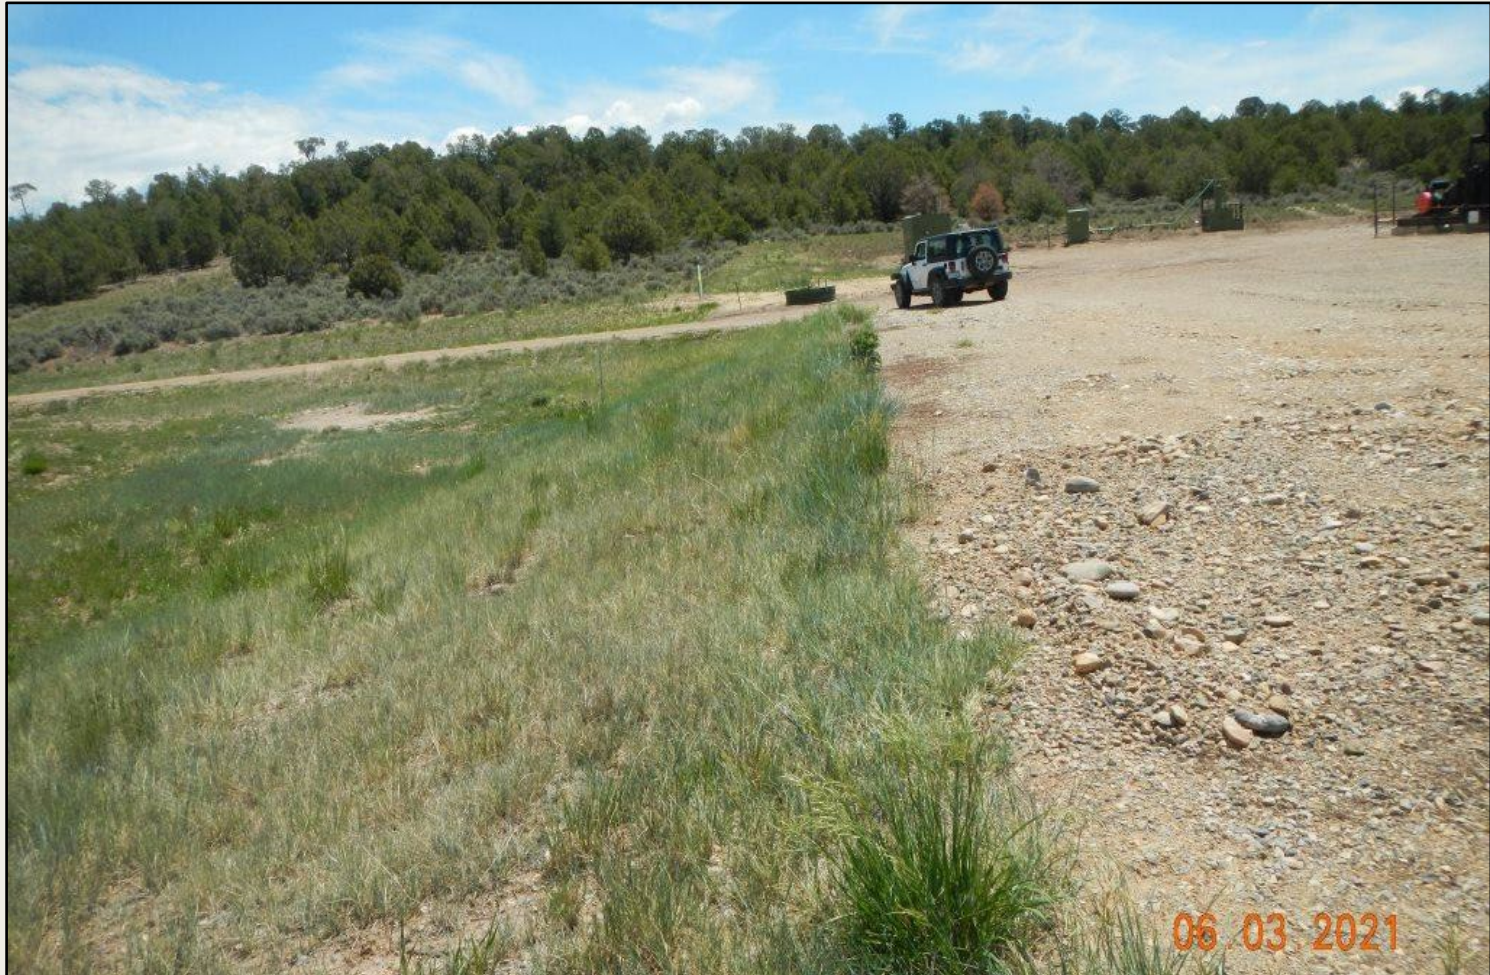
Photo 2. View of the northern project area from the northwestern corner facing eastward. Revegetation is progressing with western wheatgrass, smooth brome, and crested wheatgrass. Revegetation at final reclamation will need to use a native seed mix representative of the reference area.

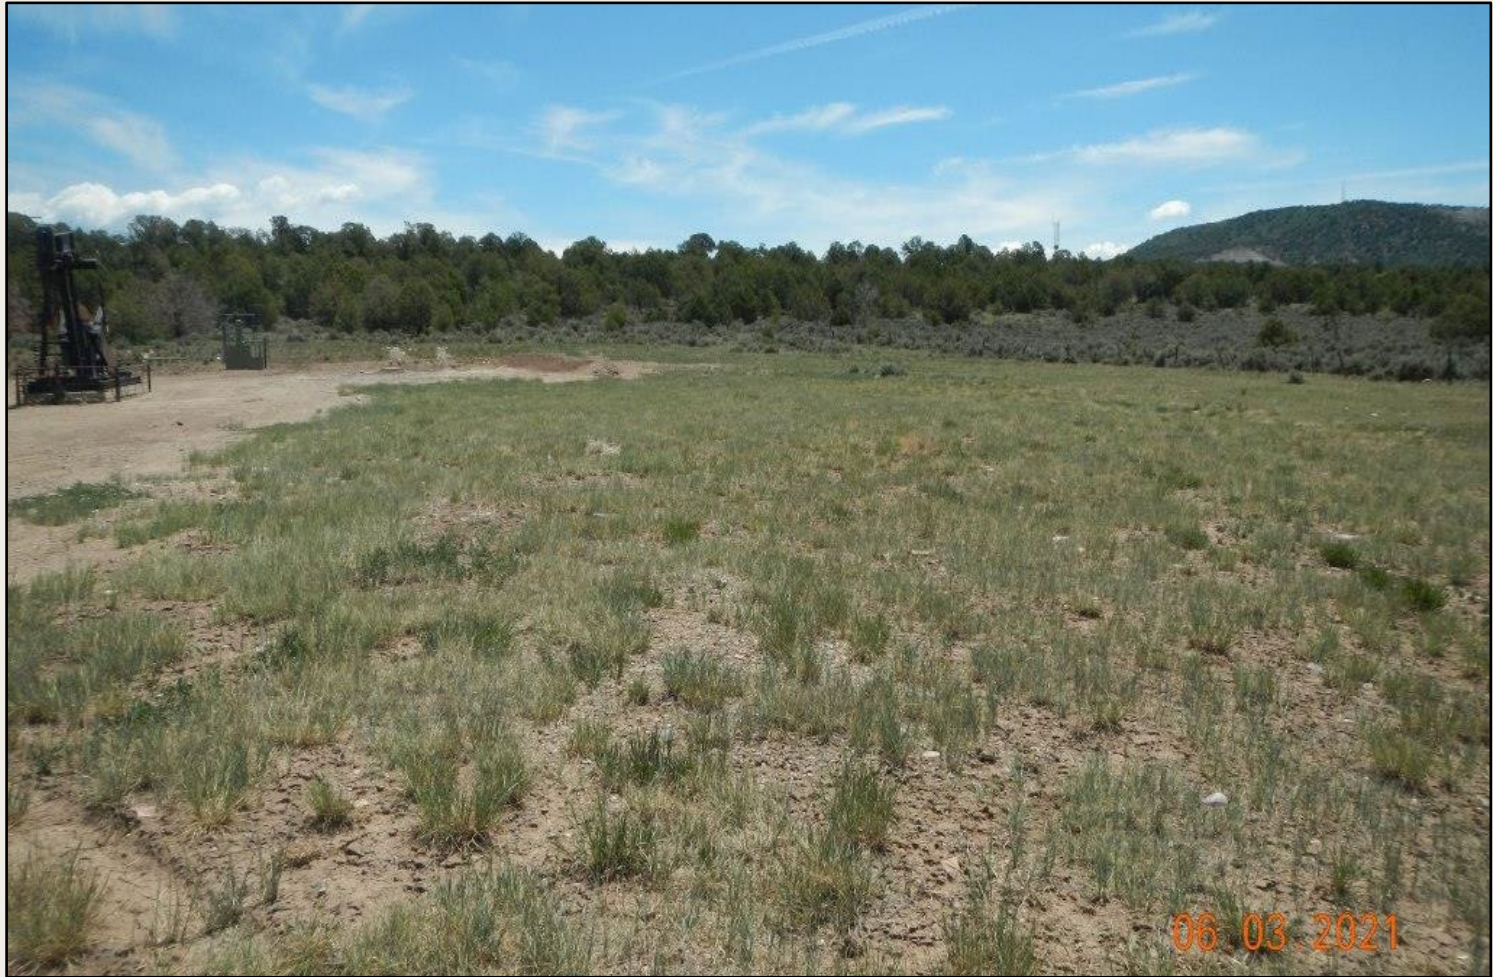
Photos 3. View of the southern project area from the southwestern corner facing eastward.

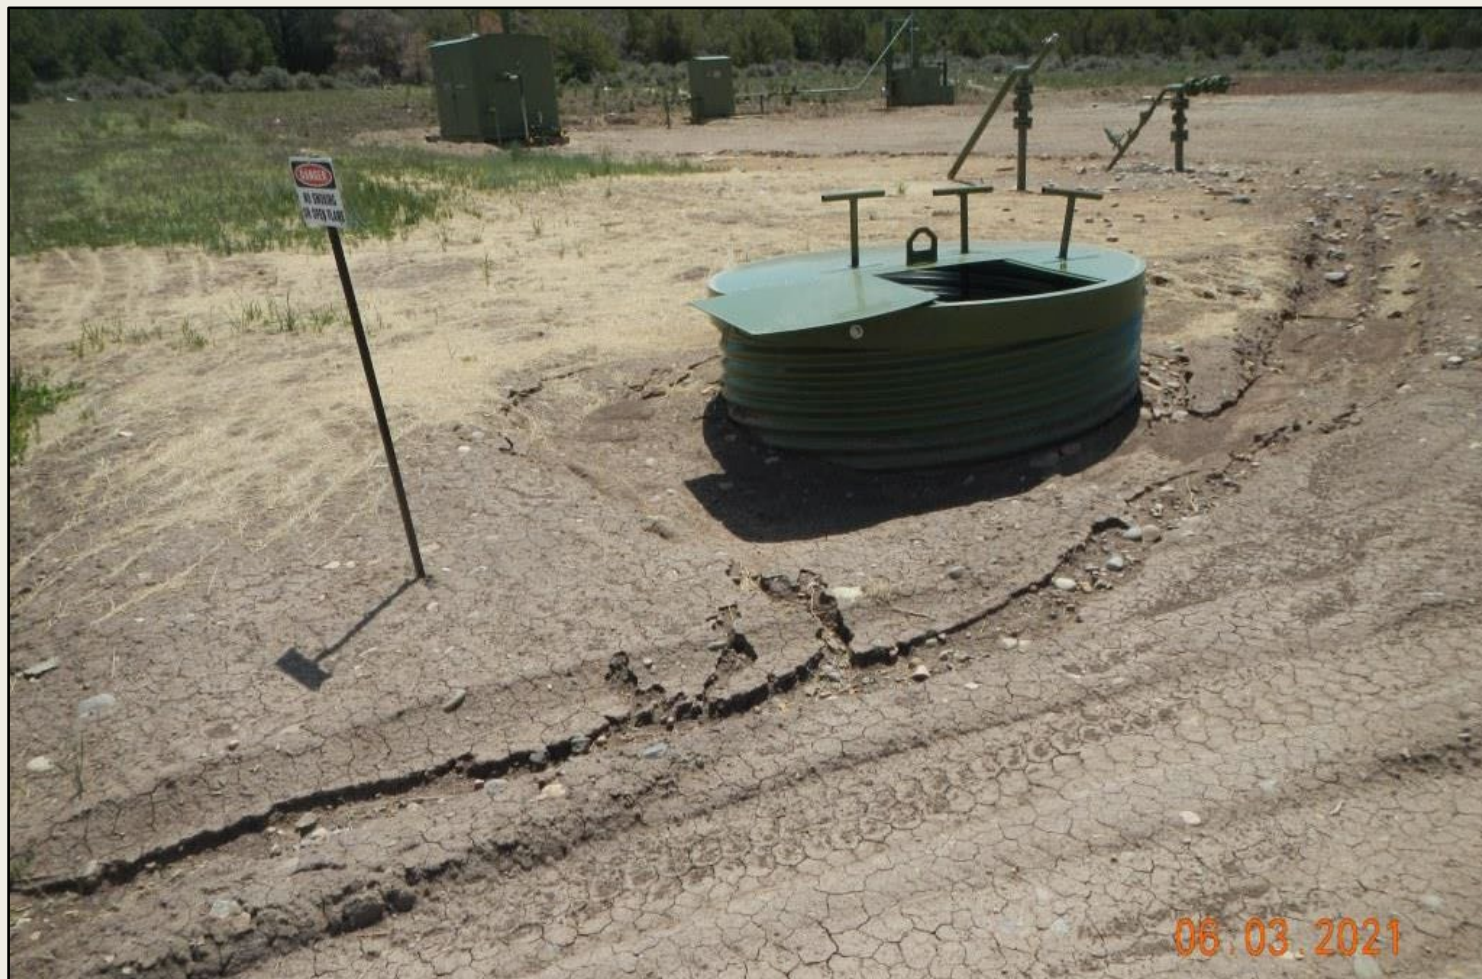
Photos 4. View of erosional rilling at well pad entrance. Stormwater BMPs need to be installed and maintained until area is stabilized with desirable perennial vegetation.

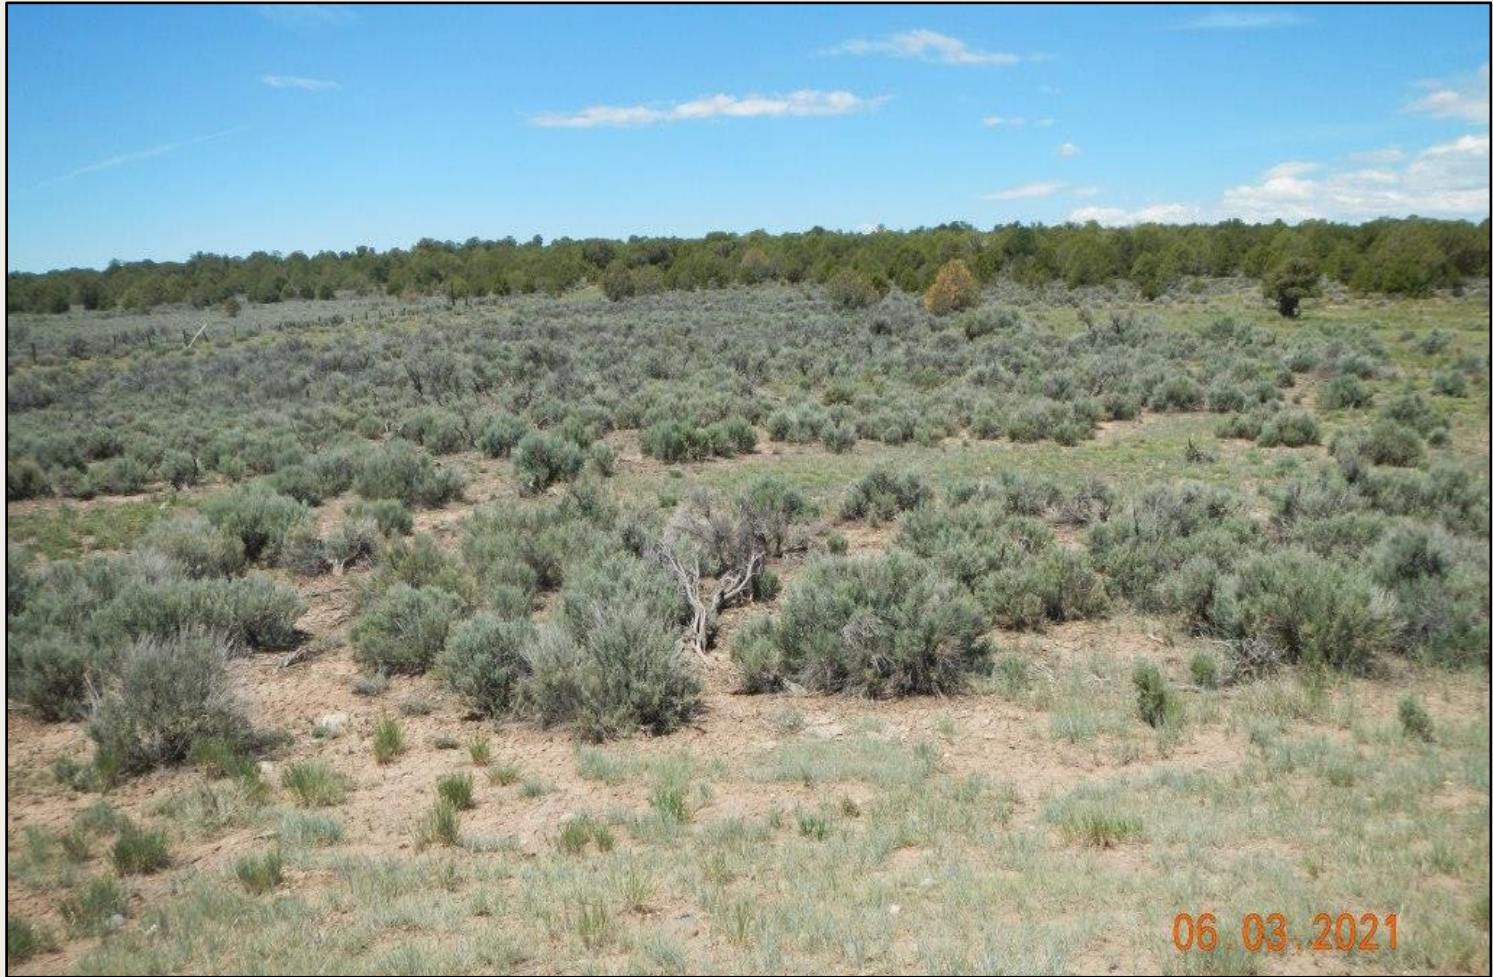
Photos 5. View of reference area comprised of big sagebrush and black sagebrush shrubland with scattered pinyon and juniper trees, and squirreltail, western wheatgrass, mat penstemon in the understory.
