Inspection Photos

API: 073-06310

Operator: NIGHTHAWK PRODUCTION LLC

Inspection Date: 6/2/2021

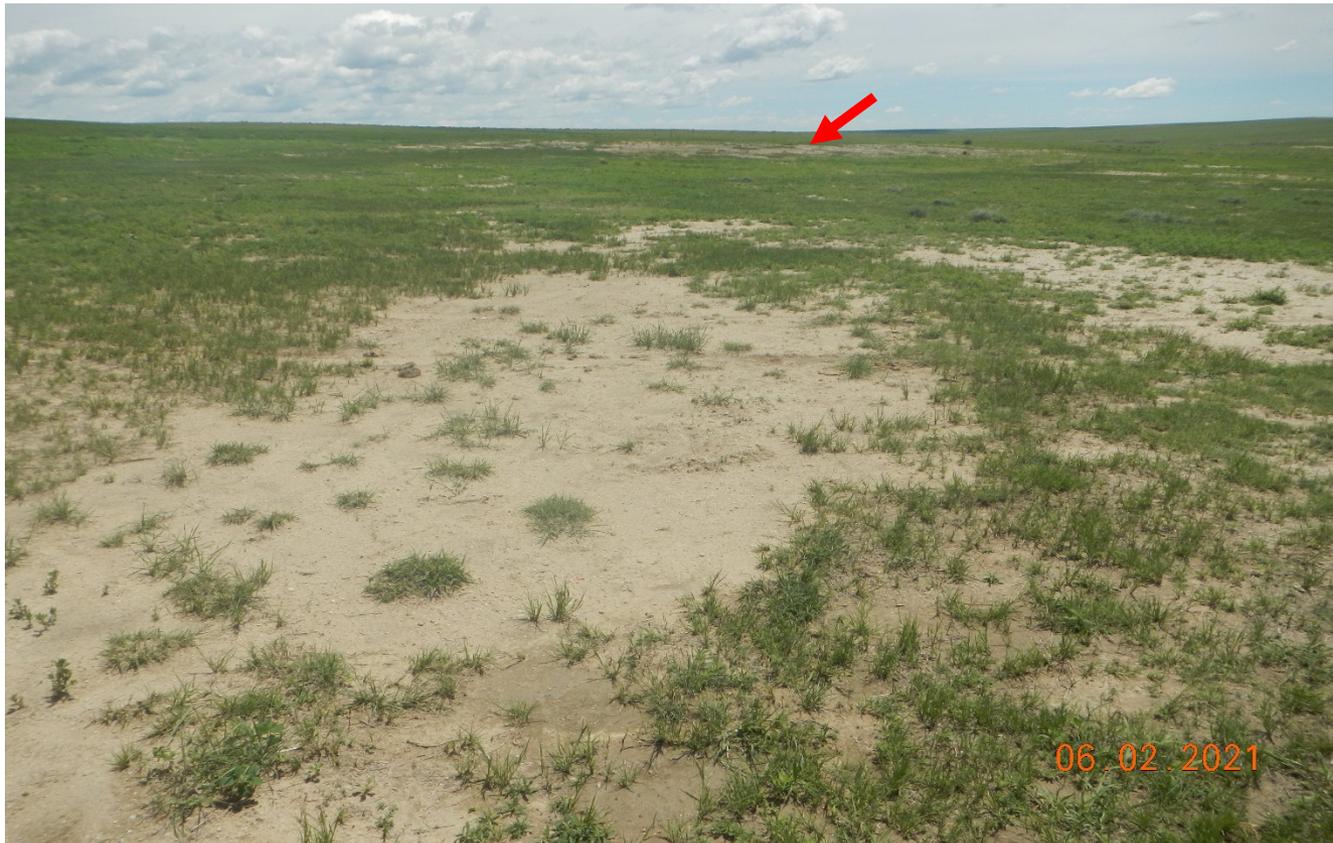
Photo 1. Facing east along the former access road. The location is shown at red arrow.

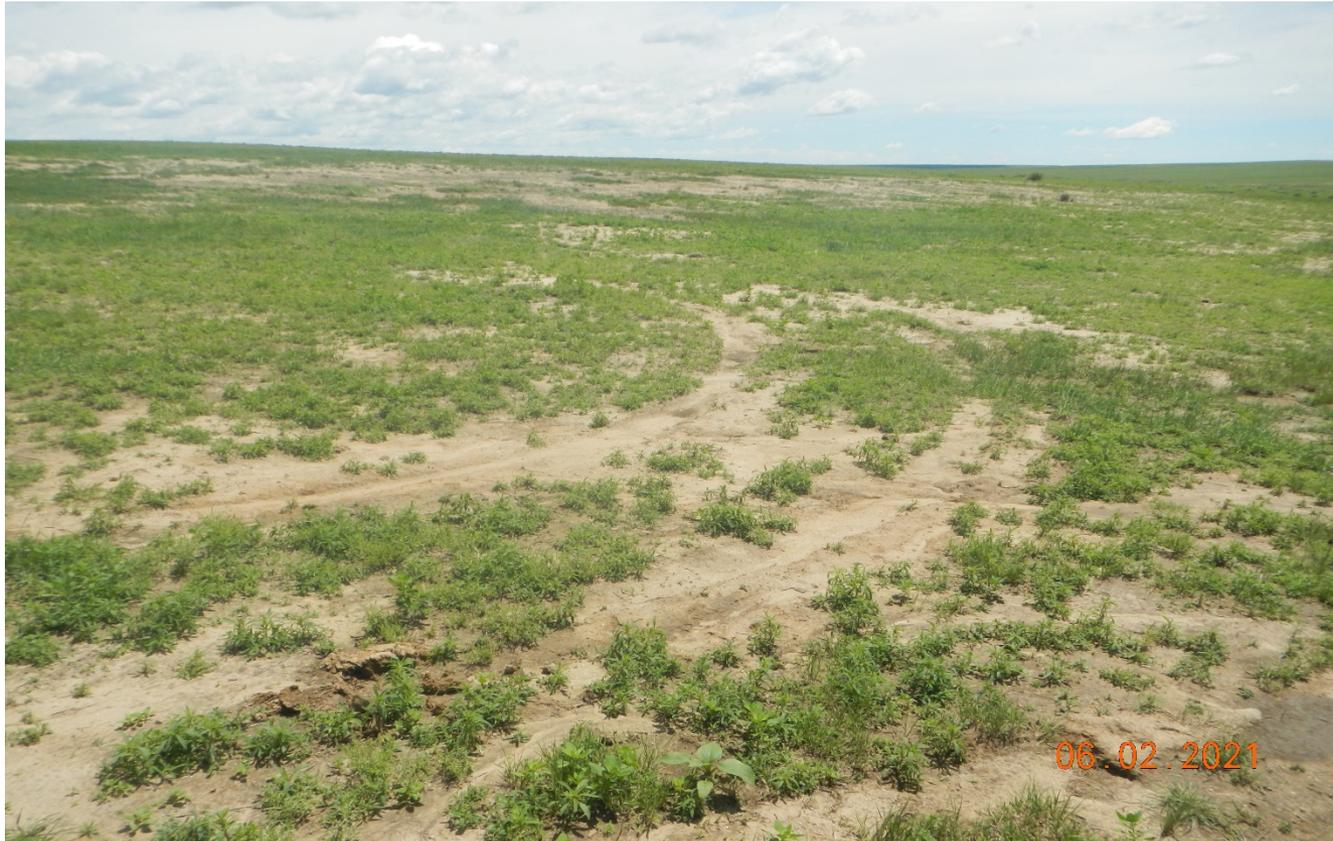
Photo 2. Facing northeast at the location. There is undesirable weeds (Kochia) growing throughout this southwest portion of the location.

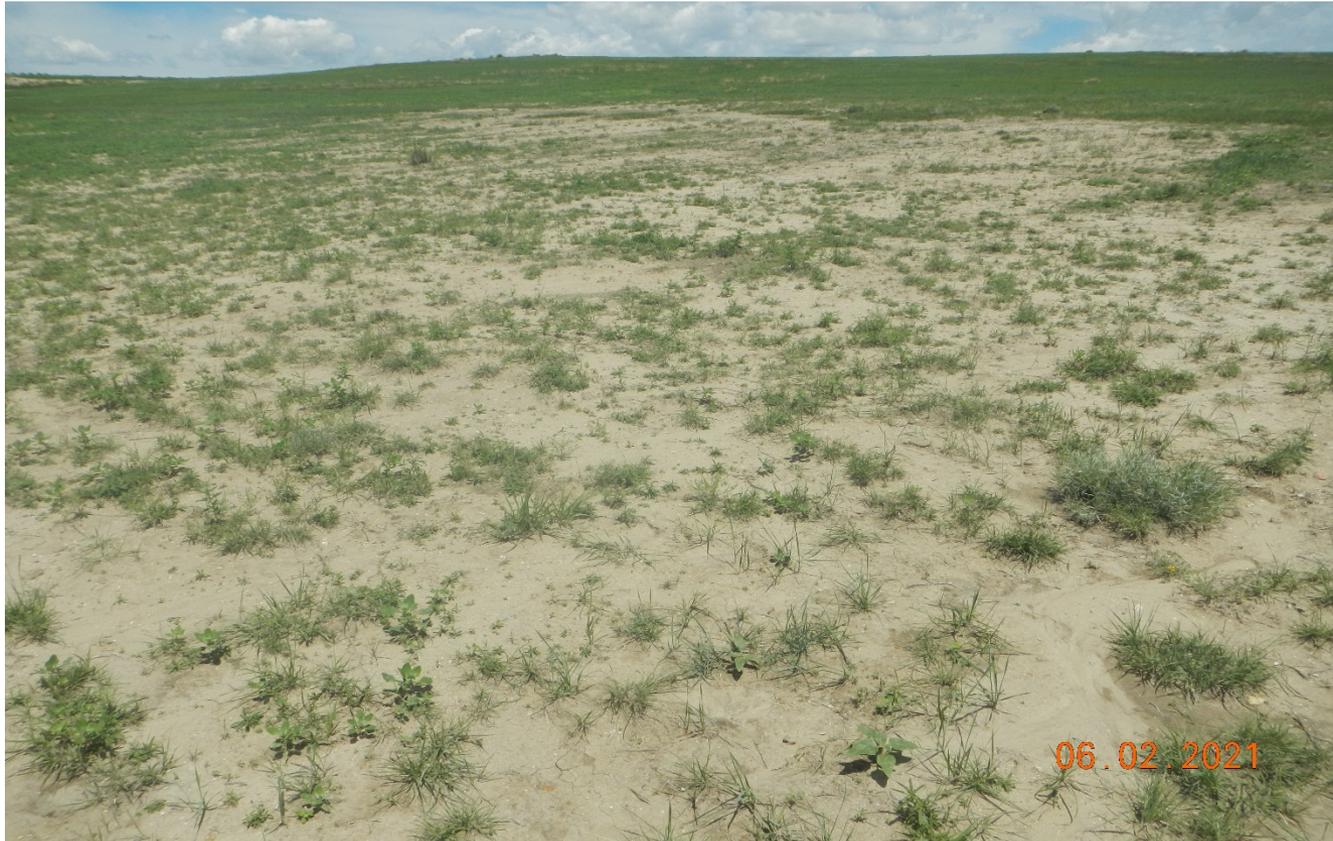
Photo 3. Facing north at the center of the location. The vegetation has not adequately established at the location.

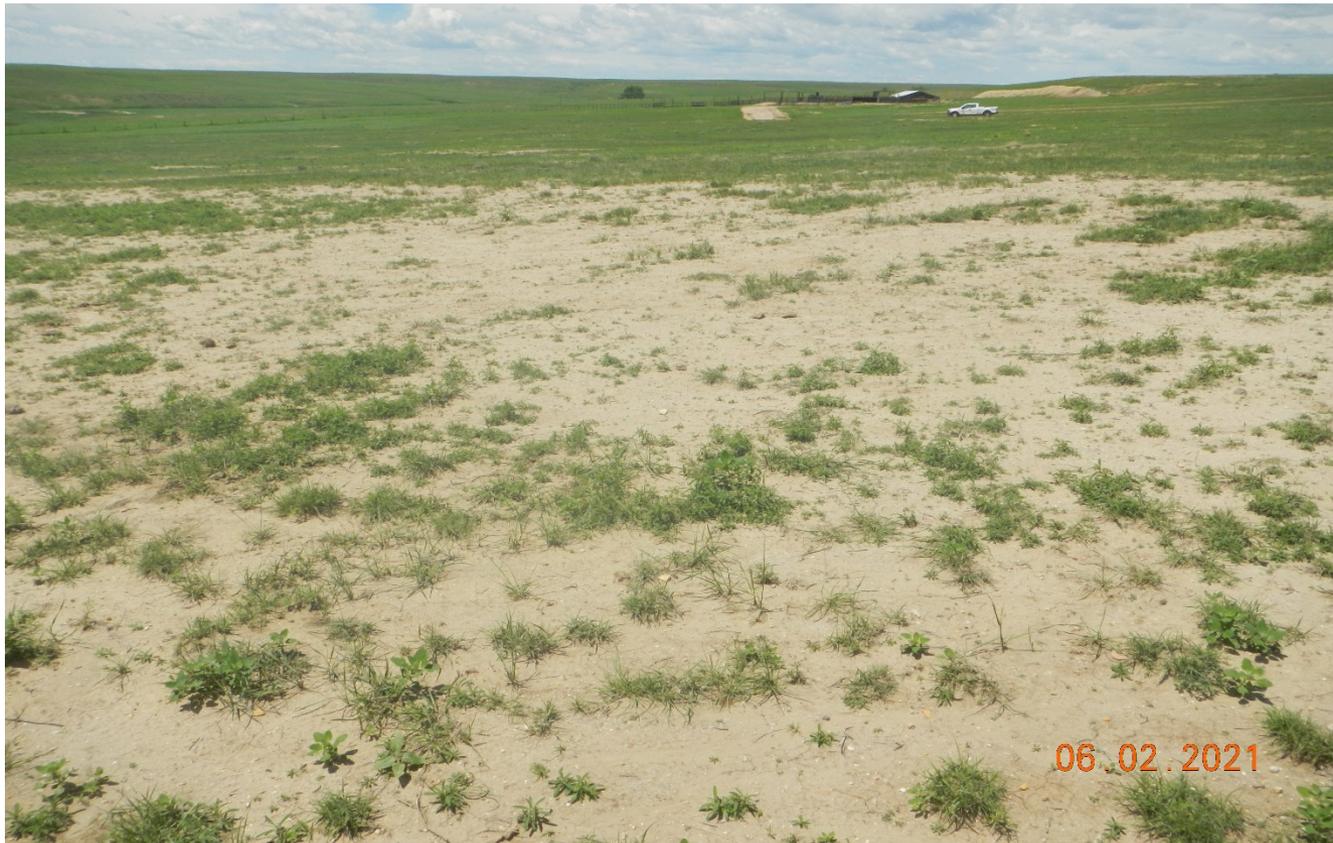
Photo 4. Facing west at the center of the location. The vegetation has not adequately established at the location.

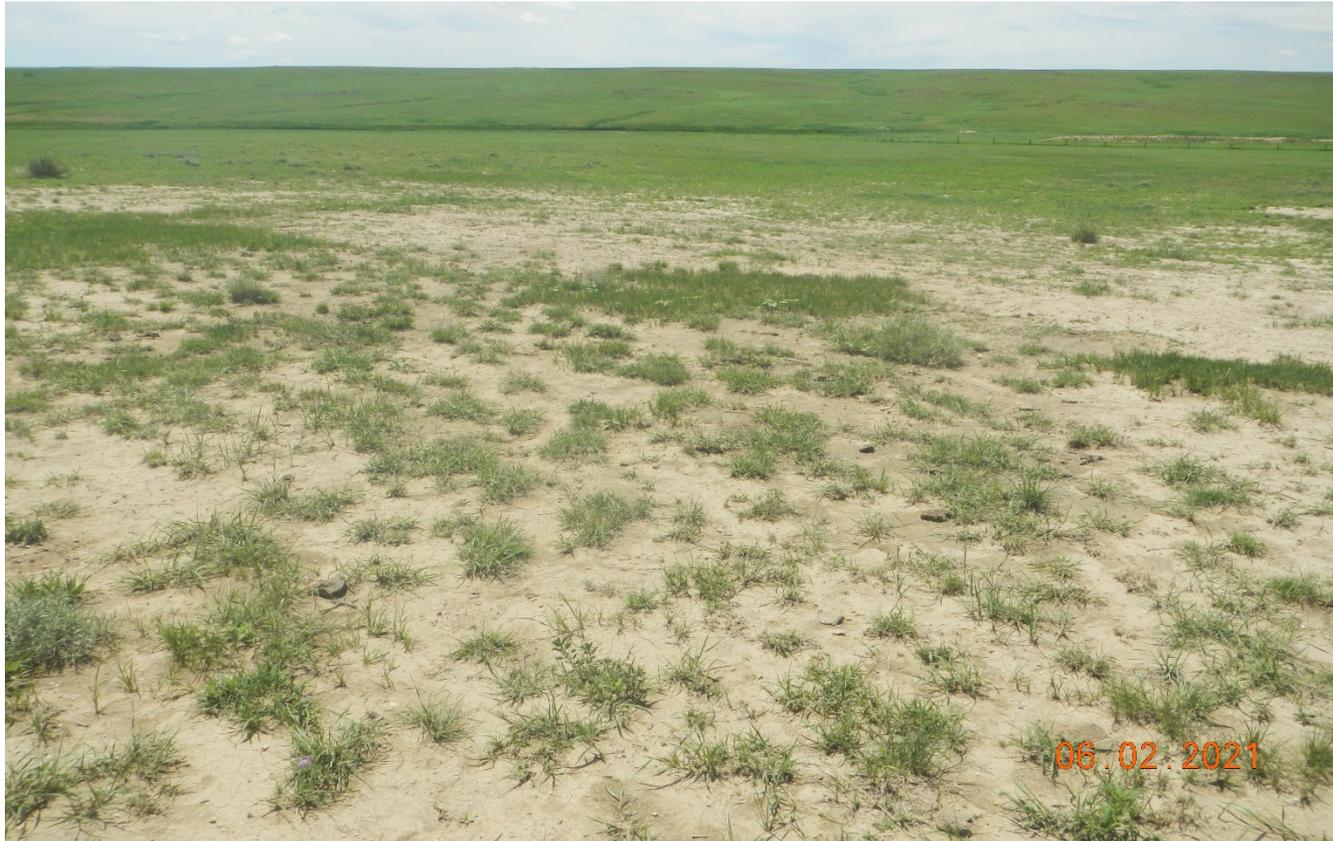
Photo 5. Facing south at the center of the location. The vegetation has not adequately established at the location.

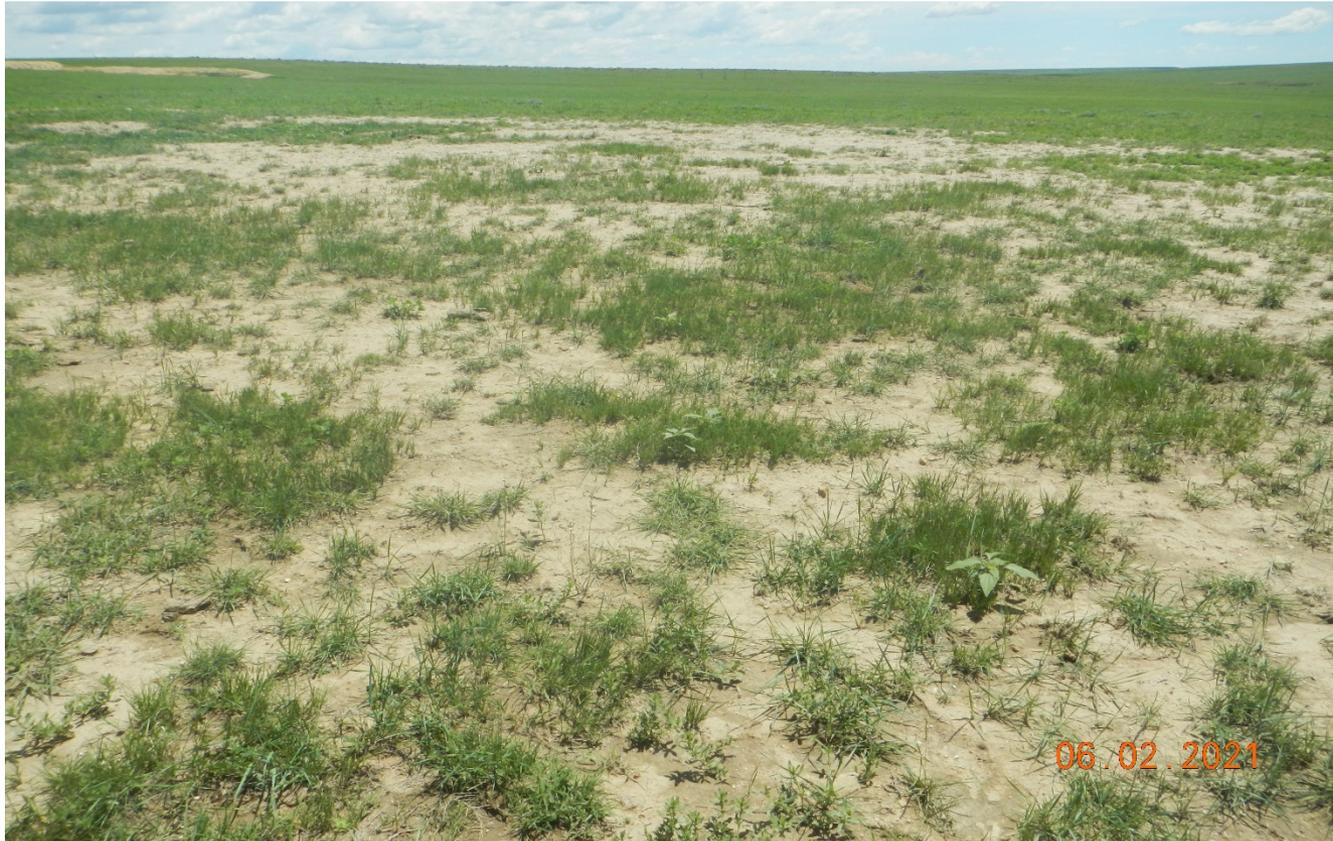
Photo 6. Facing east at the center of the location. The vegetation has not adequately established at the location.

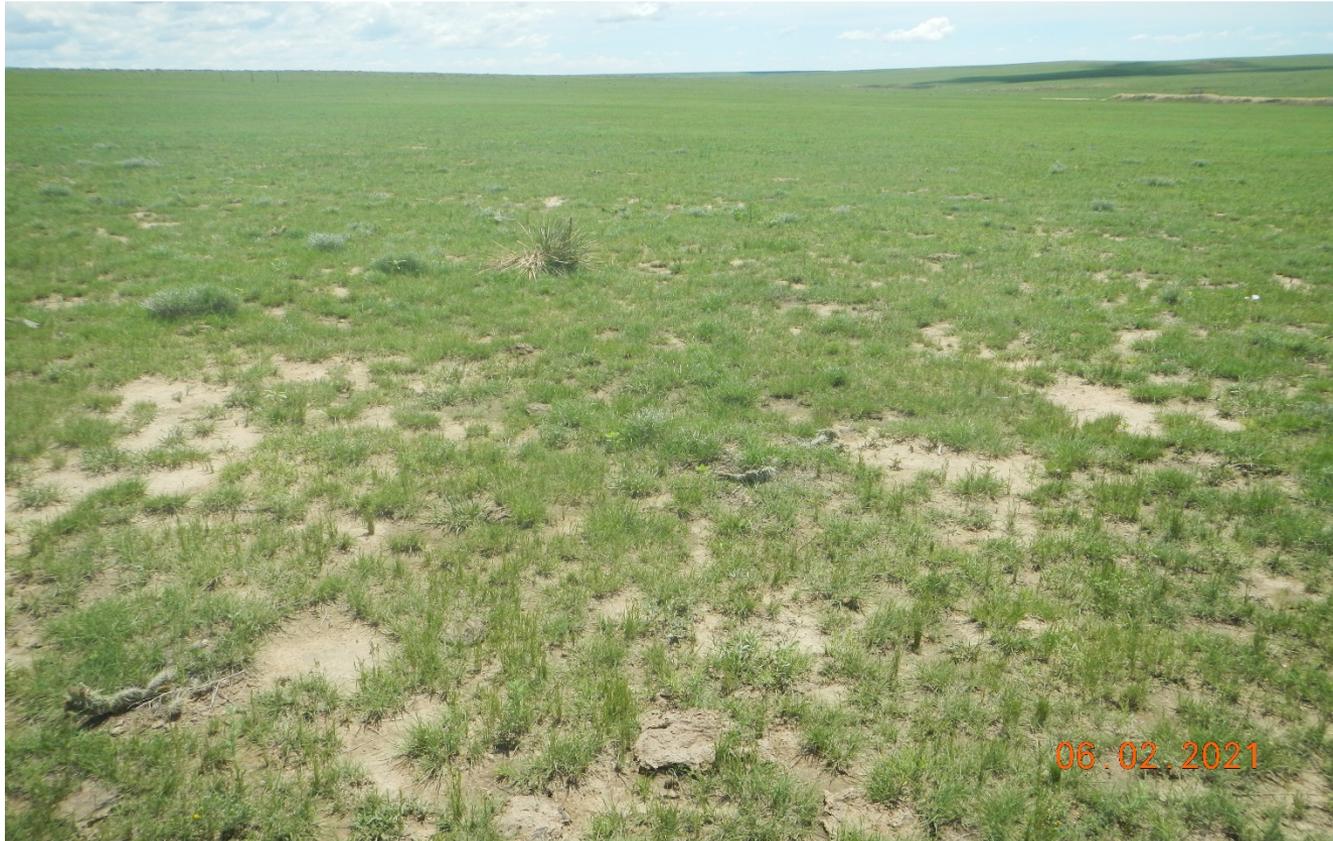
Photo 7. Facing southeast toward the undisturbed surrounding area.
