Inspection Photos

Location Name: MV 9-32 PAD

Location ID: 335087 & Spill/Release ID: 479989

Inspection Date: May 26, 2021

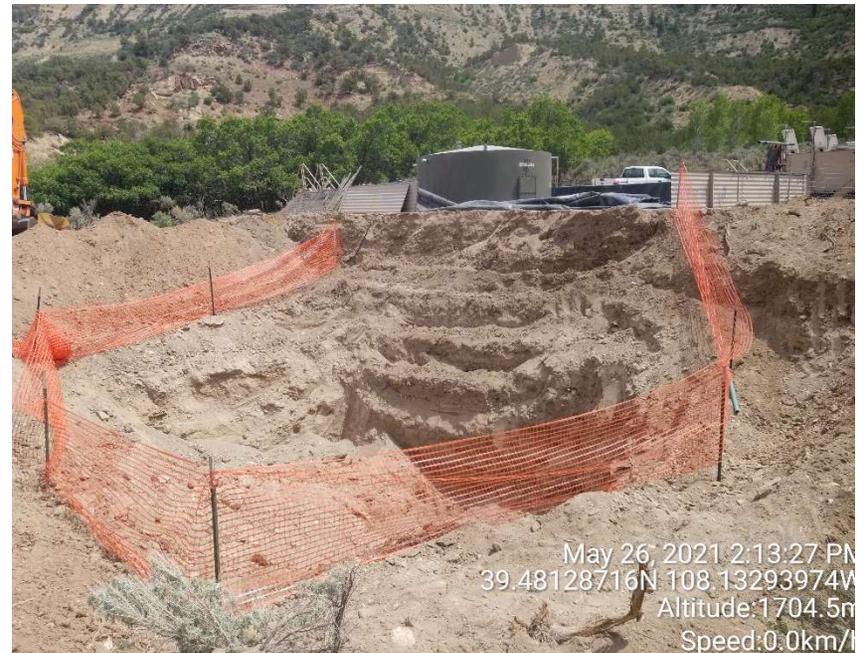
Excavation looking towards the tank battery where the spill/release originated. Note the tank battery secondary containment in disrepair.

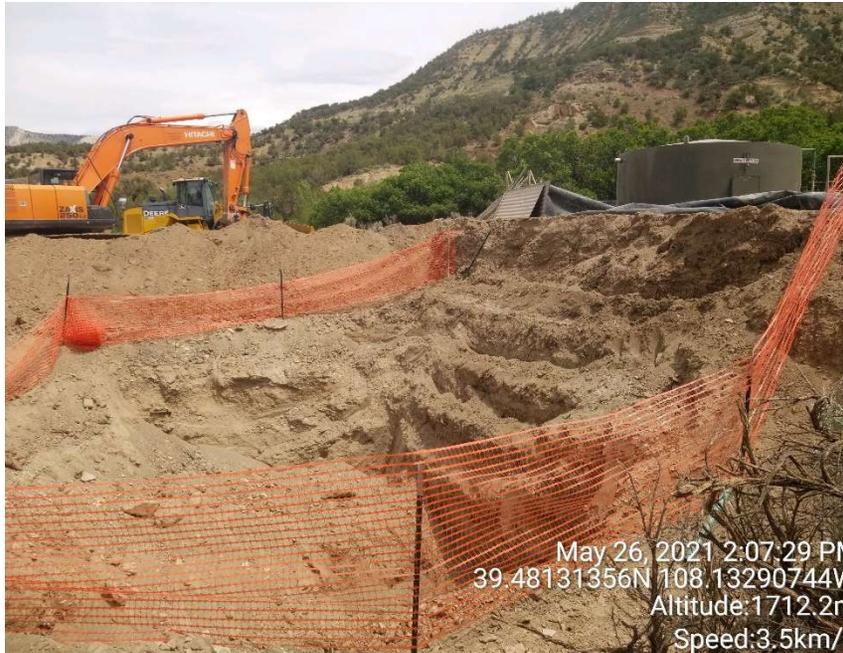
Excavation looking towards the tank battery where the spill/release originated. Note the tank battery secondary containment in disrepair.

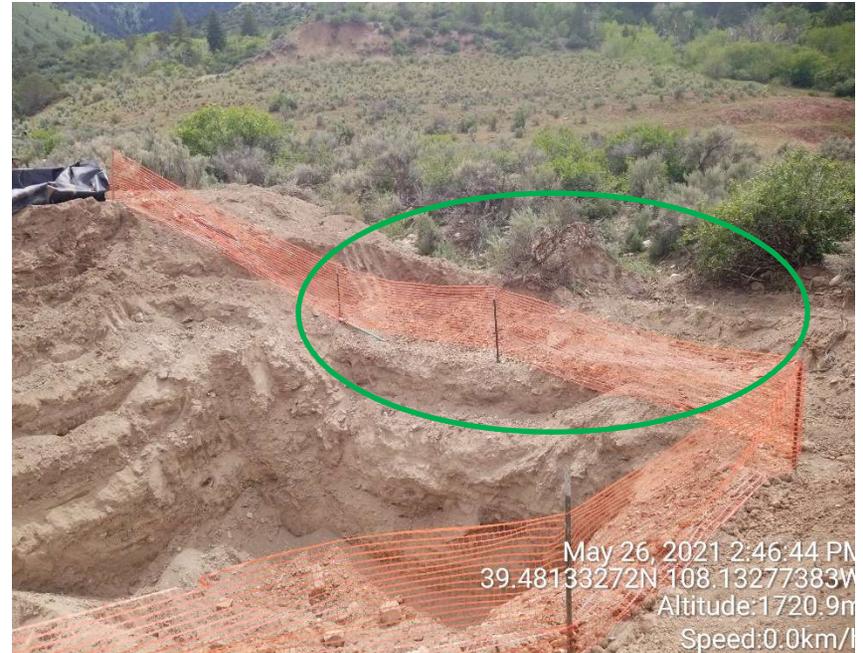
Excavation looking southwest. Note where the un-named dry arroyo intersects the excavation (green oval).

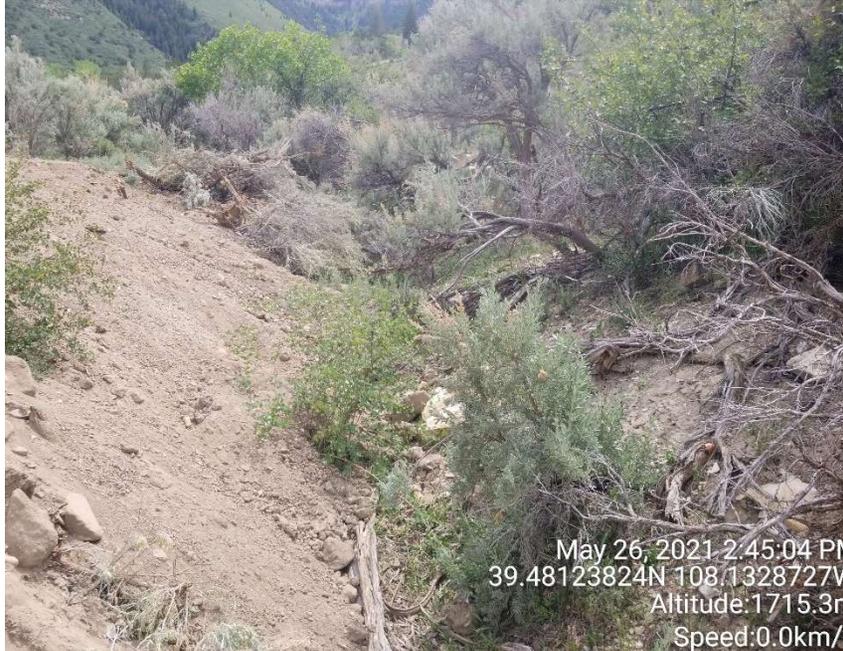
Un-named dry arroyo from the previous photo looking upstream of where it intersects with the excavation.

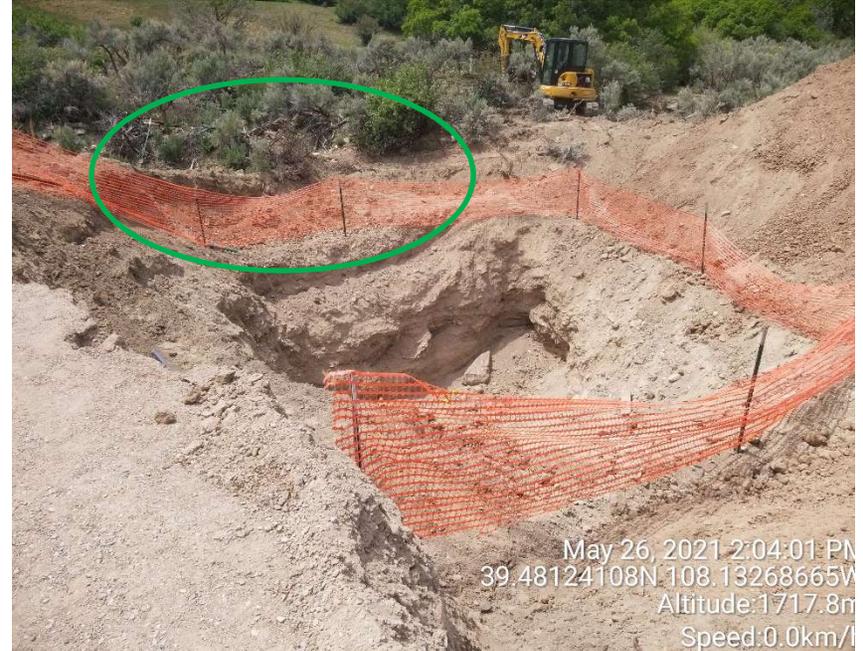
Excavation looking northwest. Note where the un-named dry arroyo intersects the excavation (green oval).

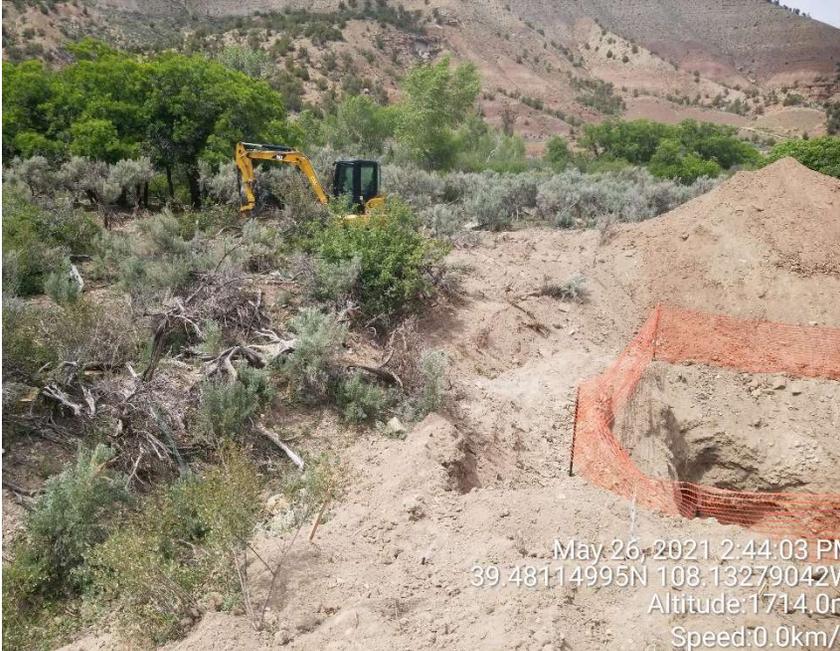
Un-named dry arroyo intersecting the excavation looking north.

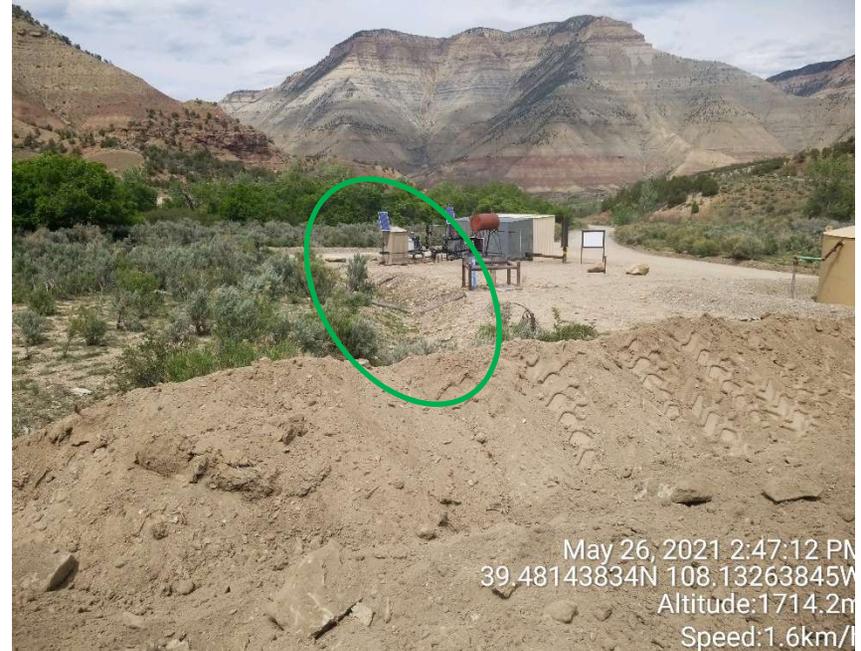
Land Treatment area built across an un-named, dry arroyo. Note where the un-named dry arroyo is visible on the northern end of the Land Treatment area (green oval).

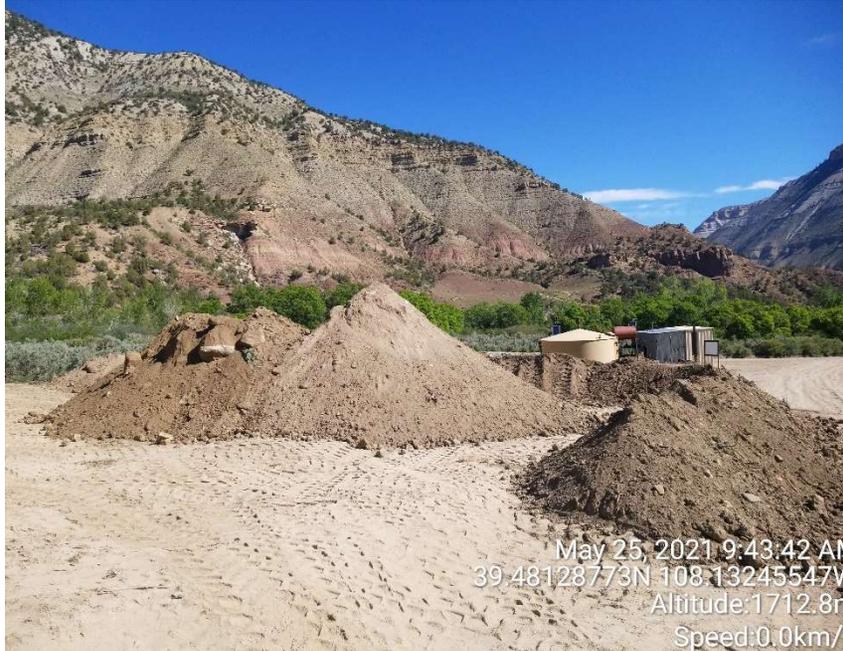
5/25/2021 Photo showing the stockpiles of potentially impacted material located adjacent to the excavation sidewalls. Some potential staining and a strong hydrocarbon odor was present at time of inspection.

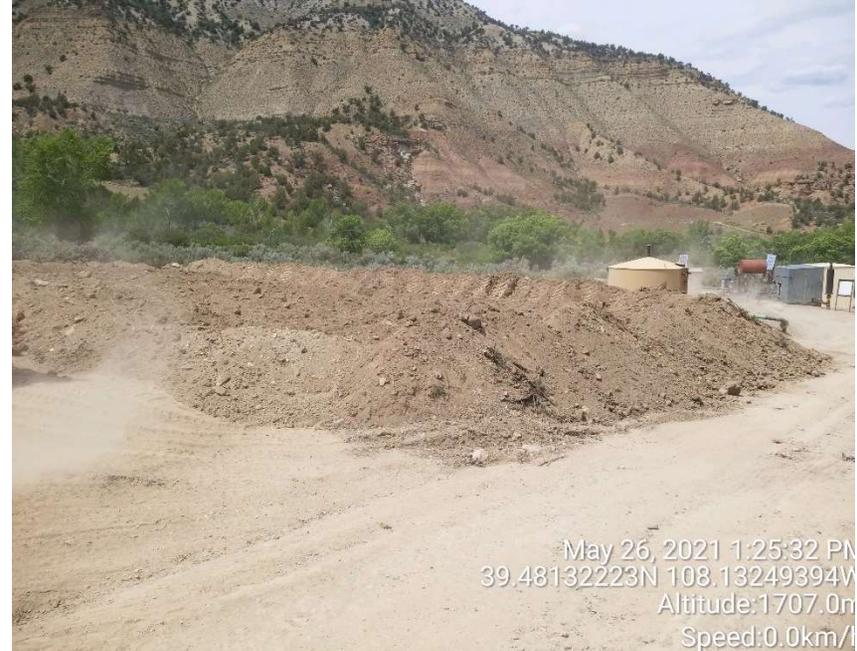
5/26/2021 Photo taken from the same approximate location as the previous photo. Note the newly constructed Land Treatment area that is not present in the previous photo. Some potential staining and a strong hydrocarbon odor was present at time of inspection.

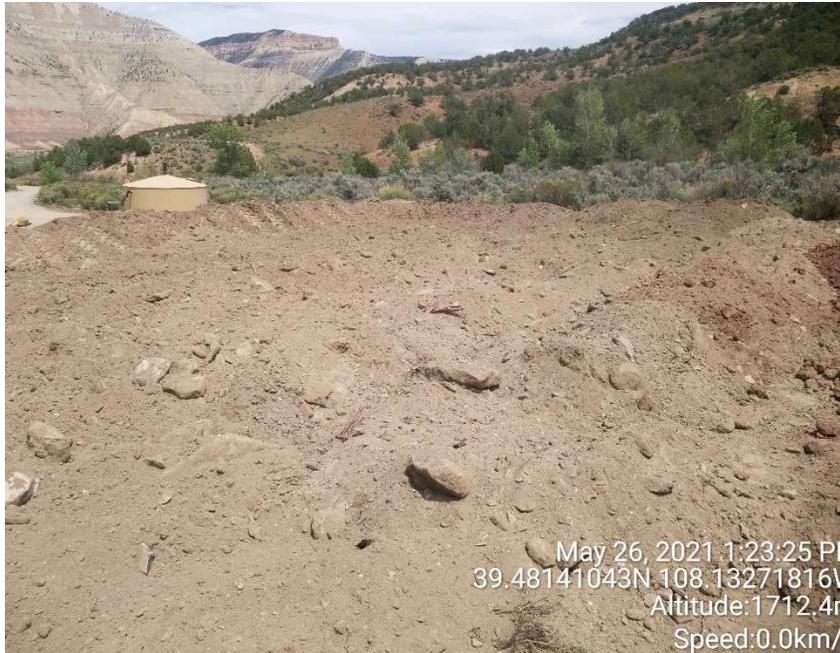
Land Treatment area looking northeast. Some potential staining and a strong hydrocarbon odor was present at time of inspection.

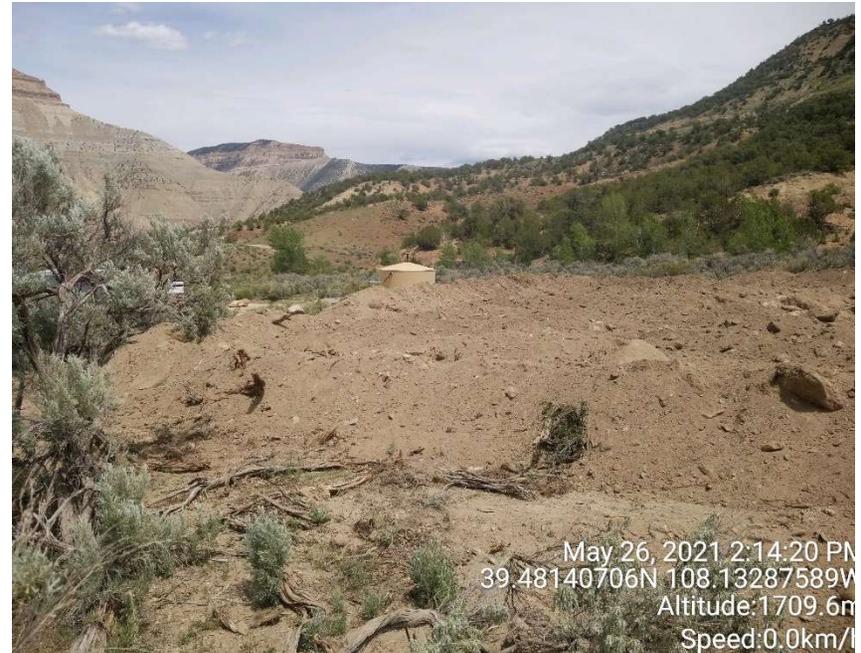
Land Treatment area looking northeast. Note the destroyed vegetation around the Land Treatment area. Some potential staining and a strong hydrocarbon odor was present at time of inspection.

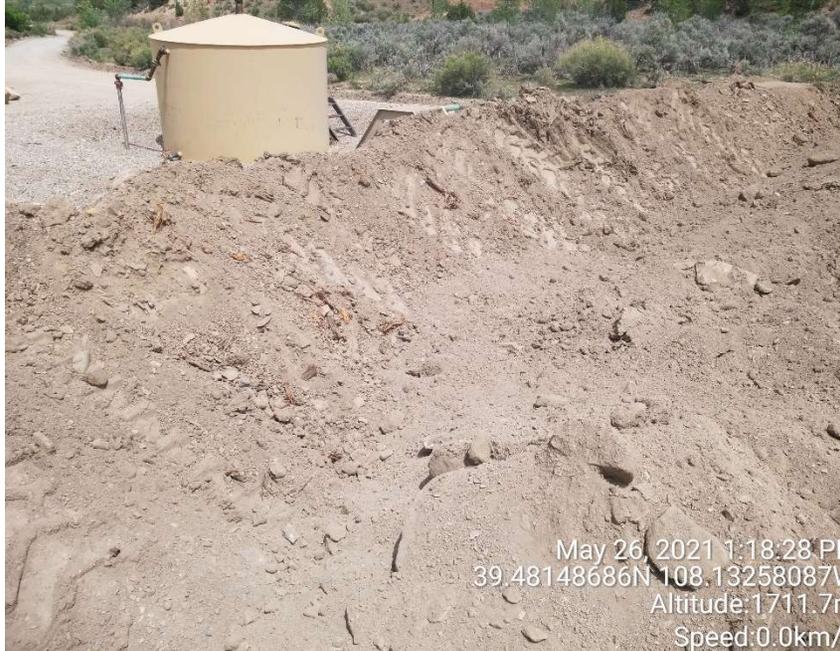
Land Treatment area encroaching on the tank battery associated with the CS_Starkey Gas Compressor Station (Facility ID 464837). Note the potential for access and safety concerns associated with the Gas Compressor Satiation location.

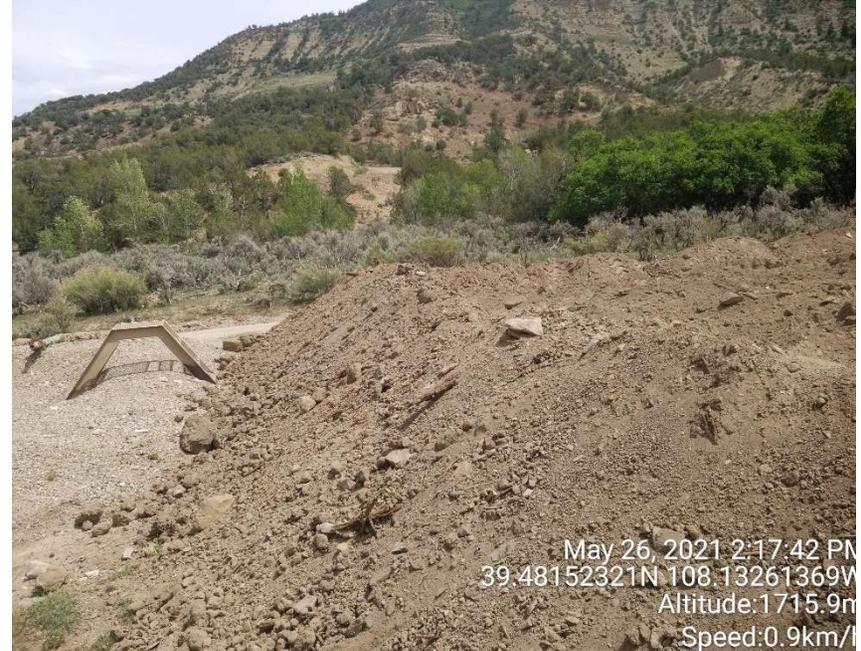
Land Treatment area encroaching on the tank battery associated with the CS_Starkey Gas Compressor Station (Facility ID 464837). Note the potential for access and safety concerns associated with the Gas Compressor Satiation location.

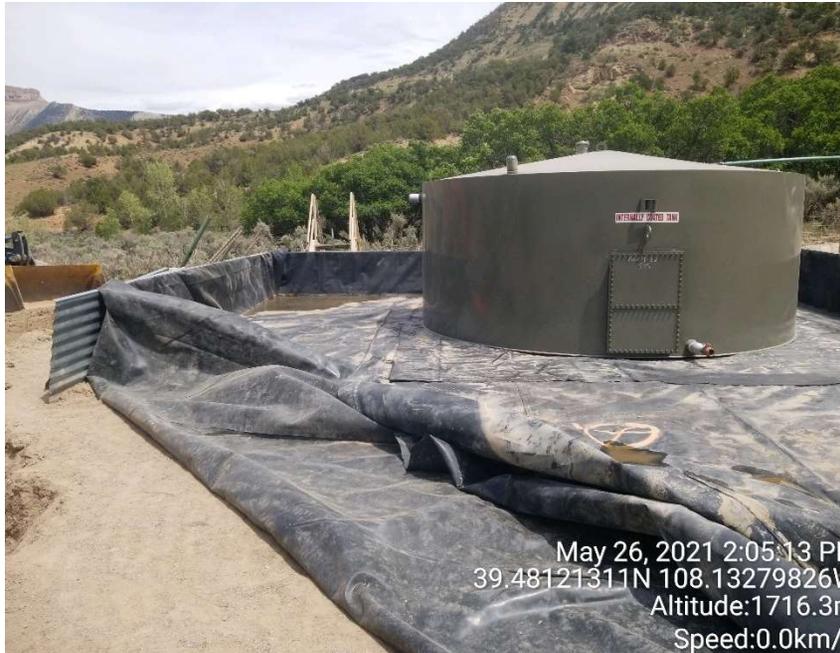
Secondary containment structure in disrepair. Note the orange spray painted area where a hole was observed in the liner of the secondary containment structure.

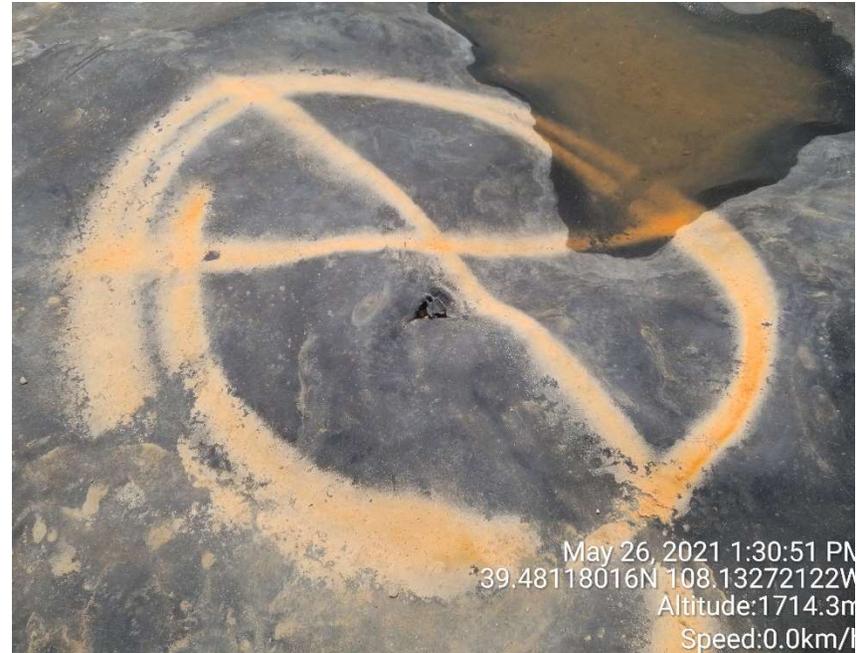
Spray painted area as observed in the previous photo. Note the storm water accumulation near the hole in the liner of the secondary containment structure.

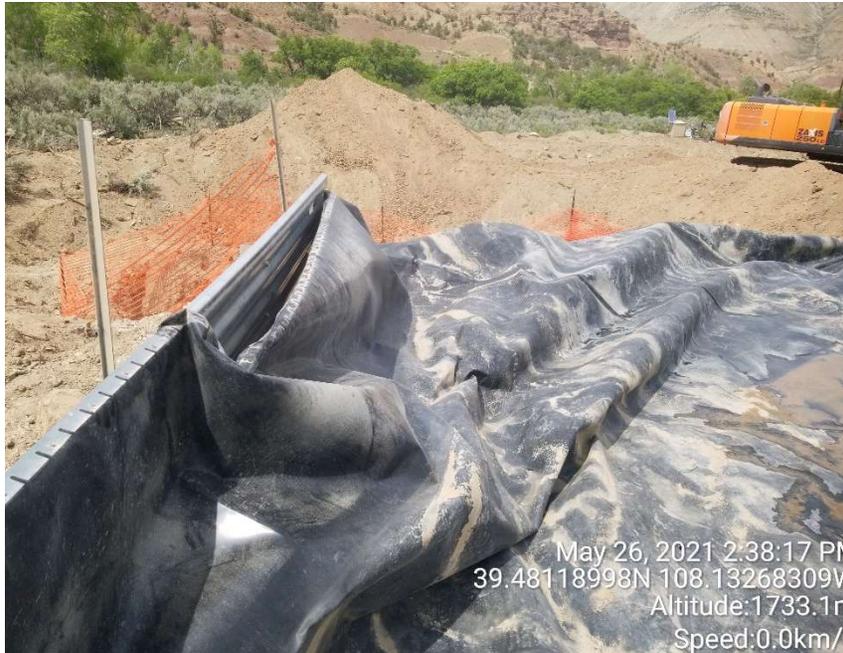
Secondary containment structure in disrepair with the excavation and Land Treatment area in the background.

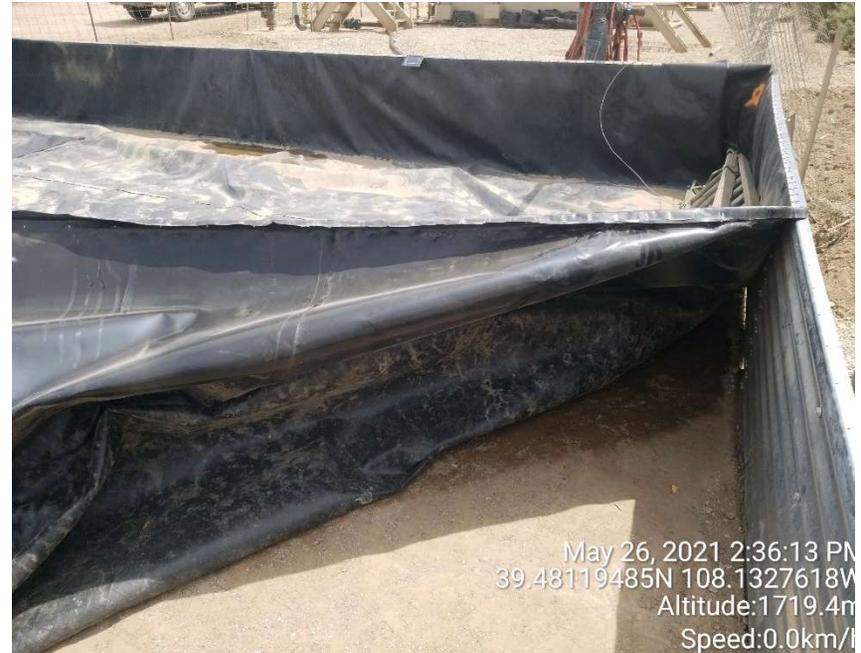
Potentially impacted material underneath the liner of the secondary containment structure around the northwest corner of the tank battery.

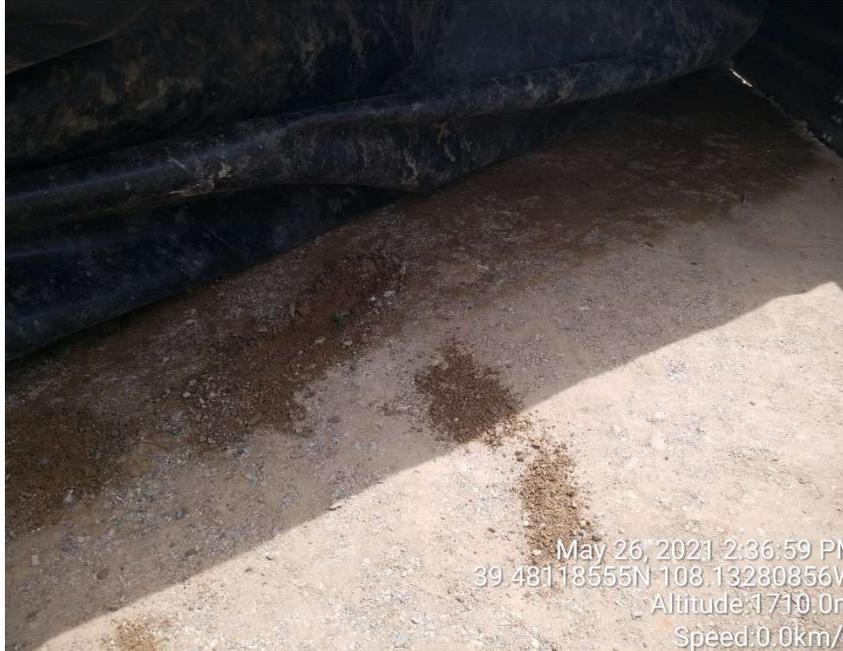
Potentially impacted material underneath the liner of the secondary containment structure around the northwest corner of the tank battery.

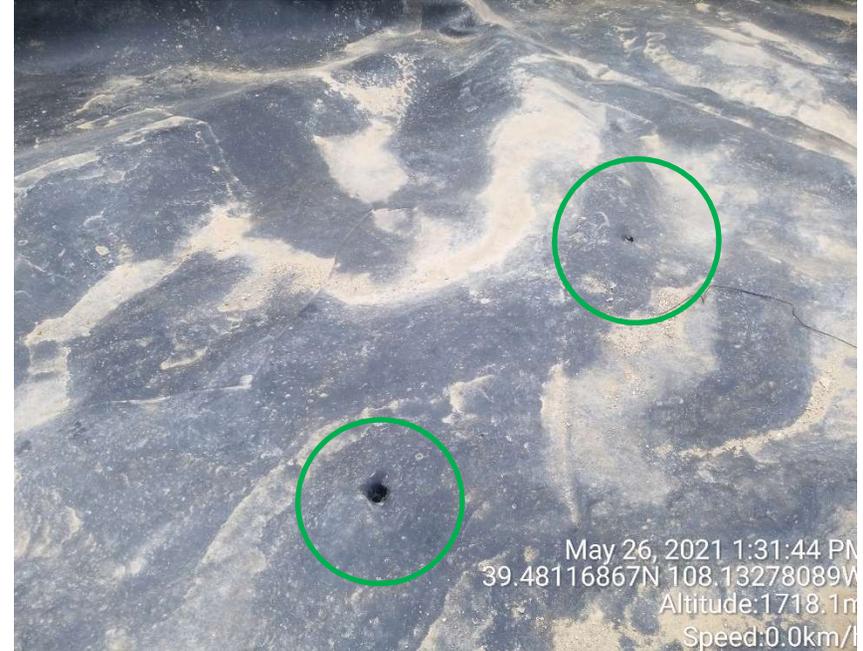
Additional holes in the liner of the secondary containment structure (green circles).

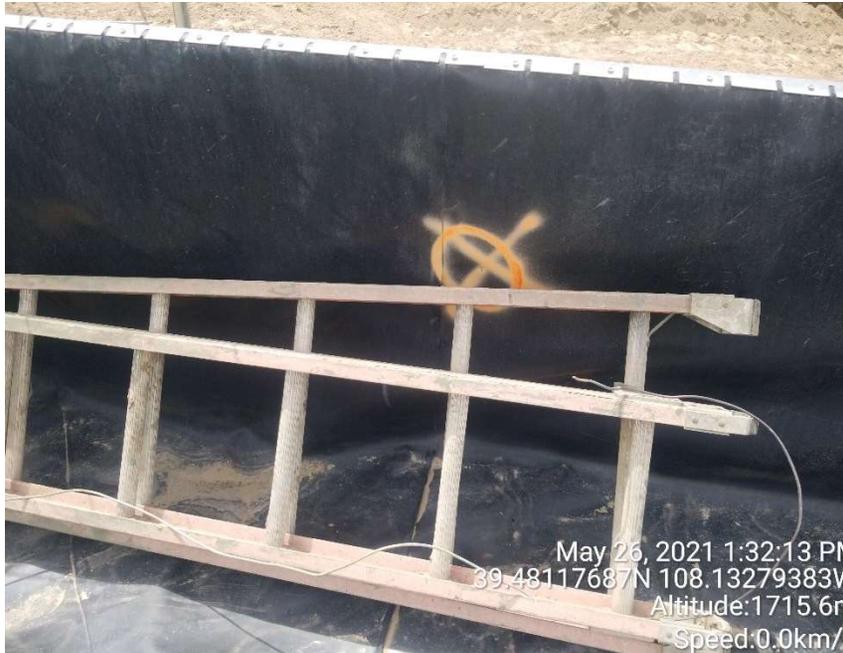
Spray painted area marking a hole in the liner of the secondary containment structure. It appears that equipment is being stored in the tank battery secondary containment structure.

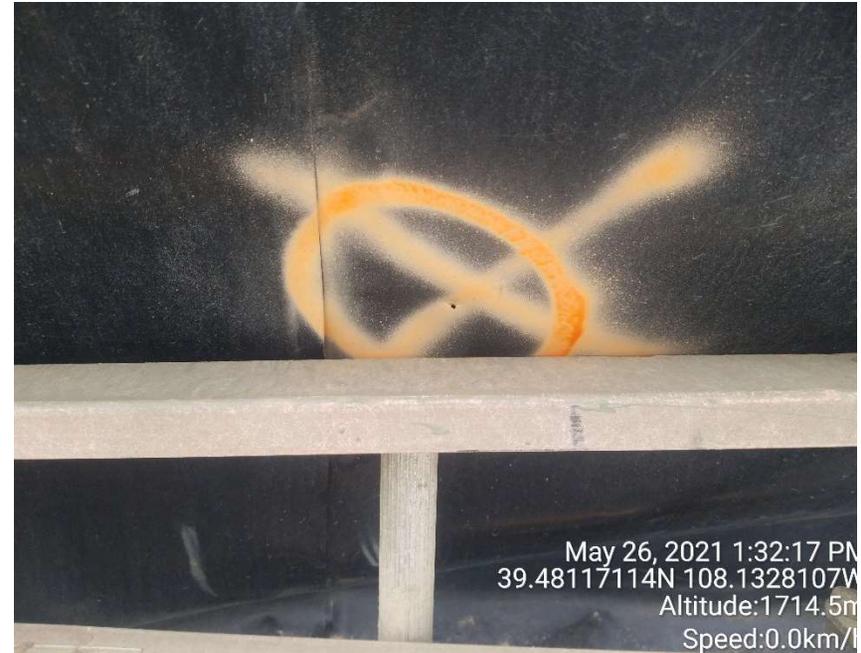
Close up of the previous photo, spray painted area marking a hole in the liner of the secondary containment structure. It appears that equipment is being stored in the tank battery secondary containment structure.

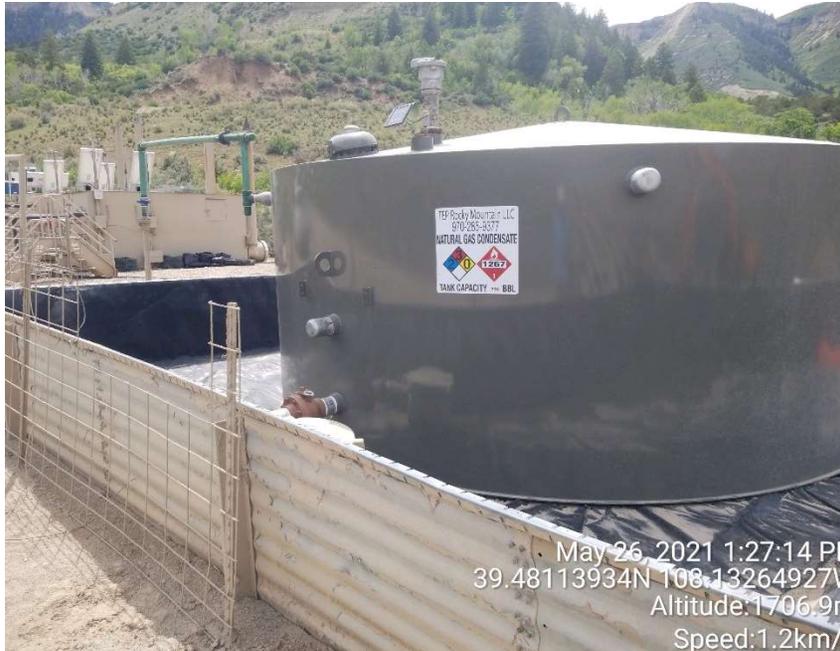
Newly installed 200 bbl Steel AST condensate tank. Note the newly installed flowline that is attached to the Steel.

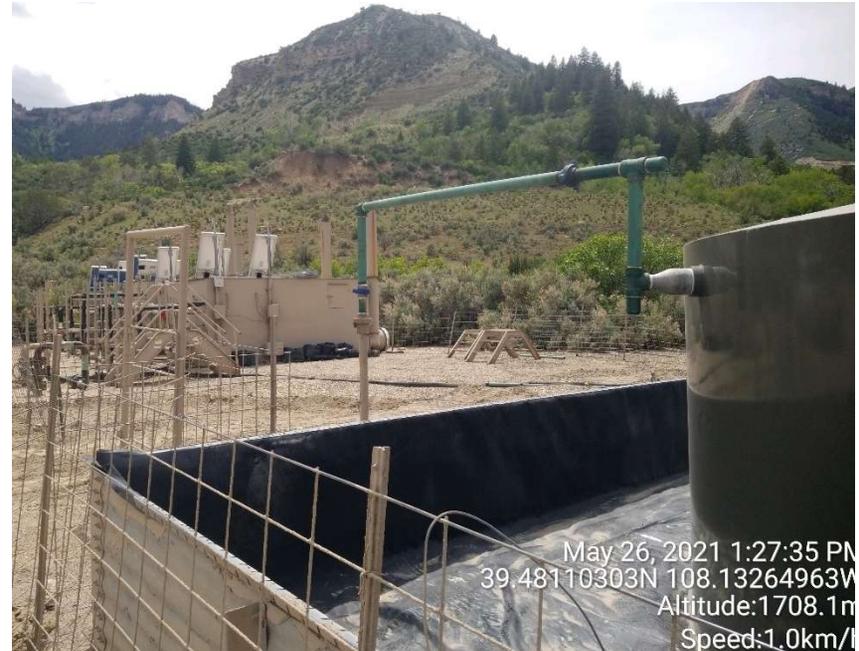
Newly installed 200 bbl Steel AST condensate tank. Note the newly installed flowline that is attached to the Steel.

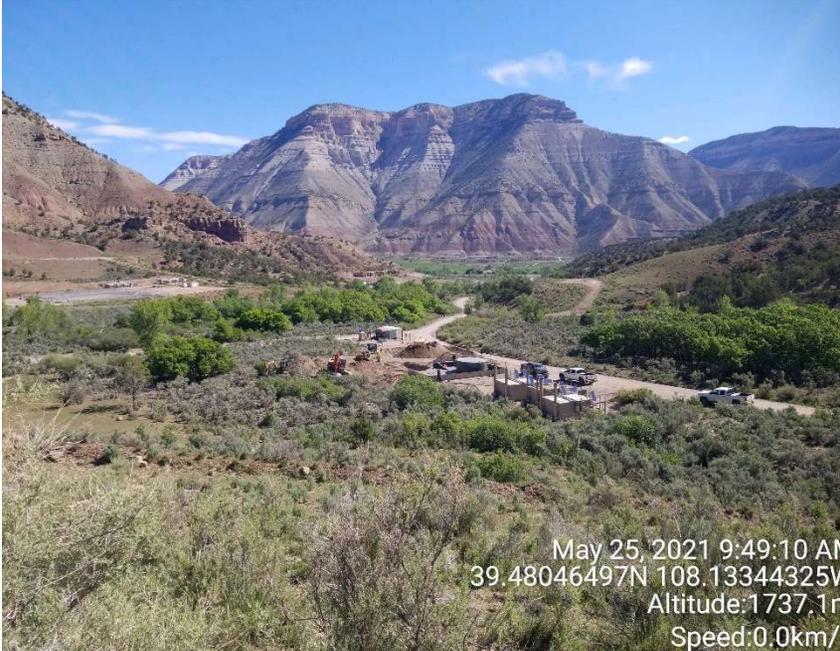
5/25/2021 View of the MV 9-32 PAD from the pad where the associated wells are located.

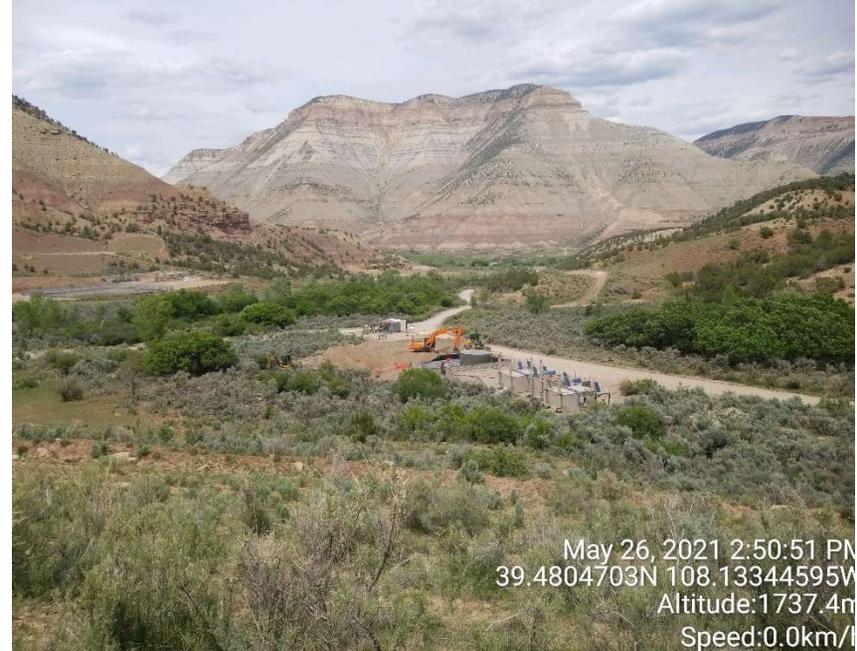
5/26/2021 View of the MV 9-32 PAD from the pad where the associated wells are located. Note the addition of the Land Treatment area and the increased size of the disturbance.
