Inspection Photos
Paul Heinze #1 Flowline & Paul Heinze #1 Flowline (No. 2)
Spill ID 479232 (AC) & Spill ID 480128 (AC)

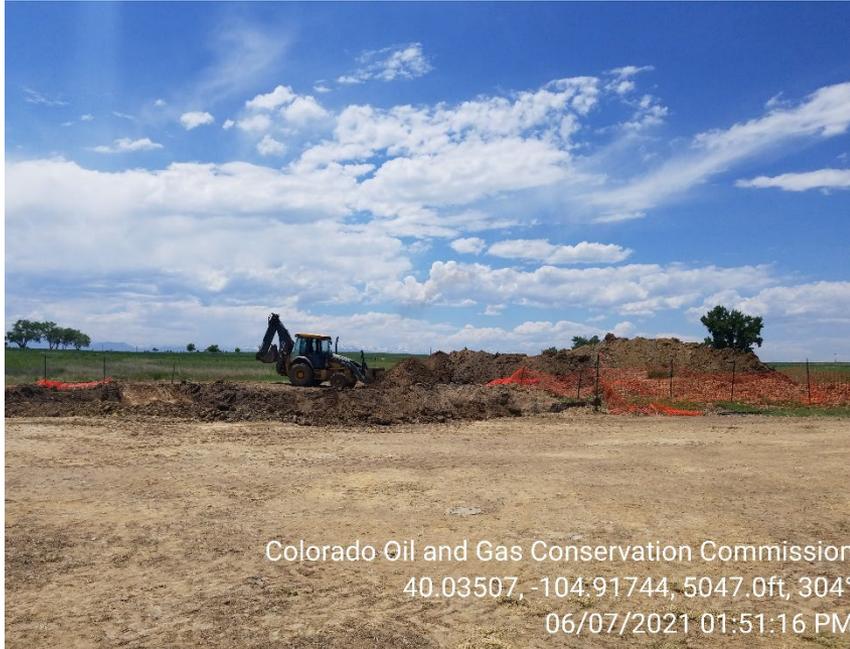
Photo 1 – Spill area. Excavation in process at the time of the inspection.

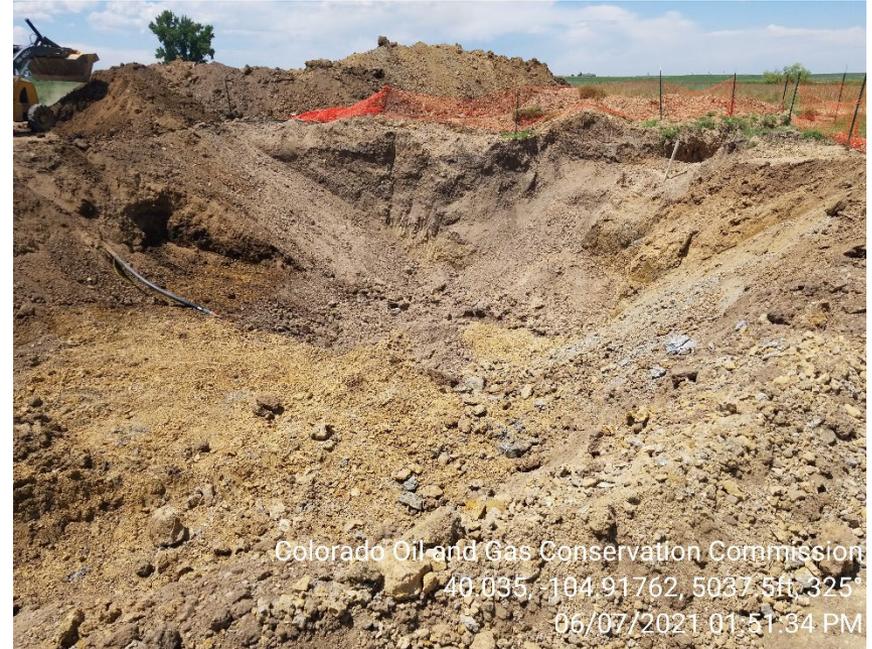
Photo 2 – Open excavation. Excavation appears to have been partially backfilled.

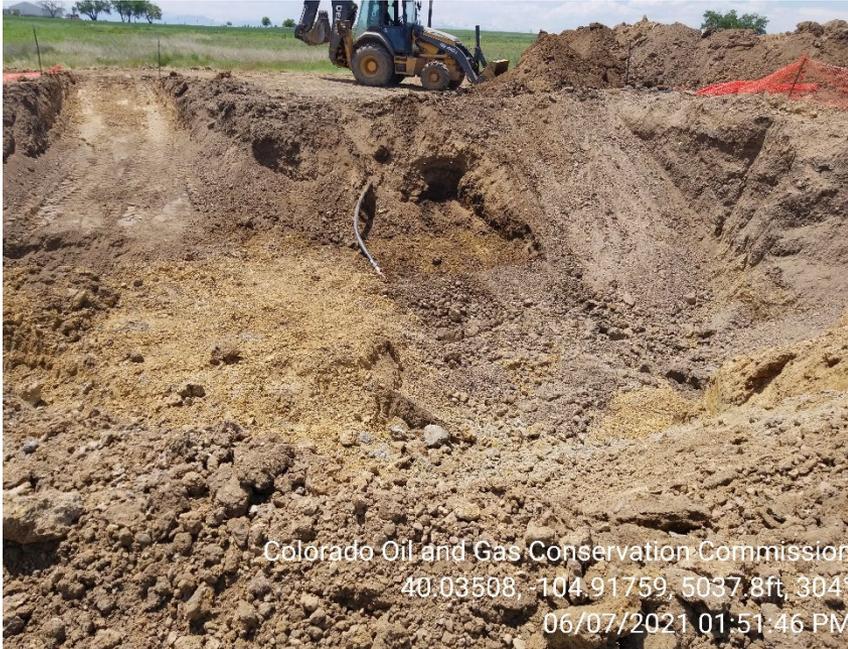
Photo 3 – Open excavation. Area where free product was previously observed appears to have been partially backfilled.

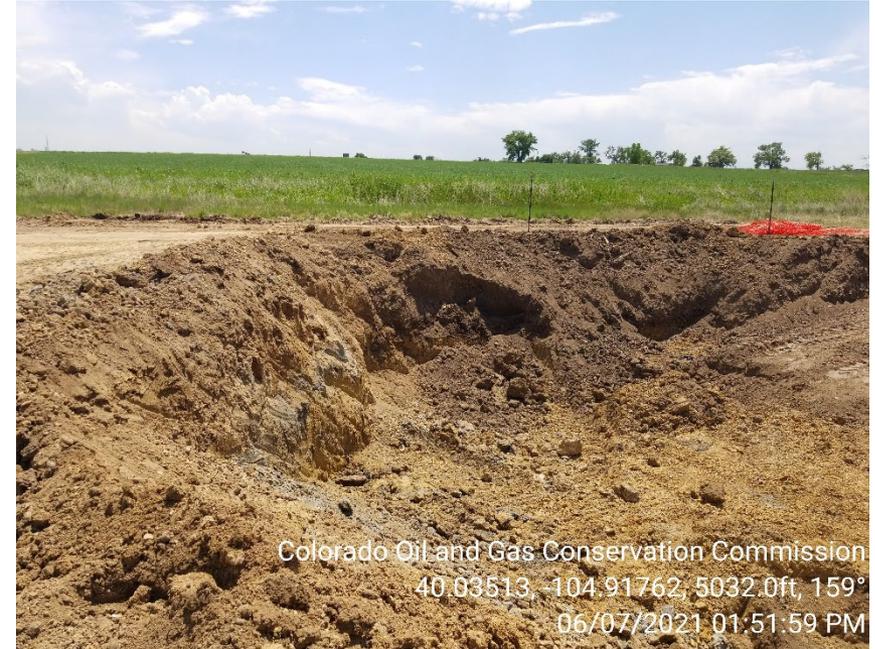
Photo 4 – Open excavation. Impacts remain in situ. Excavation appears to have been partially backfilled.

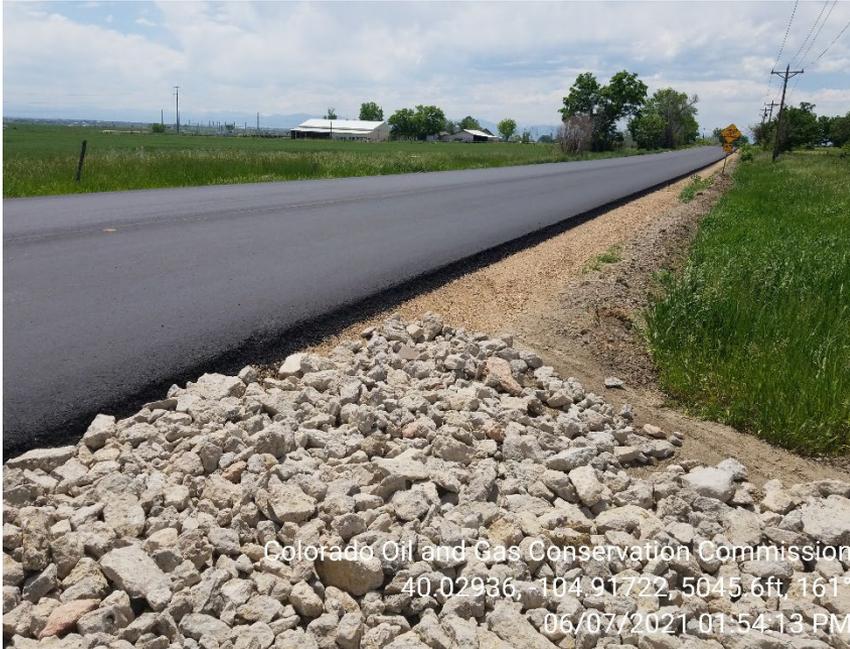
Photo 5 – Vehicle tracking BMPs have been installed and dirt previously carried of location has been removed/cleaned.

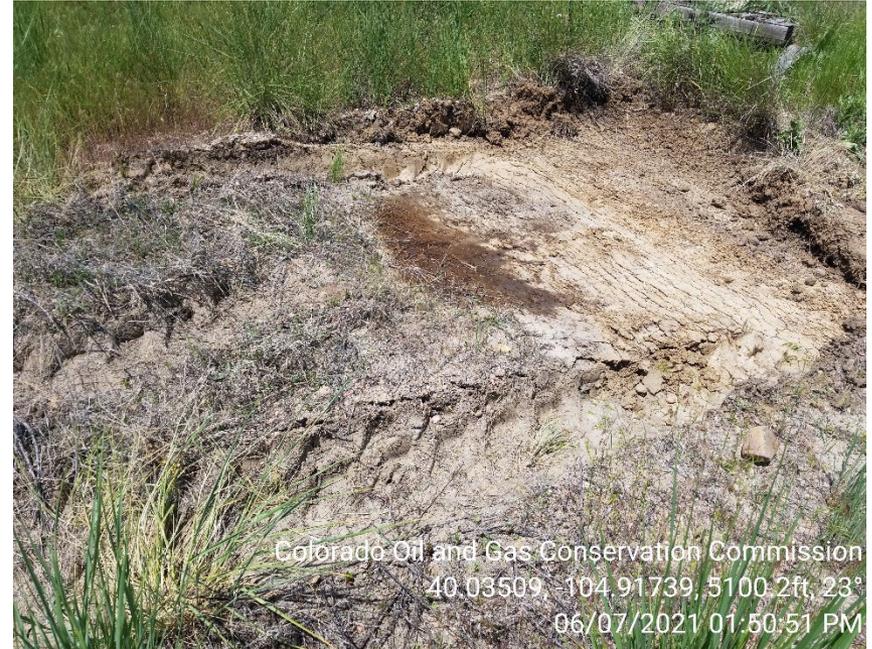
Photo 6 – New Spill (spill ID 480128). Surface area has been scraped. Impacts remain in situ and visible on the surface.
