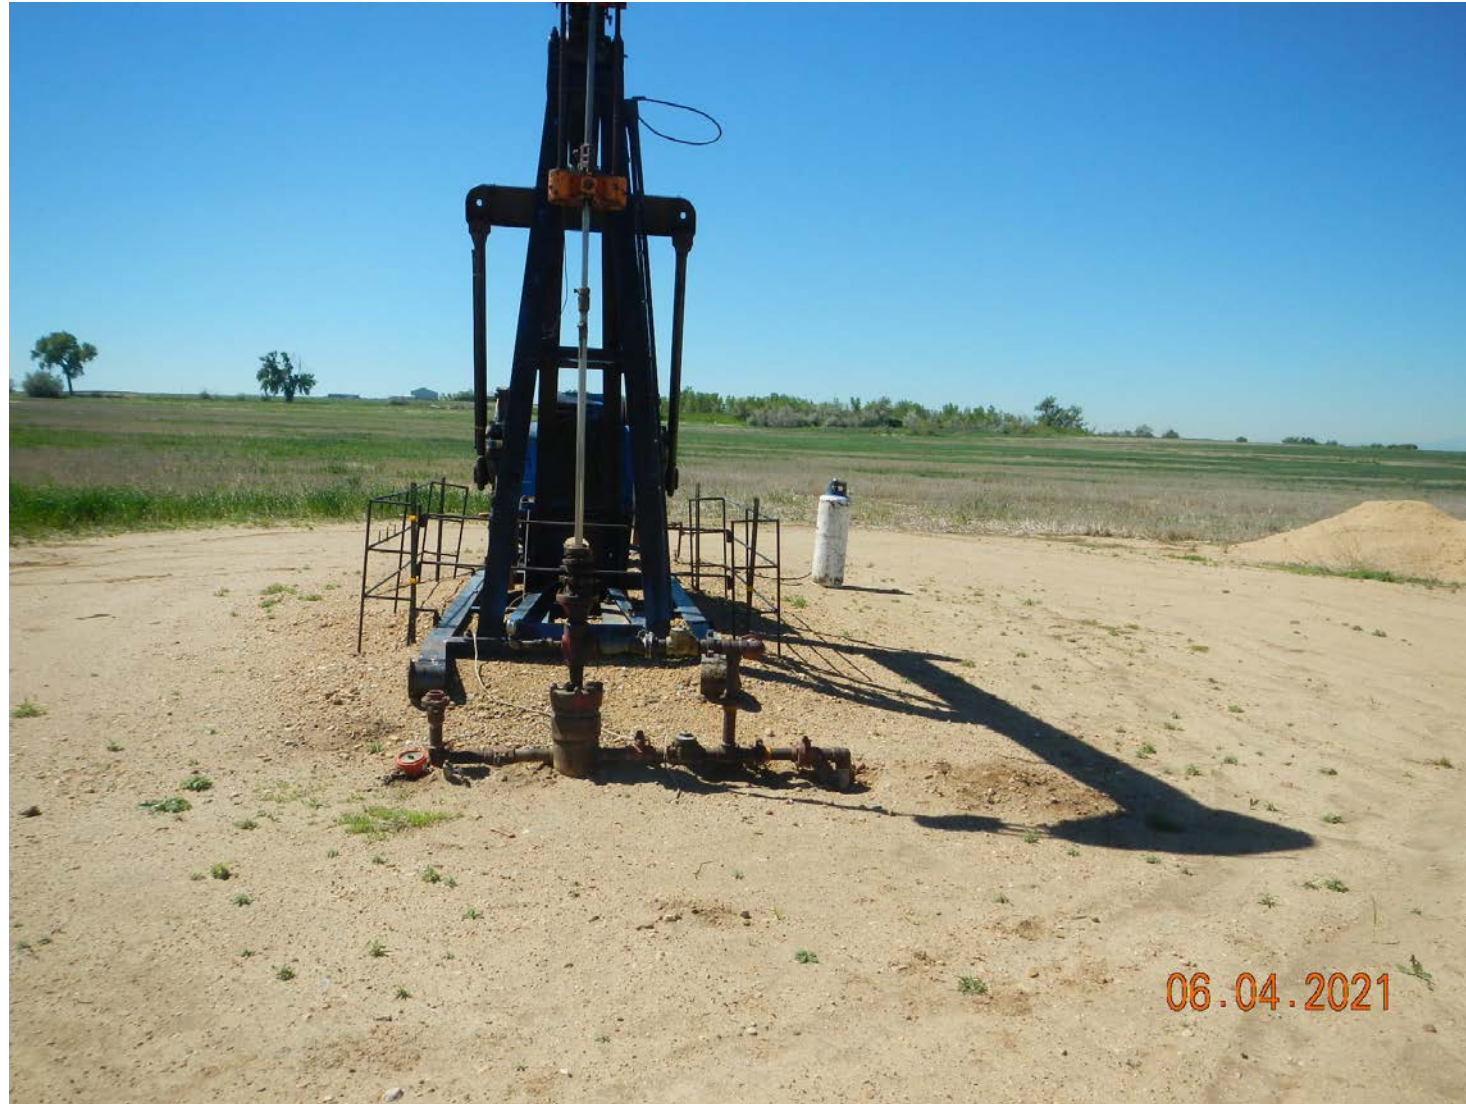
- Photo 1 – Wellhead view south, no sign at wellhead

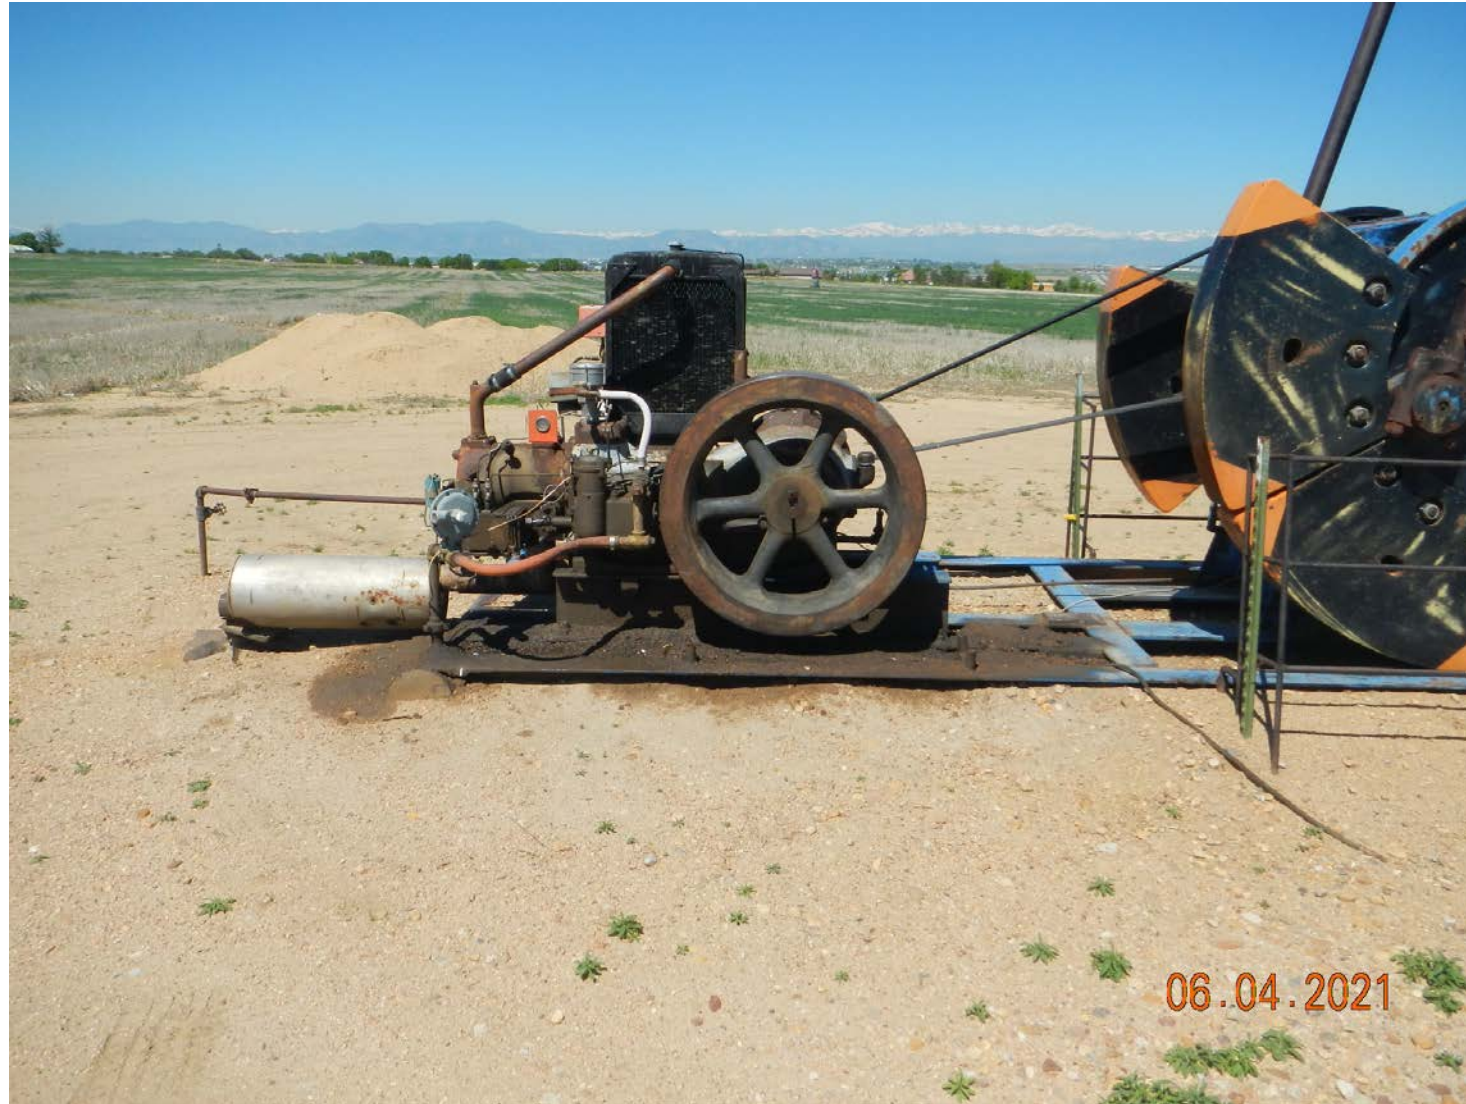
- Photo 2 – Non E&P waste impacted soil at pumping unit motor, view west

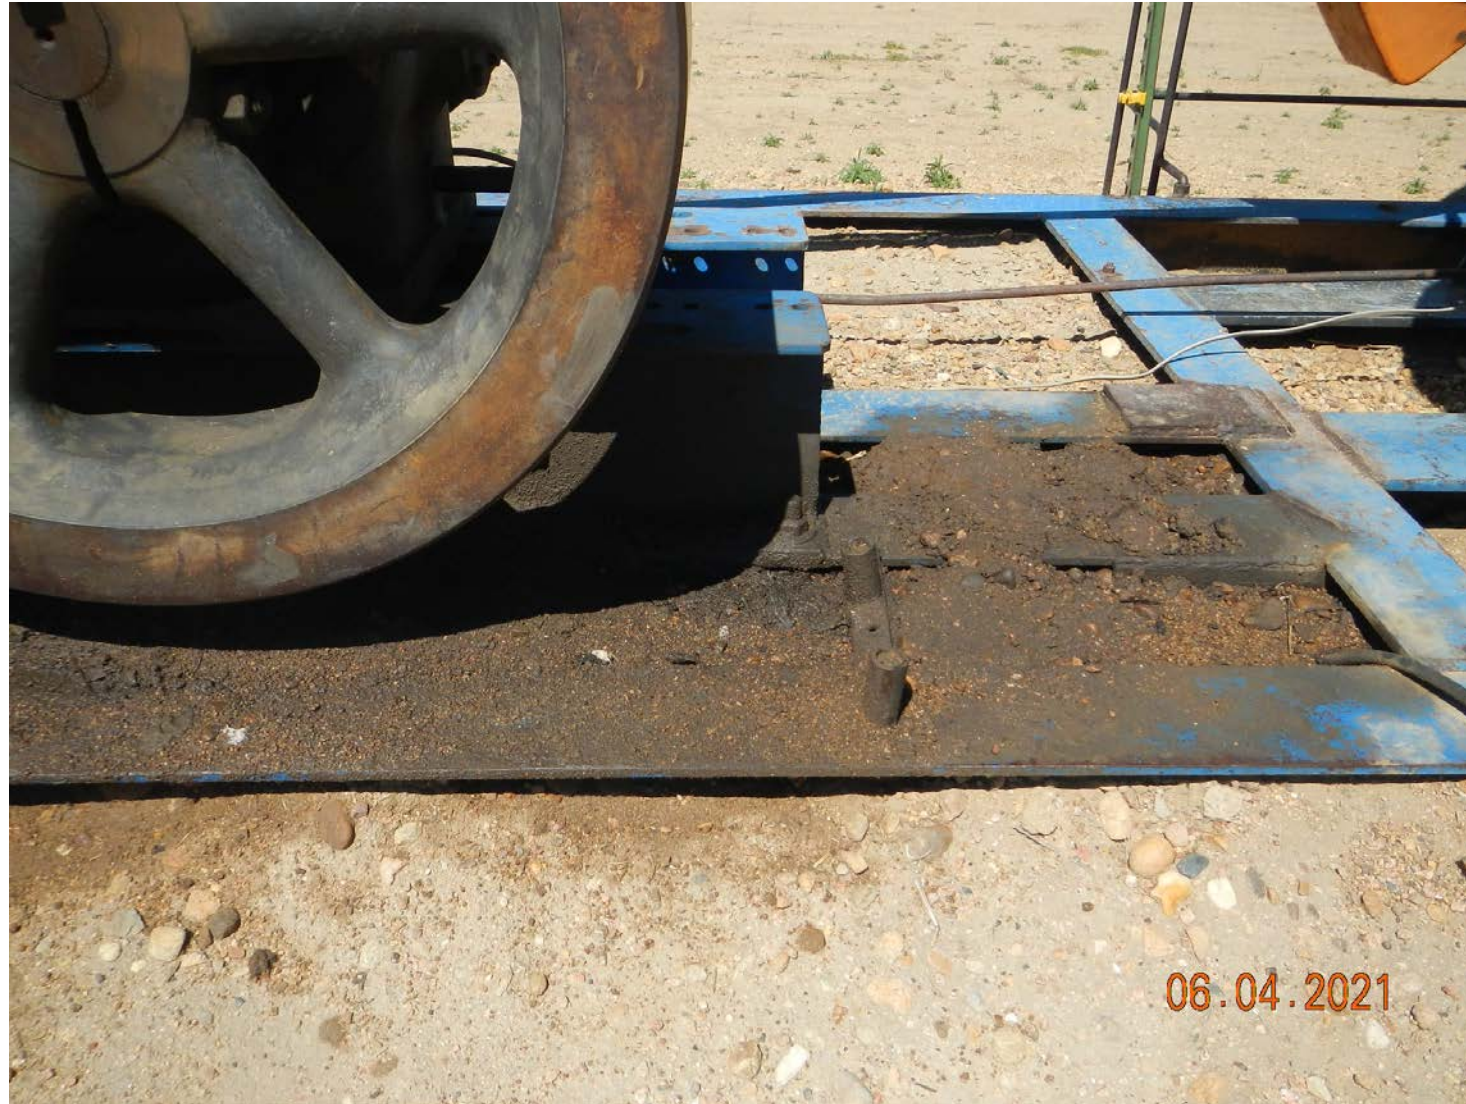
- Photo 3 – Non E&P waste impacted soil at pumping unit motor

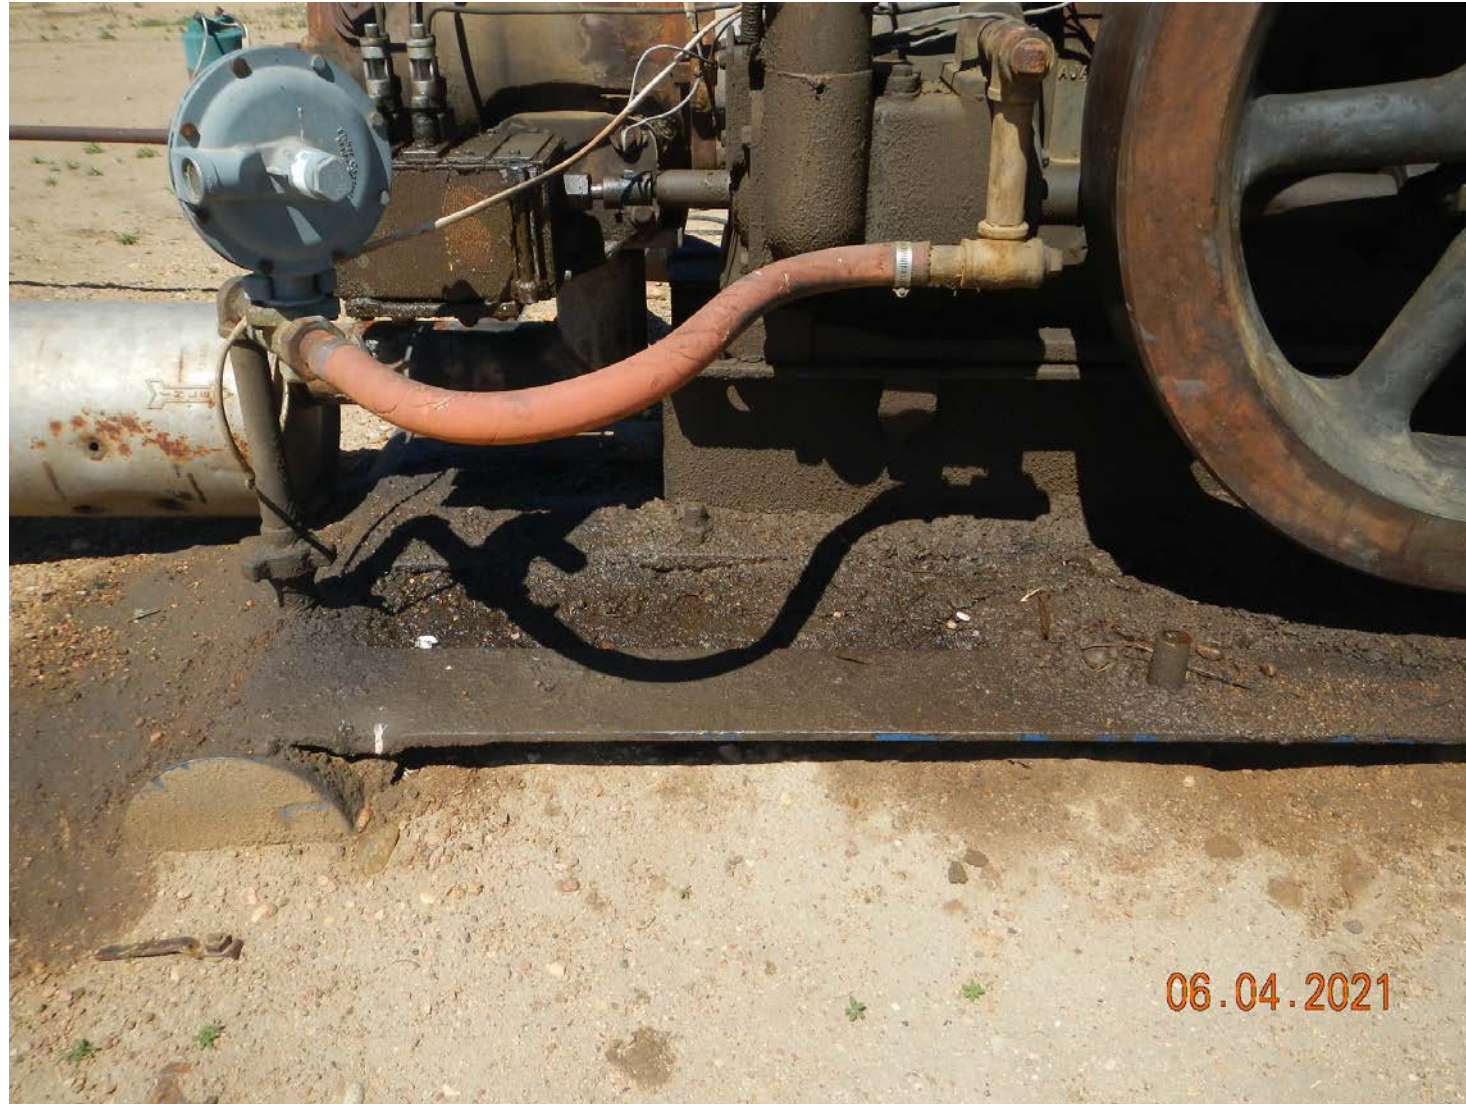
- Photo 4 – Non E&P waste impacted soil at pumping unit motor

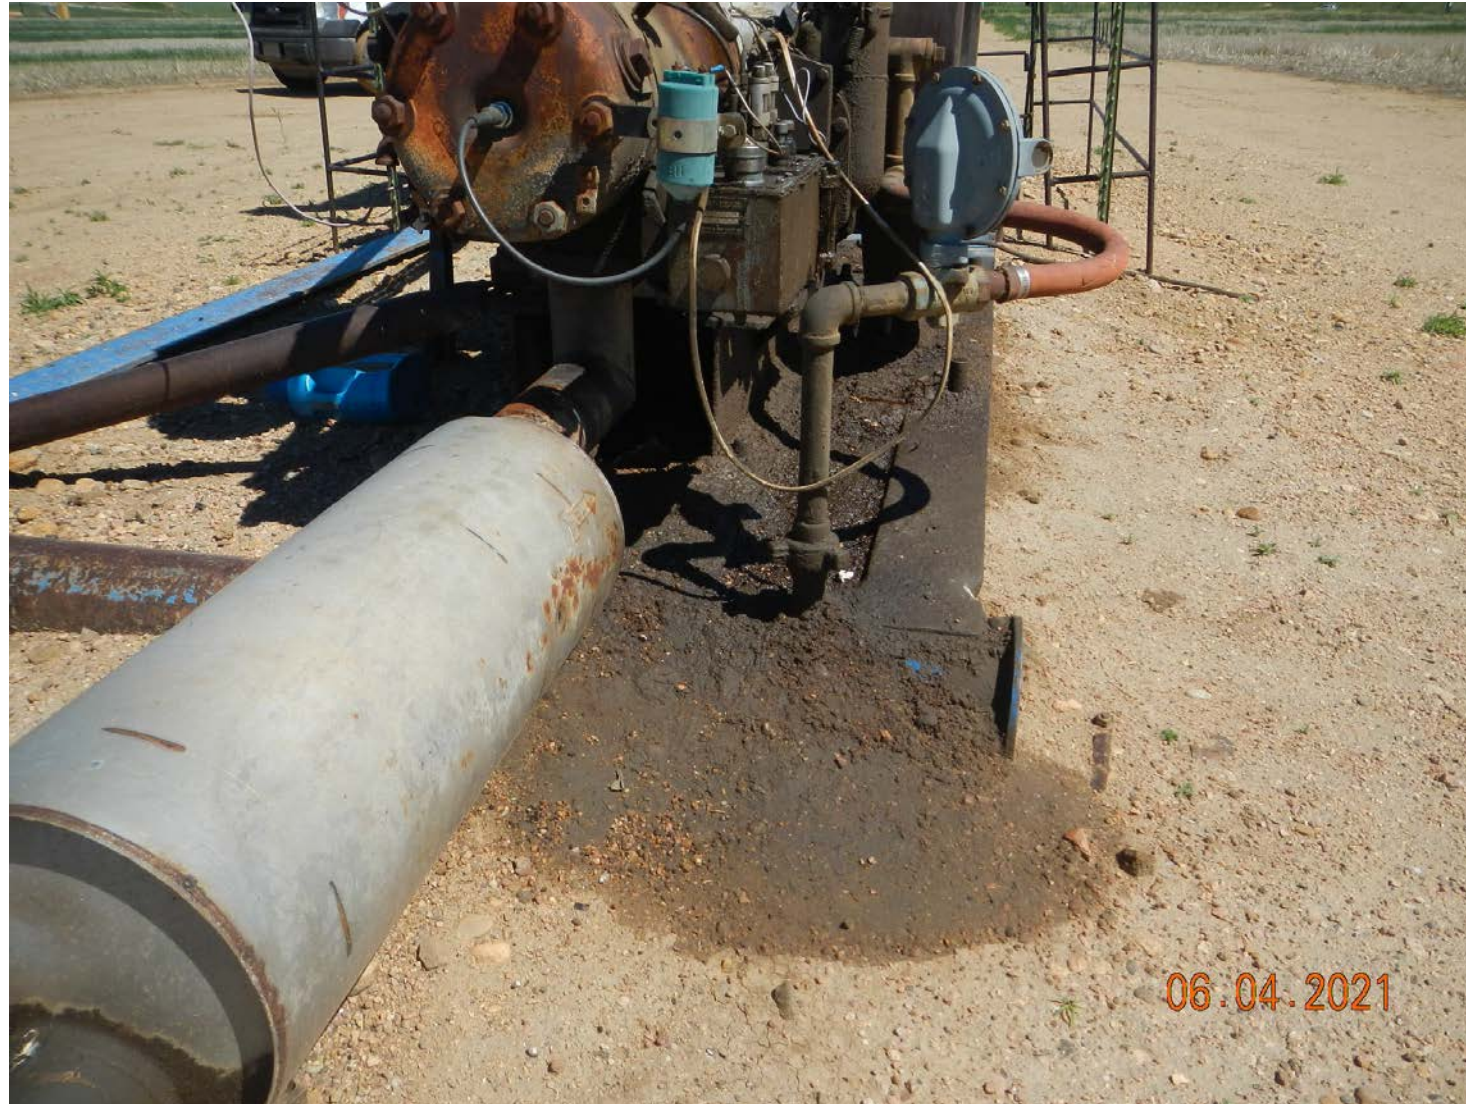
- Photo 5 – Non E&P waste impacted soil at pumping unit motor

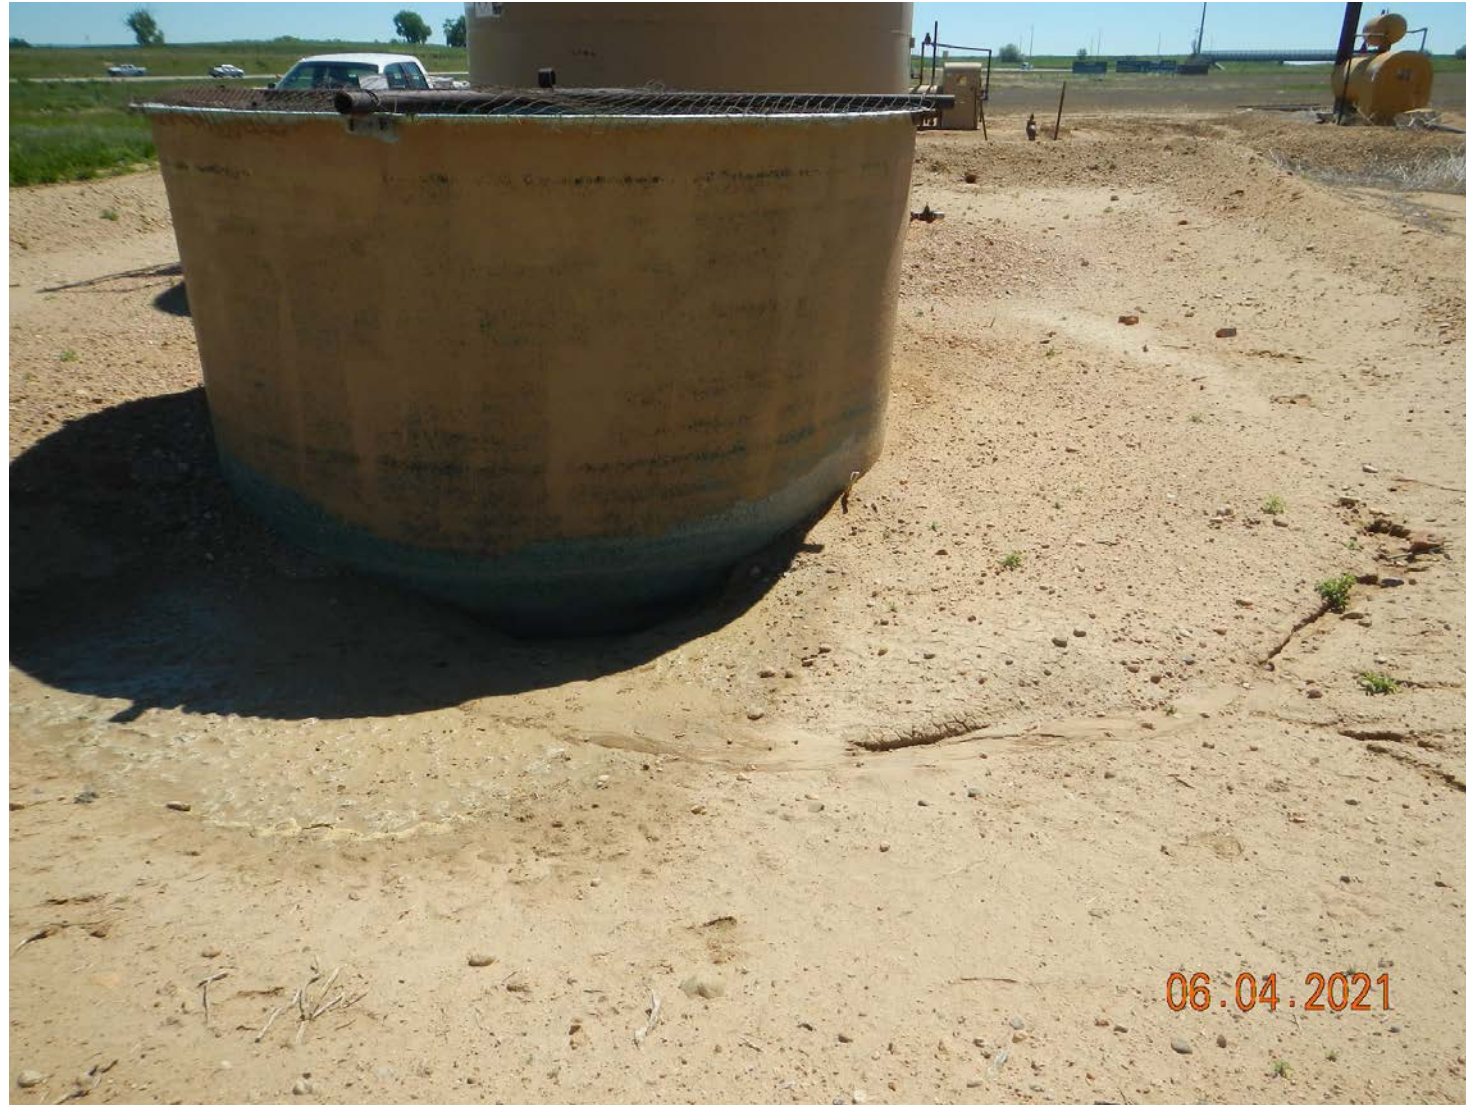
- Photo 10 – Erosion rilling indicates secondary containment rainwater drained toward depression at the base of the oil skim tank see next photo
