Inspection Photos
Location Name: Longmont Farms Unit 5
API 05-123-13222; Spill ID 479267

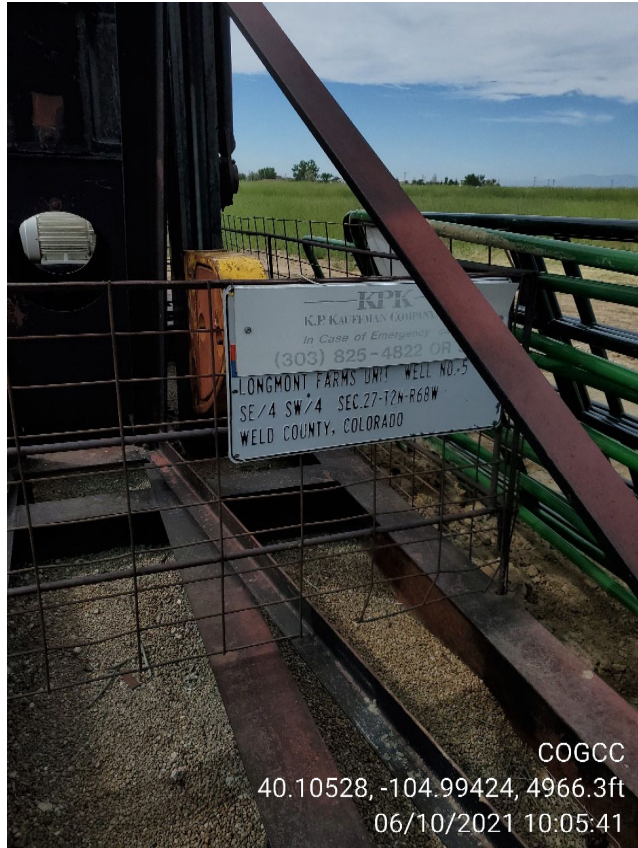
Photo 1 Well Sign

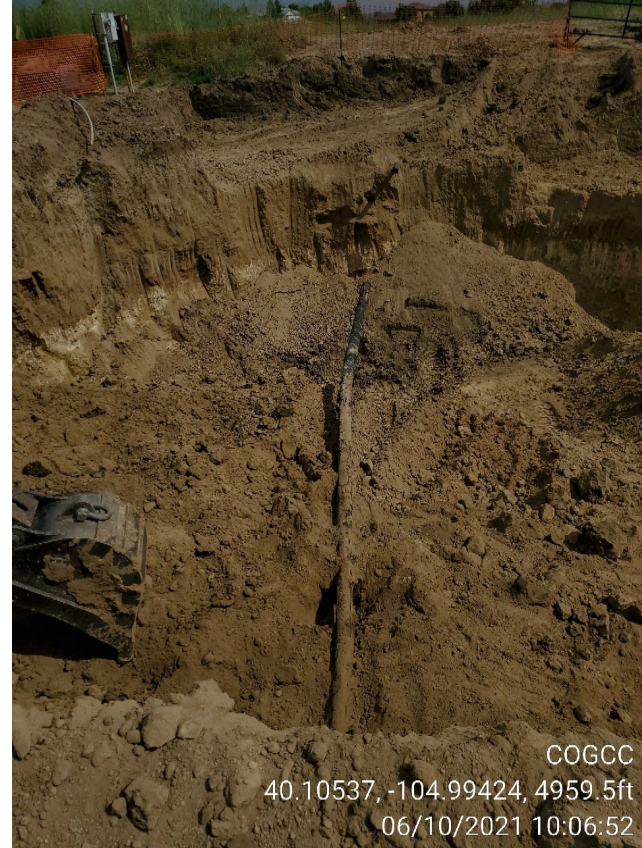
Photo 2 Flowline exposed in excavation, looking north

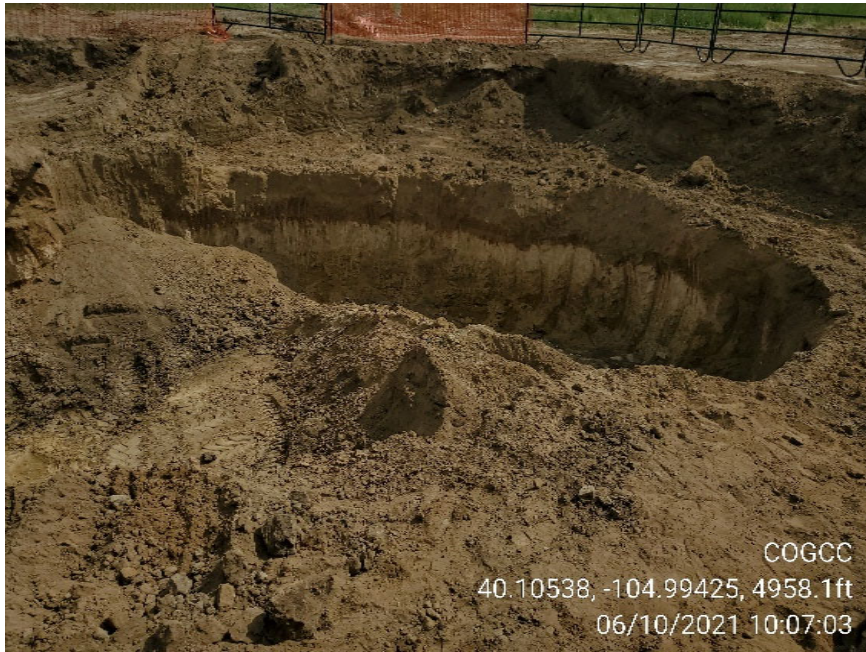
Photo 3 Eastern side of excavation looking north

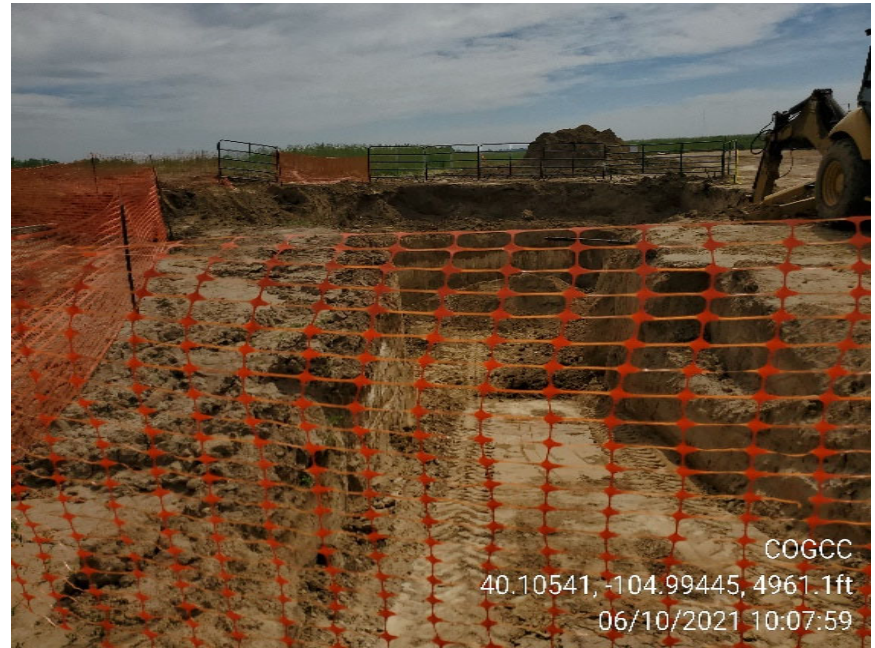
Photo 4 Western side of excavation, looking east

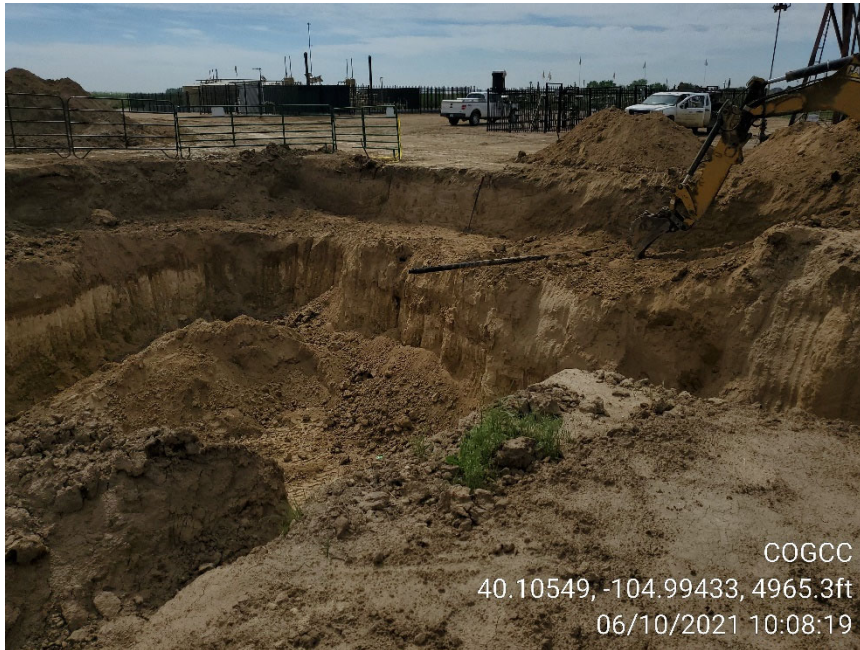
Photo 5 Northwestern side of excavation, looking southeast

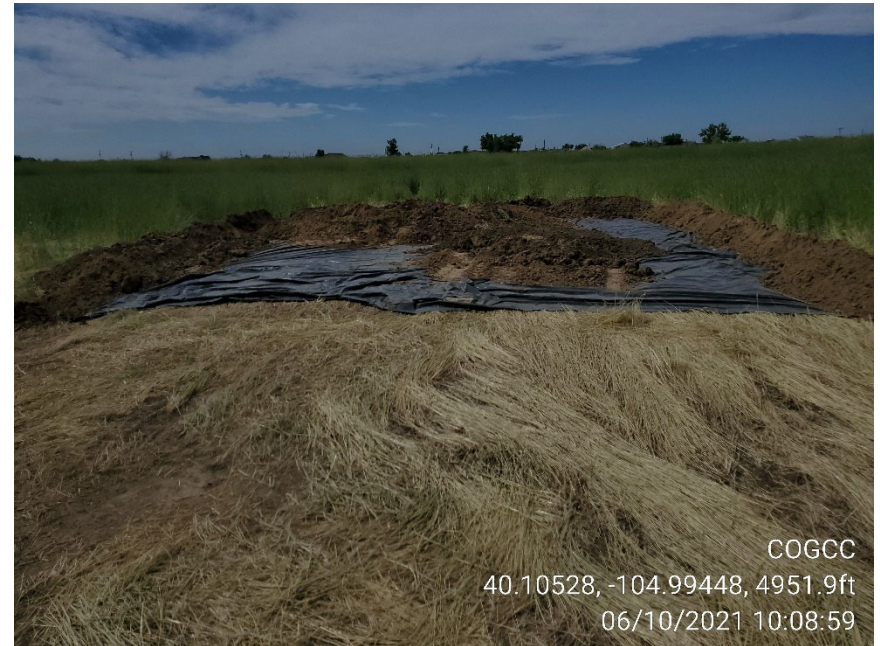
Photo 6 Stockpile area for oily waste pending disposal

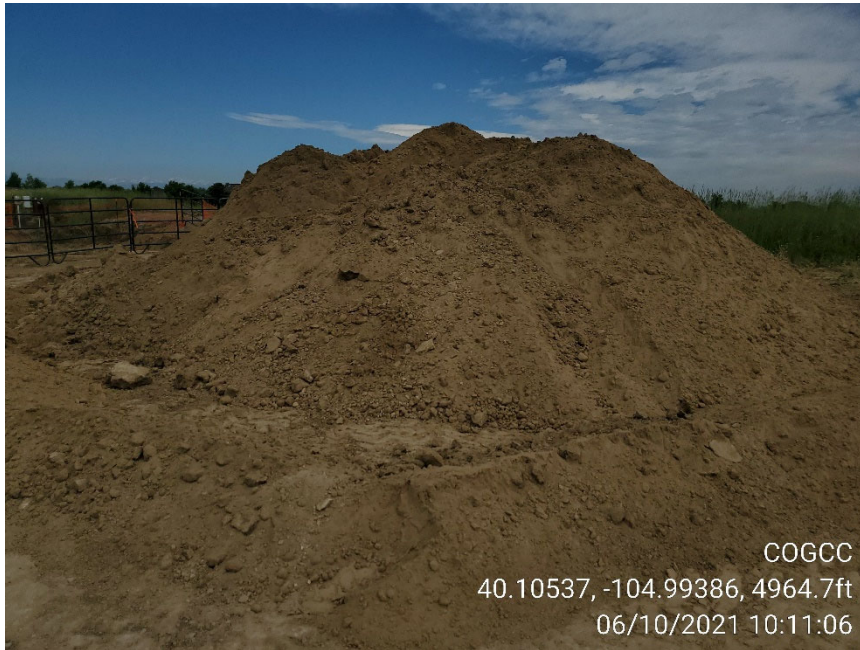
Photo 7 Clean overburden stockpile
