Inspection Photos
Location Name: Grant Tank Battery
Location ID: 446484

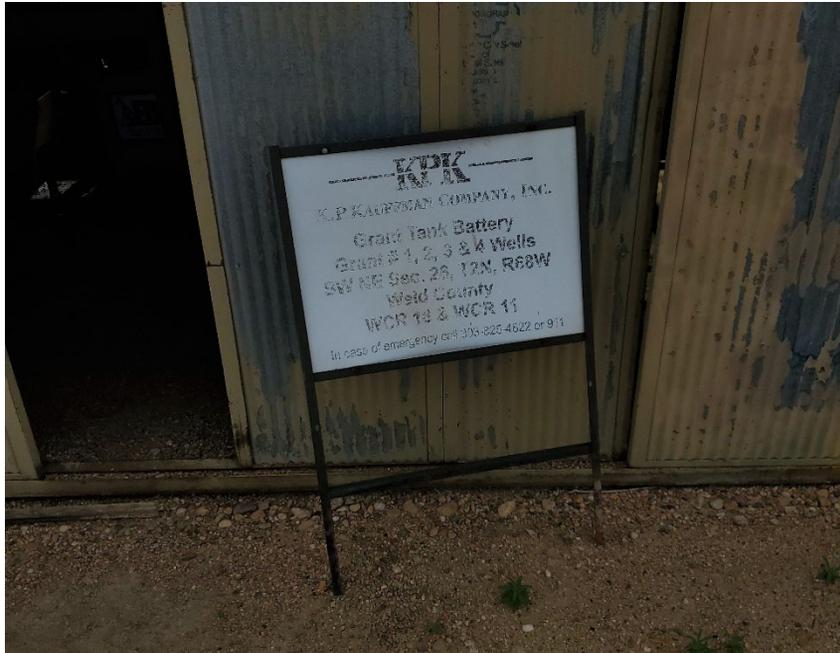
Photo 1 Tank Battery Sign

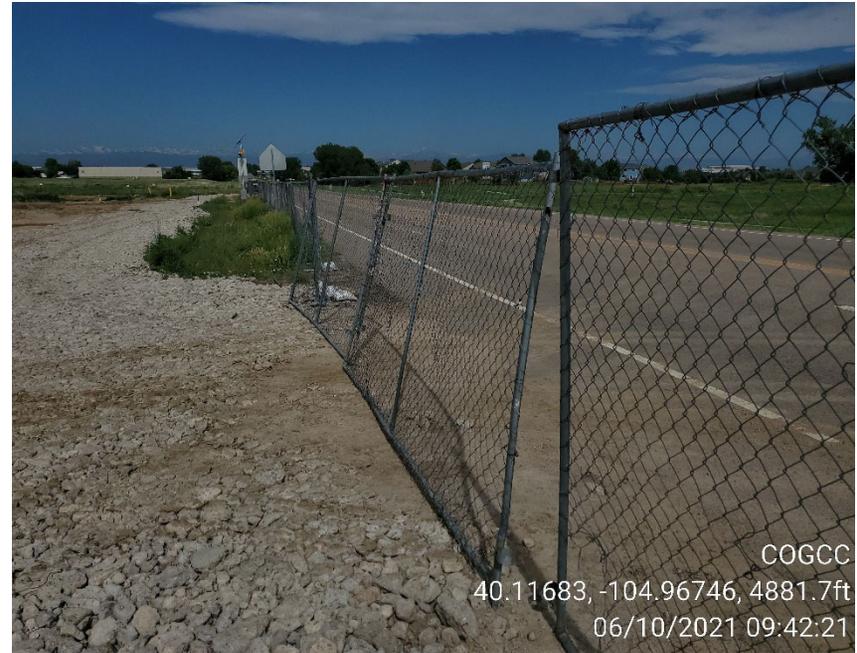
Photo 2 Fence unsecure at east end tank battery entrance

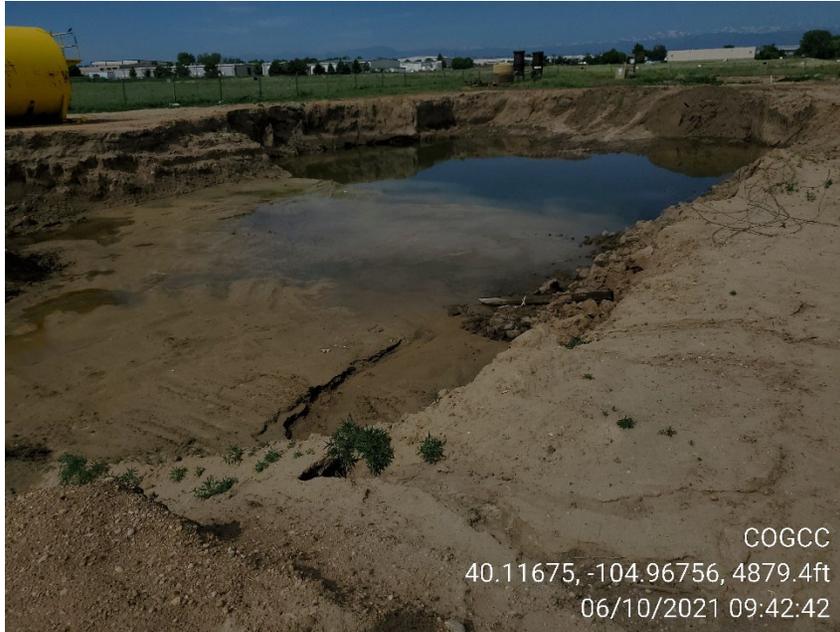
Photo 3 Eastern excavation, from northeast corner looking southwest

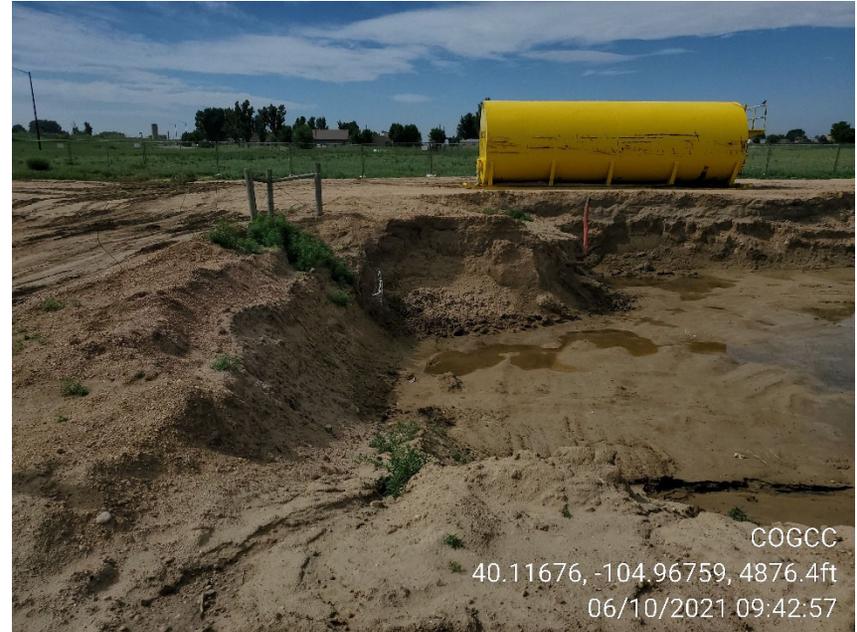
Photo 4 Eastern excavation, from northeast corner looking south

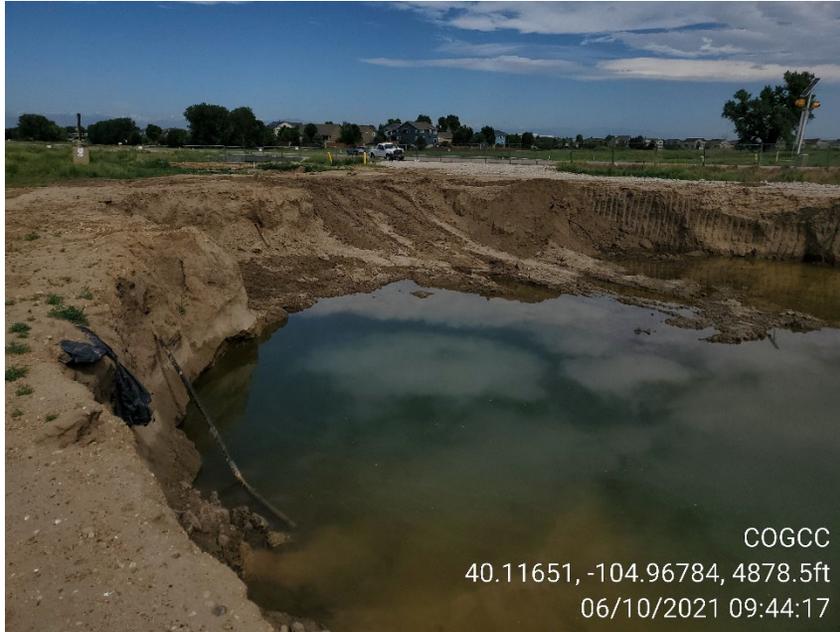
Photo 5 Eastern excavation, from south side looking northwest

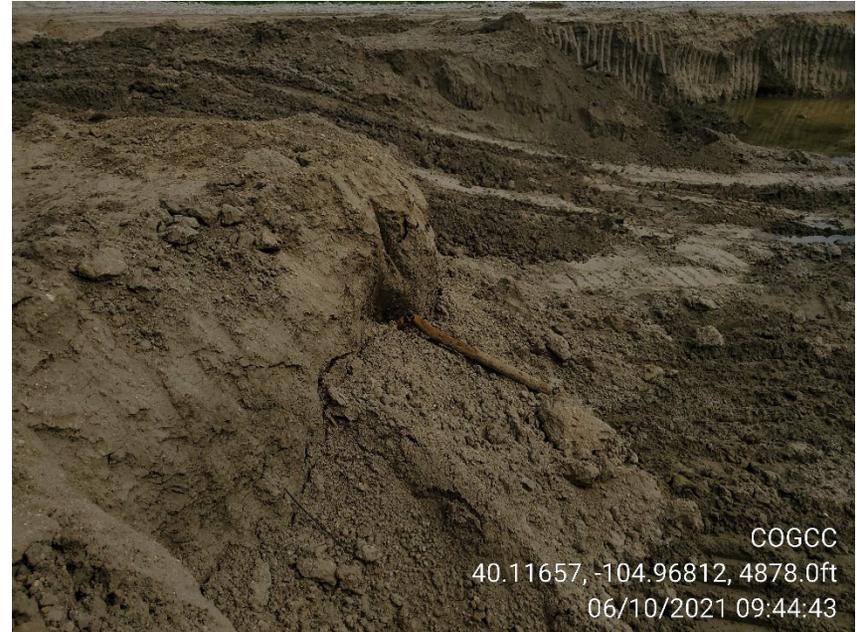
Photo 6 Flowline or dumpline piping in western wall of eastern excavation

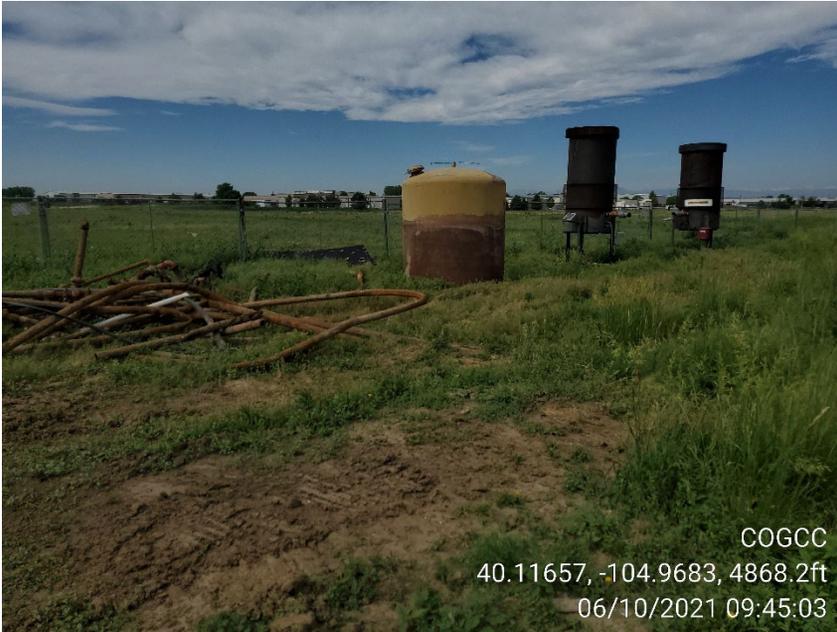
Photo 7 Flowlines, piping, produced water vessel and emission control devices stage and out of use.

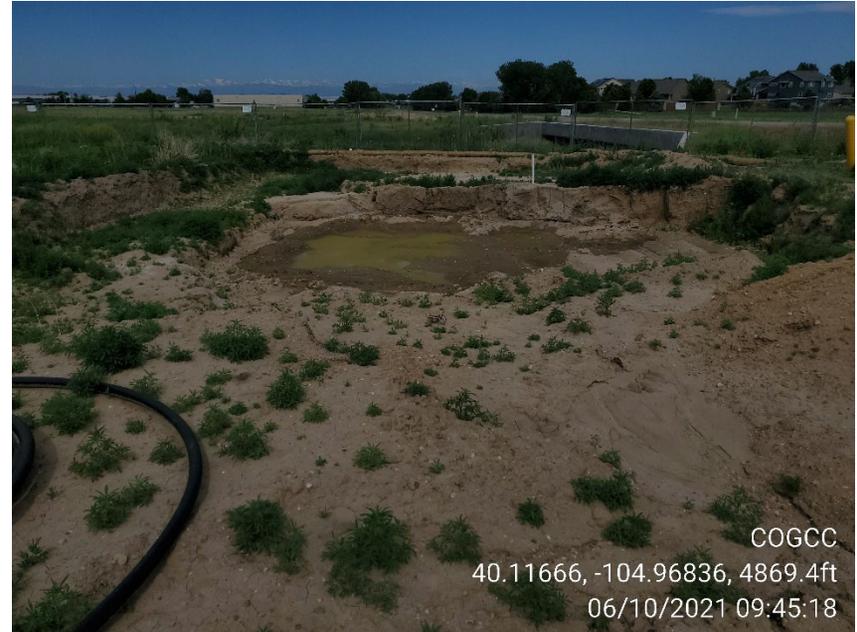
Photo 8 Western excavation looking west

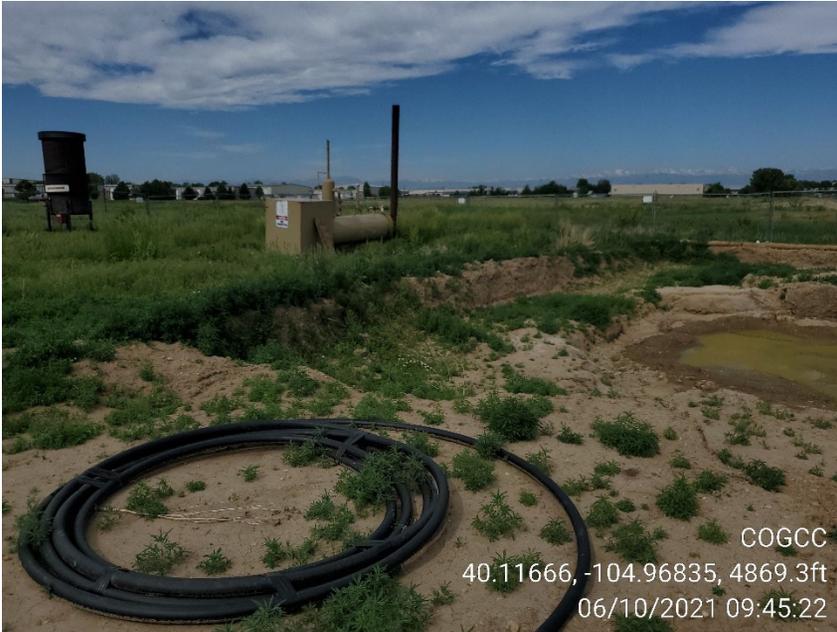
Photo 9 Separator staged and out of use.
