Inspection Photos

Location Name: CAERUS PICEANCE LLC CASS-GARBER-68S96W /1NWNE

Location ID: 334129

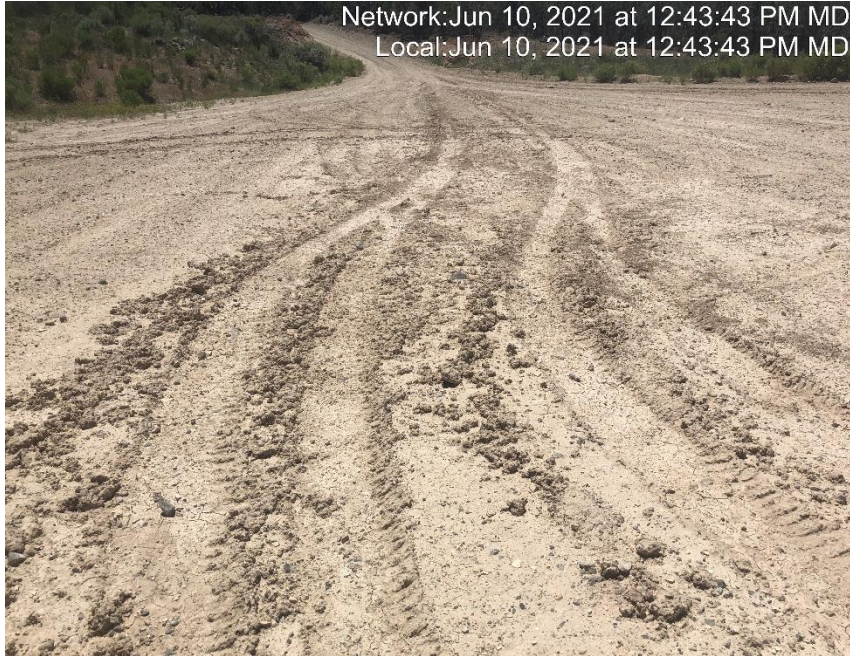
Photo #4052 Location lacks stabilization.

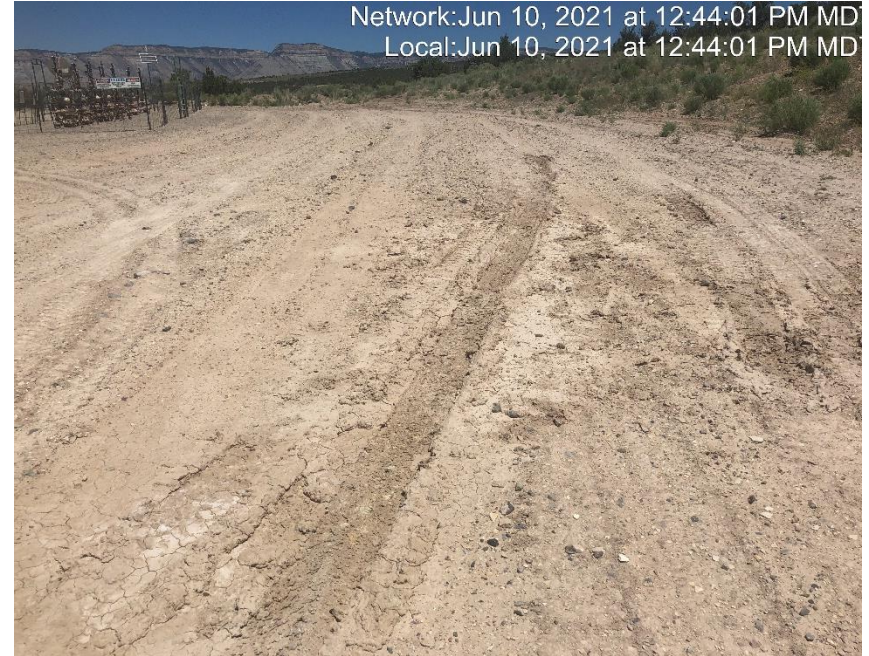
Photo #4053 Location lacks stabilization.

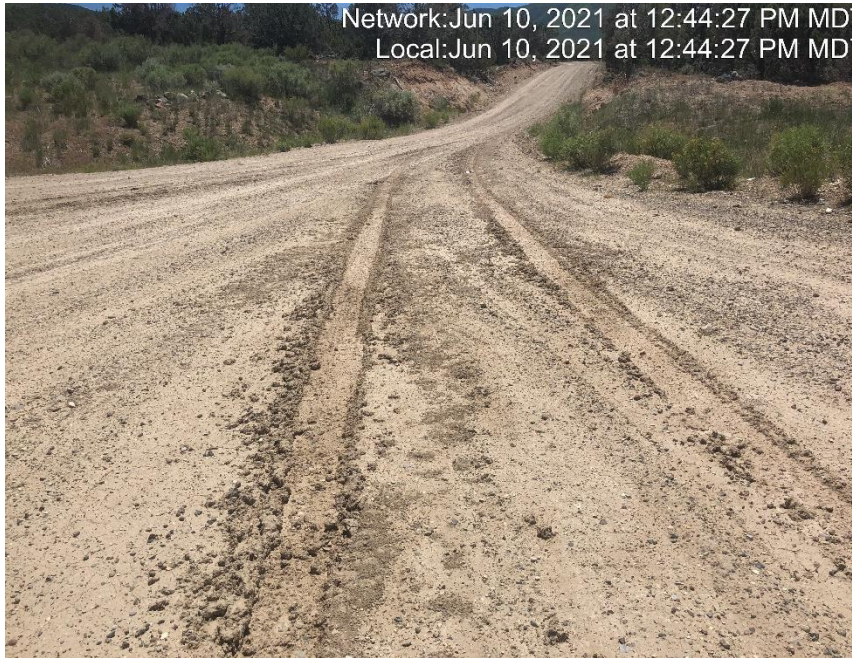
Photo #4054 No form of tracking BMP located at entrance to location.
