# Inspection Photos

API: 061-06233

Operator: OXY USA INC

Inspection Date: 6/9/2021

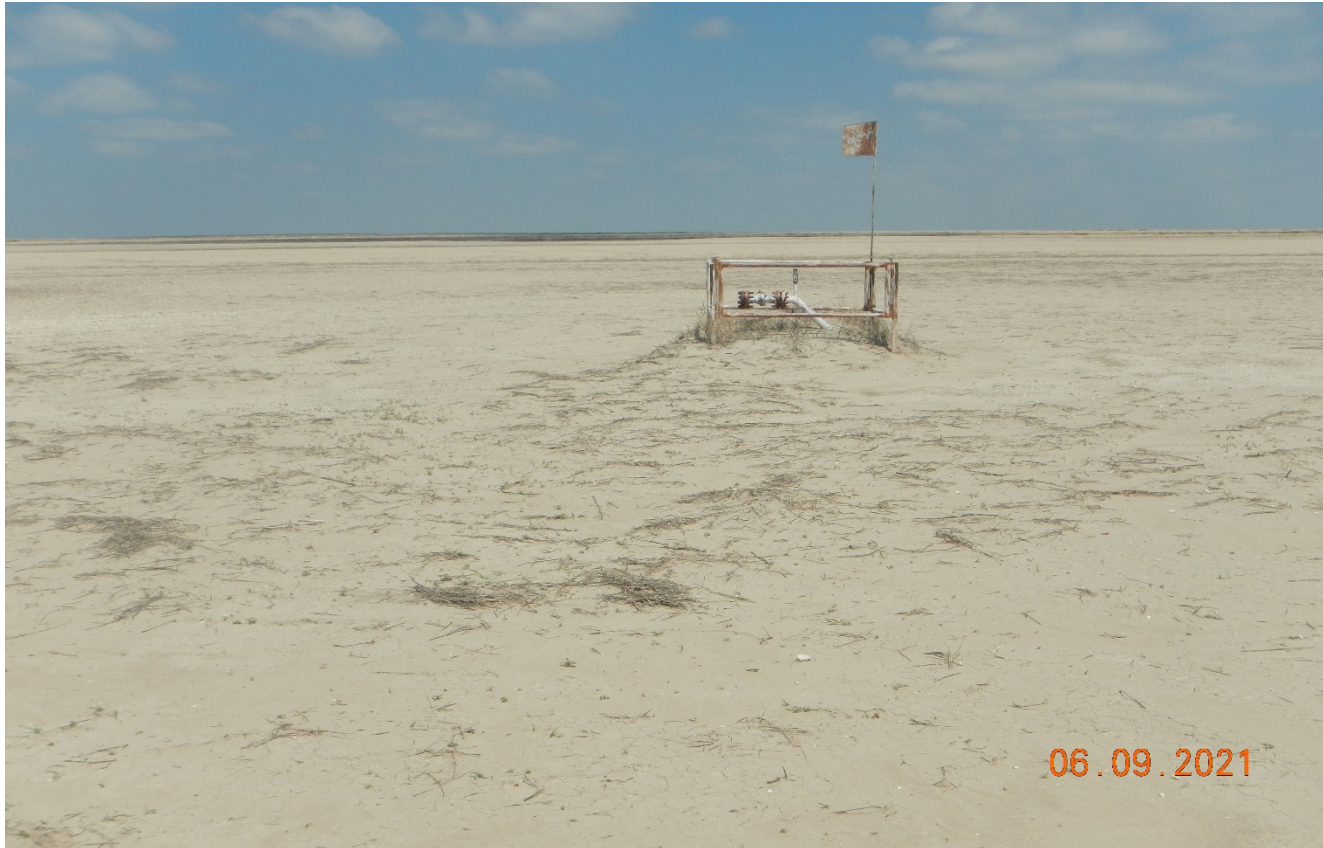
**Photo 1.** Facing northwest toward the location. There is a pipeline riser at the location. No crop was planted at the location this year to evaluate crop growth.

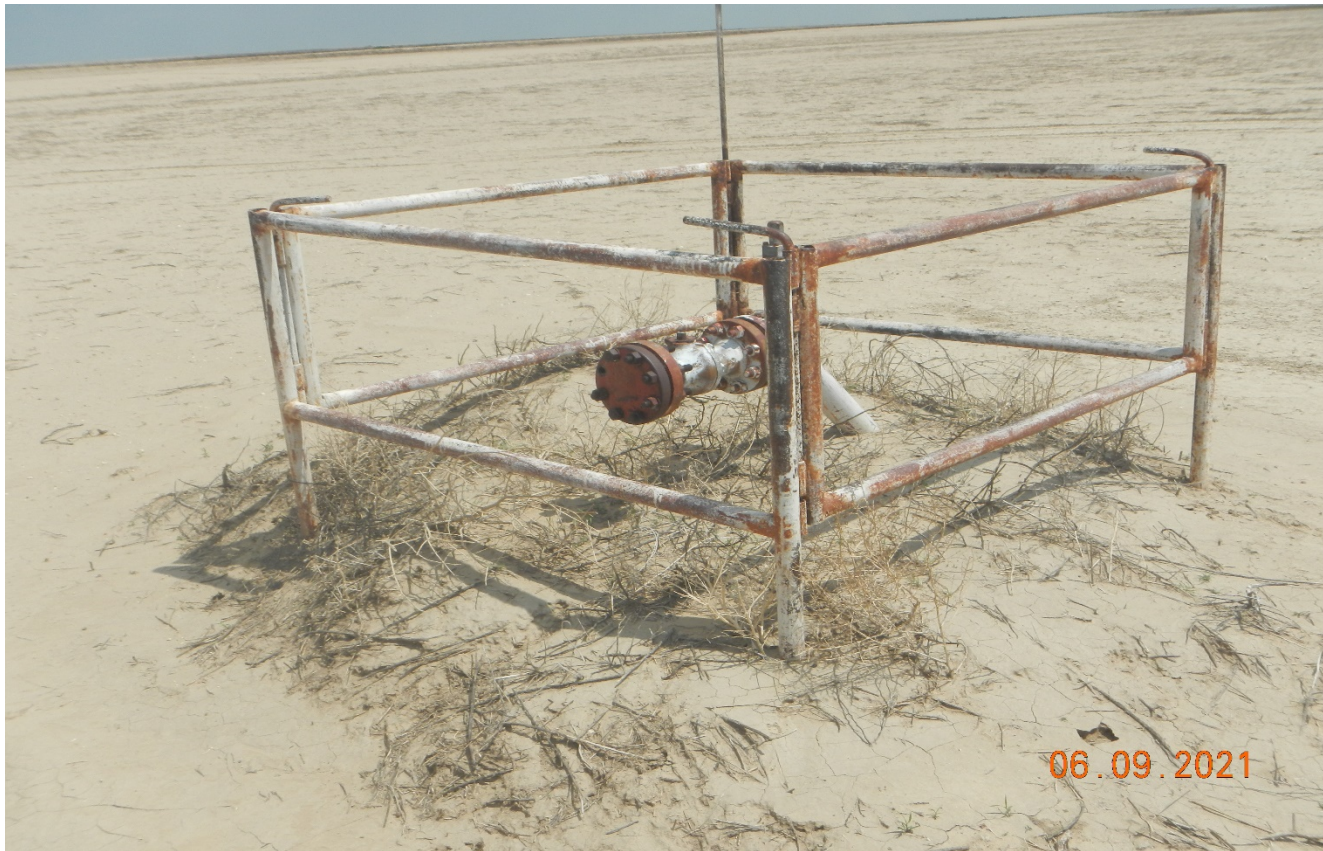
**Photo 2.** View of pipeline riser at the location. No sign identifying the riser is present.
