Inspection Photos

API: 017-07524

Operator: P O & G OPERATING LLC

Inspection Date: 6/9/2021

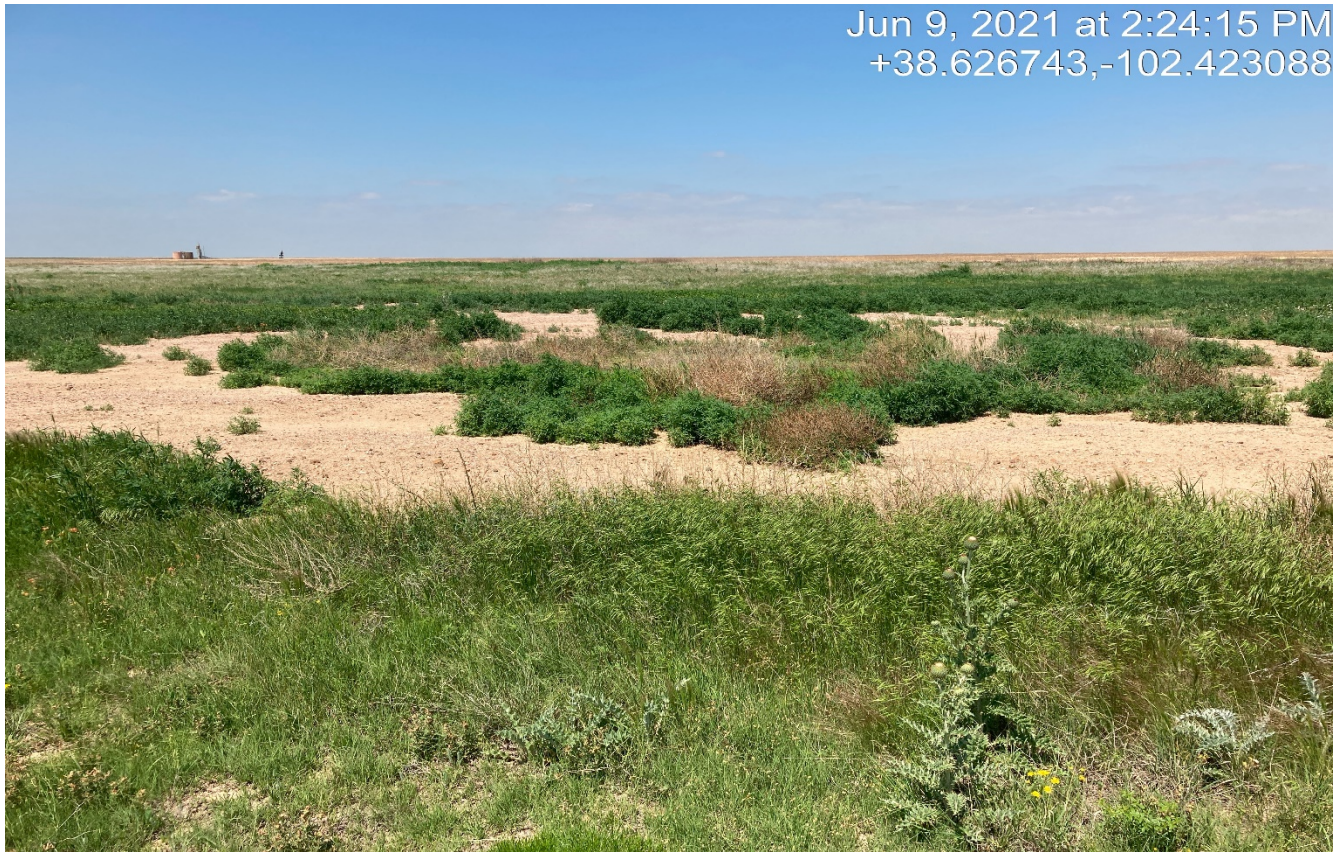
Photo 1. Facing toward the abandoned facility battery site. This area has not ben reclaimed.

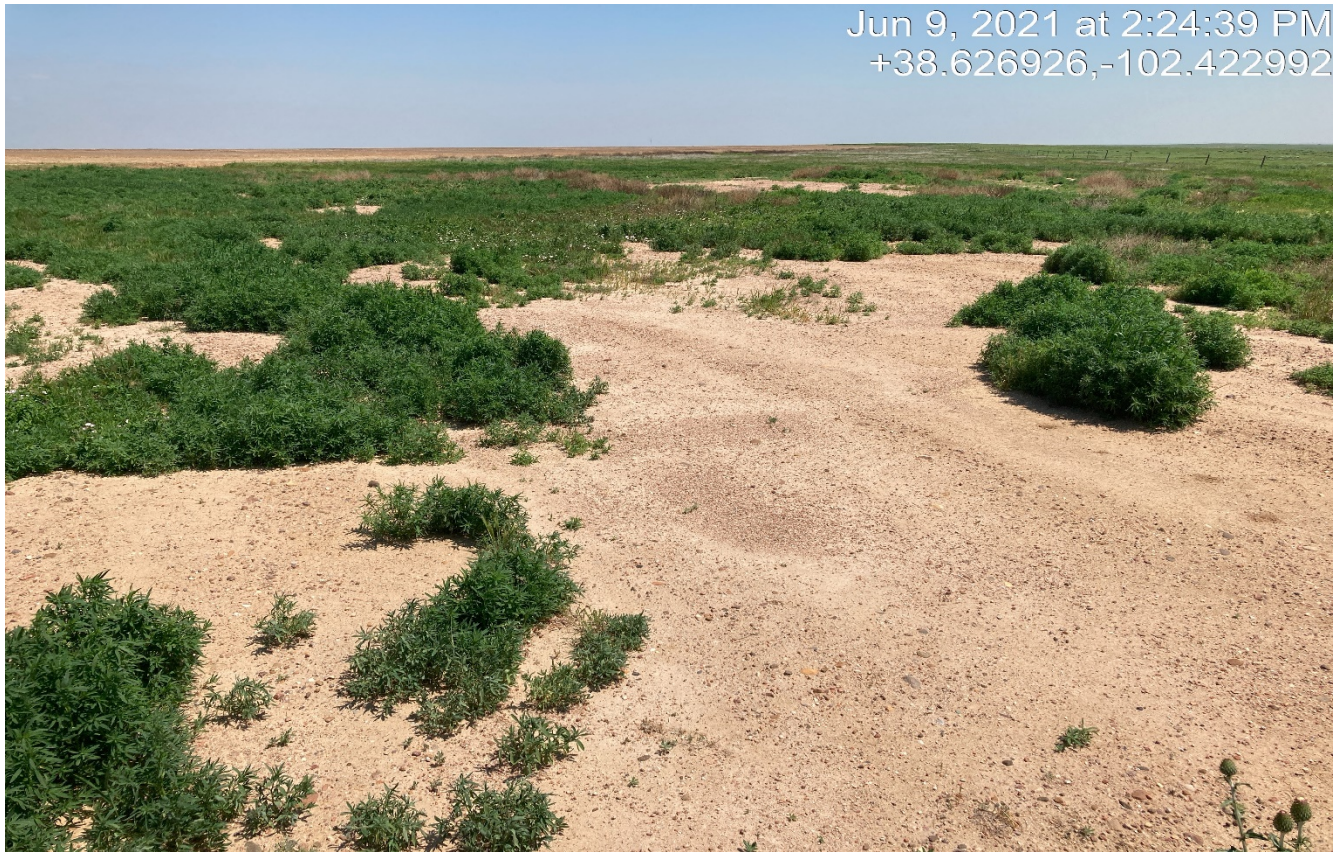
Photo 2. There are areas that are bare of vegetation growth and undesirable weeds throughout the disturbed location.

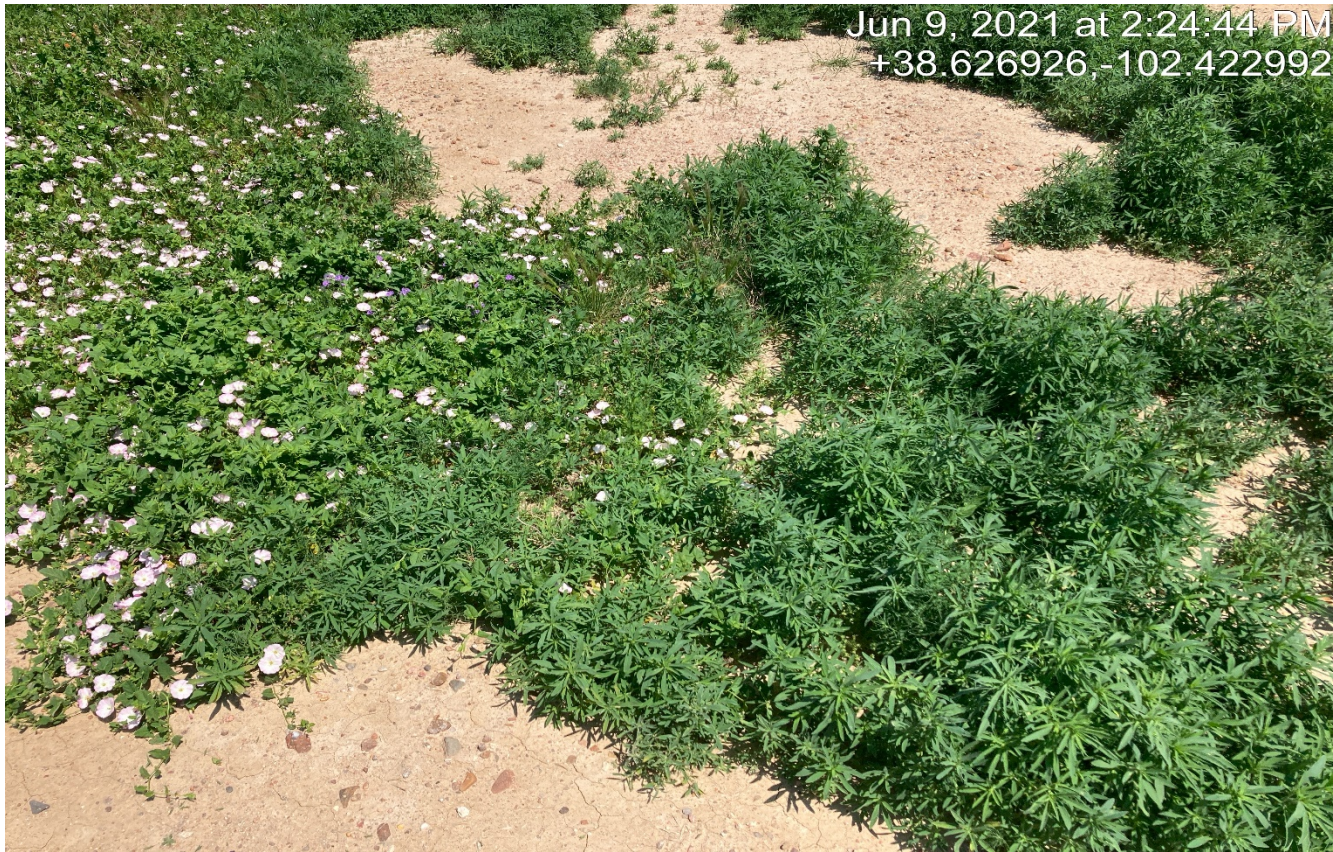
Photo 3. View of undesirable and noxious weeds (Kochia sp., Field bindweed).

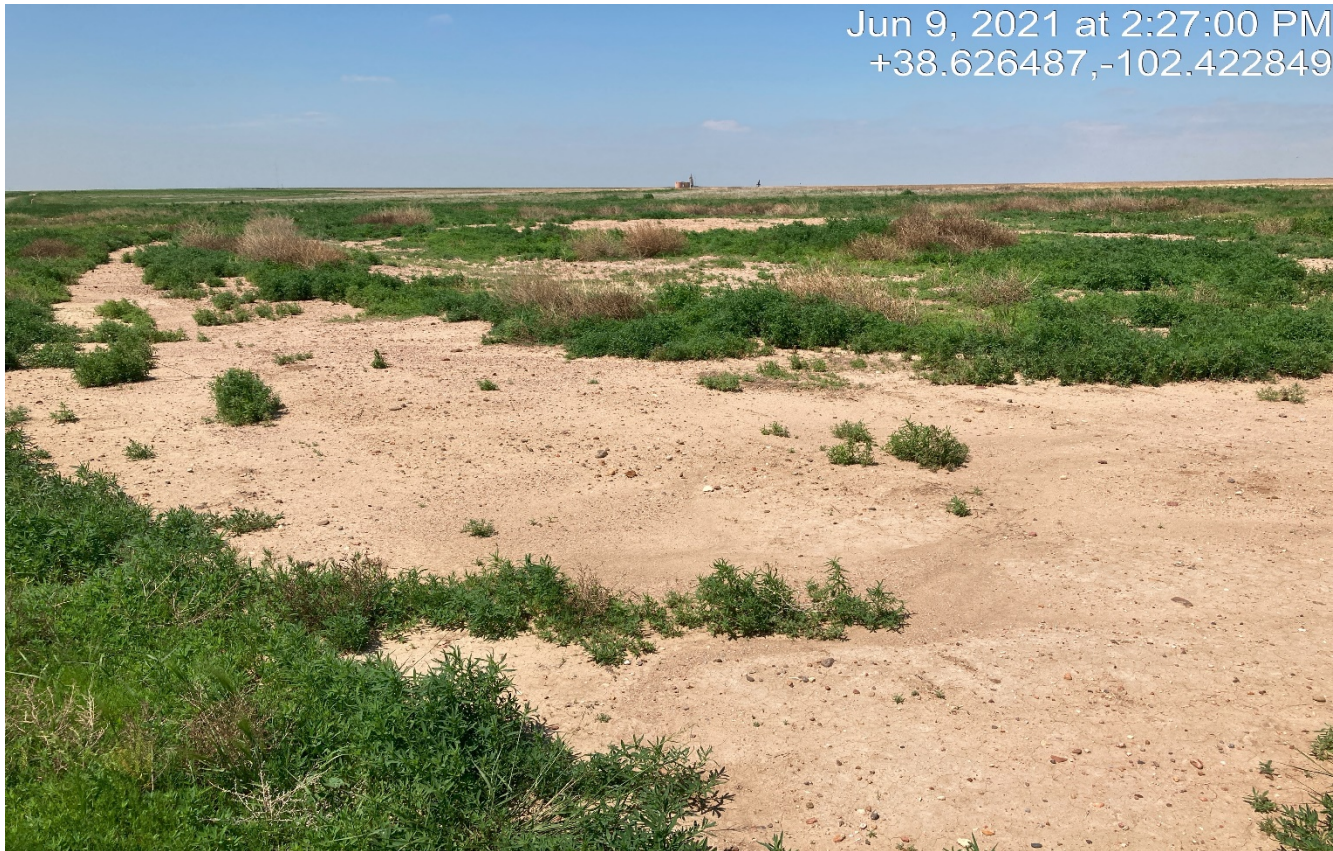
Photo 4. Facing north at the location. All disturbed areas of the location need to be reclaimed.

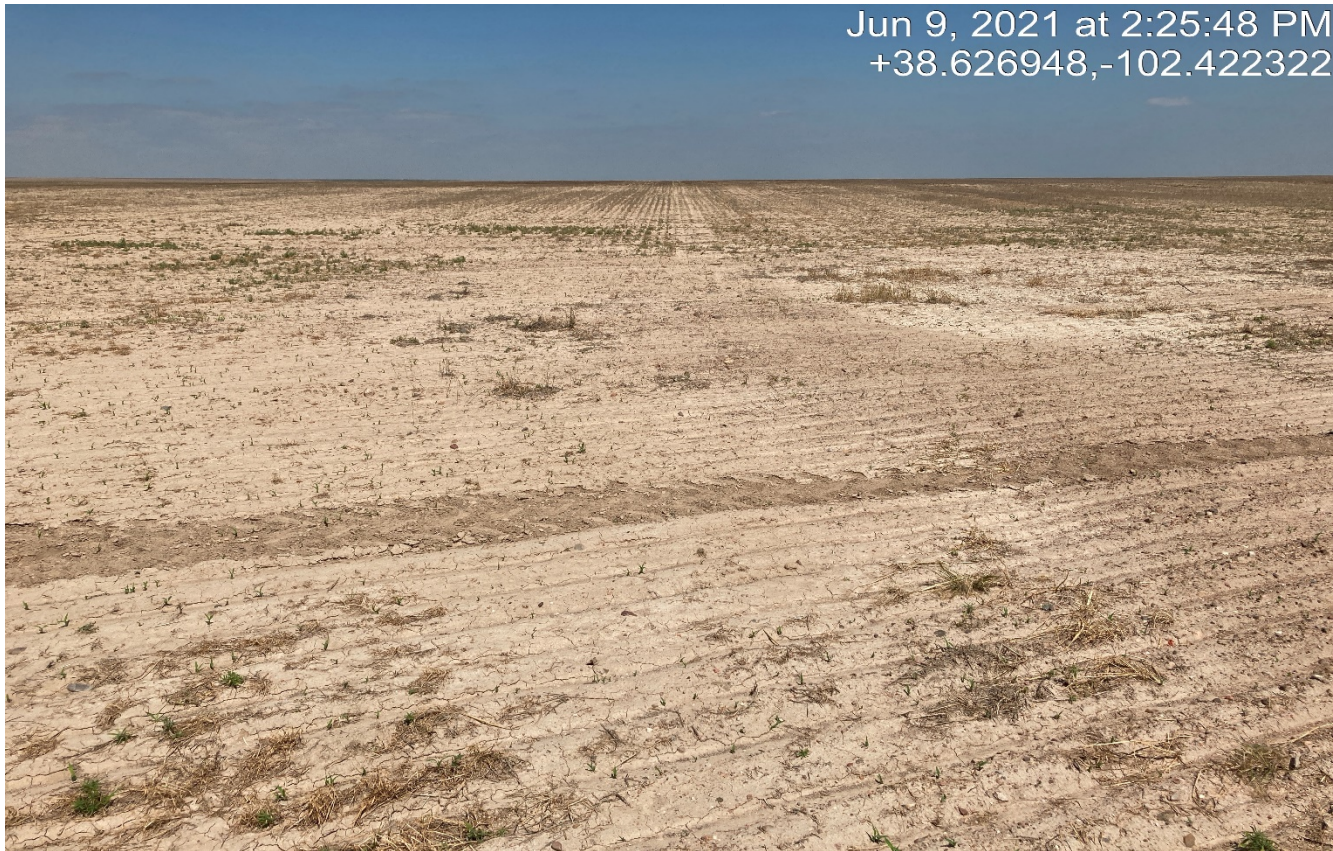
Photo 5. Facing east at the well site located in a crop field that has not been planted.

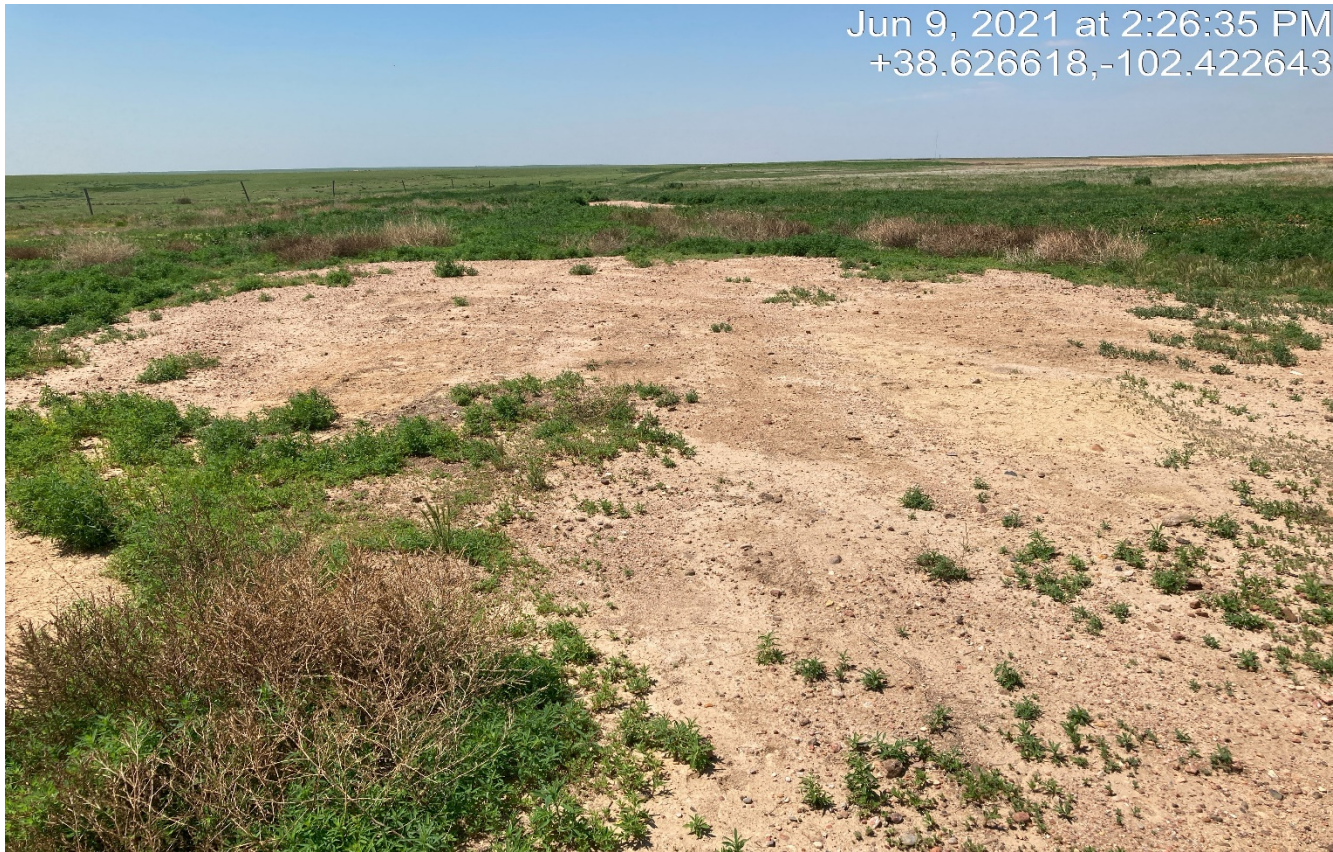
Photo 6. Facing northeast at the location. All disturbed areas of the location need to be reclaimed.

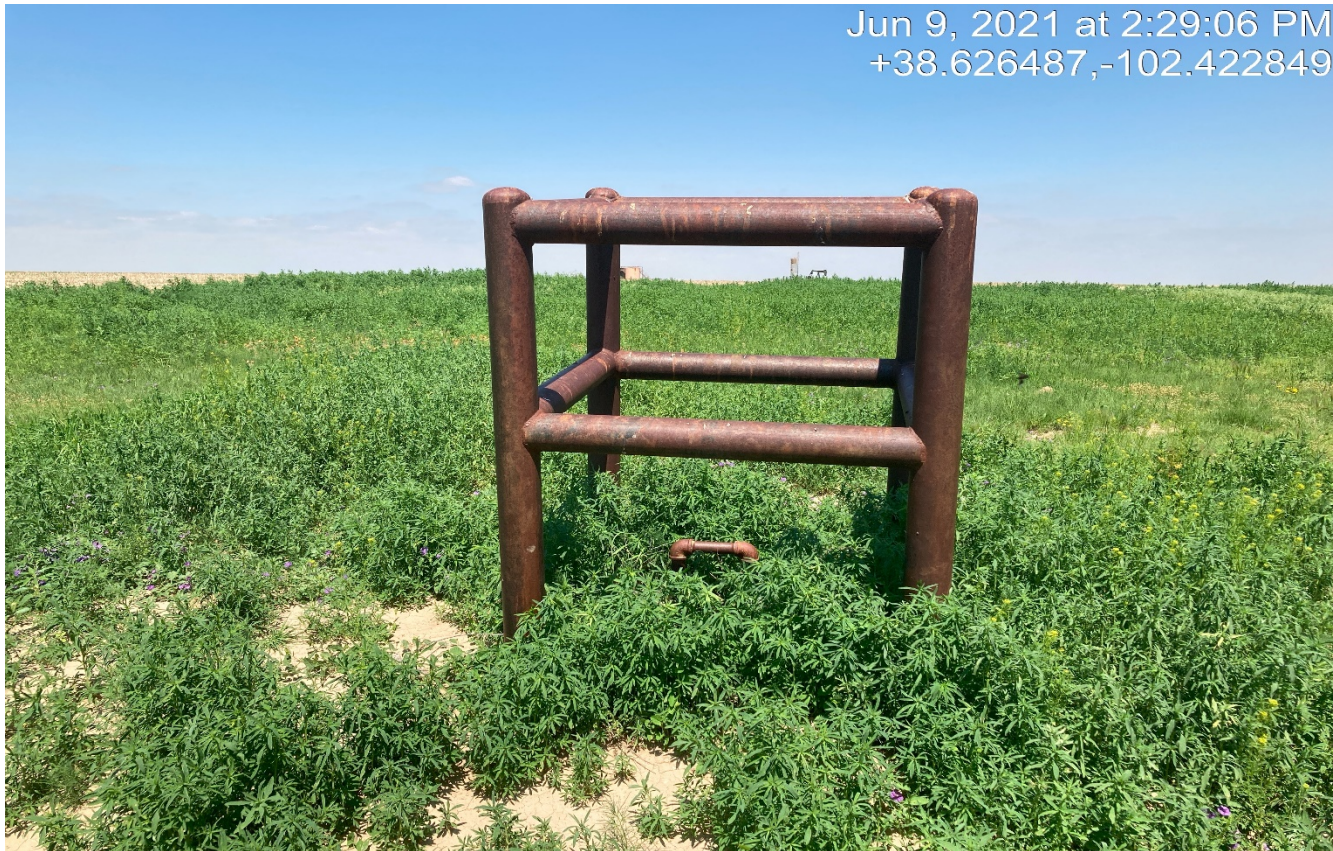
Photo 7. There is an abandoned pipe riser 1200' northwest of the location.

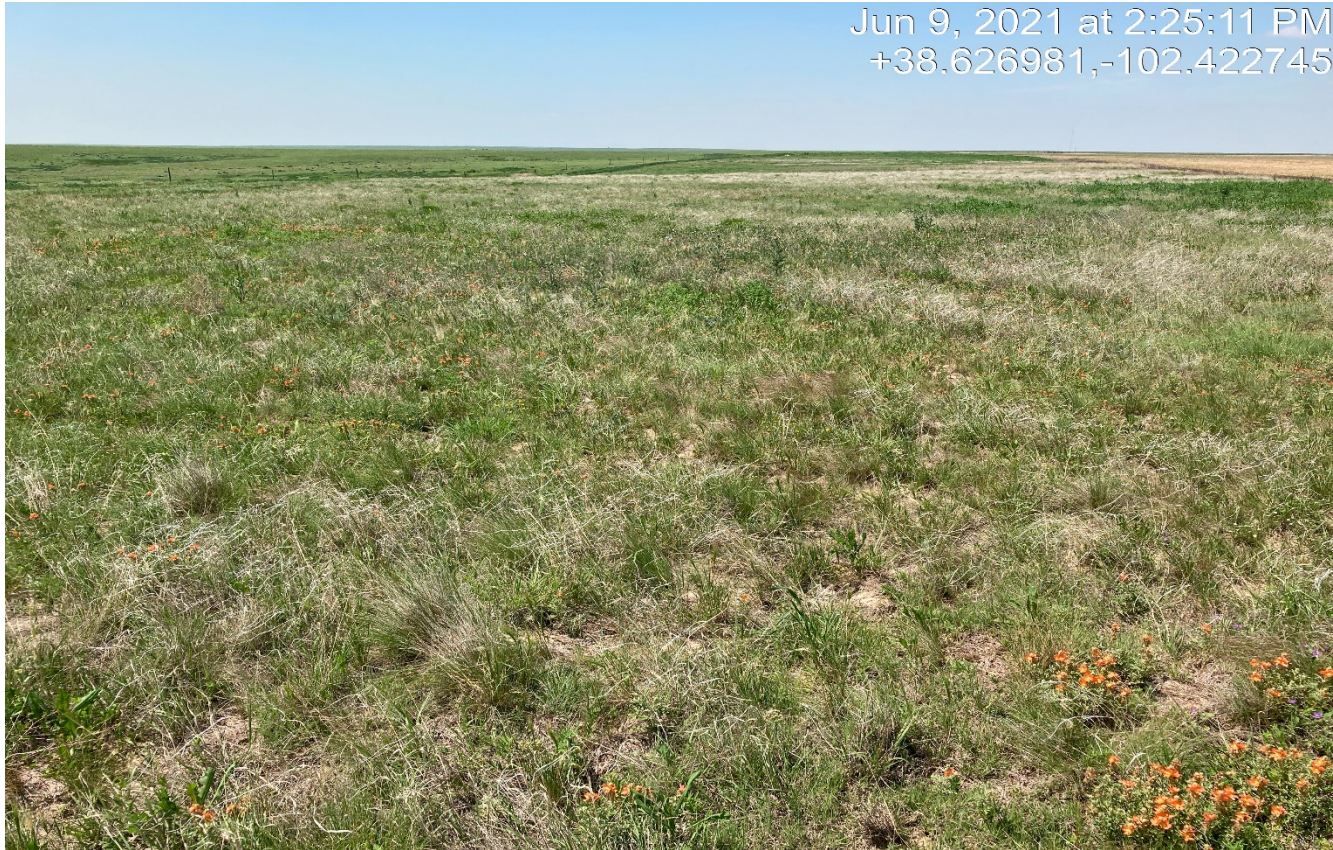
Photo 8. Facing north toward the adjacent surrounding reference area.
