Inspection Photos

API: 061-06296

Operator: STRACHAN EXPLORATION INC

Inspection Date: 6/9/2021

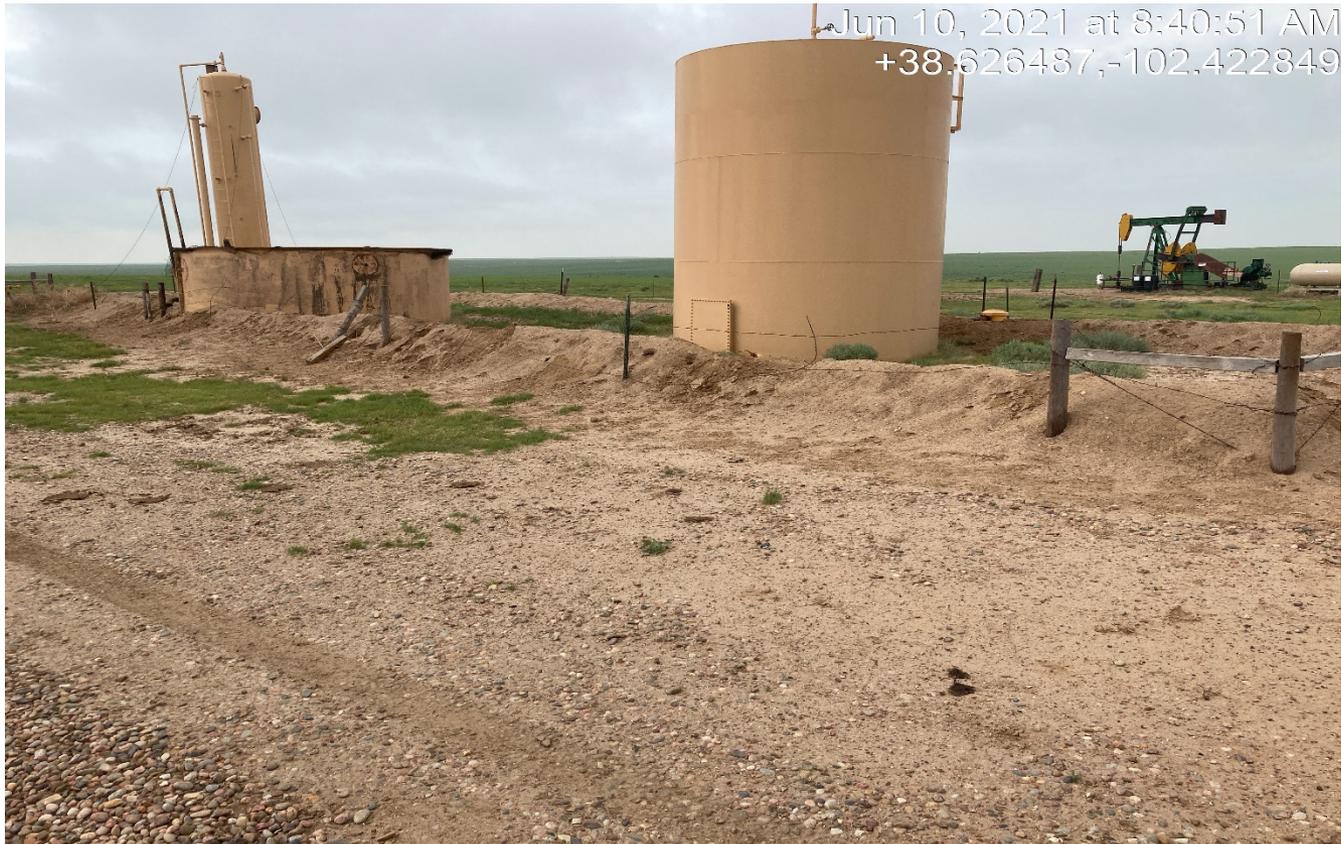
Photo 1. Facing southeast toward the tank battery.

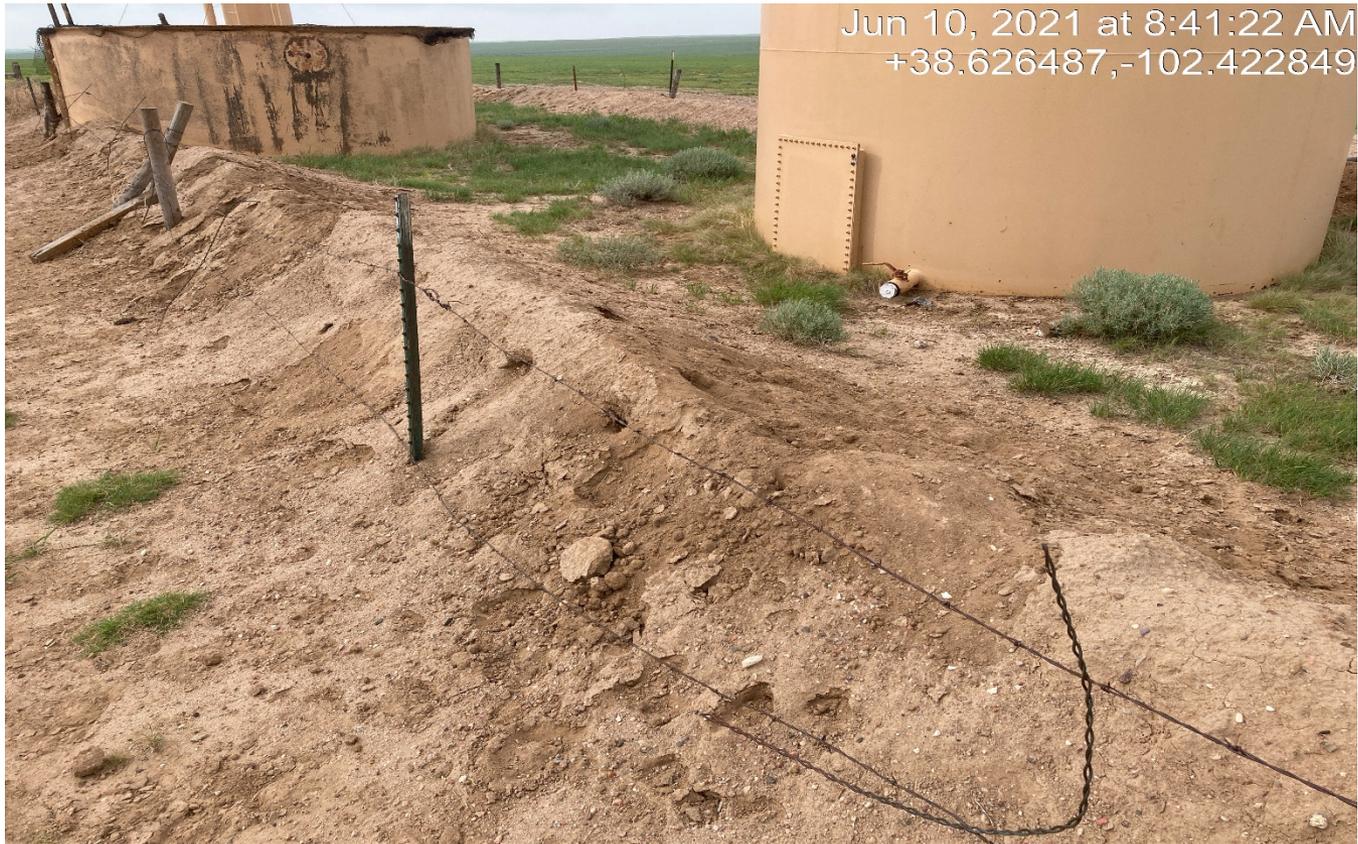
Photo 2. The fence is not maintained around the tank battery to prevent livestock entry. Cattle tracks are shown along the berm.

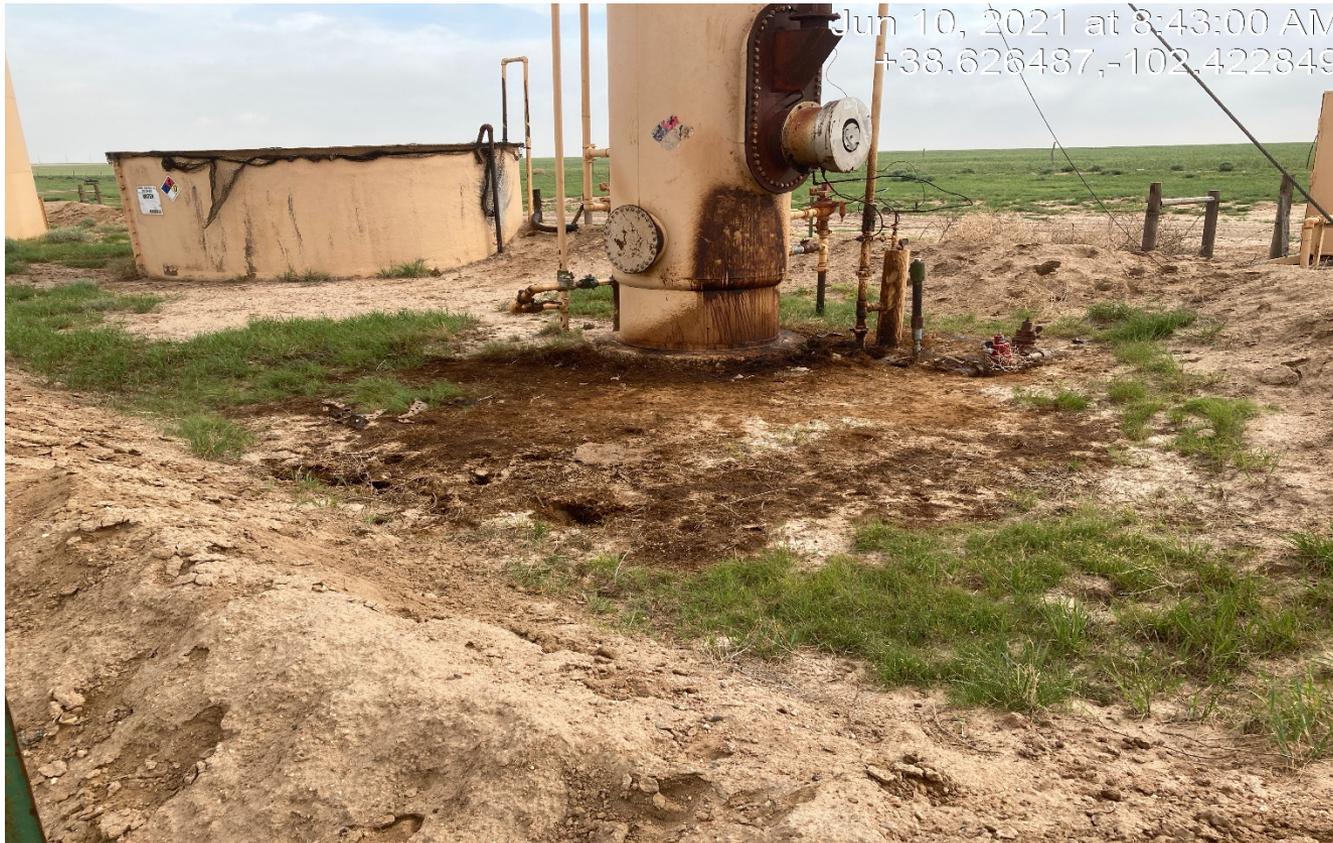
Photo 3. There is oil stained soil around the tank. The stained soil needs to be cleaned up.

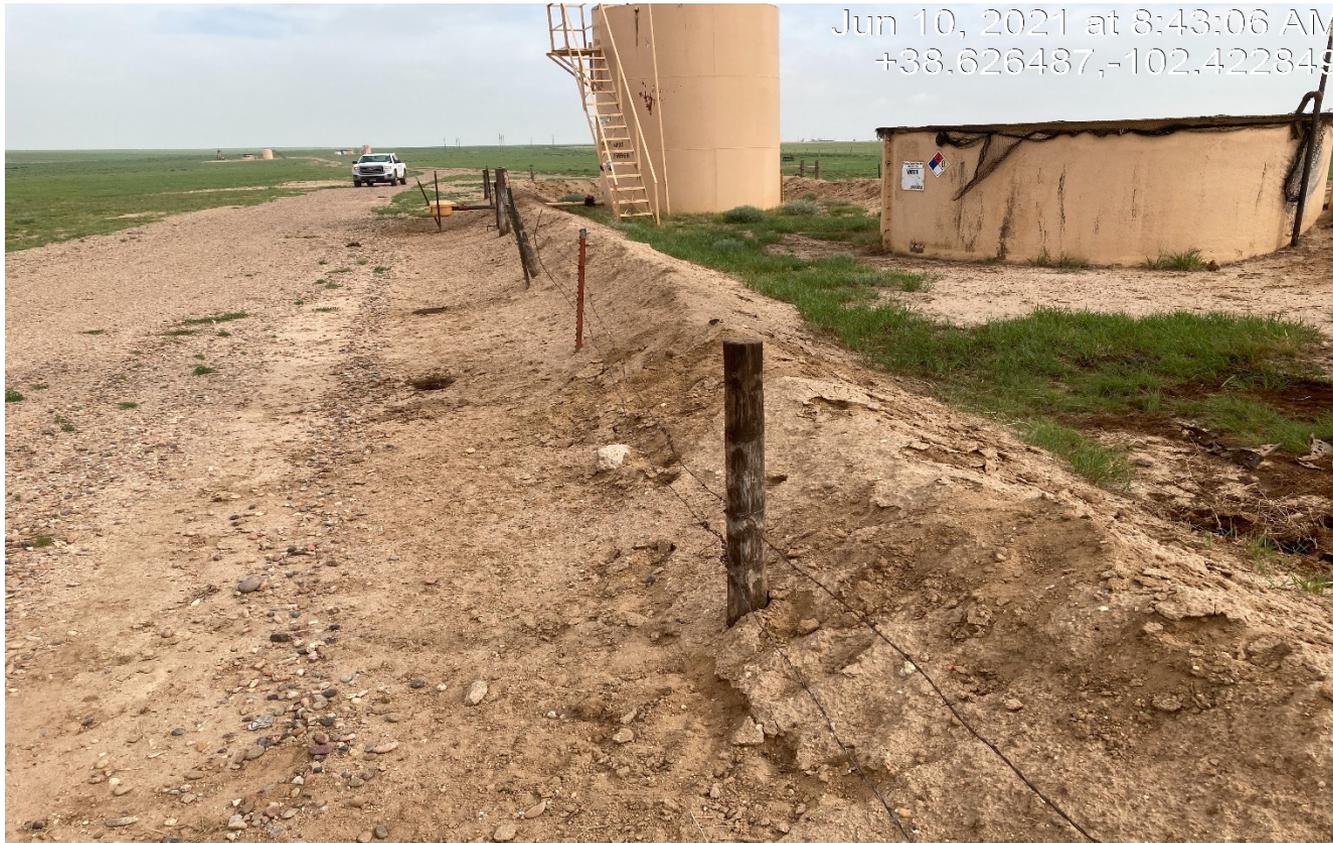
Photo 4. The fence is not maintained around the tank battery to prevent livestock entry. Cattle tracks are shown along the berm.

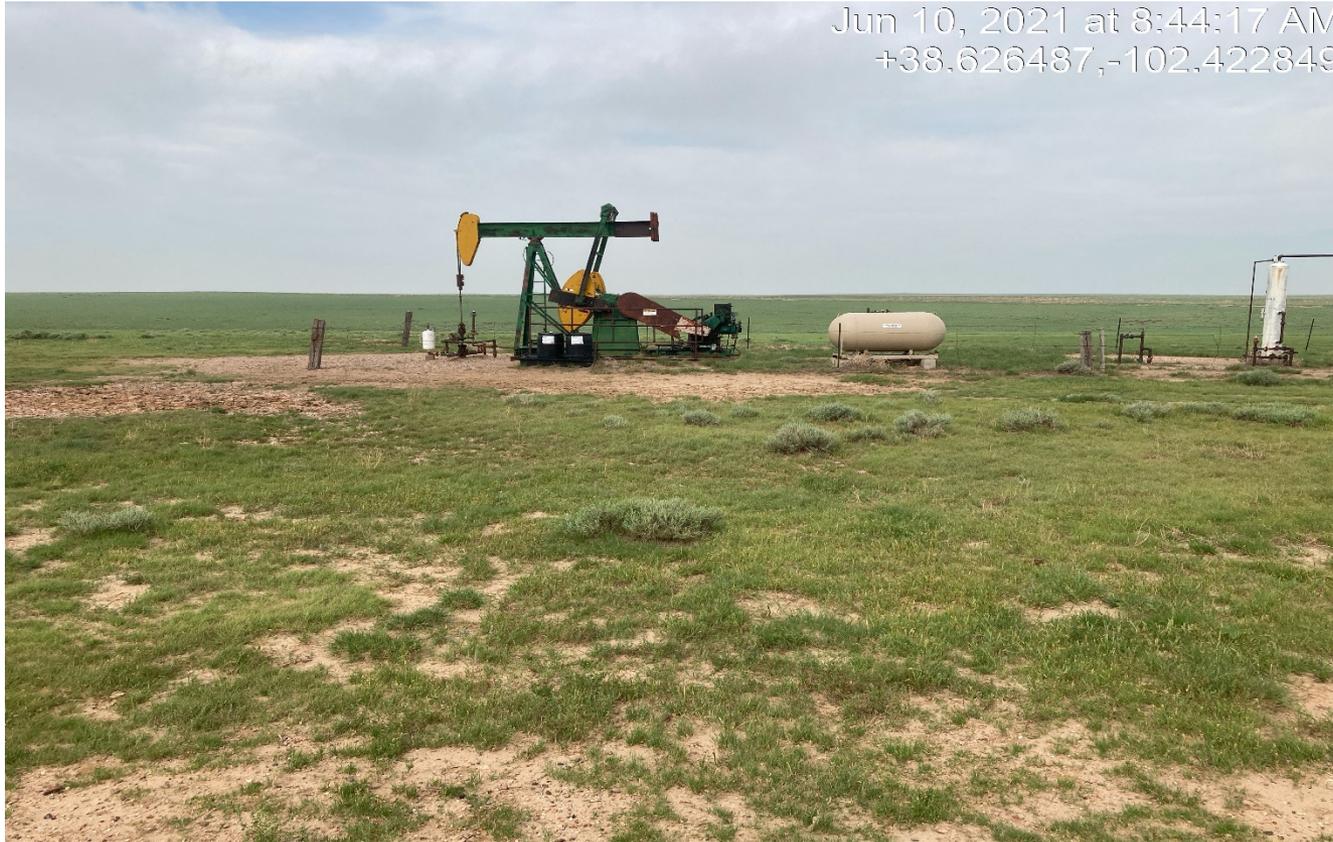
Photo 5. Facing south toward the well.
