Inspection Photos

API: 071-08776

Operator: XTO ENERGY INC

Inspection Date: 6/15/2021

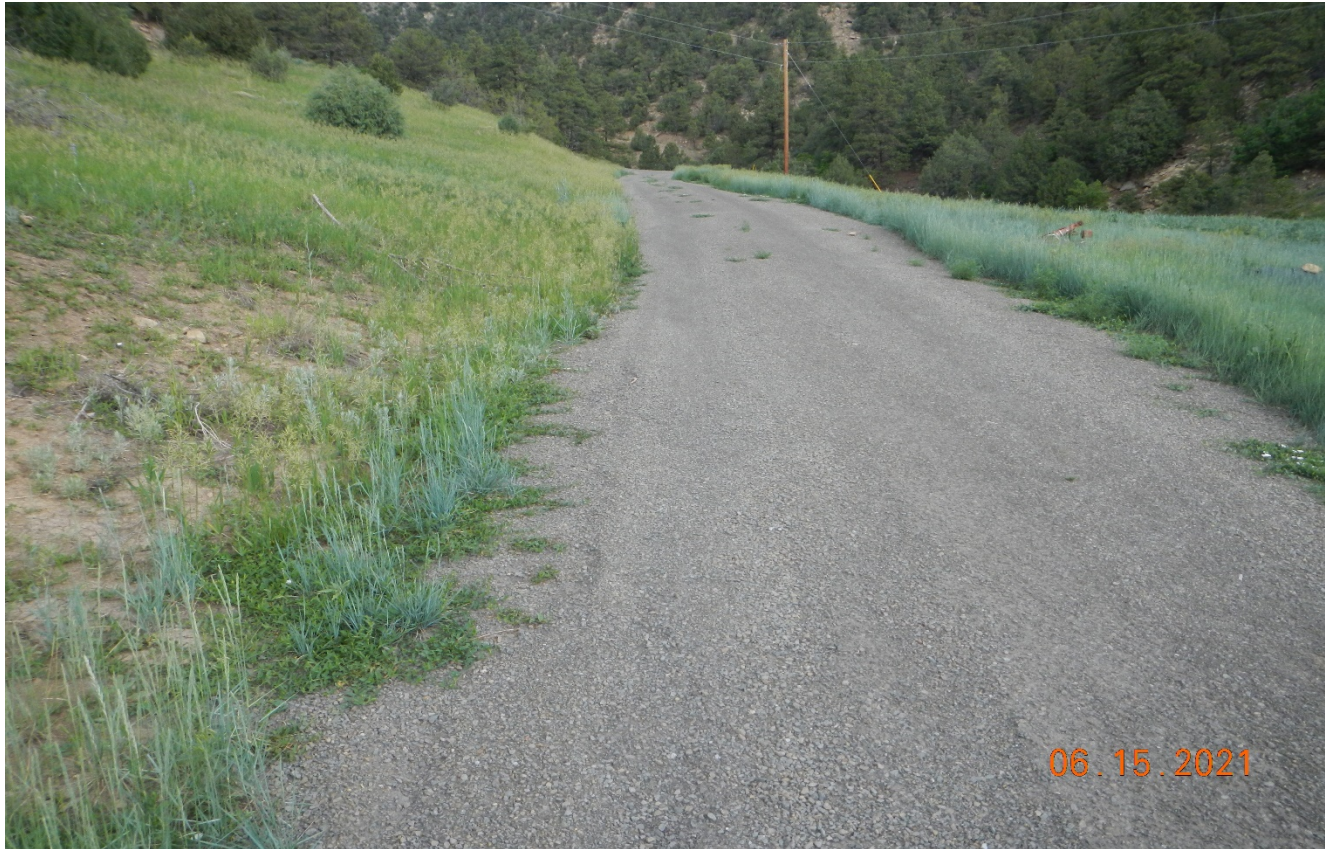
Photo 1. Facing north toward the access road. Gravel has been spread along the road for stabilization.

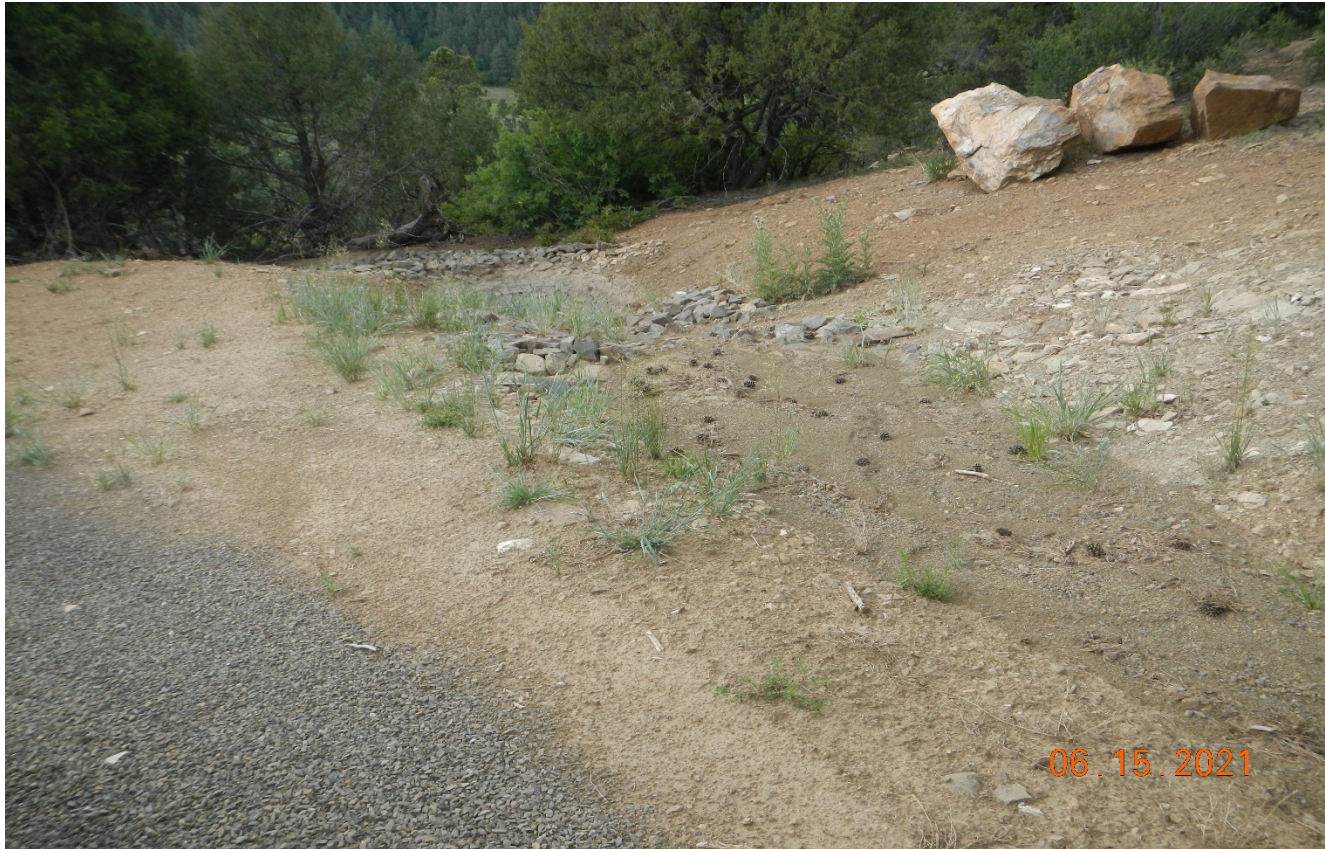
Photo 2. There is sediment accumulation along this rip/rap outlet which needs maintenance.

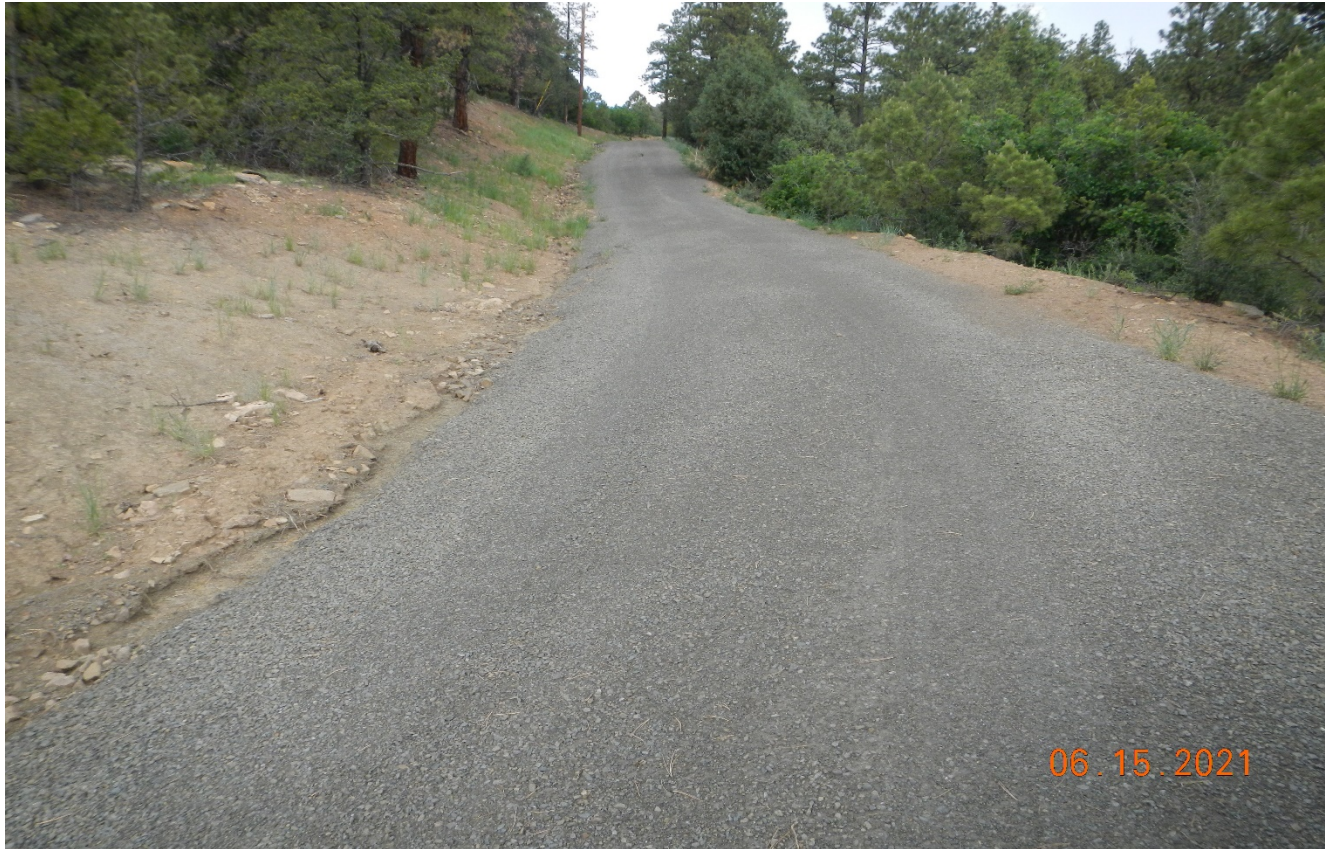
Photo 3. Facing northwest along the access road. This portion of the road appears stabilized.

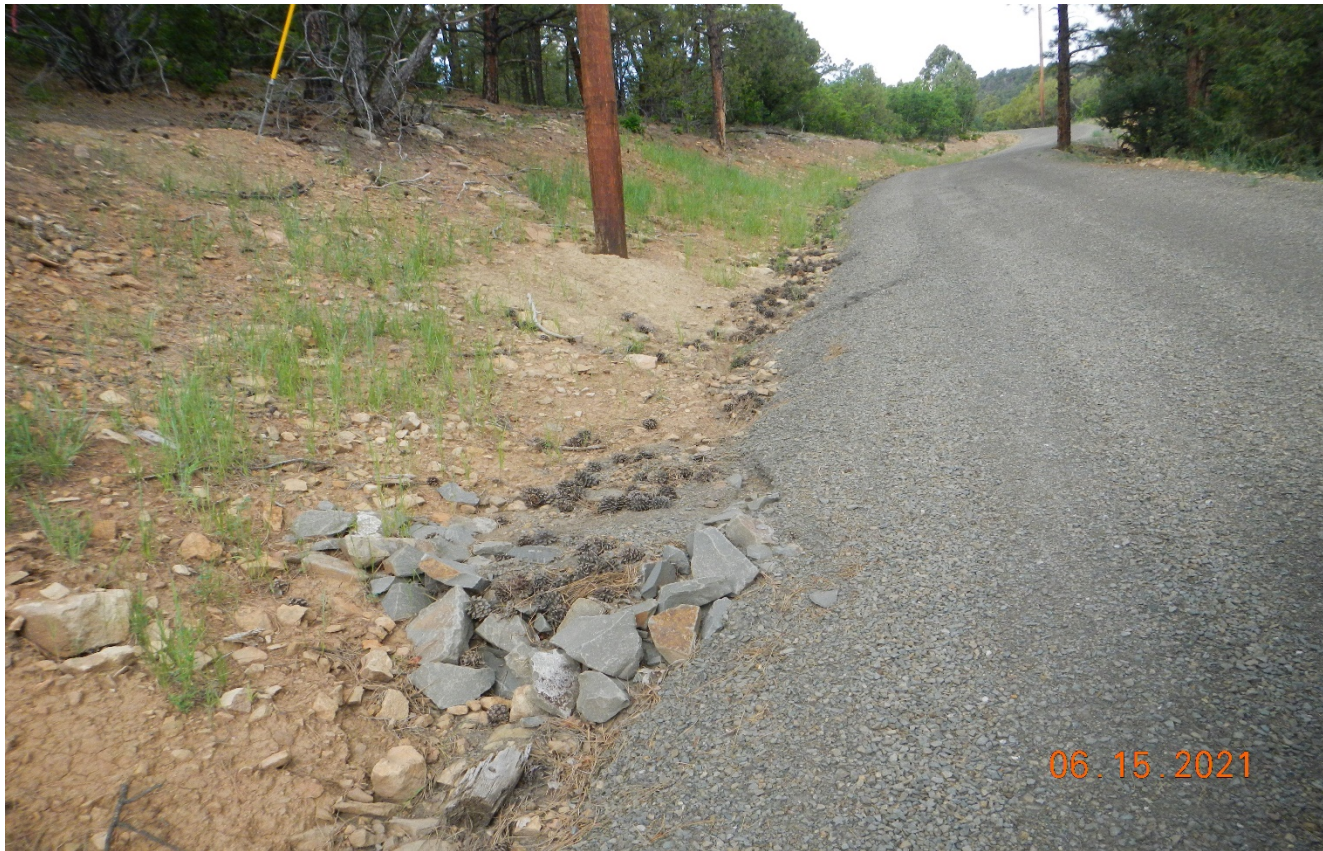
Photo 4. Sediment has accumulated on some of the check dams which need maintenance.

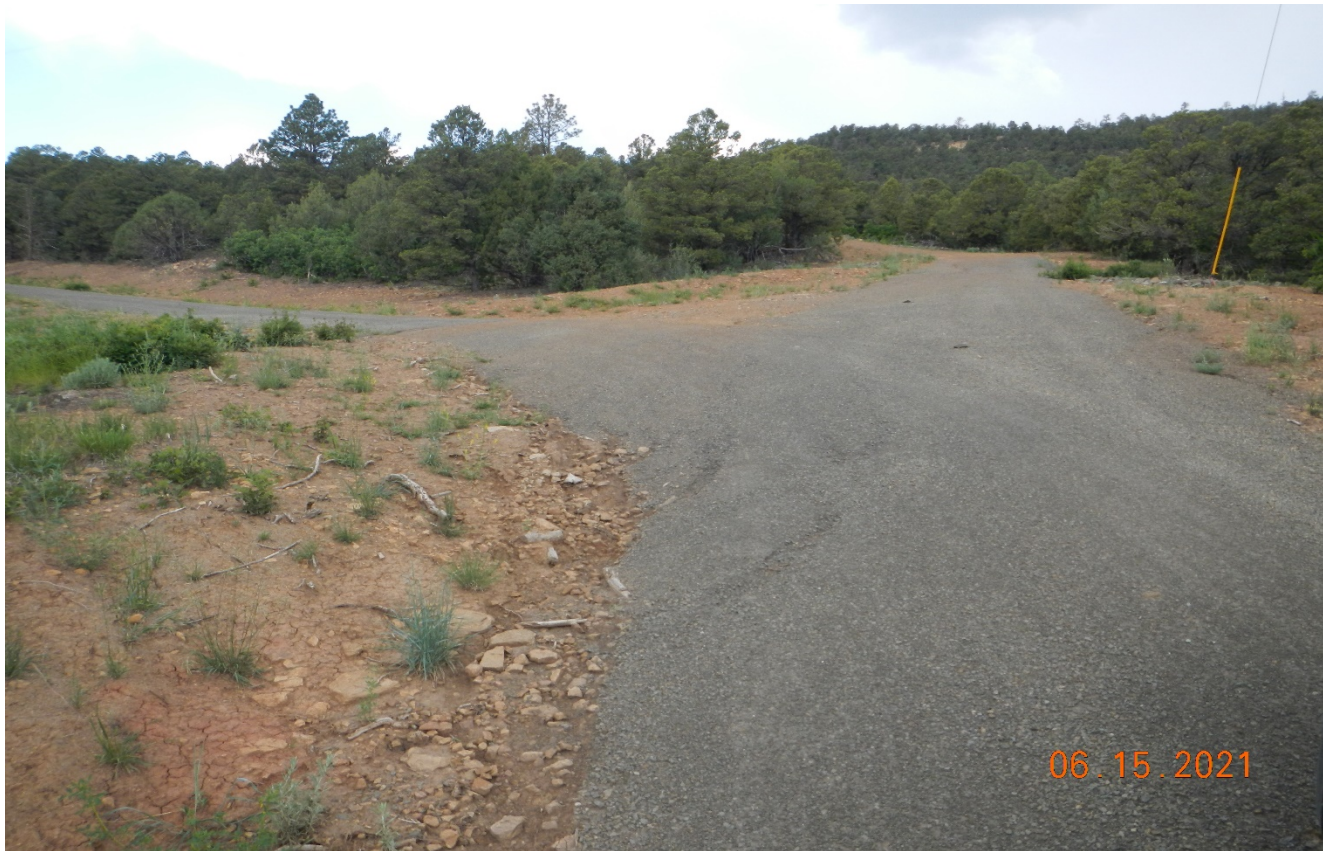
Photo 5. The access road continues to the right at this junction in the road. Gravel ends at this area.

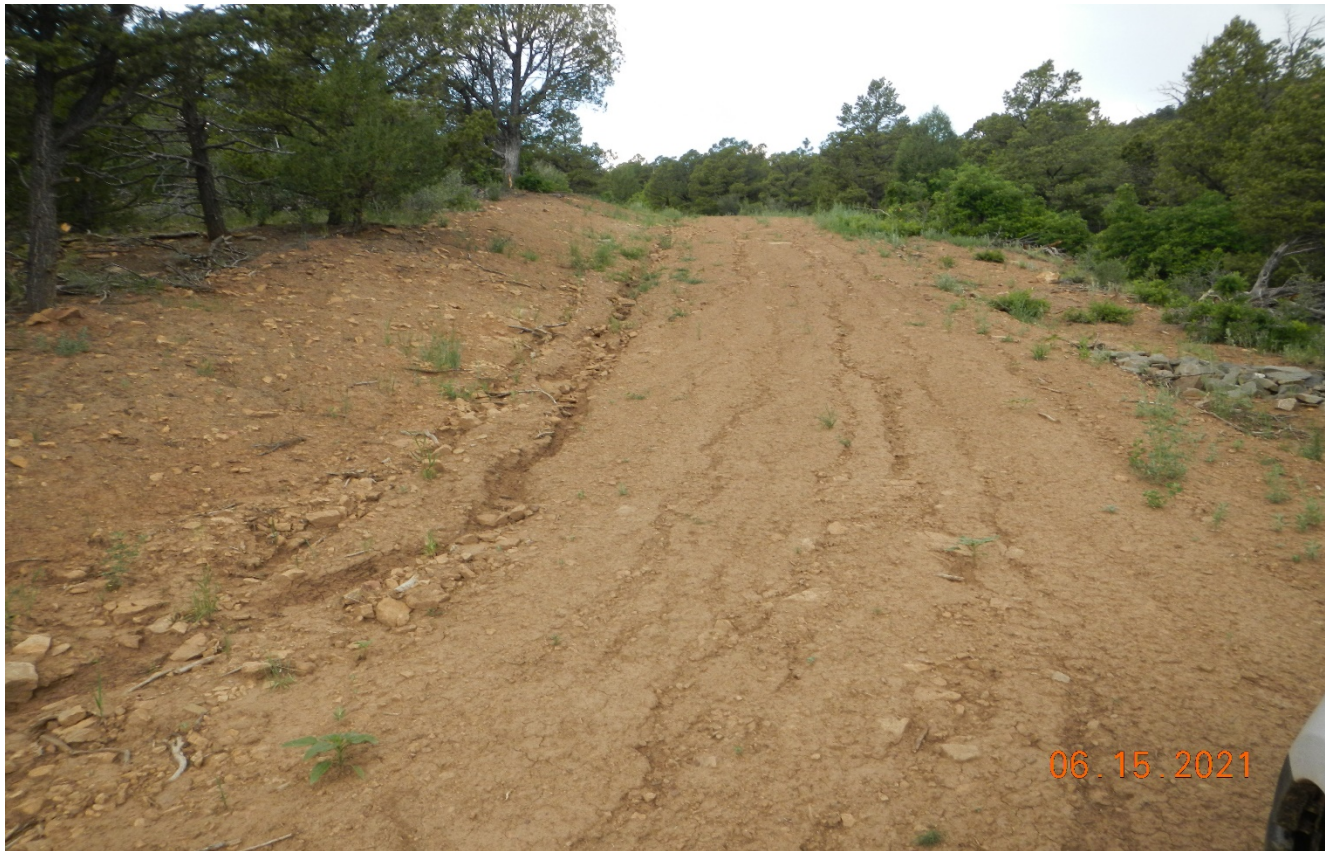
Photo 6. Facing northwest. There is erosion beginning to occur which needs maintenance.

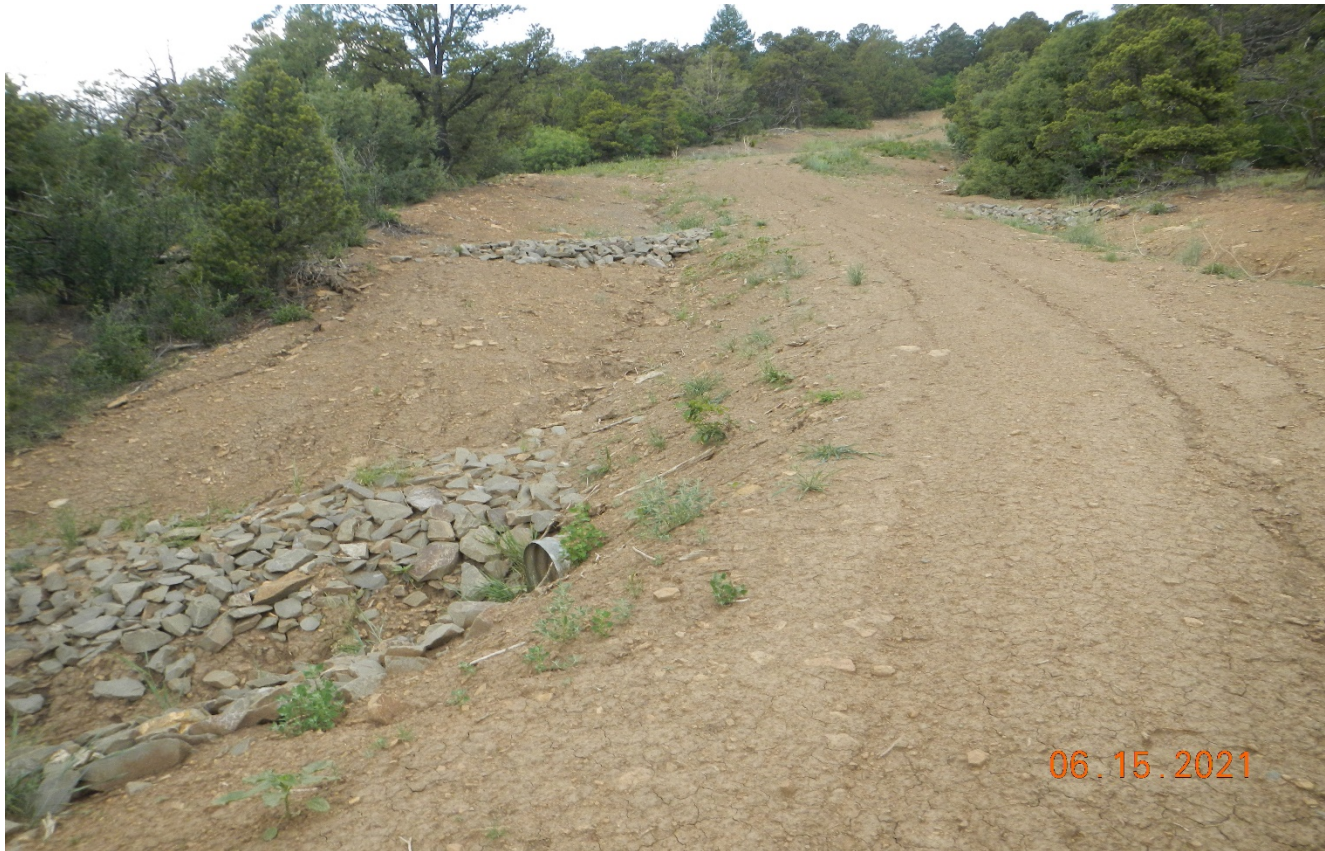
Photo 7. Facing northwest along the road. Culverts are installed along the road.

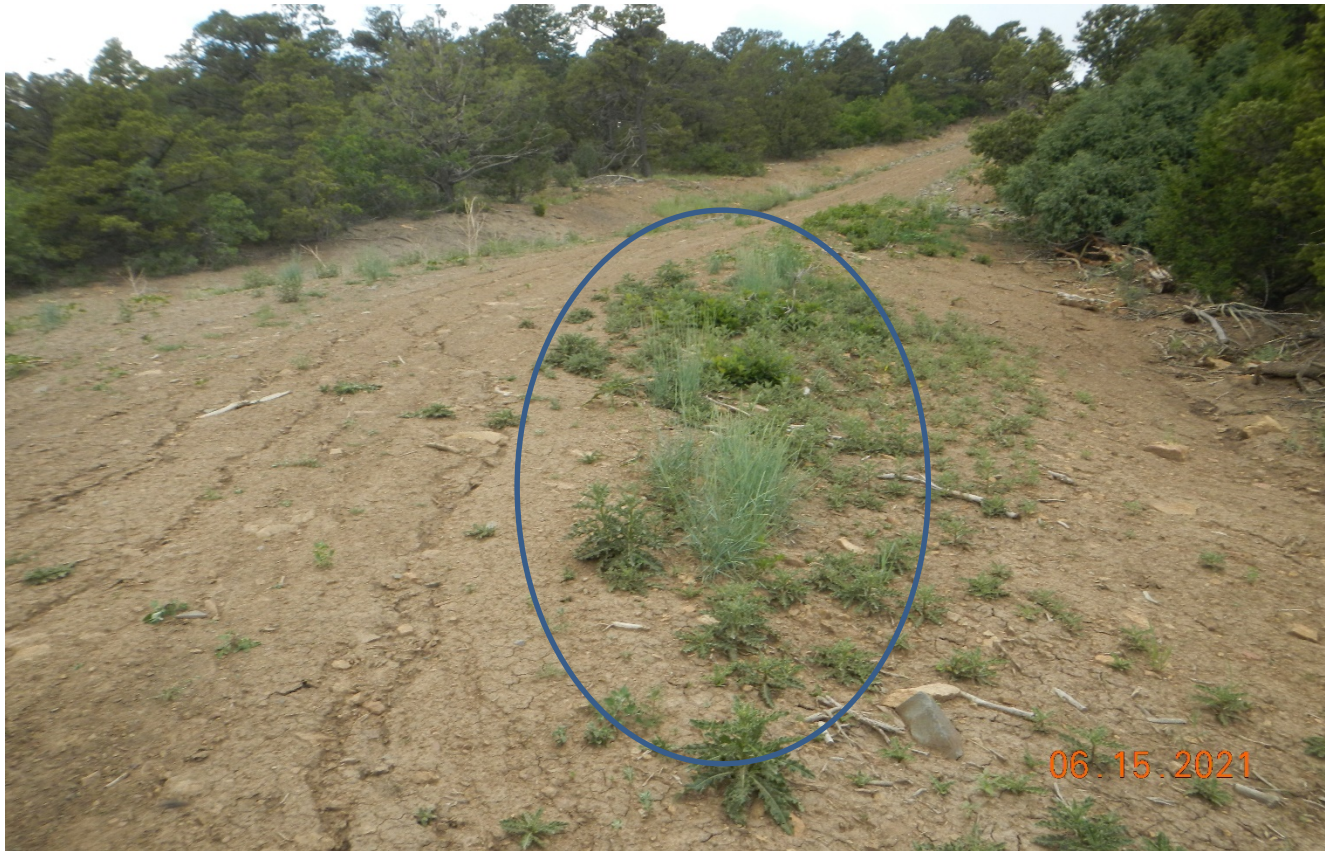
Photo 8. Facing west near the location. There are noxious weeds in the area circled which need to be controlled before further infestation occurs. (Canada thistle)

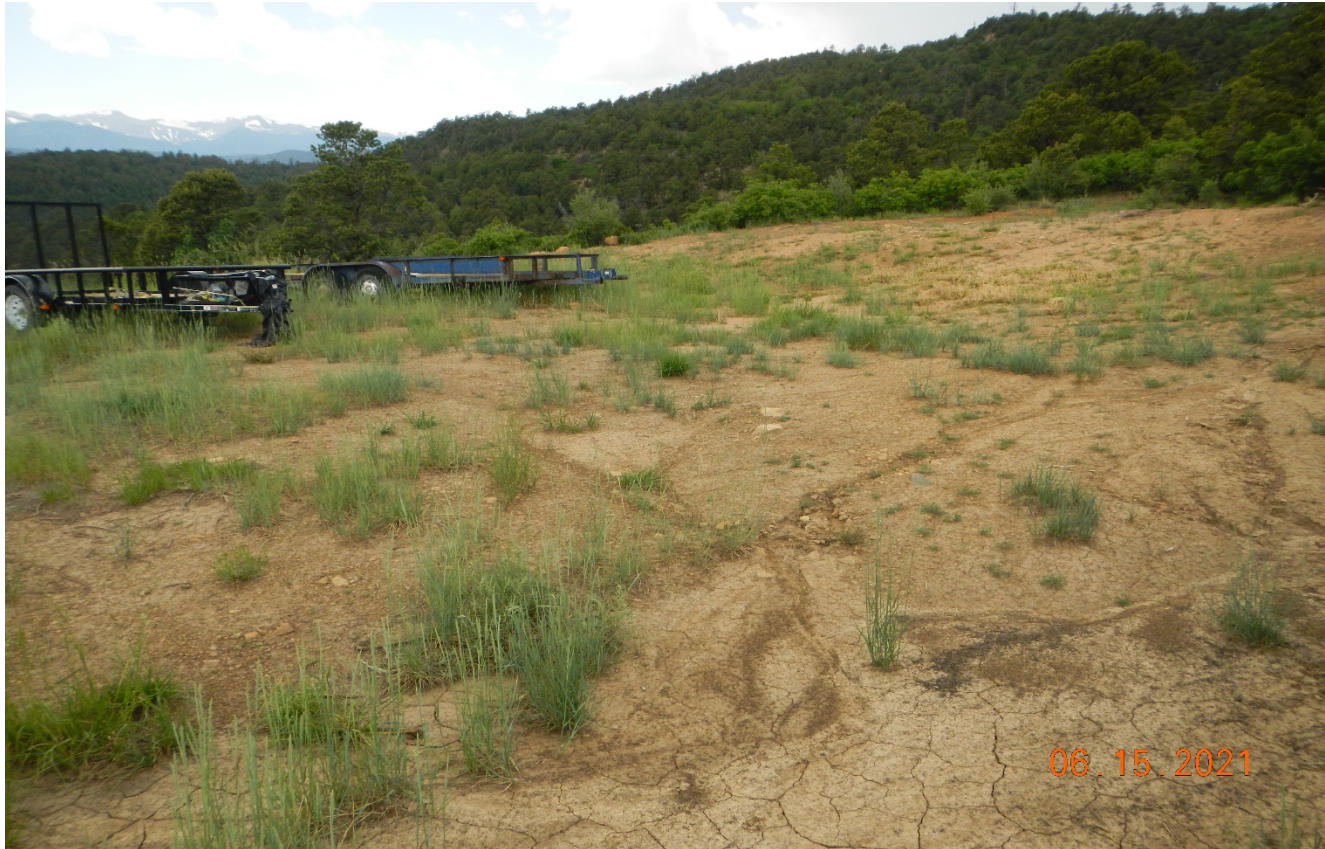
Photo 10. Facing northwest toward the location. Additional seeding along the right side of the photo.

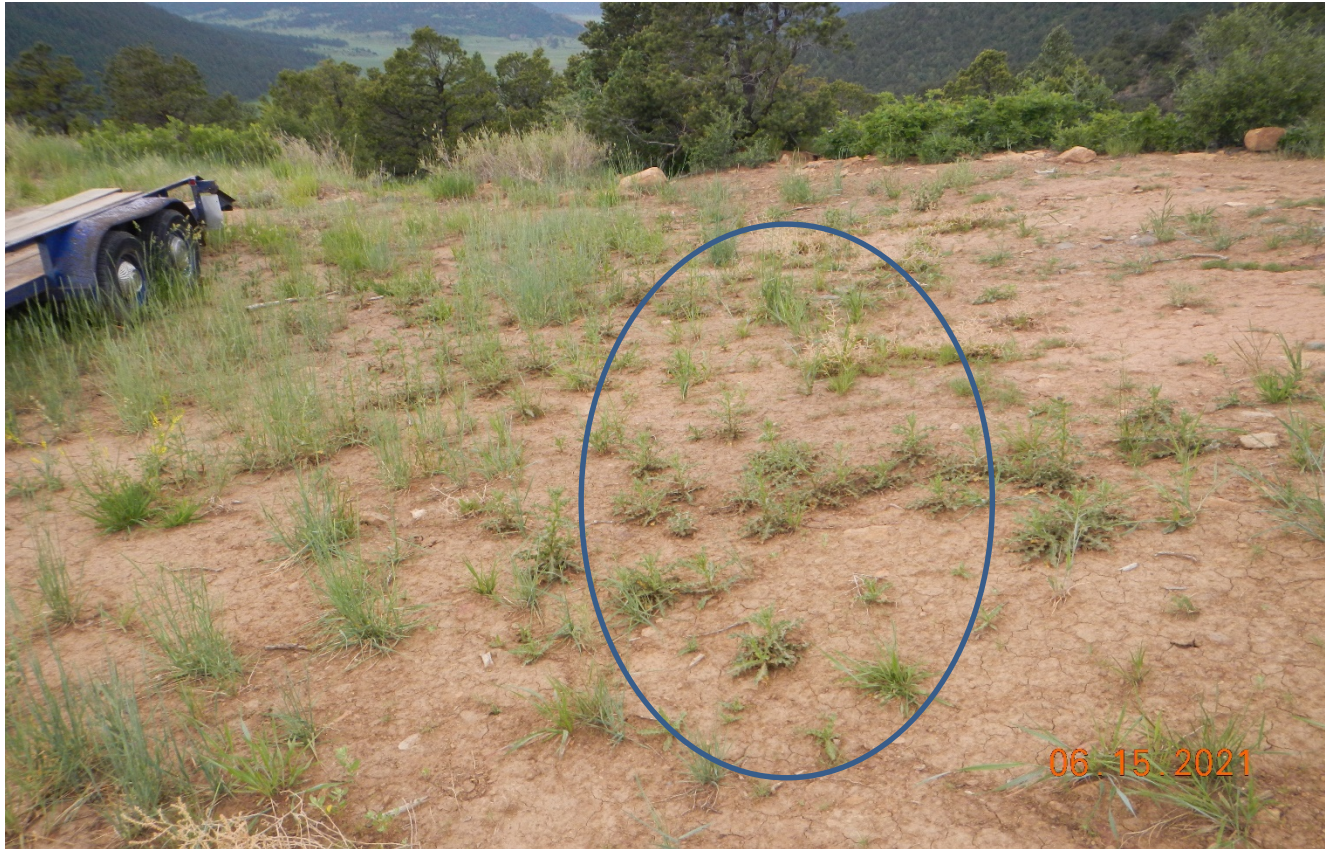
Photo 11. There are noxious weeds in the area circled which need to be controlled before further infestation occurs. (Canada thistle)
