Inspection Photos

API: 071-09381

Operator: XTO ENERGY INC

Inspection Date: 6/15/2021

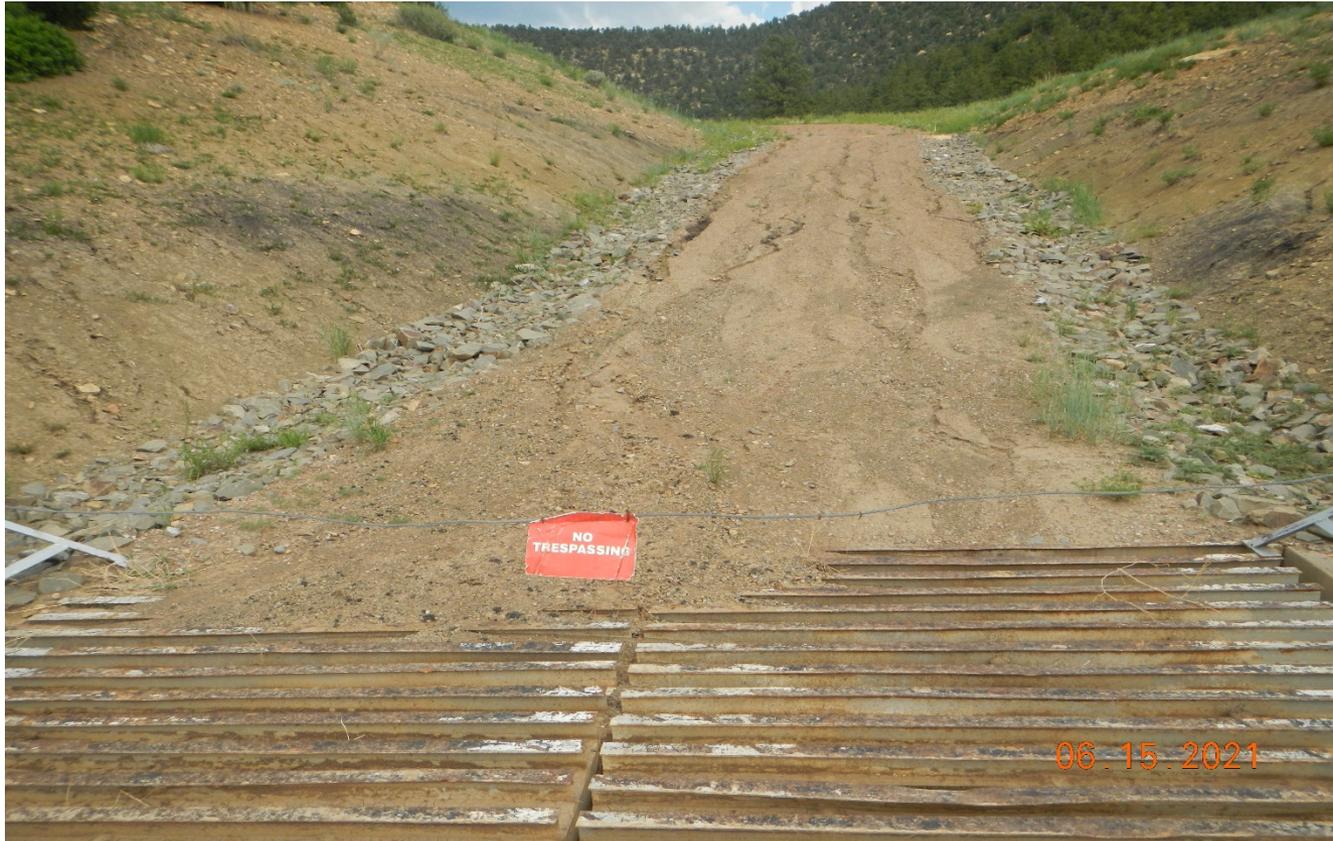
Photo 1. Facing north toward the access road. There is some sediment beginning to fill into the cattle guard.

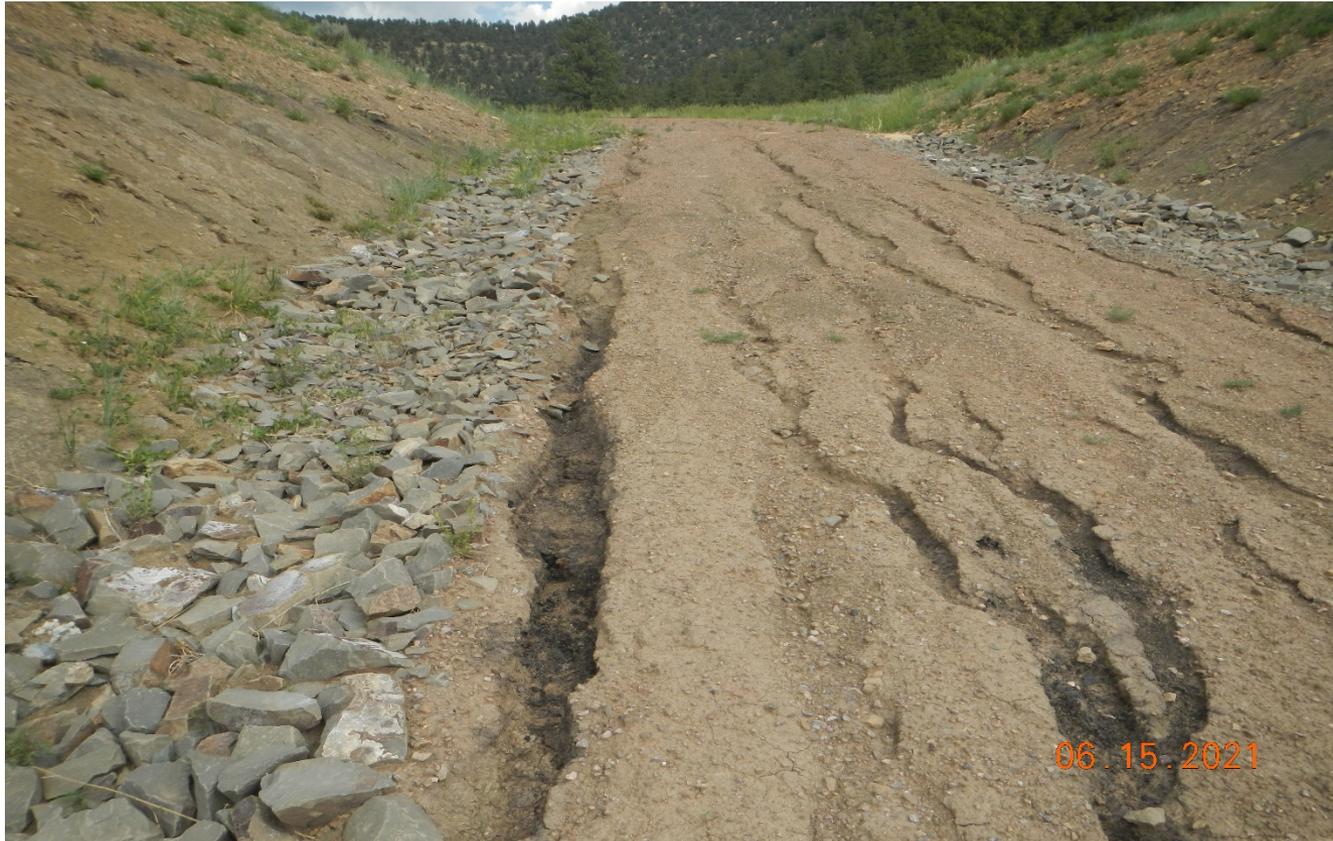
Photo 2. Stormwater is causing erosion at the beginning steep grade of the road. Storm water should be diverted off the road to prevent erosion (berm, water bar).

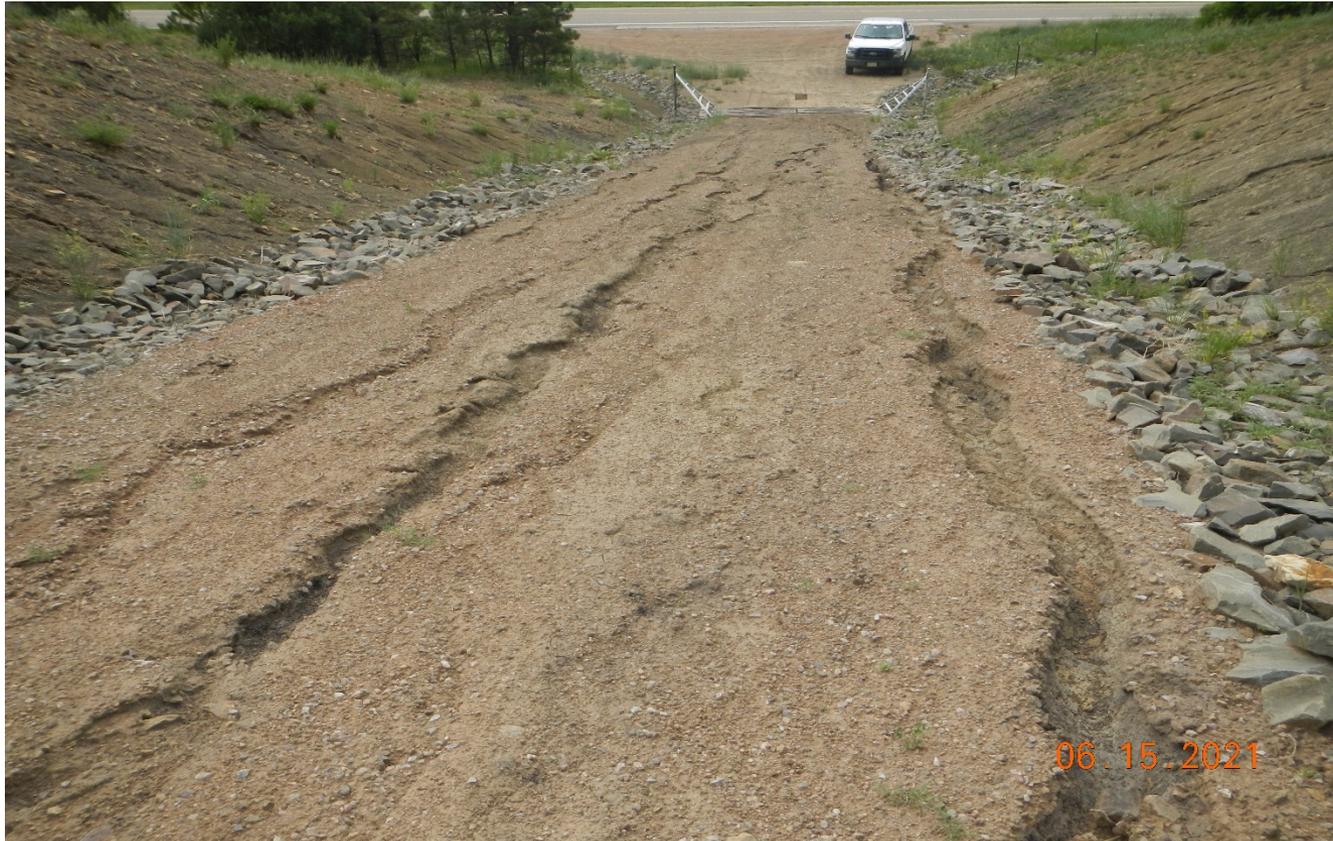
Photo 3. Facing back along the access road. Stormwater should be diverted off the road to prevent erosion.

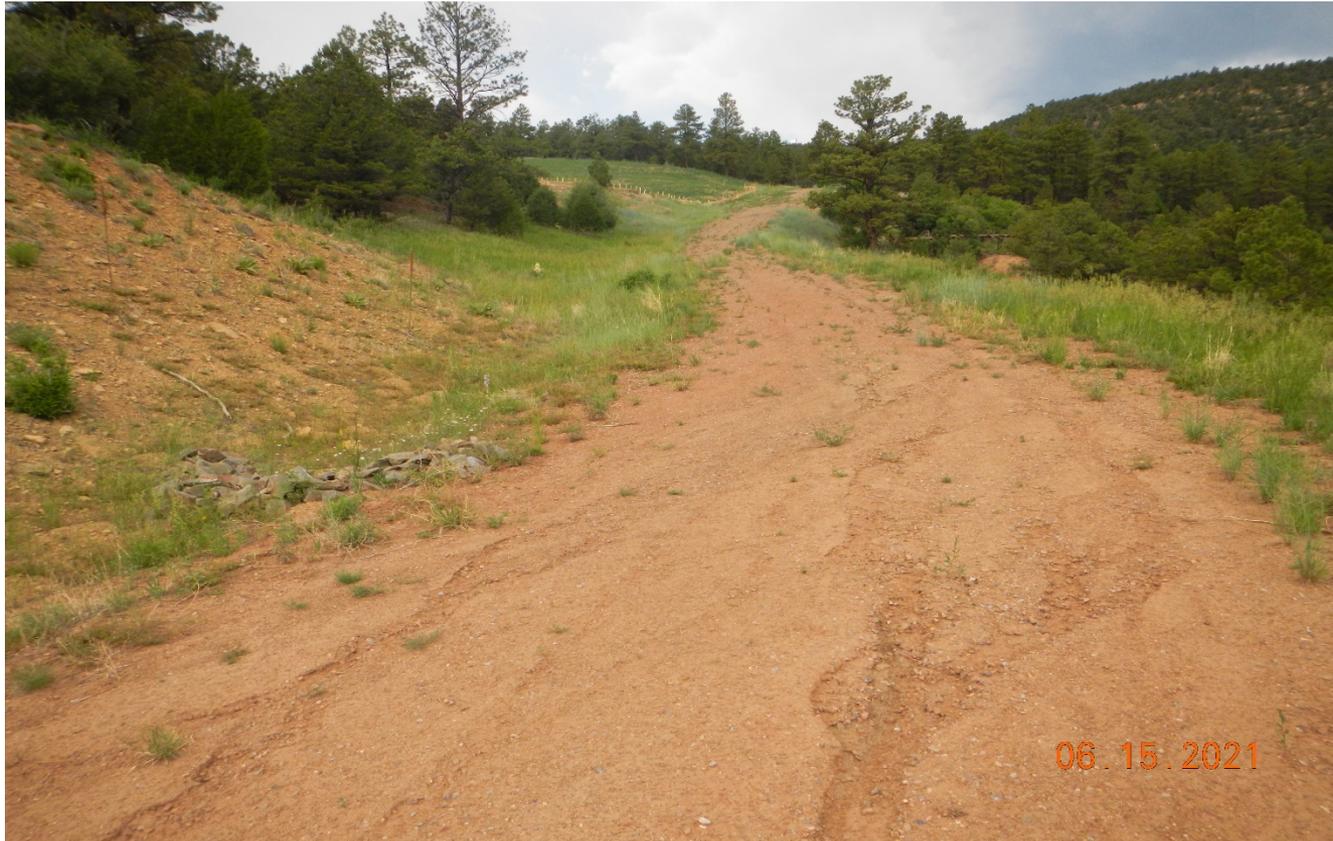
Photo 4. Facing northwest along the access road which remains per approved variance.

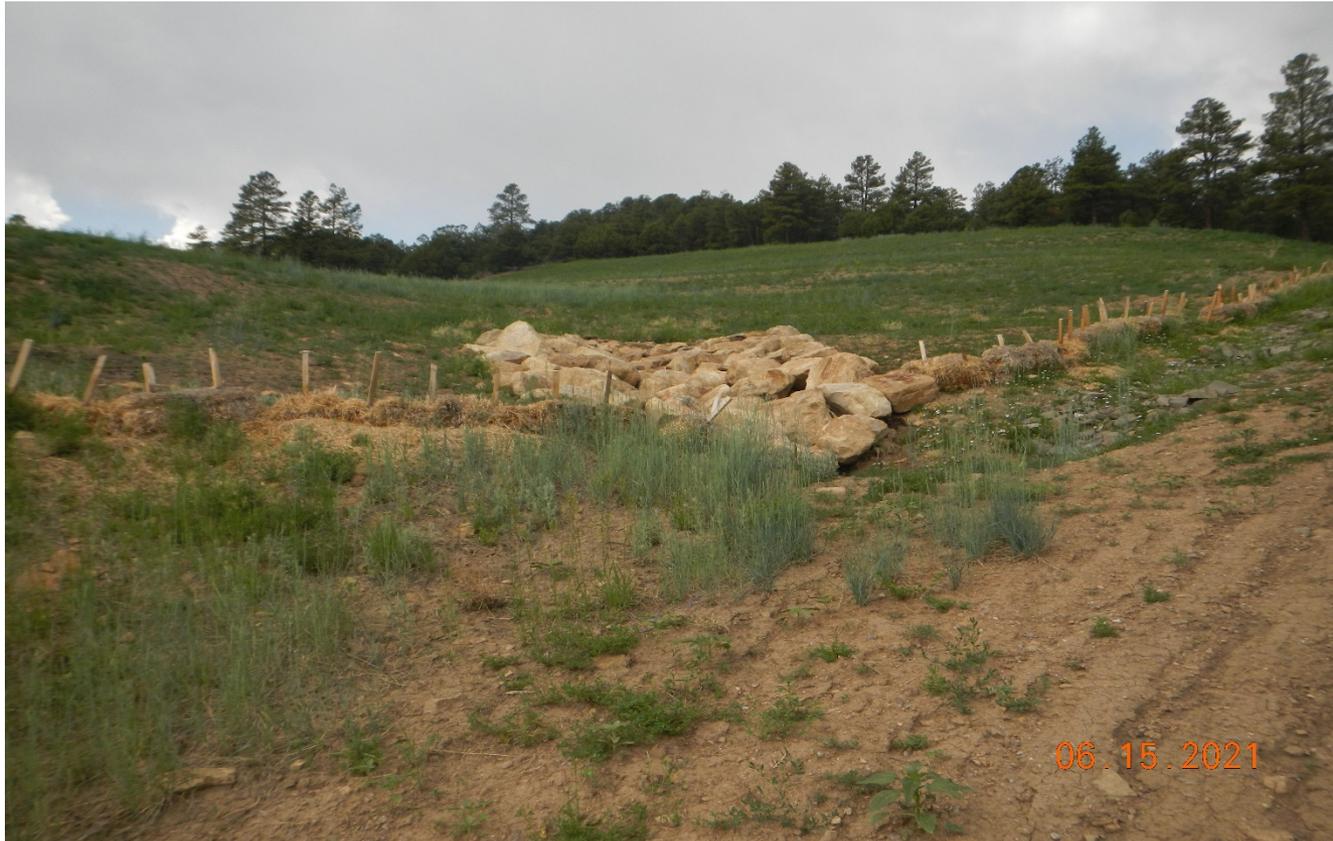
Photo 5. Facing northwest toward the reclaimed location.

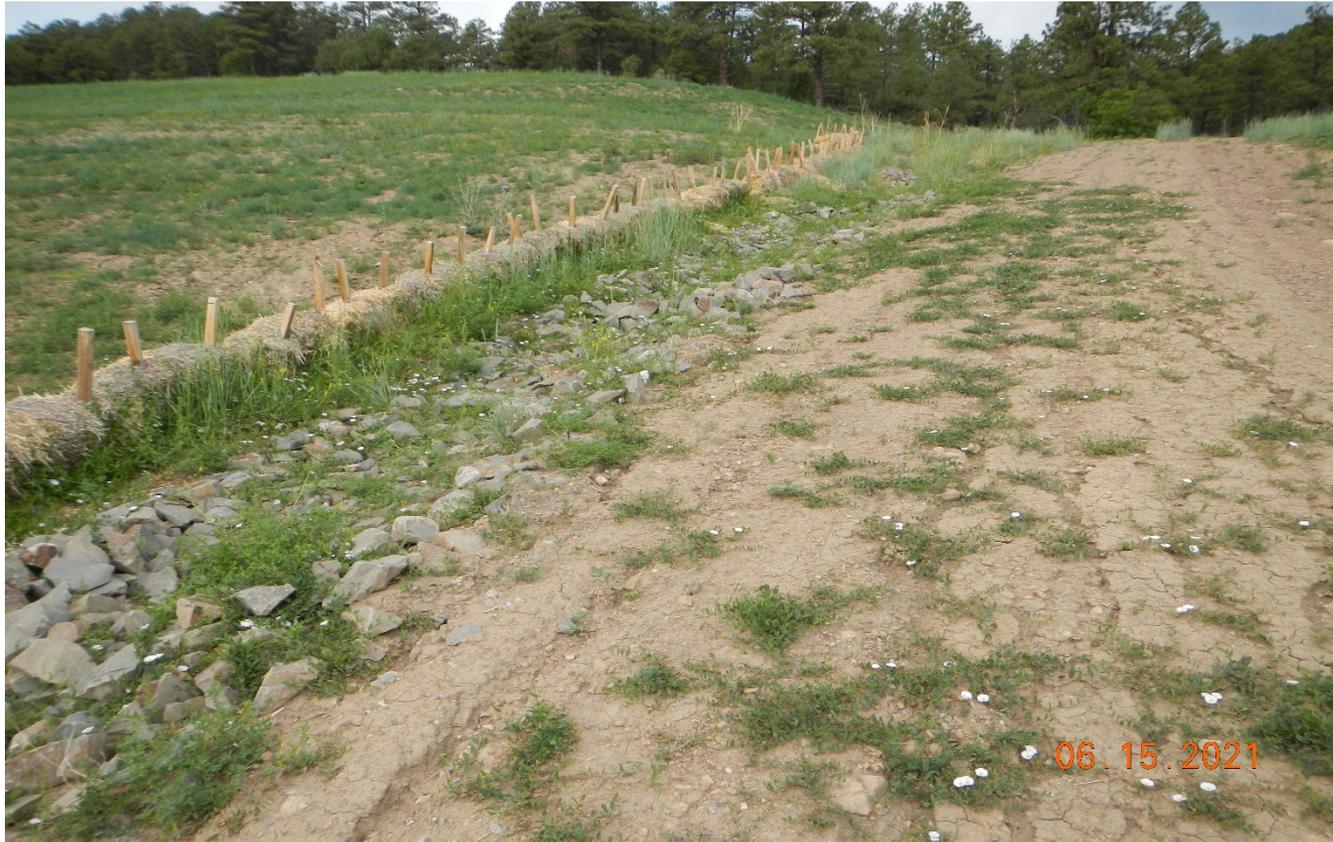
Photo 6. Facing northwest along the access road. There is field bind weed along this area which should be controlled.

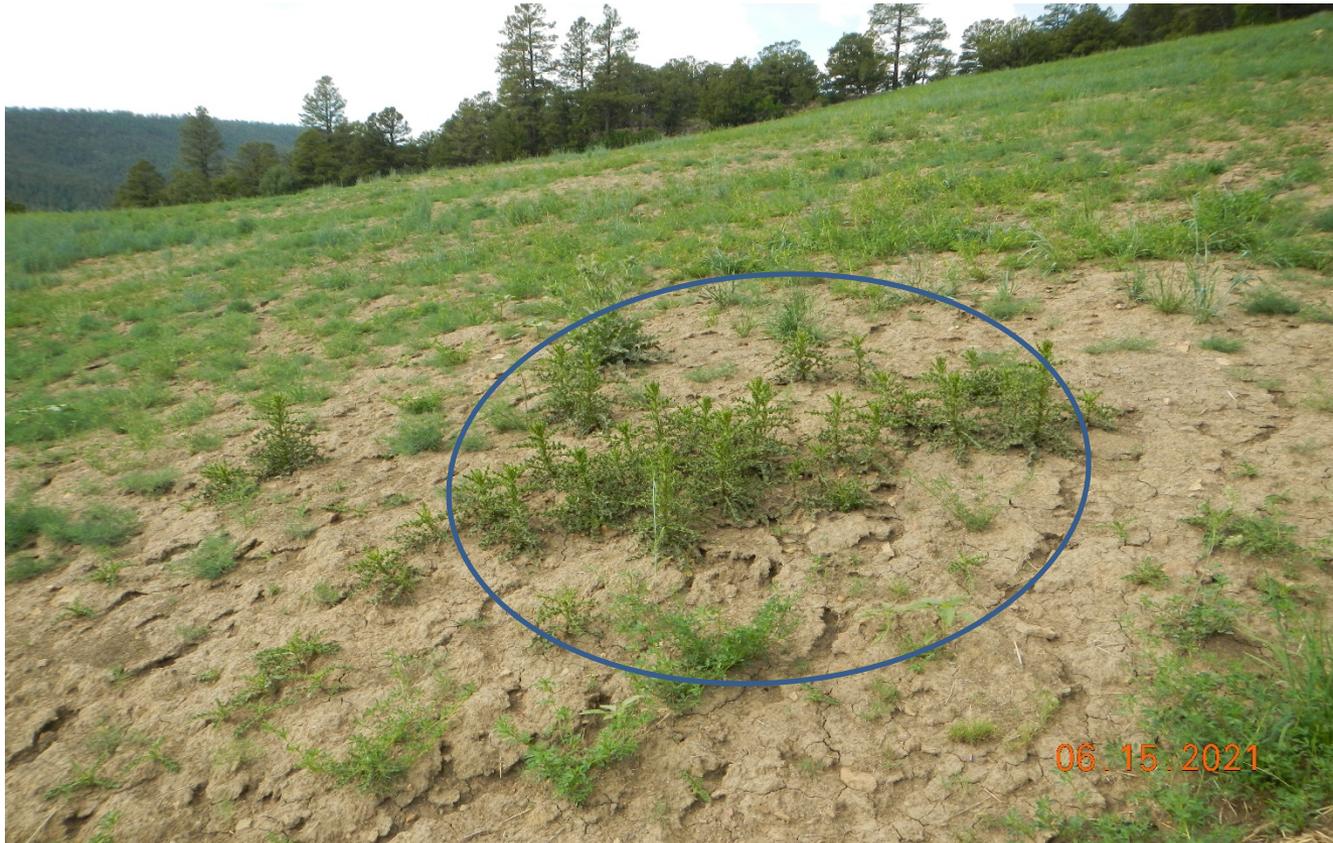
Photo 7. There are noxious weeds in the area circled which need to be controlled before further infestation occurs. (Canada thistle)

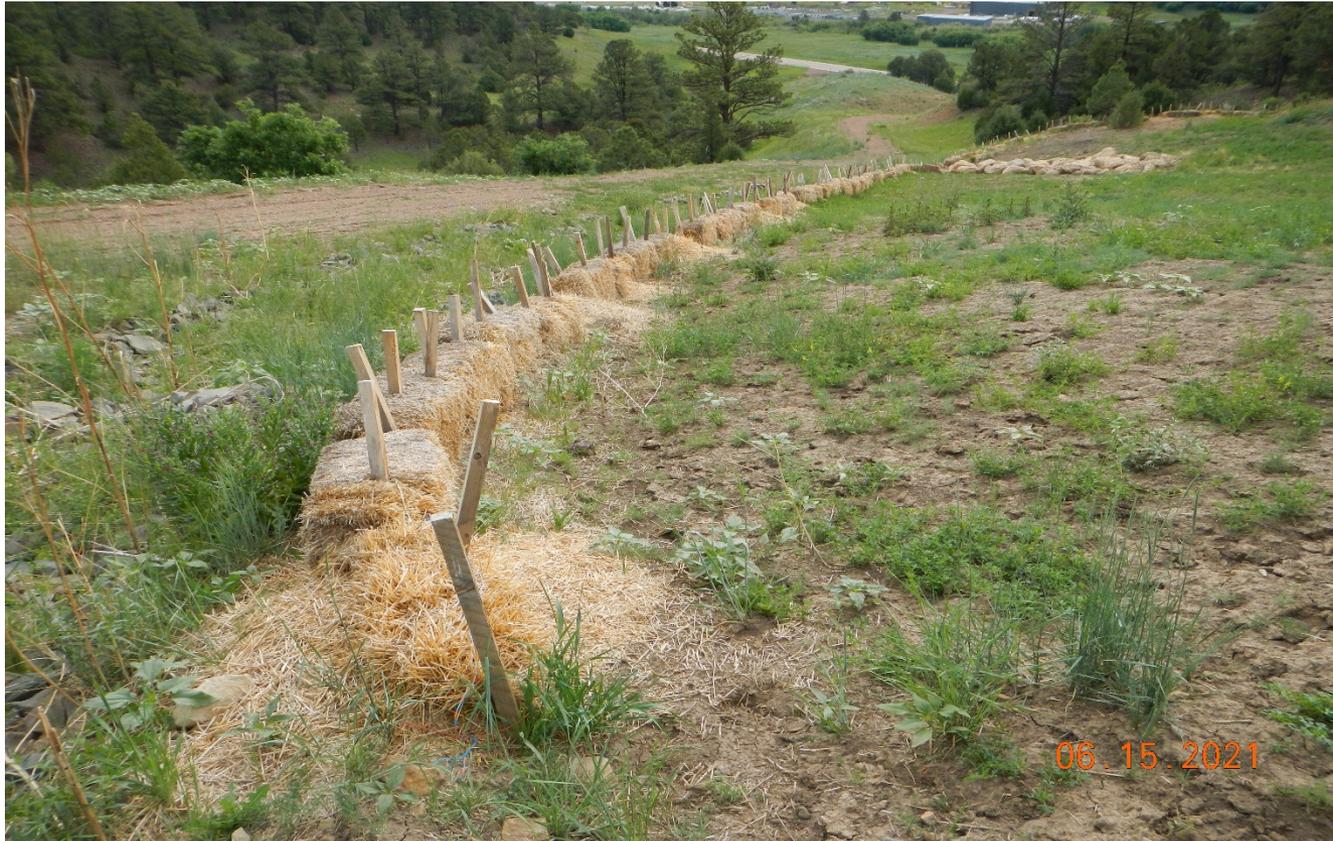
Photo 8. There are straw bales around the perimeter that have degraded. The bales should be removed or replaced if needed.

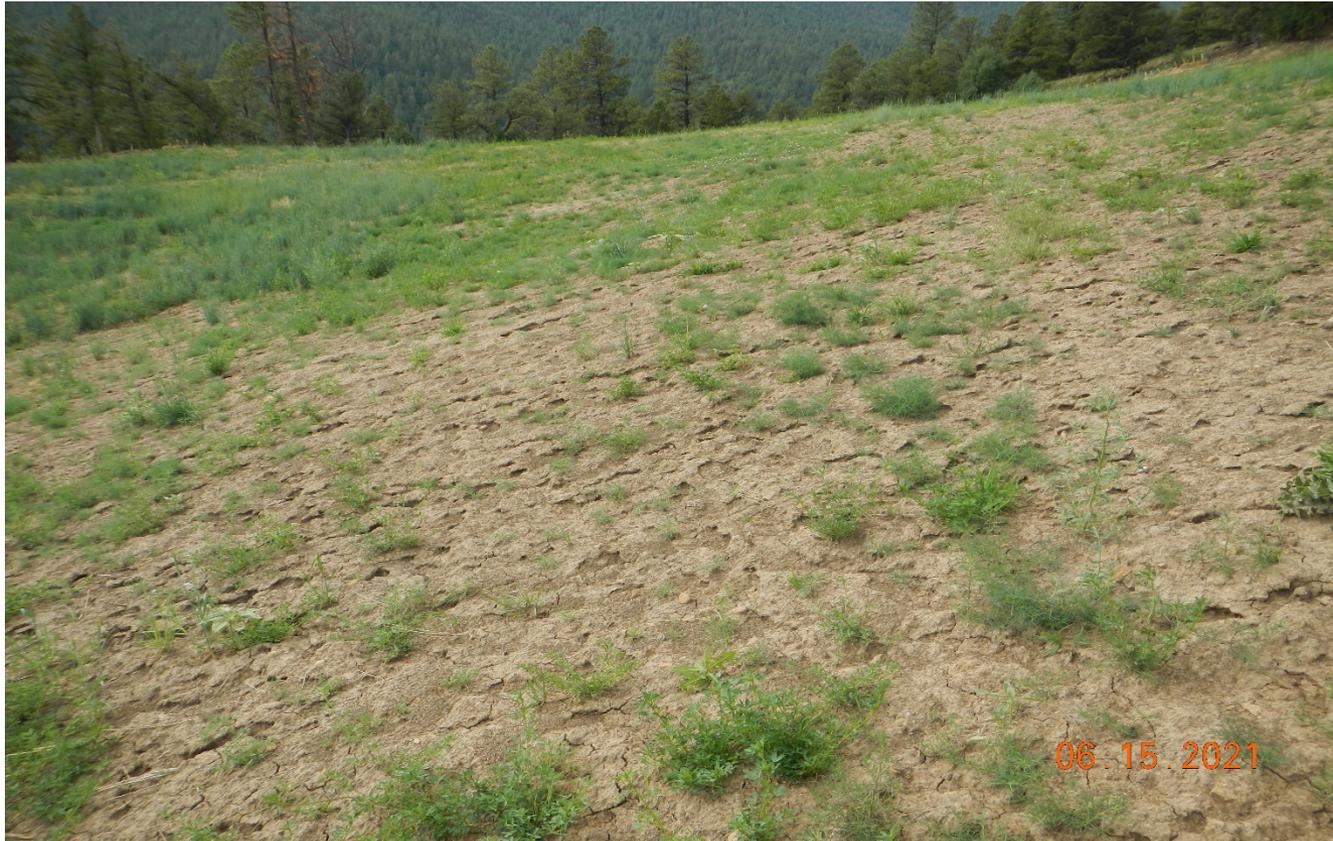
Photo 9. Facing southwest along the reclaimed location. This area could use some maintenance such as hand seeding to help establish vegetation.

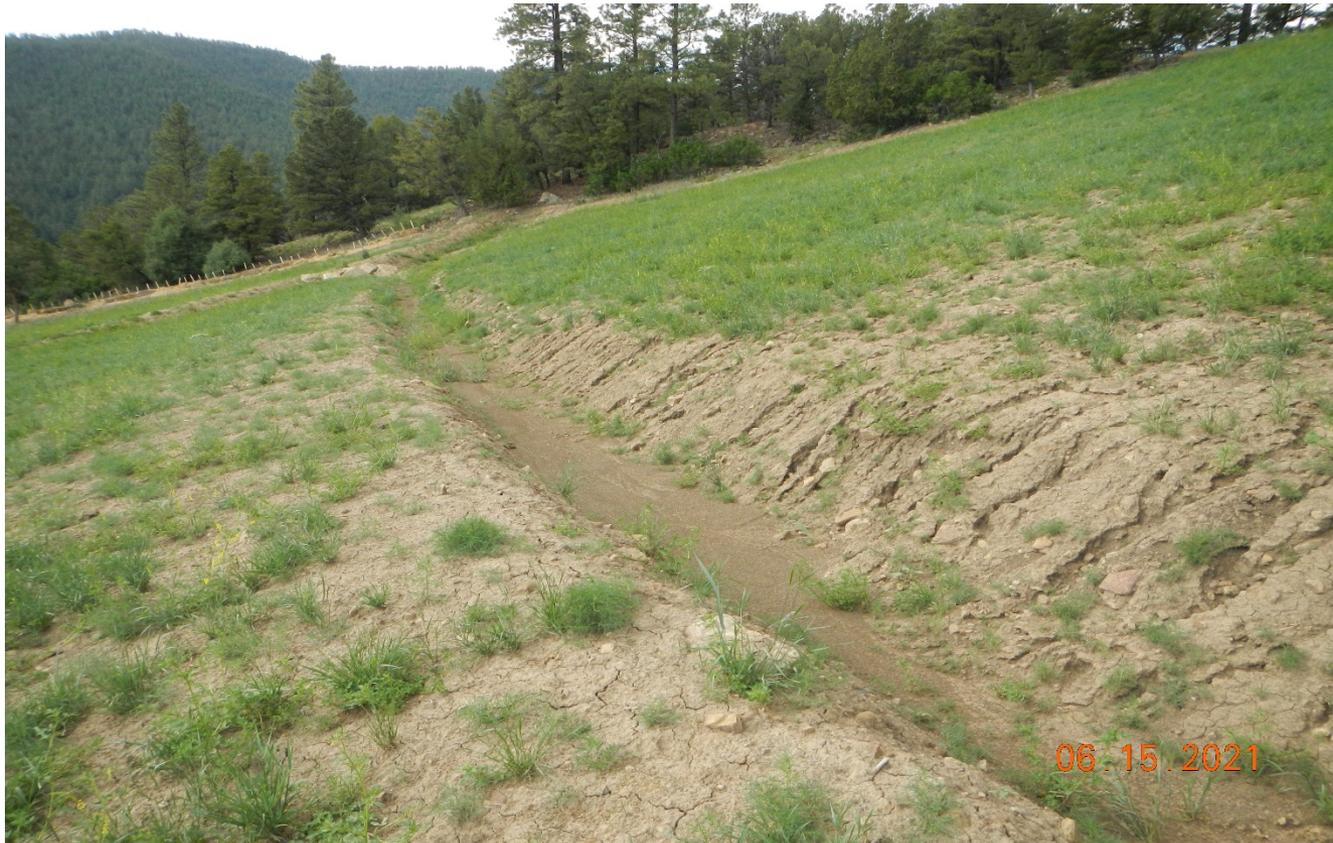
Photo 10. Facing southwest along the reclaimed location. There is a diversion berm along this area which could use some maintenance and hand seeding.

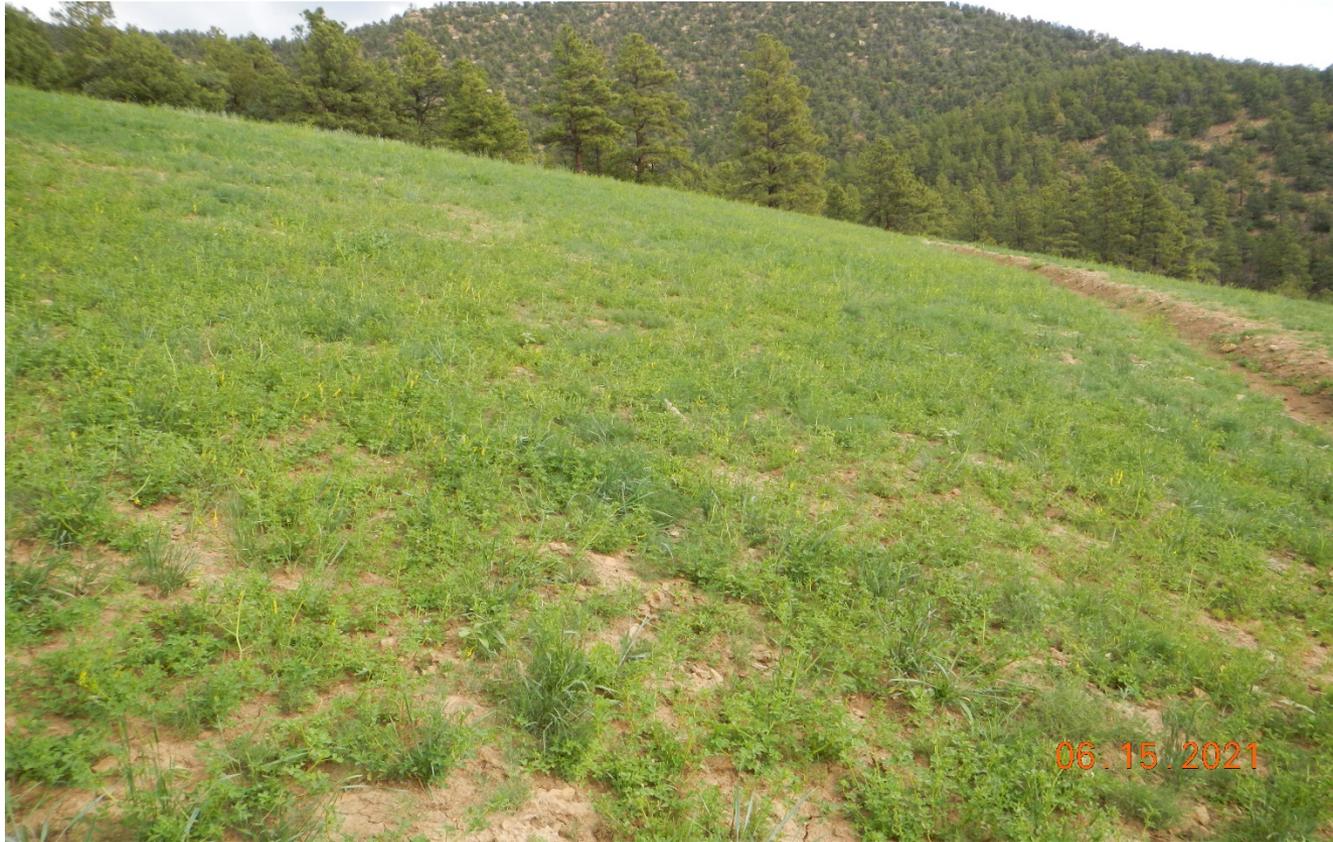
Photo 11. Facing northeast along the top portion of the reclaimed location. Vegetation is establishing well within this area.

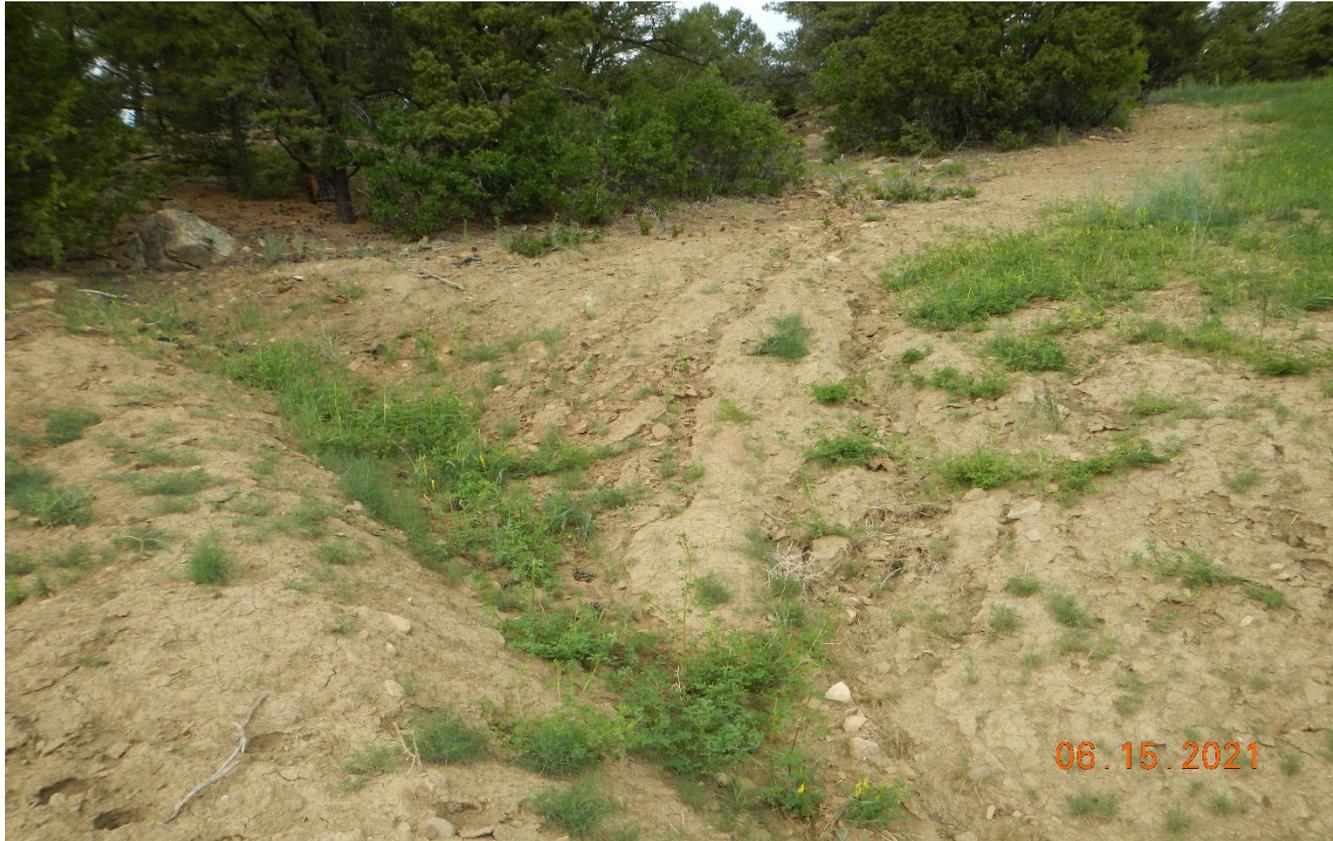
Photo 12. There is an area of erosion at the west side of the location which will need to be repaired and stabilized.

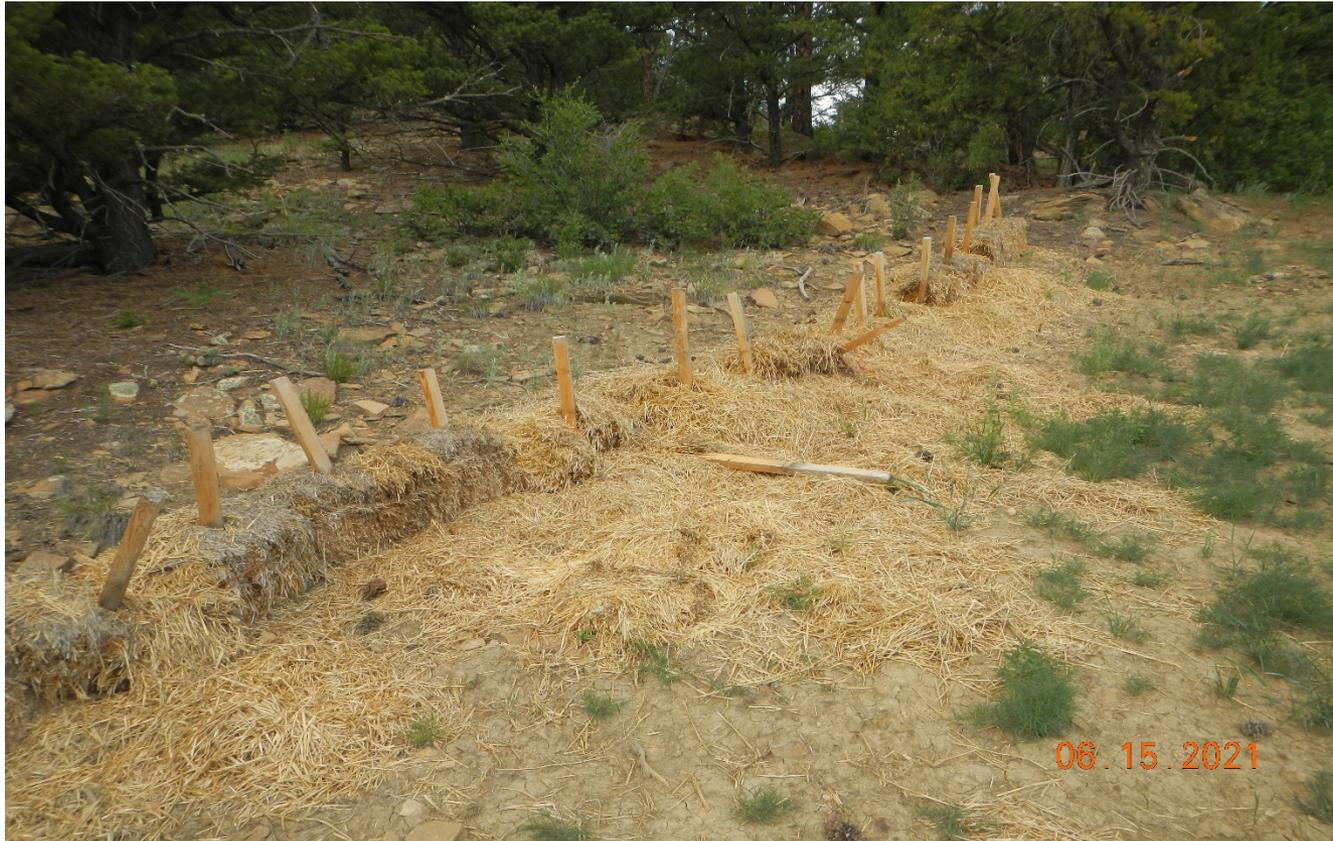
Photo 13. There are straw bales around the perimeter that have degraded. The bales should be removed or replaced if needed.

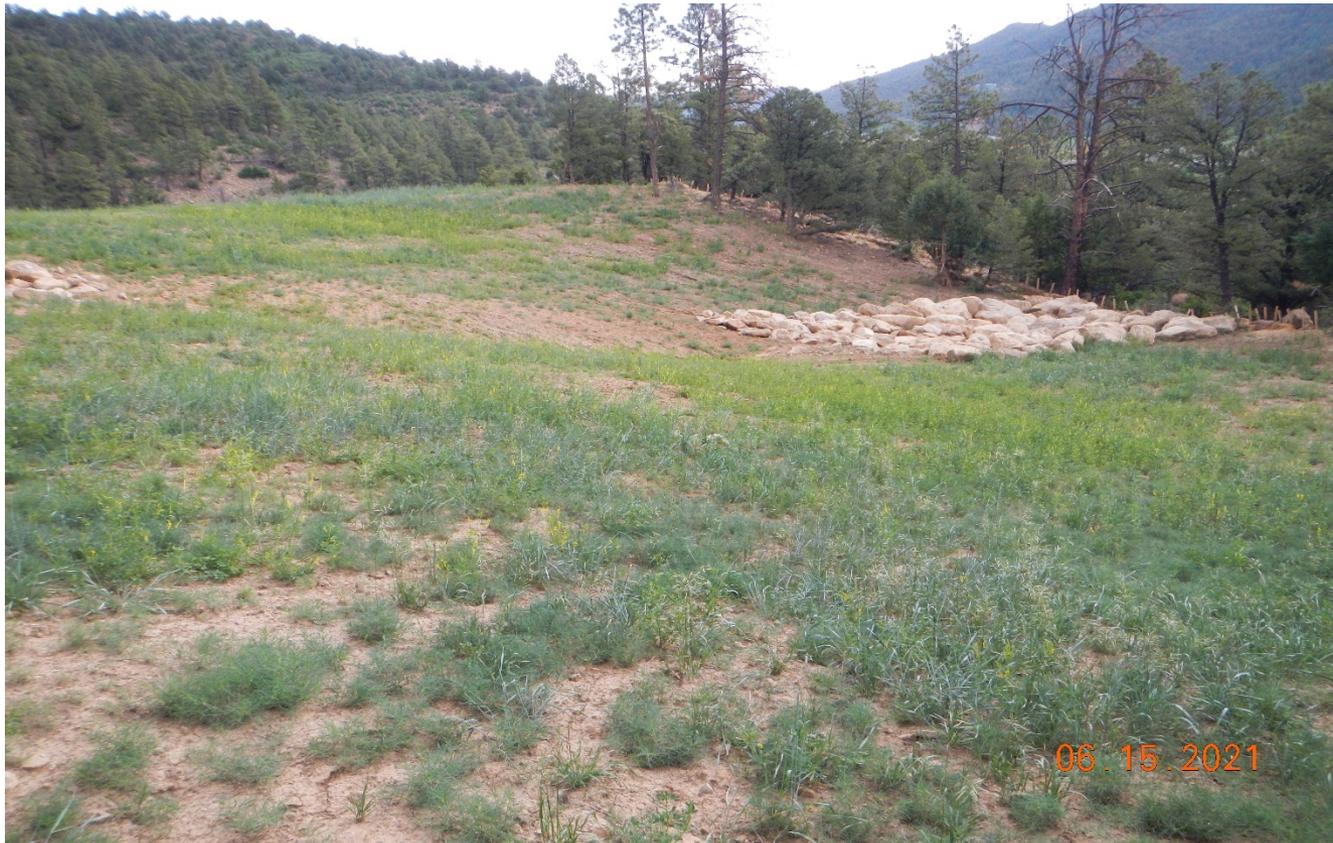
Photo 14. Facing east along the bottom of the reclaimed location.

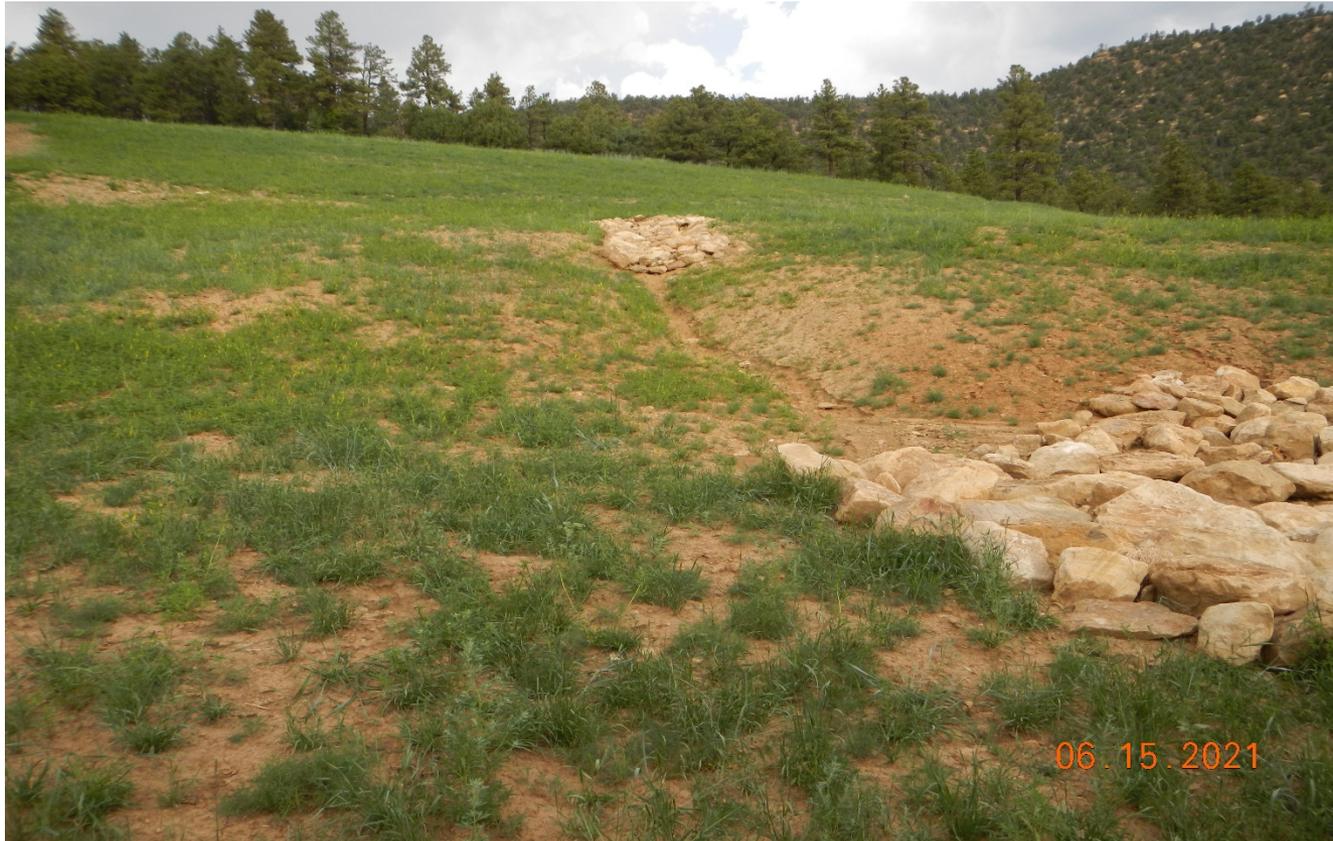
Photo 15. Facing northeast toward the reclaimed location. There is desirable vegetation progressing at the location.

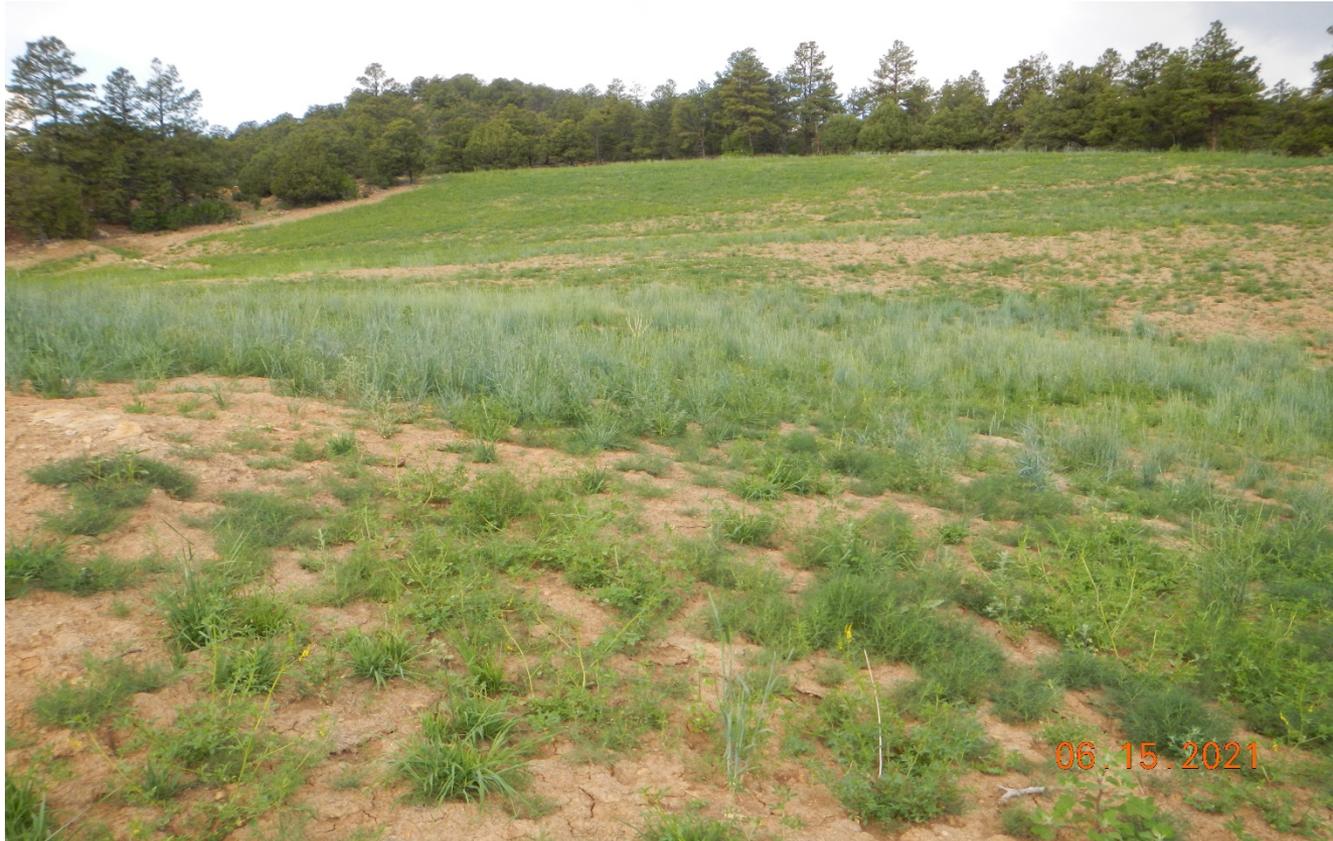
Photo 16. Facing northwest toward the reclaimed location. There is desirable vegetation progressing at the location.

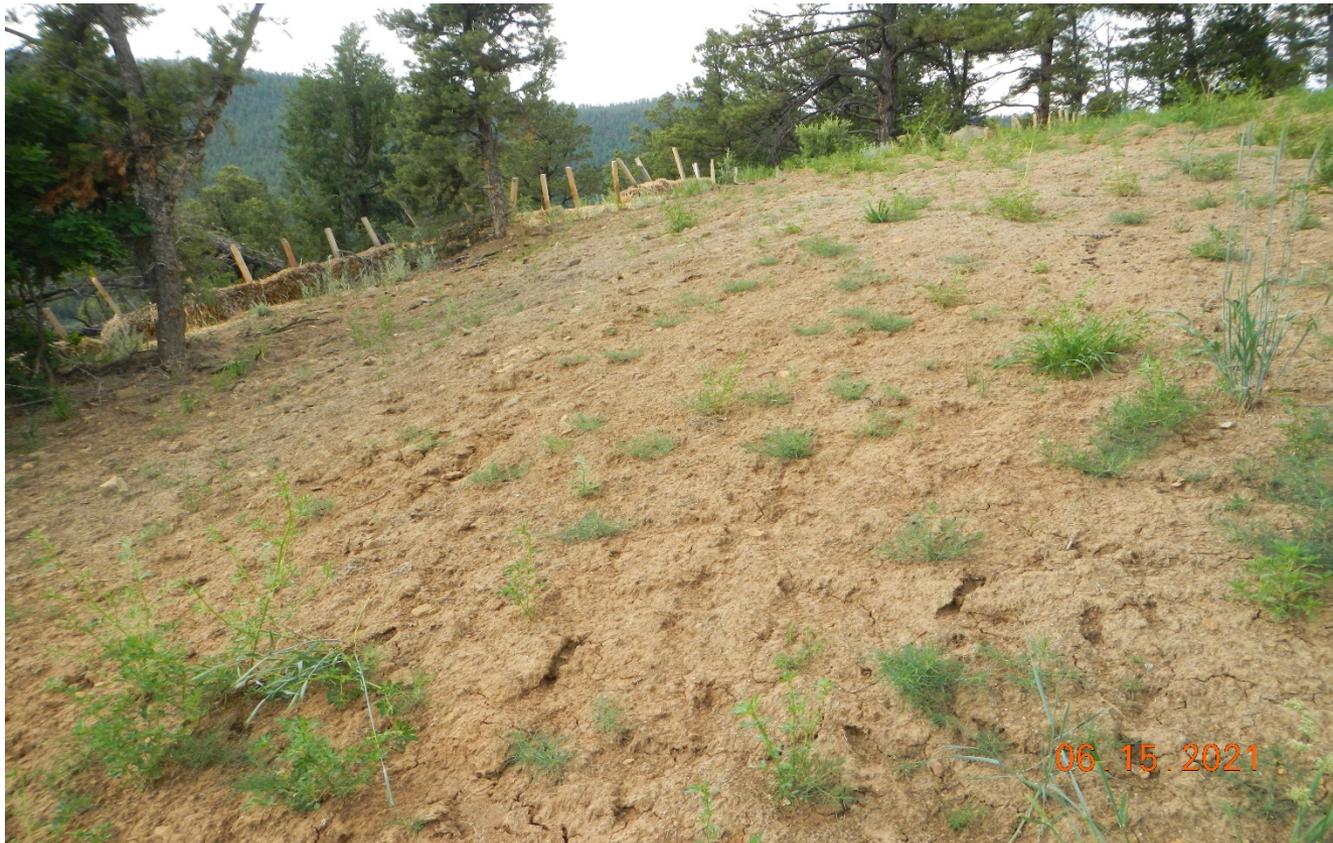
Photo 17. This area could use some maintenance such as hand seeding to help establish vegetation.

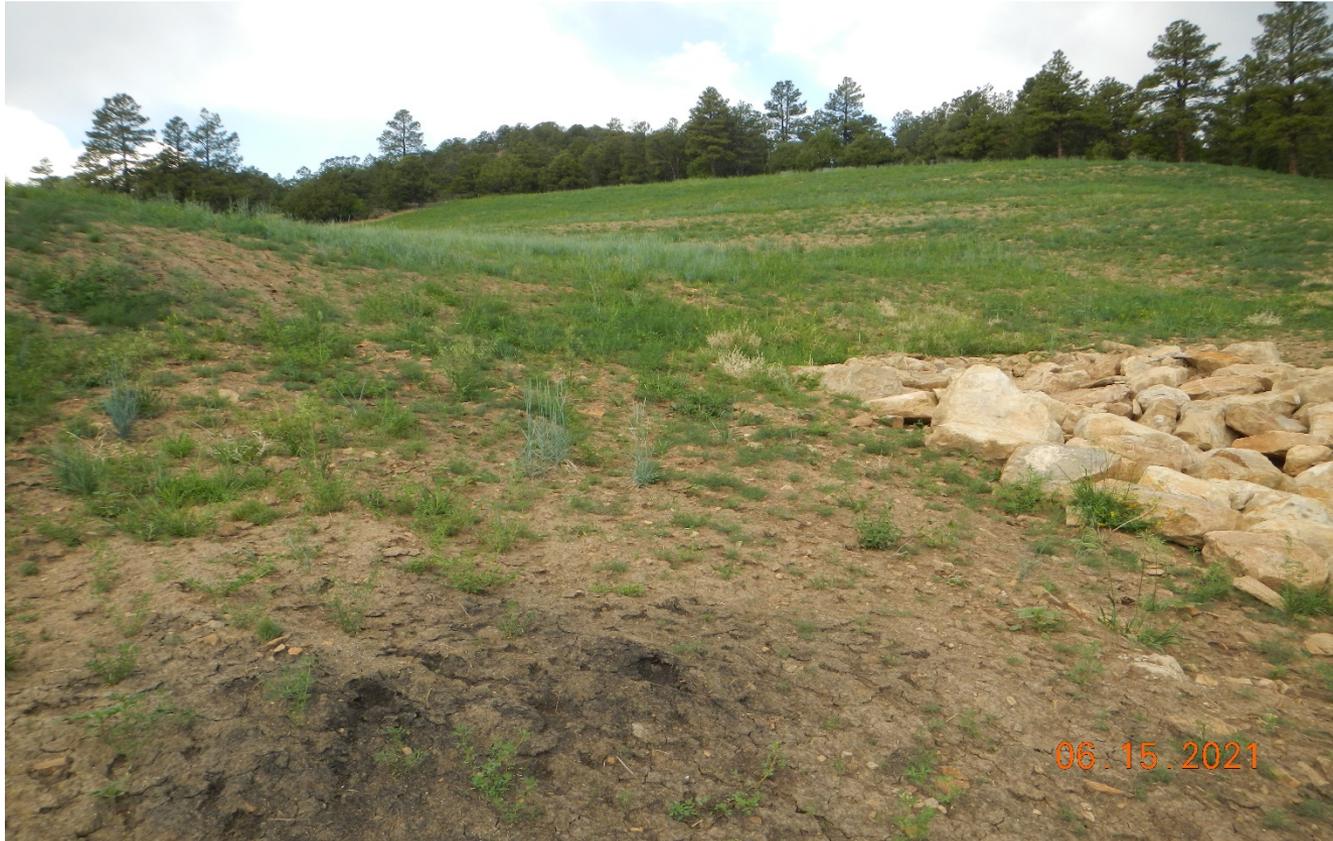
Photo 18. Facing northwest at the reclaimed location.
