Stormwater Inspection Report

Operator:	Laramie Energy, LLC
Project:	Cascade Creek
Location:	CC 632-13-22 and CC 604-12-13 Annex Pads
Date:	Monday, June 7, 2021
Weather:	Clear, Breezy, 93°, Lo 56°

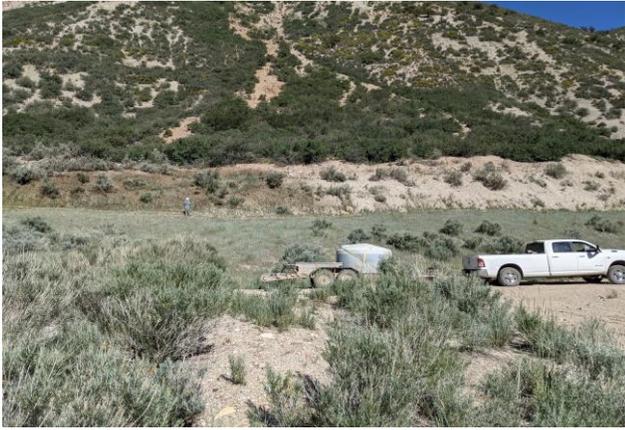
Photo 1

Irrigating Cut Slope on CC 632-13-22 Pad

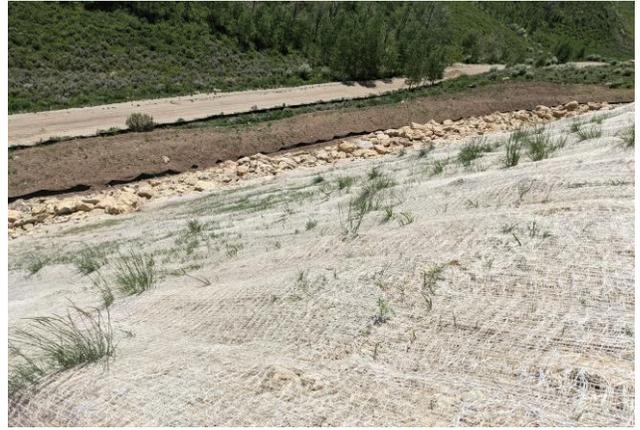
Photo 2

Desirable Vegetation Growing through Jute Netting on CC 604-12-13 Annex Pad

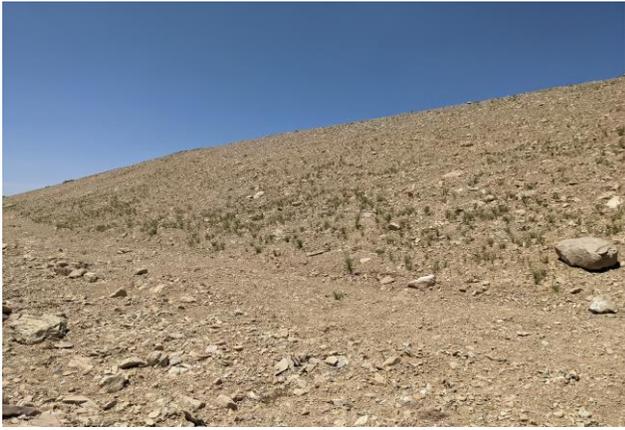
Photo 3

Desirable Vegetation Growing on Upper Section of Fill Slope on CC 604-12-13 Annex Pad

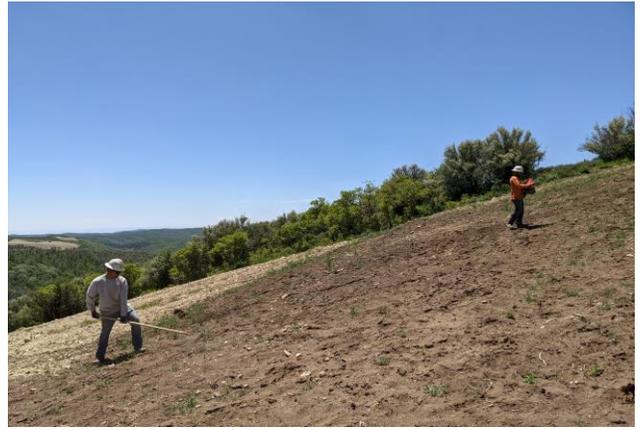
Photo 4

Seeding Areas with Weak Stands on the CC 604-12-13 Annex Pad

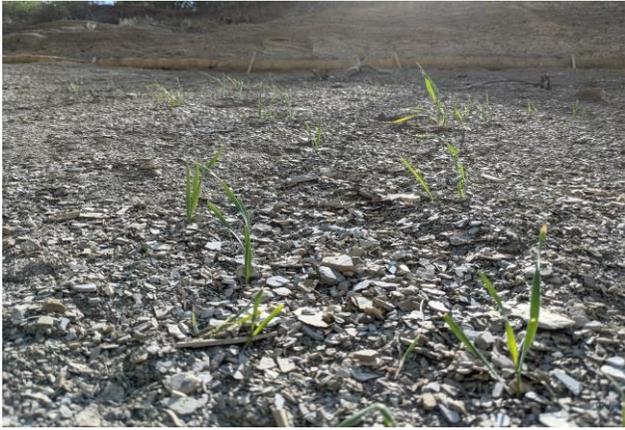
Photo 1

Seed Germinating on the CC 629-23-42 Pad

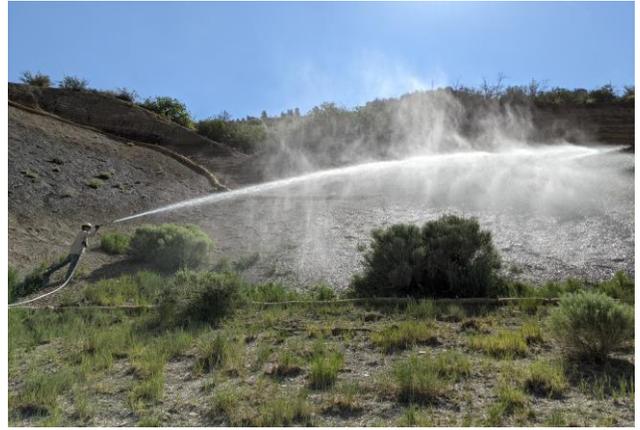
Photo 2

Irrigating the CC 629-23-42 Pad

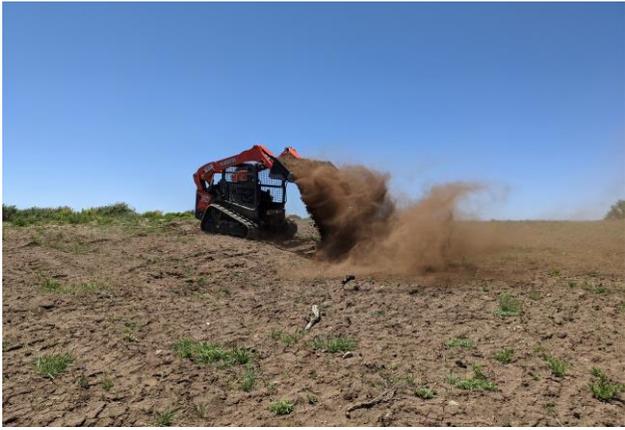
Photo 3

Filling In Areas that Settled on CC 604-12-13 Annex

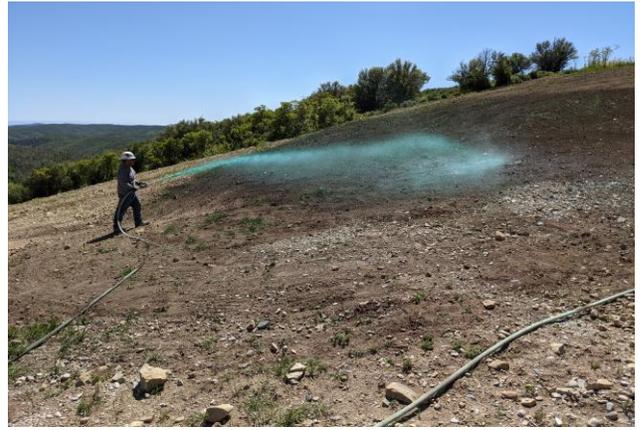
Photo 4

Applying Liquid Soil Amenities on CC 604-12-13 Annex

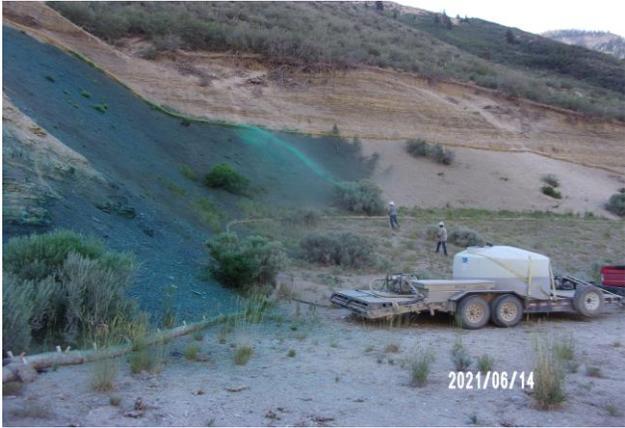
Photo 1

Applying Additional Water, Nutrients, and Soil Amenities on CC 629-23-42 Cut Slope

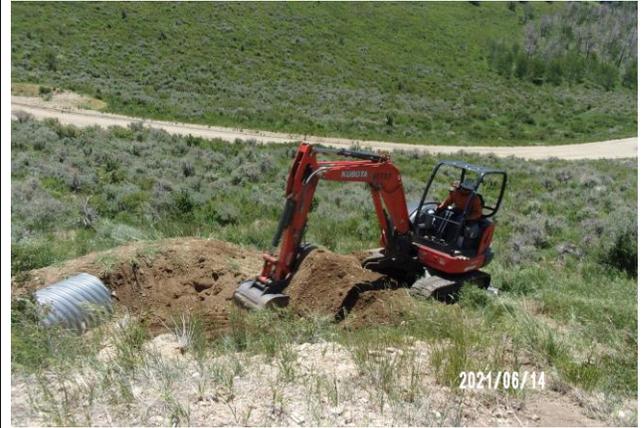
Photo 2

Installing Outlet Protection on Culvert on CC 604-12-13 Annex Access Road

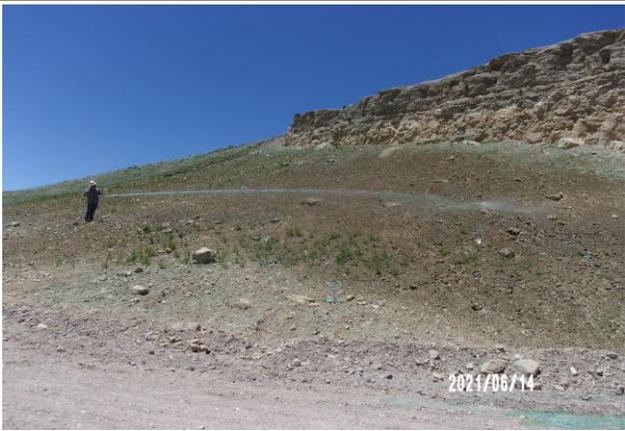
Photo 3

Irrigating Previous Seeding on the CC 604-12-13 Annex Pad

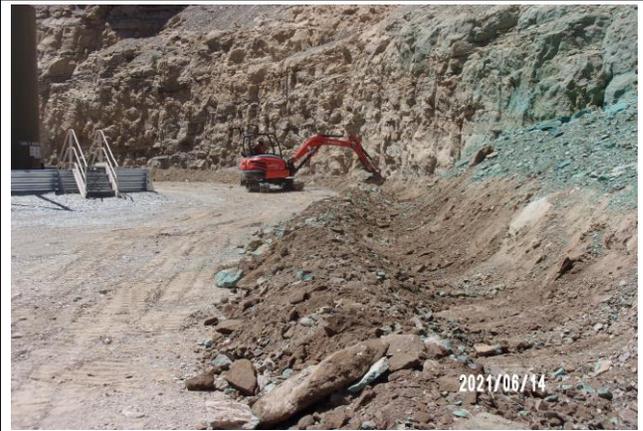
Photo 4

Installing Containment Berm Below CC 604-12-13 Annex Cut Slope
