Inspection Photos

6/15/2021

Operator: GUNNISON ENERGY LLC # 10515

Location ID: 453805

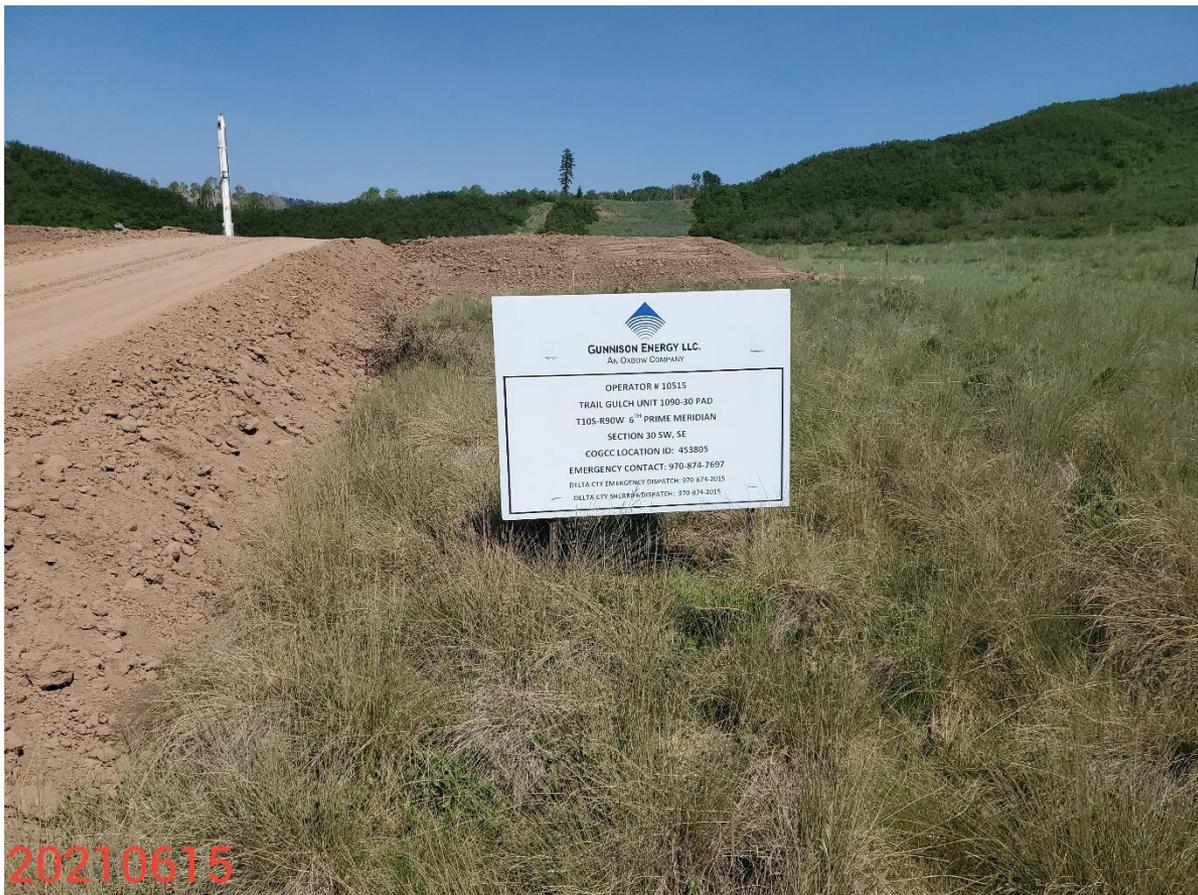
Photo 1: Photo shows sign at Location entrance.

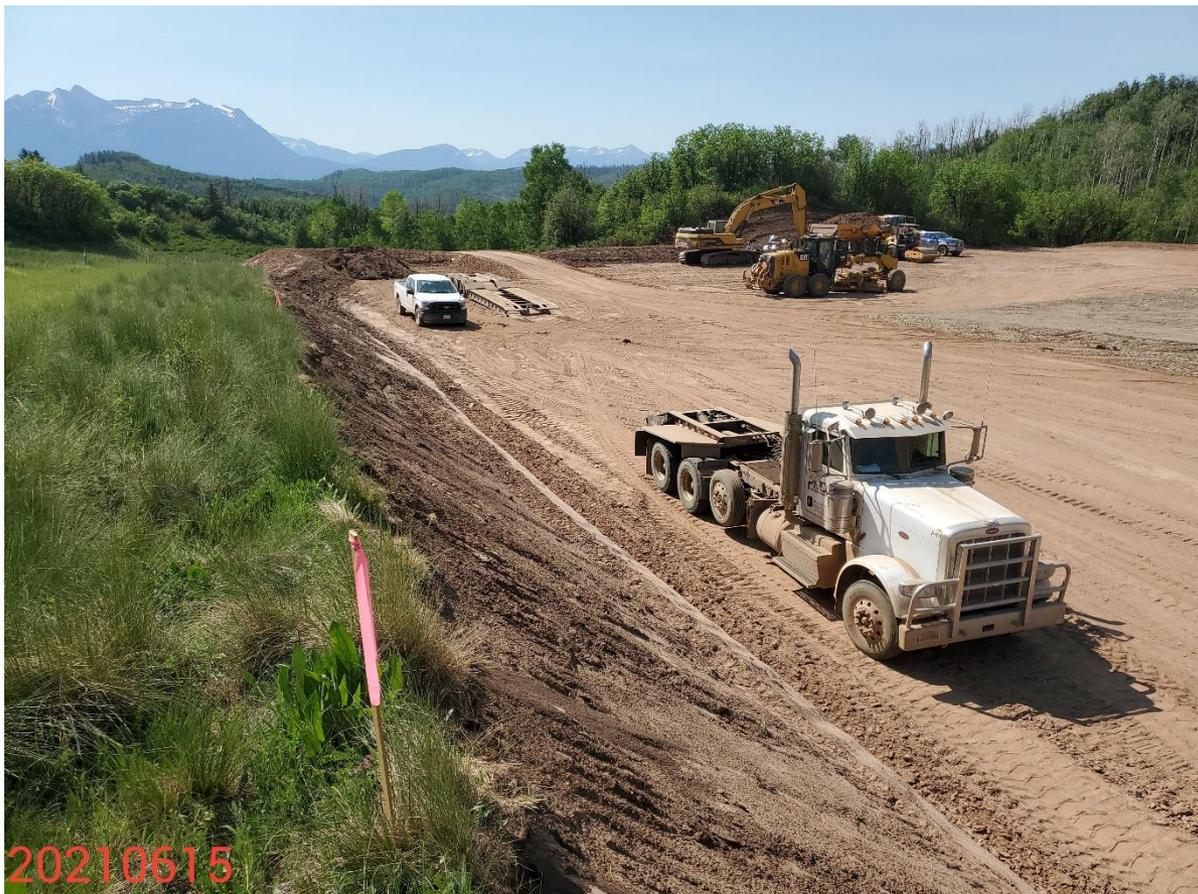
Photo 2: Photo taken from the east end of the Location, facing south. Photos 2-5 provide an overview of the Location from south, southwest, northwest to north.

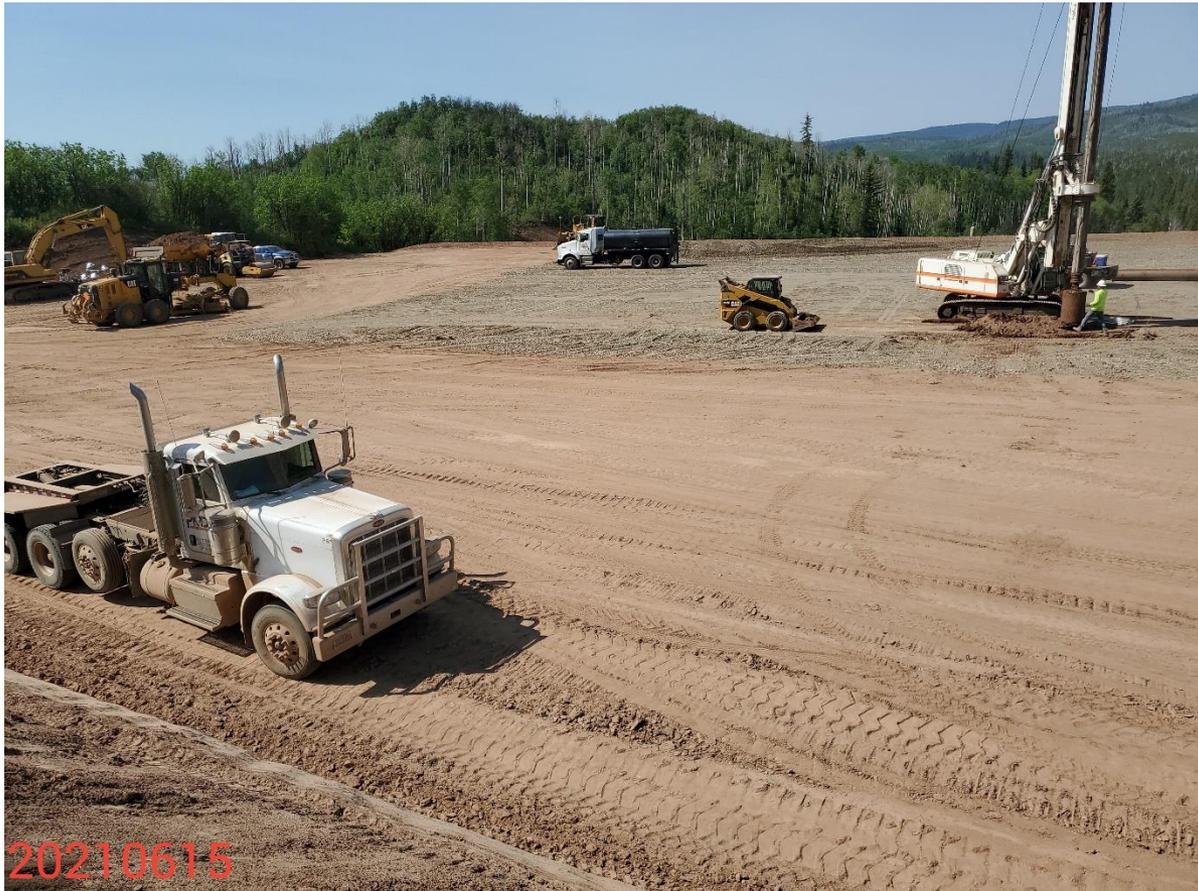
Photo 3: See comments under photo 1. Photo also show operations to install conductors was in-process at time of inspection.

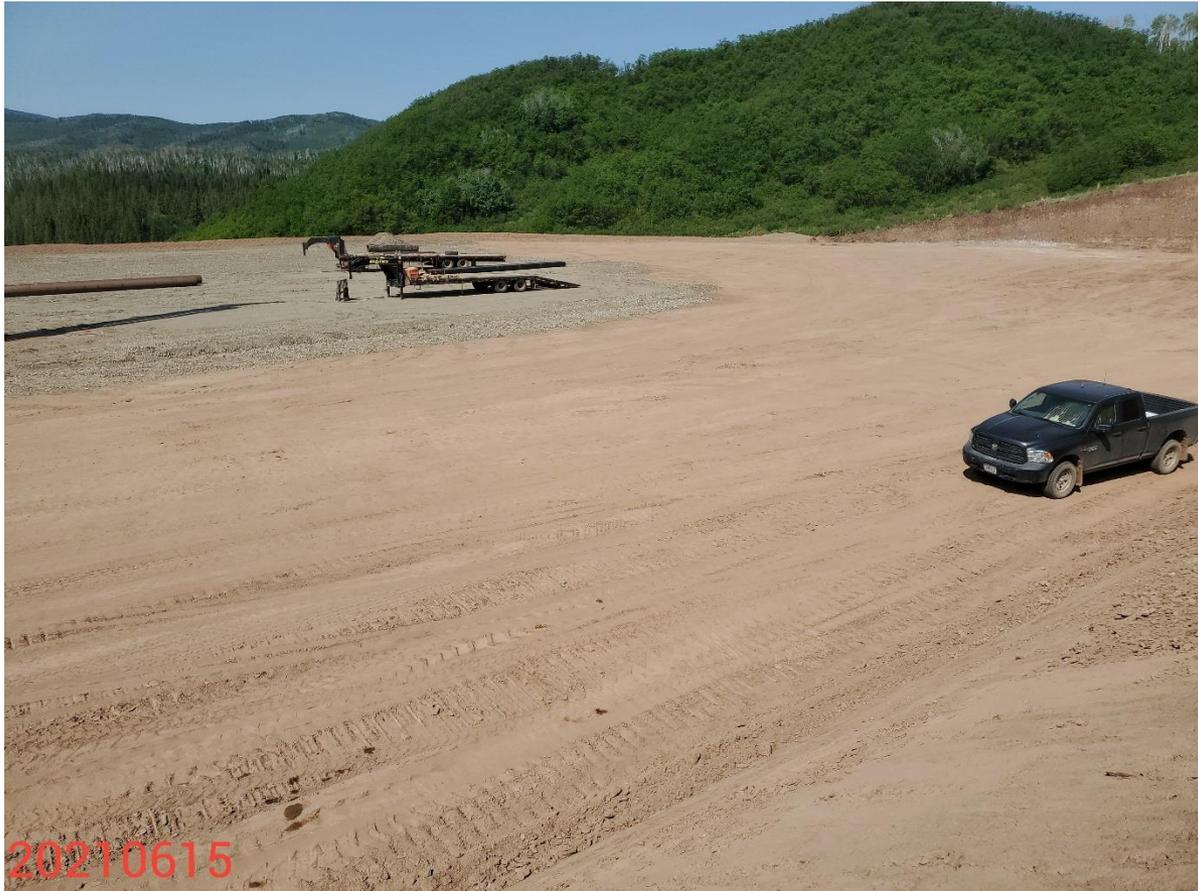
Photo 4: See comments under photo 1.

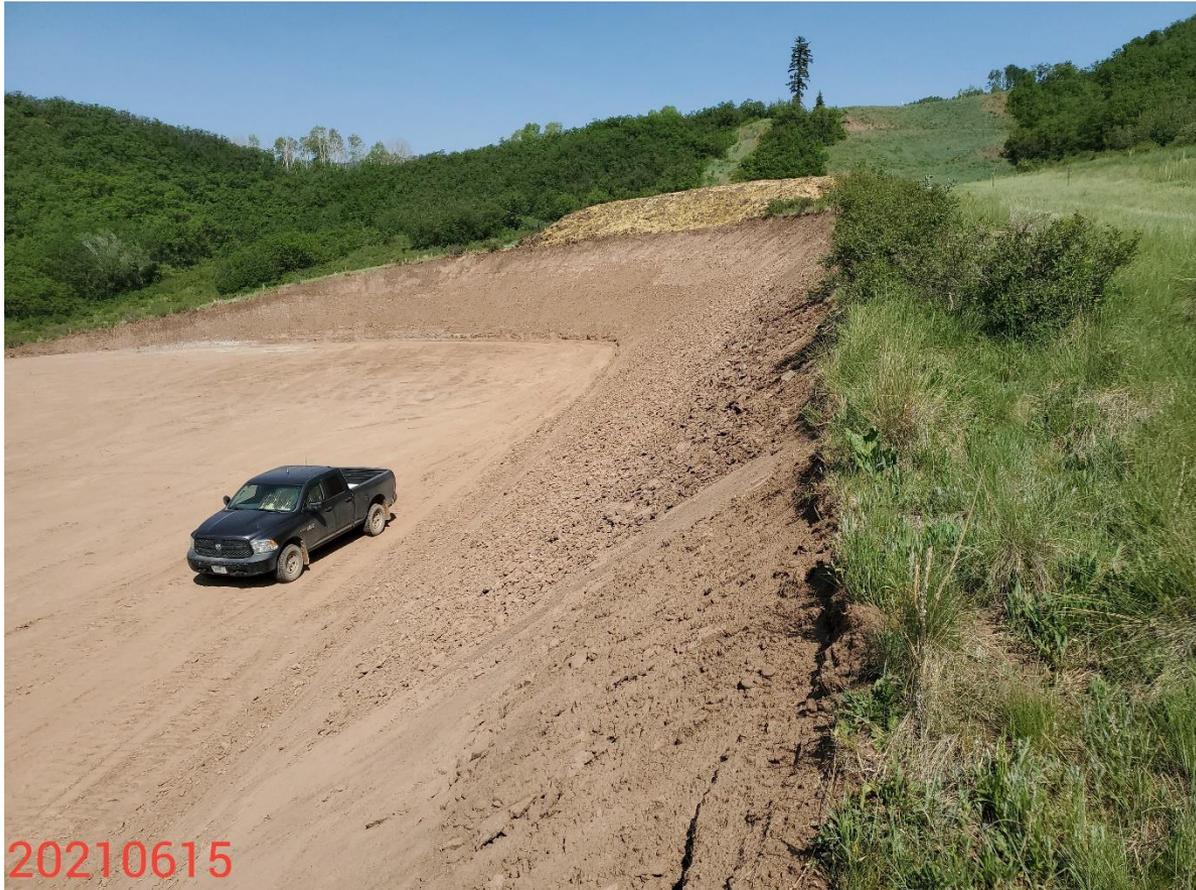
Photo 5: See comments under photo 1.

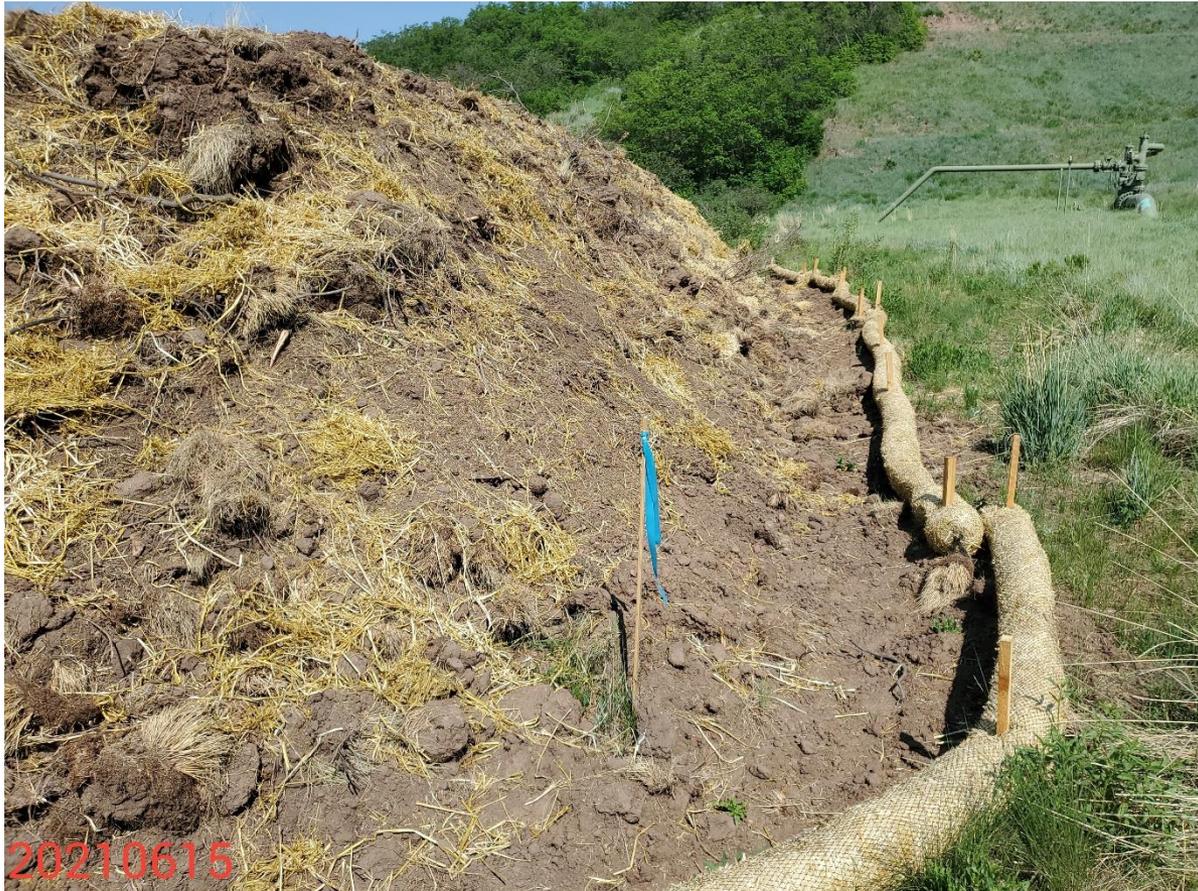
Photo 6: Photo taken from the topsoil stockpile on the north end of the Location. Photo shows Operator has applied a straw mulch onto the soil stockpile, and installed erosion logs at the base of the stockpile. Straw has not been crimped, or used in conjunction with any other stabilization BMP, and is insufficient alone to stabilize and protect the topsoil stockpile.

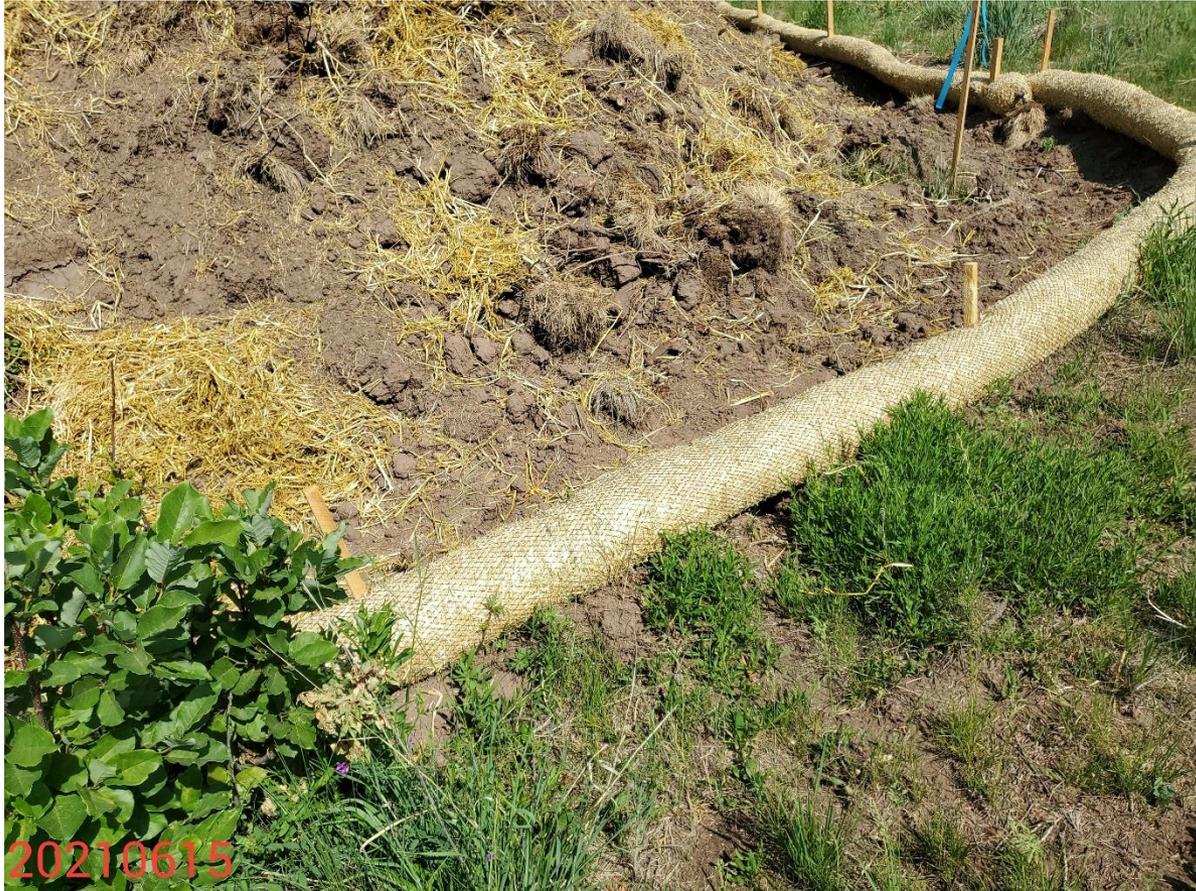
Photo 7: Continued from photo 6. Photo shows erosion logs have not been installed in accordance with good engineering practices; logs have only been placed onto the top of the soil and staked; erosion logs have not been properly trenched and backfilled.

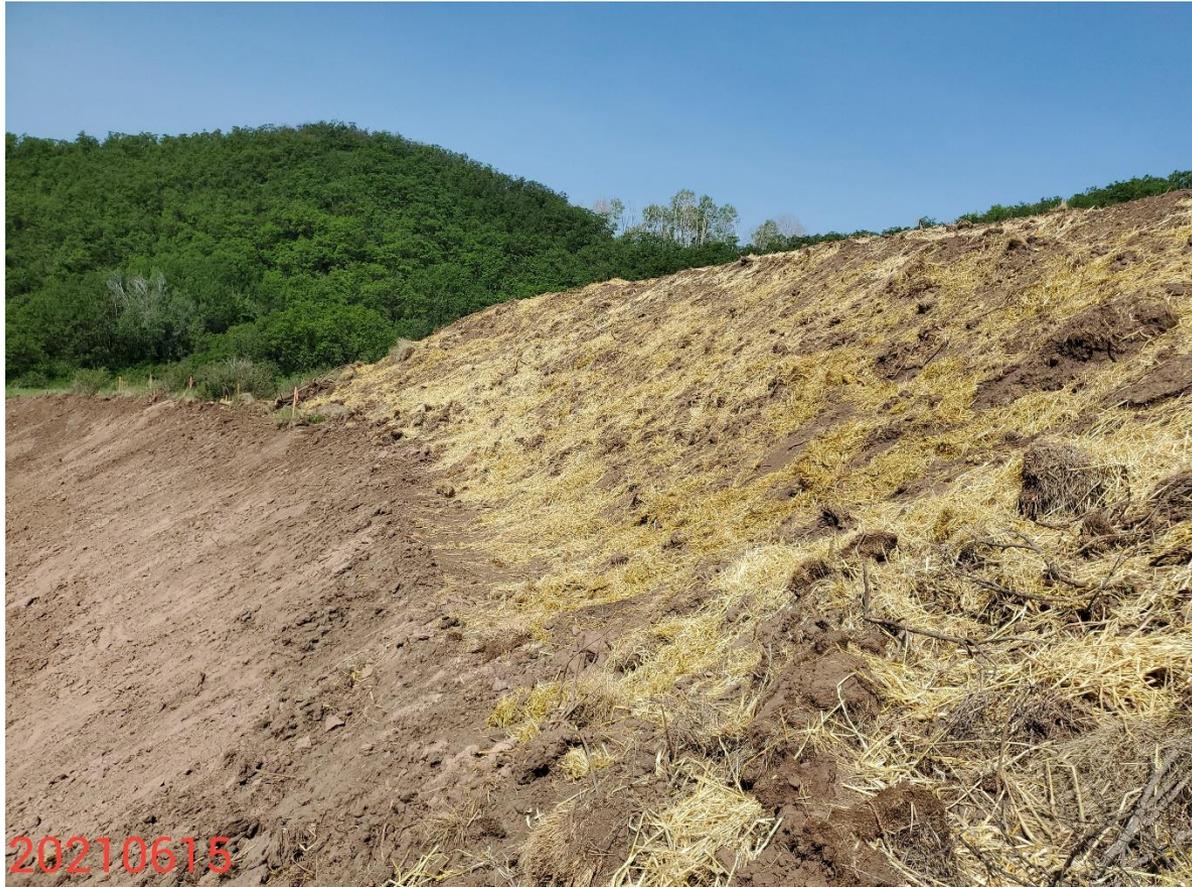
Photo 8: Continued from photo 7. Photo shows perimeter stormwater controls to mitigate sediment transport from the topsoil stockpile is missing on the southern/western ends of the topsoil stockpile

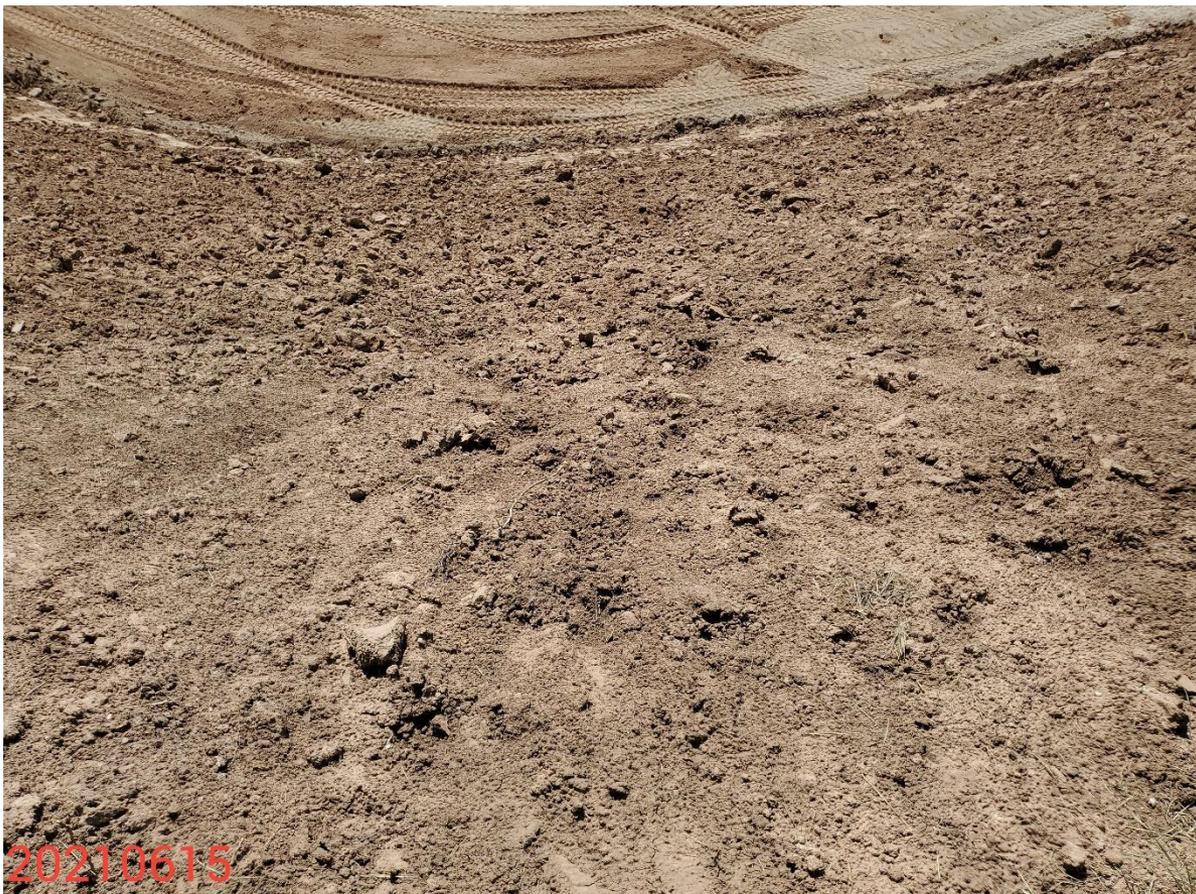
Photo 10: Photo taken from the top of the cut slope on the north end of the Location, facing south. Photo shows control measures to protect and stabilize the cut slopes are missing or insufficient.

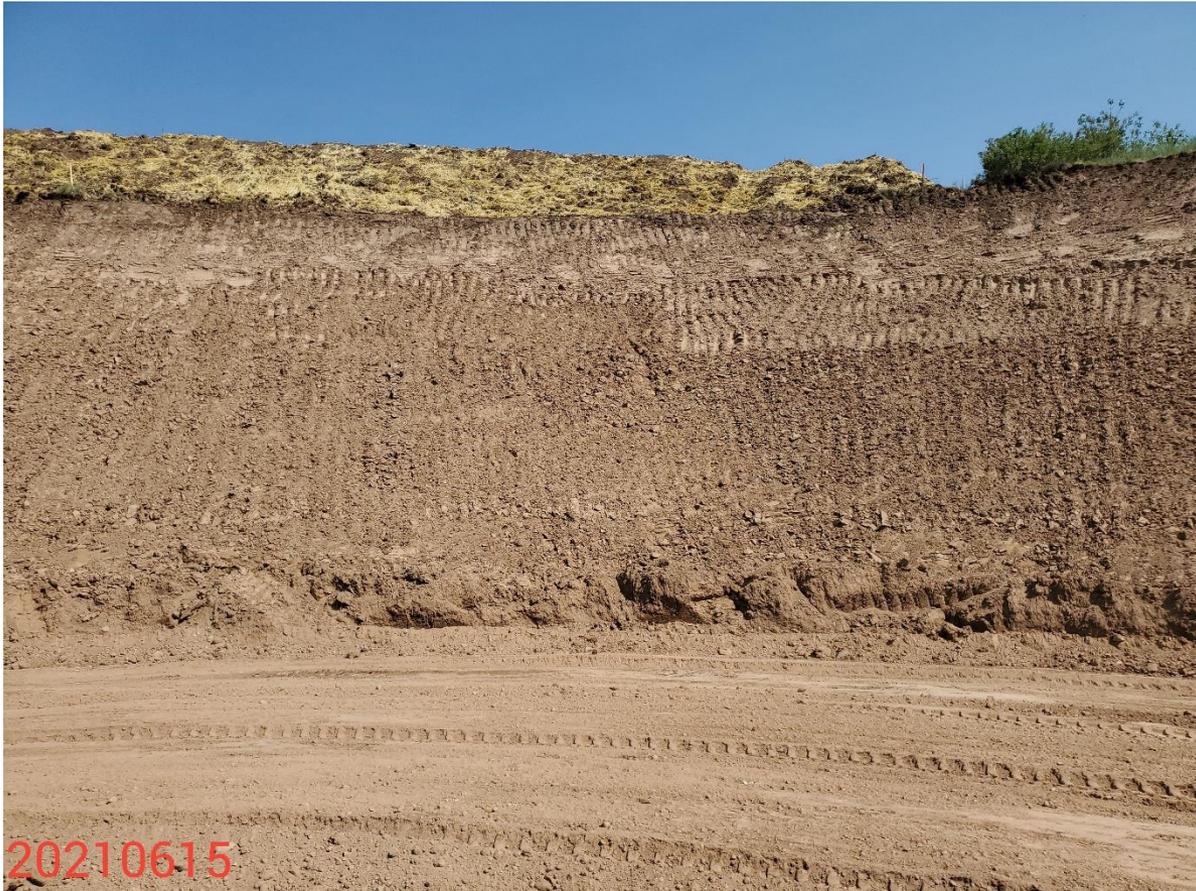
Photo 11: Photo shows the cut slope on the north end of the Location, facing northeast. Photo shows control measures to protect and stabilize the cut slopes are missing or insufficient. It appears Operator implemented tracking along slopes; tracking insufficient and was not applied up and down the slope per good engineering practices.

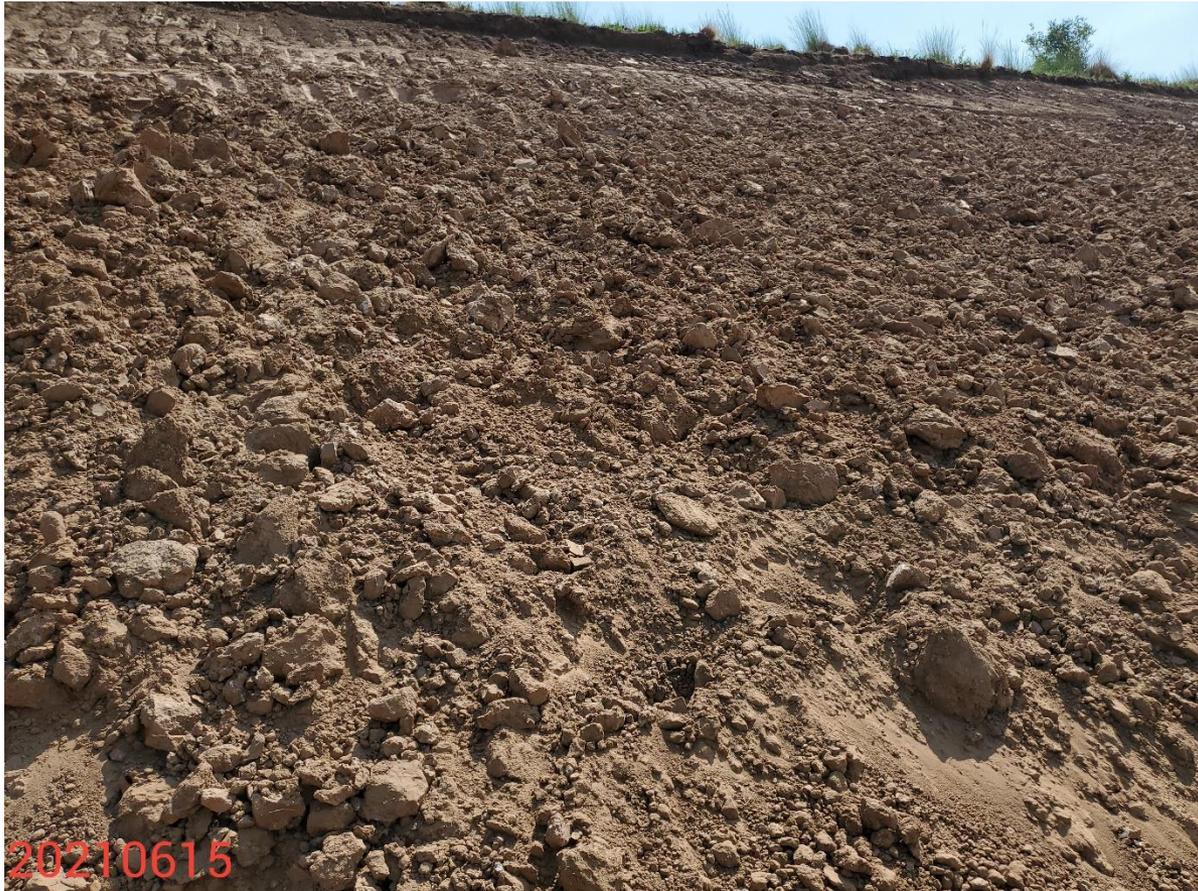
Photo 12: See comments under photo 11.

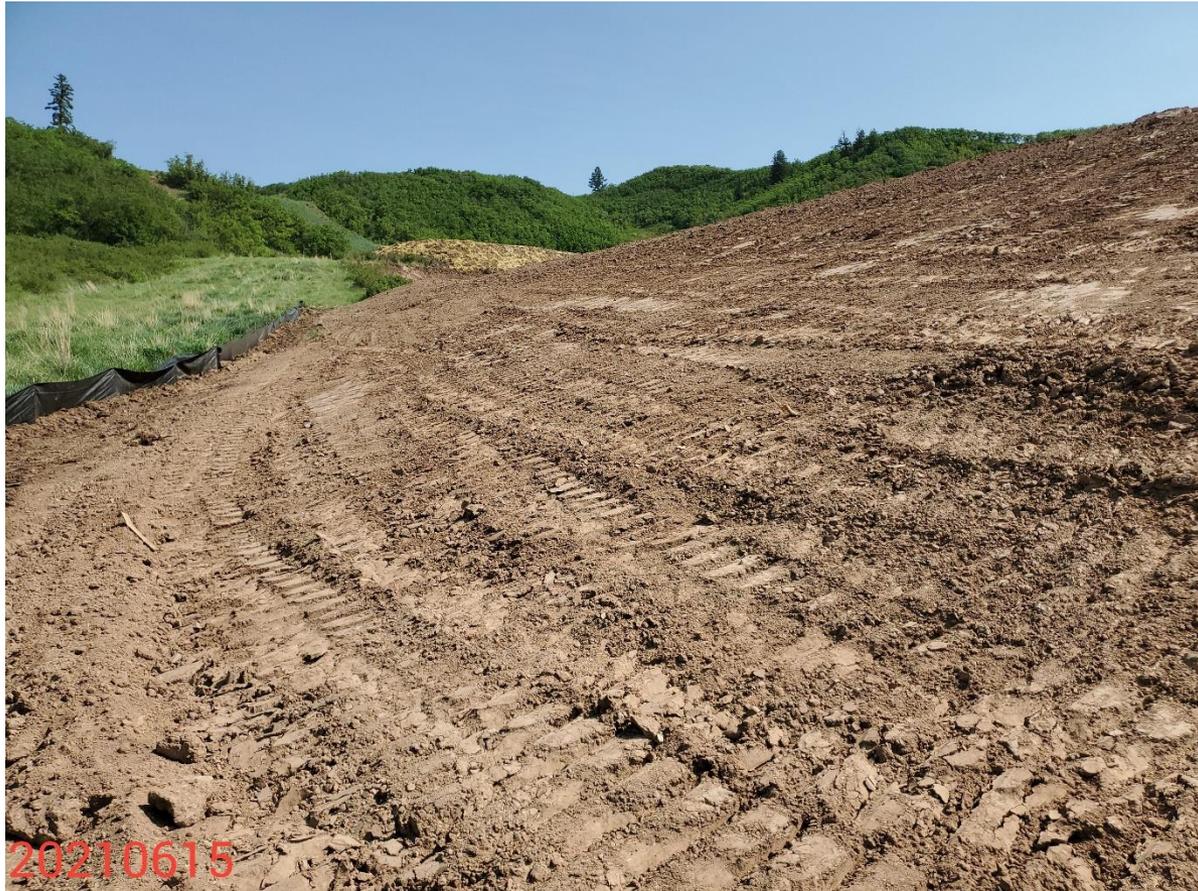
Photo 13: Photo taken from the fill slopes on the west end of the Location, facing northeast. Photo shows control measures to protect and stabilize the fill slopes are missing or insufficient. It appears Operator implemented tracking along slopes; tracking insufficient and was not applied up and down the slope per good engineering practices.

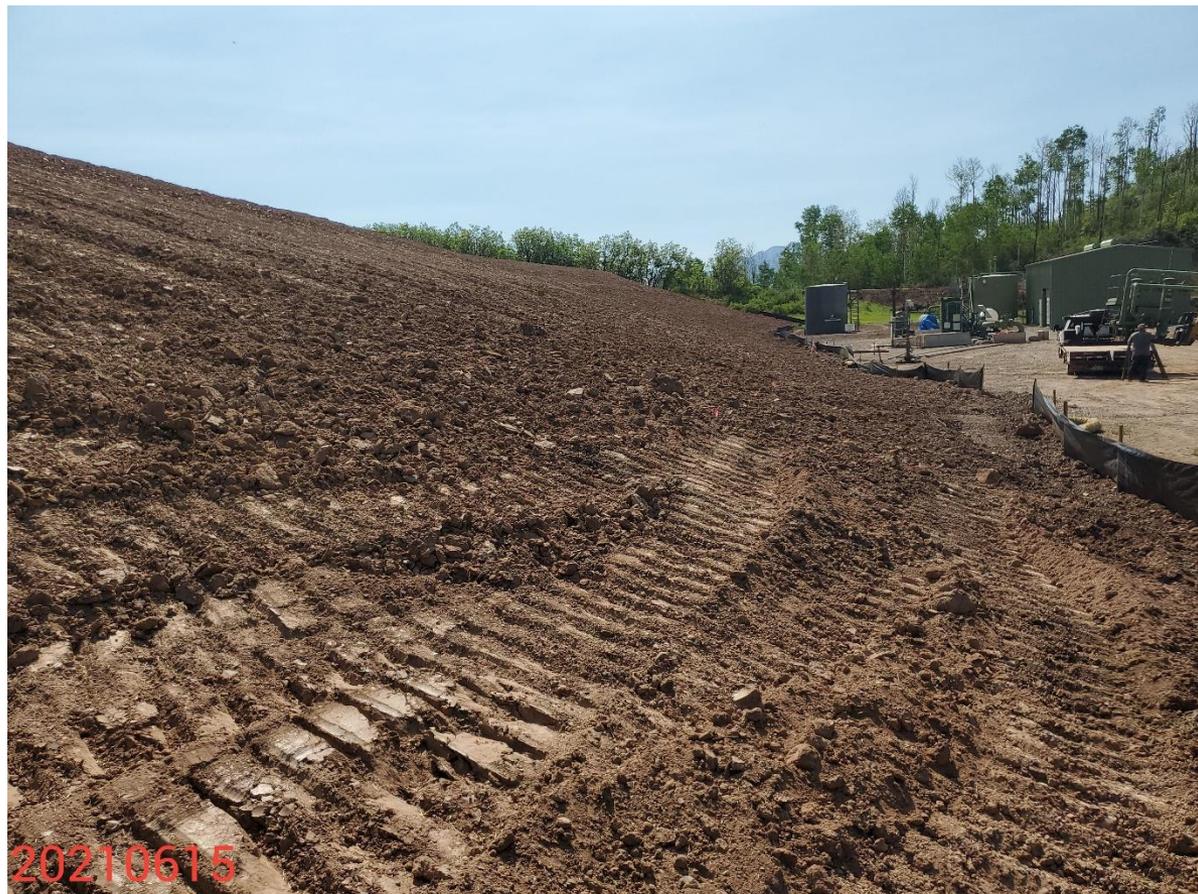
Photo 14: Photo taken from the fill slopes on the west end of the Location, facing south. See comments under photo 13.

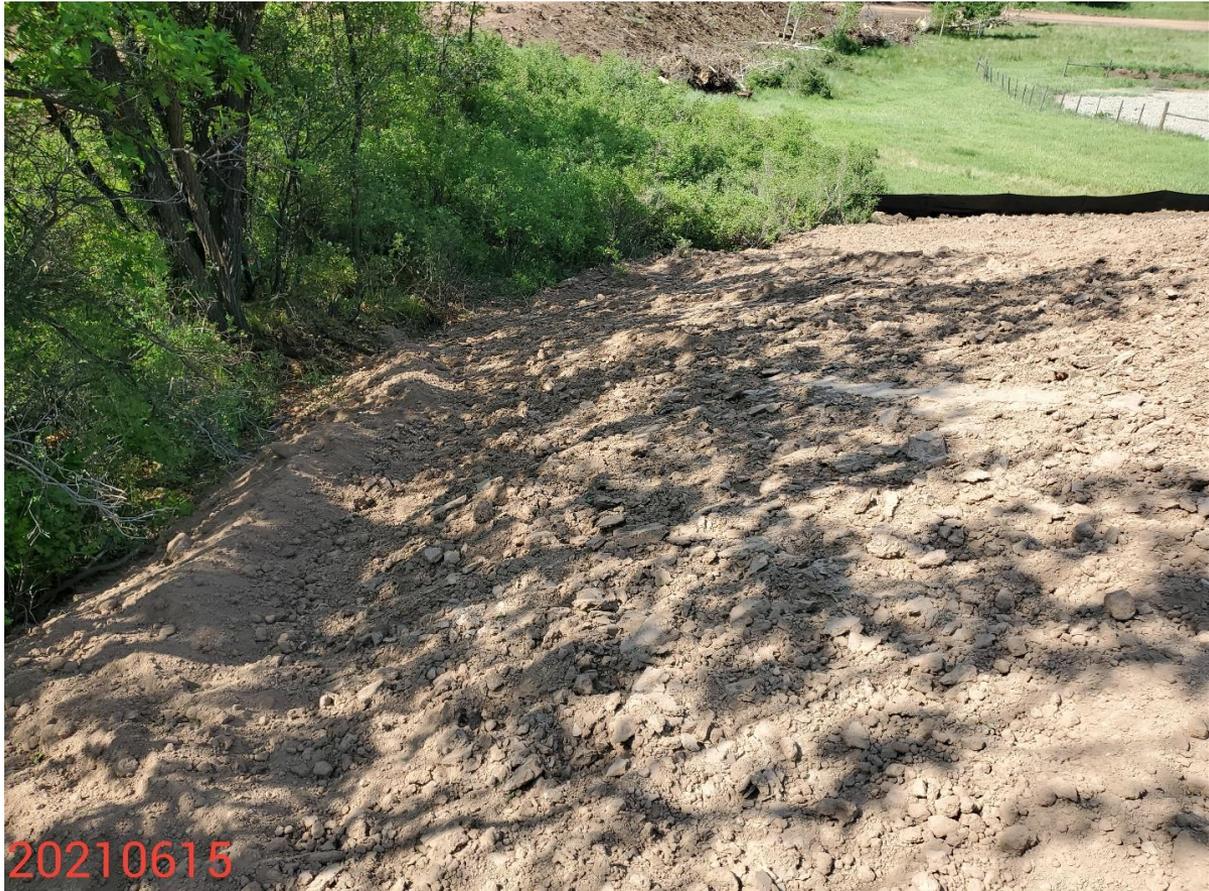
Photo 15: Photo taken from the southwest end of the Location, facing west. Photo shows control measures to protect/stabilize the slopes, and perimeter control measures to allow for sediment laden-free stormwater discharge are missing or insufficient.

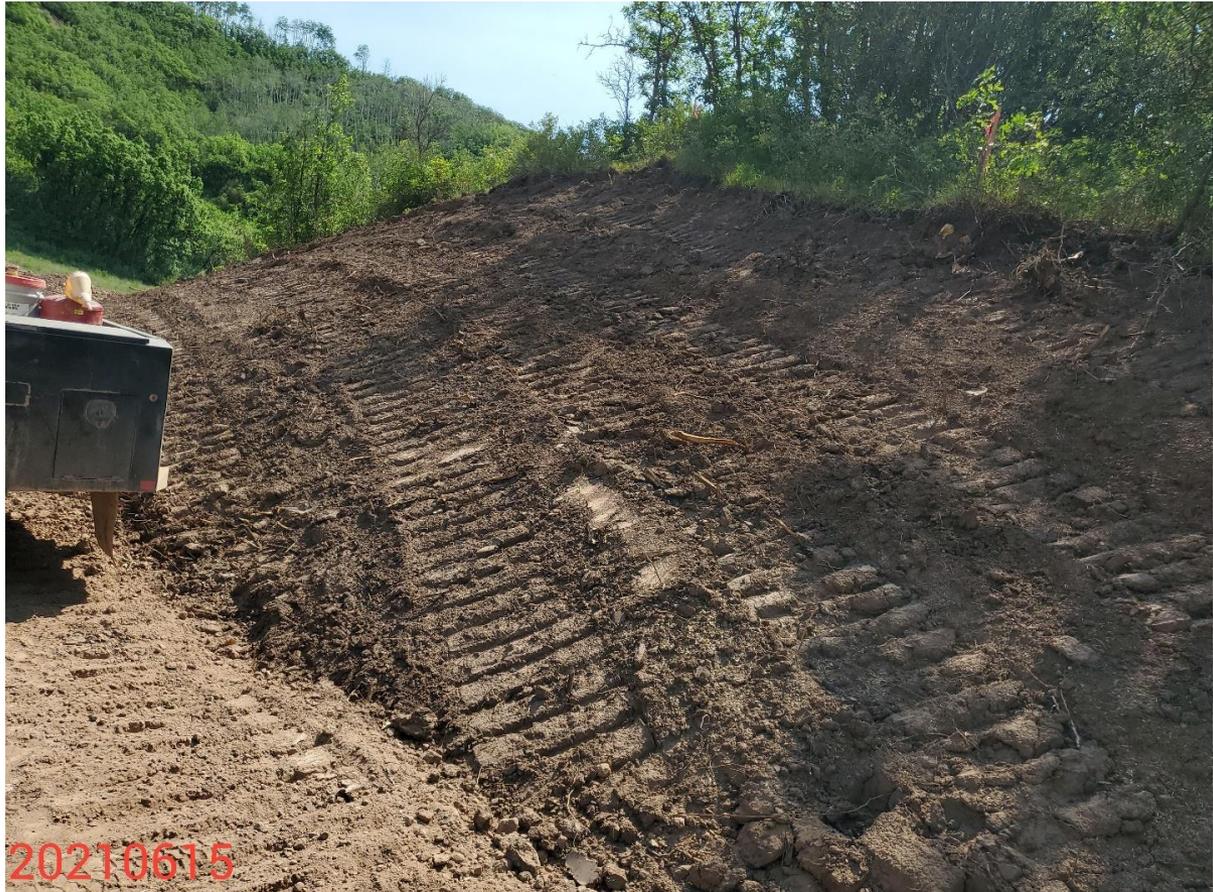
Photo 16: Photo taken from the cut slopes on the south end of the Location, facing east. Photo shows control measures to protect and stabilize the cut slopes are missing or insufficient.

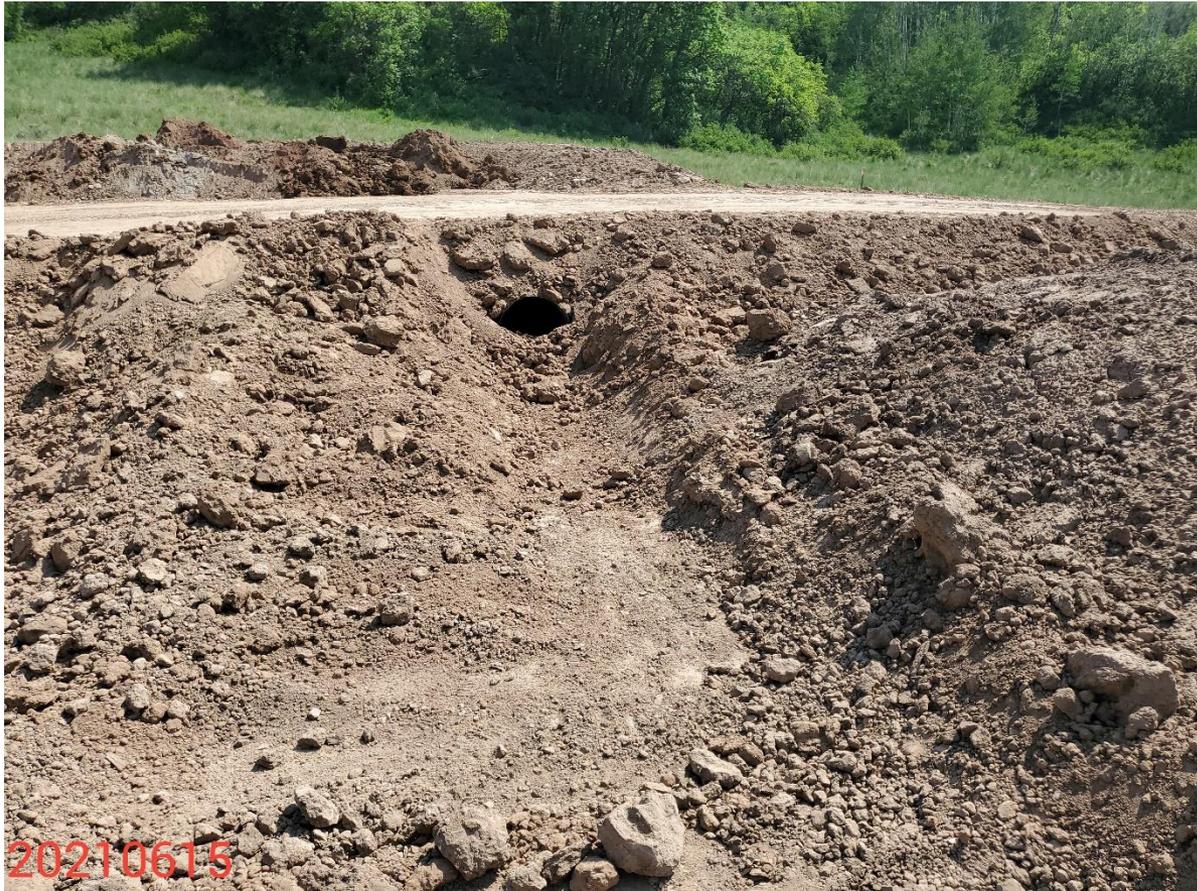
Photo 17: Photo shows culvert at the Location entrance. Sediment partially filling the inlet/outlet of culvert. Ensure culvert remains free of sediment and in proper functioning condition. .

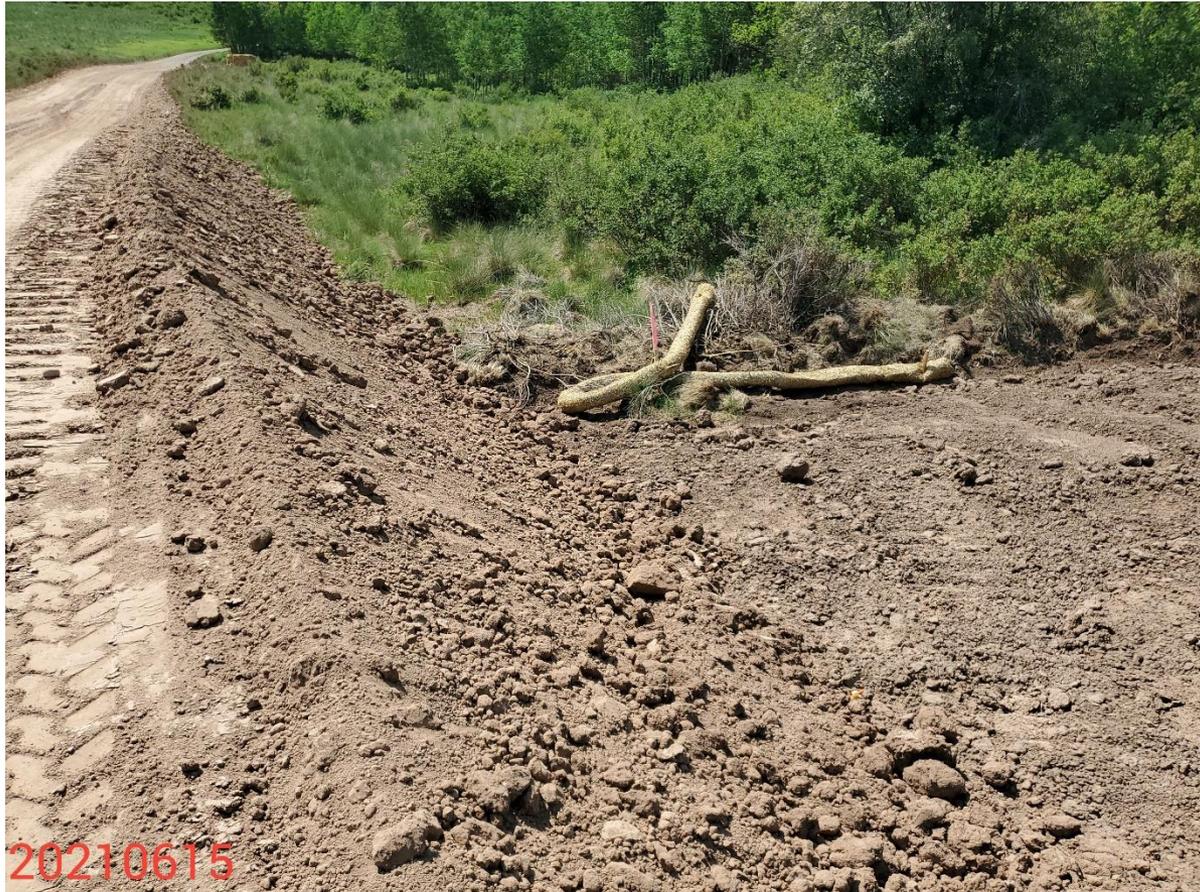
Photo 18: Photo taken from the south end of the Location, facing south. Photo shows perimeter stormwater control measures are missing or insufficient at Location perimeter/location entrance/access road. Photo also shows control measures to protect and stabilize the slopes are missing or insufficient.

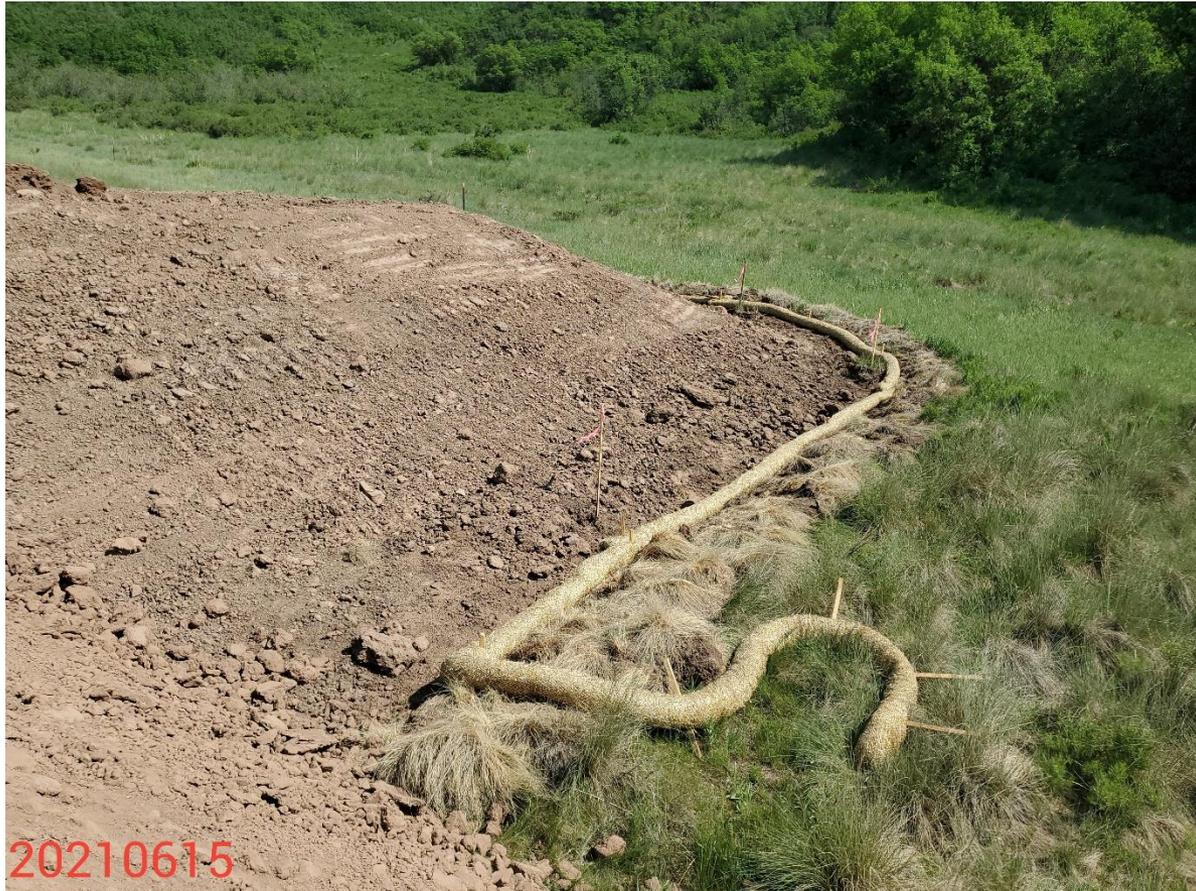
Photo 19: Photo taken from the south end of the Location, facing east. Photo shows perimeter stormwater control measures are missing or insufficient at Location perimeter and entrance. Photo also shows control measures to protect and stabilize the slopes are missing or insufficient.

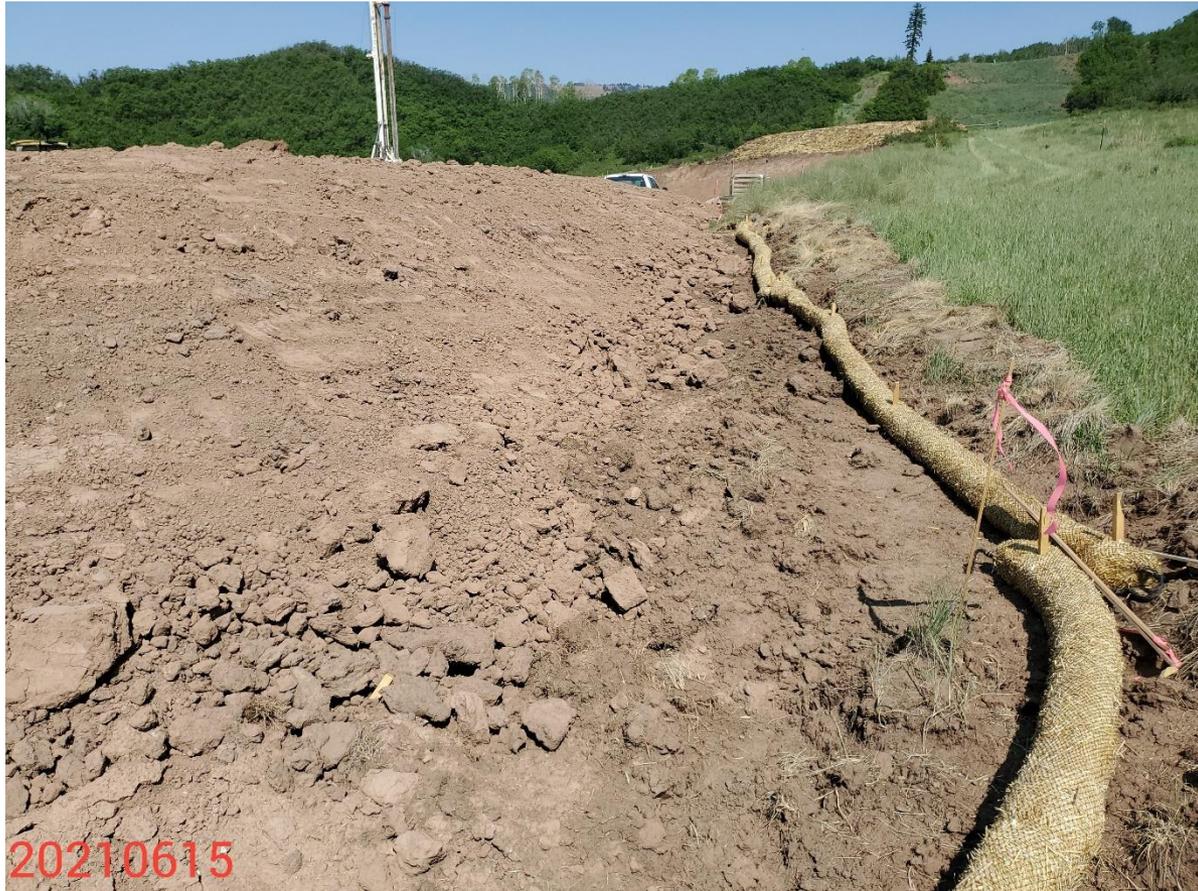
Photo 20: Photo taken from the southeast end of the Location, facing north. Photo shows perimeter stormwater control measures are missing or insufficient at Location perimeter and access road entrance. Photo also shows control measures to protect and stabilize the slopes are missing or insufficient. Wattles have not been installed in accordance with good engineering practices.

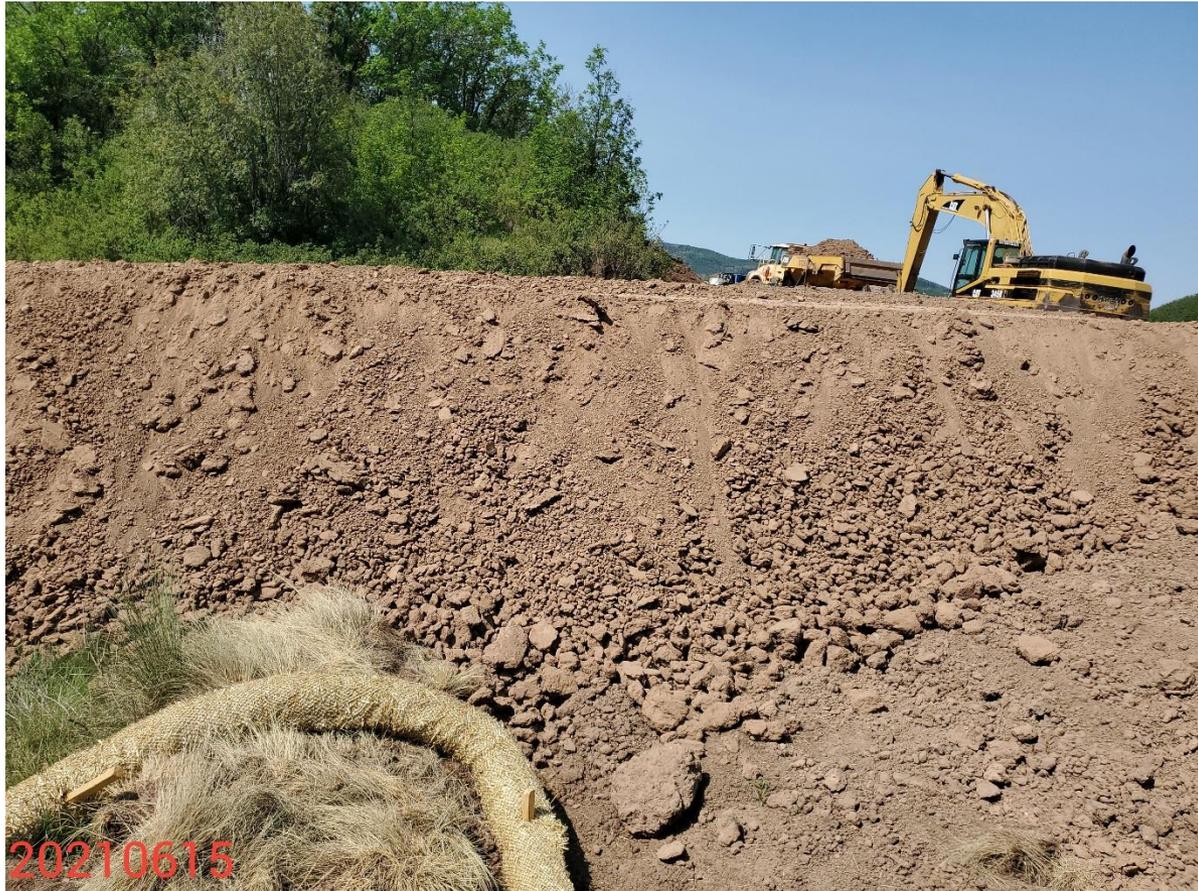
Photo 21: See comments under photo 20.
