Inspection Photos

6/15/2021

Operator: GUNNISON ENERGY LLC # 10515

Location ID: 453805

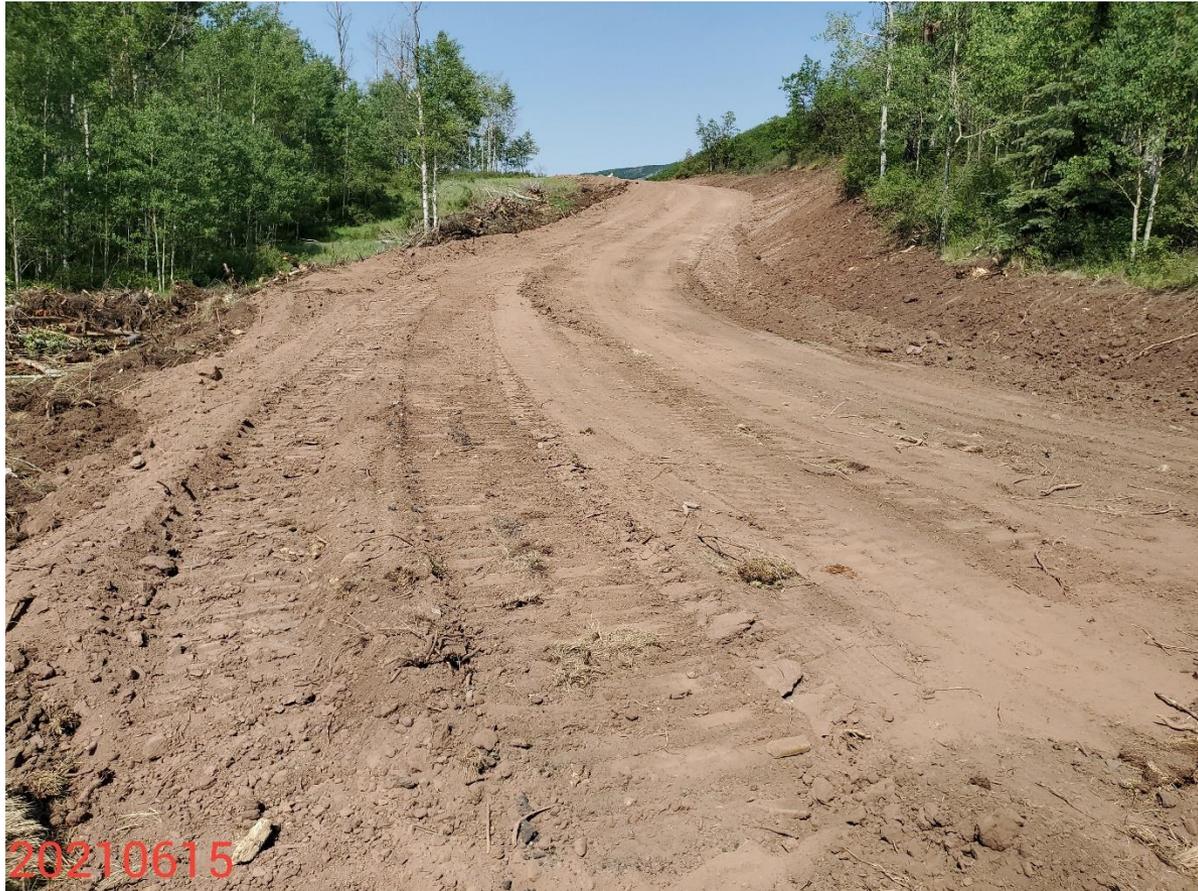
Photo 22: Photo taken from the newly constructed access road, south of the Location.

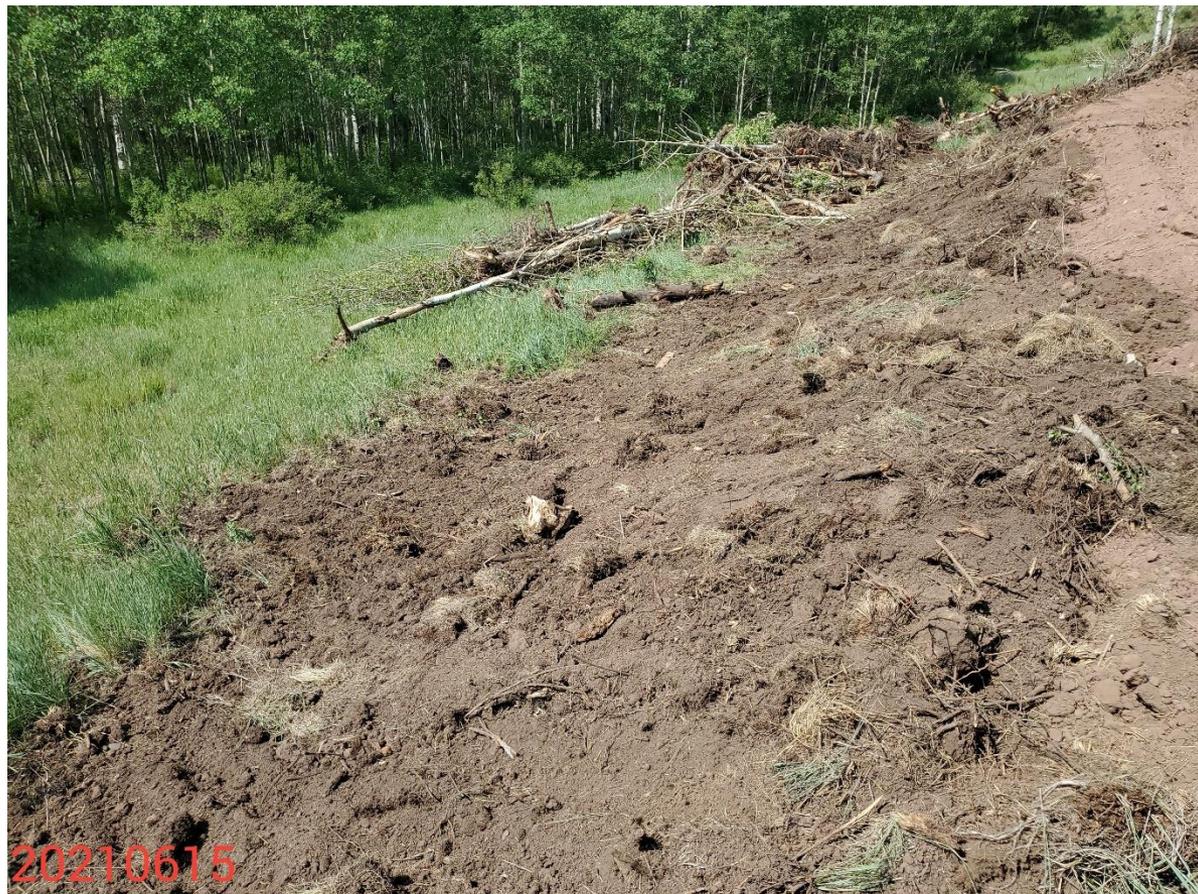
Photo 23: Continued from photo 22. Photo shows Stormwater erosion control BMPs to prevent off site sediment transport, and to stabilize the slopes along the access road remain missing or insufficient.

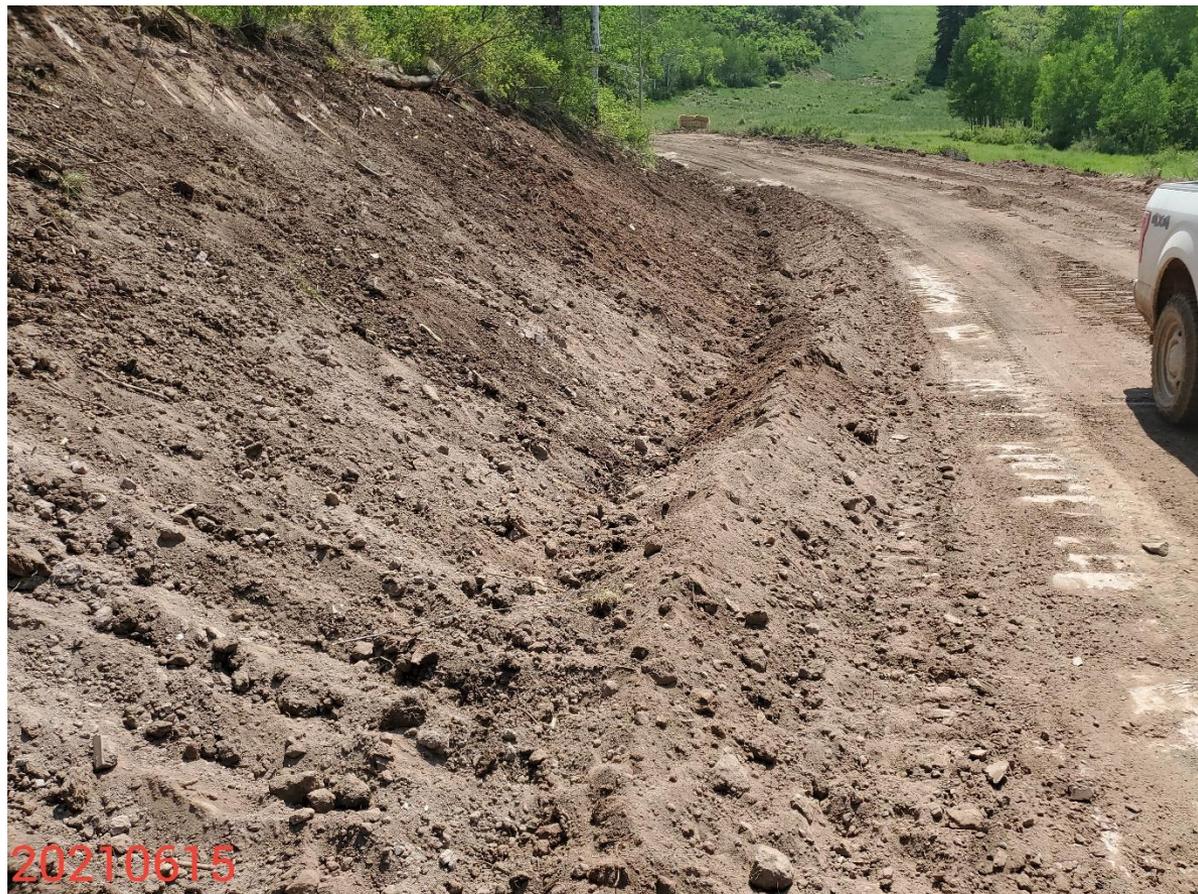
Photo 24: Photo shows control measures to protect/stabilize the cut slopes along the access road are missing or insufficient.

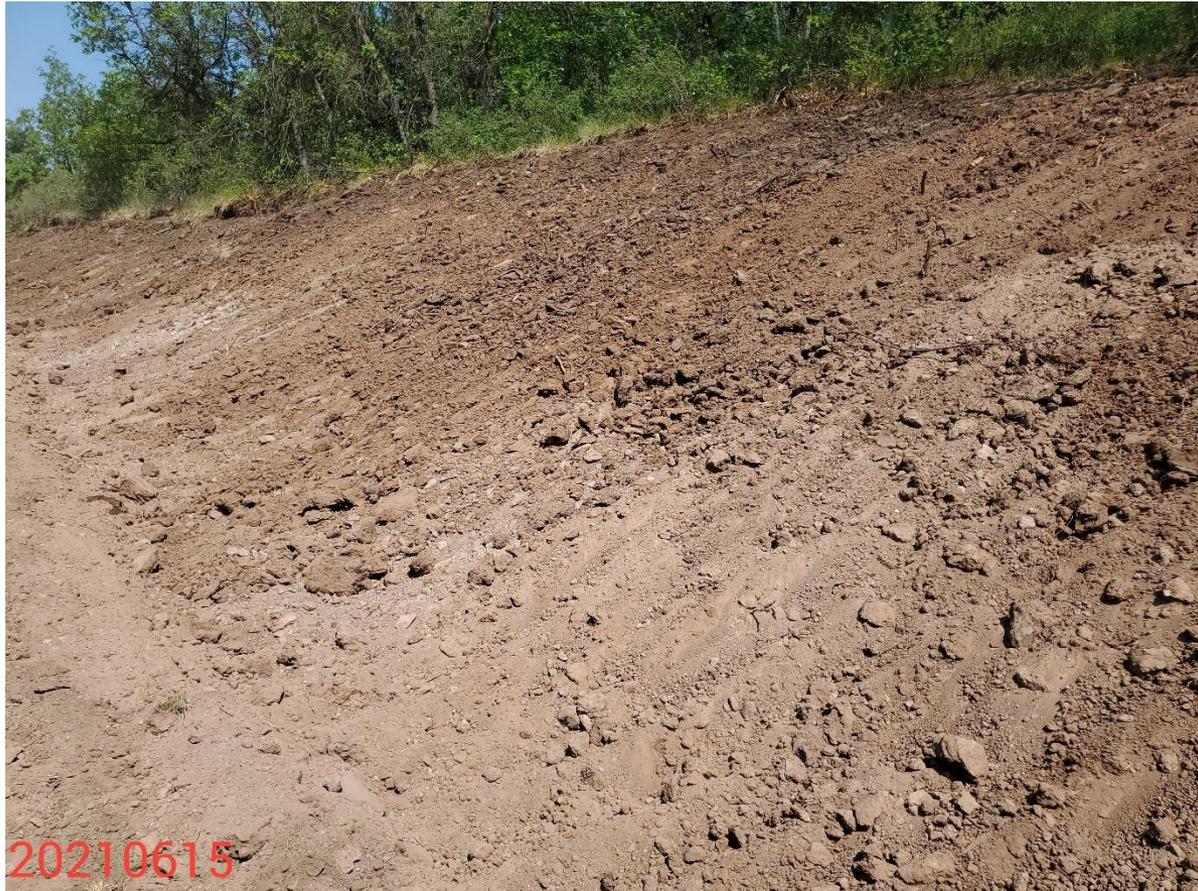
Photo 25: Photo shows control measures to protect/stabilize the cut slopes along the access road are missing or insufficient.

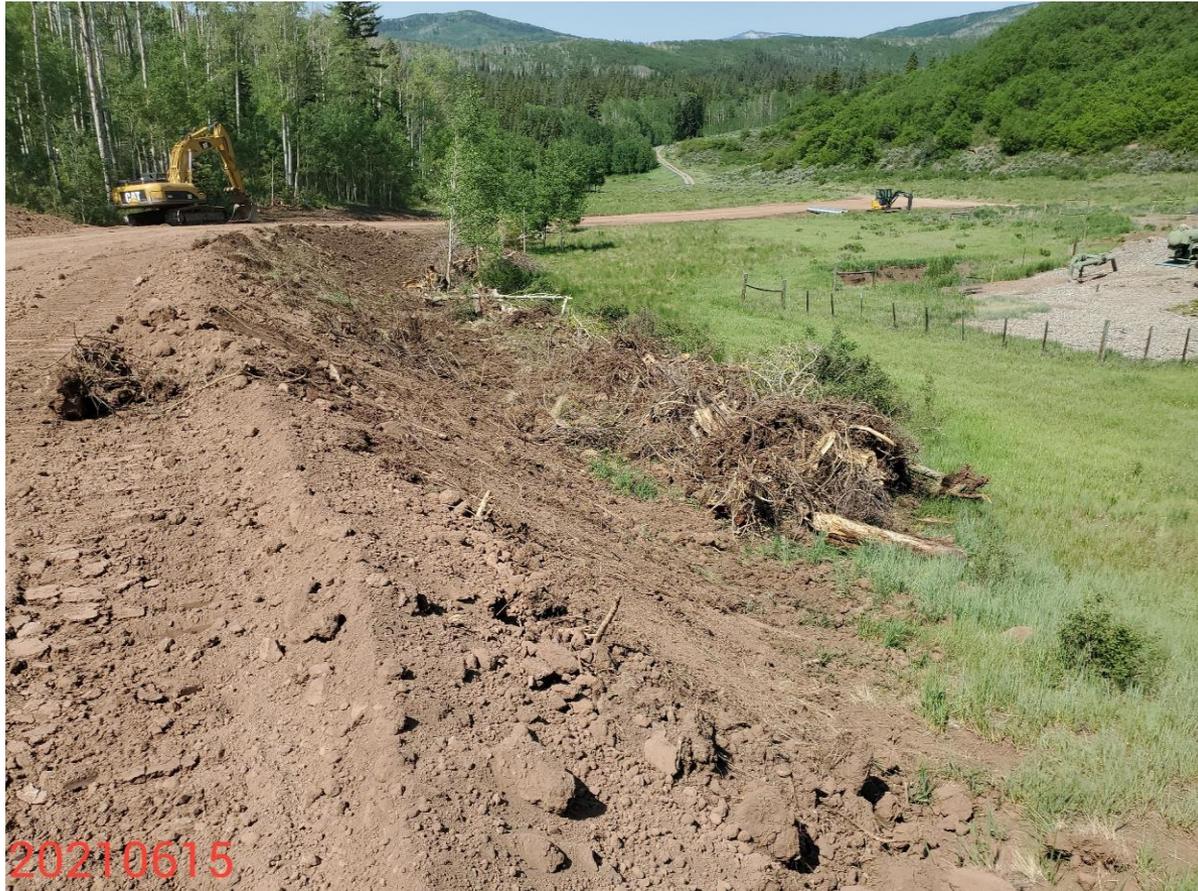
Photo 26: Photo shows Stormwater erosion control BMPs to prevent off site sediment transport, and to stabilize the slopes along the access road remain missing or insufficient.

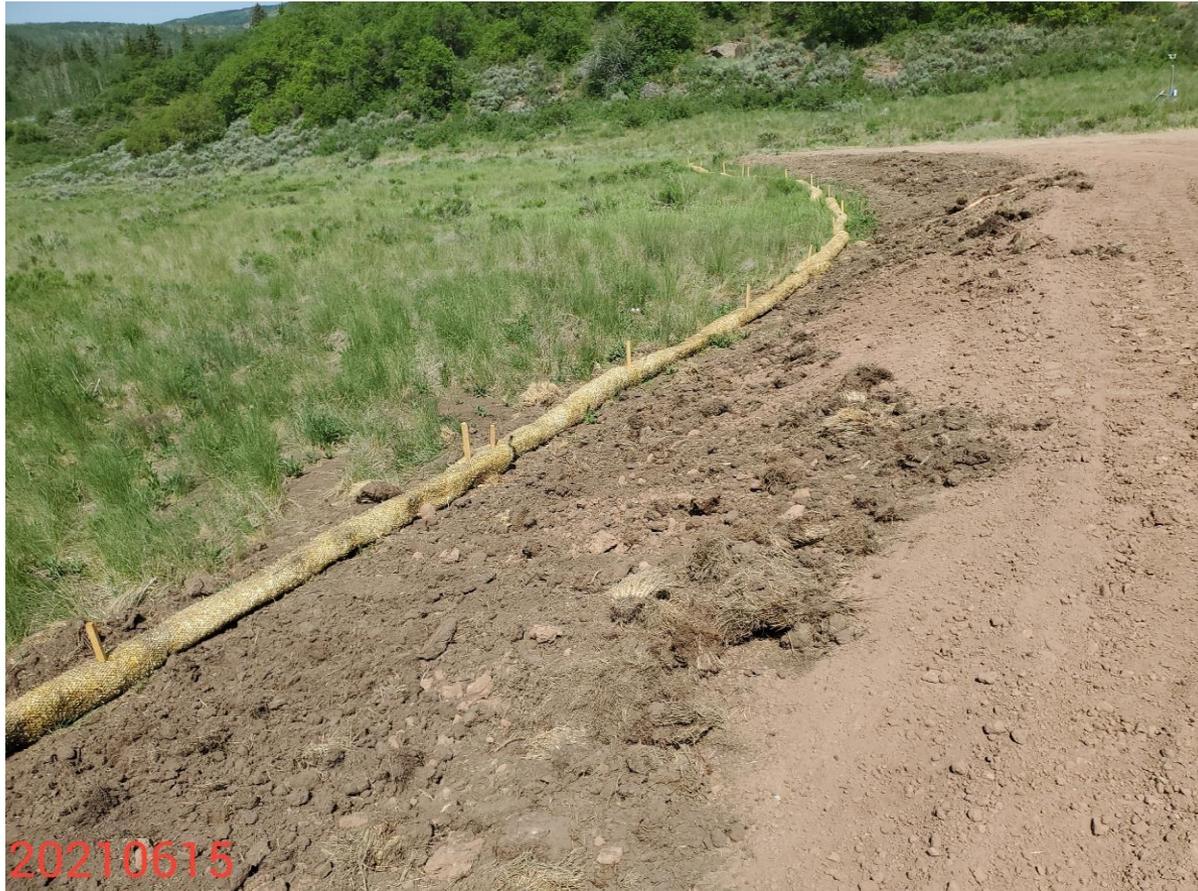
Photo 27: Photo taken from the newly constructed access road, west of the Location. Photo shows Operator has installed approximately 100-200 feet of erosion logs along the western portion of the road. Erosion logs have not been installed in accordance with good engineering practices; logs have only been placed onto the top of the soil and staked; erosion logs have not been properly trenched and backfilled.

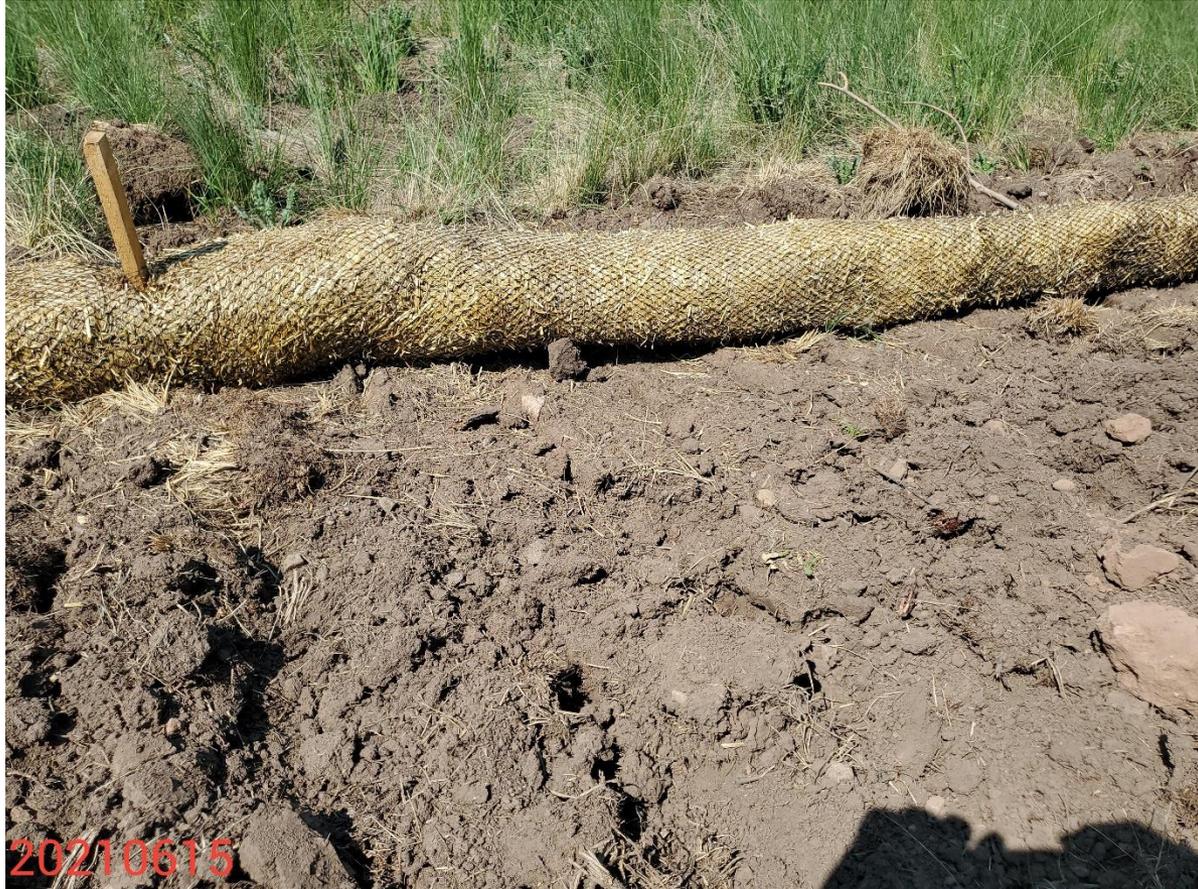
Photo 28: Continued from photo 22. Erosion logs have not been installed in accordance with good engineering practices; logs have only been placed onto the top of the soil and staked; erosion logs have not been properly trenched and backfilled.

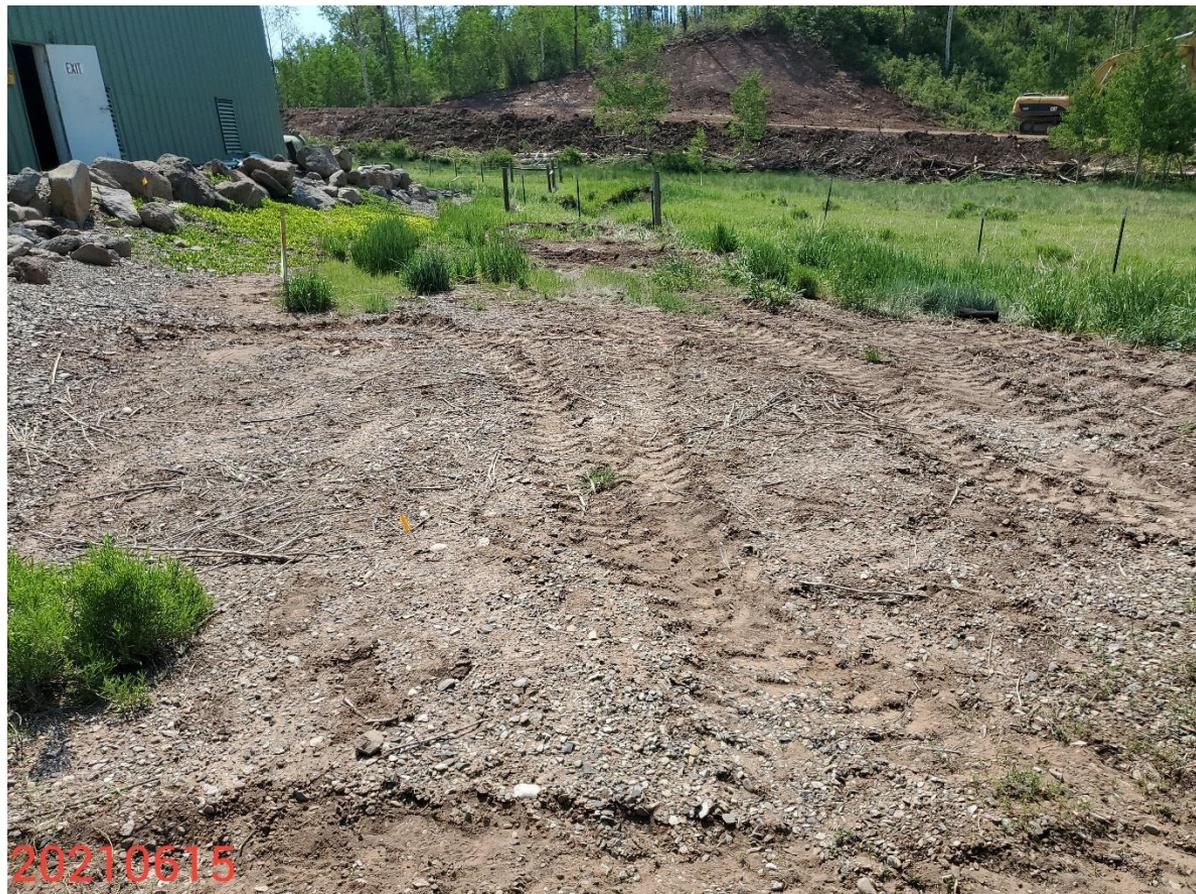
Photo 29: Photo shows areas west of the Location identified within the location drawing where a sediment pond was planned to be constructed. Photo shows BMP has not been constructed.
