Inspection Photos

6/15/2021

Operator: GUNNISON ENERGY LLC # 10515

Location ID: 324464

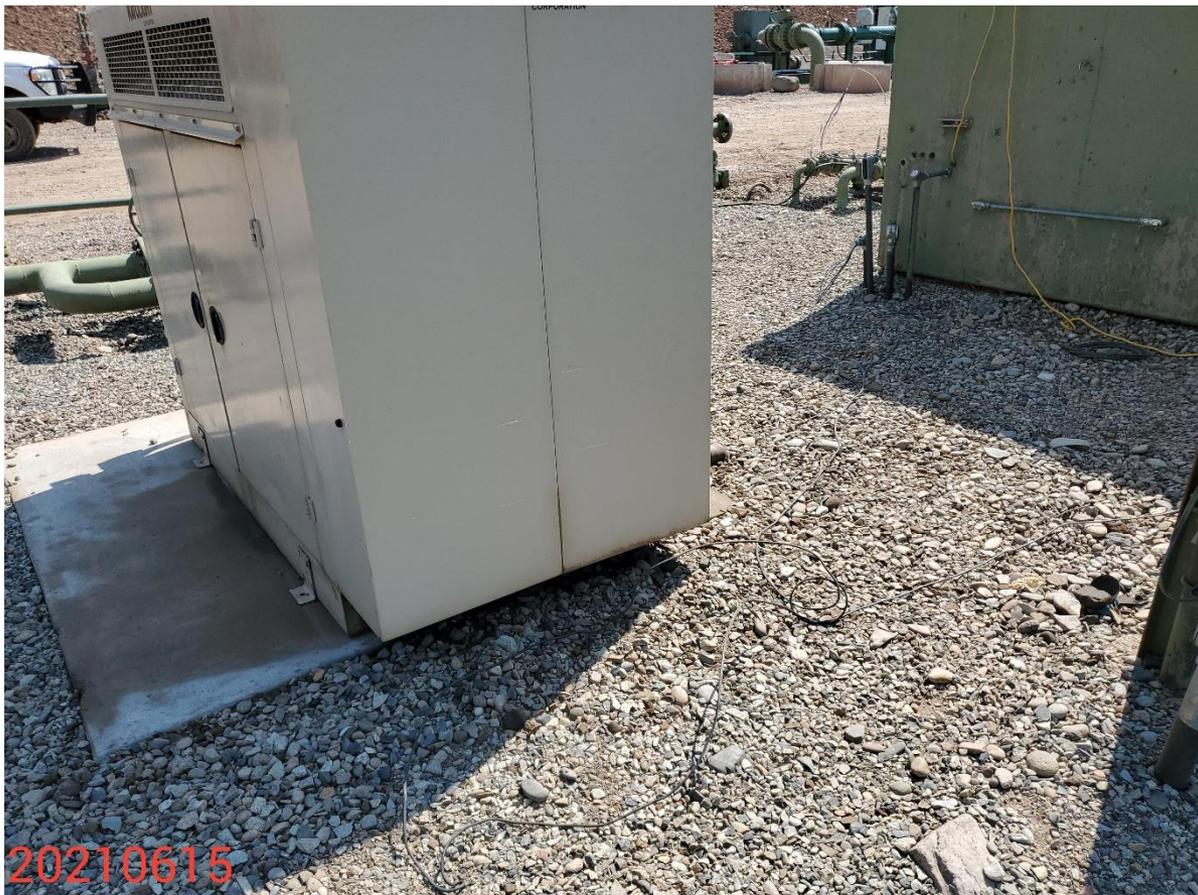
Photo 1: Photo shows equipment observed to be leaking, and where stained soils were documented in previous inspection. Photo shows stained soils have been removed.

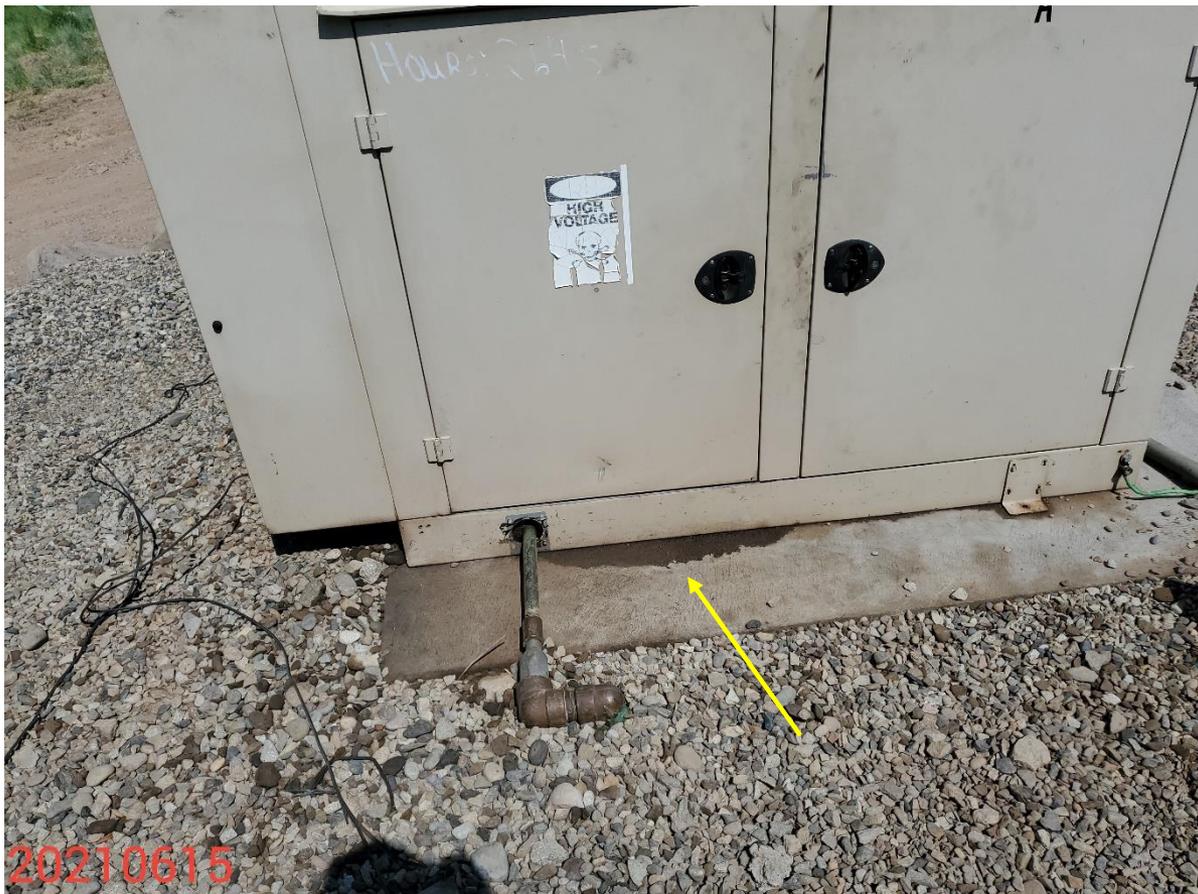
Photo 2: Continued from photo 1. Photo shows mechanical issues appear to remain an issue for the equipment, as additional fluids can be observed leaking at the base (arrow).

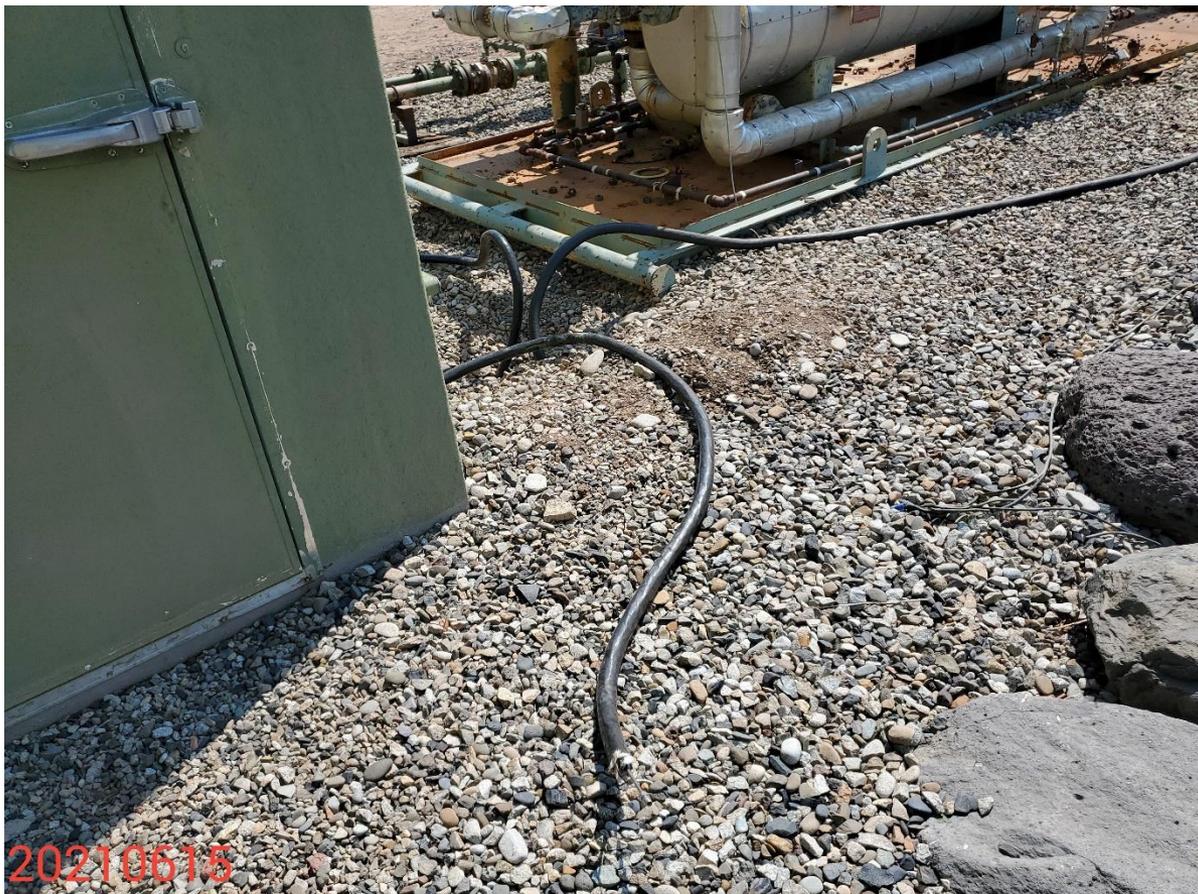
Photo 3: Photos 3-7 show various unused equipment or trash debris previously documented, have not been removed per the corrective actions.

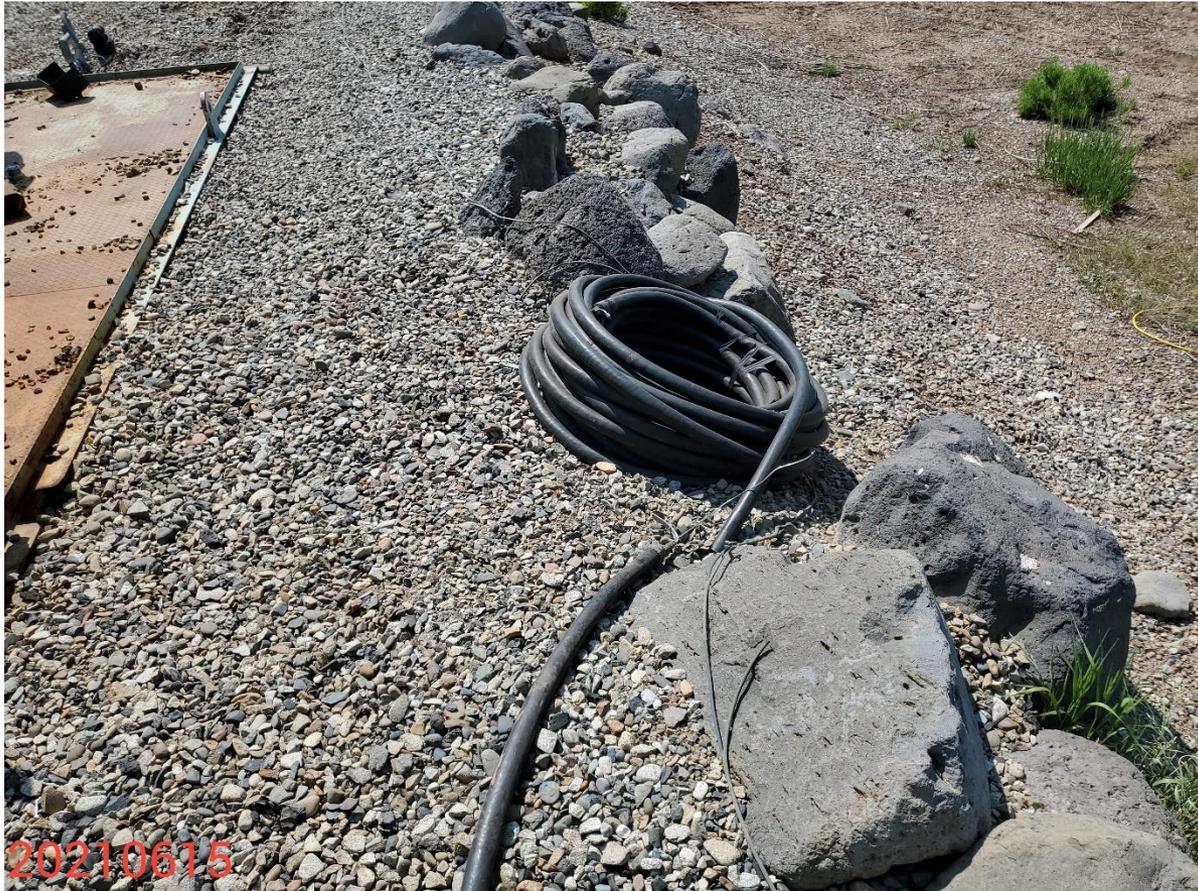
Photo 4: See comments under photo 3.

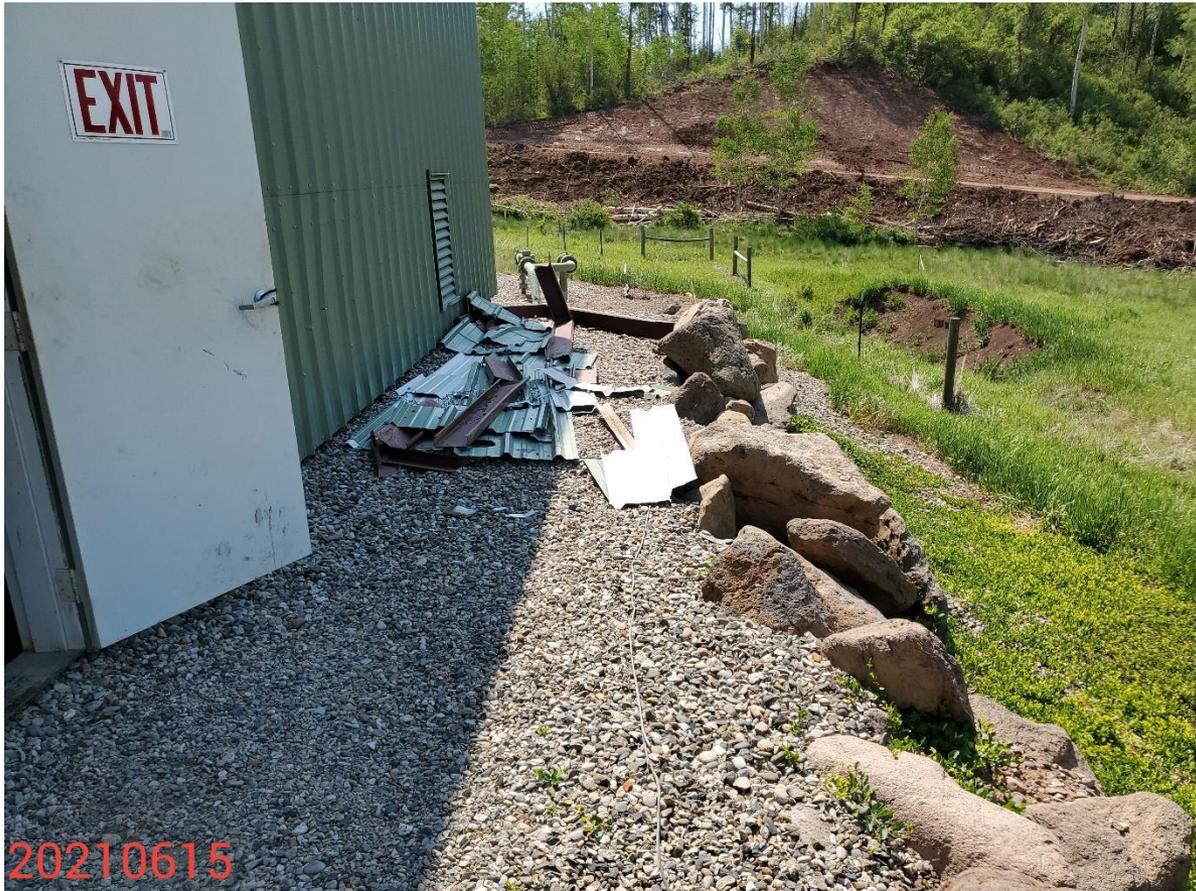
Photo 5: See comments under photo 3.

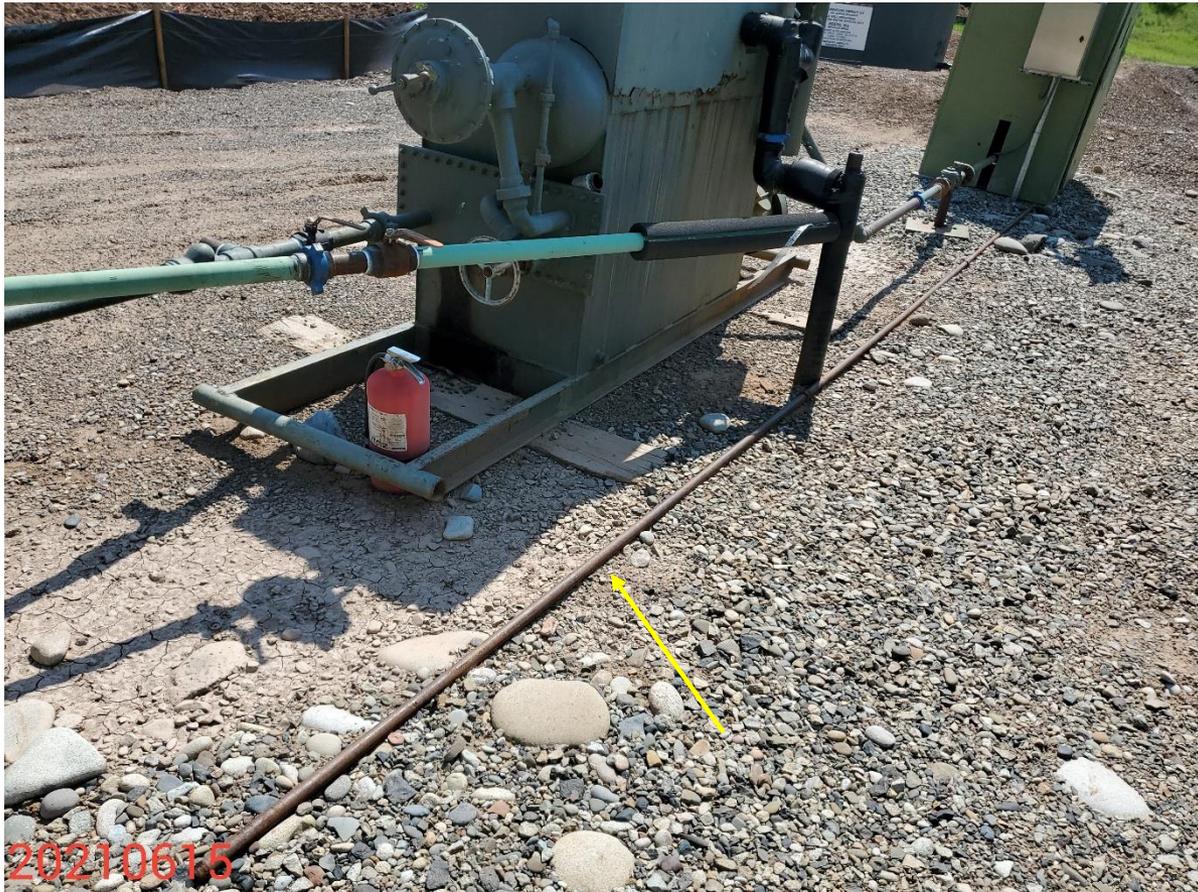
Photo 6: See comments under photo 3.

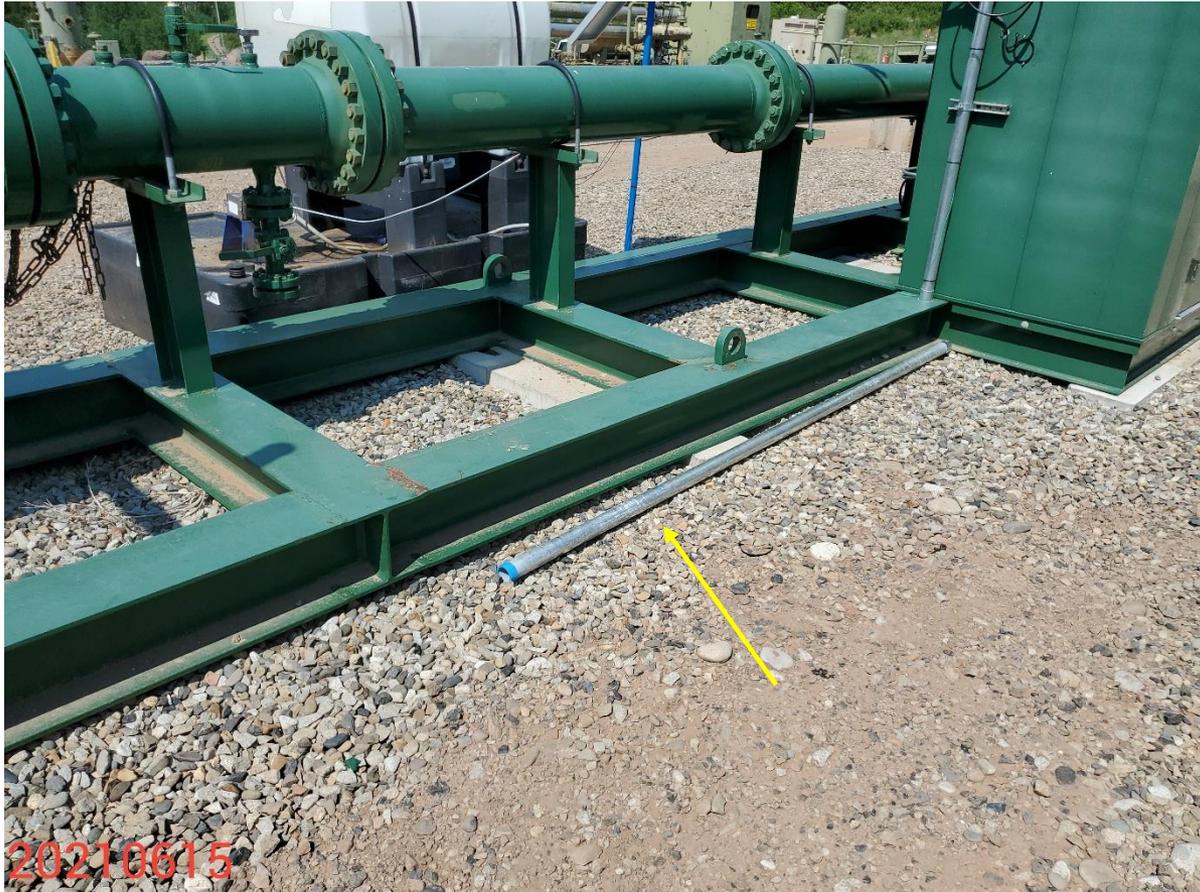
Photo 7: See comments under photo 3.

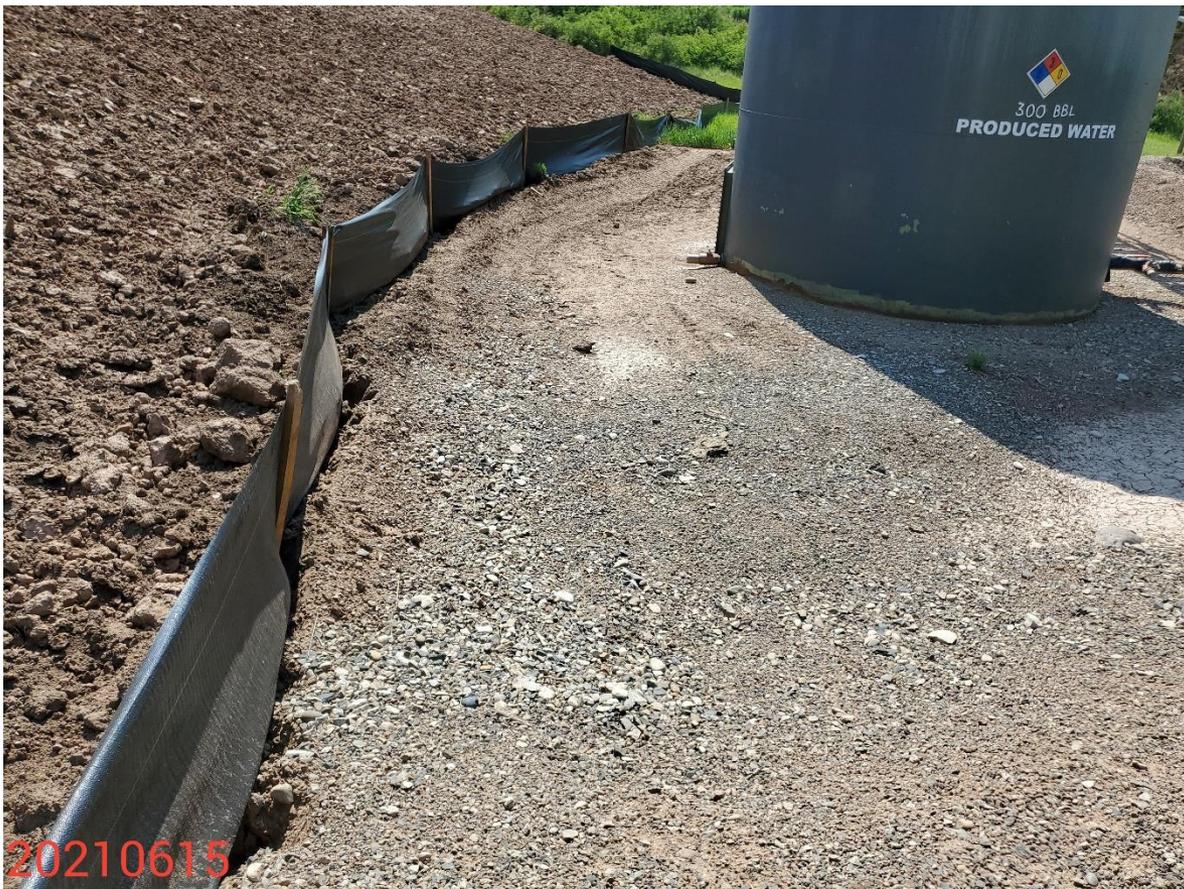
Photo 8: Previous inspection observed that the containment BMP at the tanks was inadequate. Photo shows that BMP appears to remain inadequate in accordance with Rule 603.o

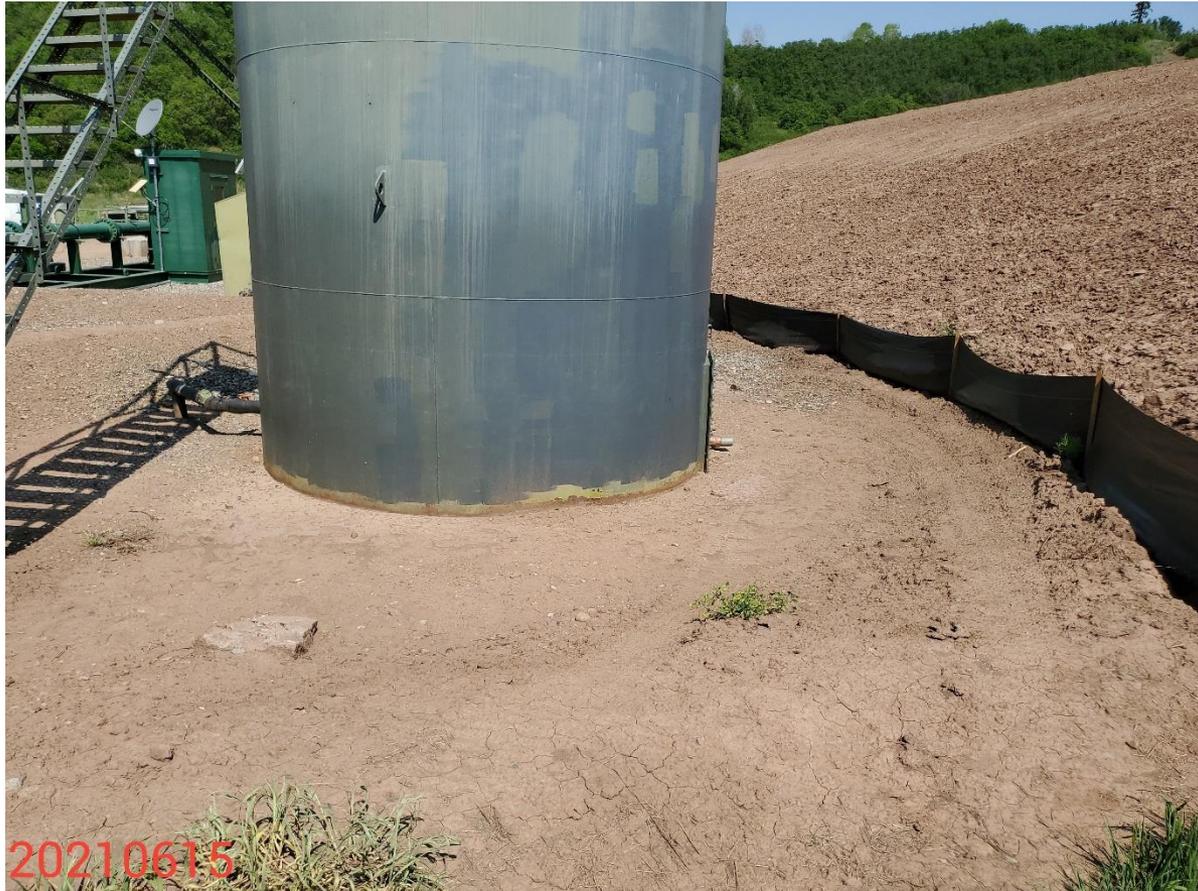
Photo 10: Previous inspection observed that the containment BMP at the tanks was inadequate. Photo shows that BMP appears to remain inadequate in accordance with Rule 603.o

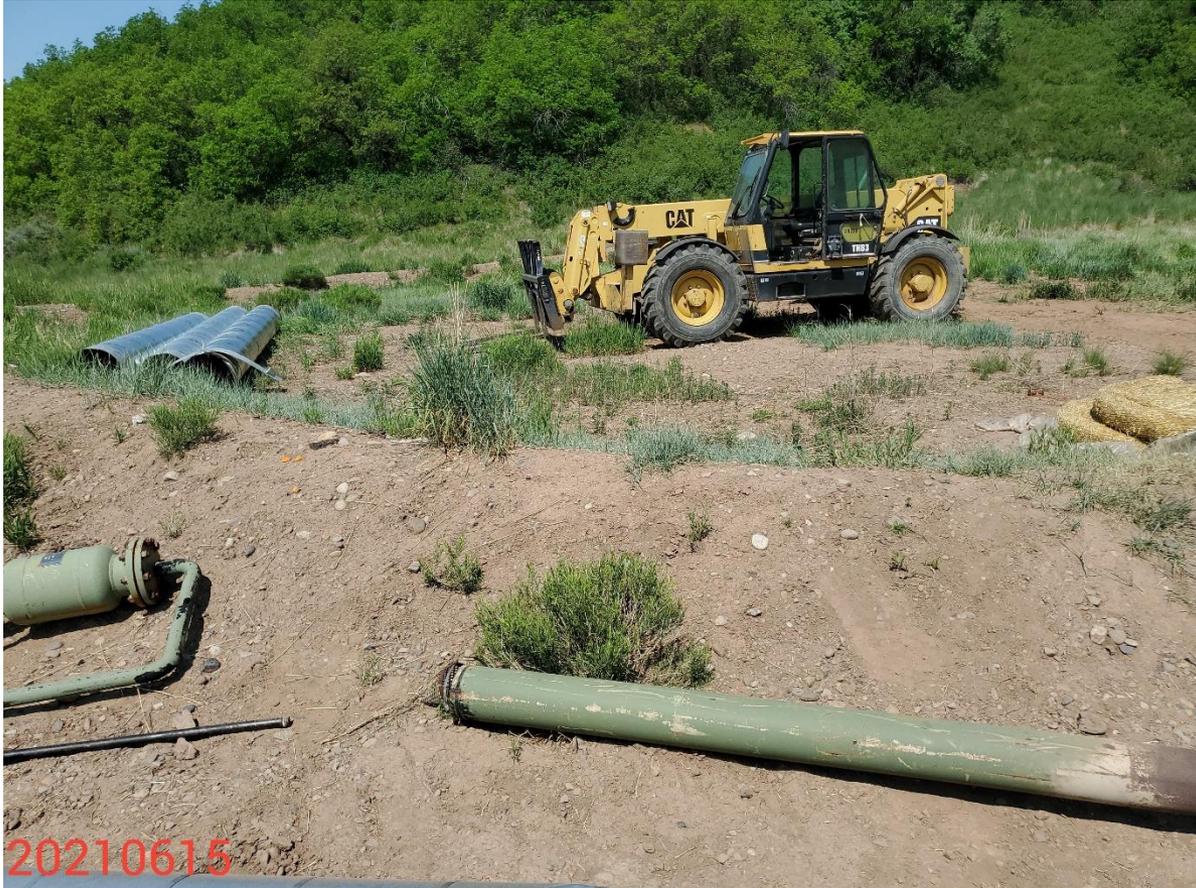
Photo 11: Photo shows areas on the northwest end of the Location have not been reclaimed in accordance with Rule 1003.b. Area observed being used to store equipment.

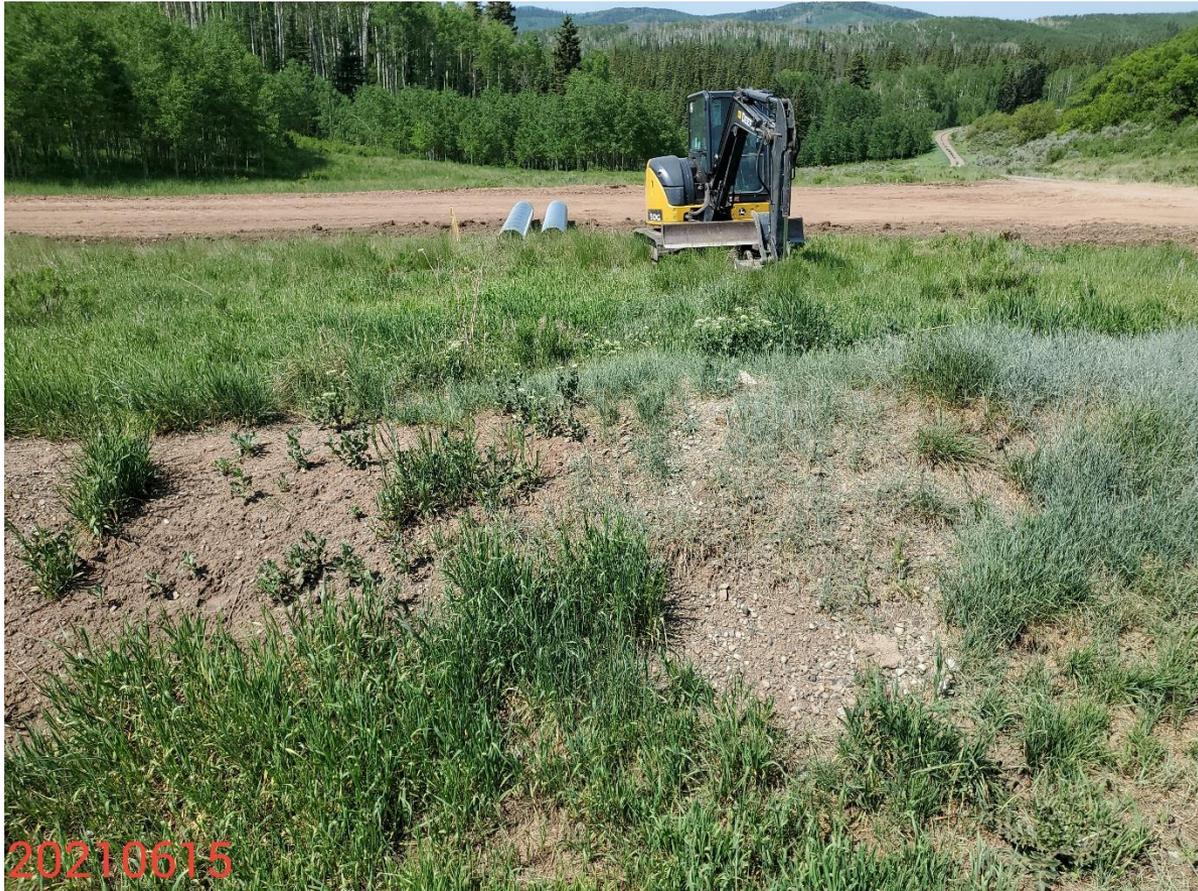
Photo 12: Photo taken from the sediment trap on the southwest end of the Location. Previous inspections observed noxious weeds within the trap, as well as other areas of the Location. Photo shows Hoary cress also has established on Location.

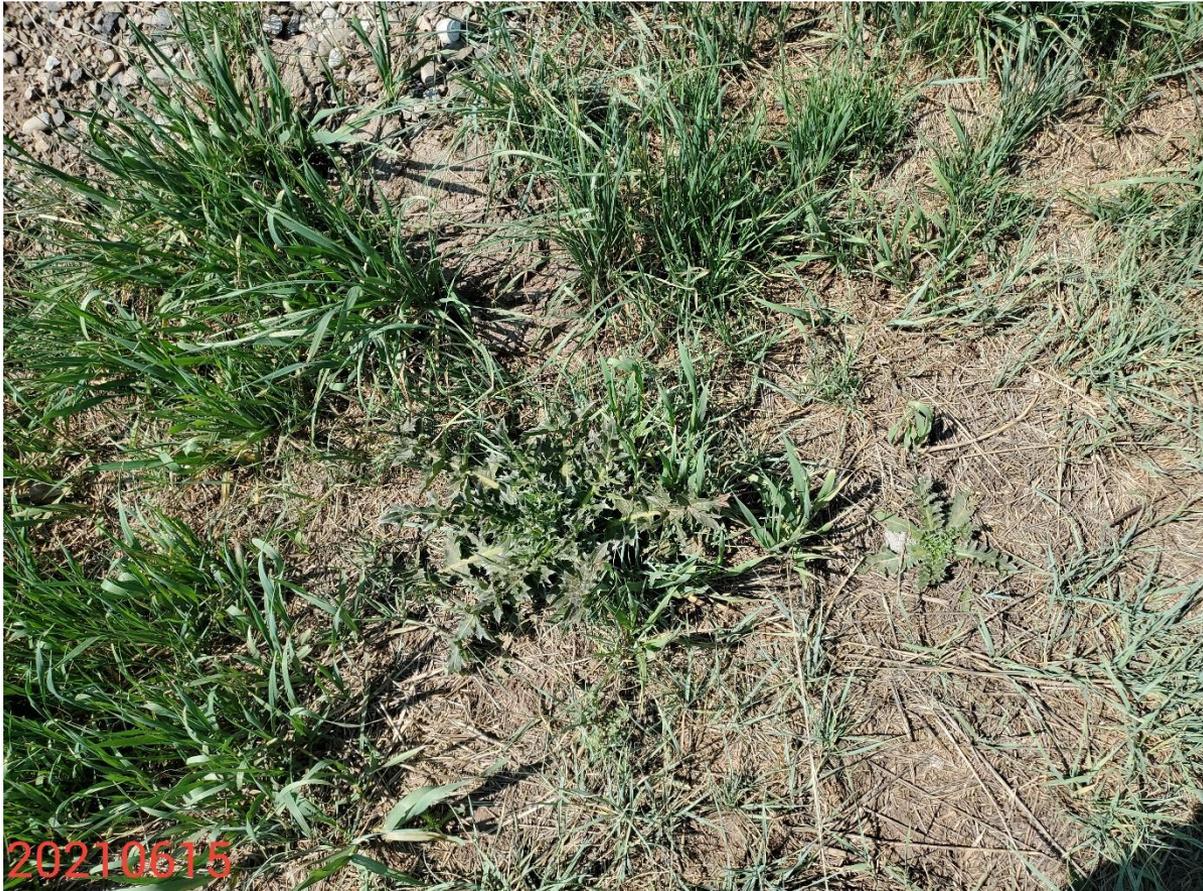
Photo 13: Photo shows musk thistle rosette observed on the southern areas of the Location.

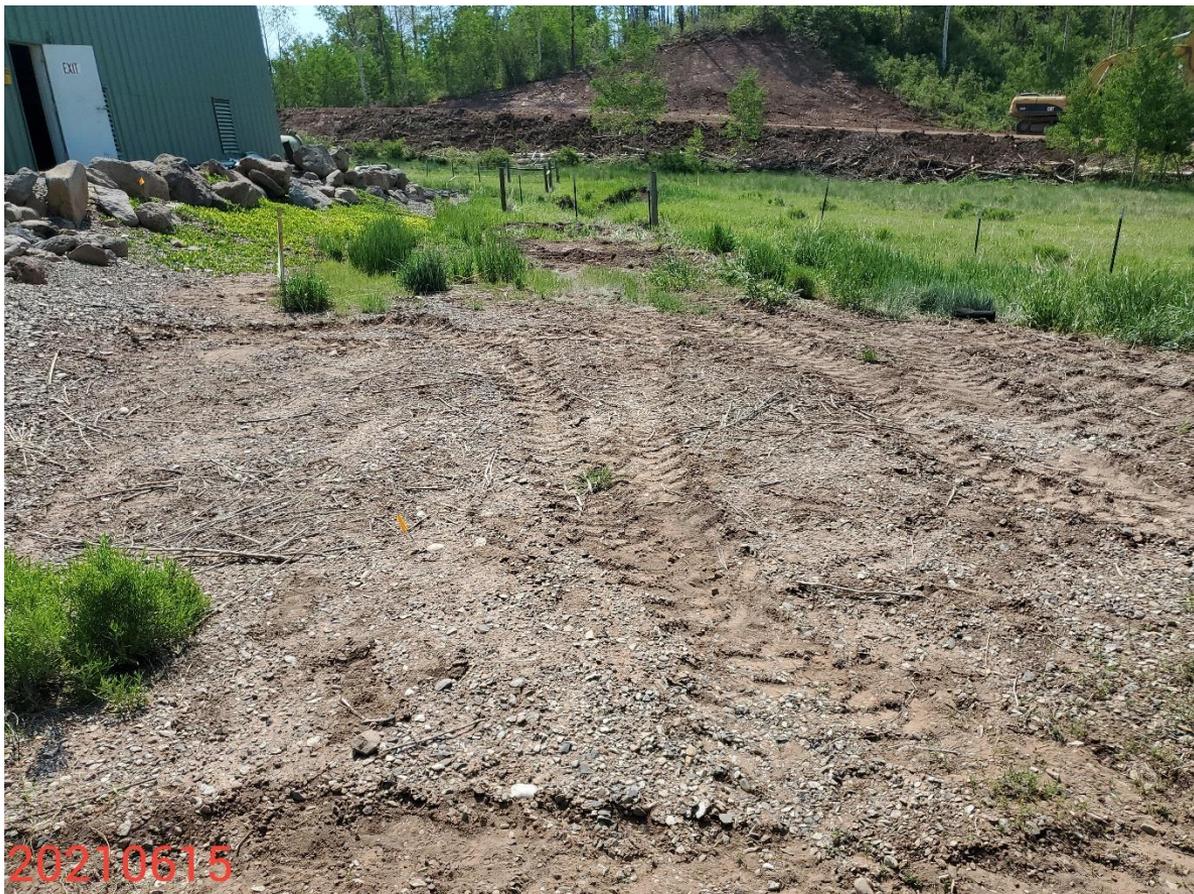
Photo 14: Photo shows that neither a sediment pond/trap BMP has been installed, or reclamation conducted on the southern areas of the Location.
