Inspection Photos

API: 055-06190

Operator: EVERGREEN NATURAL RESOURCES

Inspection Date: 6/16/2021

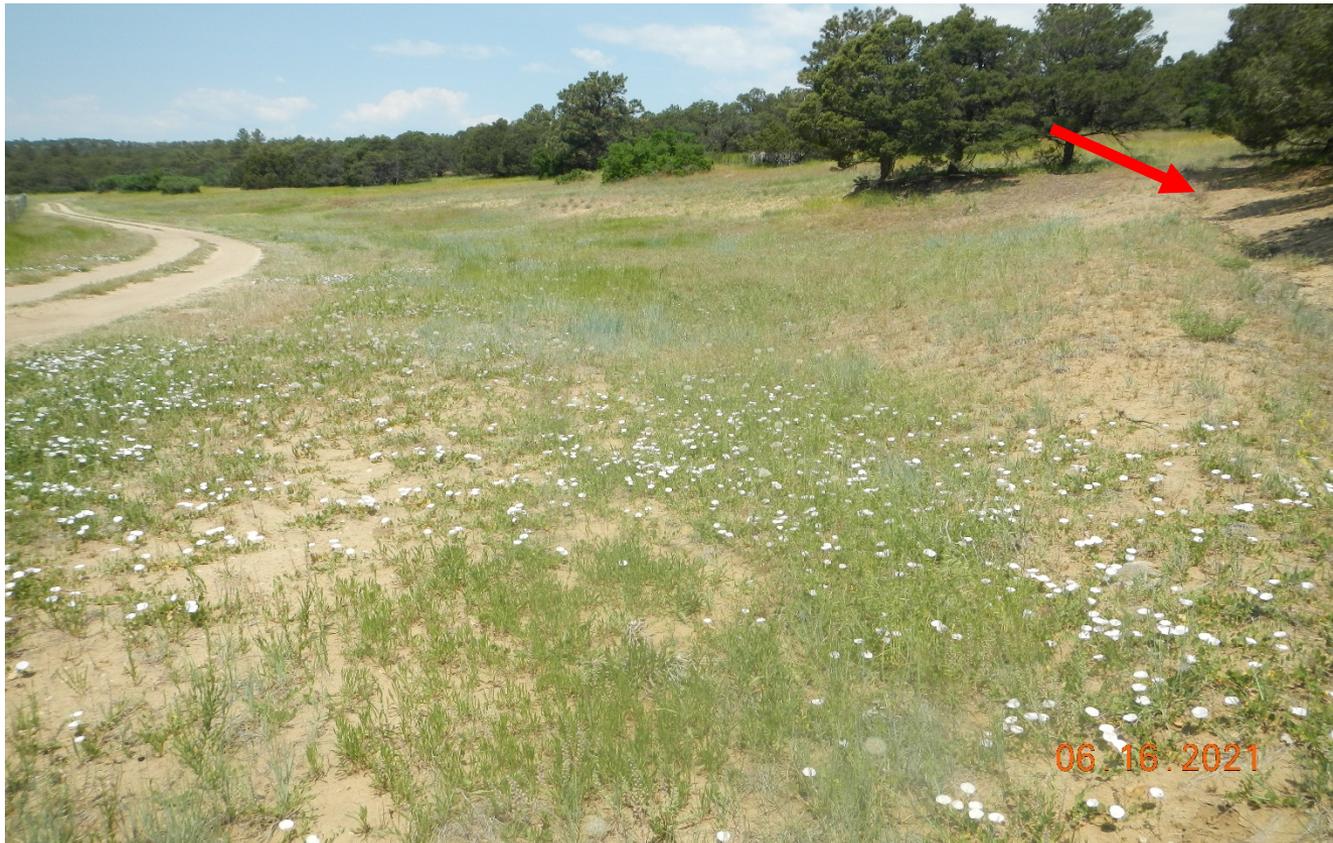
Photo 1. Facing northwest toward the location. A road travels thru the center of the location. The cut slope of the location is visible along the right side of photo and run-on ditch shown at red arrow.

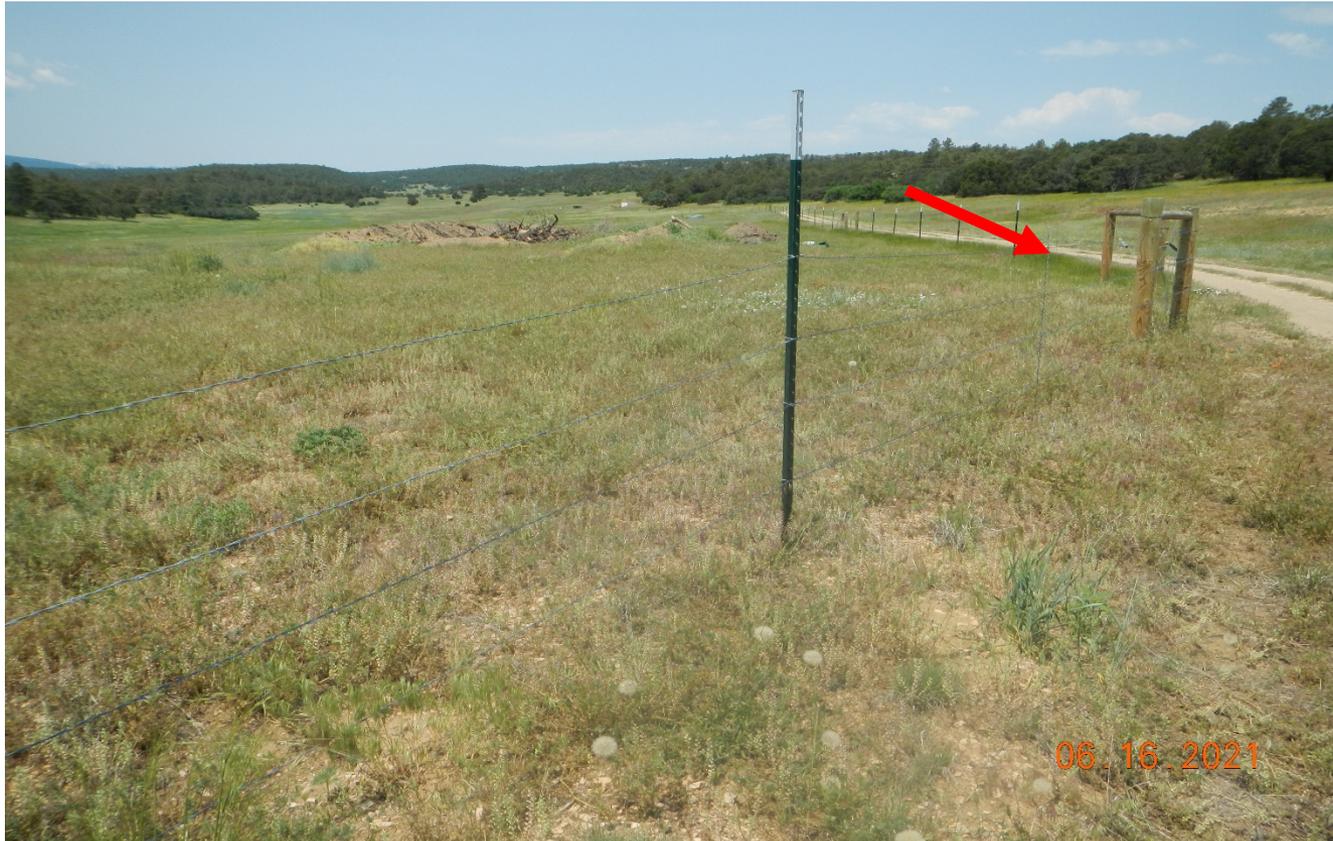
Photo 2. Facing west toward the location. A road travels thru the center of the location shown at red arrow.

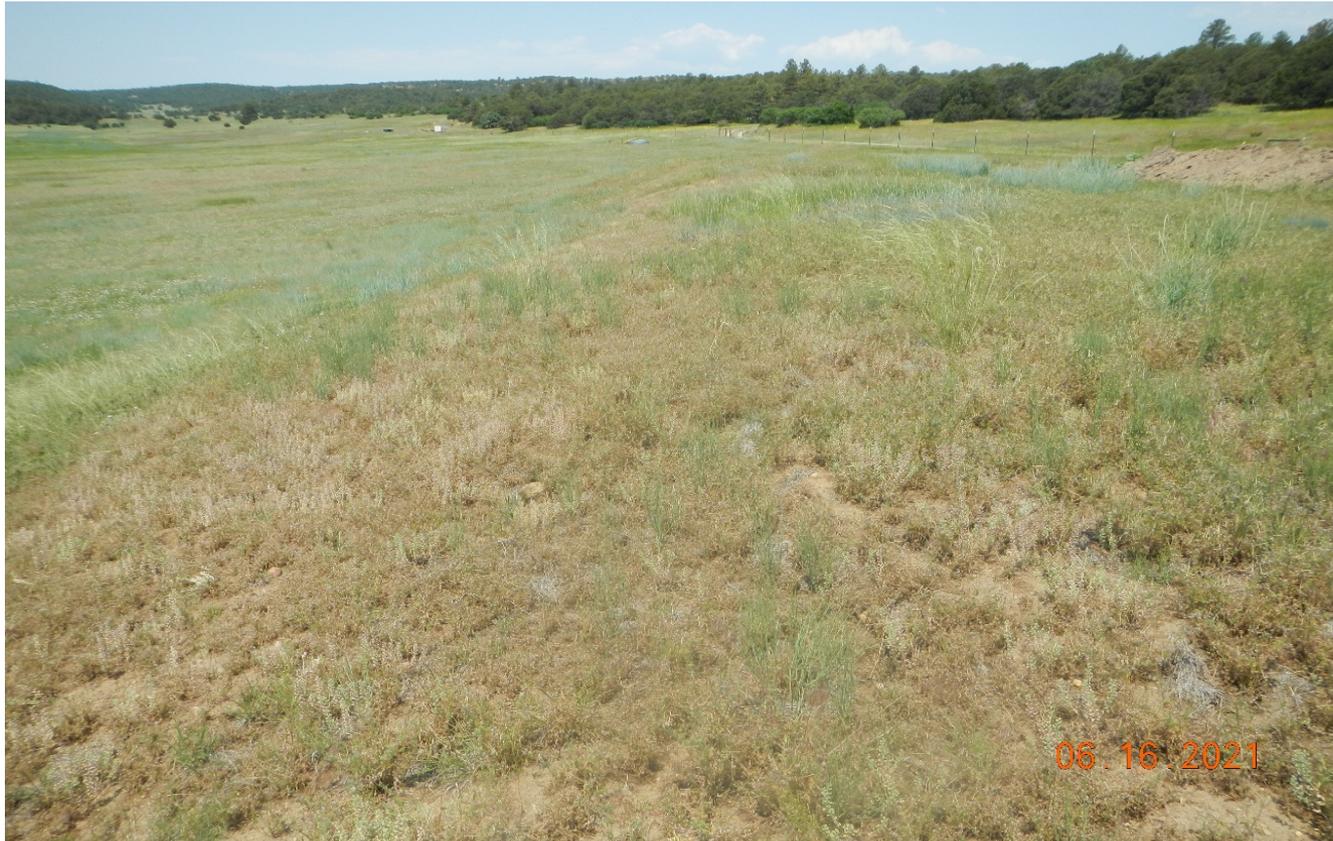
Photo 3. Facing west along the fill slope of the location. The location consists predominately of noxious weeds.

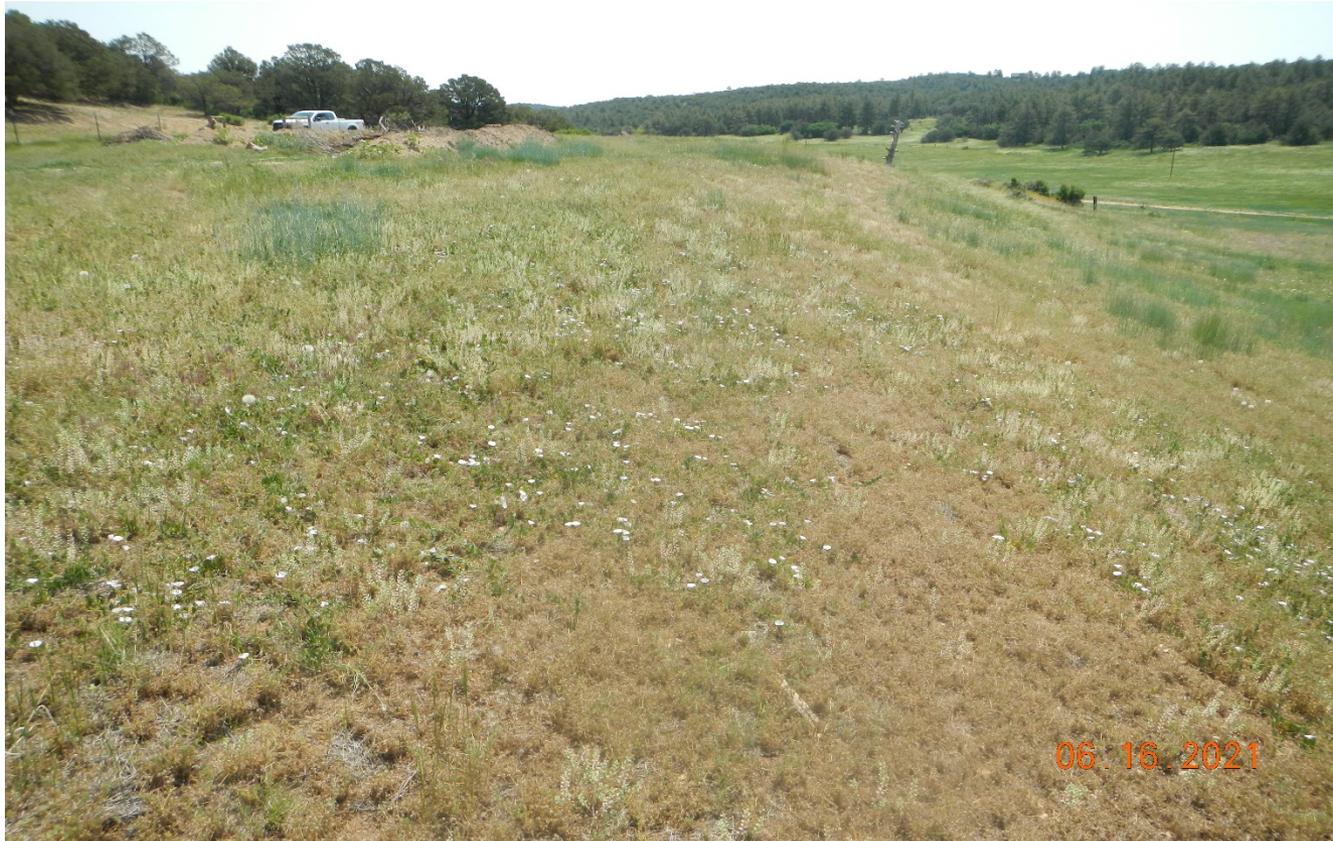
Photo 4. Facing east along the fill slope of the location. The location consists predominately of noxious weeds.

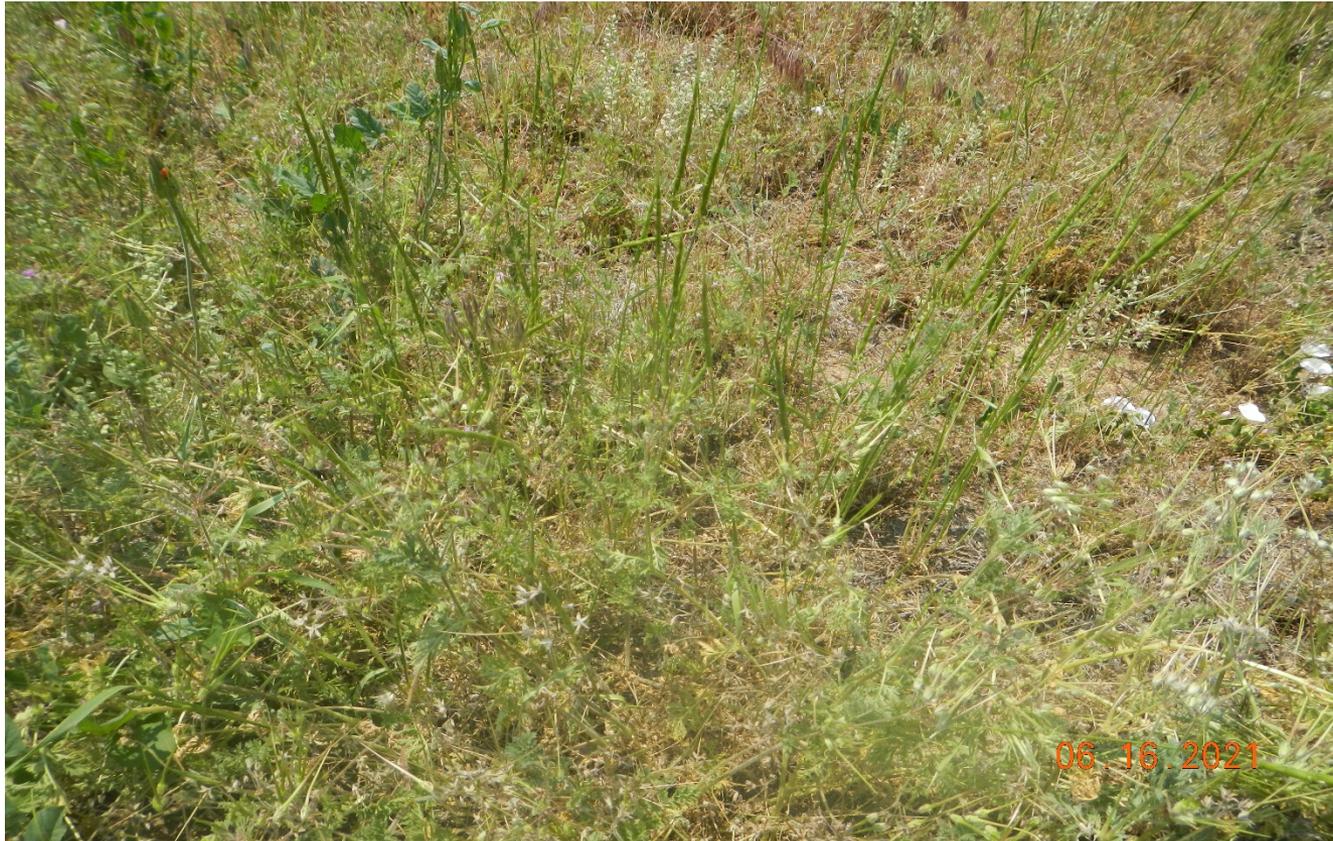
Photo 5. View of noxious weeds observed at the location include: Cheat grass, Red stem filaree, Field bind weed, and Jointed Goat grass.

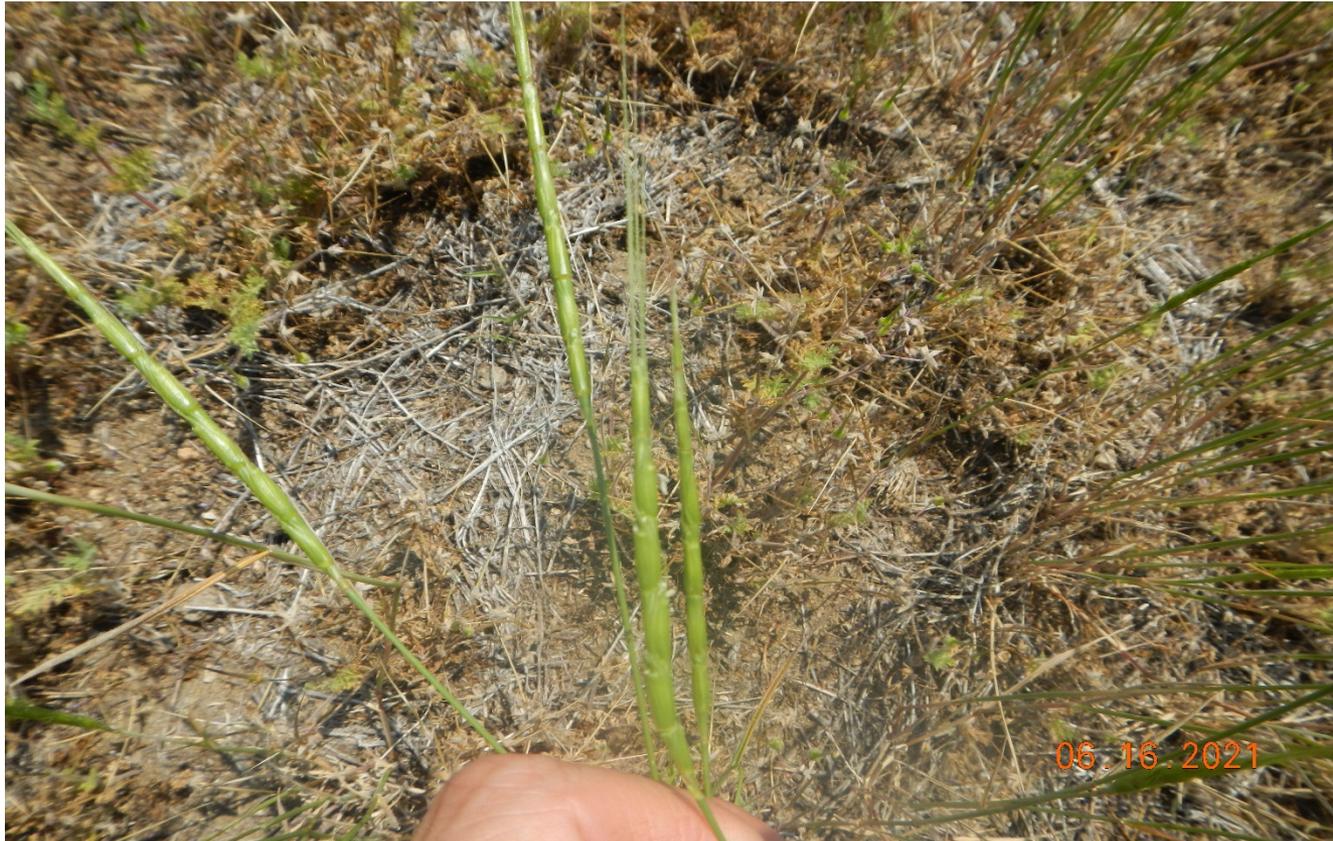
Photo 6. View of Jointed goatgrass found on the location which is a List B noxious weed.

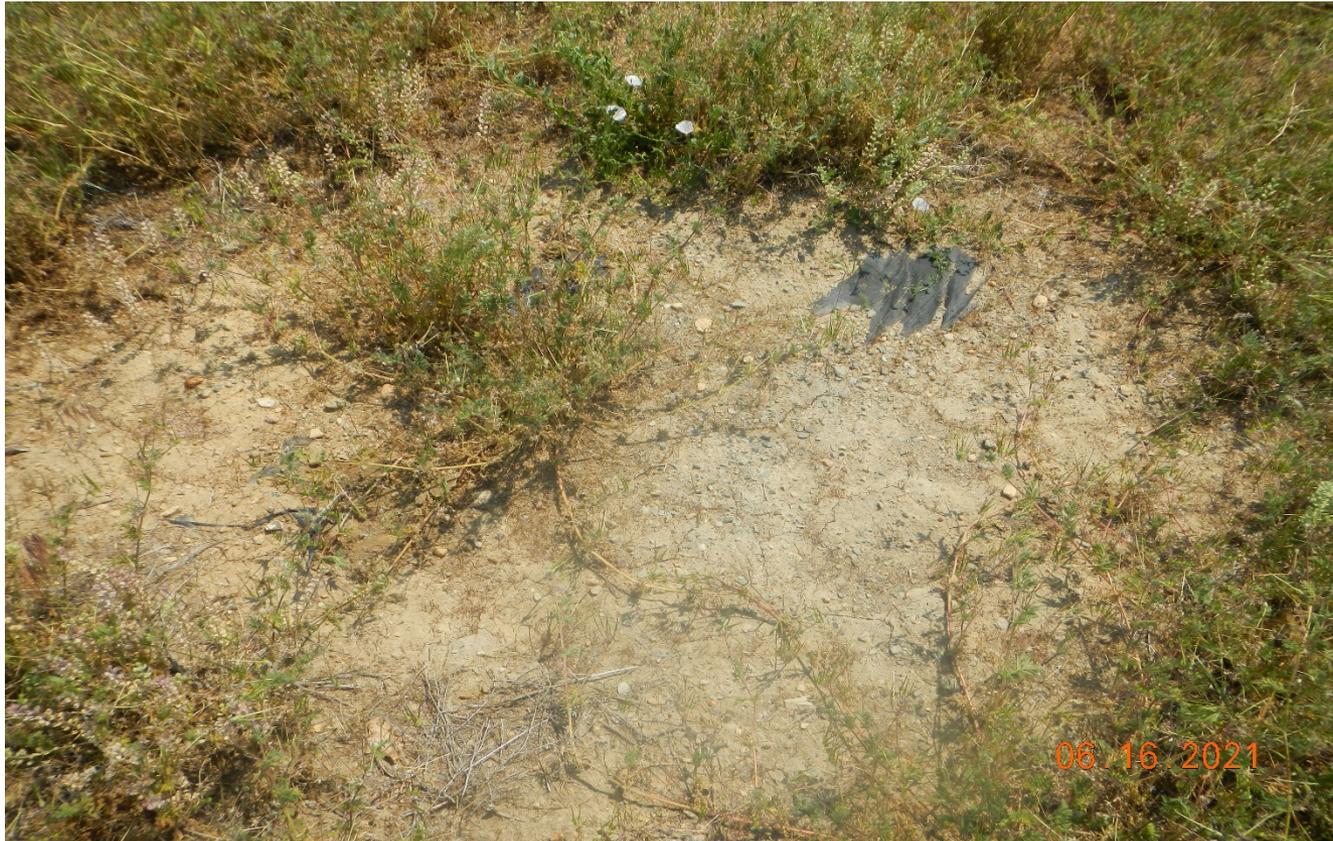
Photo 7. There appears to be pit liner at the surface at the southwest side of the pad.

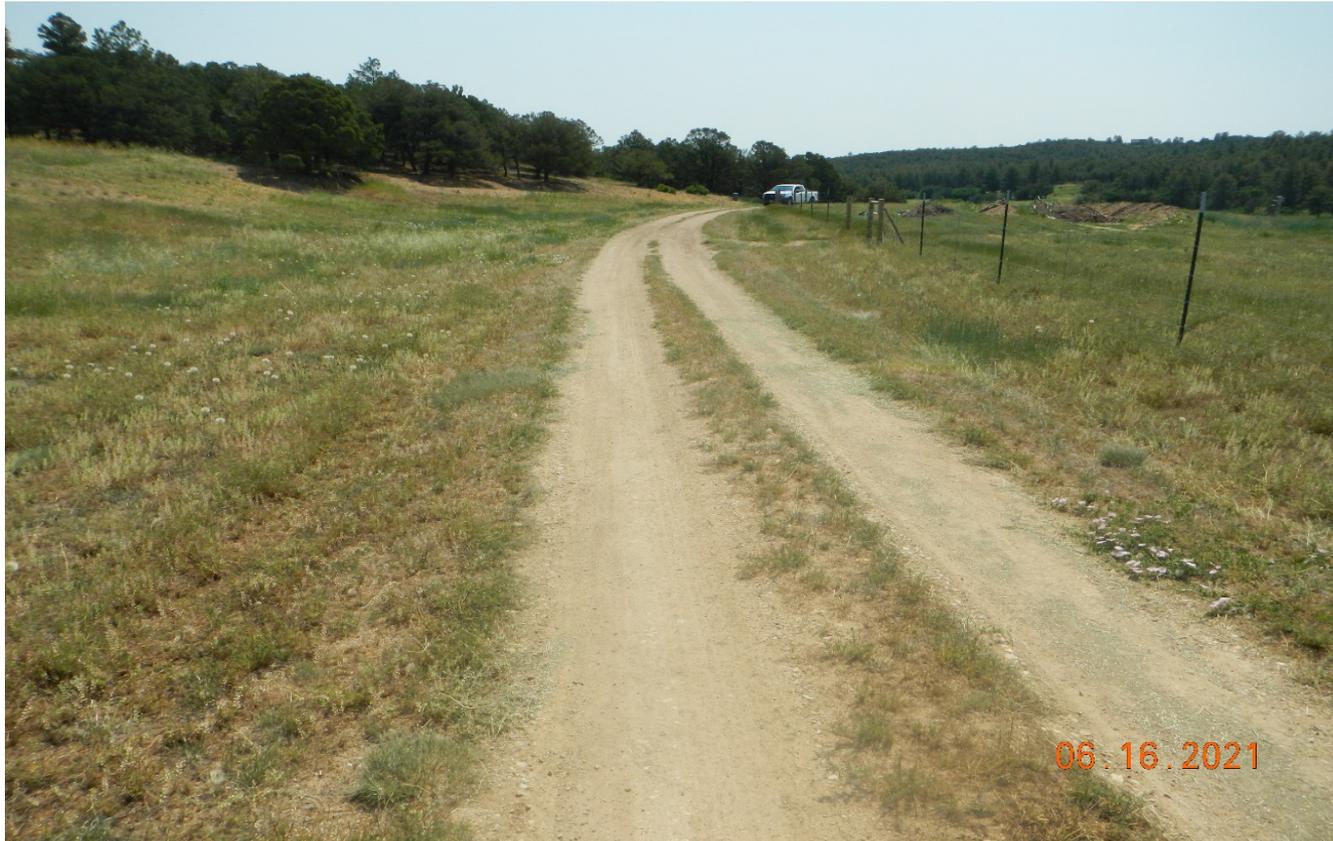
Photo 8. Facing east. The access road travels thru the location.

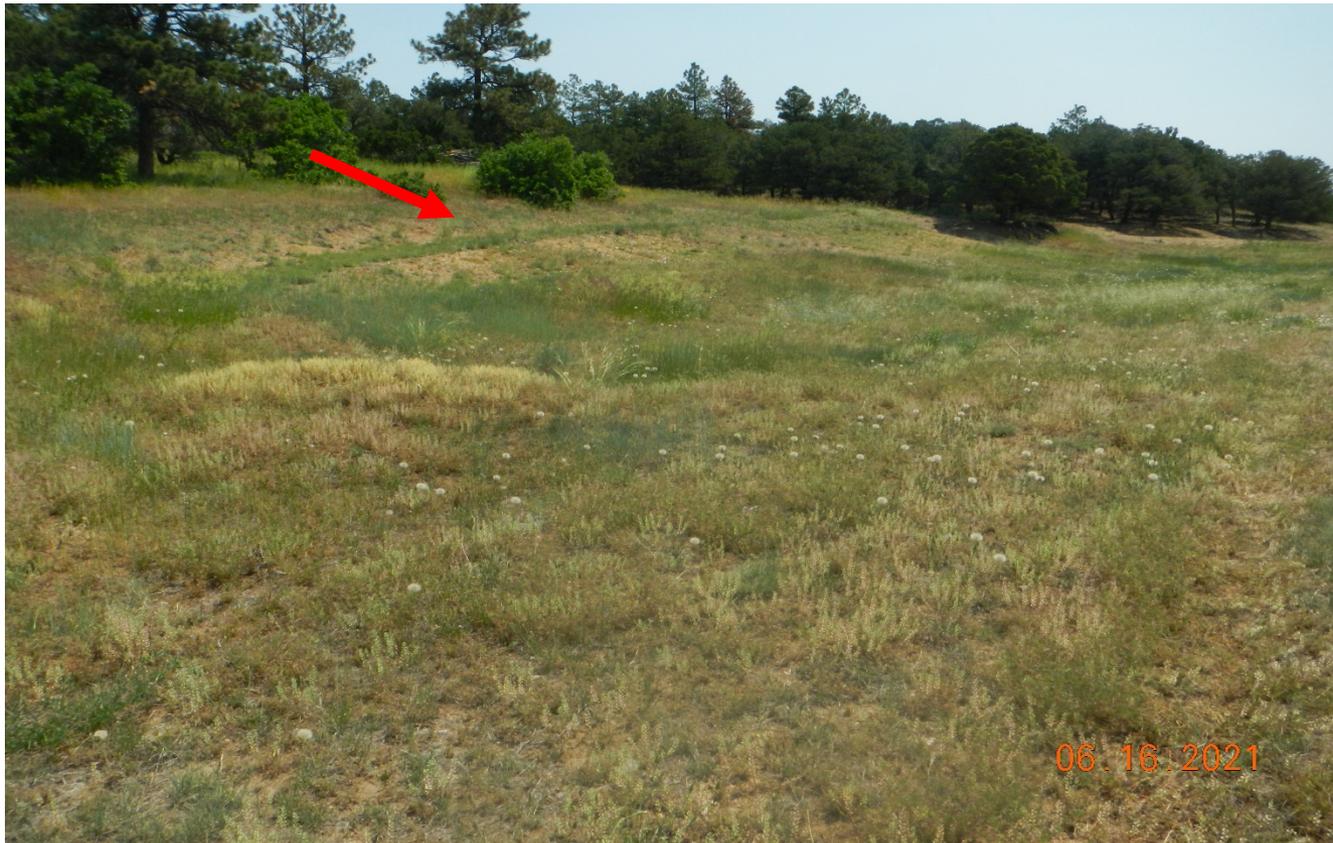
Photo 9. Facing northeast toward the location. The cut slope of the location is visible along the center of photo and run-on ditch shown at red arrow.
