Inspection Photos

Operator: Kinder Morgan
API: 083-06730
Date: 6/17/2021

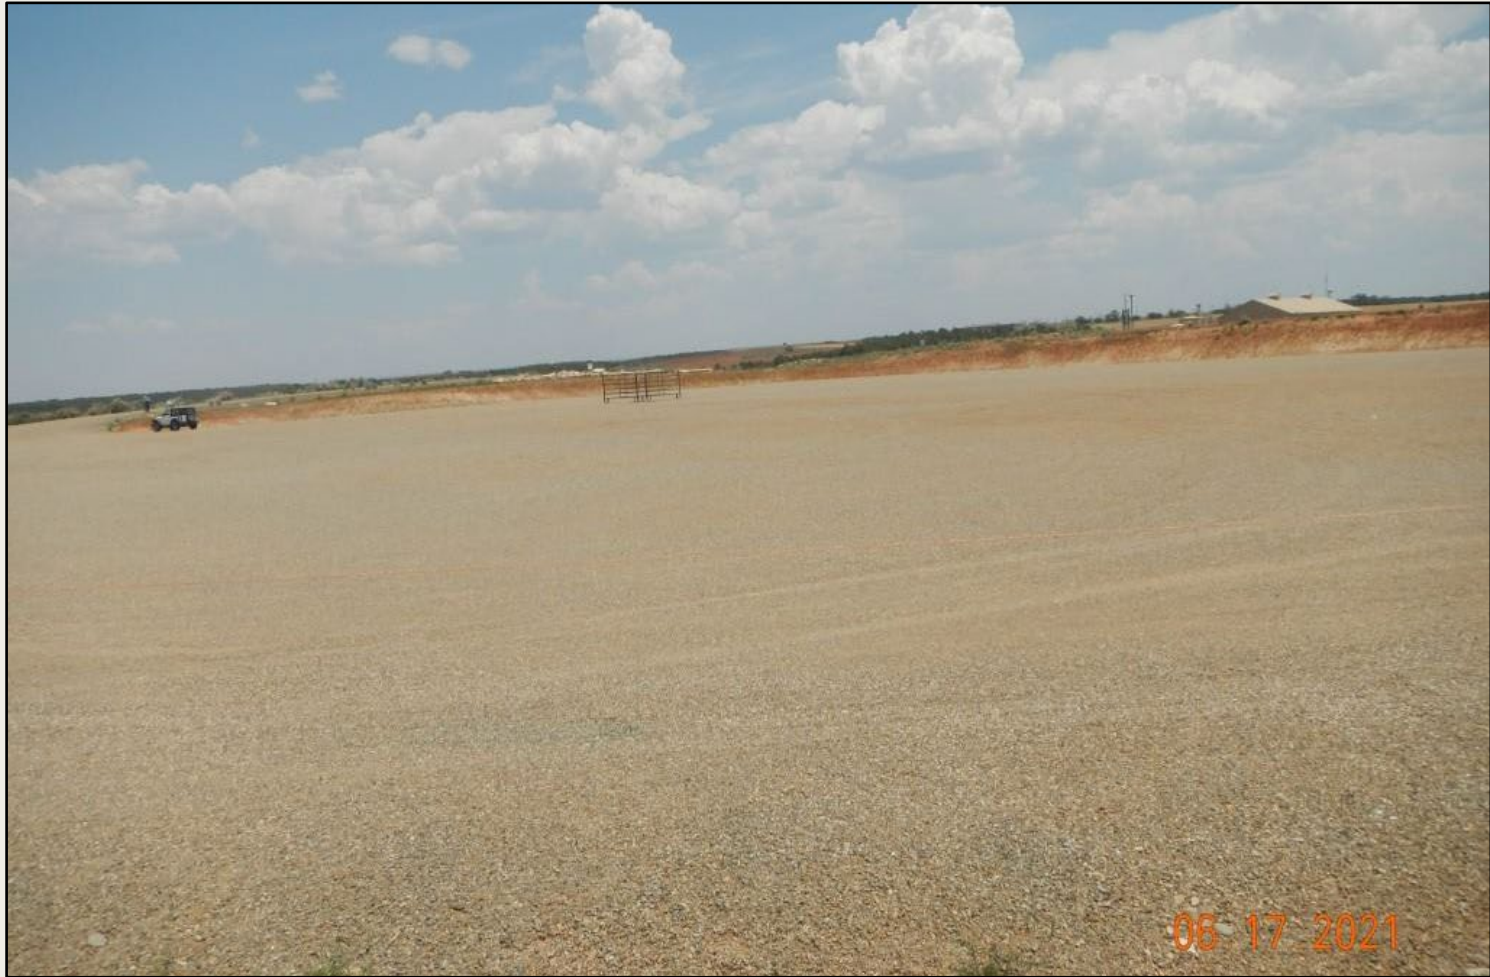
Photo 1. View the project area facing center from the southwestern corner of the working area facing center.

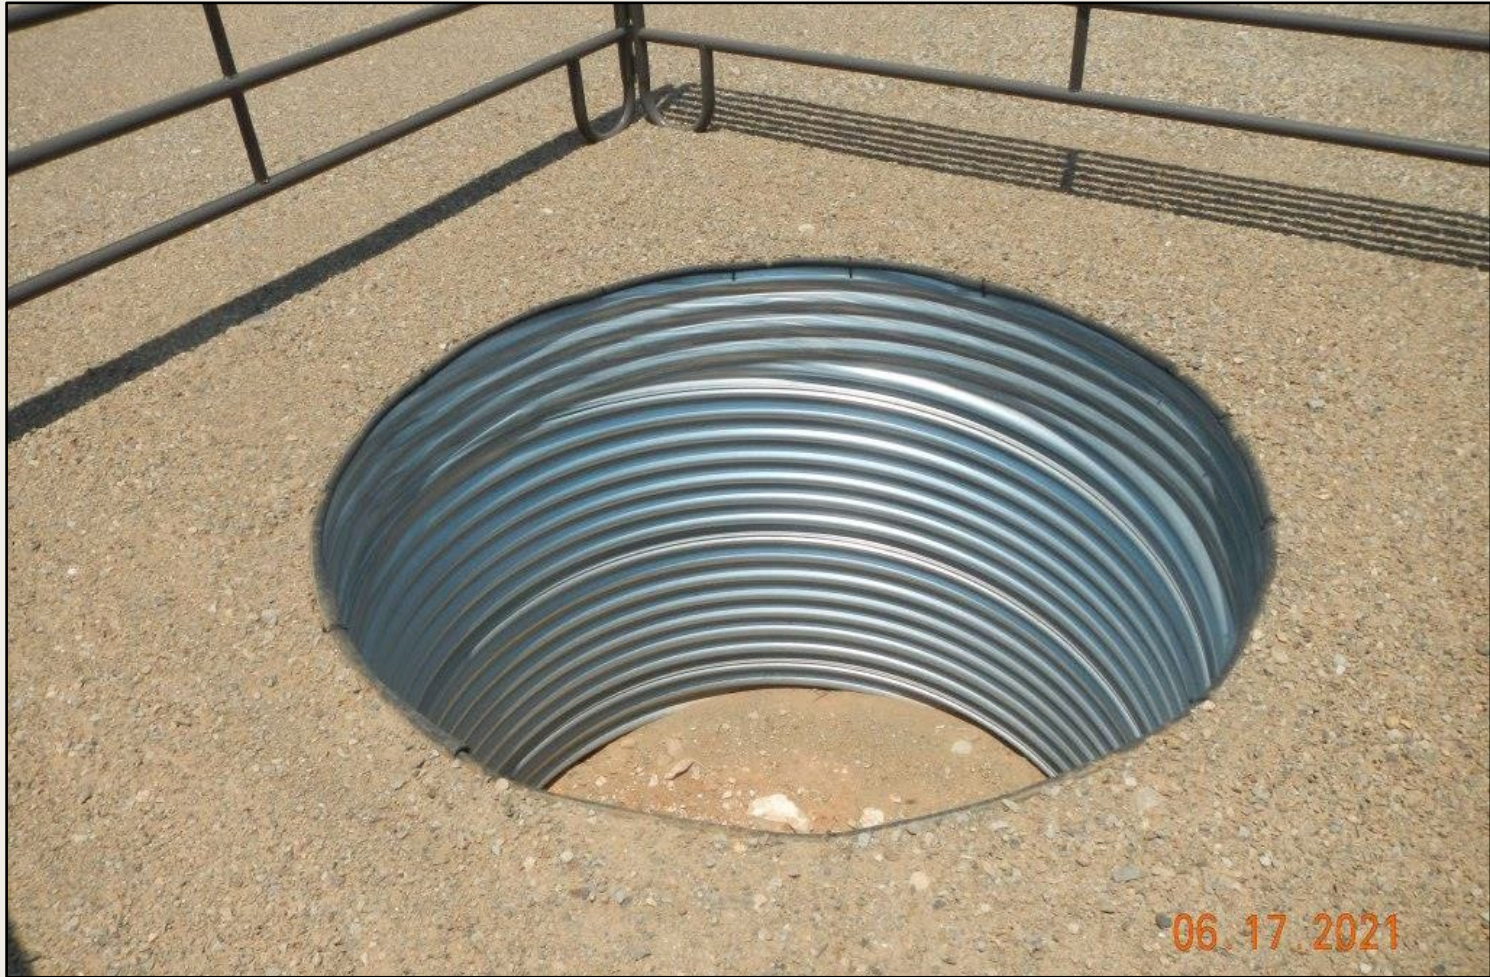
Photo 2. View of cellar that is approximately 6-feet deep observed on the well pad. This needs to be covered or wildlife escape ramp installed.

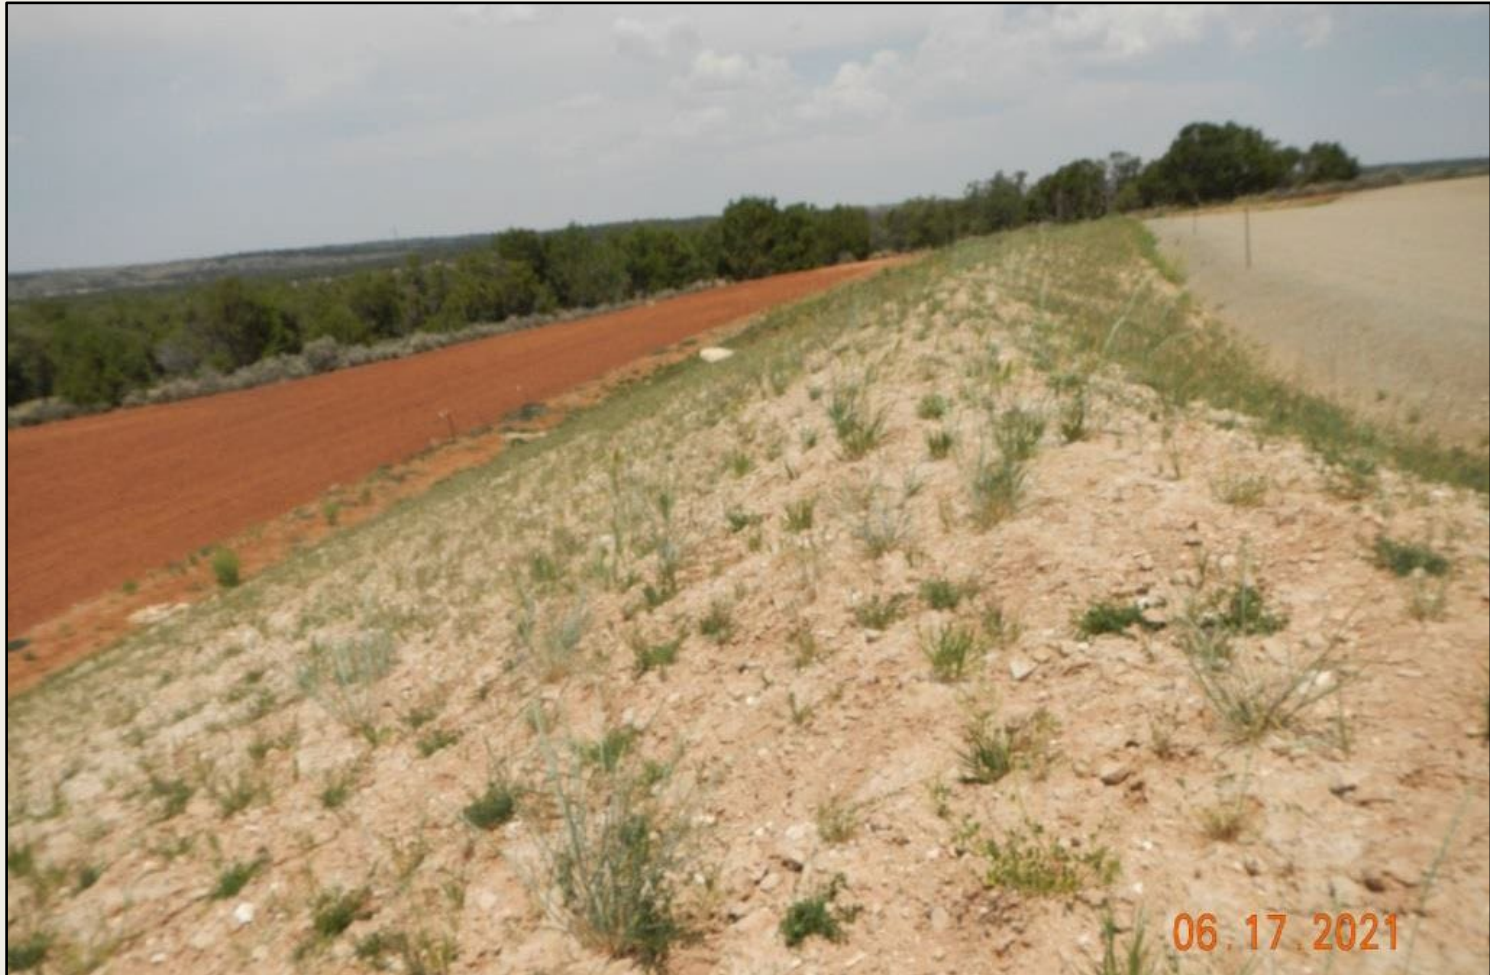
Photo 3. View of the western project area from the southwestern corner of the working area, facing northward. Revegetation is progressing with western wheatgrass, alfalfa, smooth brome, and locoweed.

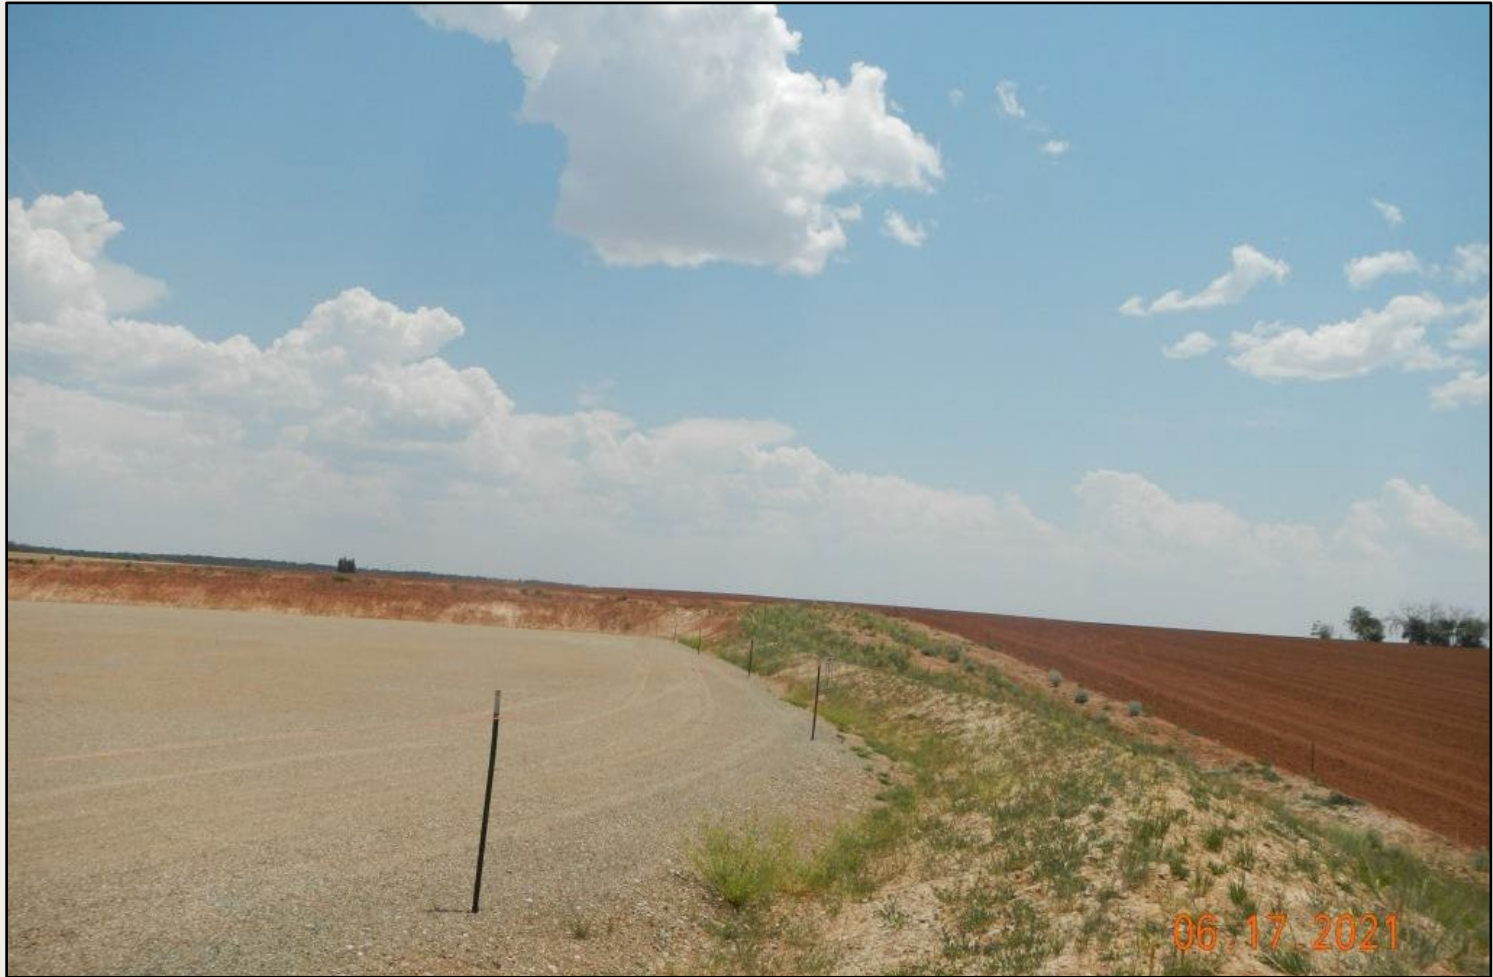
Photo 4. View of the southern project area from the southwestern corner facing eastward.

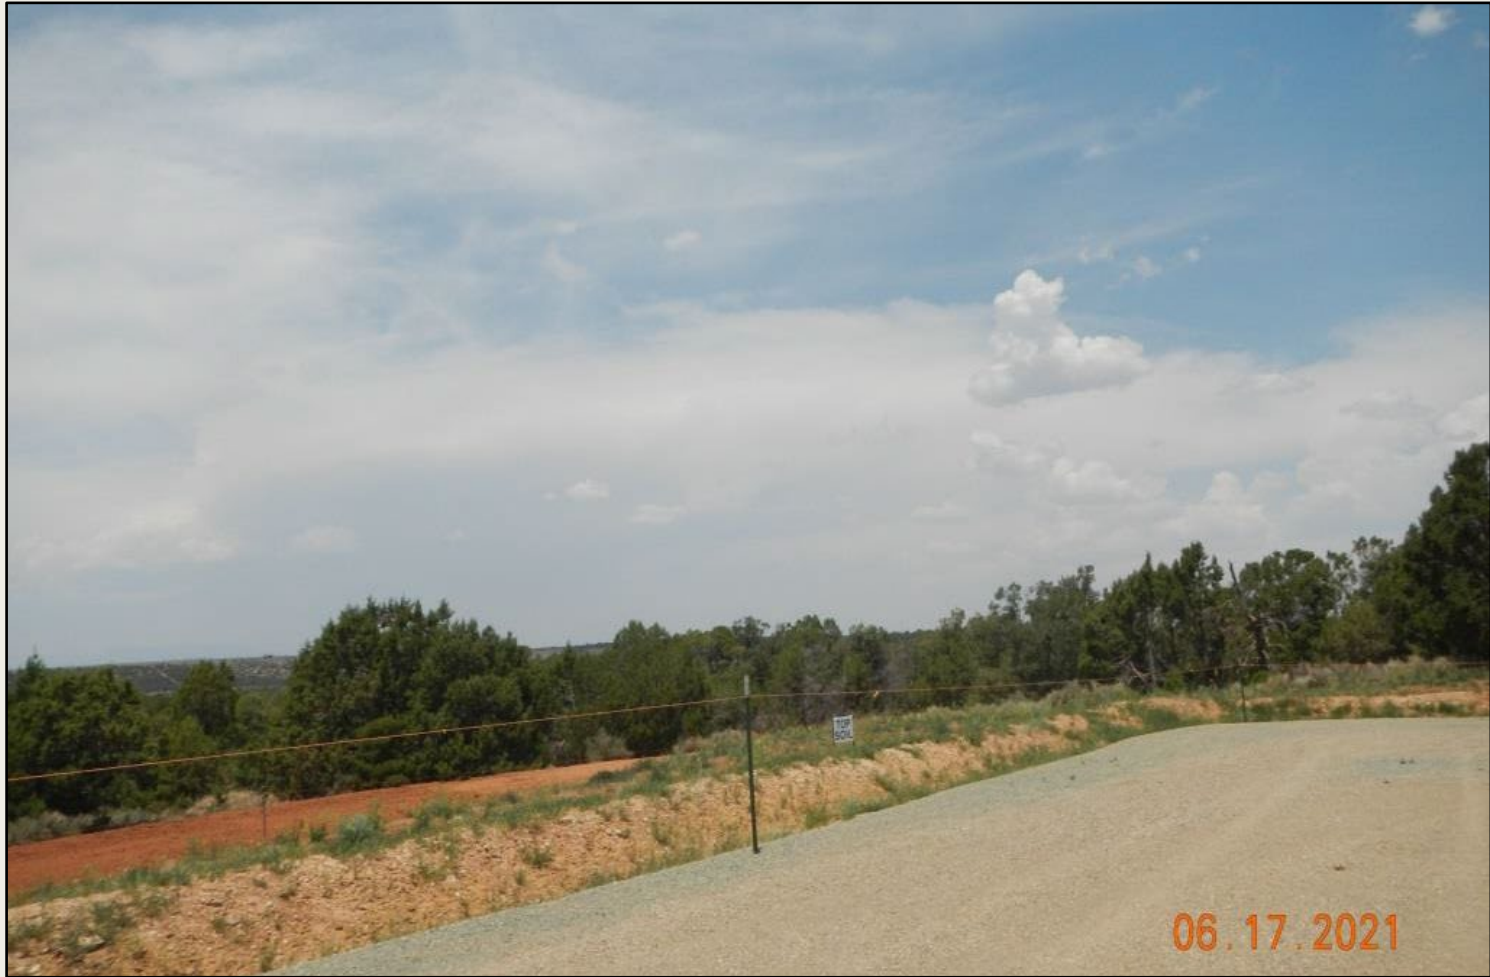
Photo 5. View of signed topsoil within the southwestern project area. Additional topsoil storage observed within the eastern project area.

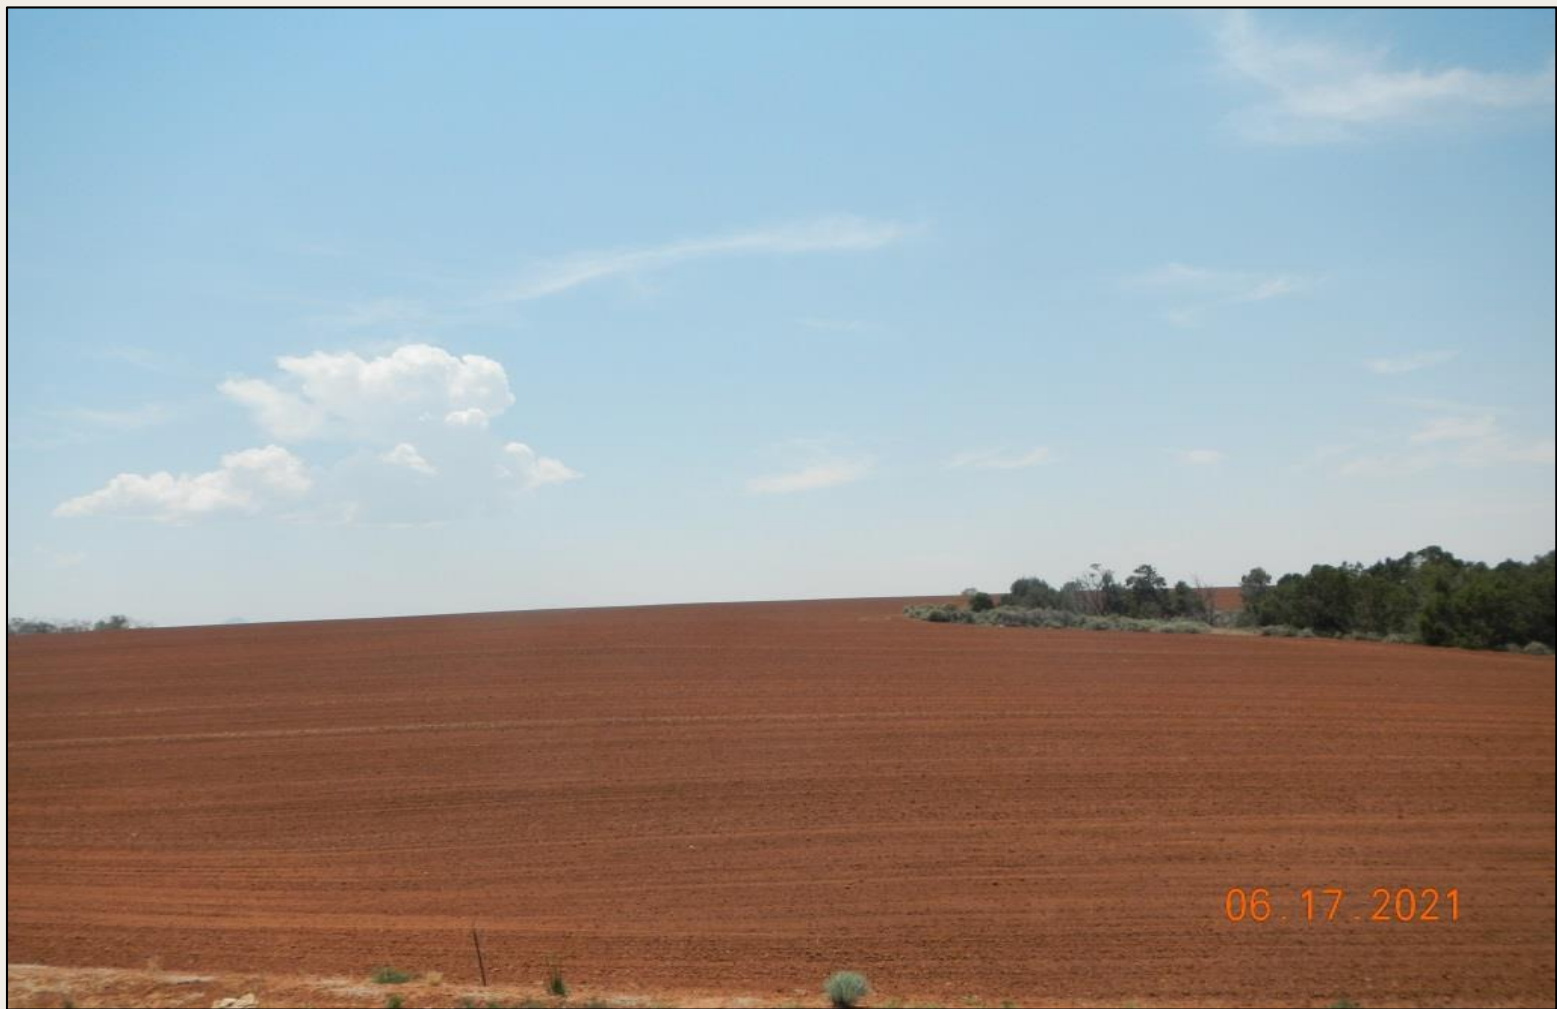
Photo 6. View of reference area comprised of dryland cultivated field appears to be prepped for seeding.
