Inspection Photos
Operator: Seeley Operating
API: 083-06542
Date: 6/17/2021

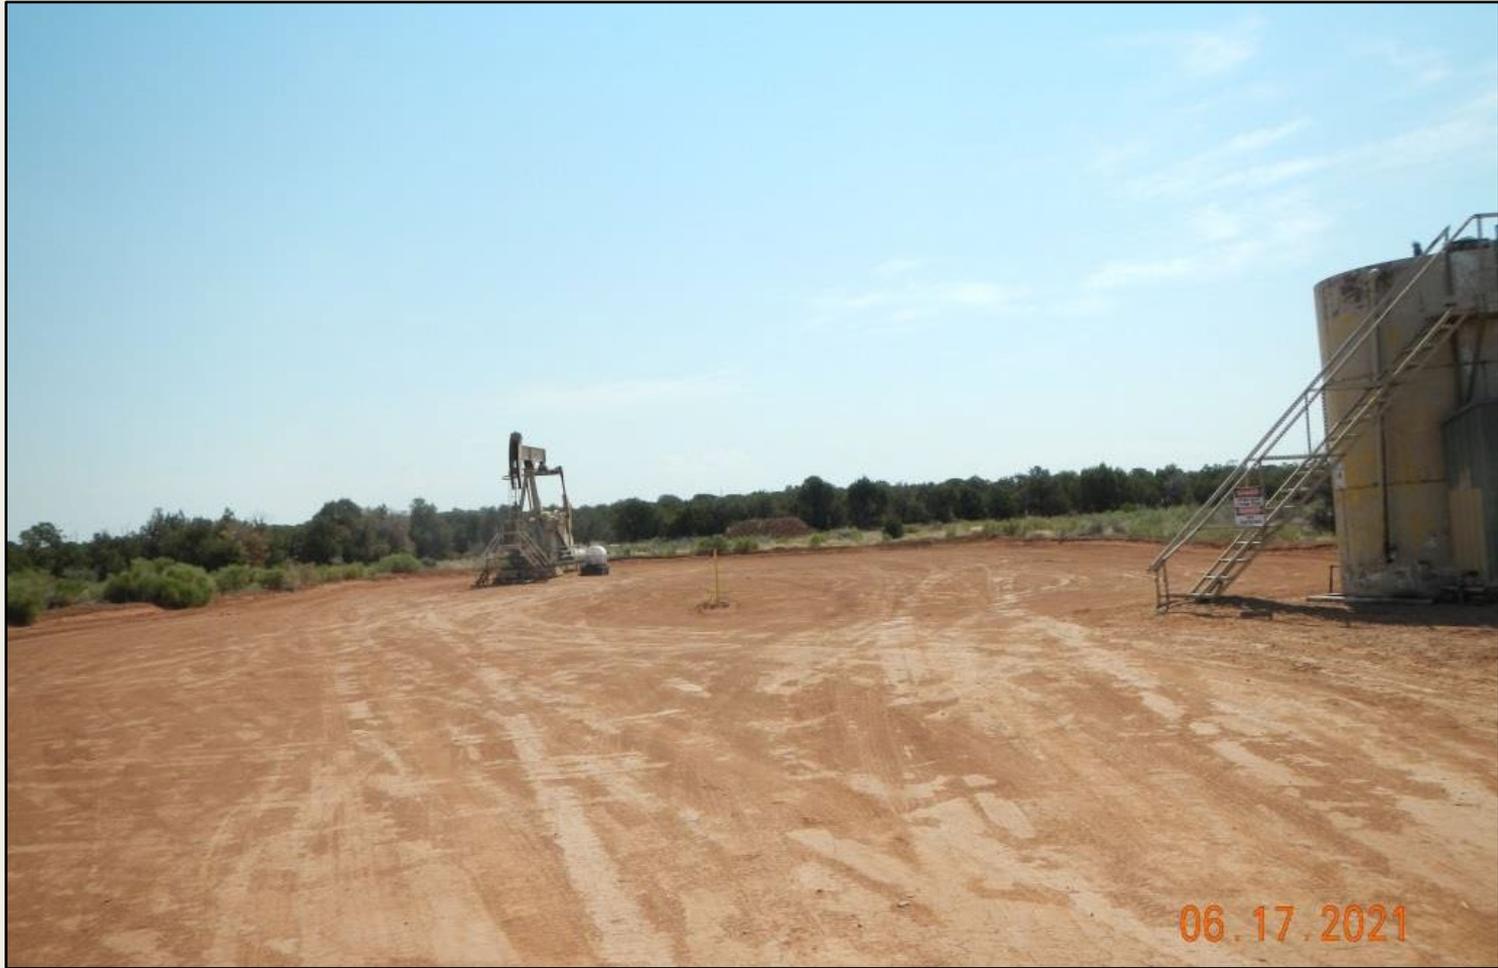
Photo 1. View the project area from the well pad entrance facing center.

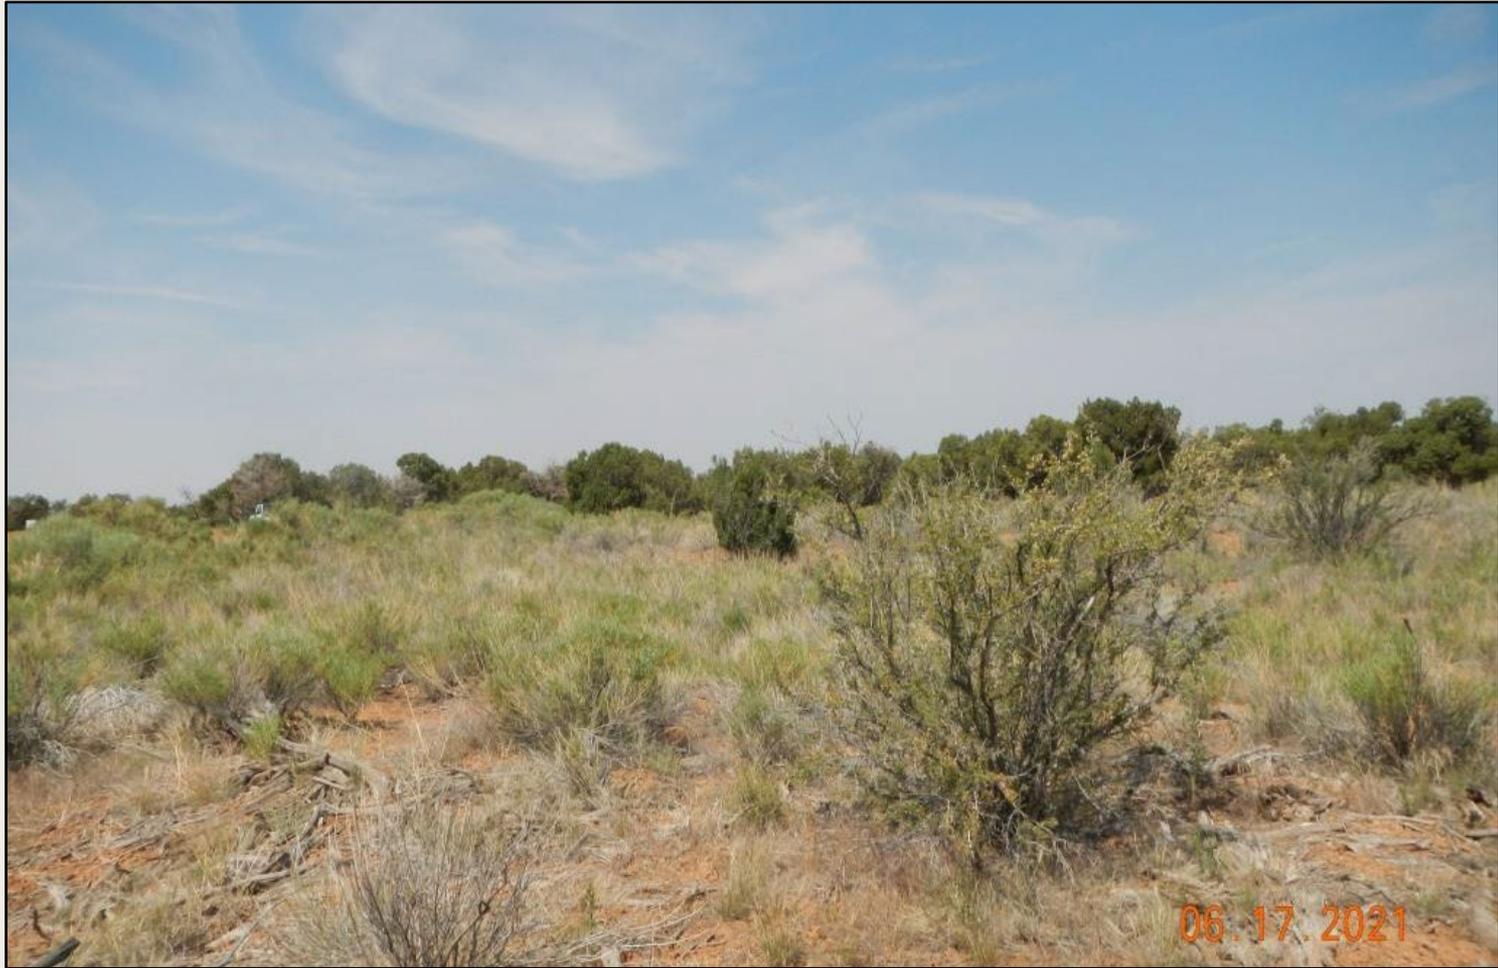
Photo 2. View of the northern project area from the northeastern corner facing westward. Revegetation is progressing with Indian ricegrass, cliffrose, rubber rabbitbrush, squirreltail, and young pinyon and juniper trees.

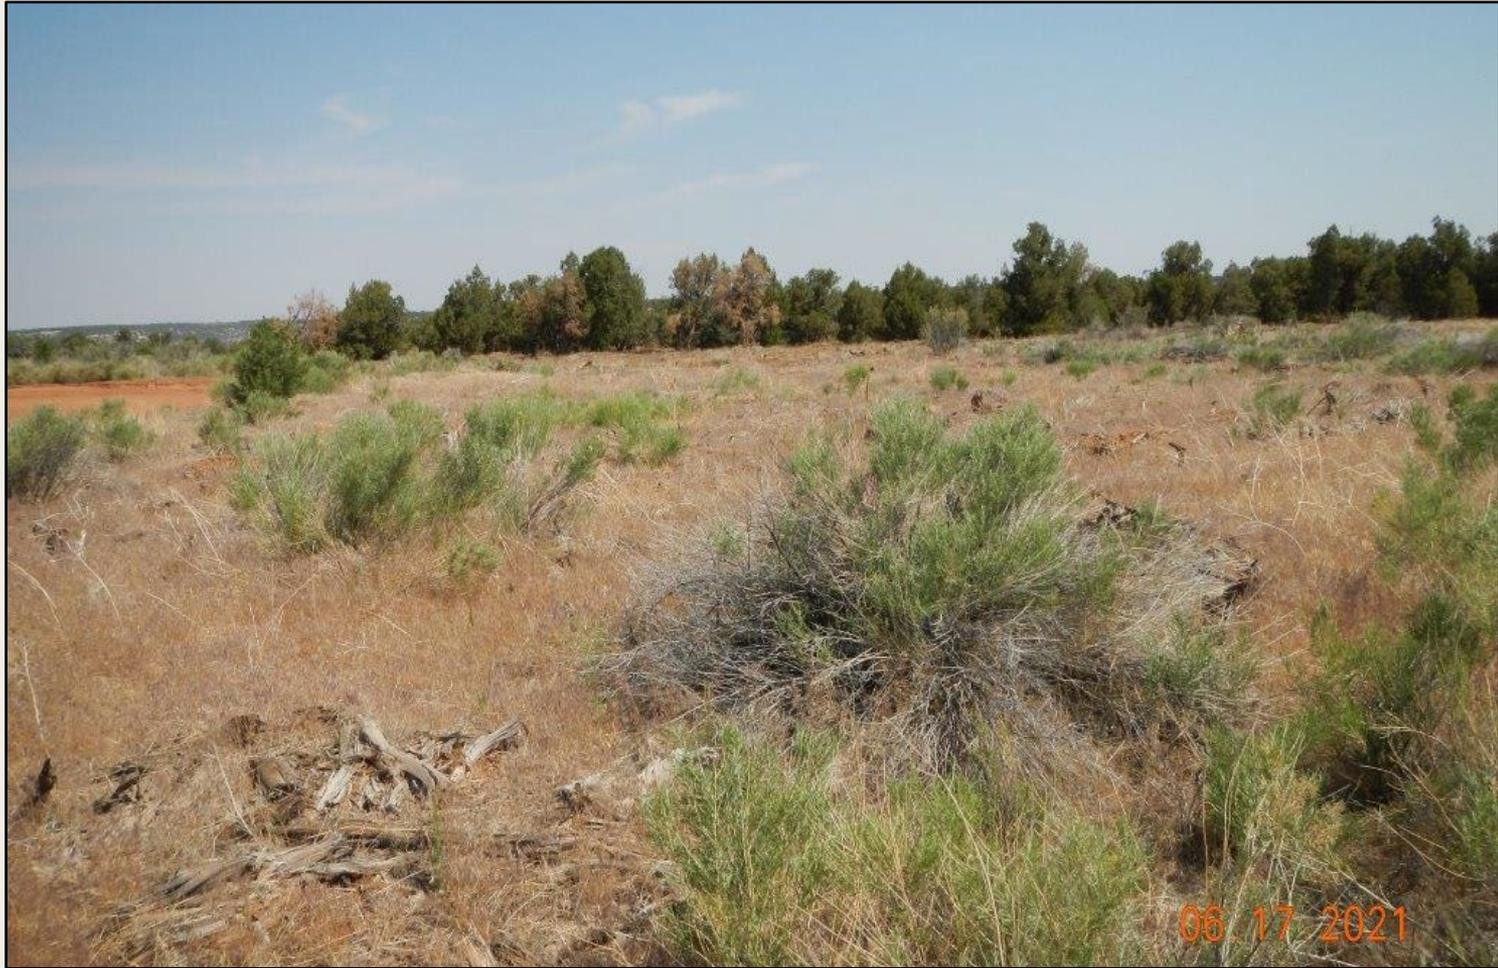
Photo 3. View of the eastern project area from the northeastern corner facing northward.

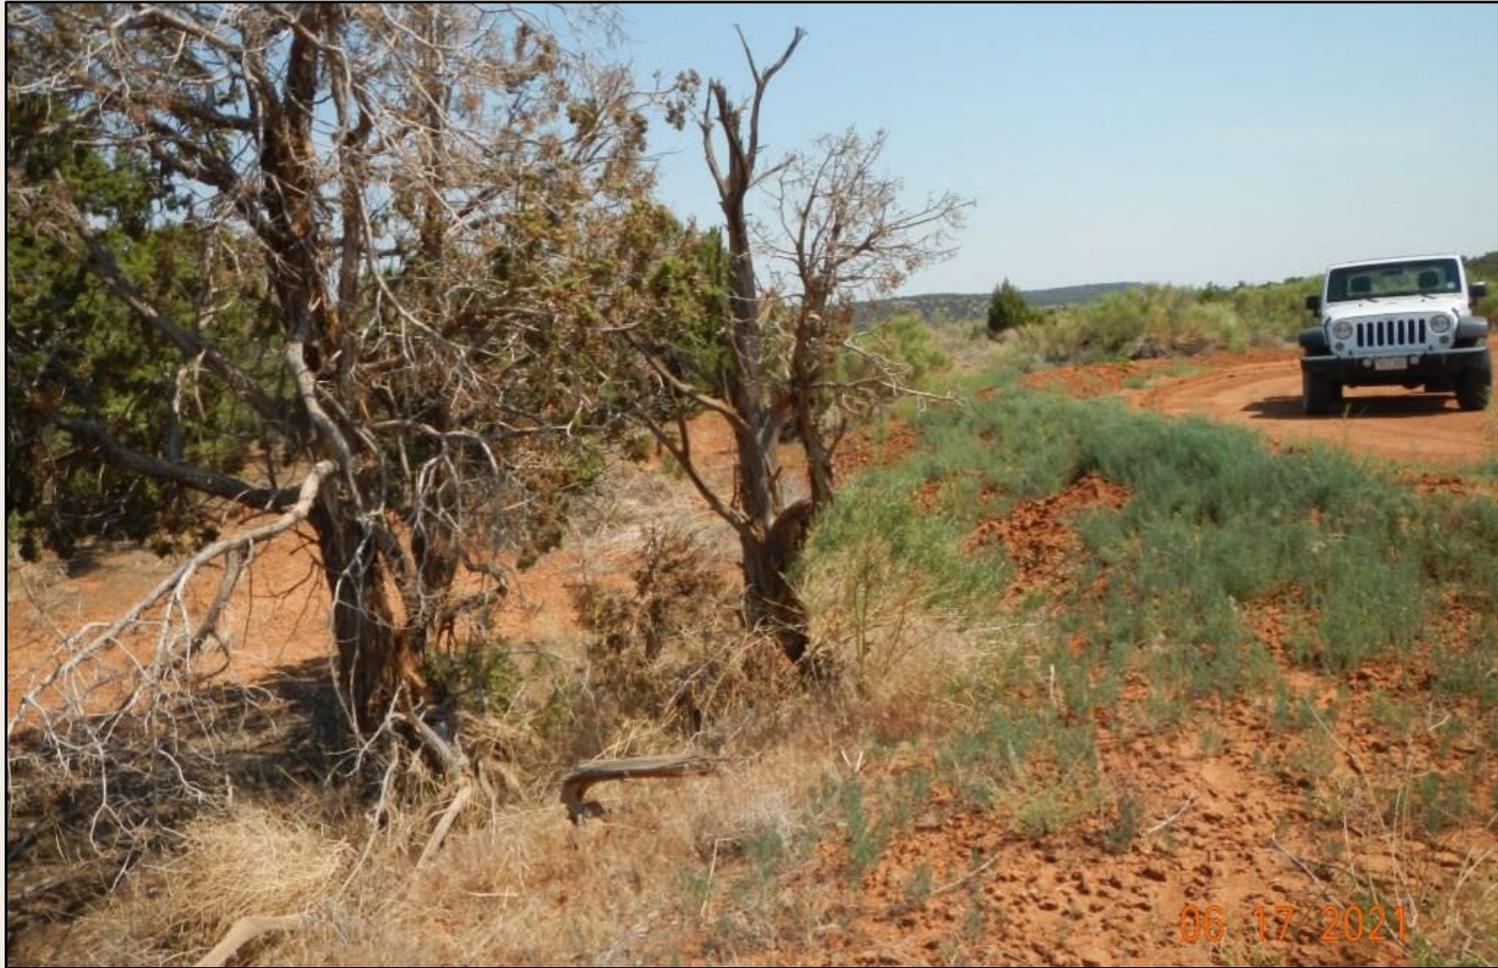
Photo 4. View of the northwestern berm at the well pad entrance.

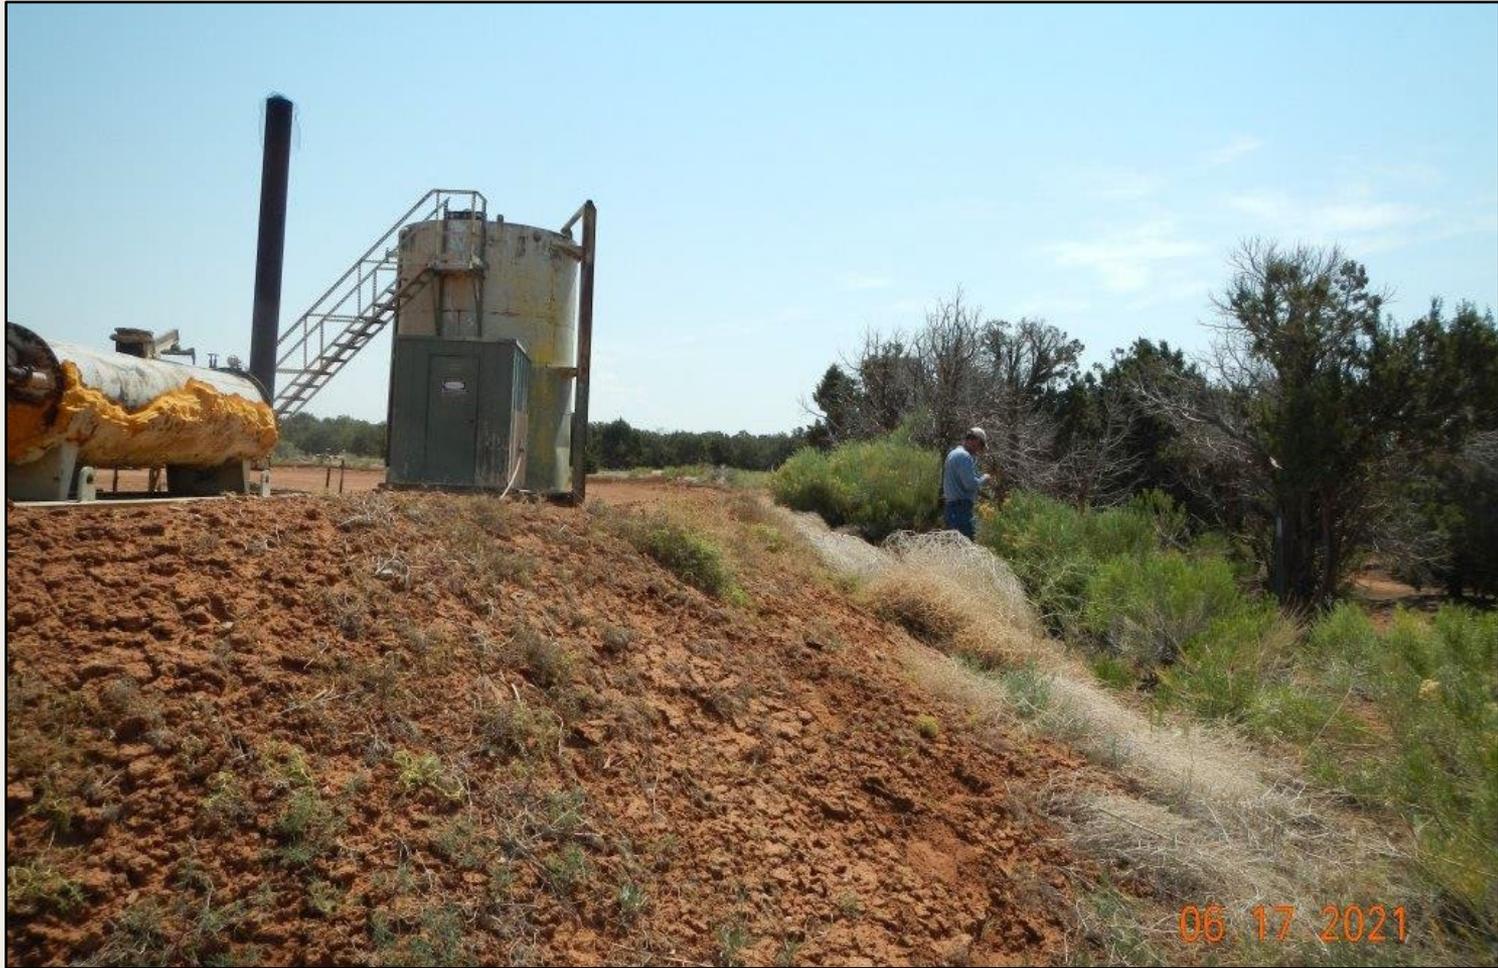
Photo 5. View of the southern project area from the southwestern corner facing eastward.

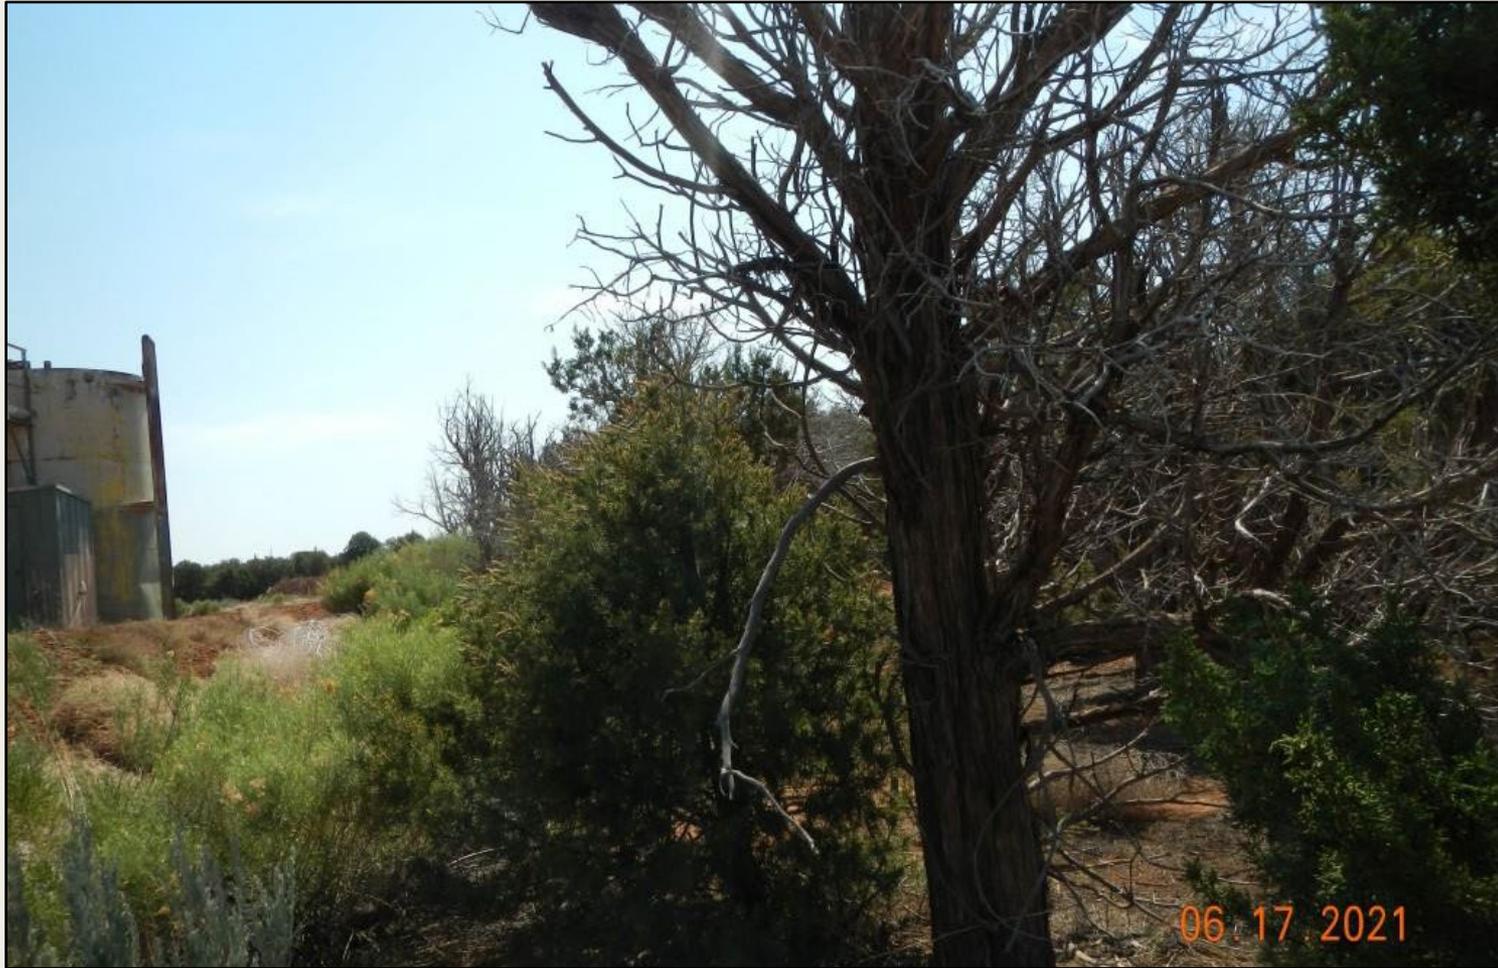
Photo 6. Another view of the southern project area. Young pinyon tree established beneath dead tree here.

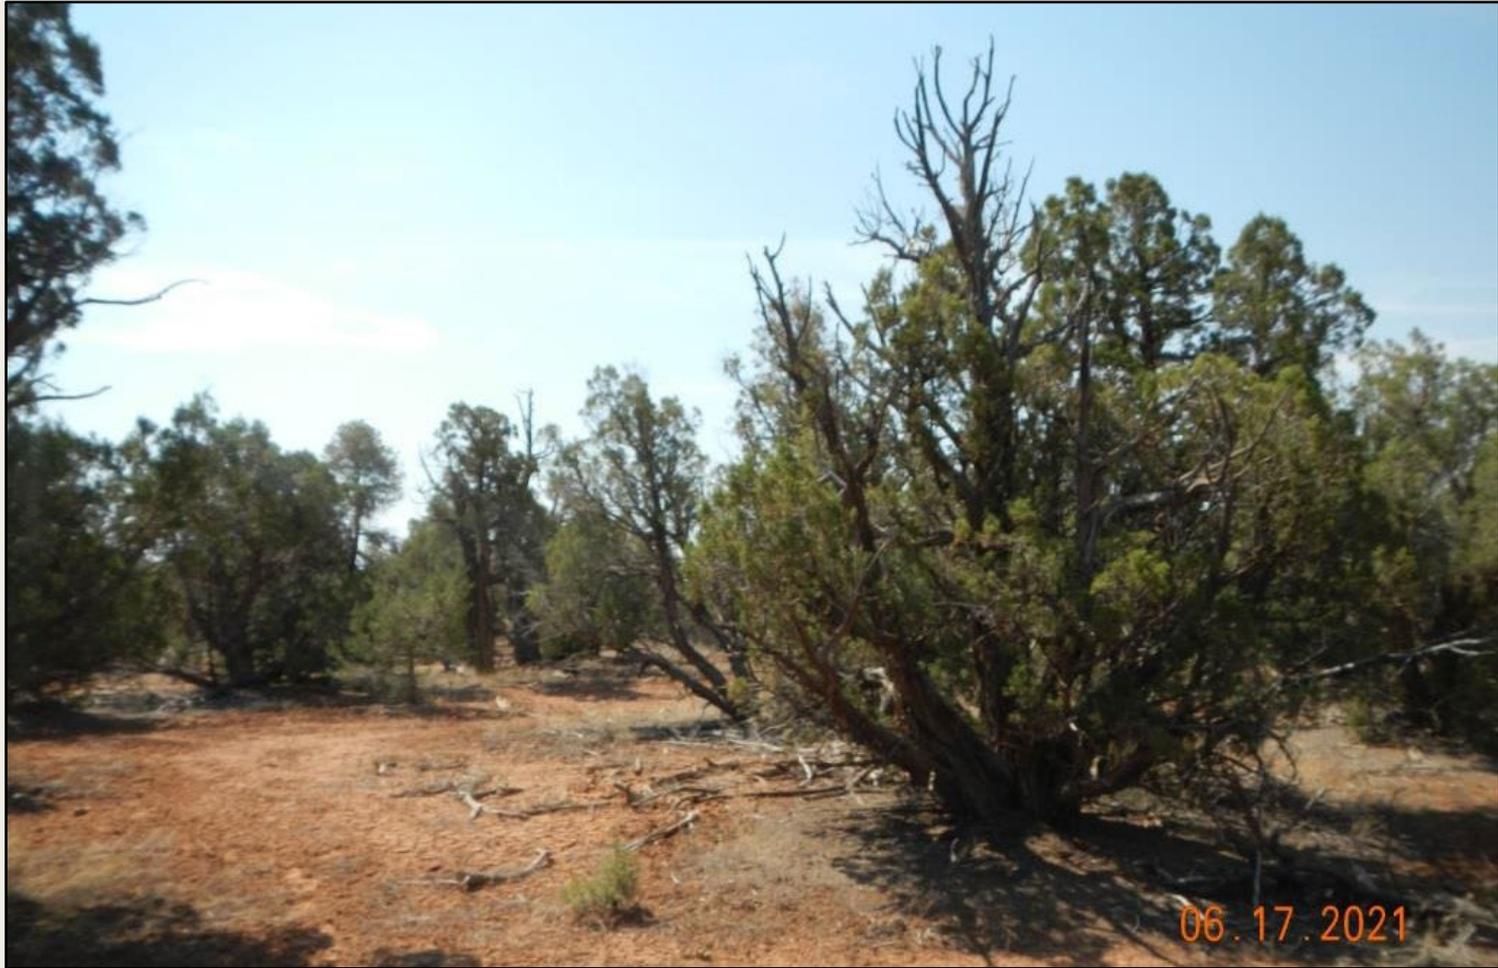
Photo 7. View of reference area comprised of pinyon and juniper woodland mixed with prickly pear, snakeweed, and squirreltail.
