Inspection Photos
Operator: Catamount
API: 067-09024
Date: 5/19/2021

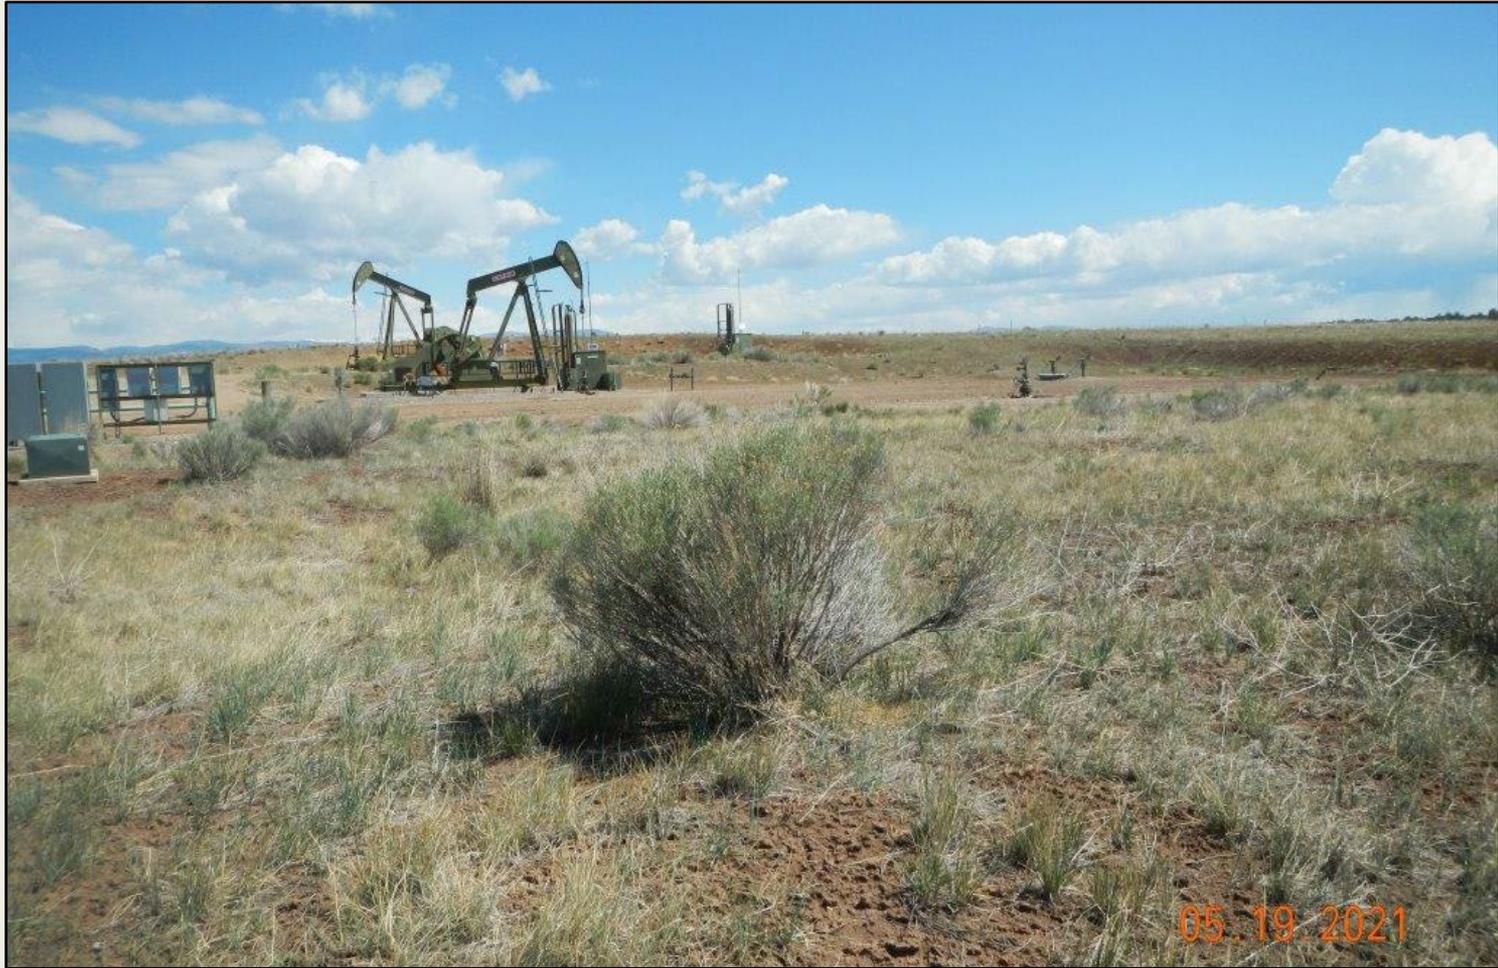
Photo 1. View of project area from well pad southwestern corner facing center.

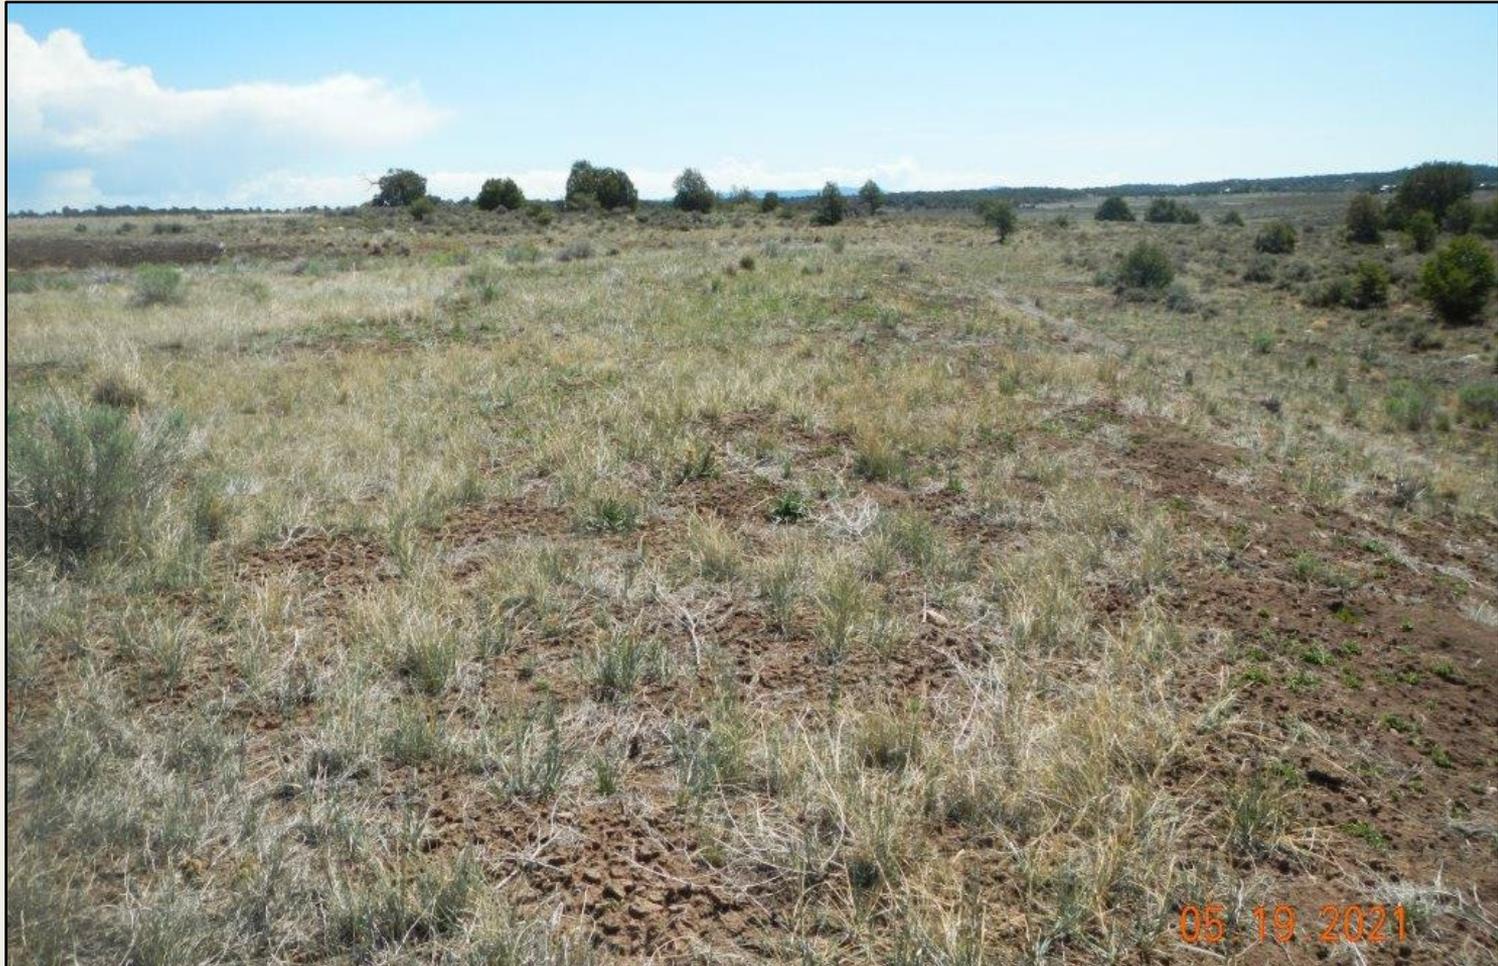
Photo 2. View of the southern project area from the southwestern corner facing eastward. Revegetation is progressing with grasses such as wetern wheatgrass, sand dropseed, and intermediate wheatgrass.

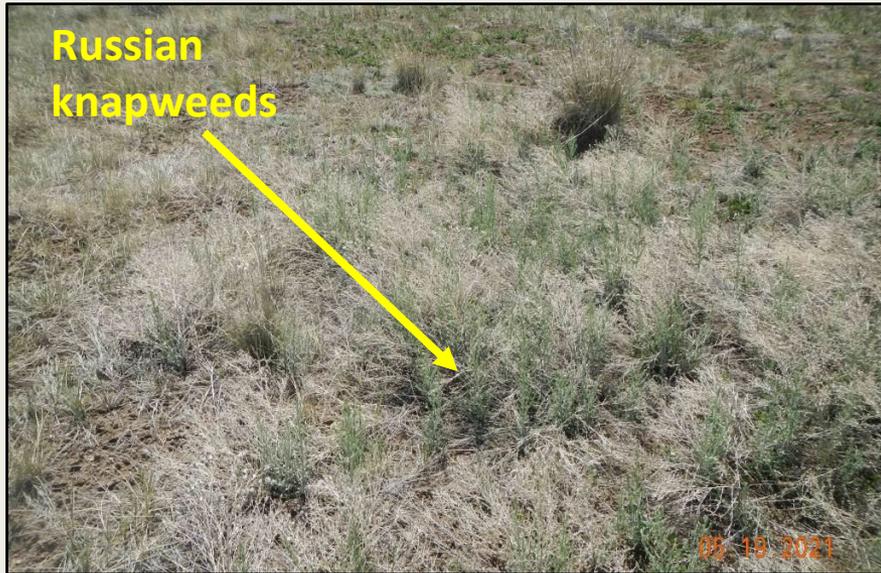
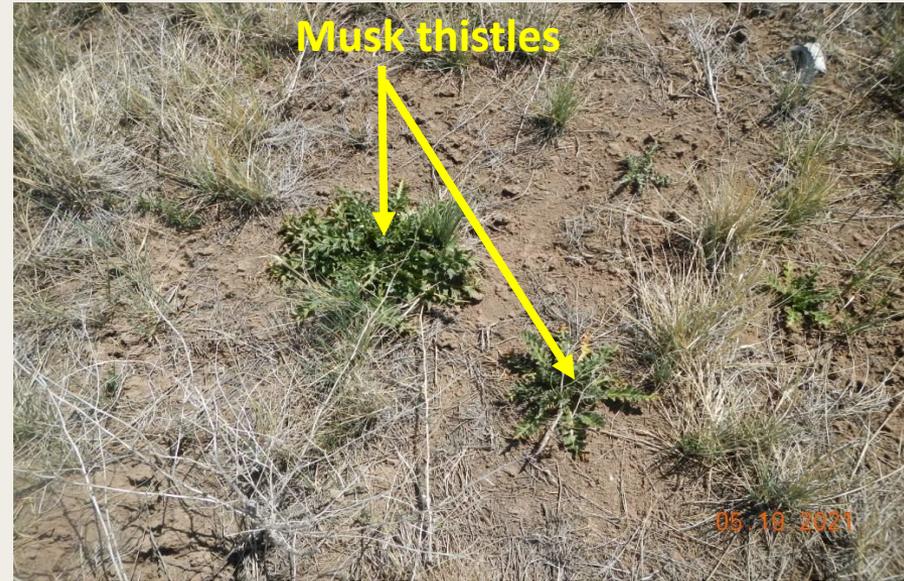
Photos 3/4. View of musk thistles (approx 25 untreated; right photo) and 200 Russian knapweeds (left photo) observed within the project area.

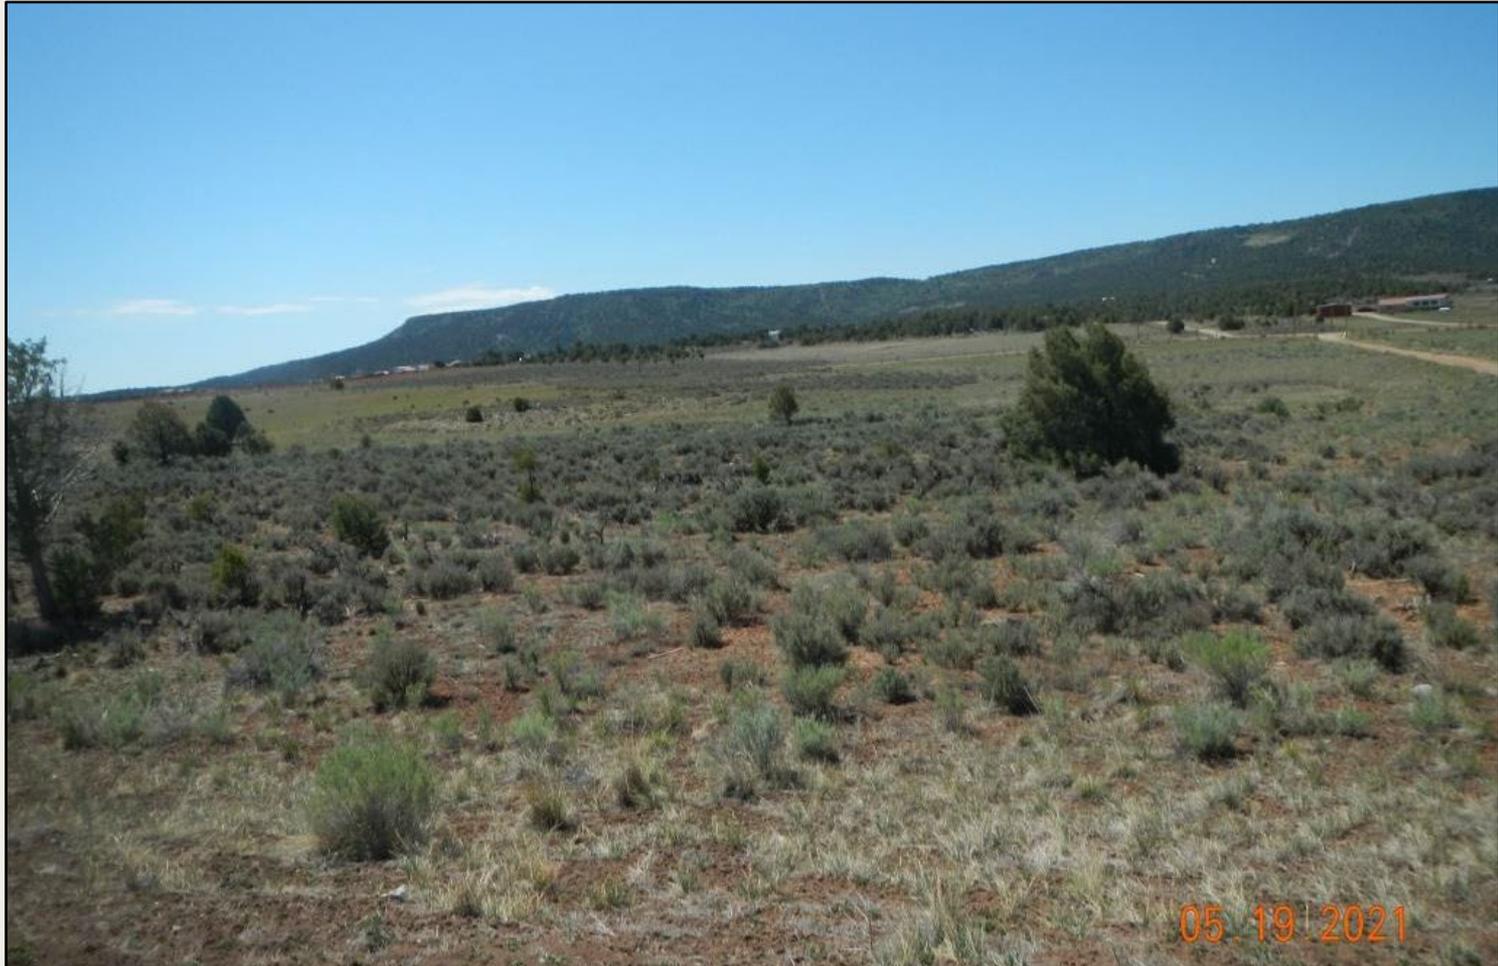
Photo 5. View of reference area comprised of sagebrush shrubland with understory of grasses and forbs such as western wheatgrass, squirreltail, and mat penstemon.
