Inspection Photos
Location Name: Champlin 485 Amoco #1
Location ID: 320071

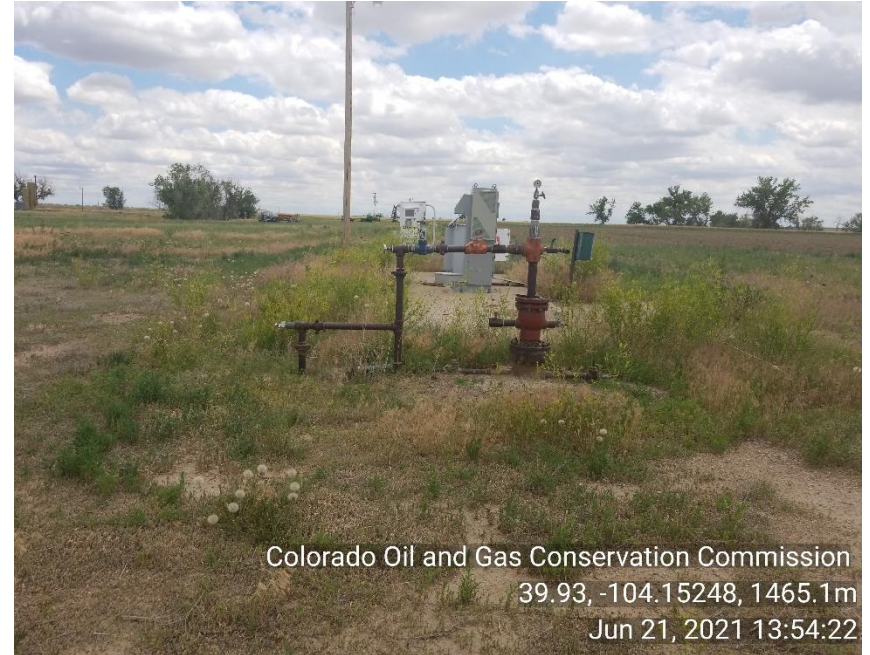
Photo 2 WH no sign

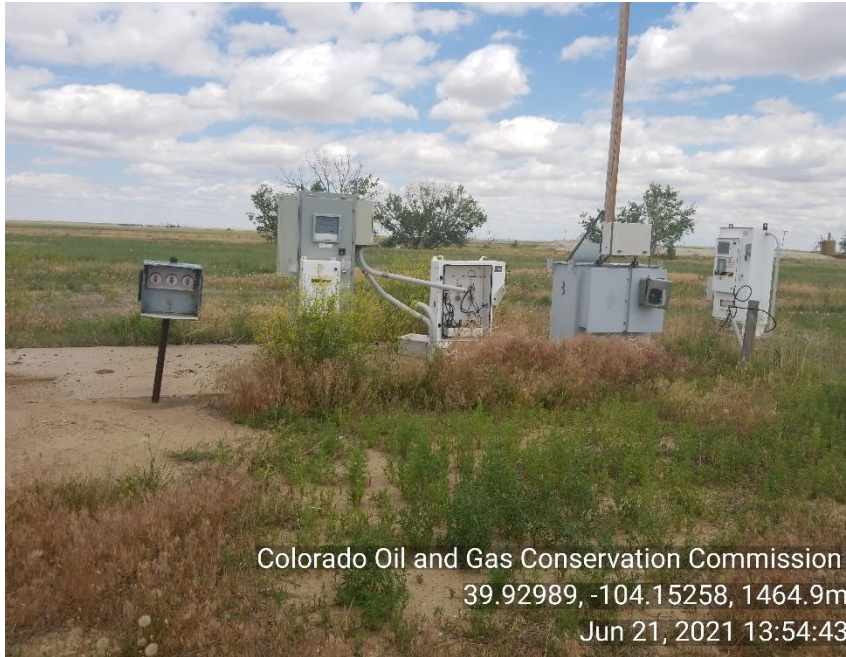
**Photo 3 Electric equipment in disrepair not able to operate.
Weeds on well site**

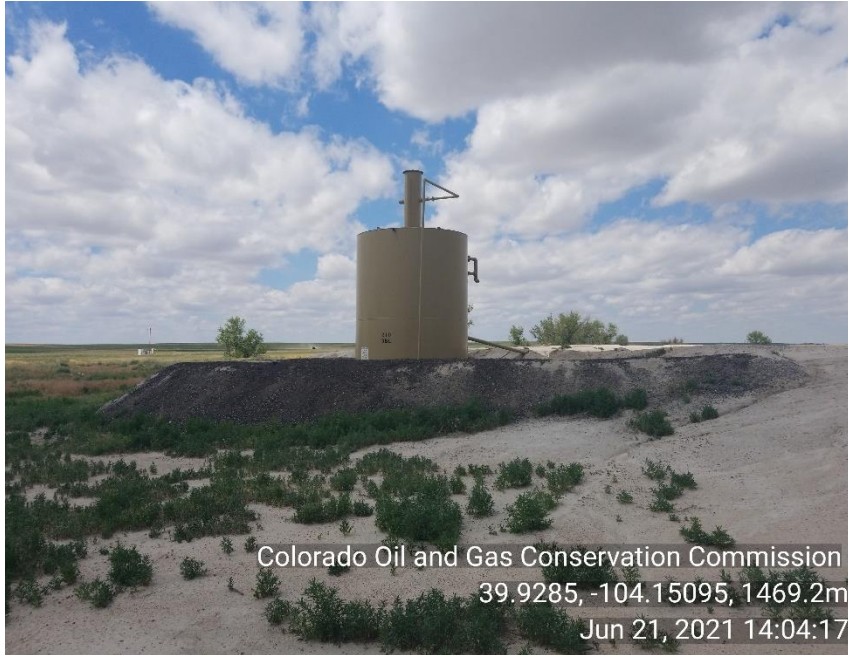
Photo 5 Produced water tank.

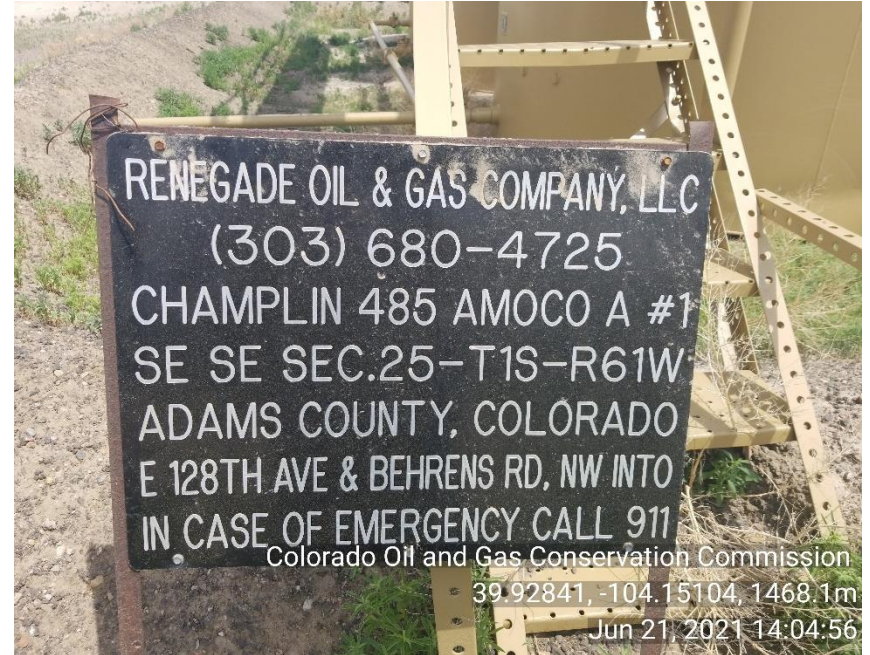
Photo 6 tank battery sign.

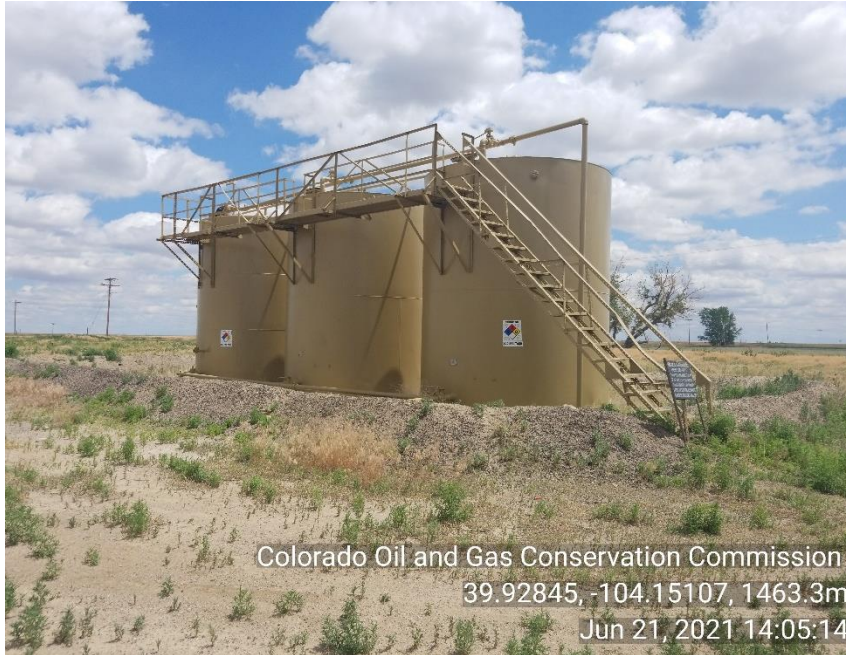
Photo 7 Crude oil tanks

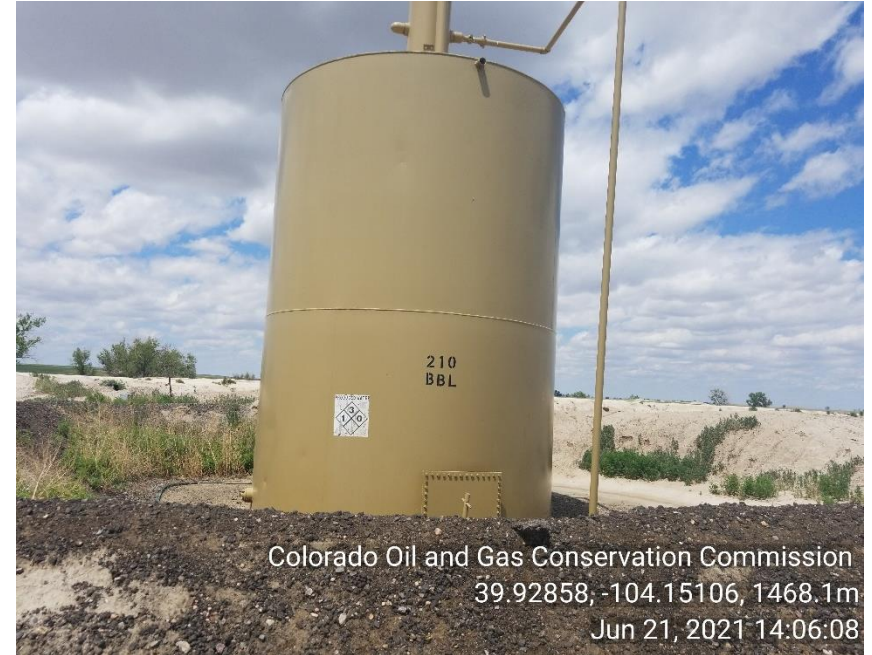
Photo 8 Produced water tank NFPA placard faded need to be replaced.

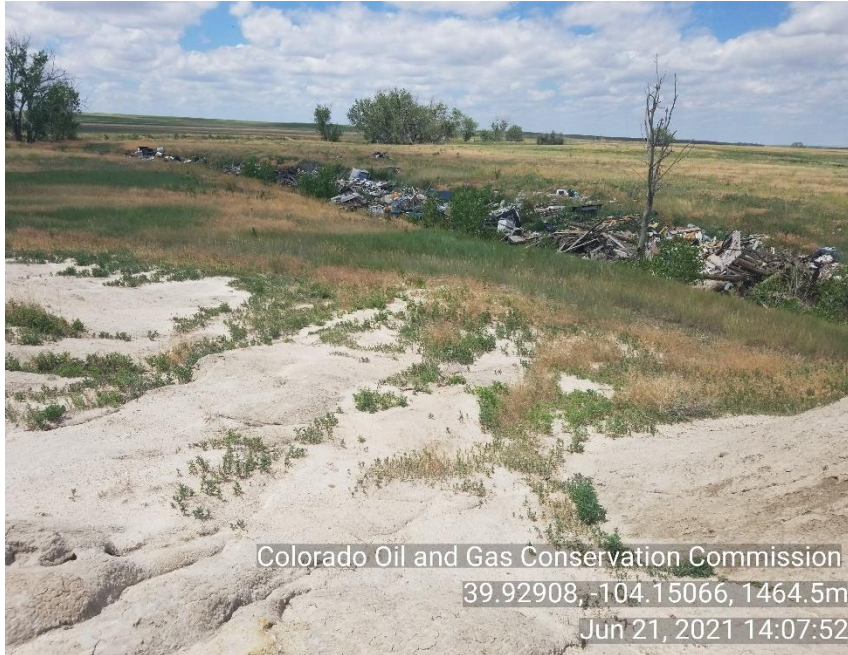
Photo 11 no BMP in place to prevent pit berm sediment from leaving location.

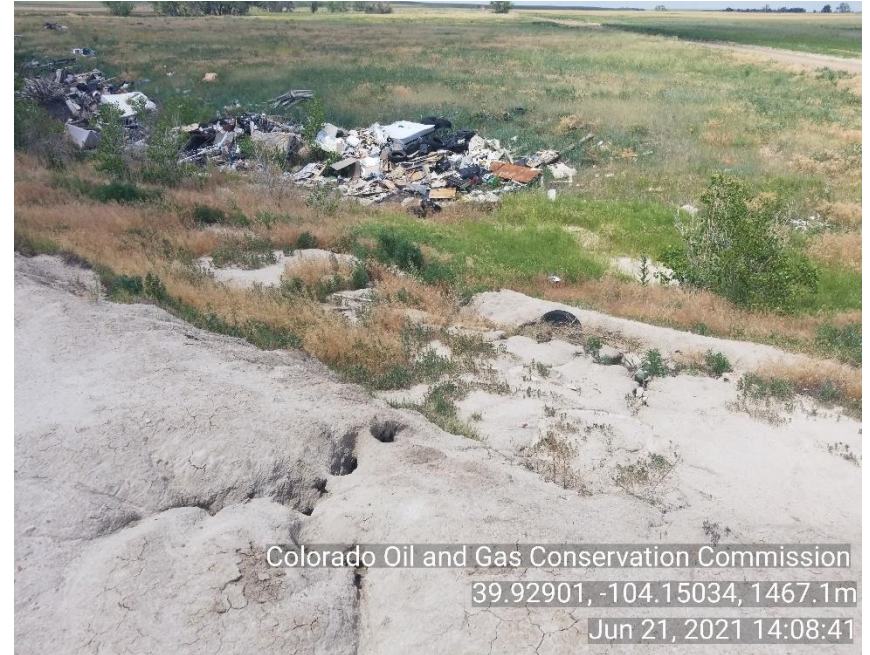
Photo 12 pit berm sediment running into drainage.

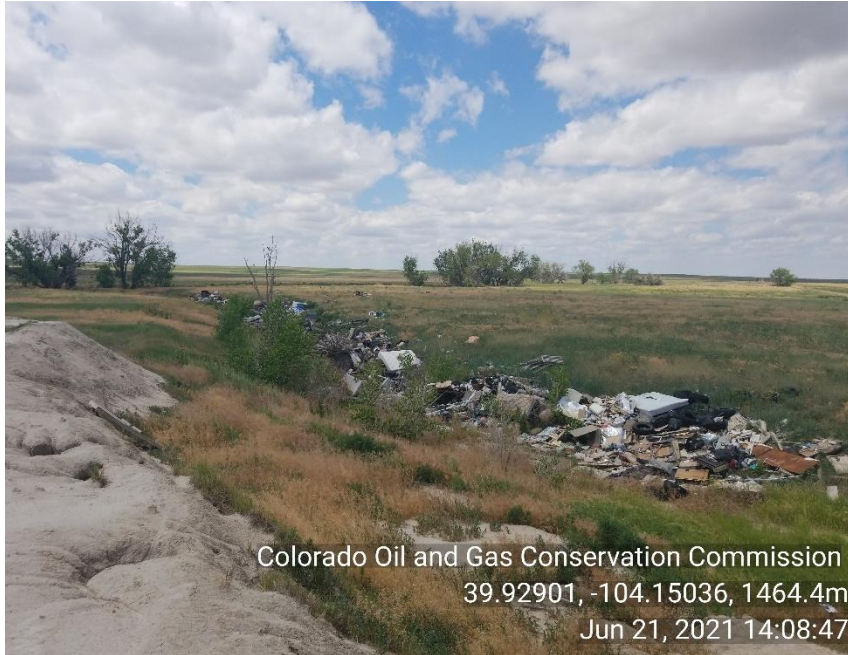
Photo 13 photo of ditch on back side of facility. It appears to a dump site.

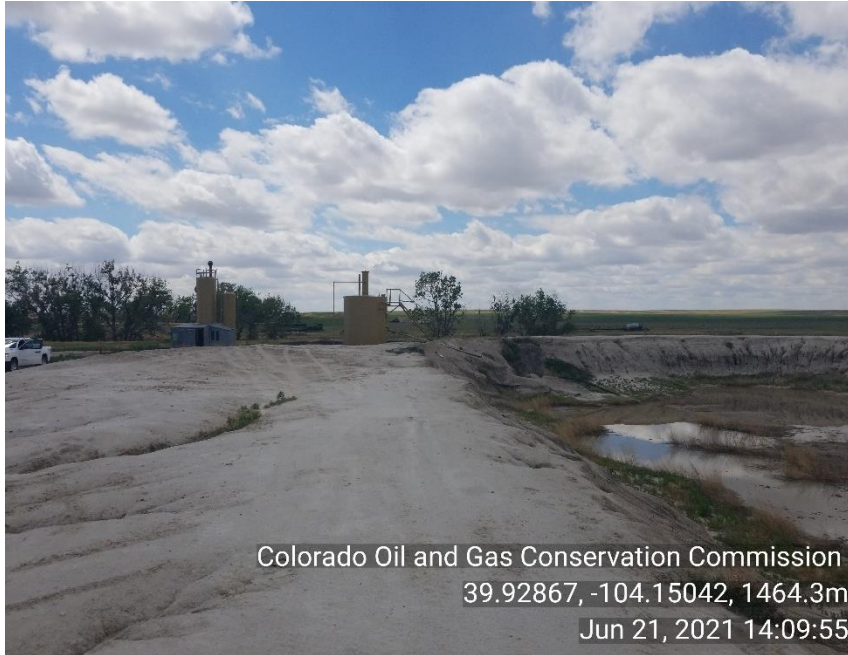
Photo 15 Large reels on pit berm.

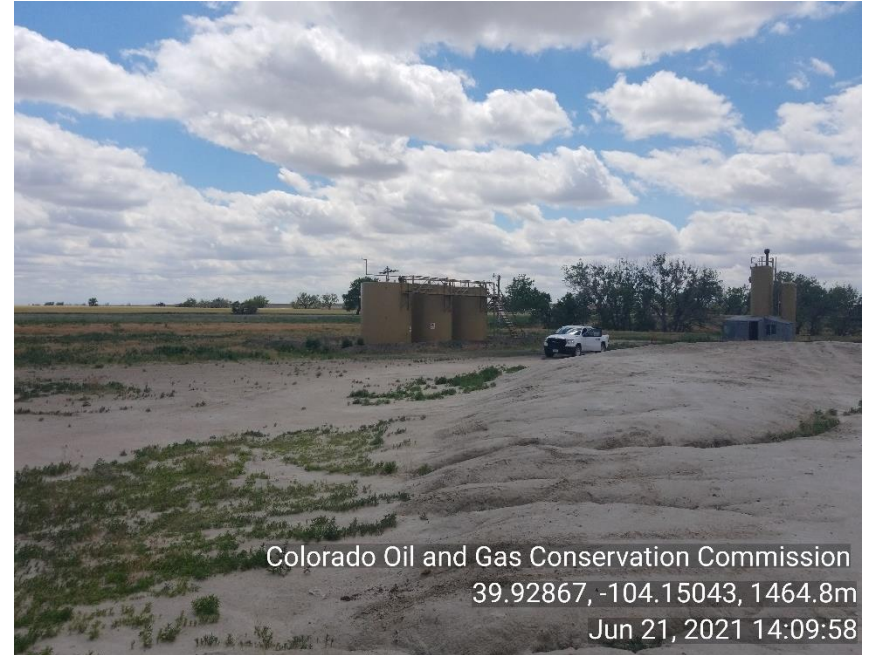
Photo 16 large reels on pit berm.

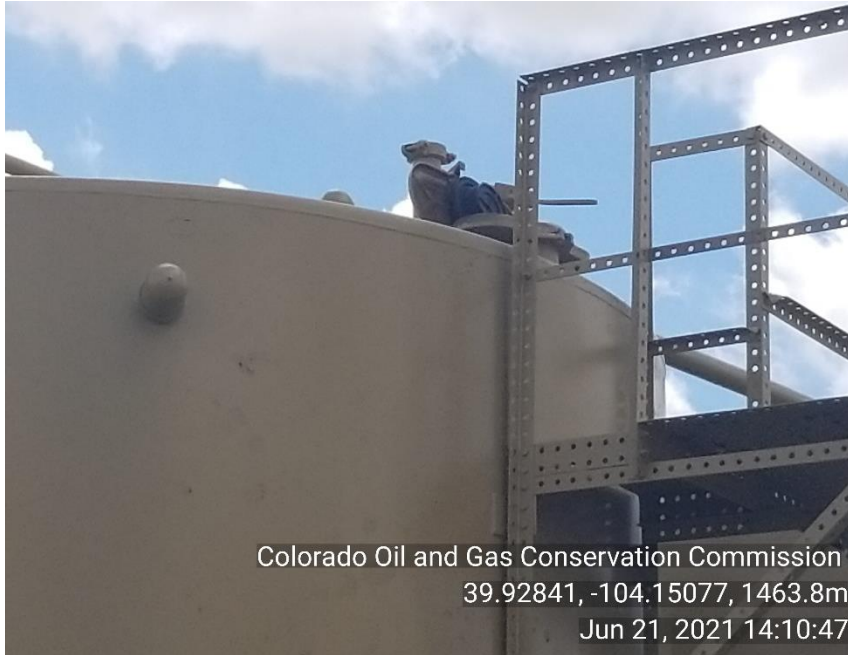
Photo 17 gauge hatch open on crude oil tank.
