# Inspection Photos

6/21/2021

Operator: UTAH GAS OP LTD DBA UTAH GAS  
CORP - 10539

Location ID: 323915  
Garfield County, CO

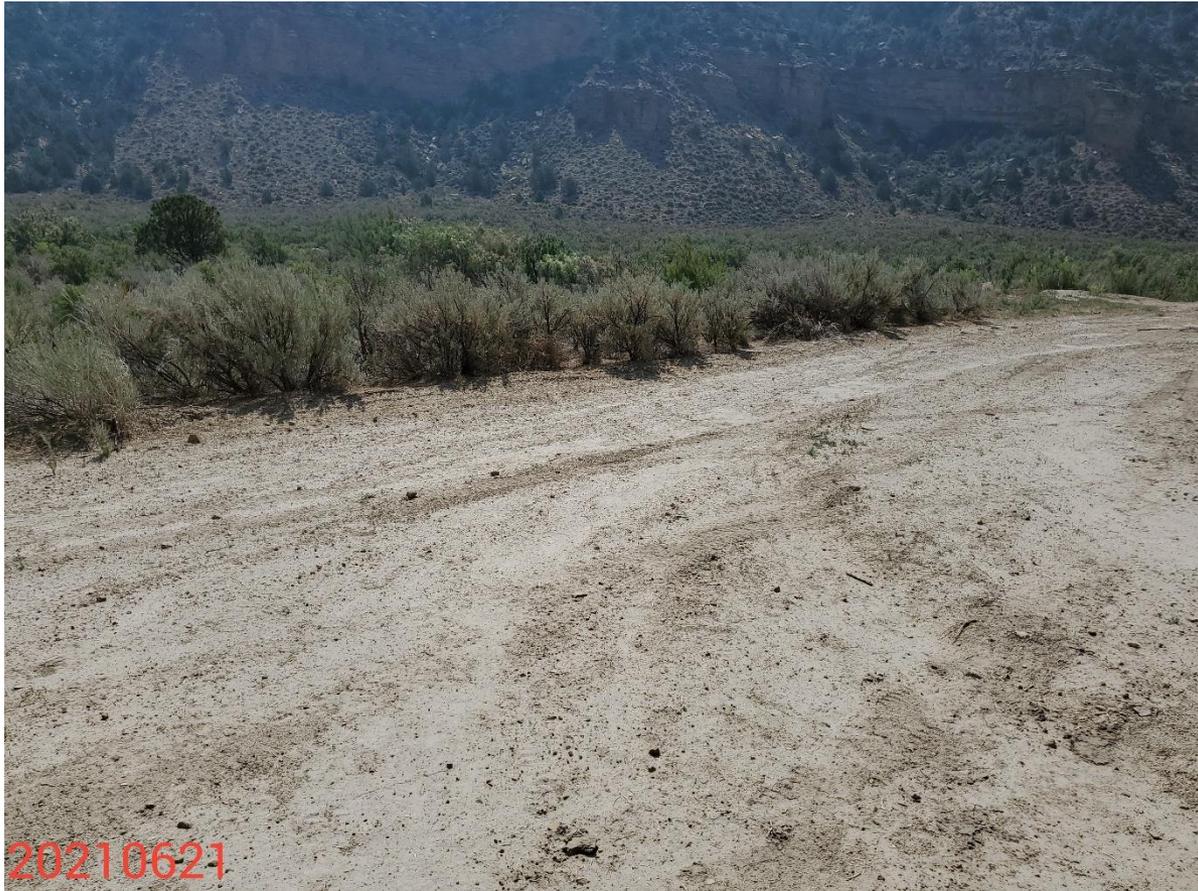
**Photo 1:** Photo taken from the north end of the Location, facing east. Photos 1-4 provide an overview of the Location from east, southeast, southwest to west.

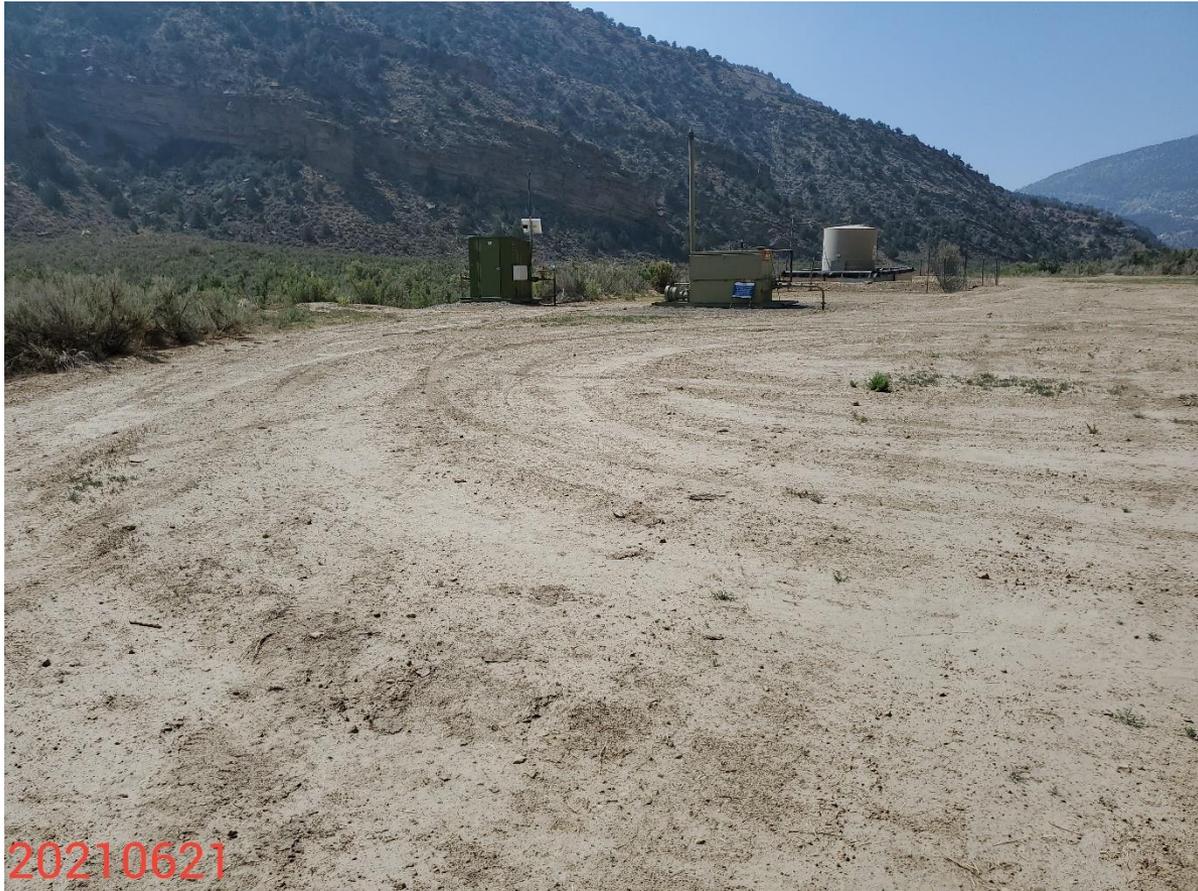
**Photo 2:** See comments under photo 1.

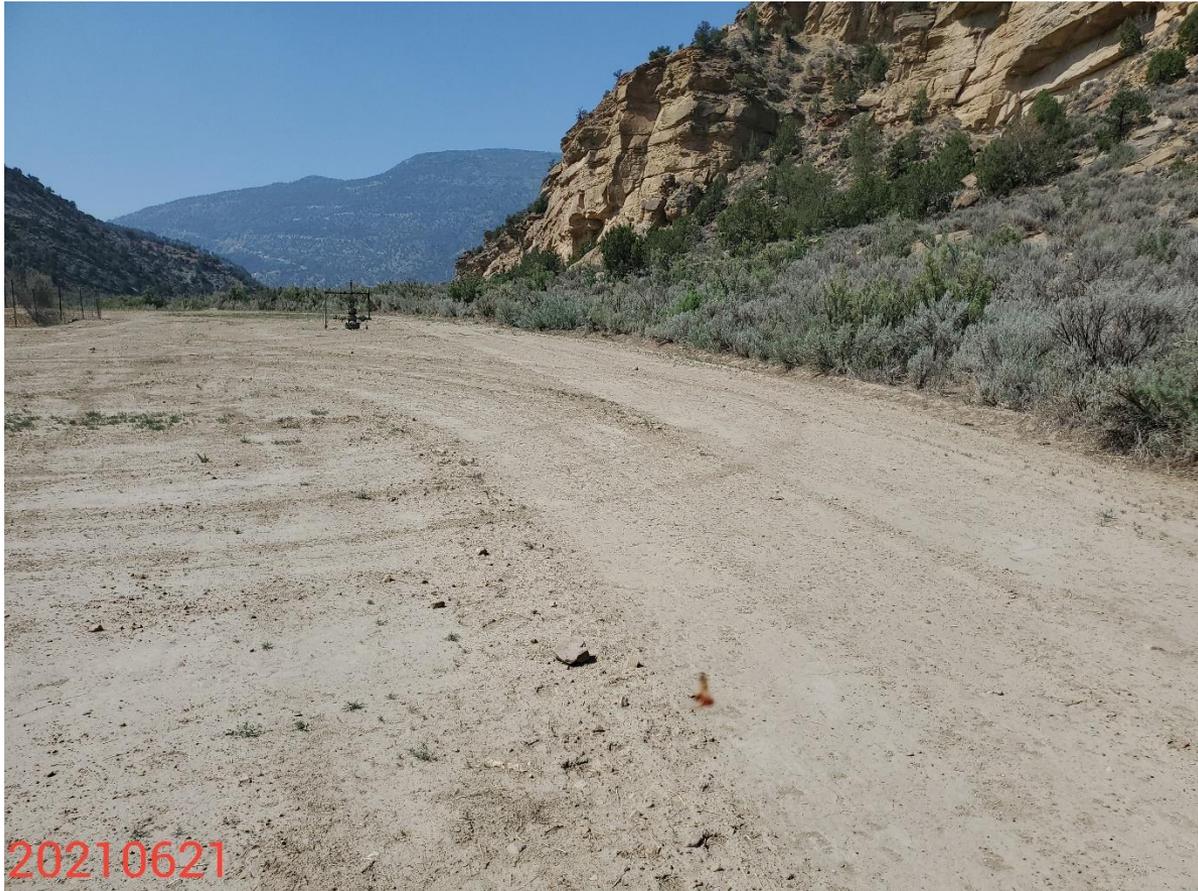
**Photo 3:** See comments under photo 1.

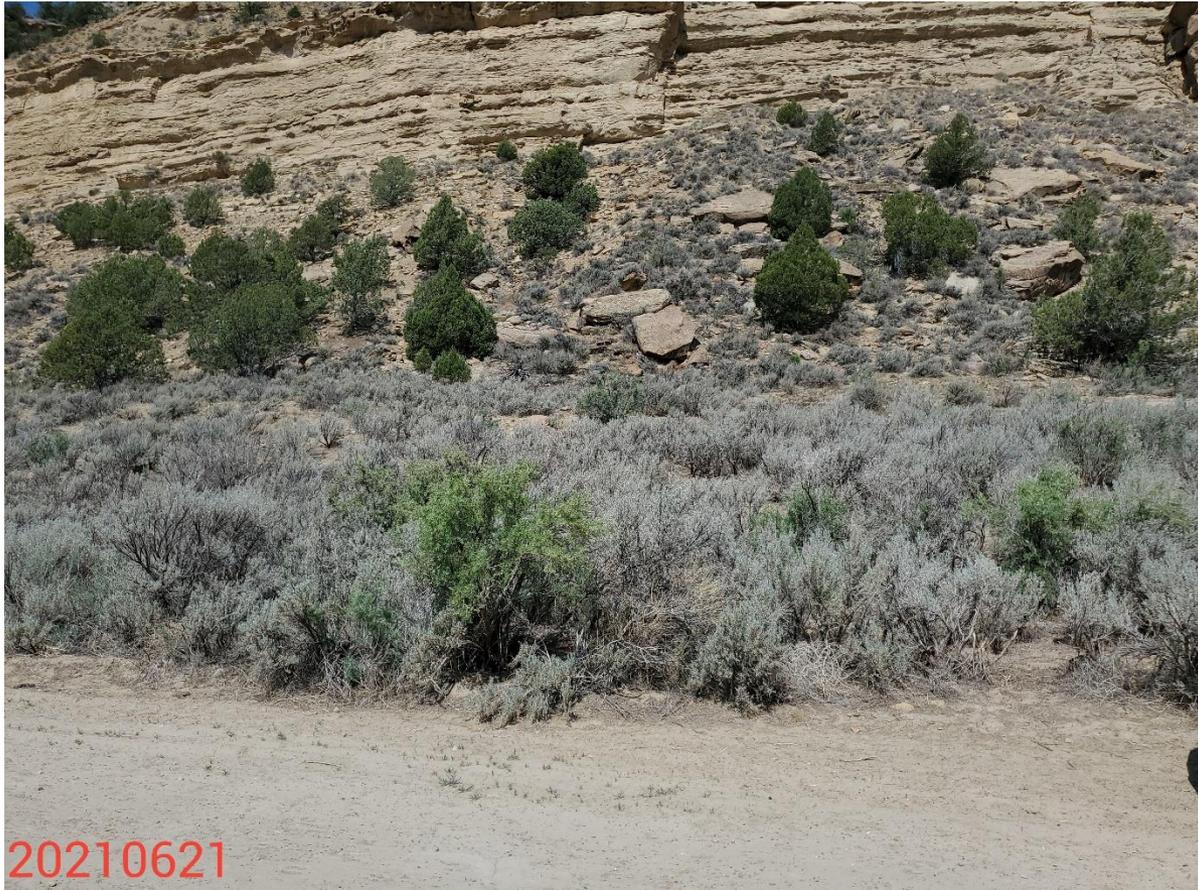
**Photo 4:** See comments under photo 1.

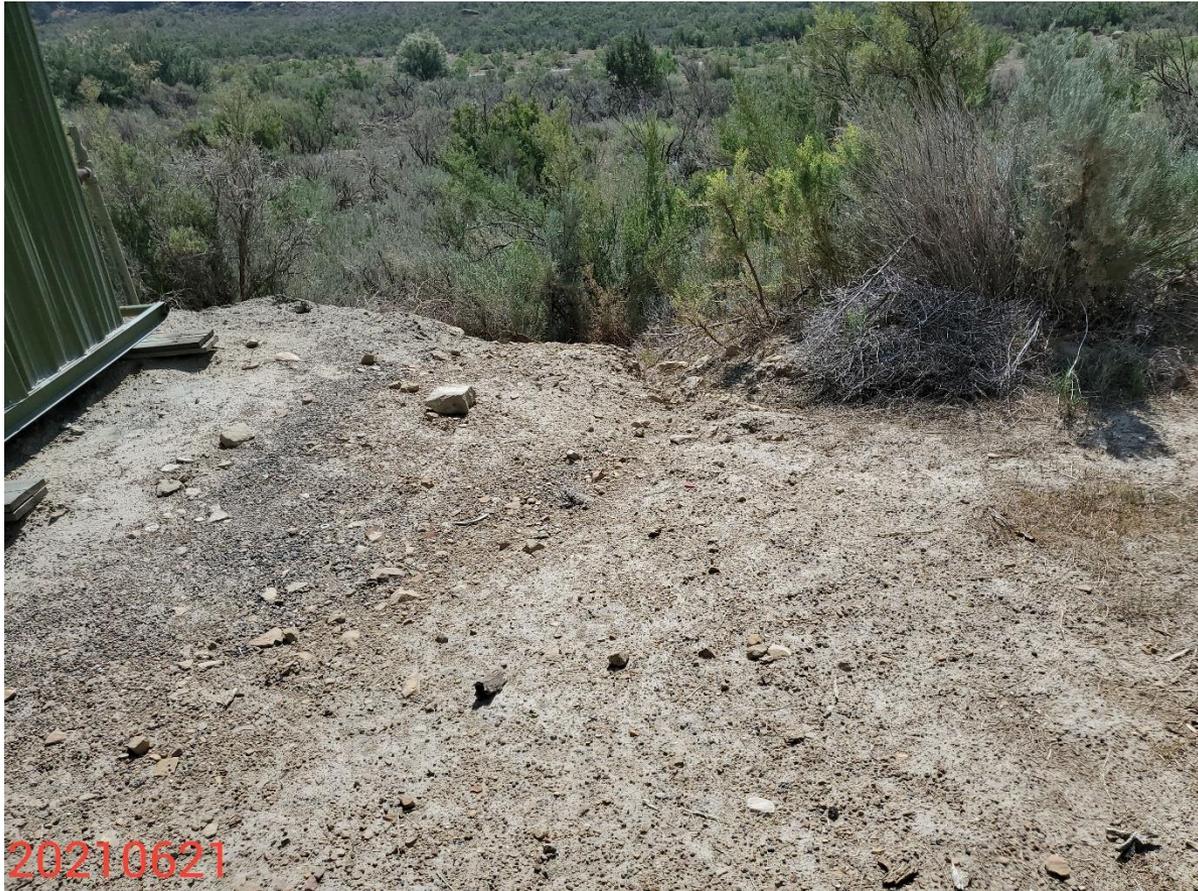
**Photo 5:** Photo taken from the east end of the Location, facing east. Photo shows areas where stormwater runoff concentrates and discharges from the pad.

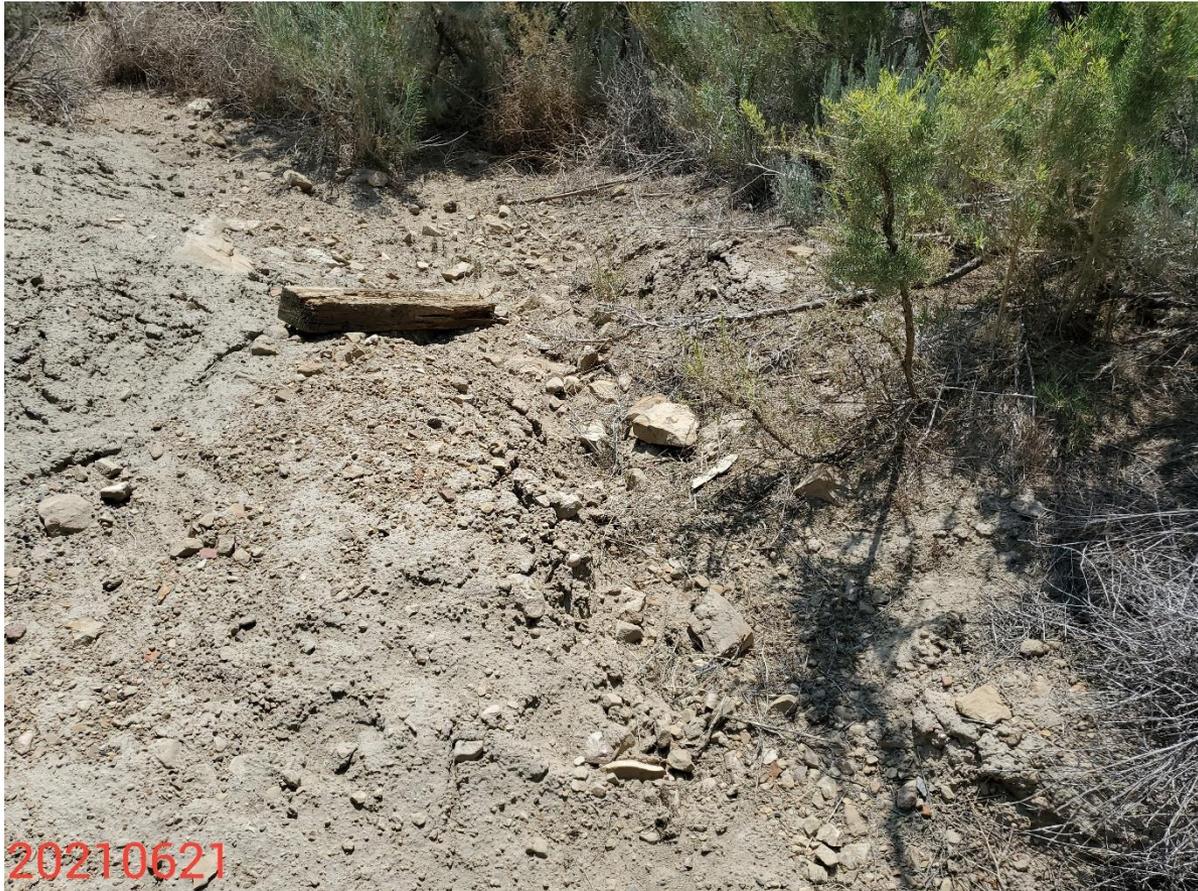
**Photo 6:** Continued from photo 5. Photo shows erosion degradation (gully formation) observed on the slopes of the Location. Stormwater and erosion control measures to protect/stabilize slope, and to allow for proper stormwater discharge are missing or insufficient.

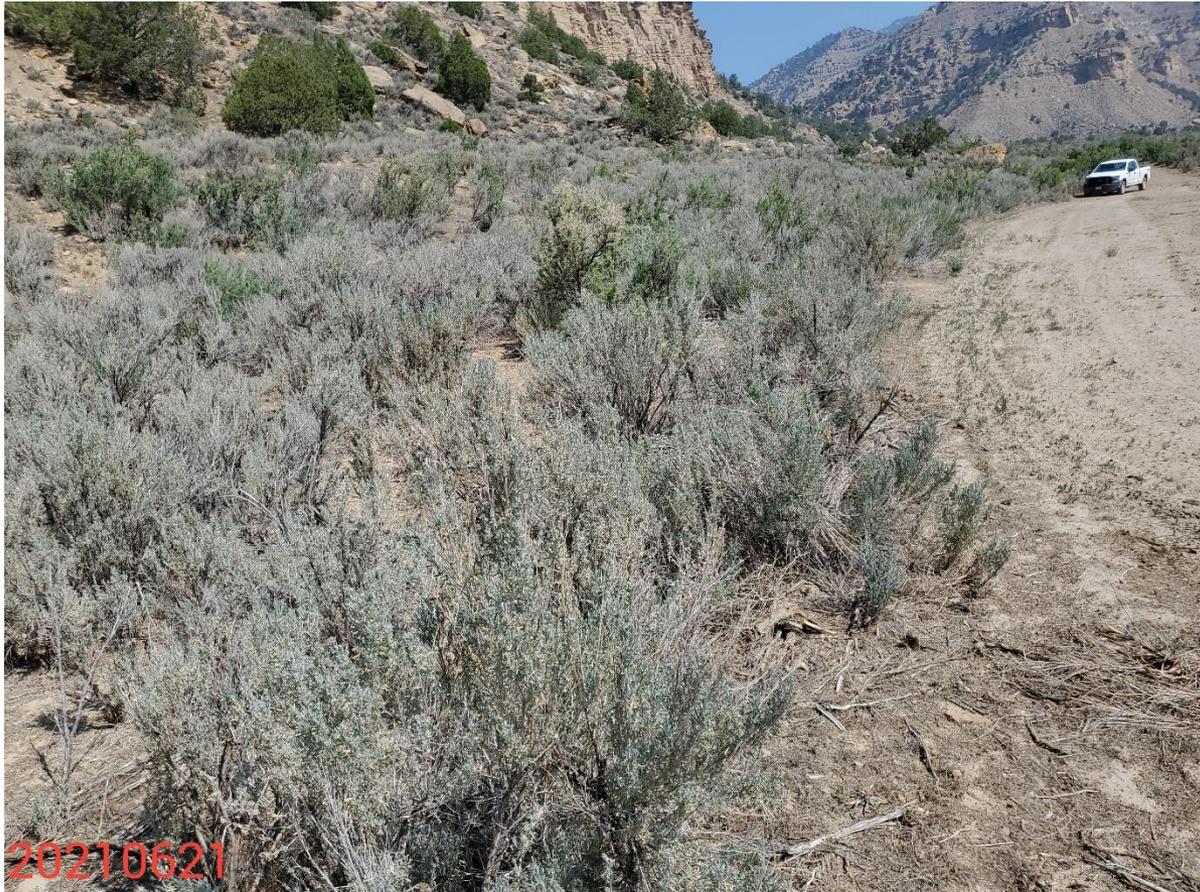
**Photo 7:** Photo taken from the west end of the Location, facing north. Photo shows example of uniform vegetative establishment observed on the interim areas.
