Caerus Piceance LLC
ELU #8905C-24
Location # 316505

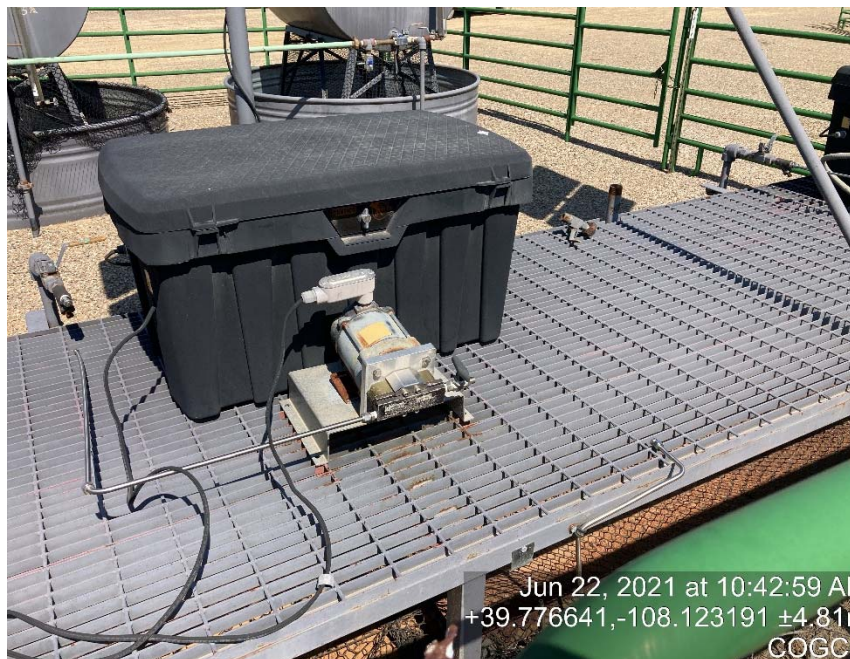
Unused equipment

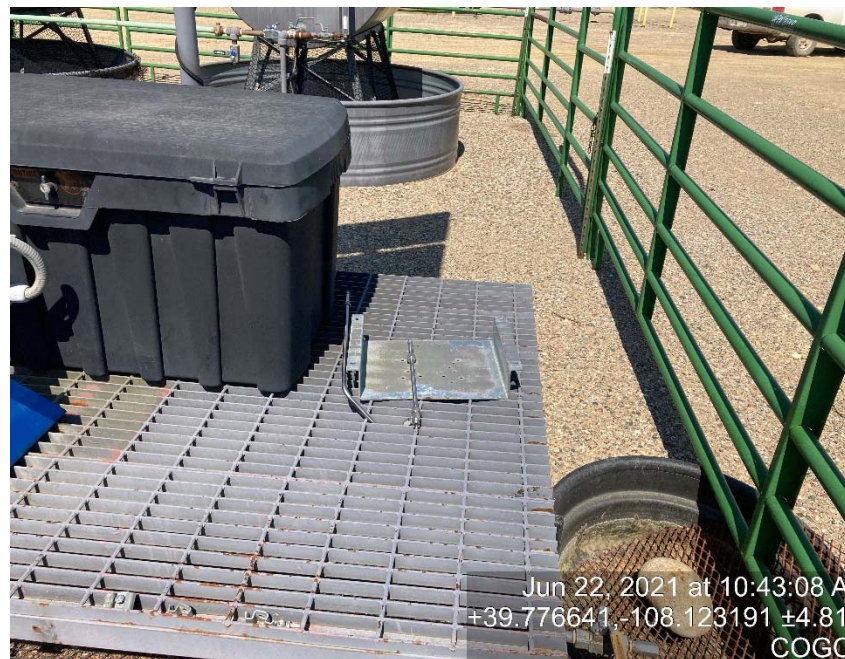
Debris

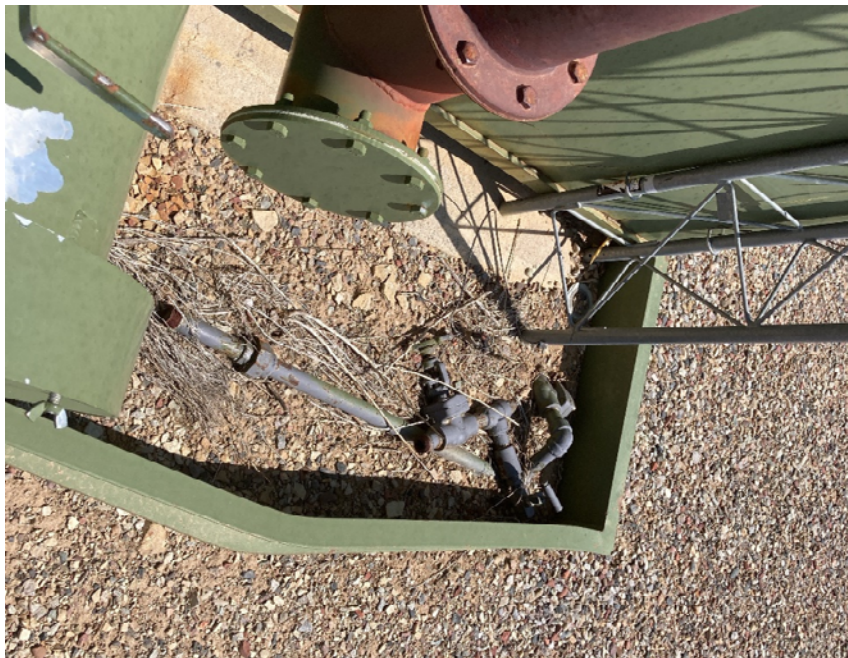
Debris

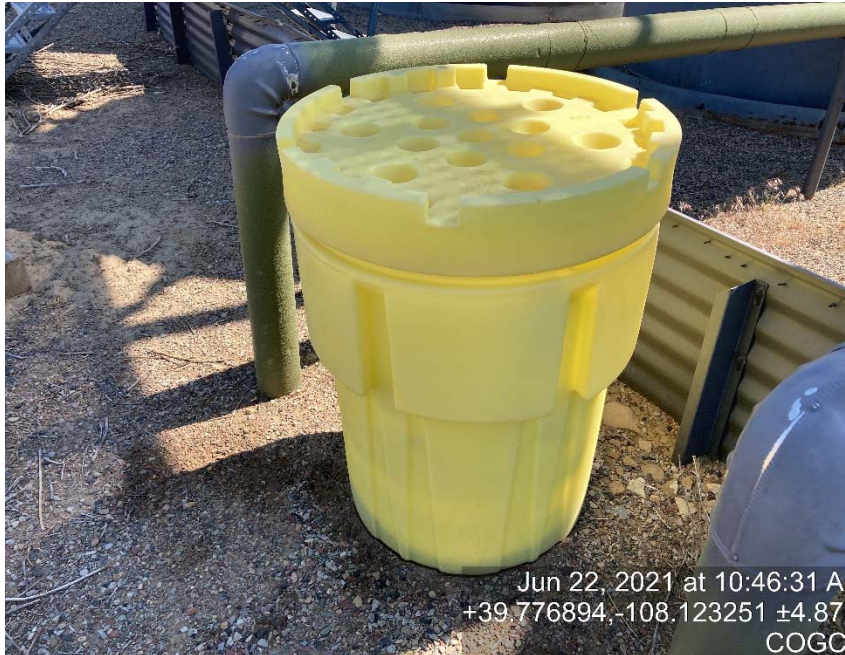
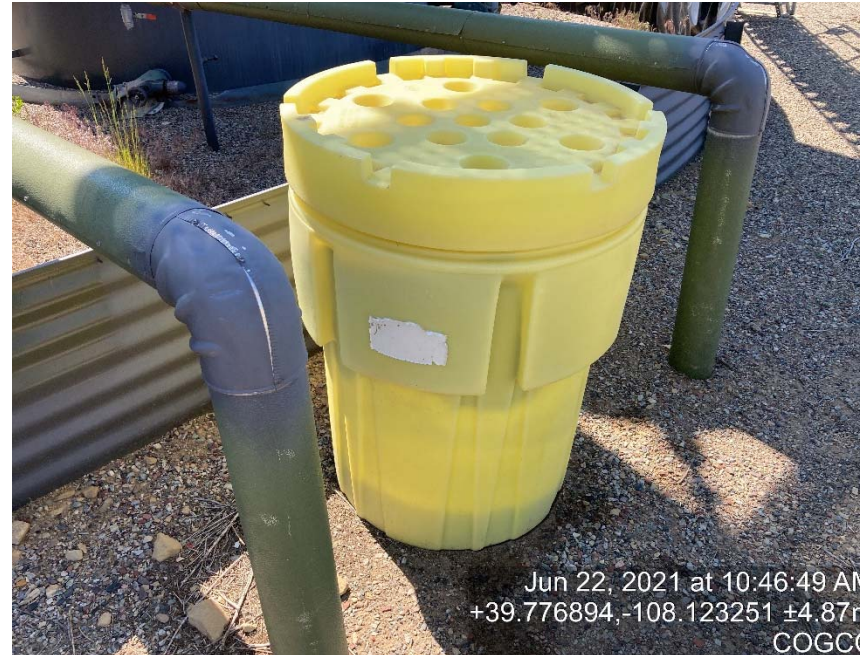
Container (full of fluid) in front of tank battery has No labeling nor is it in a containment.

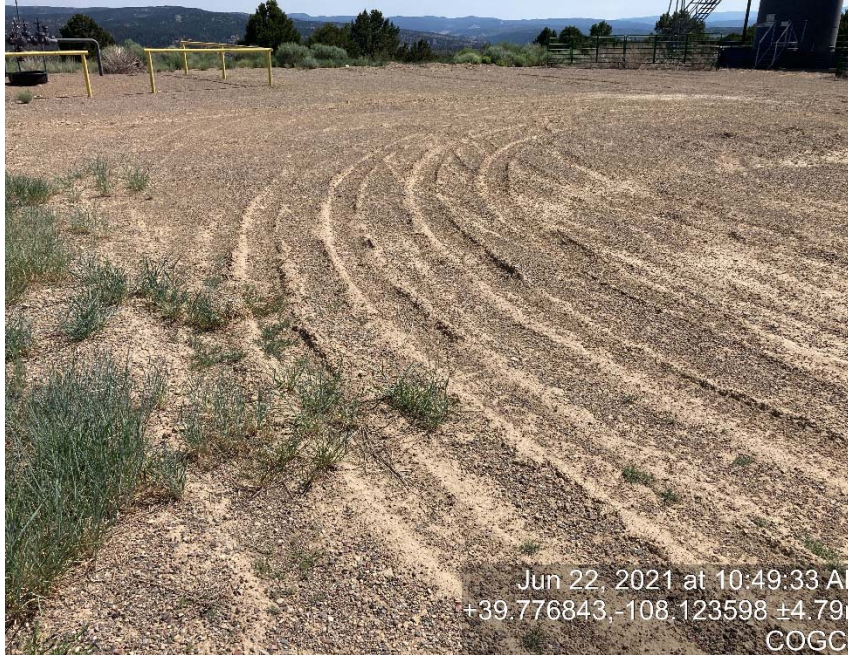
Lack of stabilization/compaction

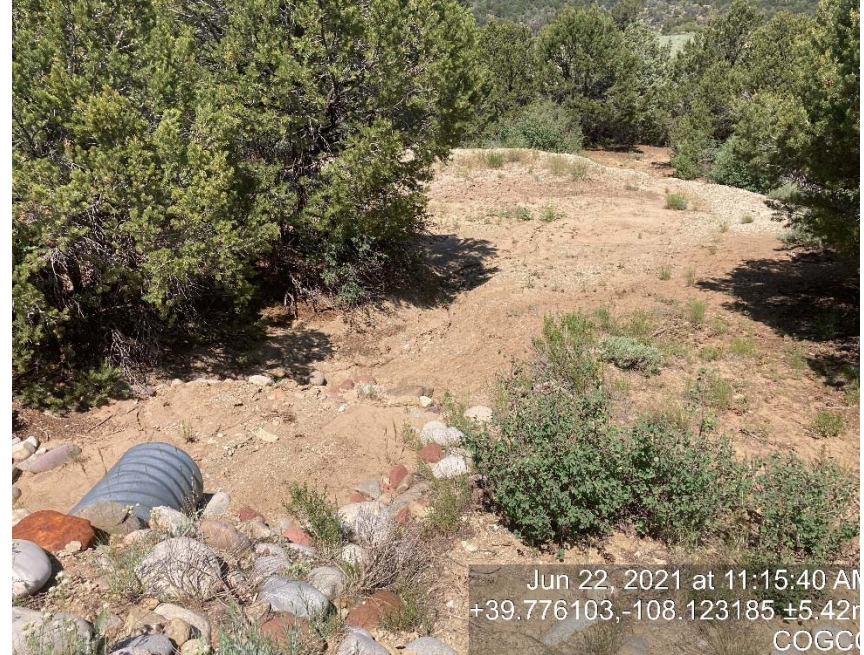
One of the sediment traps along access road

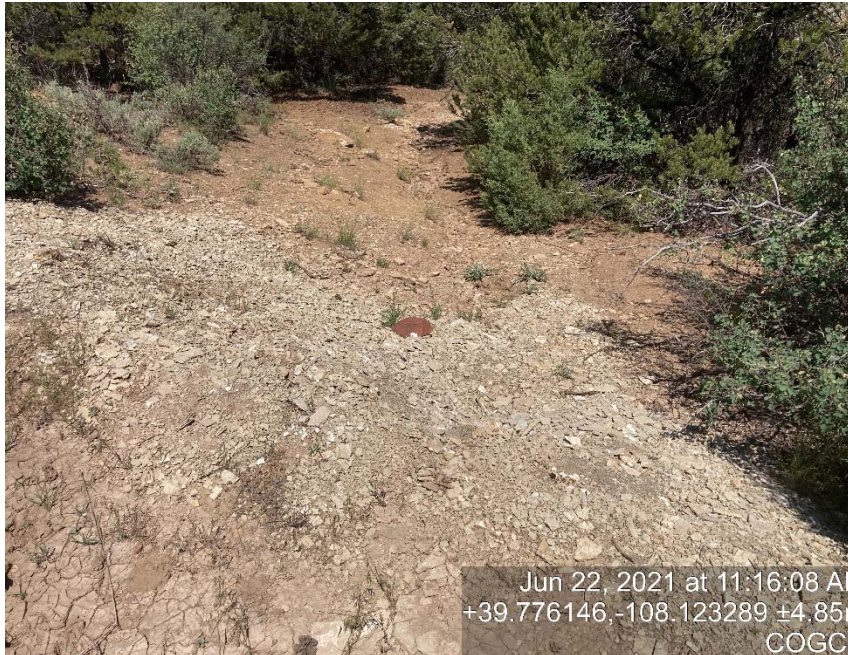
One of the sediment traps along access road

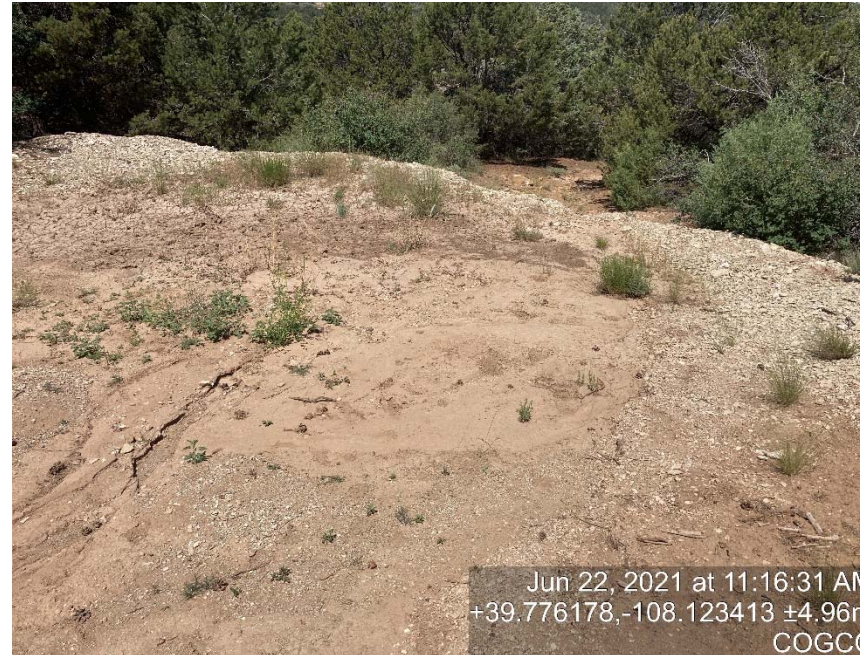
One of the sediment traps along access road

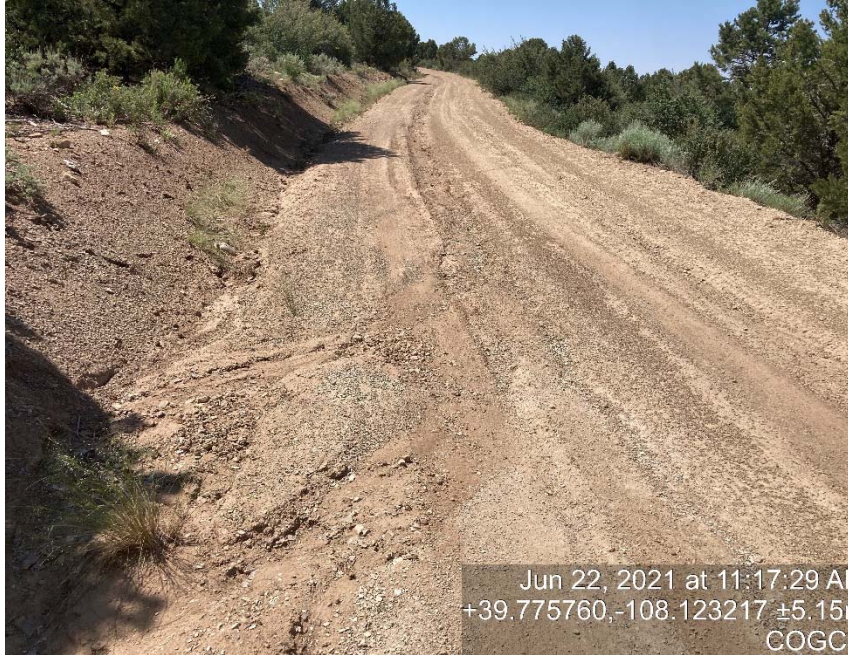
Lack of stabilization/compaction/erosion

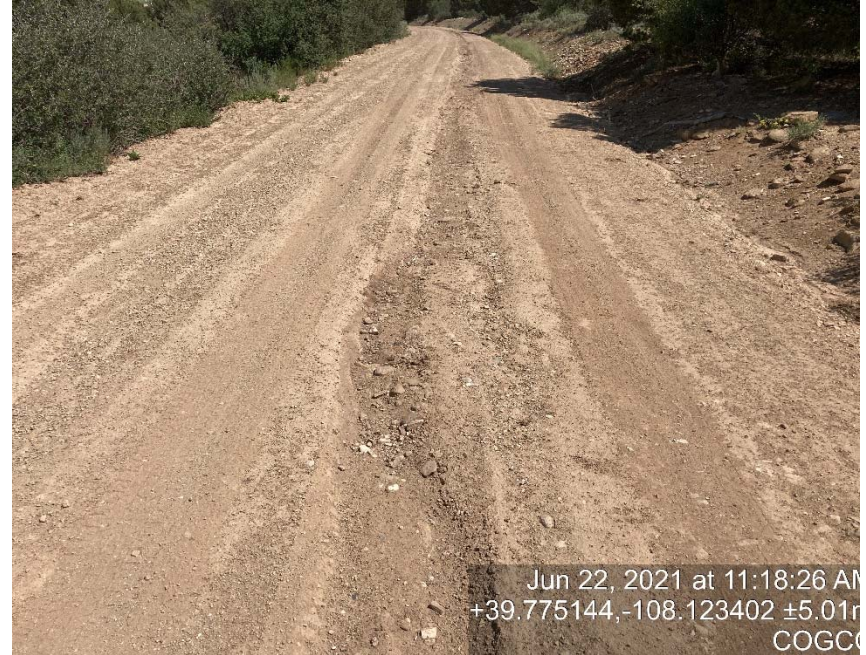
Lack of stabilization/compaction/erosion

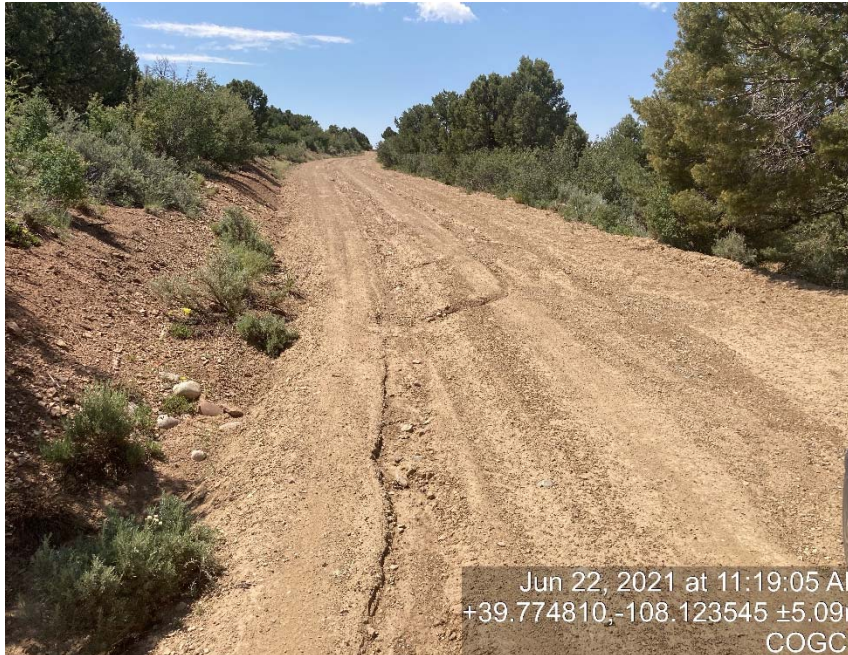
Lack of stabilization/compaction/erosion

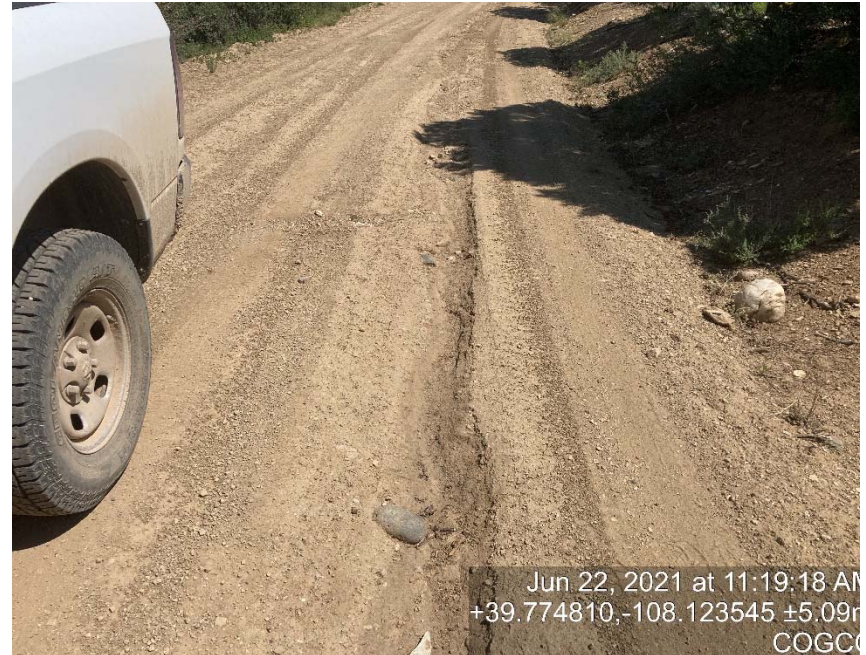
Lack of stabilization/compaction/erosion

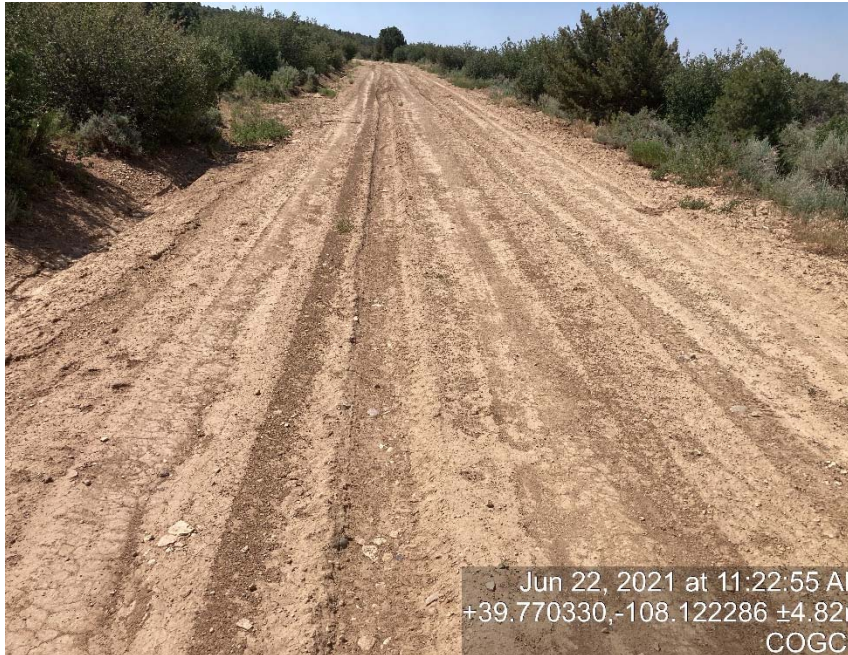
Lack of stabilization/compaction/erosion

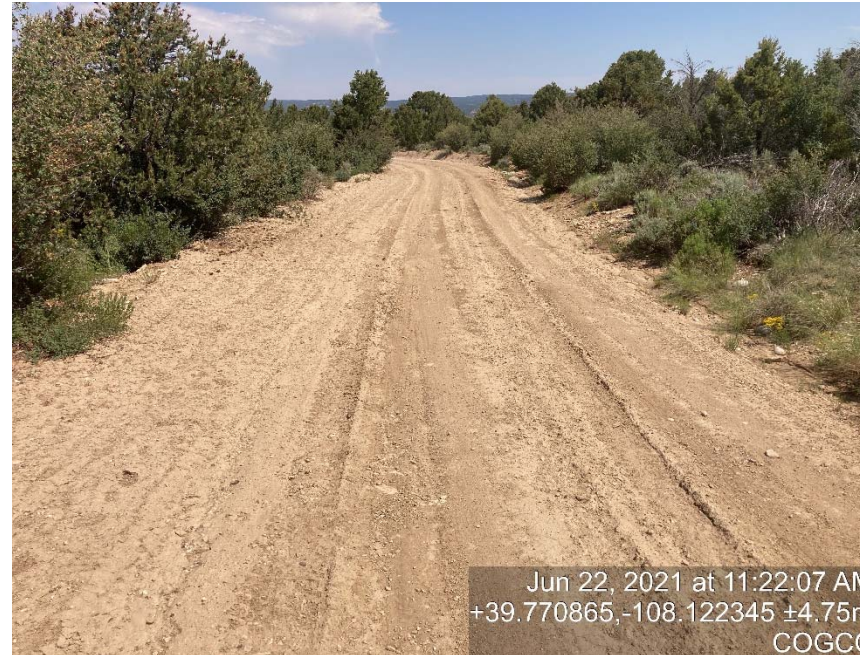
Lack of stabilization/compaction/erosion
