Inspection Photos

API: 009-06047

Operator: DOVER ATWOOD CORPORATION

Inspection Date: 6/21/2021

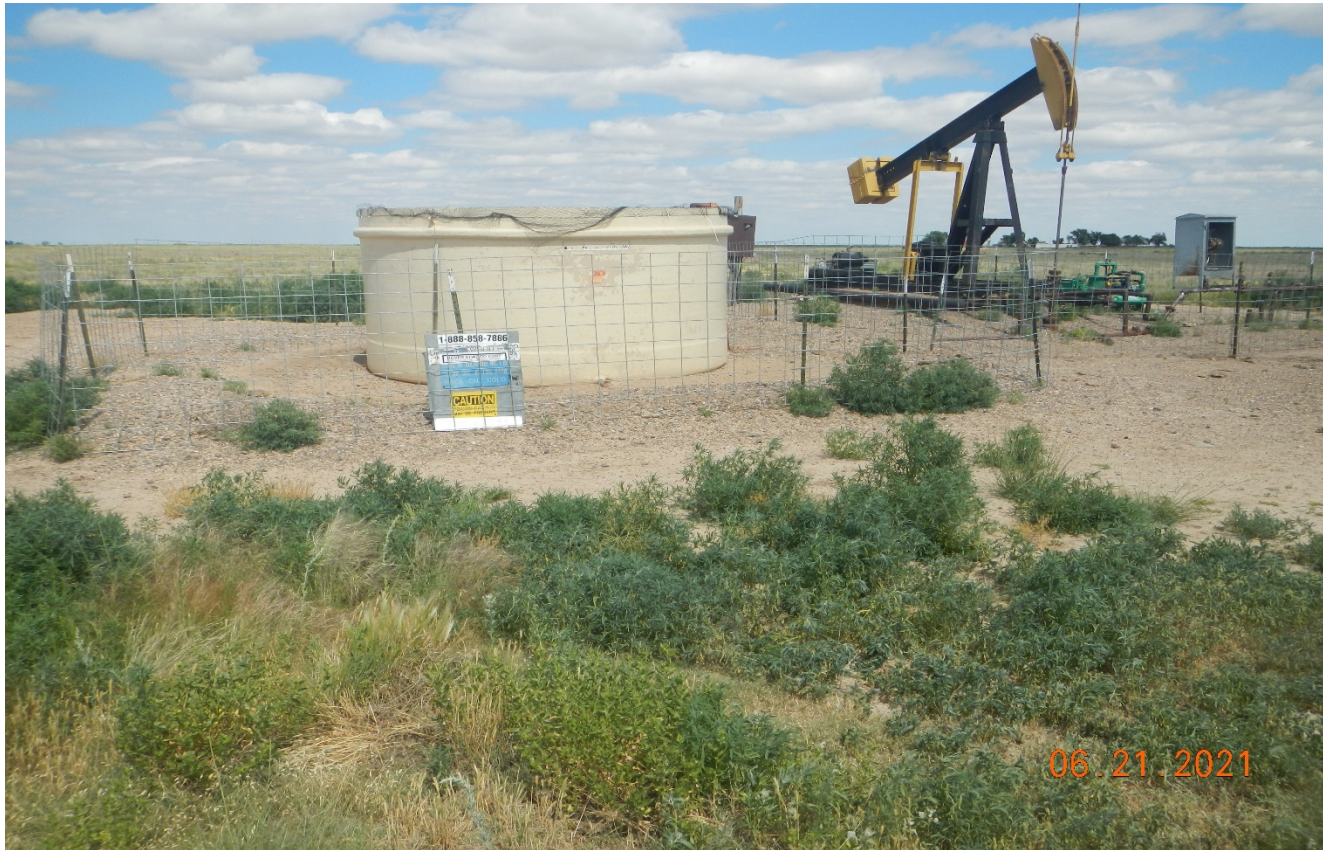
Photo 1. The well sign does not comply with 605. Incorrect Operator Emergency number and missing information. Name was updated. Missing tank NFPA labeling and INFO.

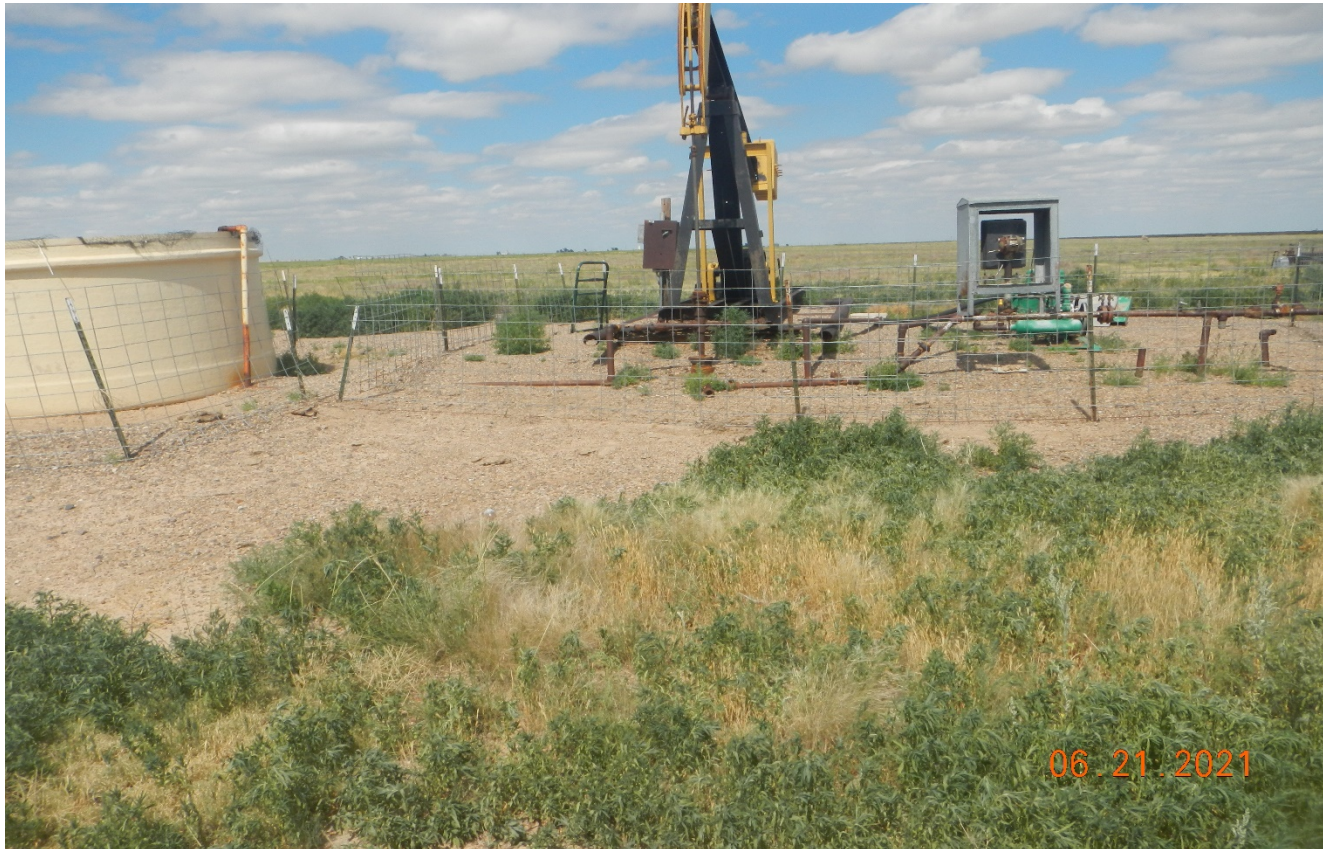
Photo 2. The fencing around the pump jack has been fixed.

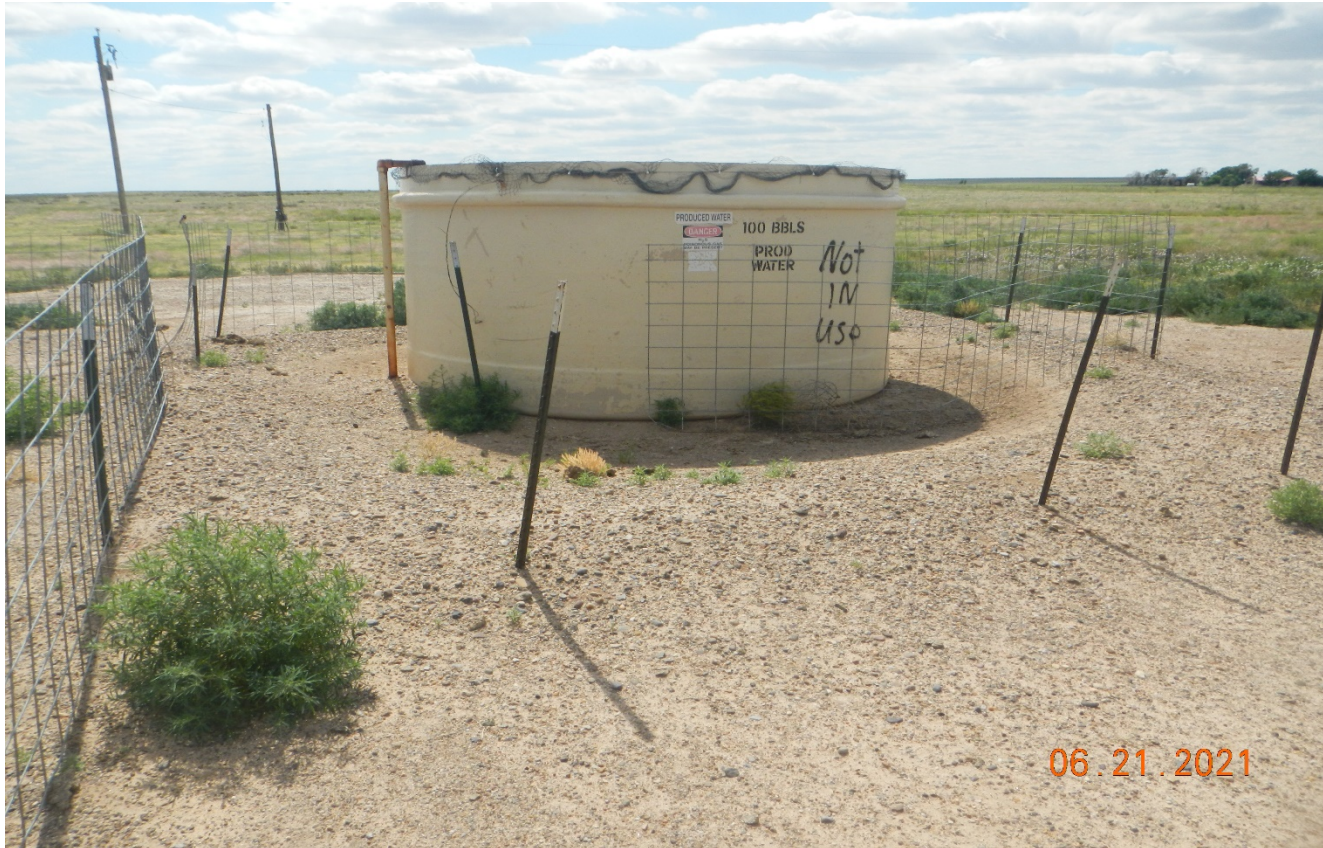
Photo 3. The tank is marked as not in use and labeled Produced Water. Next photo shows fluids inside the tank which apparently the tank is in use. Secondary containment is inadequate to contain 150% of the volume of the tank.

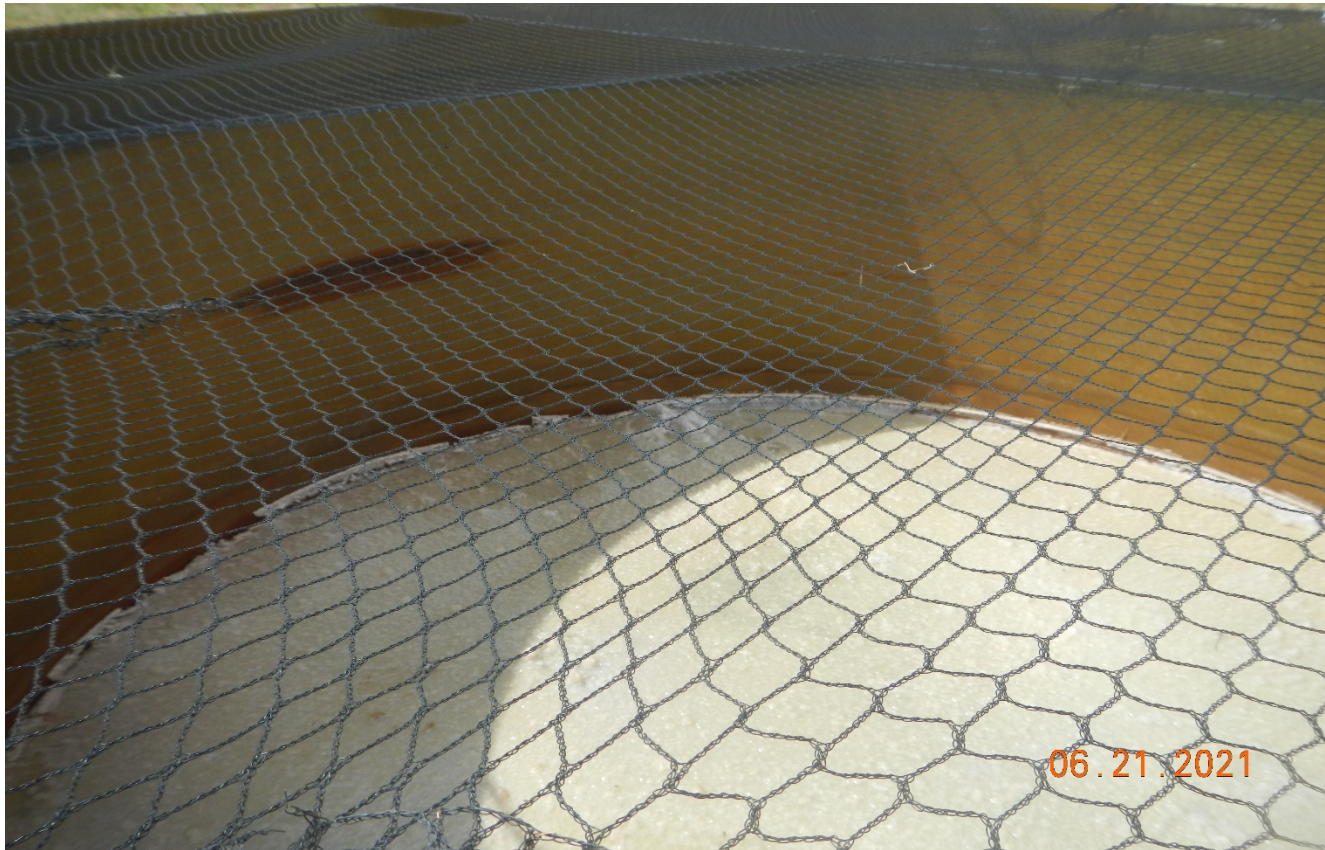
Photo 4. View of fluids inside the tank. Tank is labeled Produced Water. The netting appears to have been repaired.

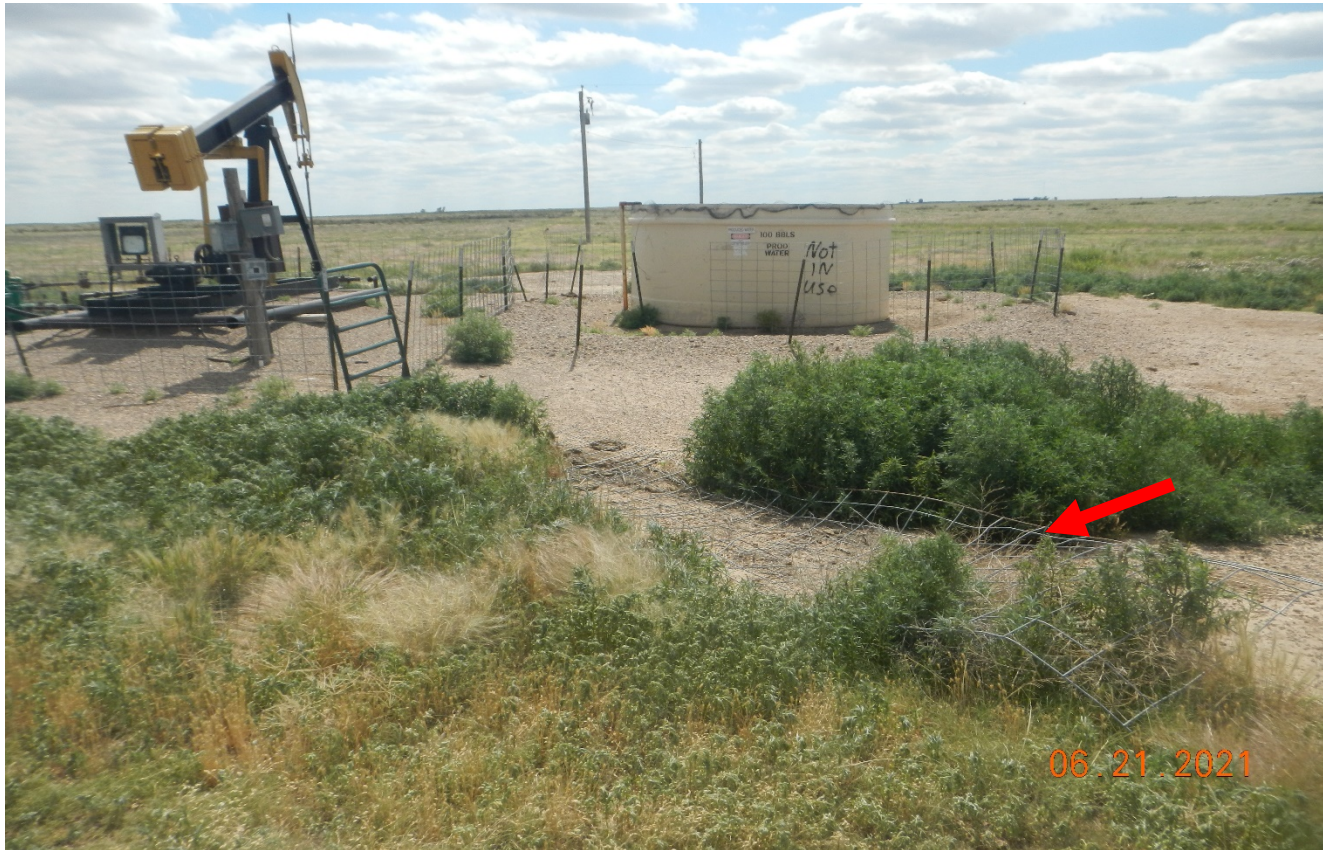
Photo 5. There is a metal panel laying on the ground.
