Inspection Photos

API: 009-06082

Operator: DOVER ATWOOD CORPORATION

Inspection Date: 6/21/2021

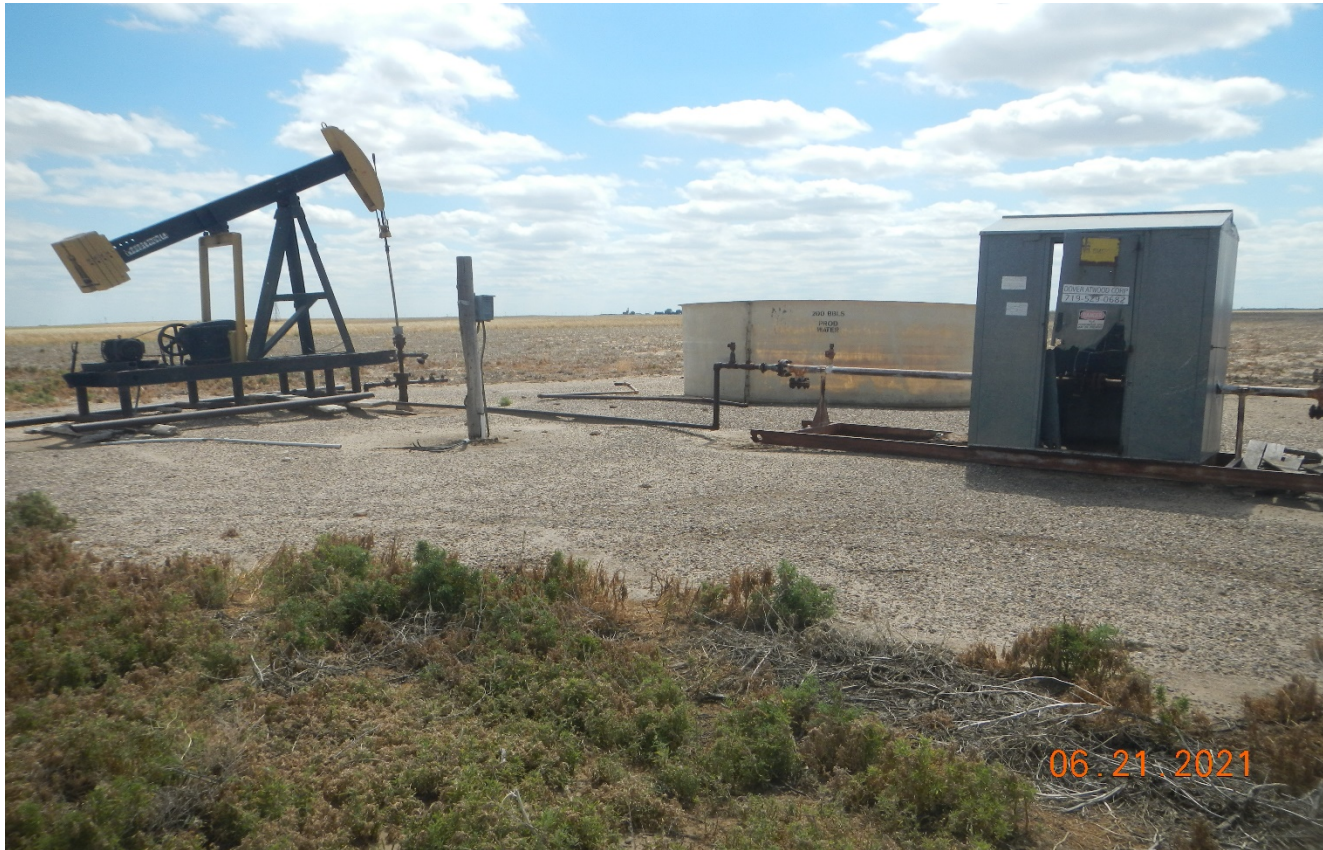
Photo 1. Facing east toward the location. There is no well sign posted at the location.

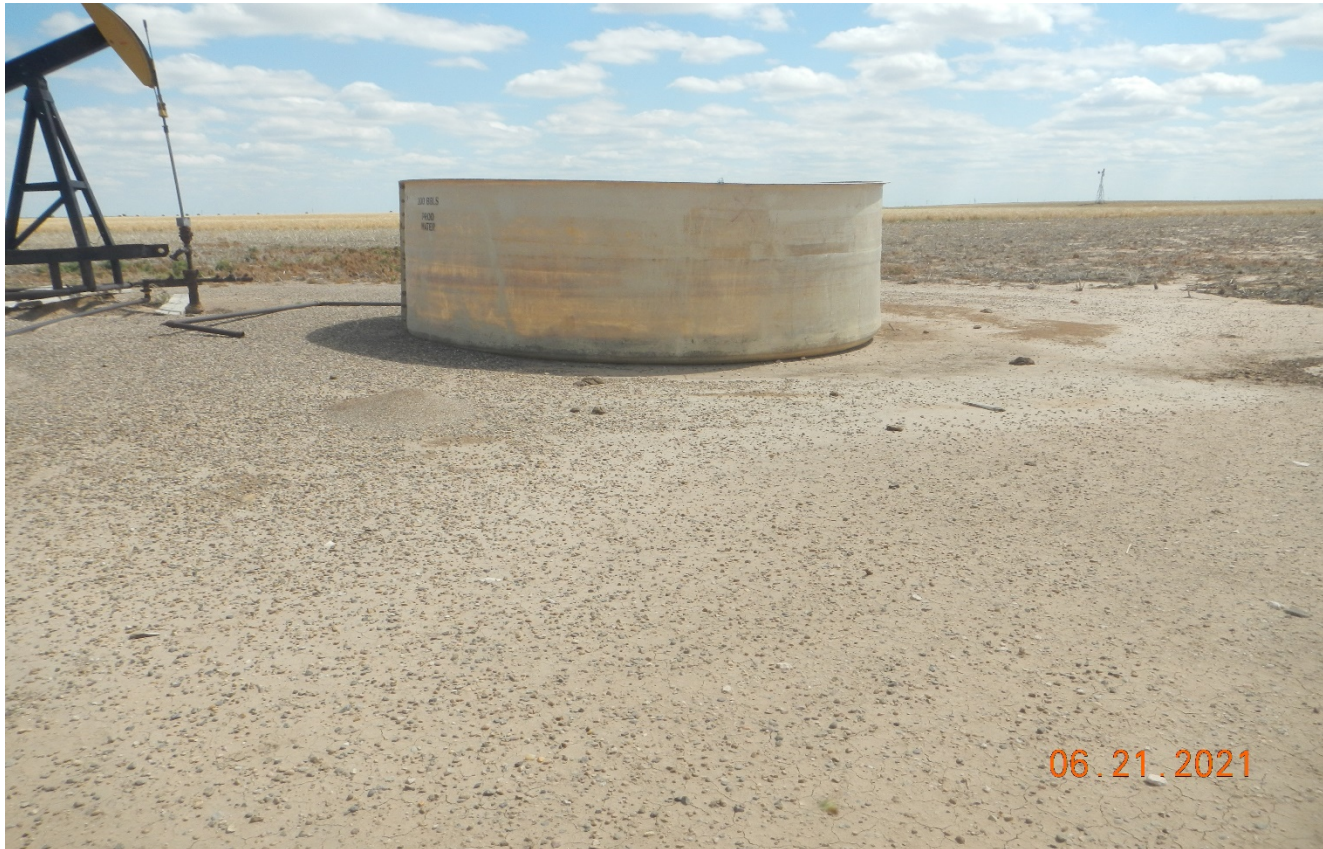
Photo 2. Missing tank NFPA labeling and missing INFO per 605.h..

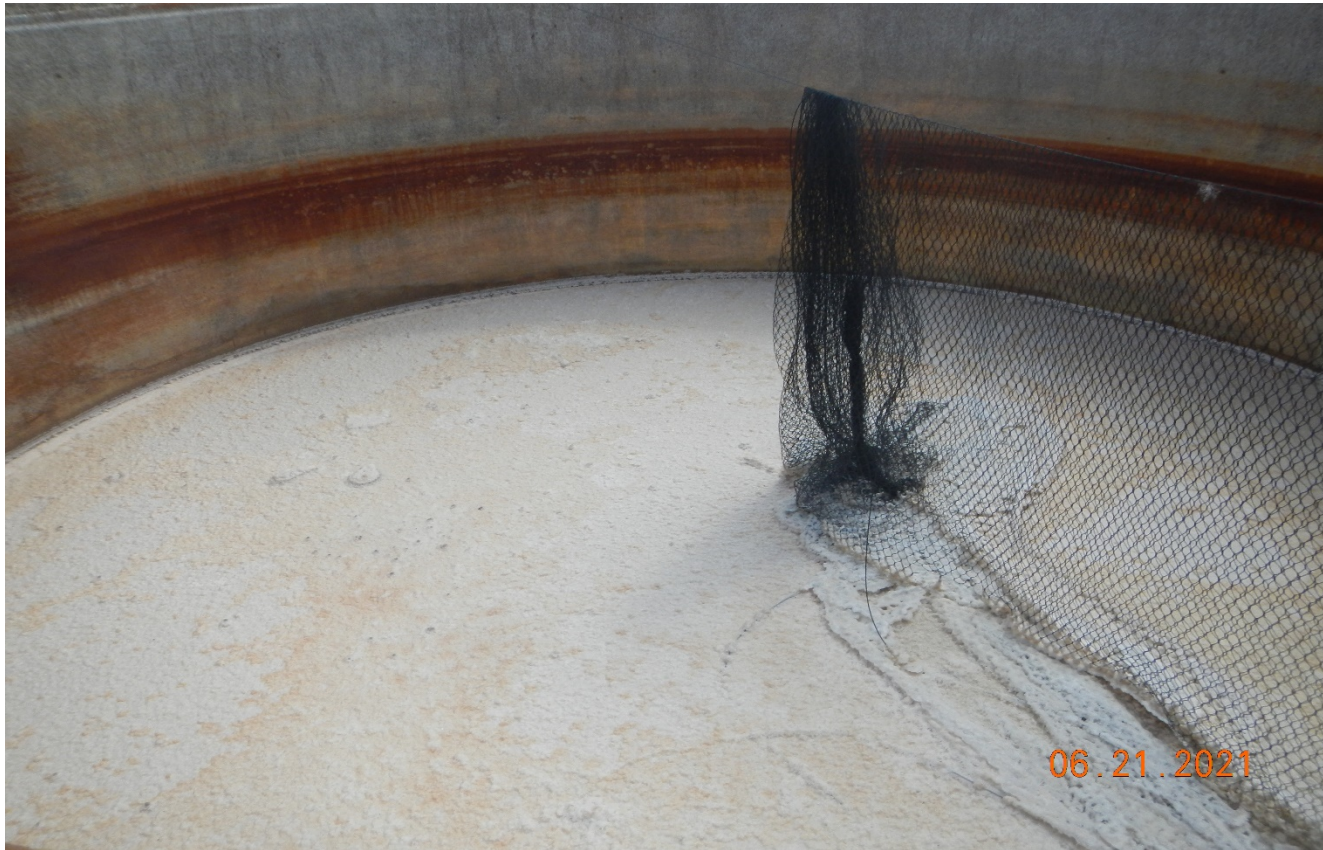
Photo 5. View of fluids inside the tank. Tank is labeled Produced Water. It appears to be solidified salty produced water. The netting on the tank is in disrepair.

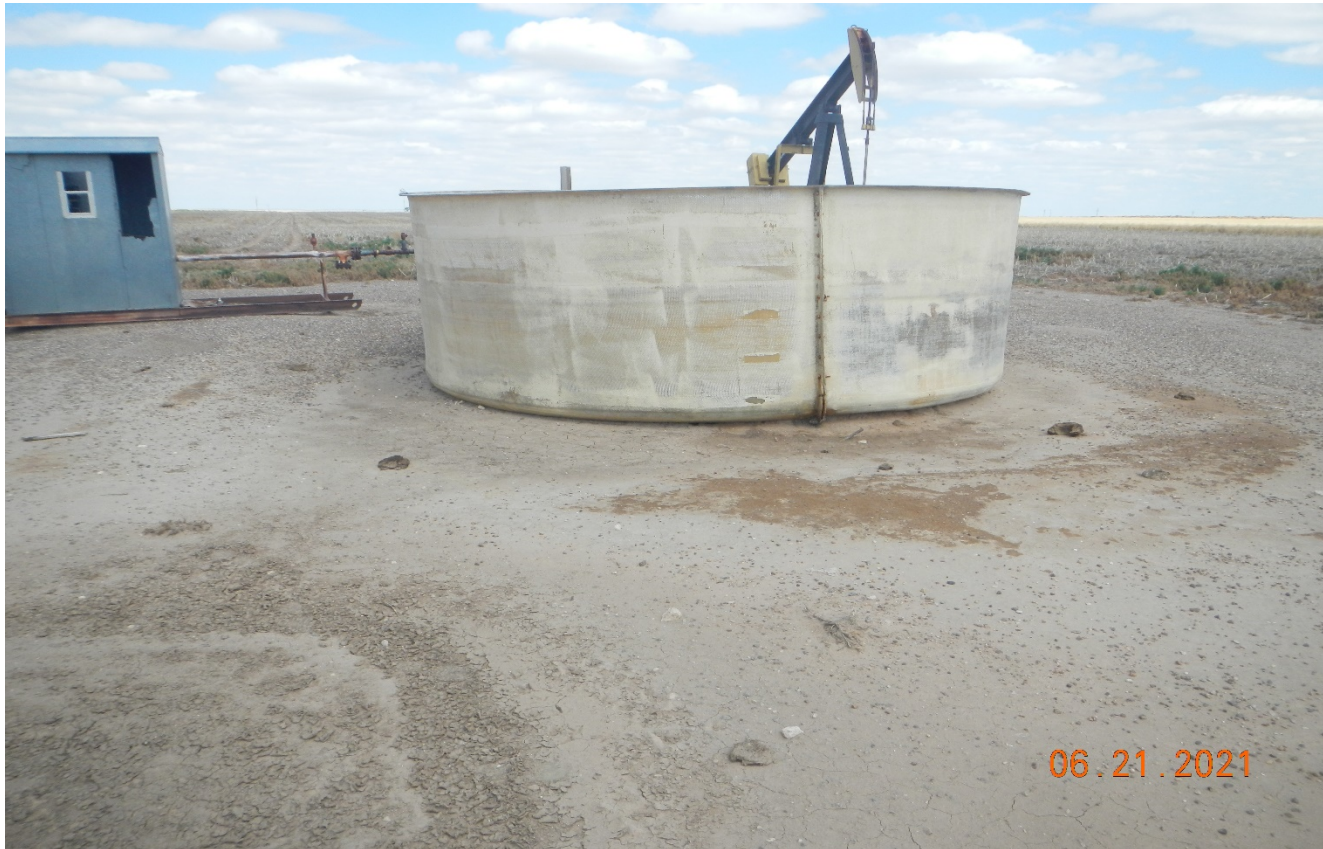
Photo 5. Secondary containment is inadequate to contain 150% of the volume of the tank.

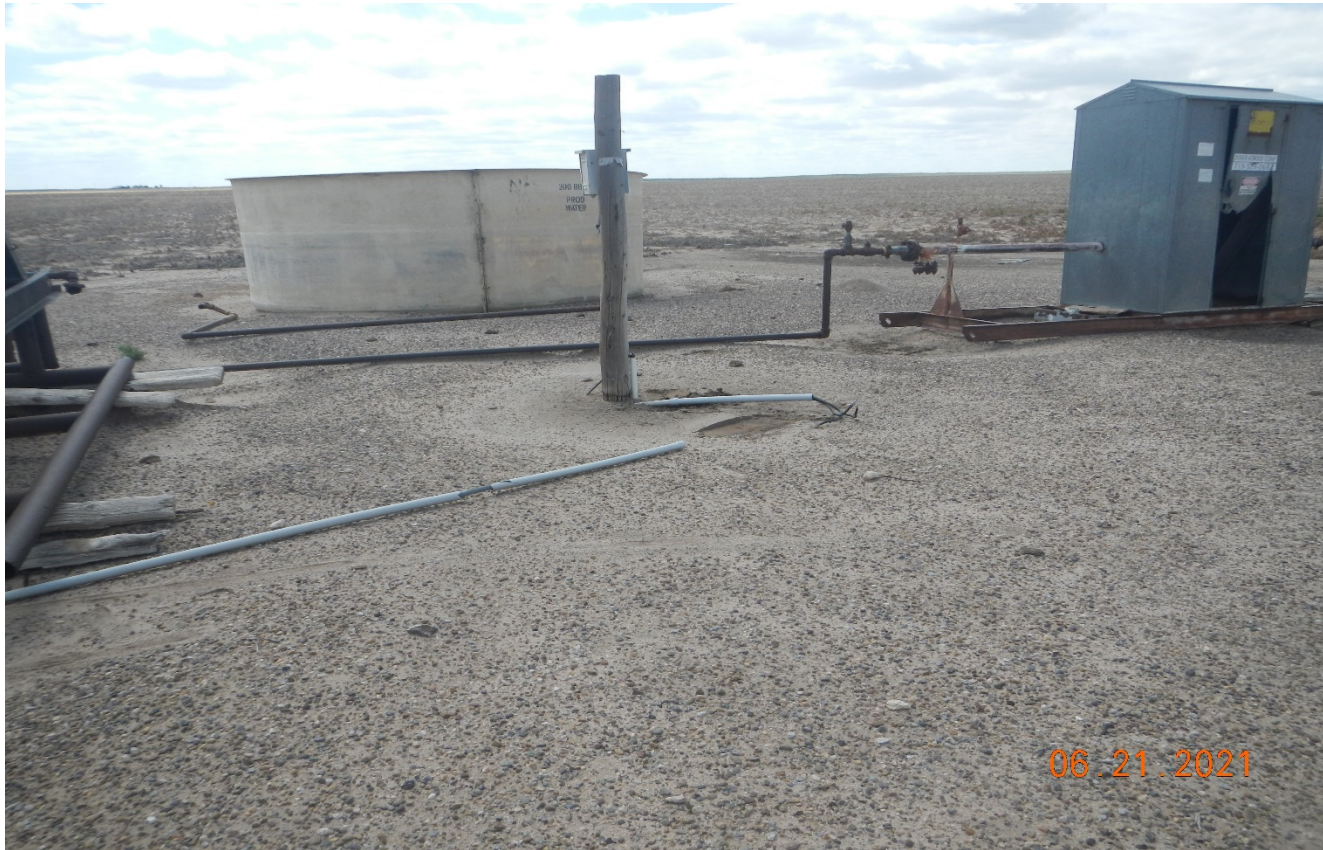
Photo 6. There is exposed electrical wire on the ground and panel box. All unused supplies and equipment need to be removed.
