Inspection Photos

ID:429852

Operator: DOVER ATWOOD CORPORATION

Inspection Date: 6/21/2021

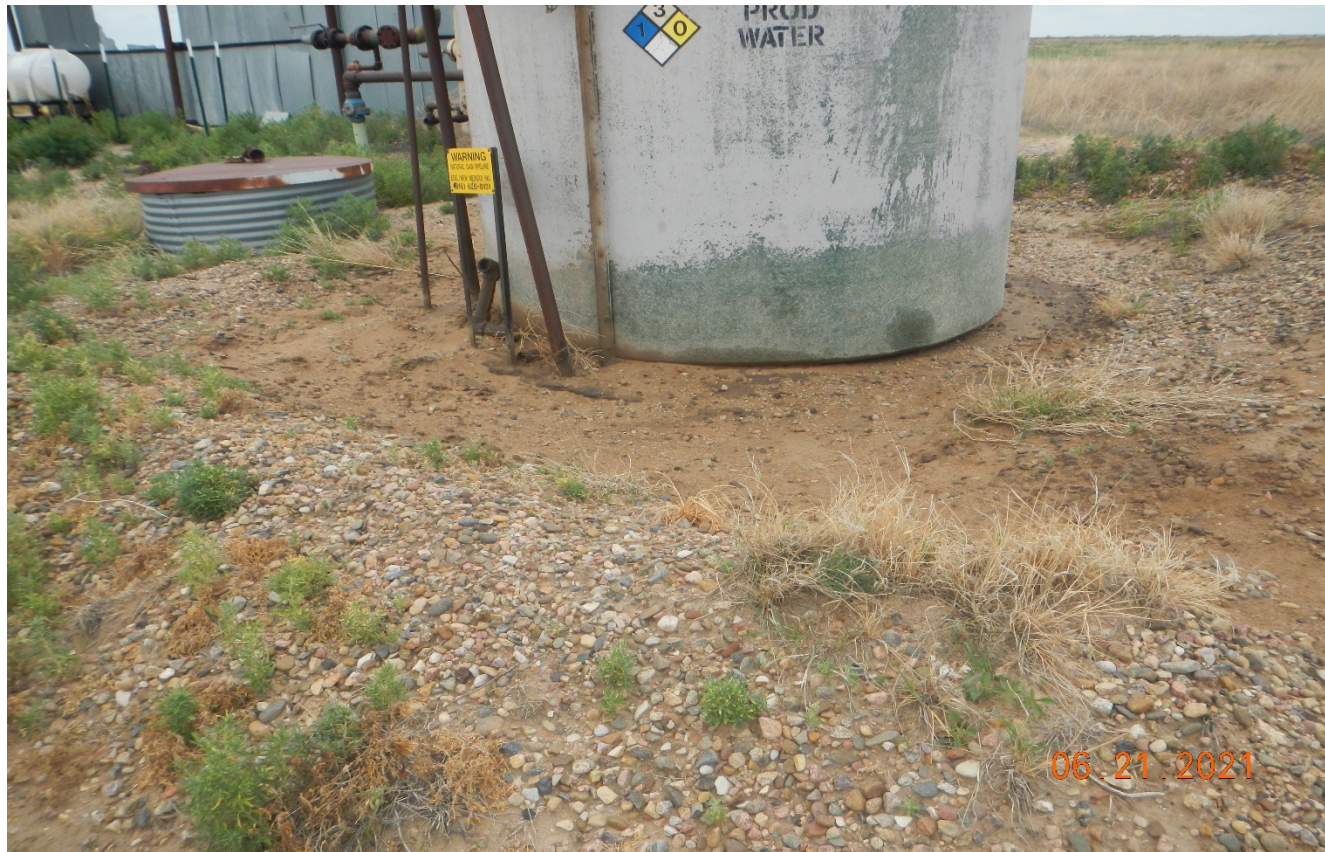
Photo 2. There is oil stained soil near the Produced Water tank. The tank is labeled produced water but appeared to contain oily fluid. Netting was over the top of tank. Additionally the berm does not appear to be sufficient to contain a spill.

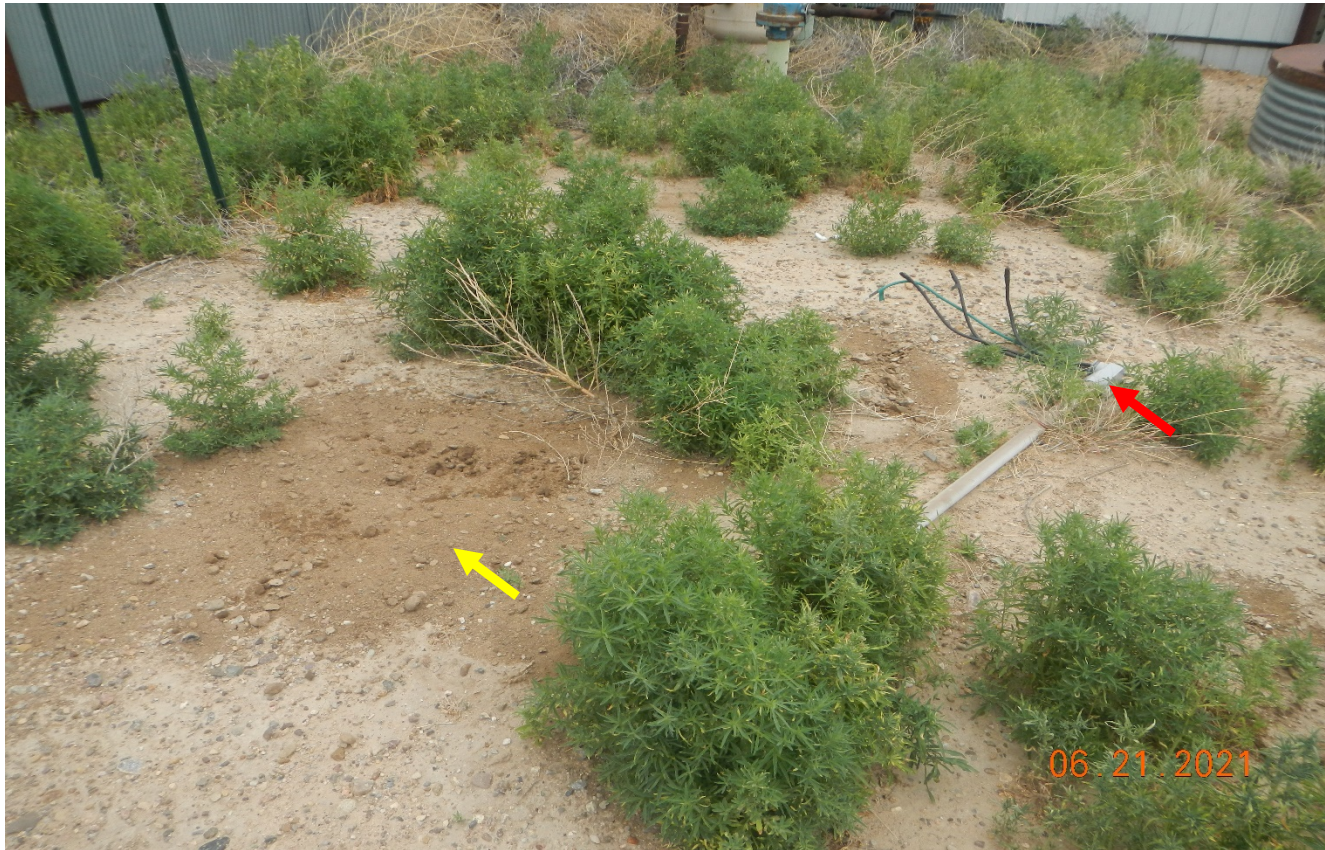
Photo 3. There is an exposed electric utility that remain at red arrow. There is oil stained soil shown at yellow arrow.

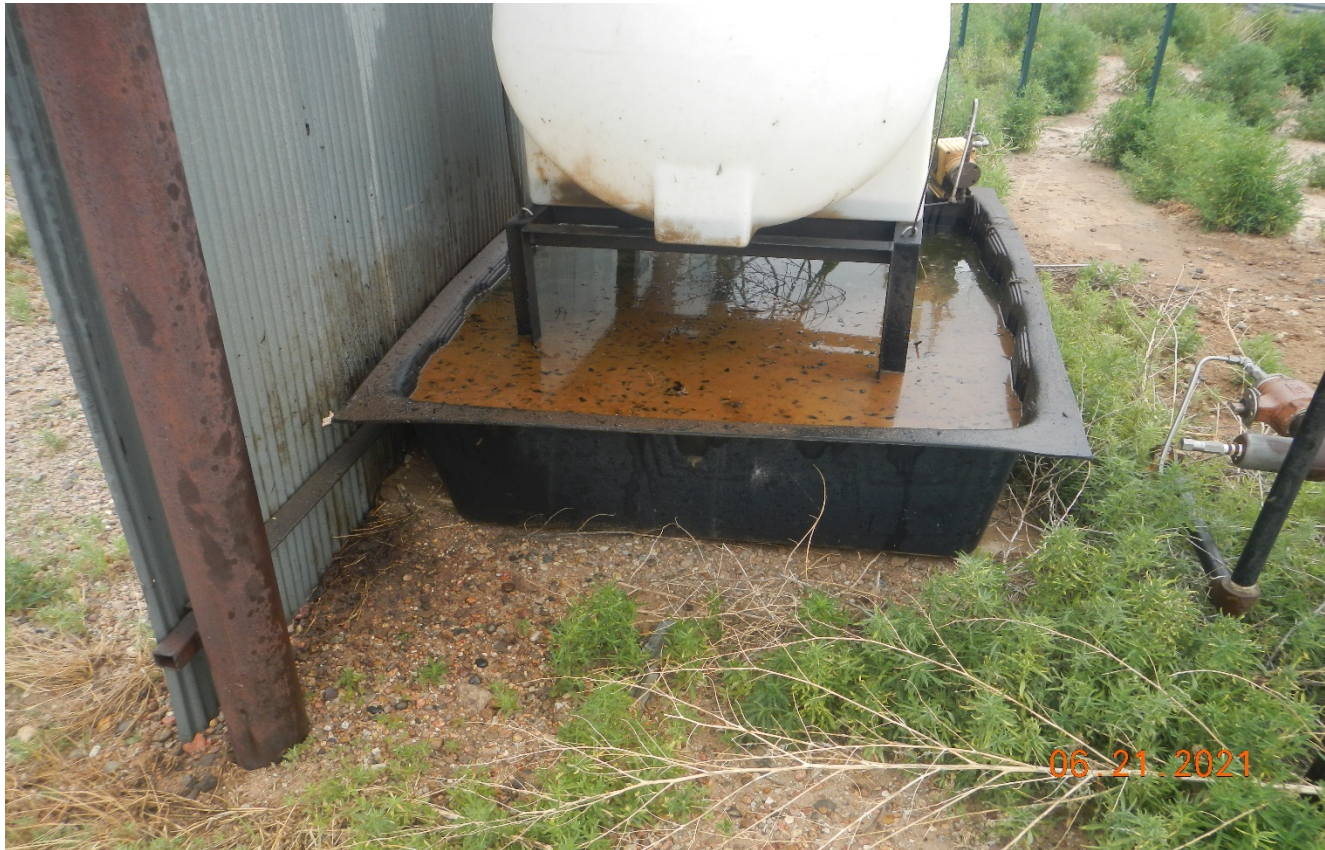
Photo 4. There is oily waste inside this containment which is near the top of the containment and appears to have spilled over. The oily waste has not been removed and properly disposed since last inspection. A dead bird was previously observed in the oily fluid.

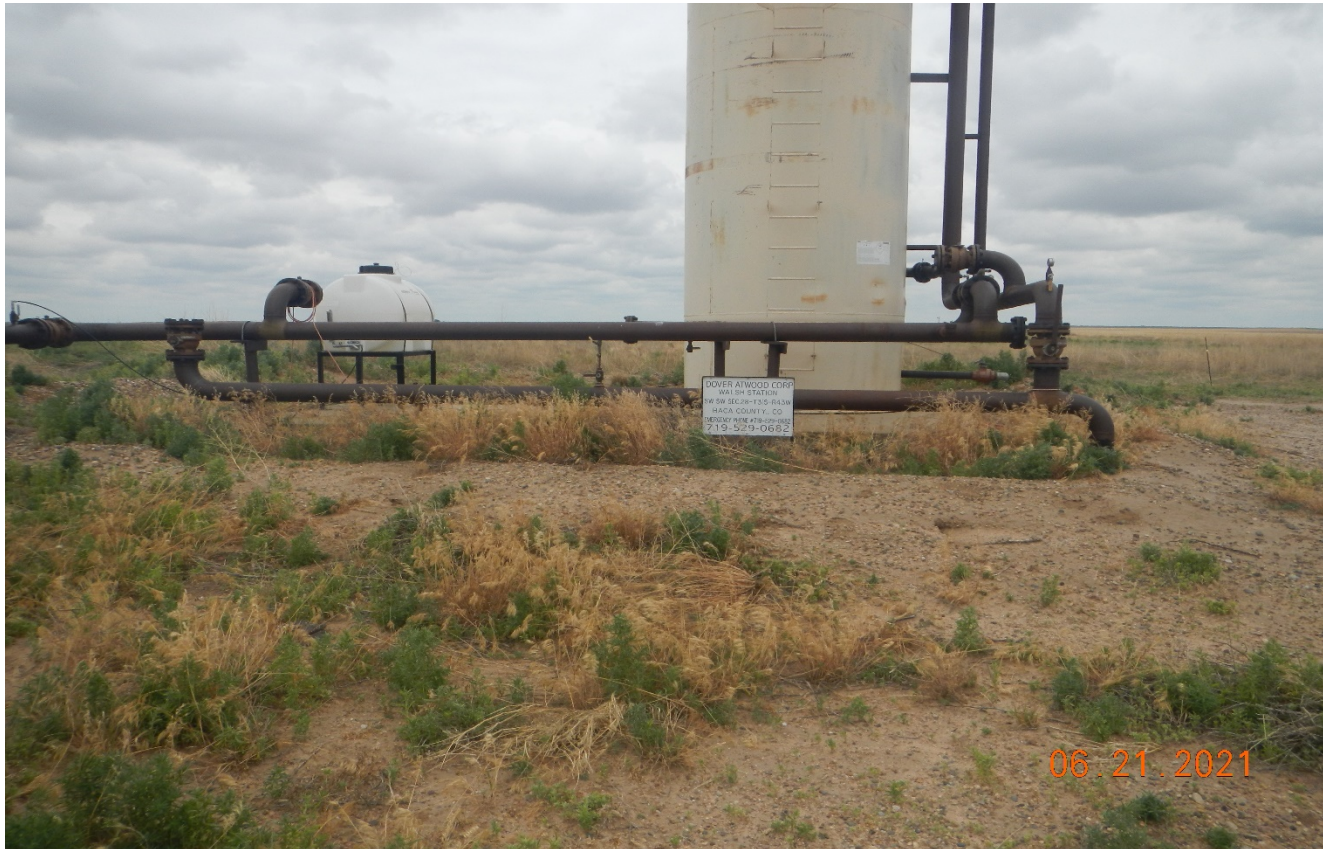
Photo 5. The facility sign is posted but contains incomplete and inaccurate information. Previous corrective action was not performed.

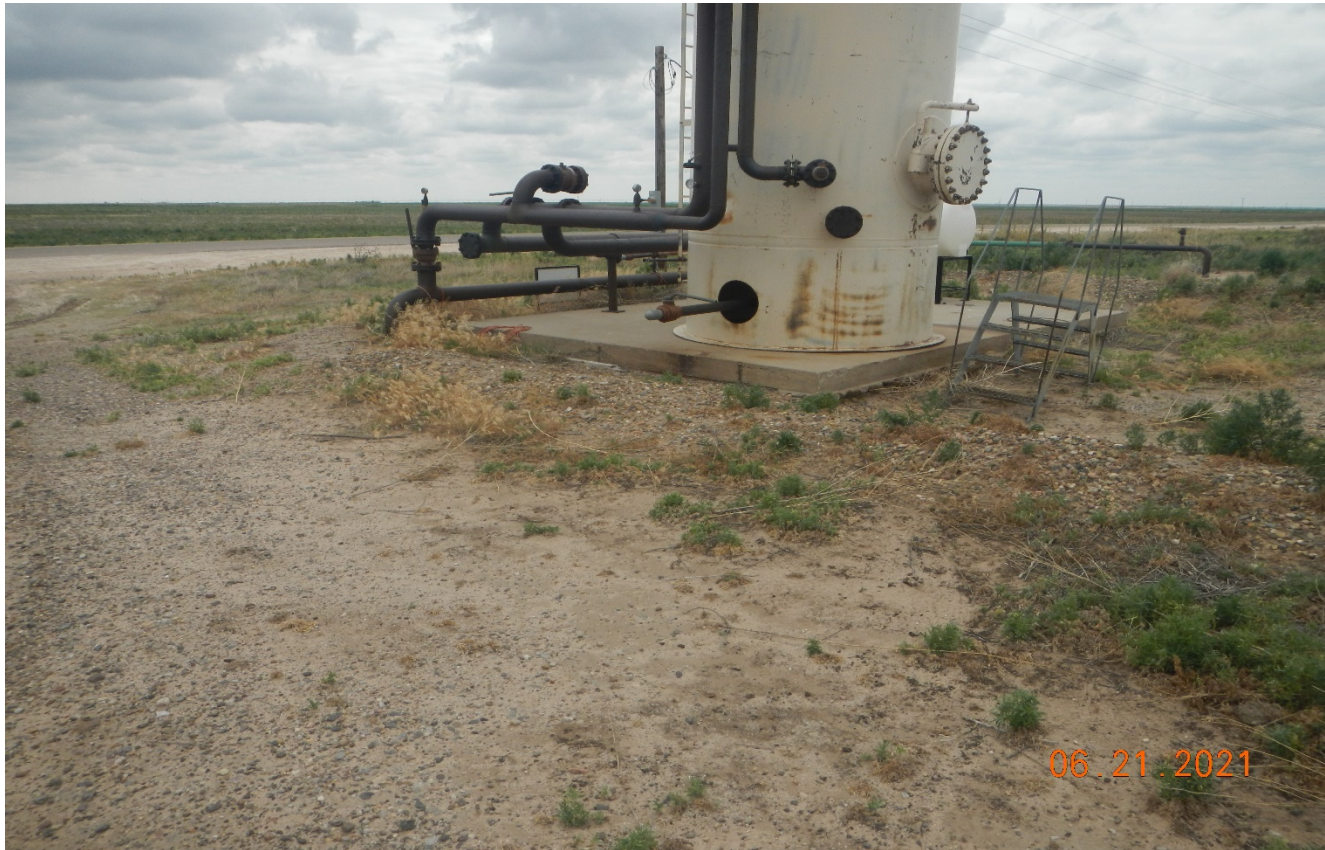
Photo 6. The berm around the tank vessel is inadequate in size and has animal burrows in it. The berm has not been repaired since previous inspection.

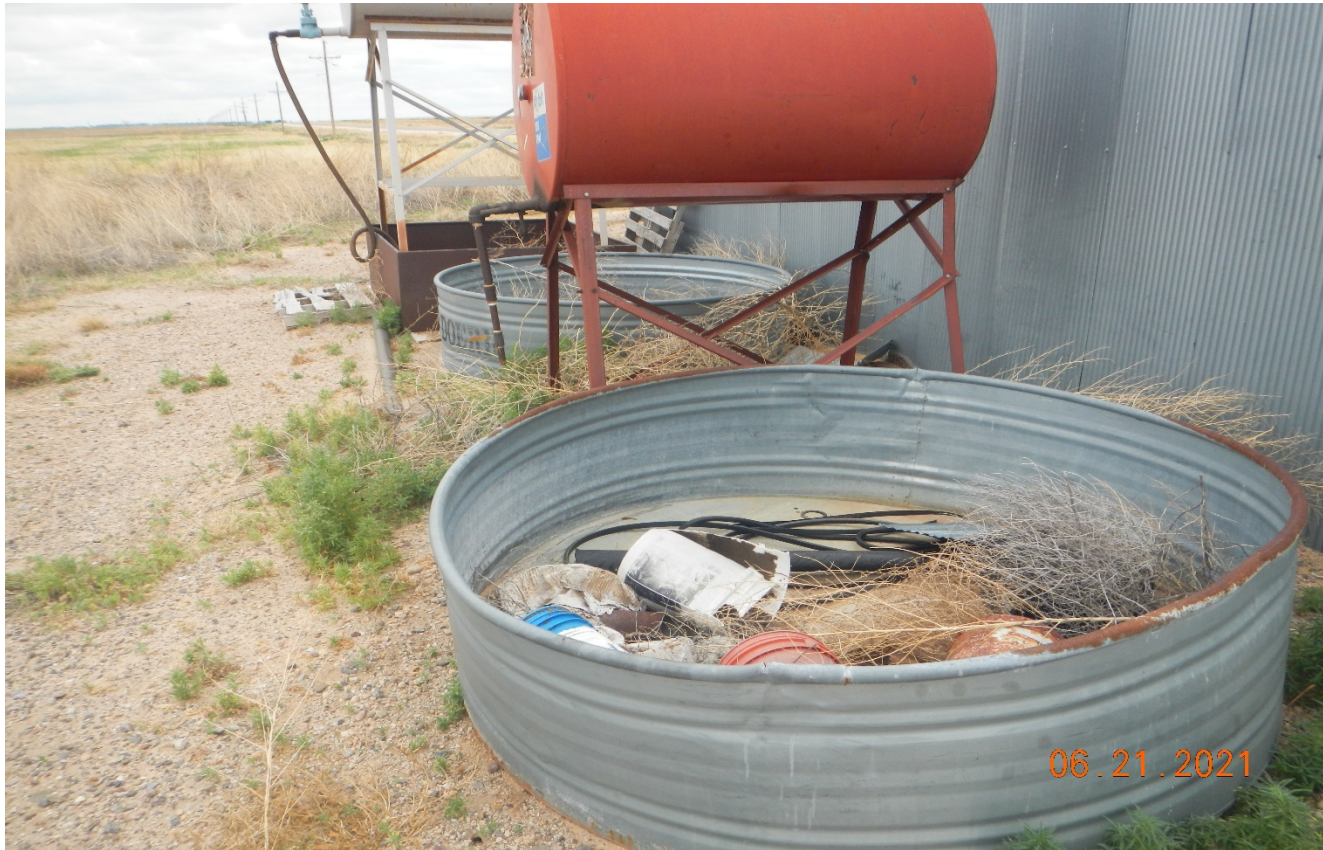
Photo 7. On the backside of the metal panels is unused equipment. There is various supplies and waste stored in the tanks. Unused equipment/supplies has not been removed. Previous corrective action was not performed.

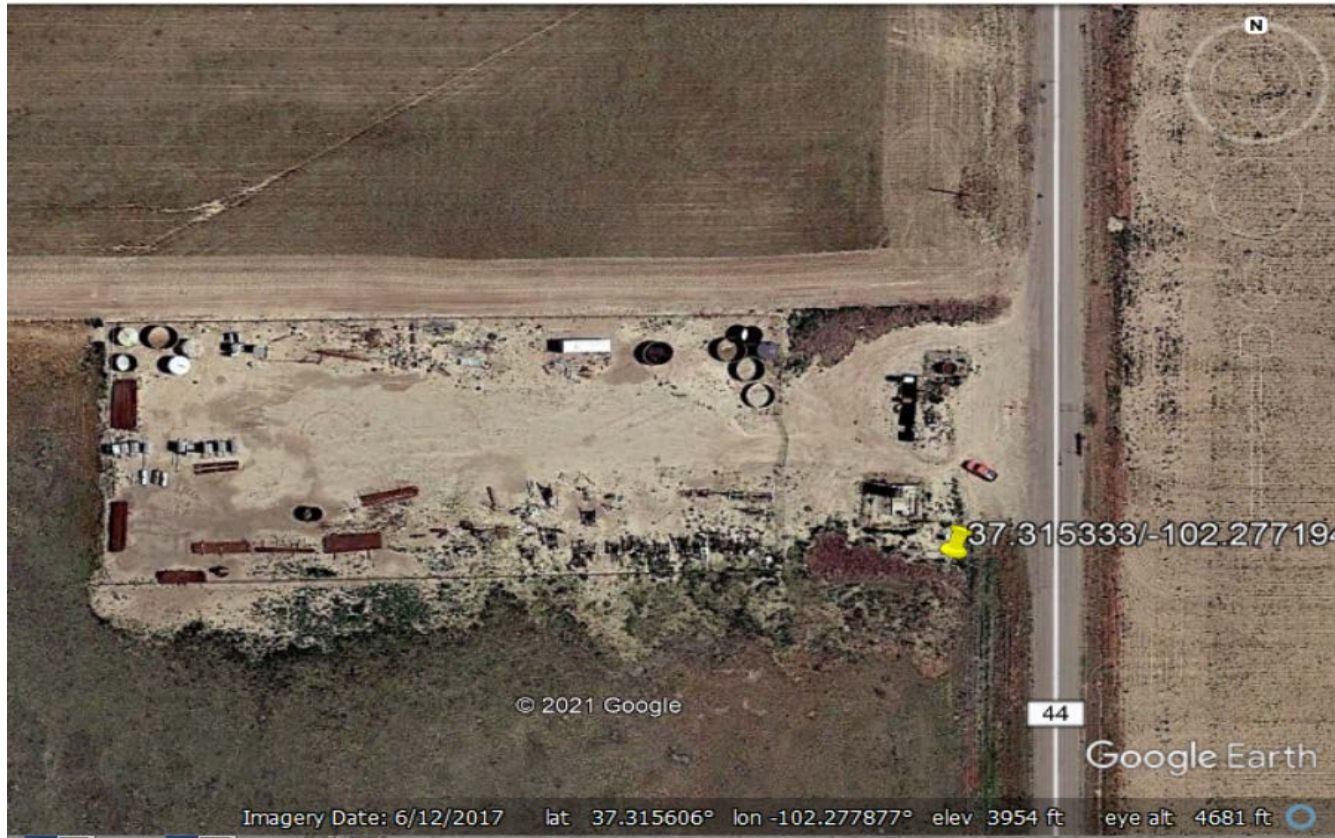
Photo 8. Aerial imagery shows a storage yard behind the compressor facility. The storage yard no longer exists however, the disturbance area needs to be reclaimed.

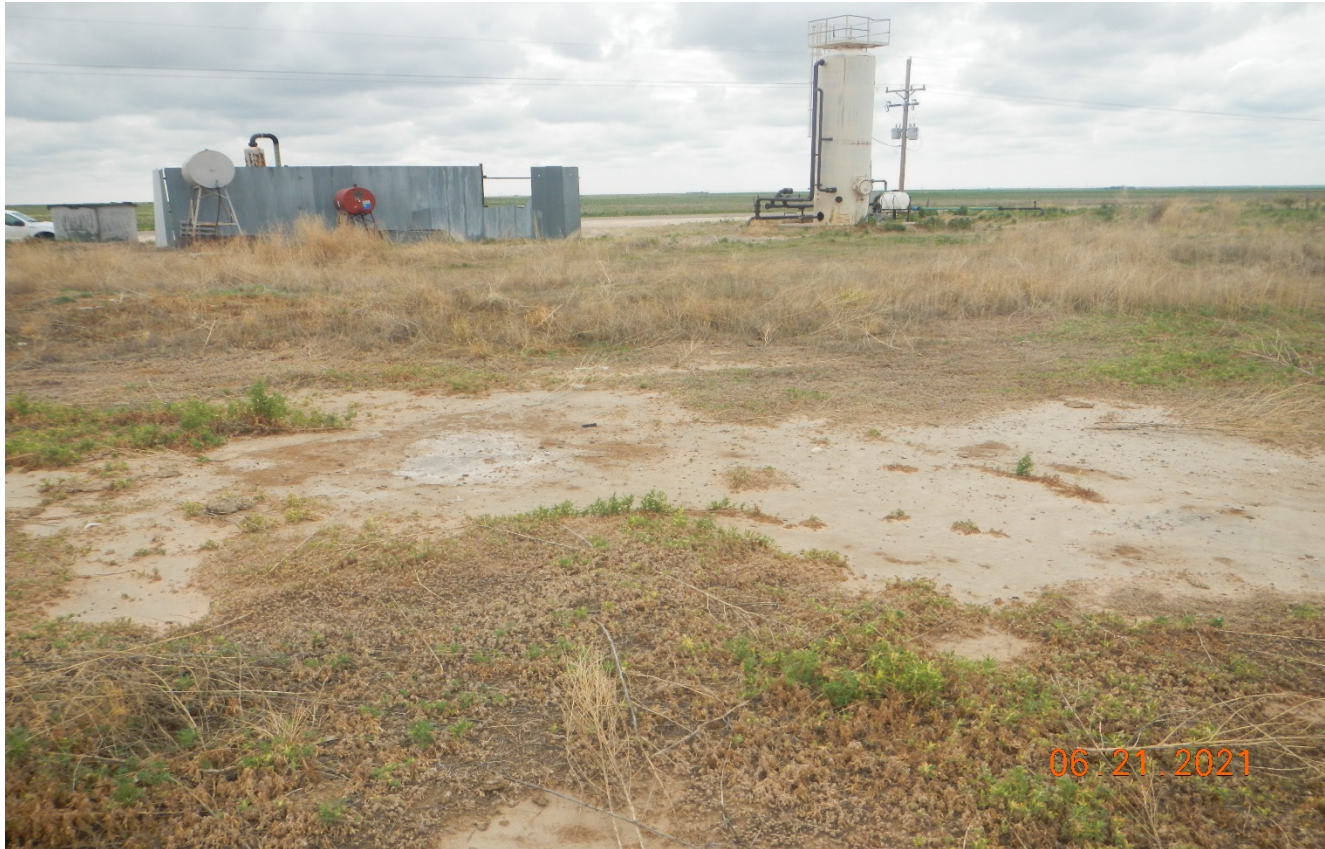
Photo 9. Facing southeast behind the compressor facility. There is undesirable weeds throughout this disturbed area which weeds will need to be controlled and the disturbance area reclaimed.

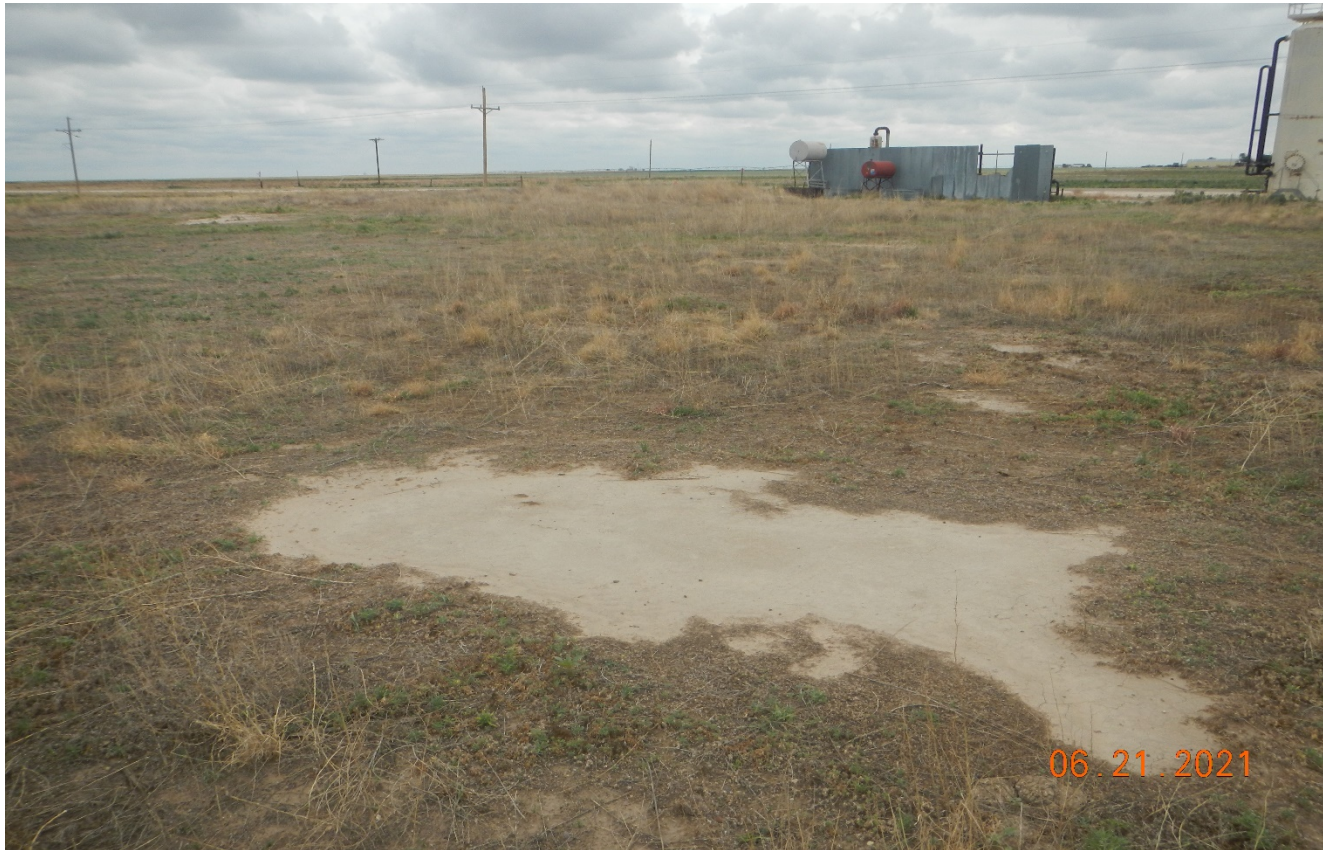
Photo 10. Facing northeast behind the compressor facility. There is undesirable weeds throughout this disturbed area which weeds will need to be controlled and the disturbance area reclaimed.
