Inspection Photos

ID# 441082

Operator: DOVER ATWOOD CORPORATION

Inspection Date: 6/21/2021

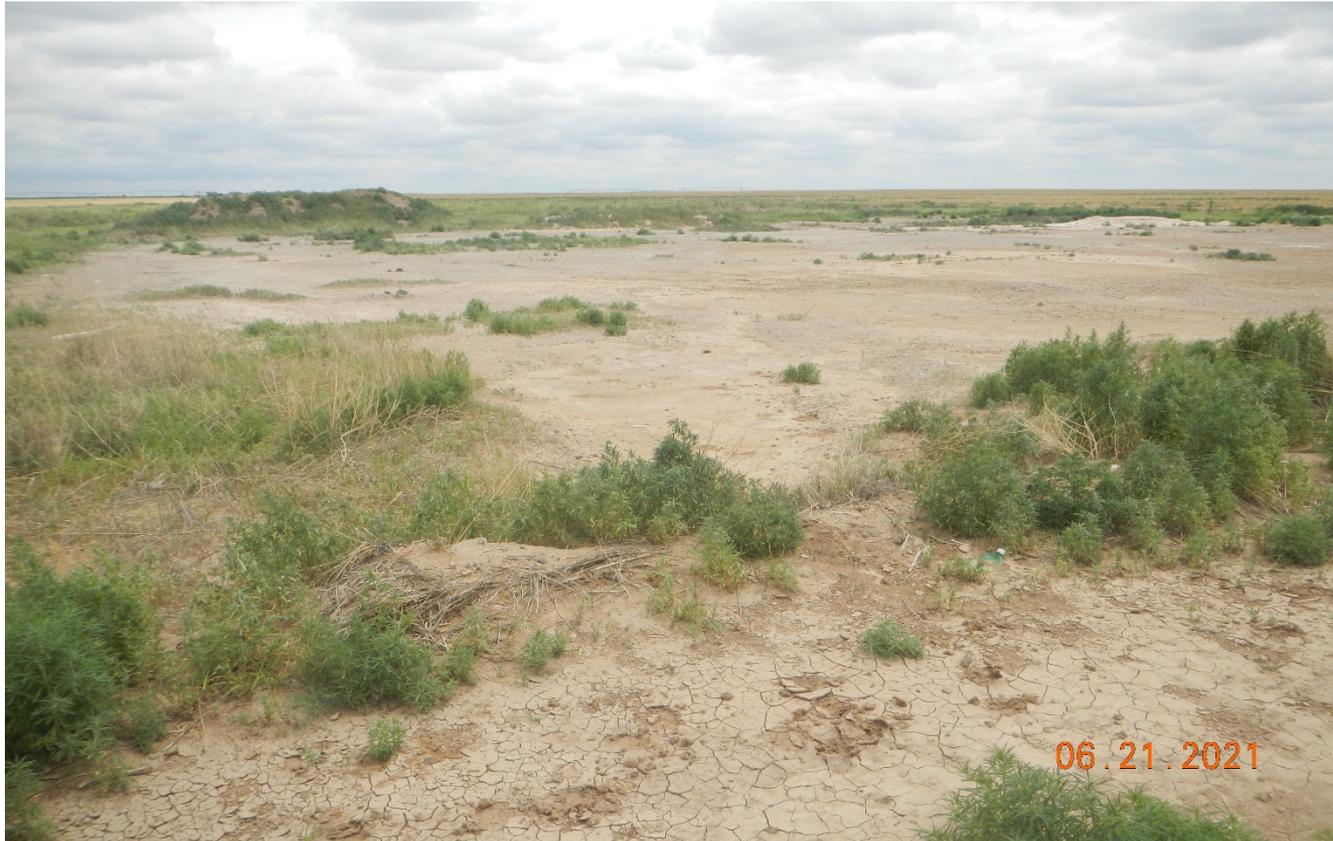
Photo 1. Facing northeast toward the location. The disturbed location has not been reclaimed. Previous corrective actions were not performed.

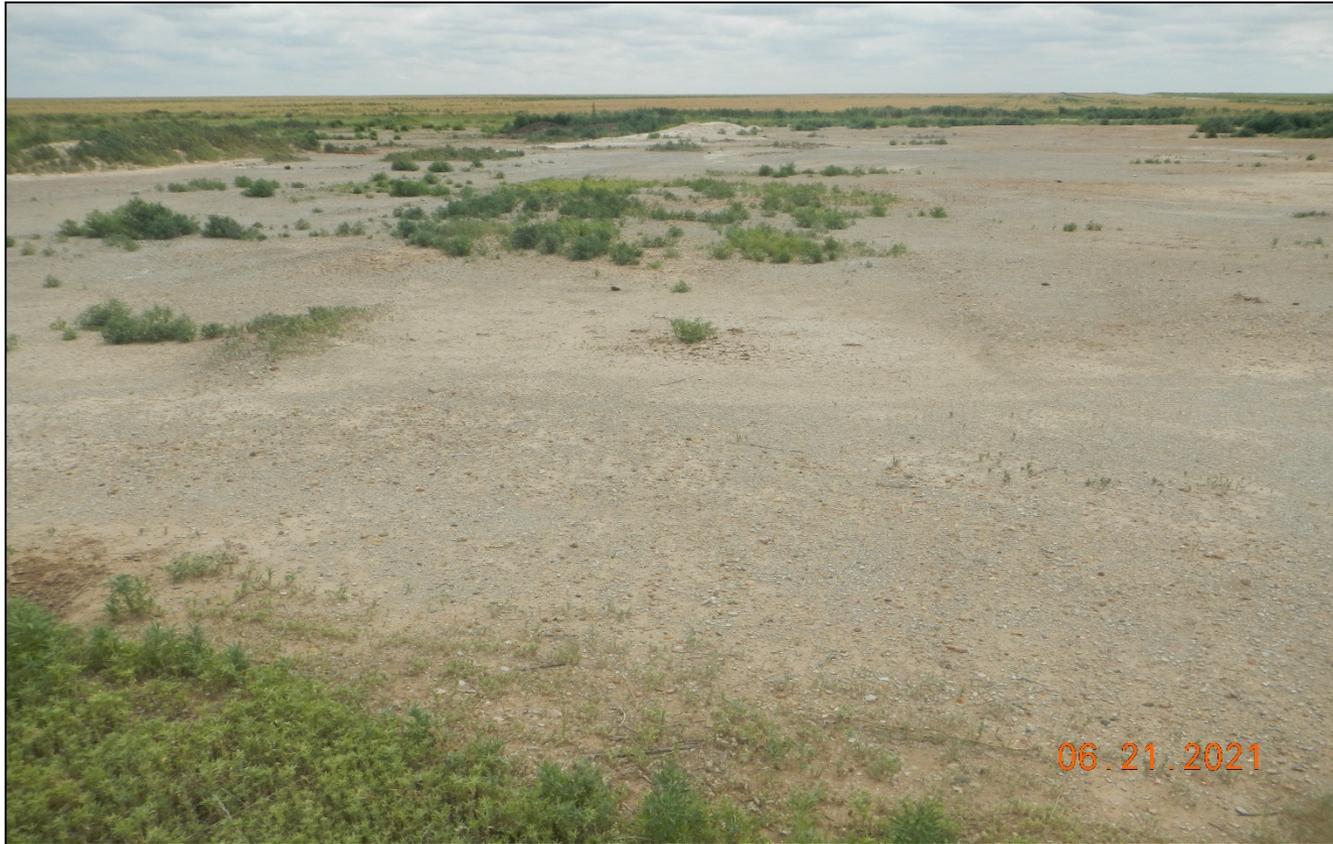
Photo 2. Facing northeast at the location. Soils are compacted and the location has not been reclaimed. Previous corrective actions were not performed. Soils must be decompacted by cross ripping to a depth of 18 inches.

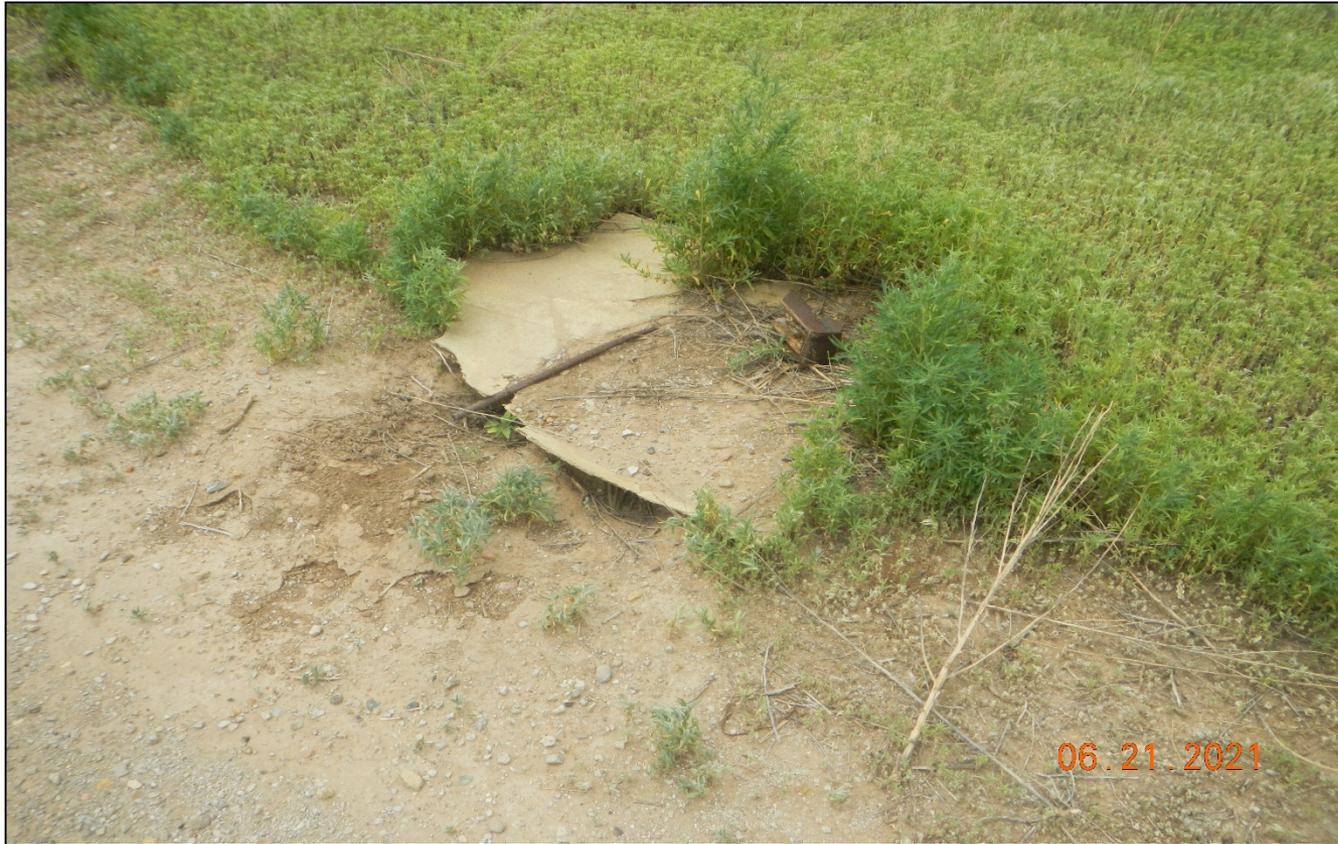
Photo 3. There is various debris that remains around the location.

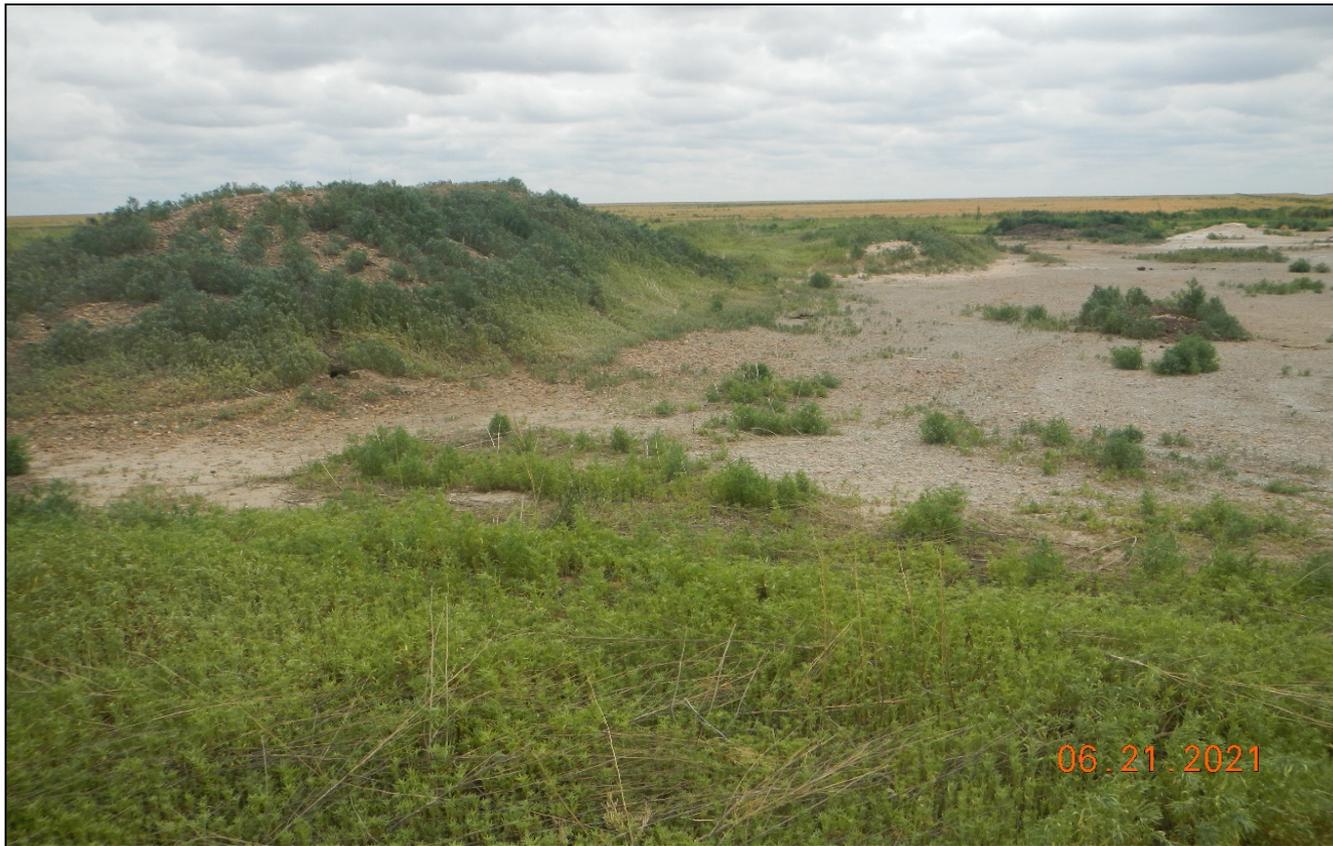
Photo 4. There are gravel and soil piles that remain at the north side of the location. The piles need to be removed. There are undesirable weeds growing on the piles.

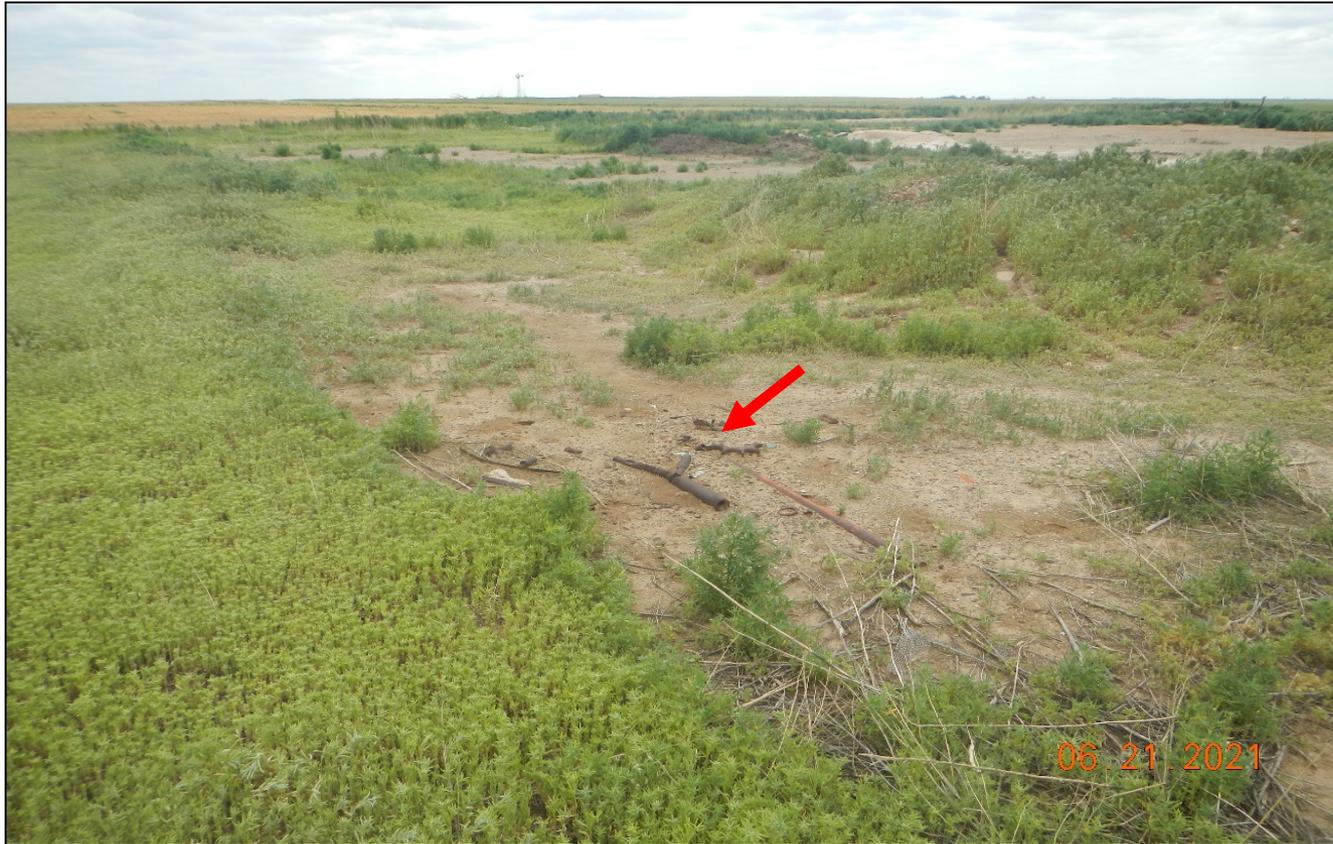
Photo 5. Facing east at the north side of the location. There is undesirable growing throughout the location. Weed control must be performed. There is metal debris shown at red arrow.

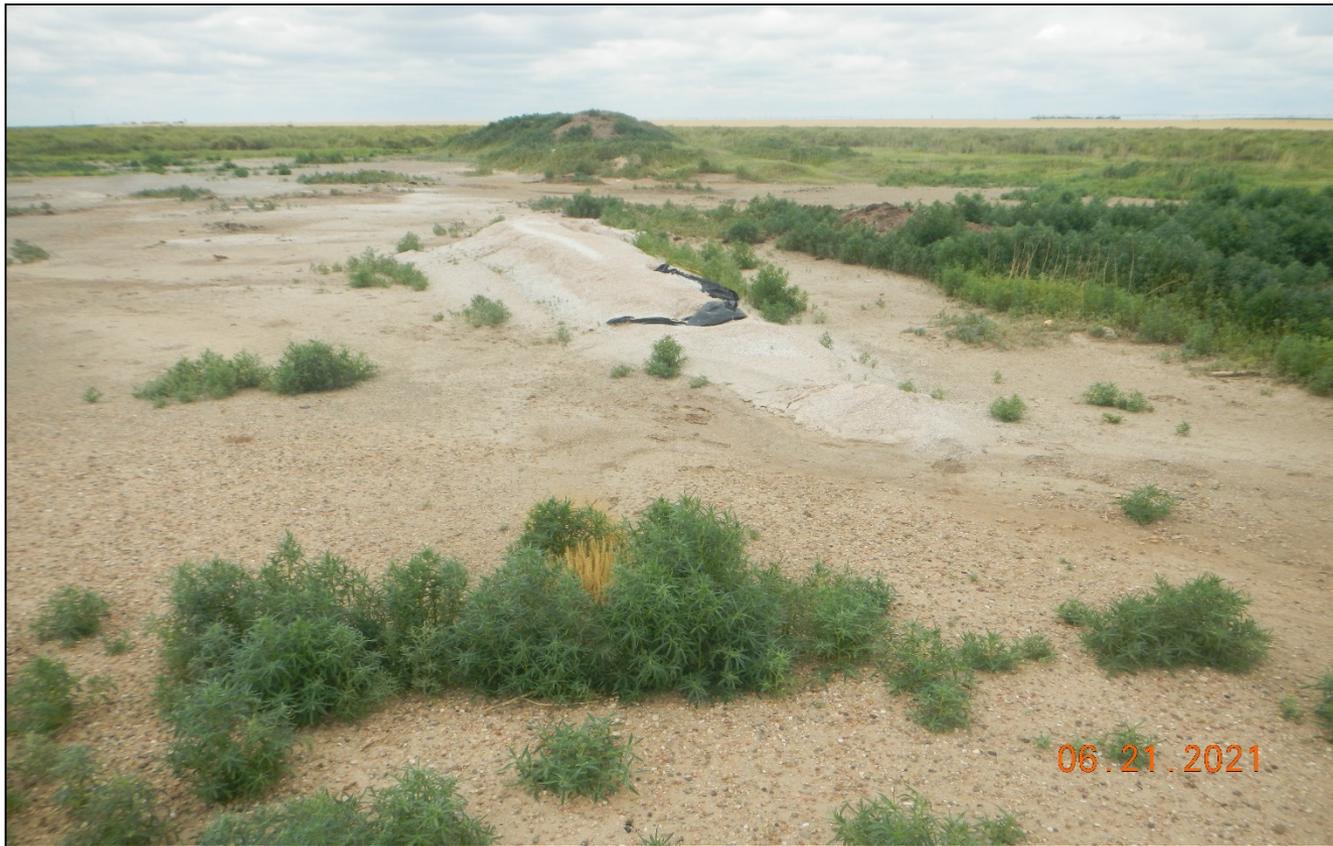
Photo 6. There is piles of manure and material left on the location.

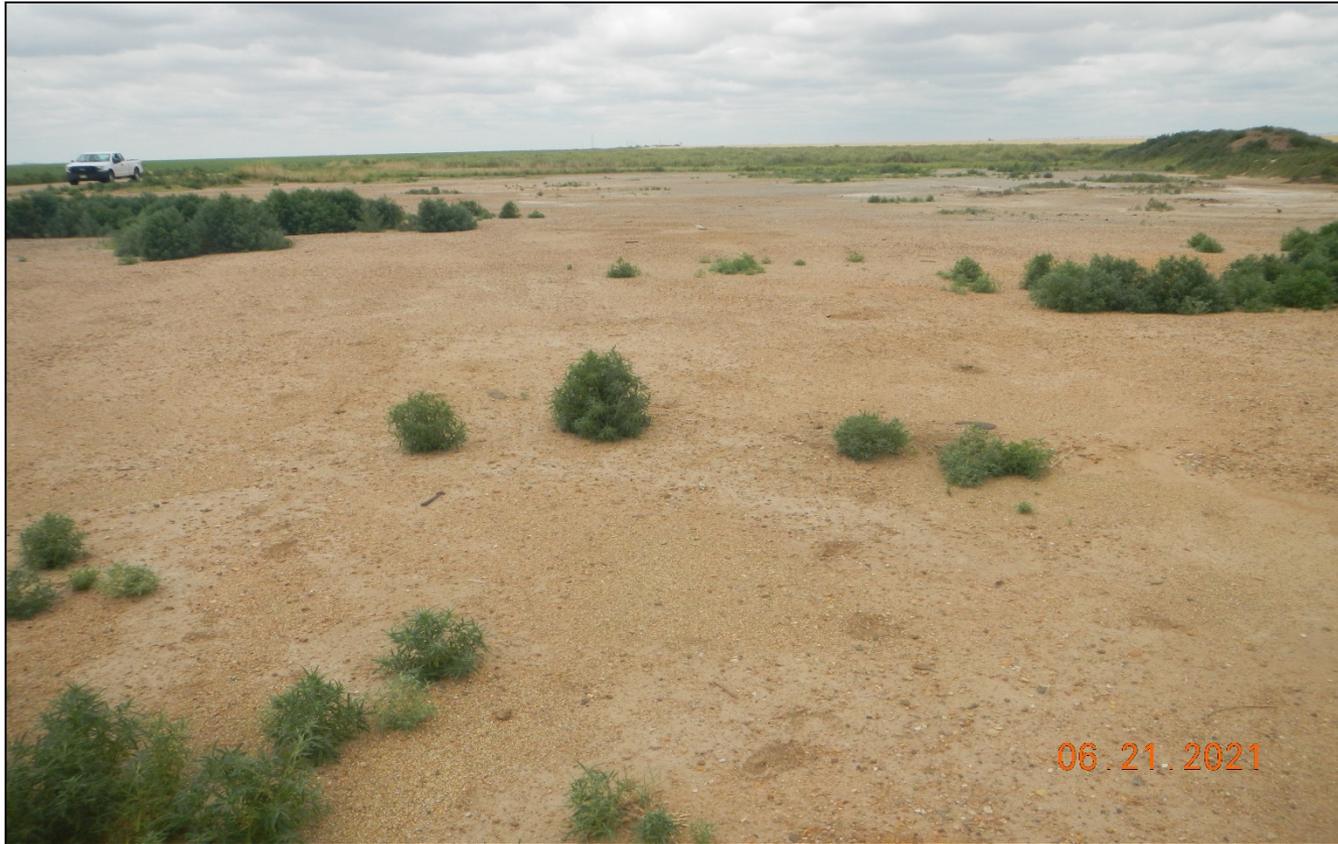
Photo 7. Facing west at the location. Soils are compacted and the location has not been reclaimed. Previous corrective actions were not performed.

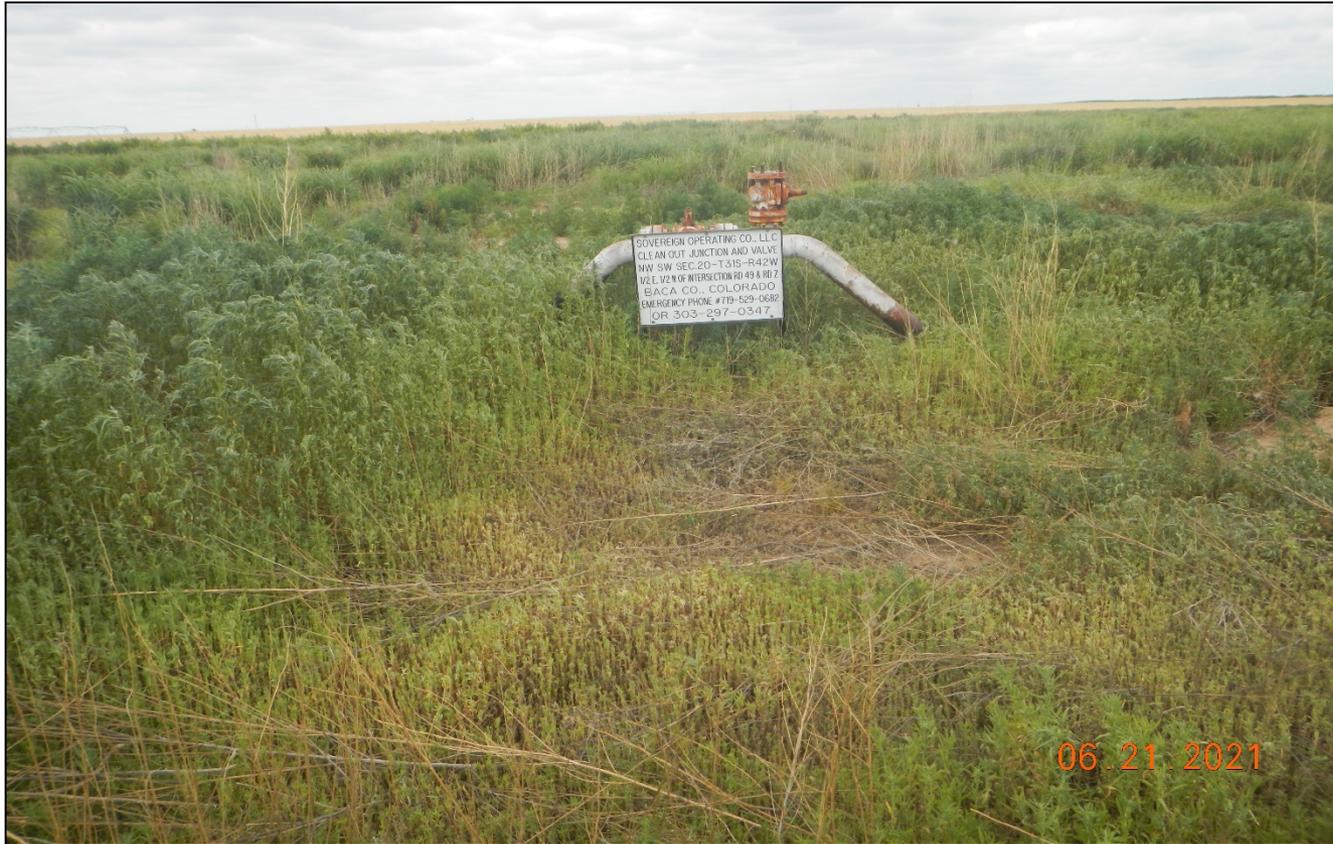
Photo 8. There is a cleanout junction 1850 ft. north of the pipeline which is associated with the former gas compressor station and must be removed.

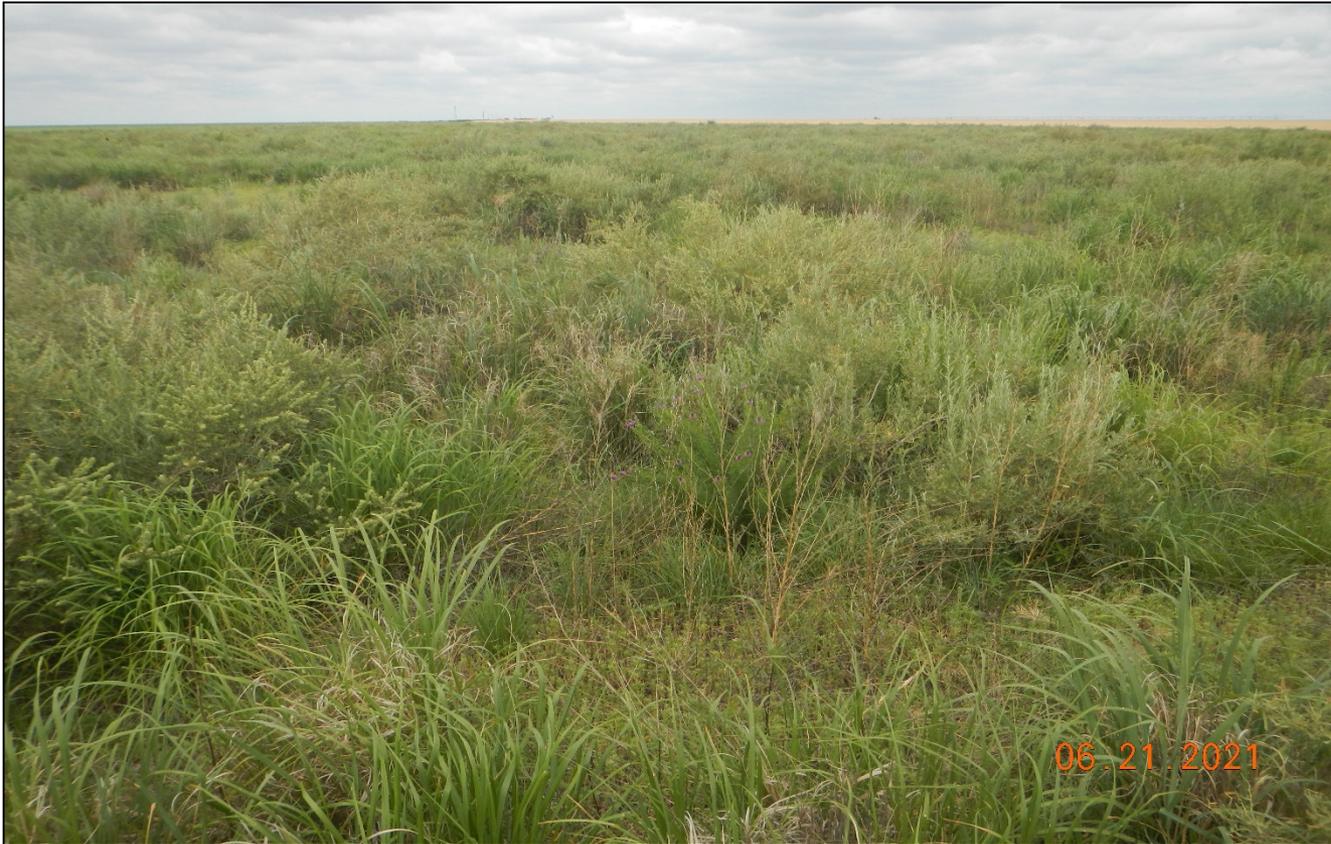
Photo 9. Facing east toward the surround reference vegetation which consists of desirable vegetation cover.
