Inspection Photos

Location Name: TEP ROCKY MOUNTAIN LLC EXXON-67S95W /6SWNE

Location ID: 334957

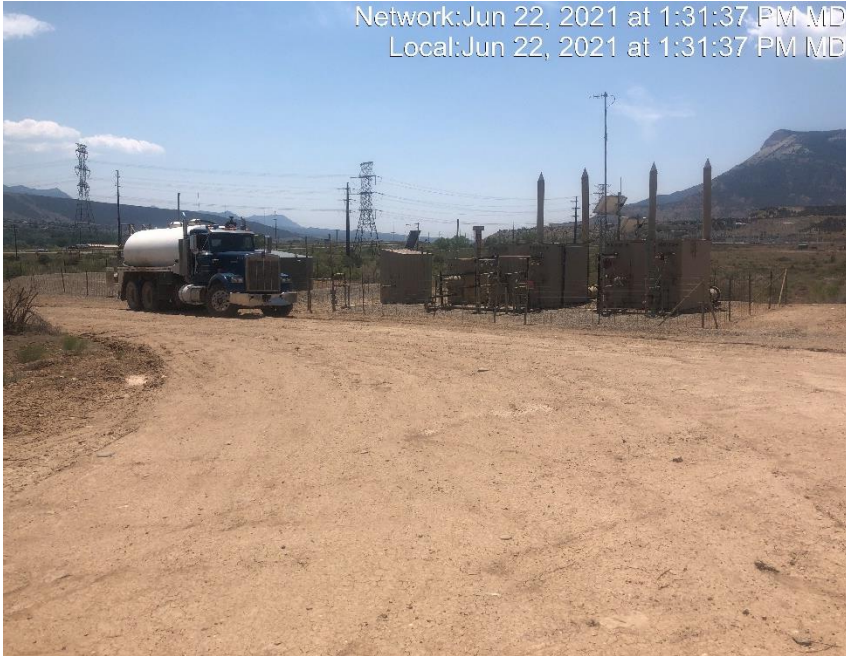
Photo #4135 from entrance to location.

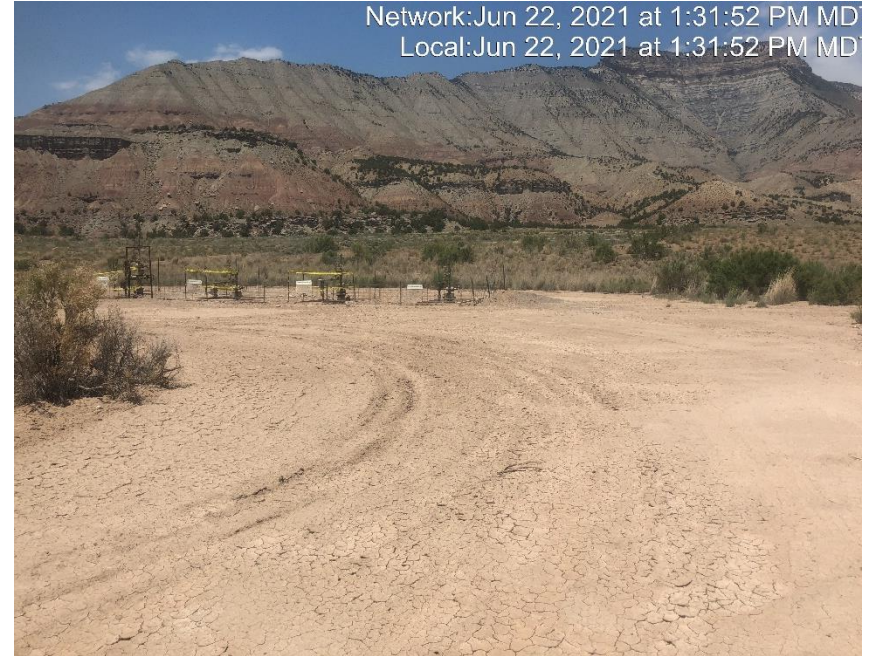
Photo #4136 from entrance to location.

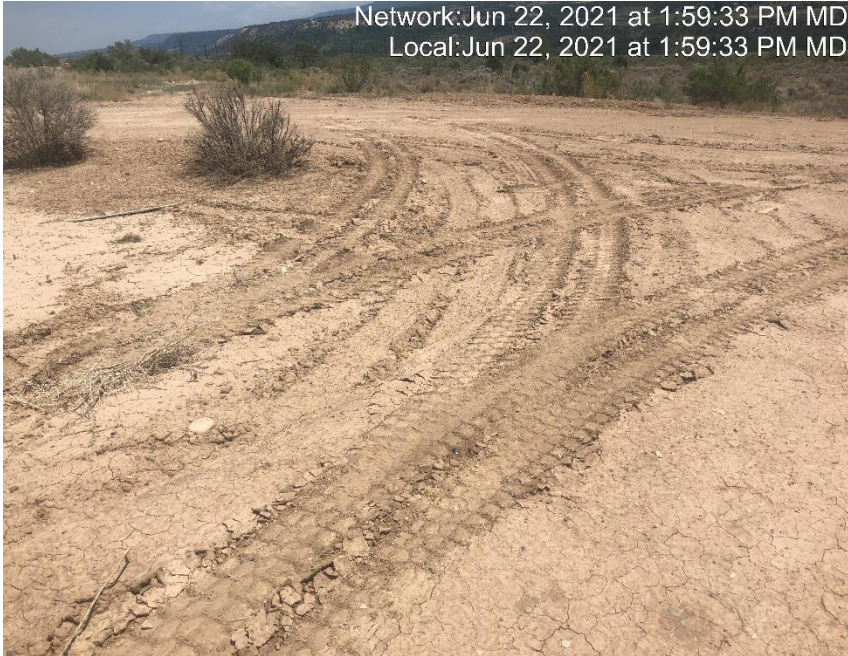
Photo #4146 Location lacks stabilization.

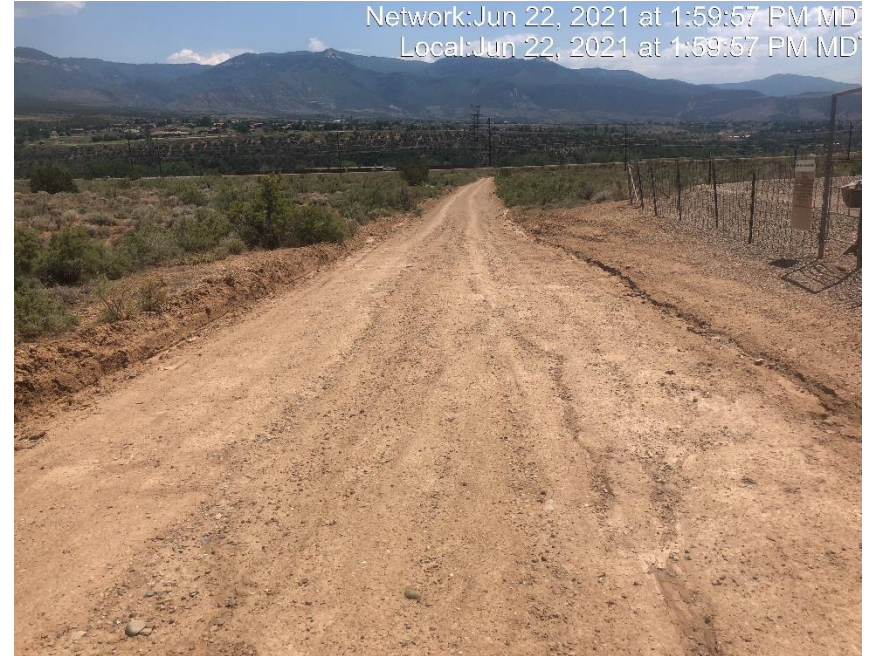
Photo #4147 No form of tracking BMP Located at entrance to location.

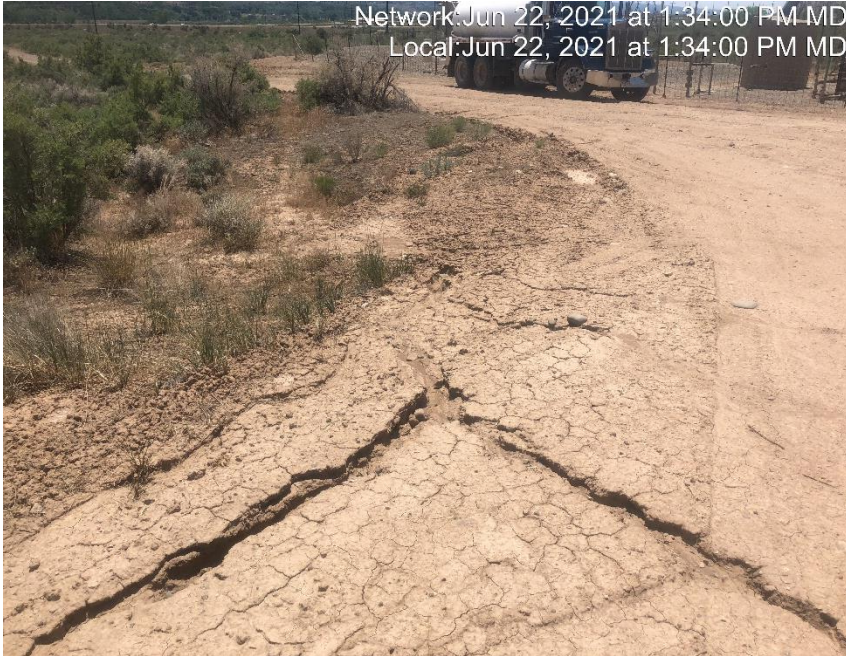
Photo #4137 Multiple places with Rill erosion occurring on location.

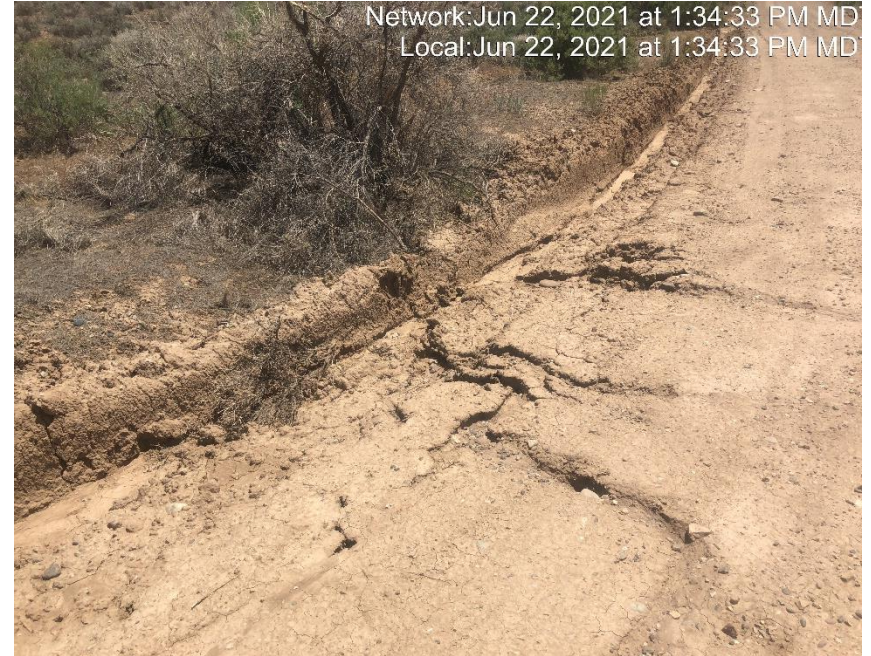
Photo #4138 Multiple places with Rill erosion occurring on location.

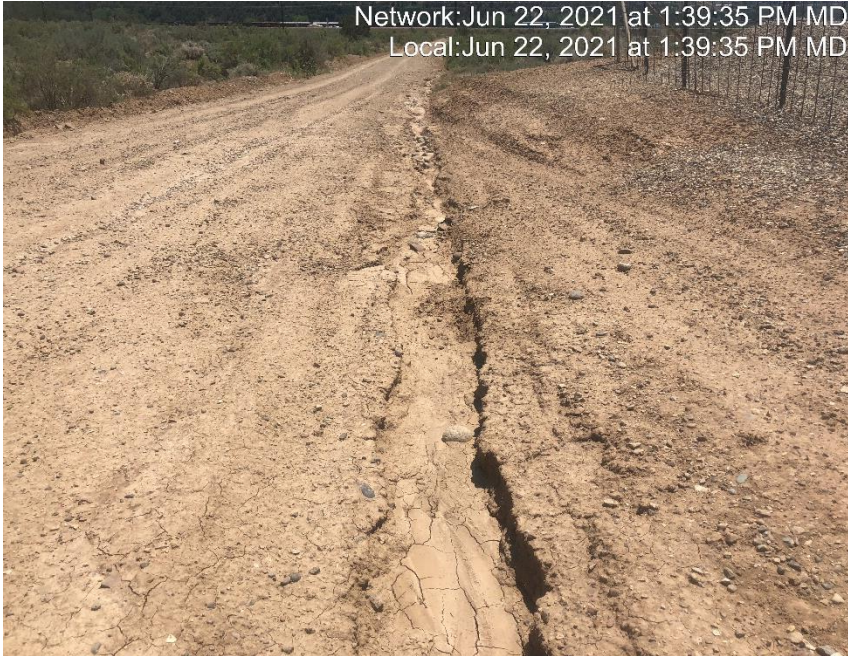
Photo #4140 No velocity checks located in ditches.

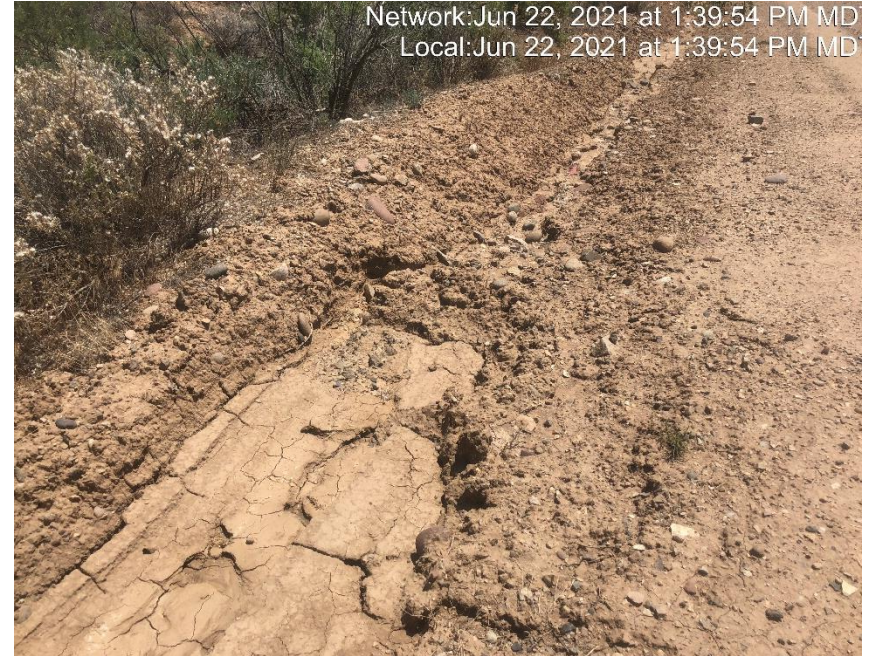
Photo #4141 No velocity checks located in ditches.

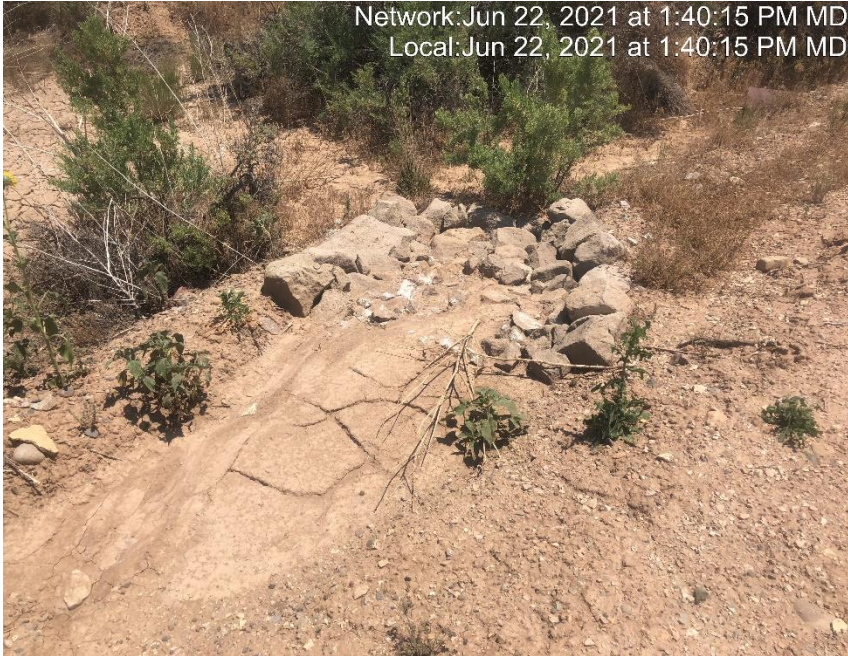
Photo #4142 Sediment trap insufficient.

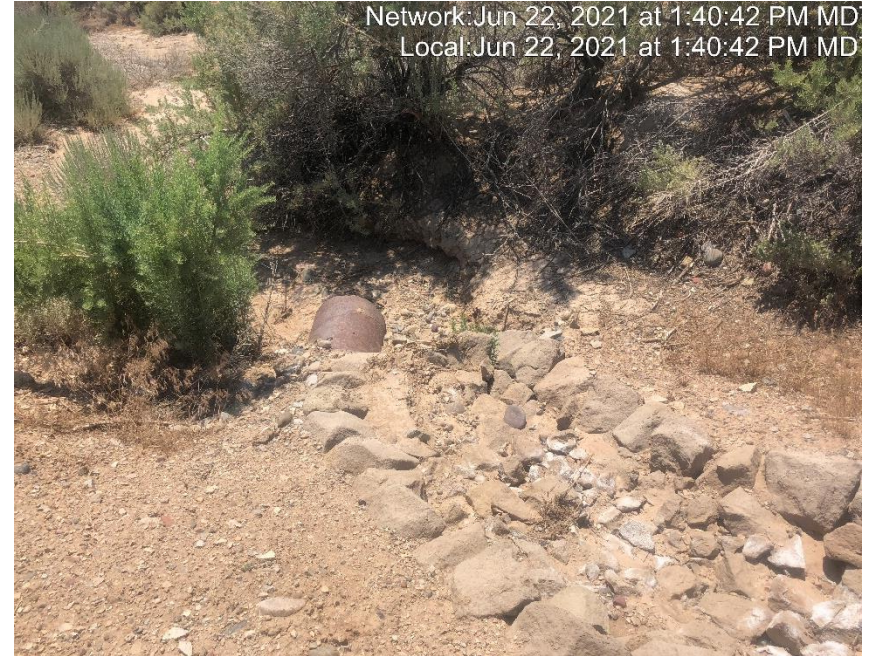
Photo #4144 Sediment trap insufficient.

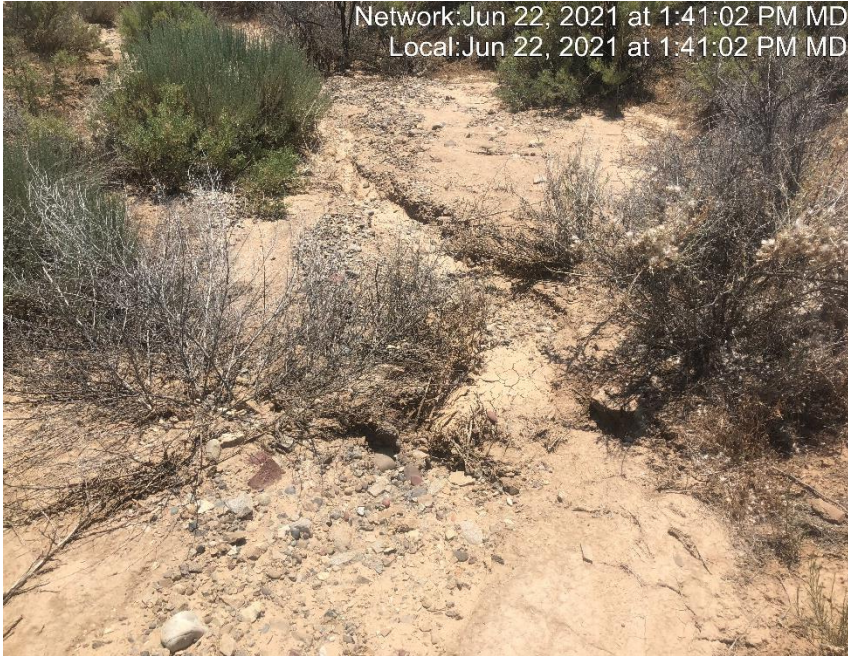
Photo #4145 Sediment migration and gully erosion occurring downstream of location and access road BMP's.
