# Inspection Photos

API: 009-06162

Operator: SOVEREIGN OPERATING COMPANY

Inspection Date: 6/21/2021

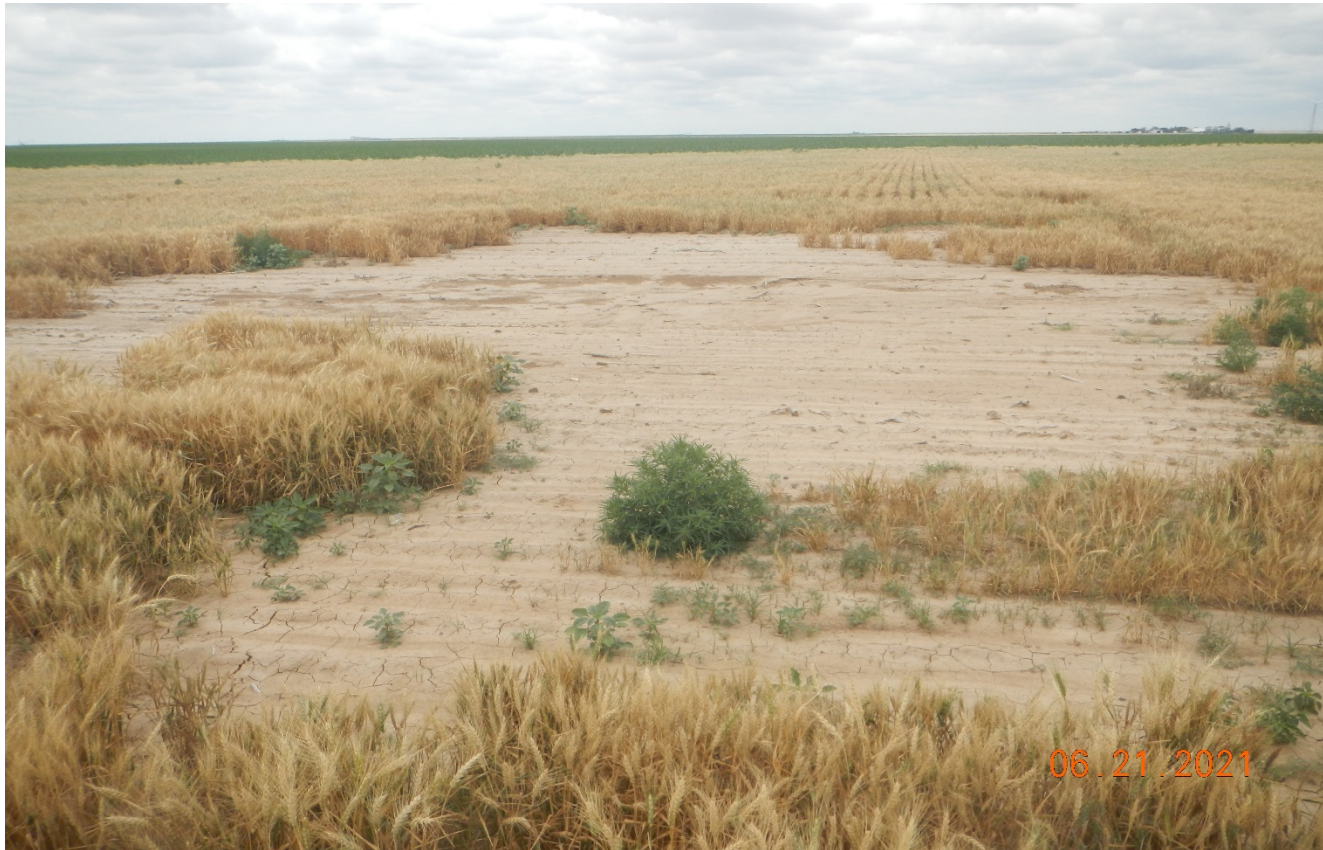
**Photo 1.** Facing east at former tank site. This area has not re-established a crop at 50'x40' area.

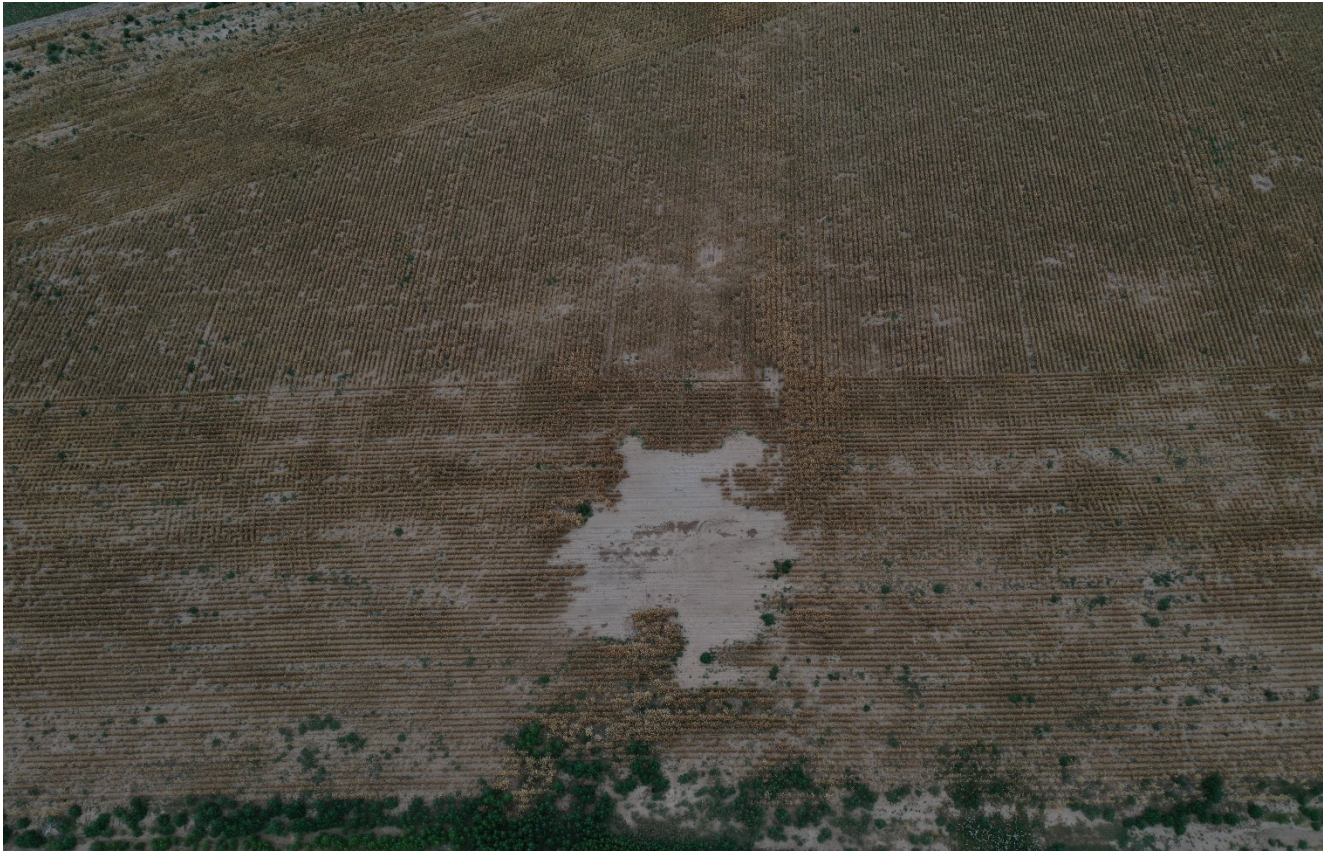
**Photo 2.** Drone aerial photo of tank battery sited which has not re-established crop cover.

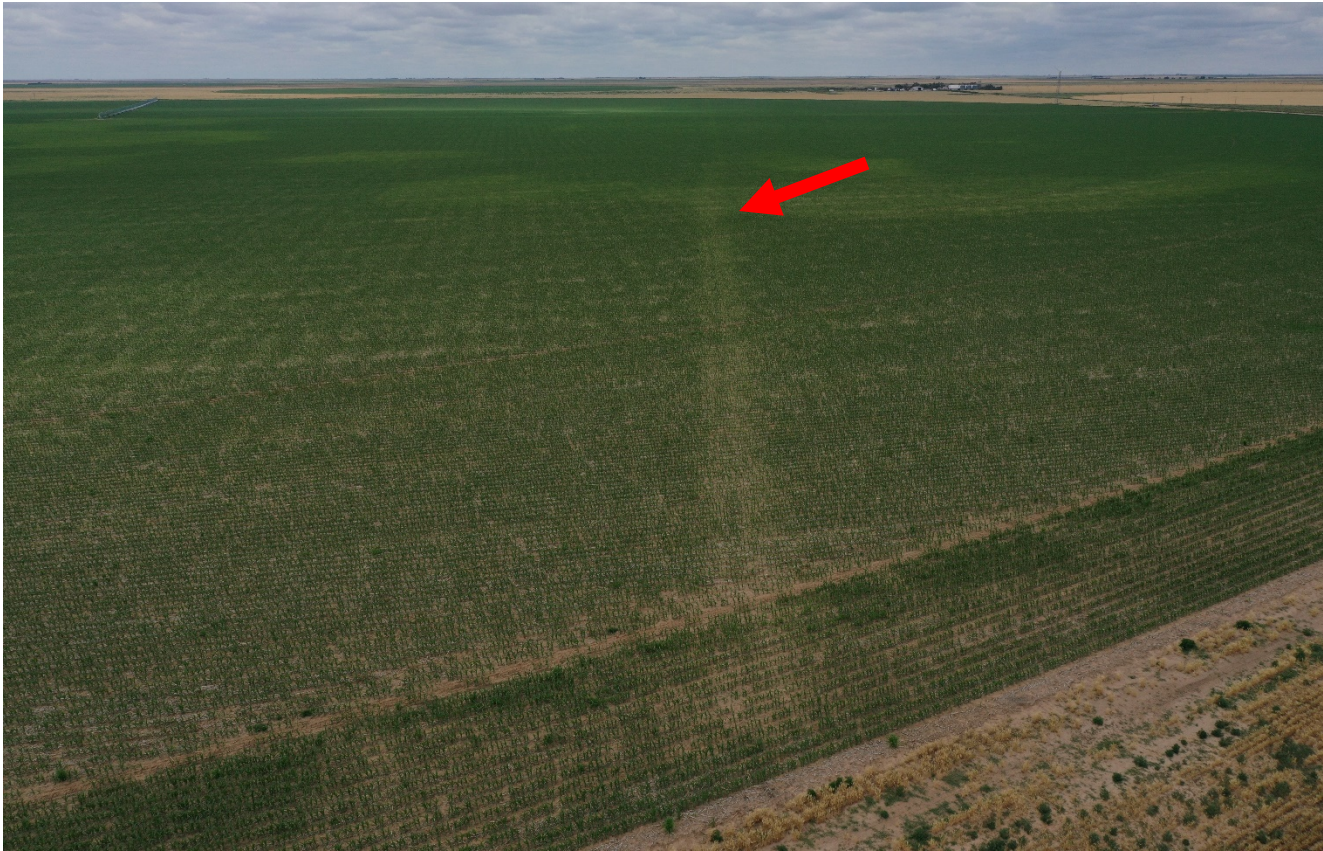
**Photo 3.** Drone aerial photo facing east toward access road and location shown at red arrow.

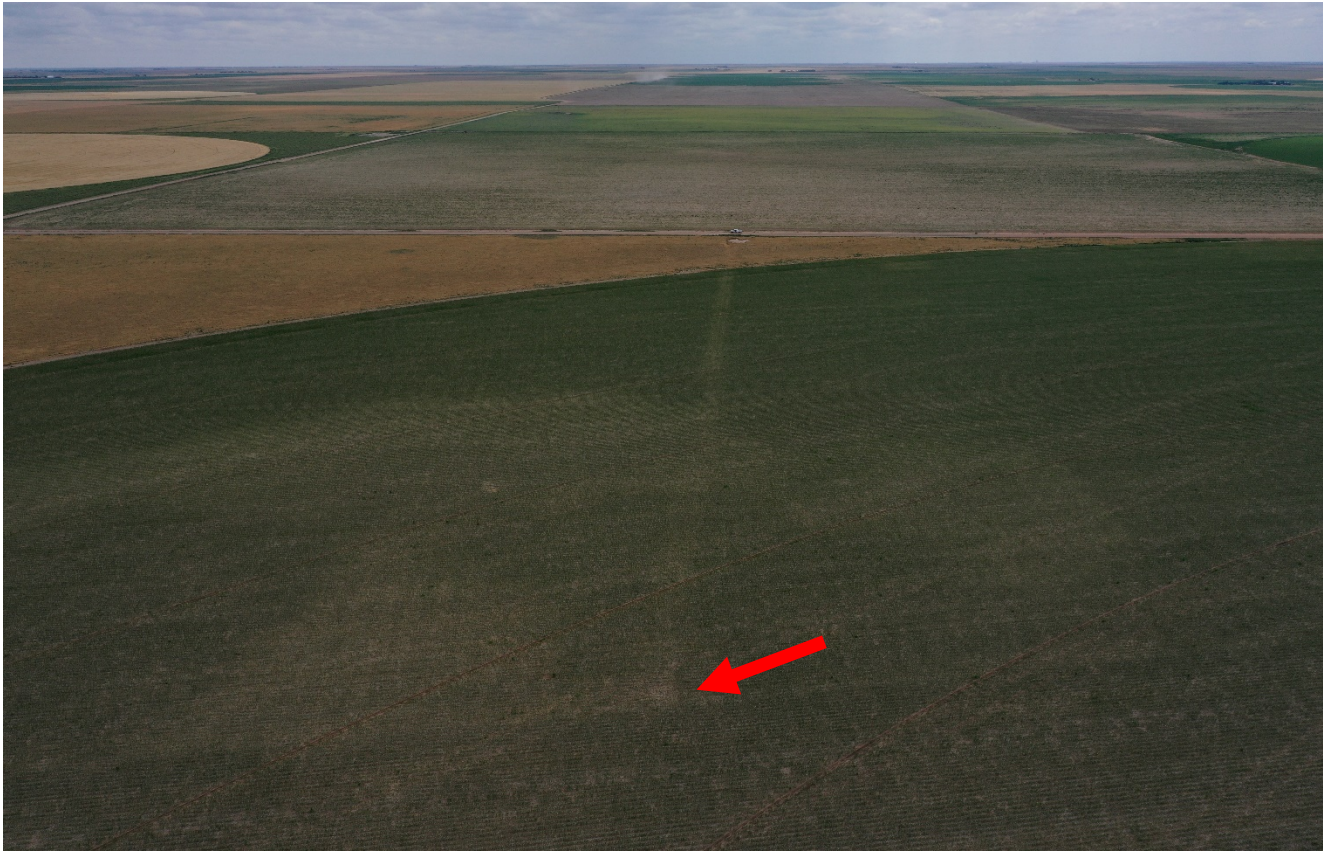
**Photo 4.** Drone aerial photo facing west toward access road and location shown at red arrow. It appears the crop has re-established along the access road and location.
