Inspection Photos

API: 009-06134

Operator: SAMSON OIL COMPANY

Inspection Date: 6/21/2021

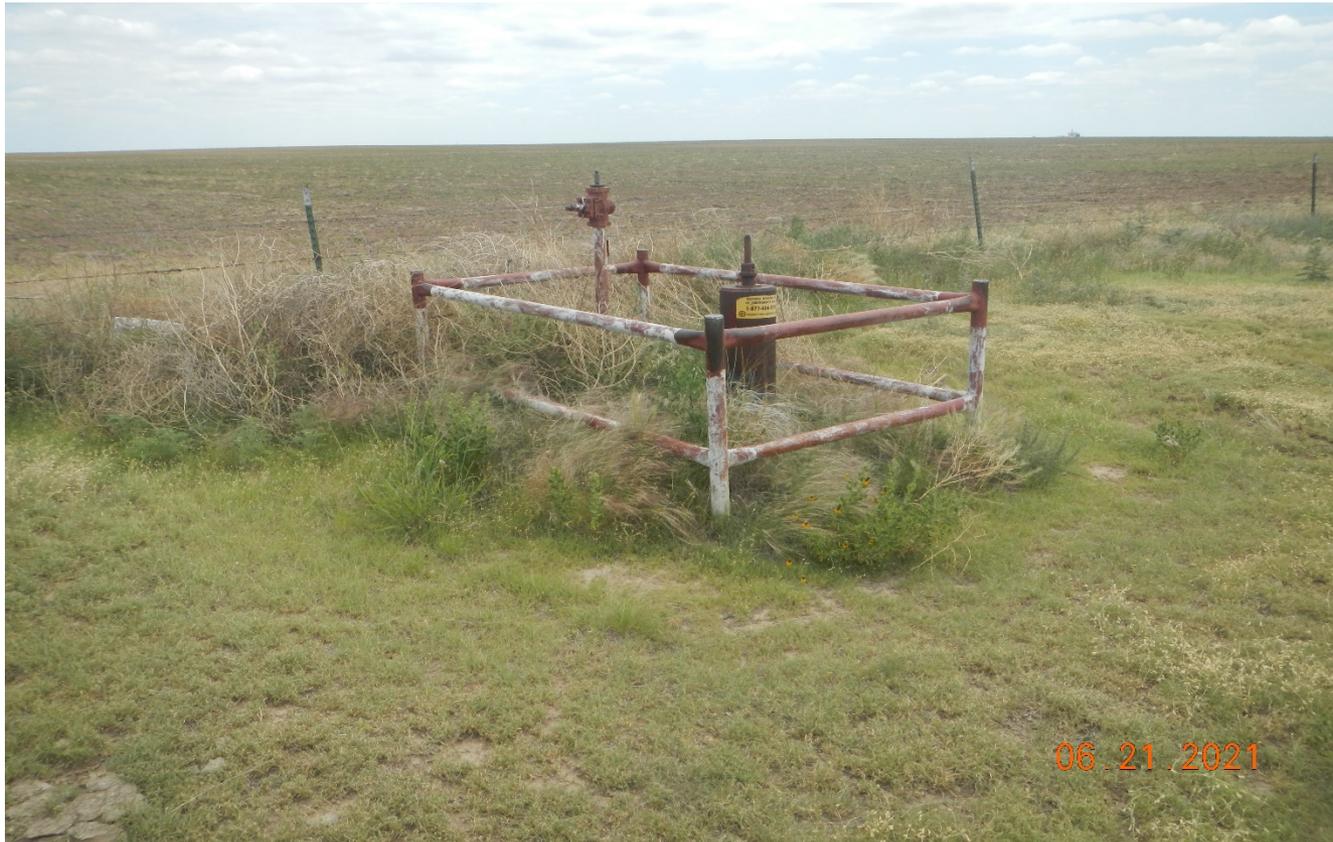
Photo 1. Approximately 100' northeast of the location is an abandoned pipeline user which must be removed.

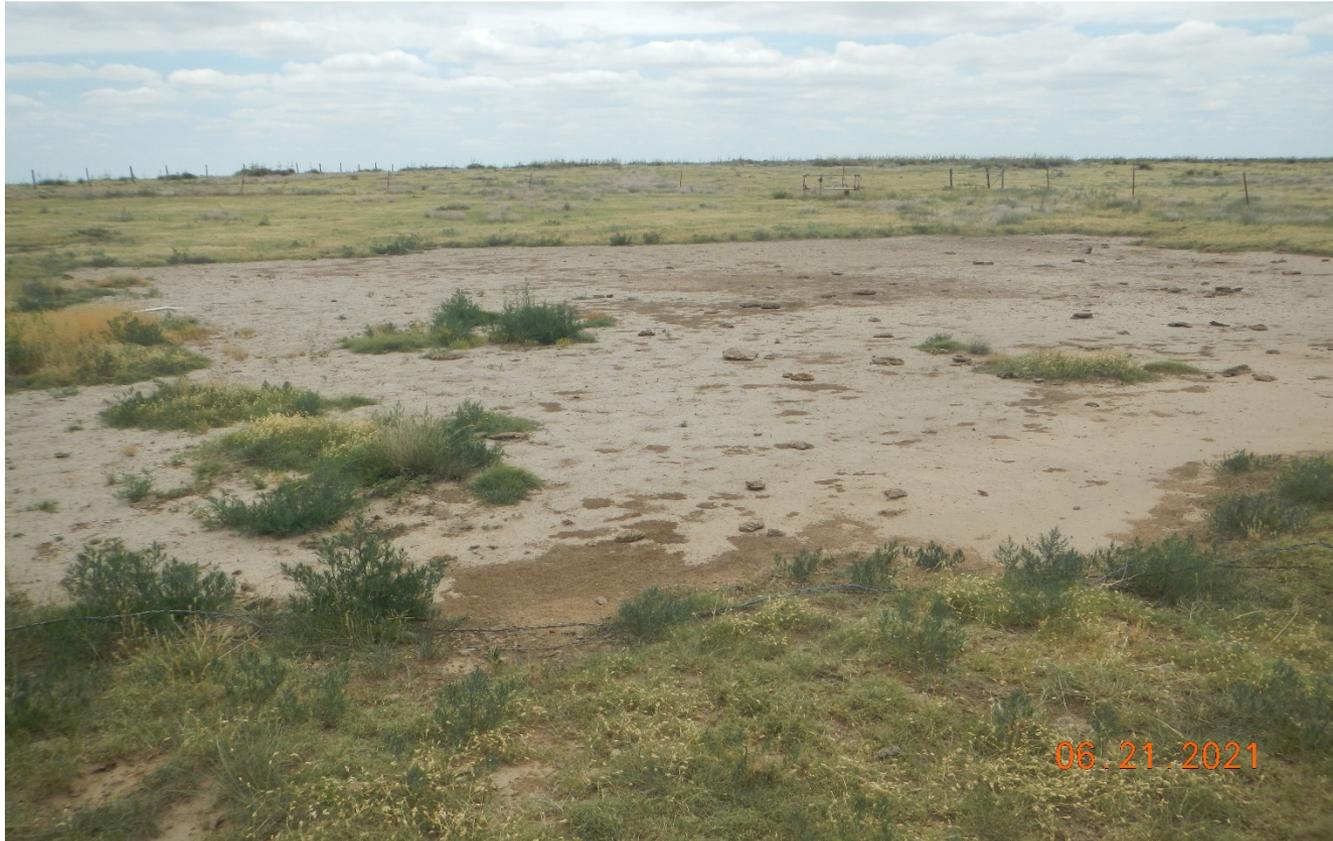
Photo 2. Facing south toward the location. There is no vegetation growth on this area of the location approximately 70'x70'.

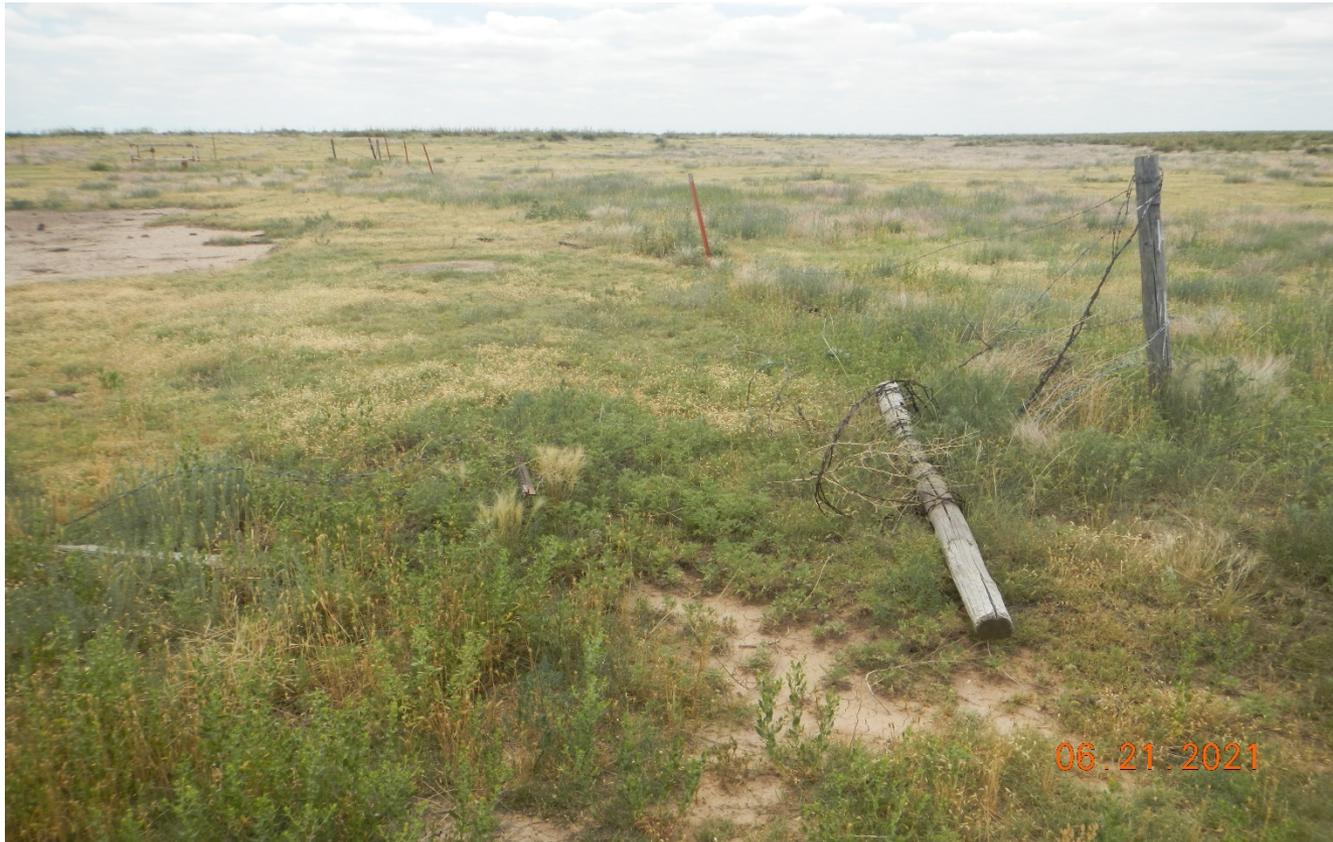
Photo 3. The perimeter fence remains in disrepair around the location.

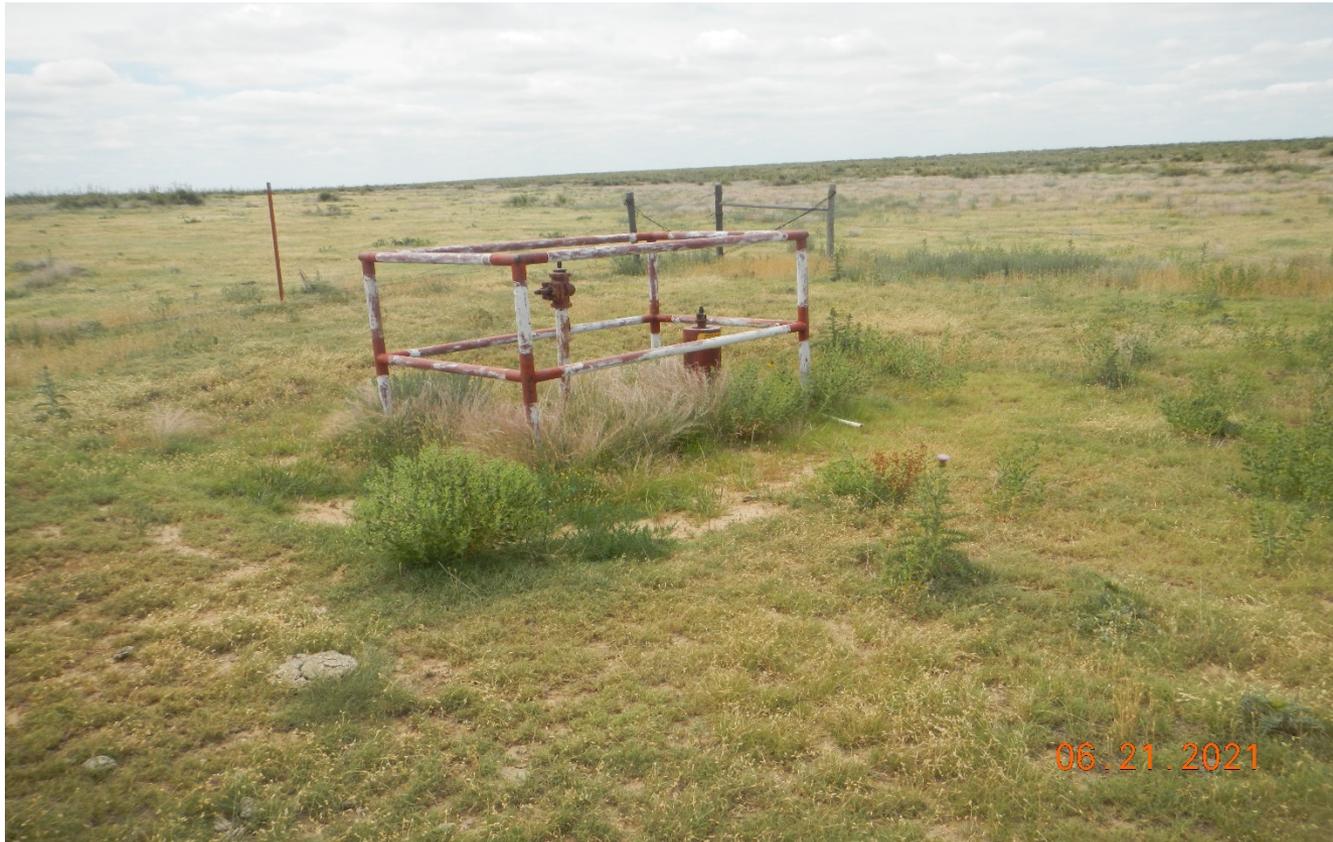
Photo 4. There is another pipeline riser that remains at the location that has not been removed.

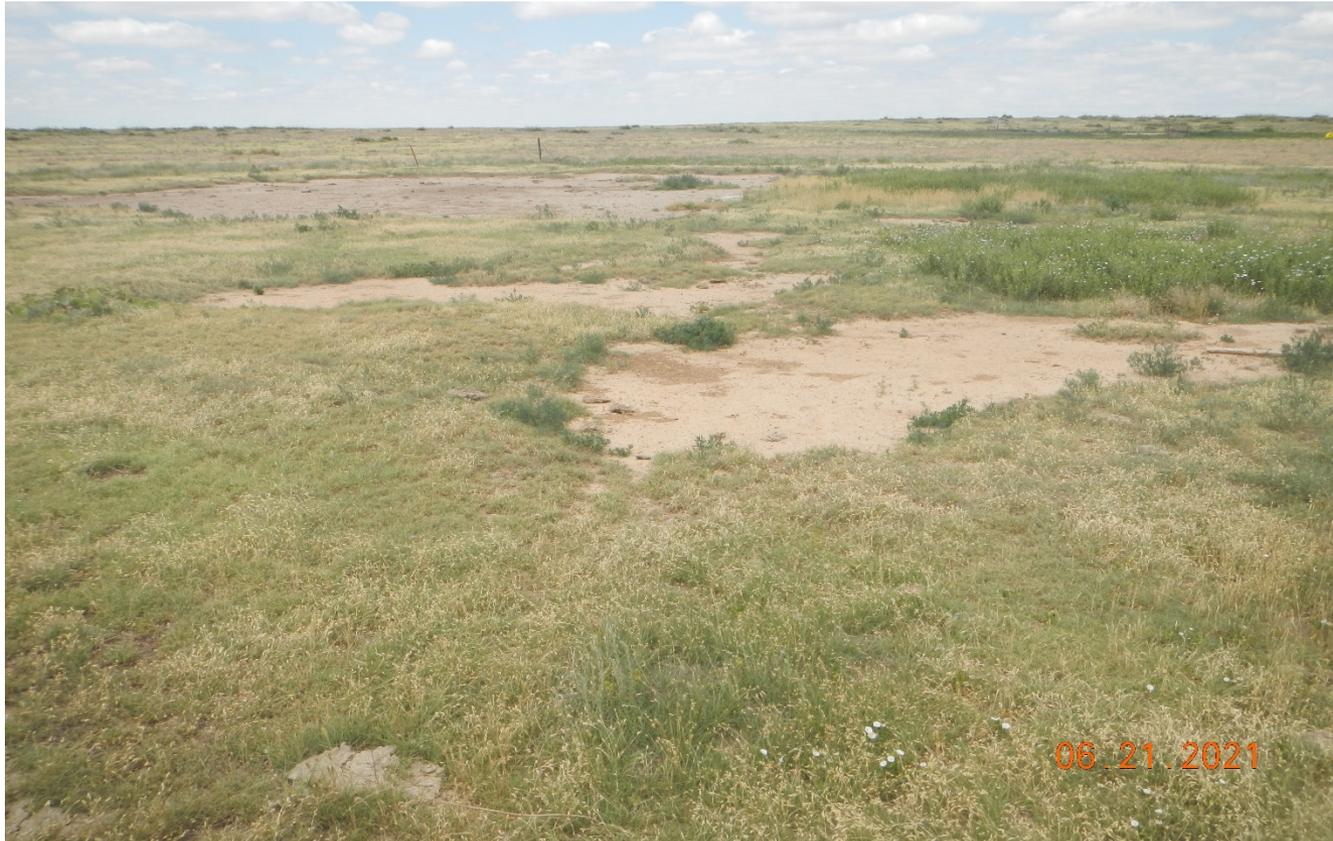
Photo 5. Facing northwest towards area that remain devoid of vegetation growth.
