Inspection Photos

API: 009-05157

Operator: PONCHO PRODUCTION COMPANY

Inspection Date: 6/21/2021

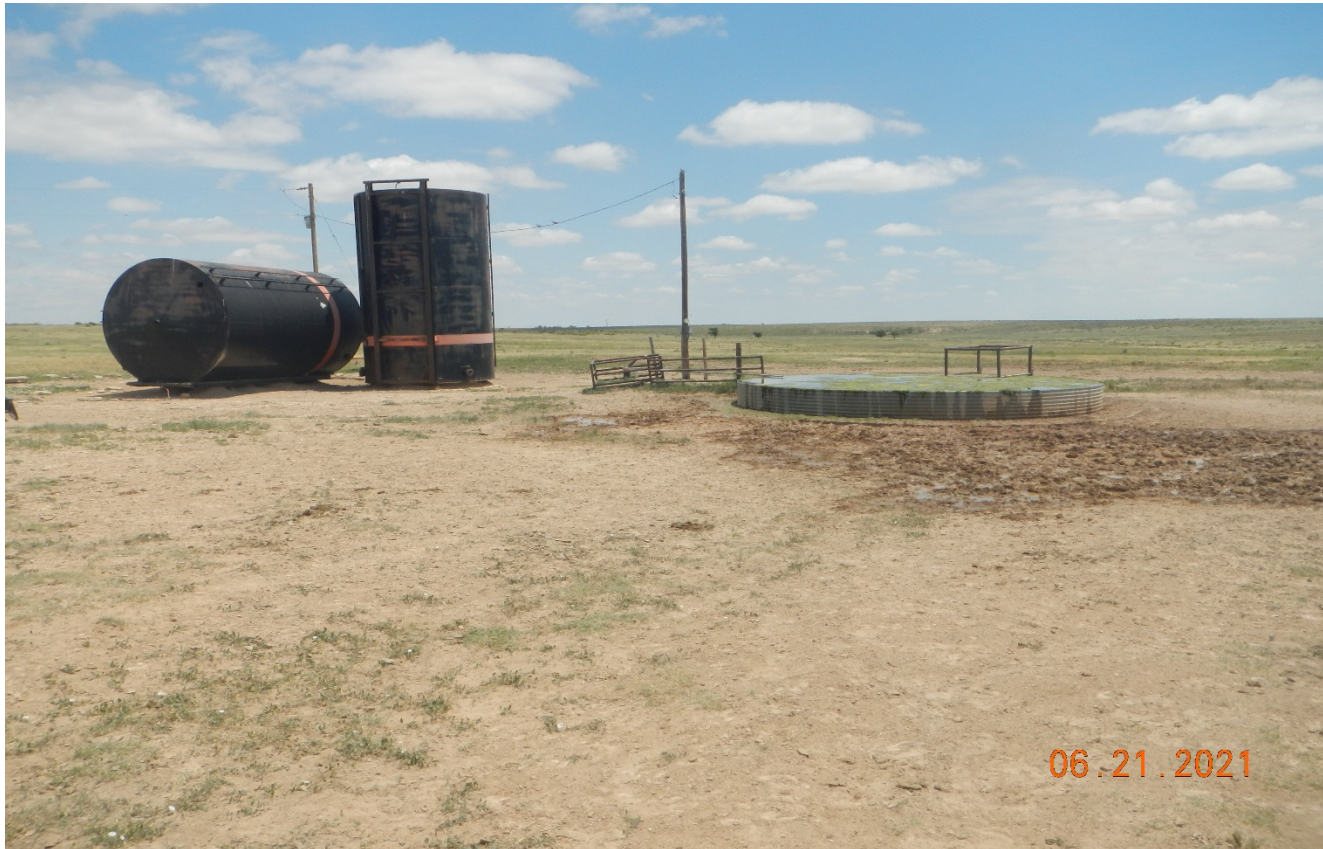
Photo 1. Facing southeast toward the location. There is a water well and stock tank at the location belonging to the landowner. The black two tanks shown were equipment from the well site which need to be removed.

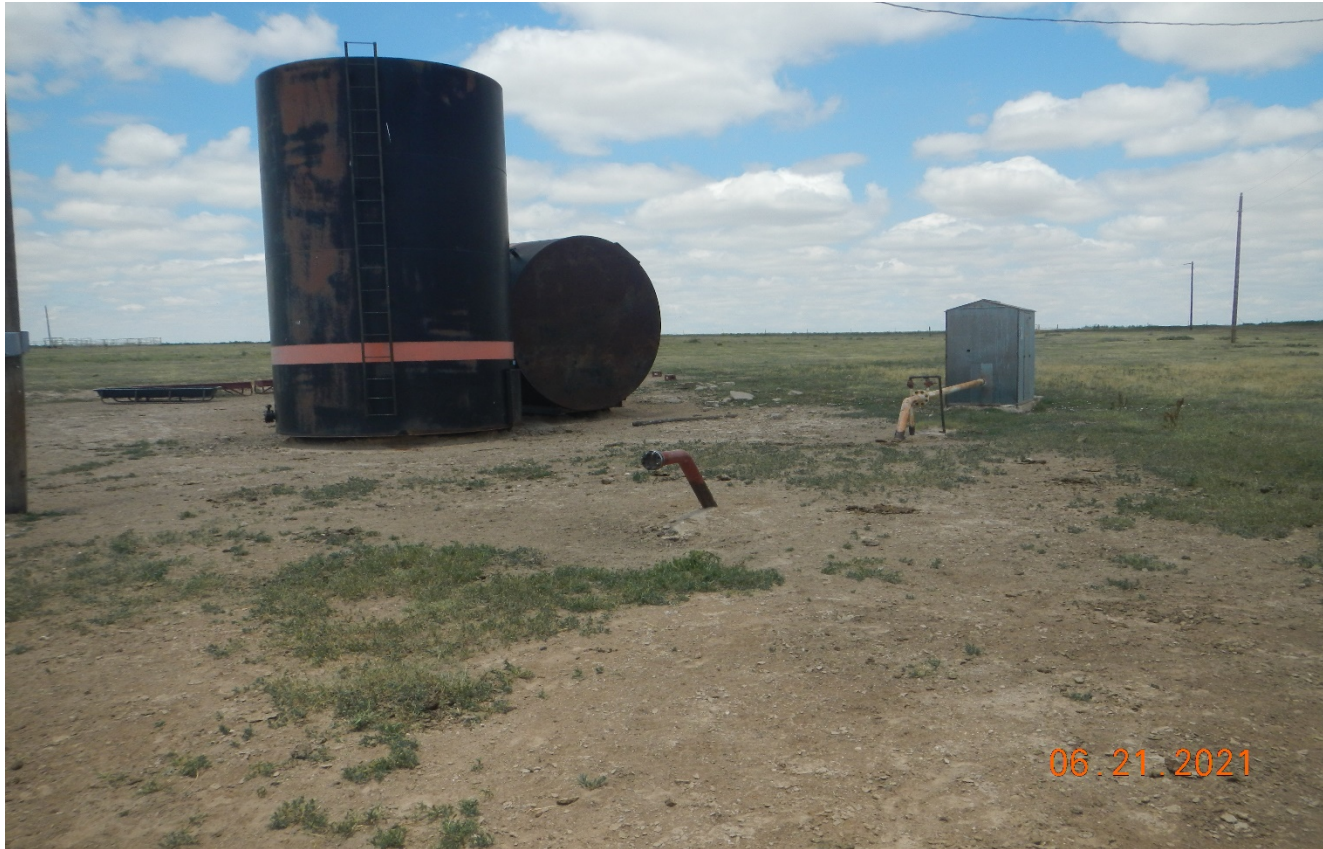
Photo 2. There are two tanks, pipe riser, and meter run that remain. All equipment should have been removed within 3 months of well abandonment.

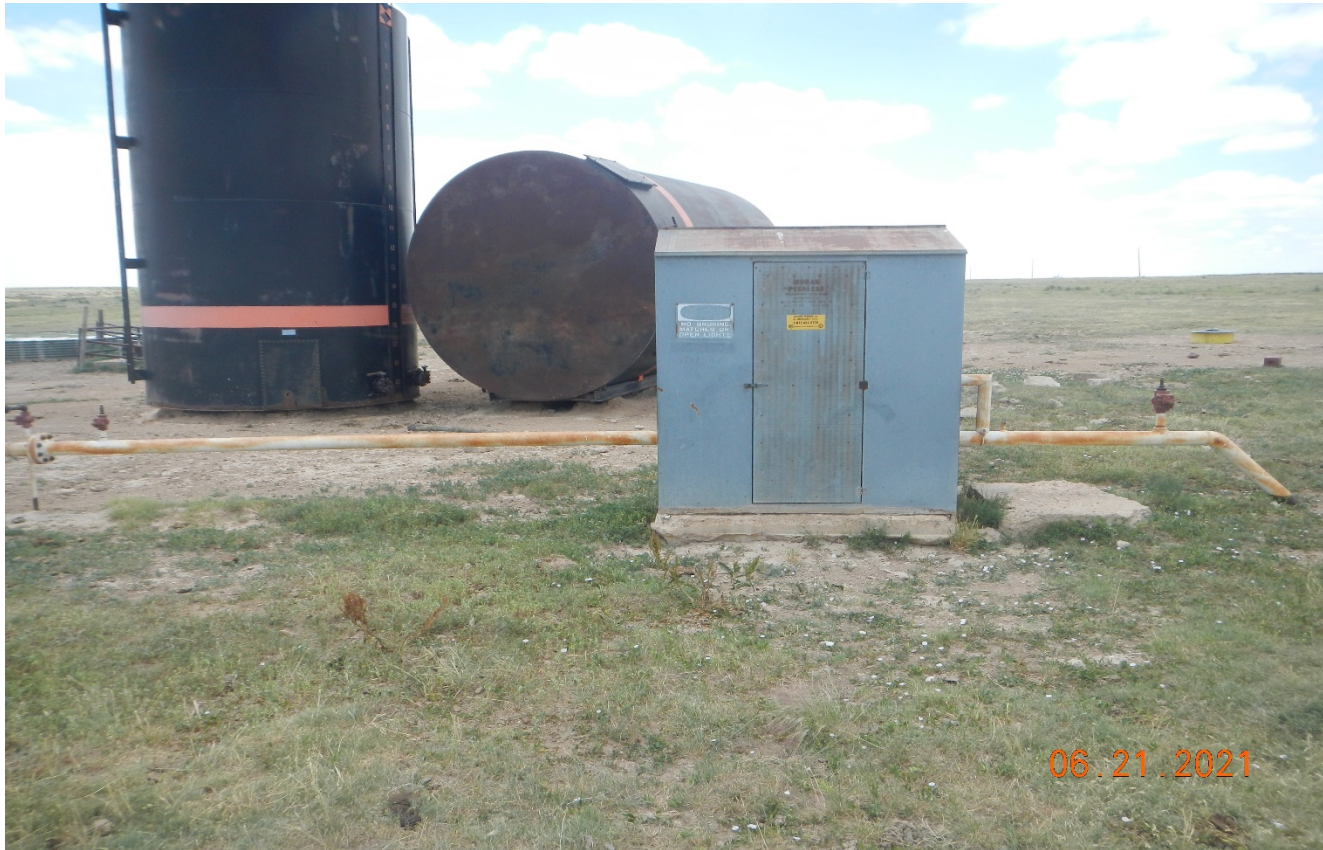
Photo 3. The meter run and shed remain at the location. All equipment should have been removed within 3 months of well abandonment.

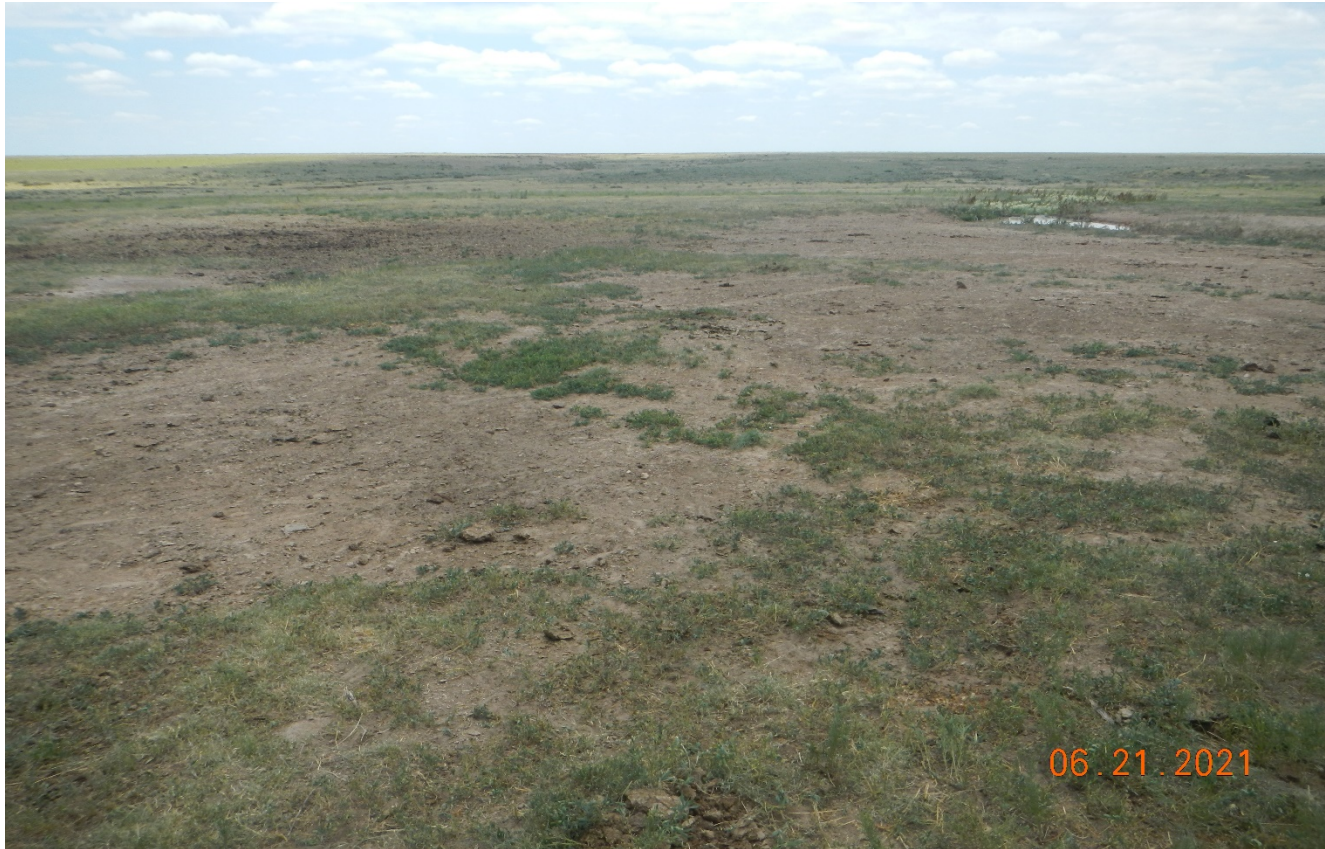
Photo 4. Facing southeast at the location. There are areas of the location with no vegetation growth which will need to be reclaimed.
