Inspection Photos

ID# 292827

Operator: JONES ENERGY LTD

Inspection Date: 6/21/2021

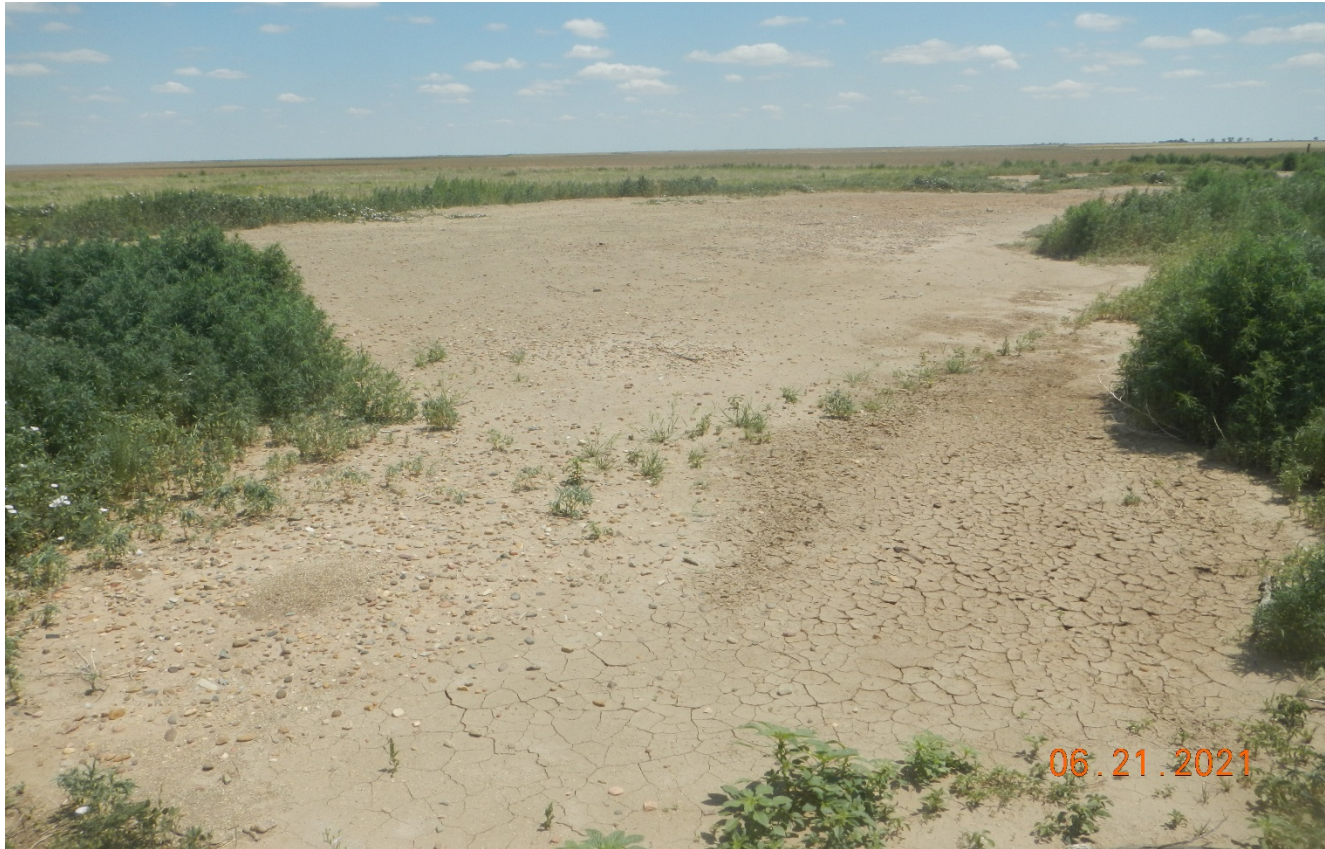
Photo 1. Facing southeast toward the location. There are undesirable weeds and areas with no vegetation growth at the location. The location is being farmed around and has not been returned to cropland production

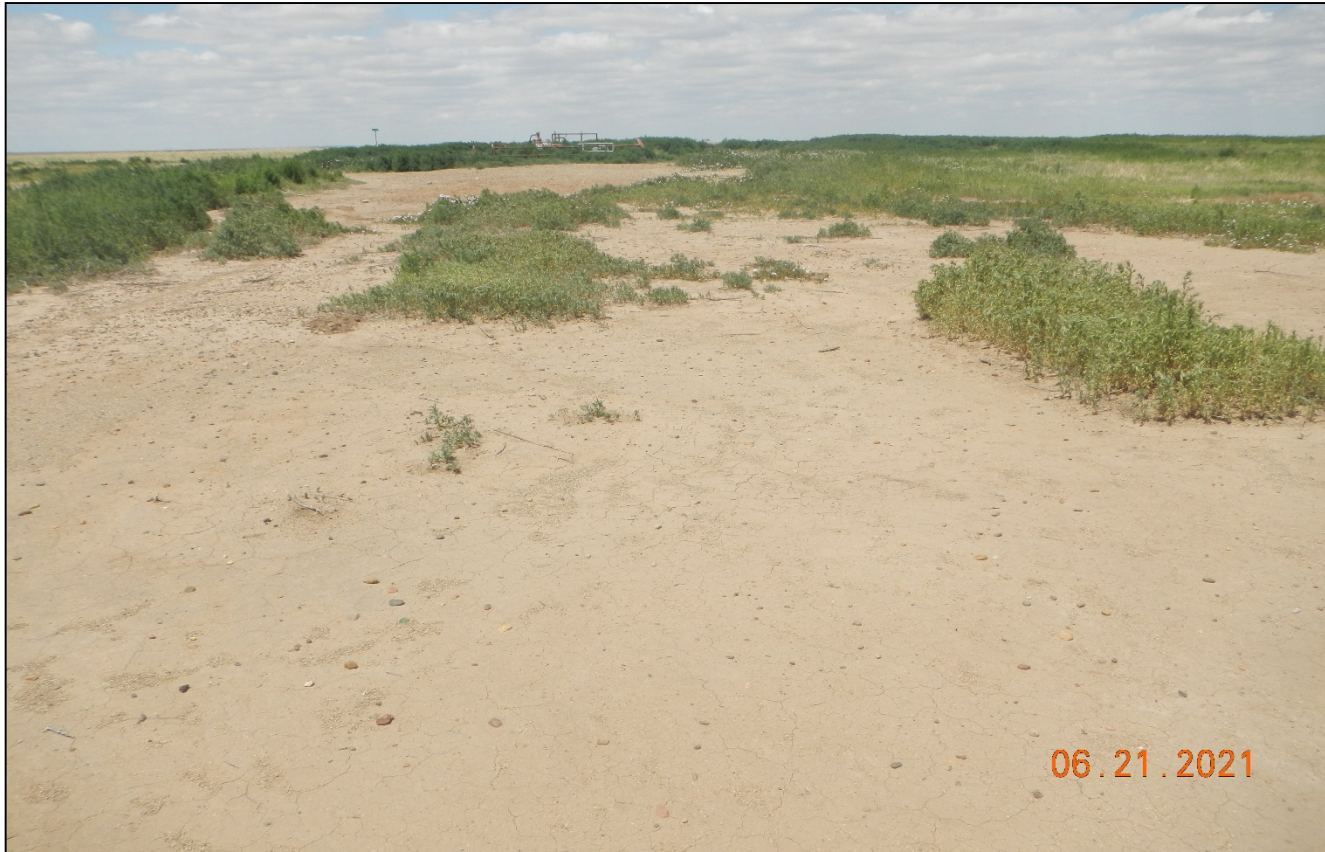
Photo 2. Southwest side of the location facing north. There are undesirable weeds and areas with no vegetation growth at the location.

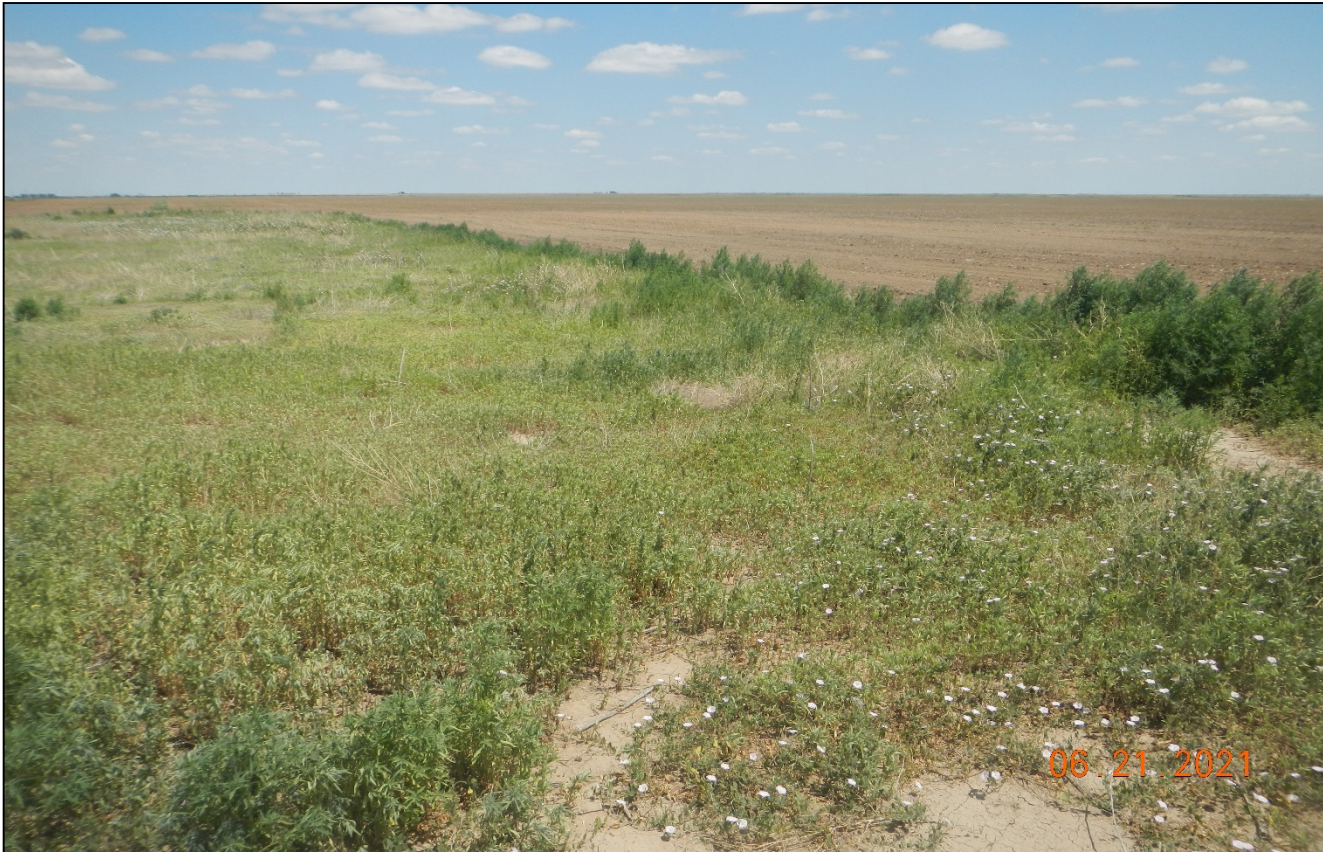
Photo 3. Facing southeast along the southern side. The location is being farmed around and has not been returned to cropland production. There are undesirable weeds throughout the location.

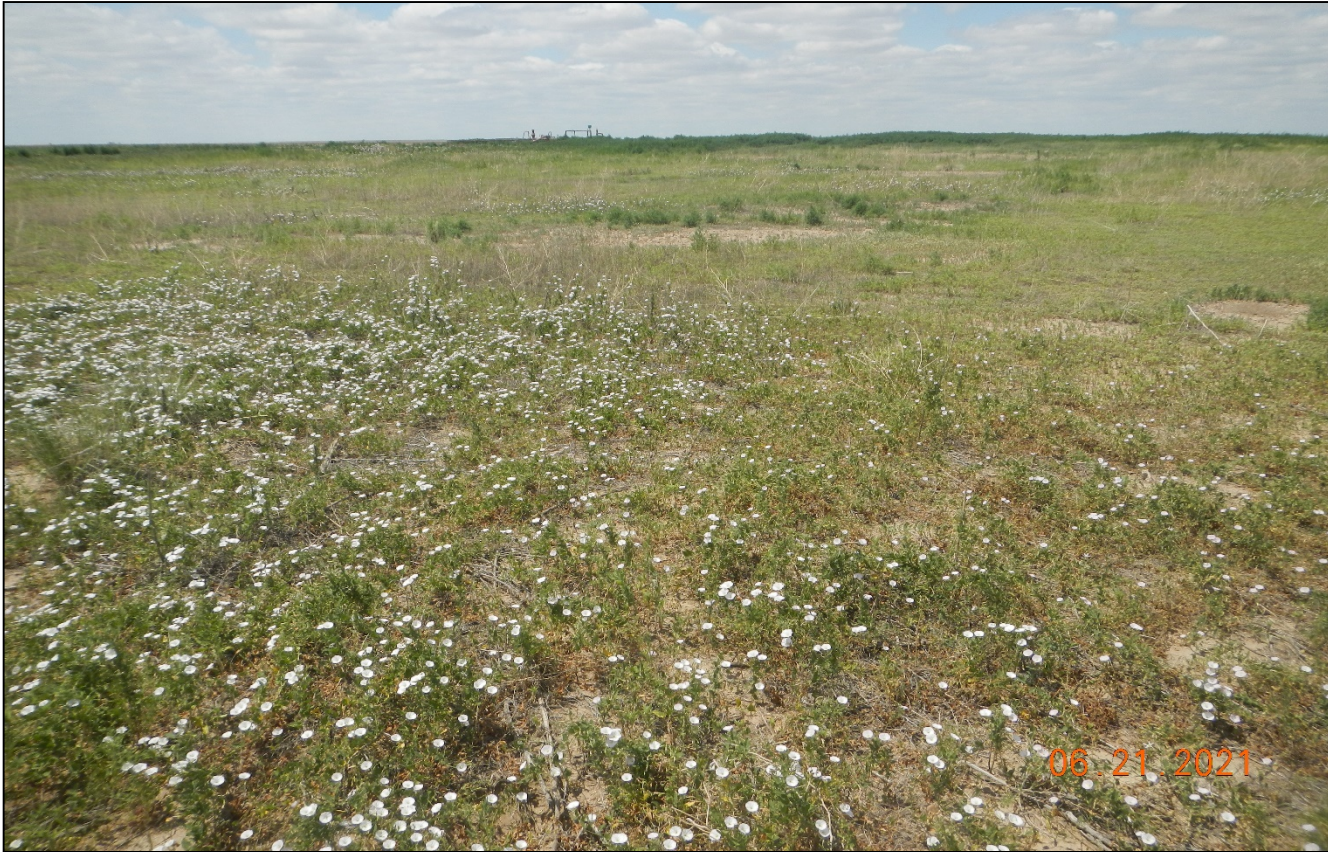
Photo 4. Southeast side of the location facing northwest. There are undesirable and noxious weeds throughout the location.

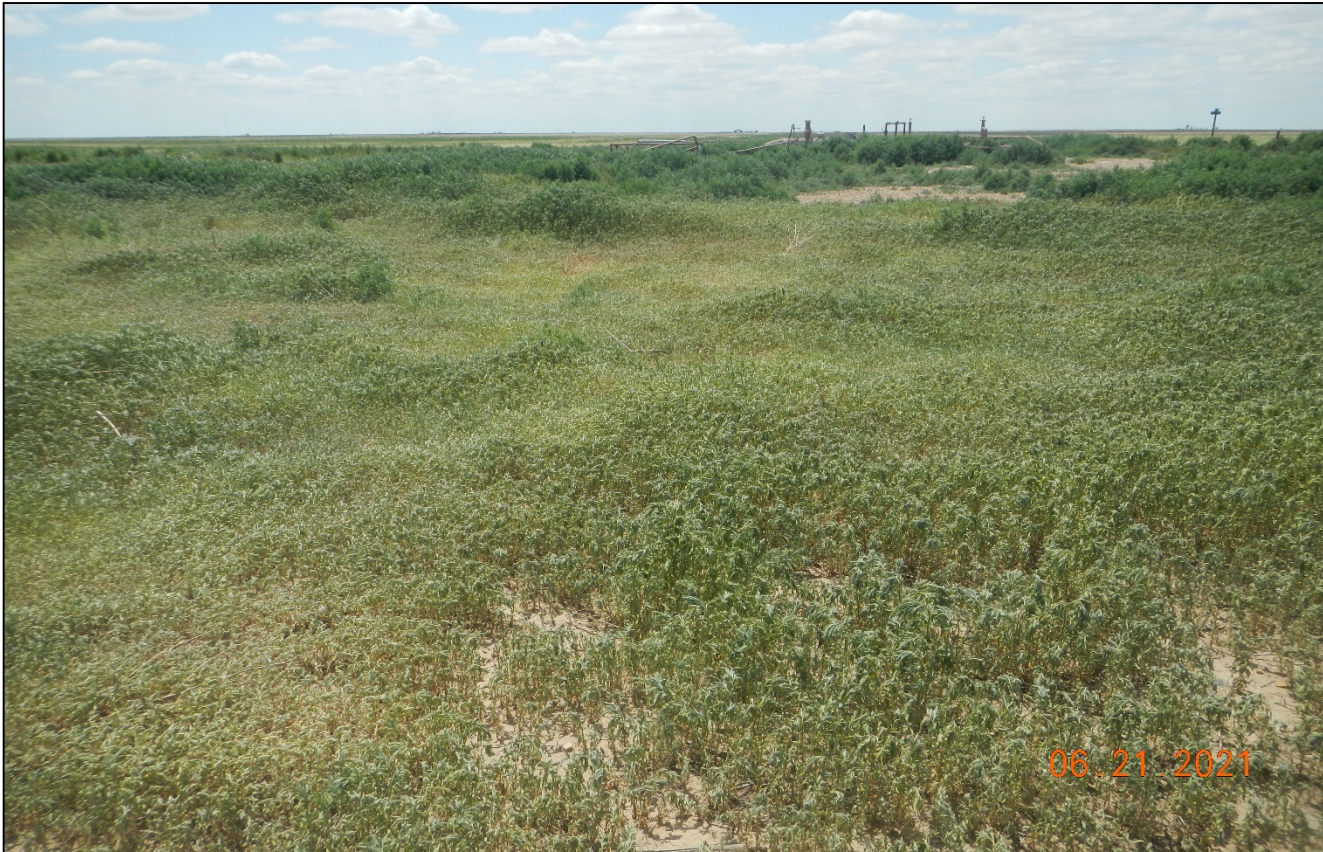
Photo 5. North side of the location facing west. Undesirable weeds are growing throughout this area.

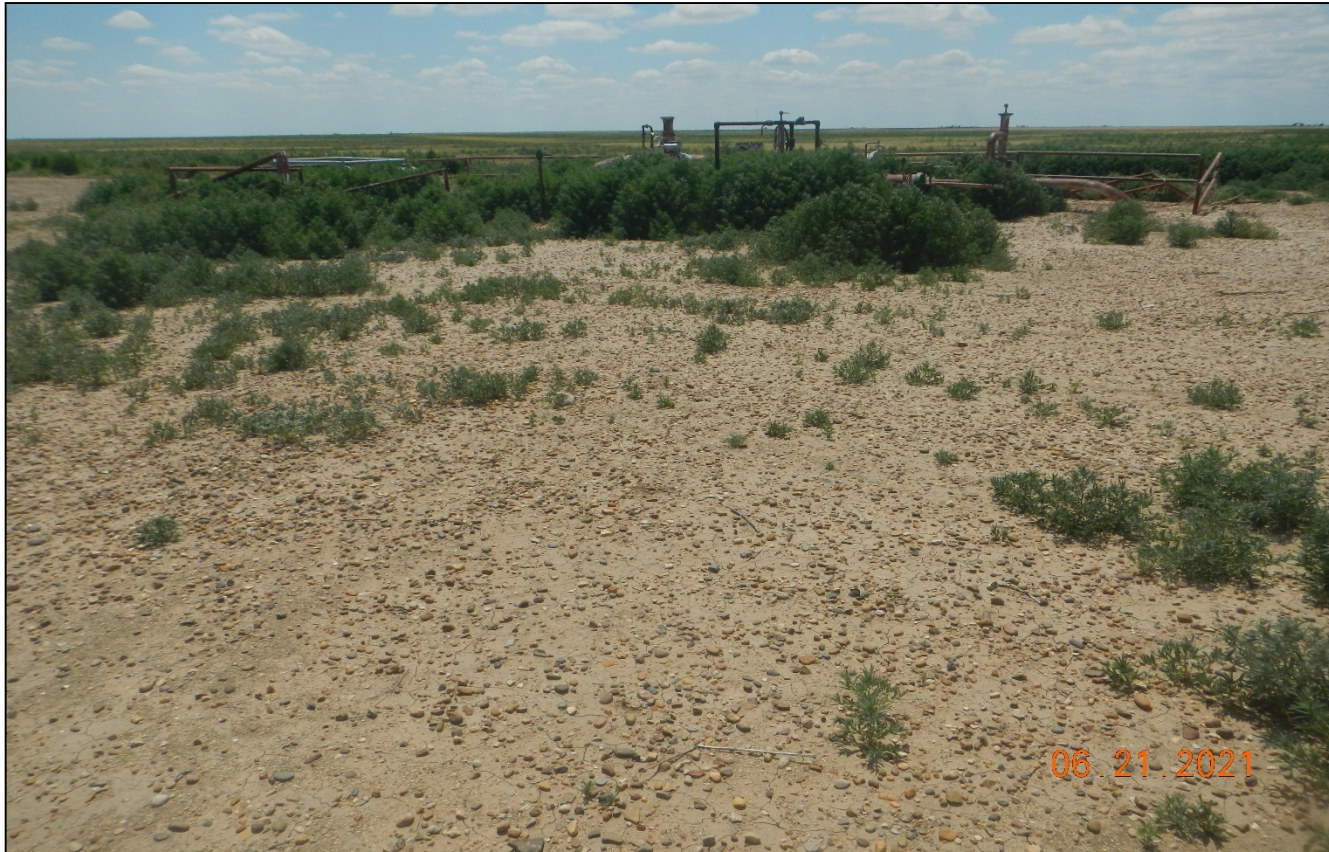
Photo 6. The pipeline riser remains at the northwest side of the location.
