Inspection Photos

6/23/2021

Operator: LARAMIE ENERGY LLC - 10433

Location ID: 335815

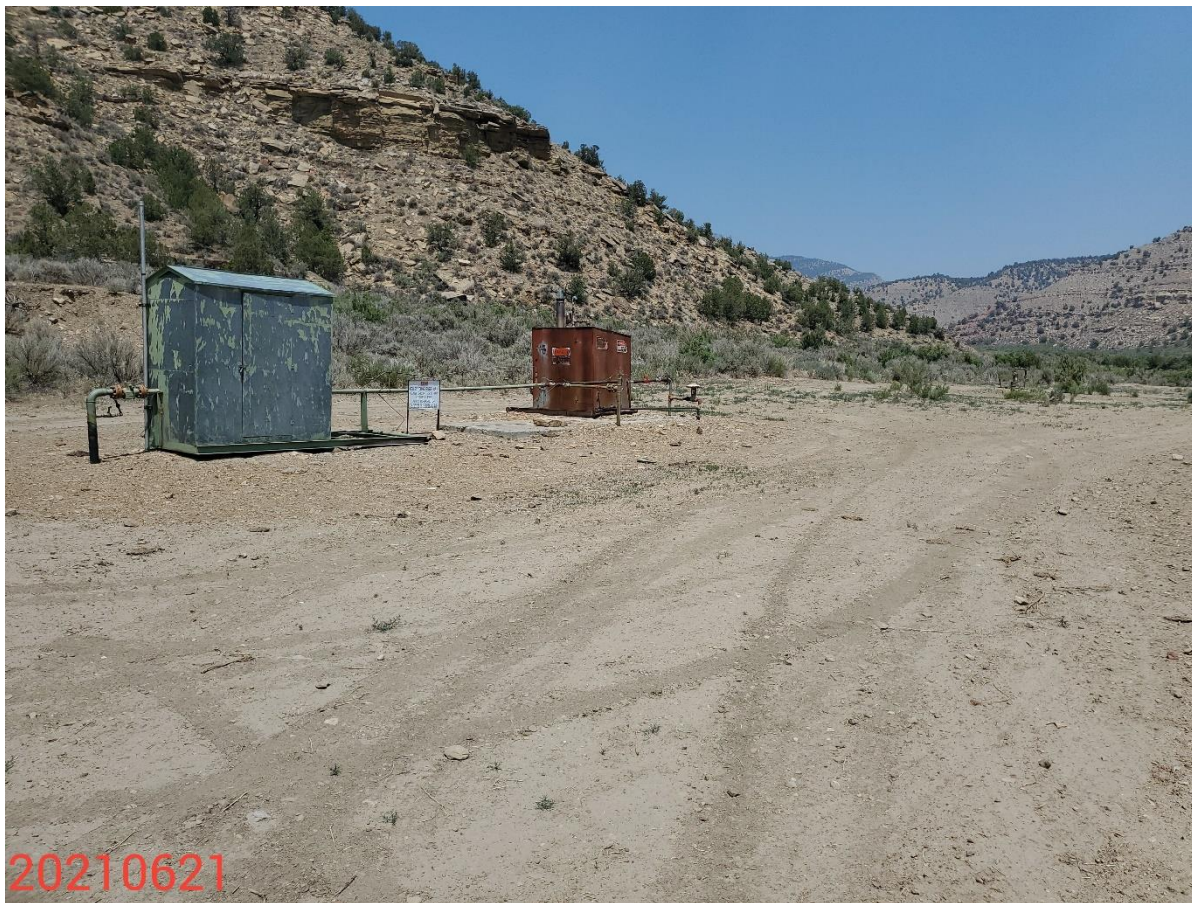
Photo 1: Photo taken from the south end of the Location, facing northwest. Photo provides an overview of the Location.

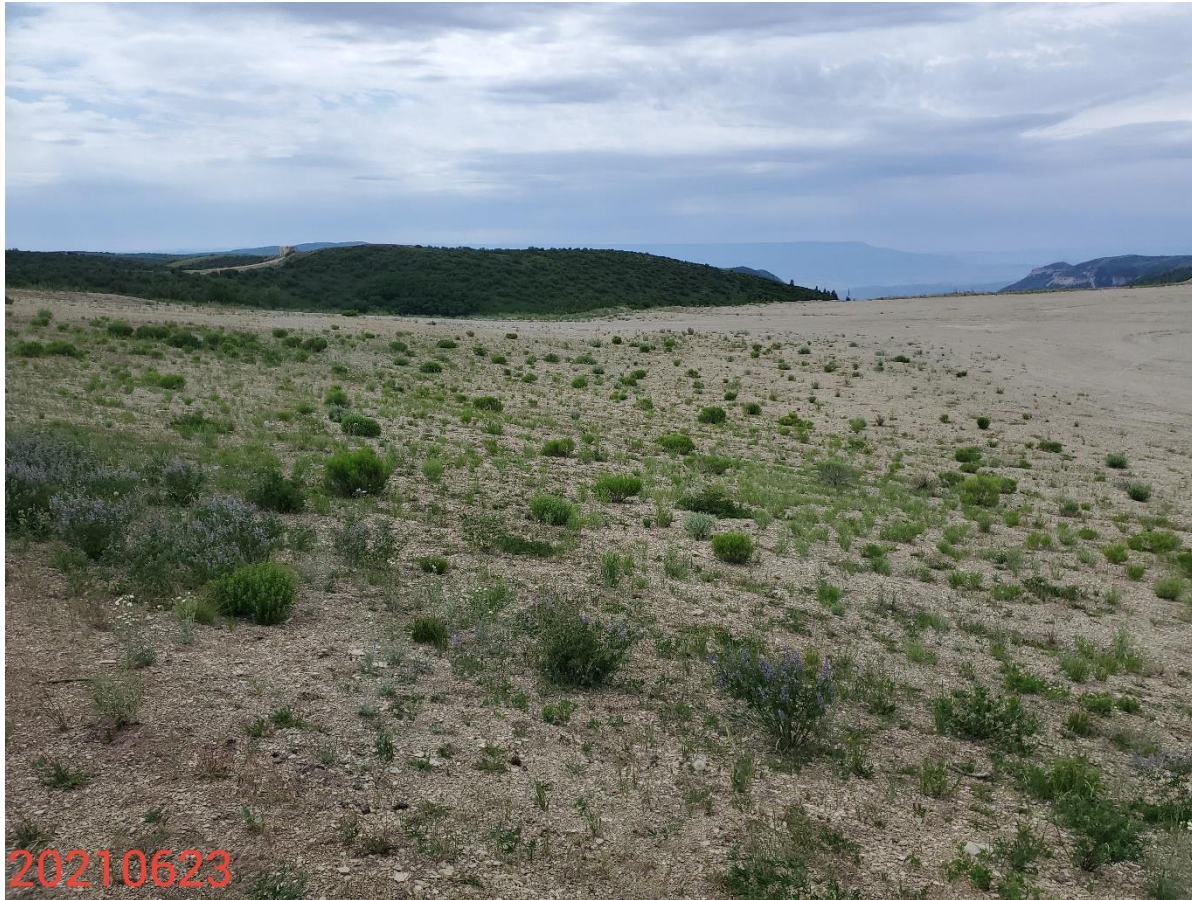
Photo 2: Photo taken from the North end of the Location facing southeast. Photos 2-5 provide and overview of the Location from southeast, south, southwest to west. Photos show interim reclamation of areas not needed for production has not been performed in accordance with 1003 Rules and Corrective actions.

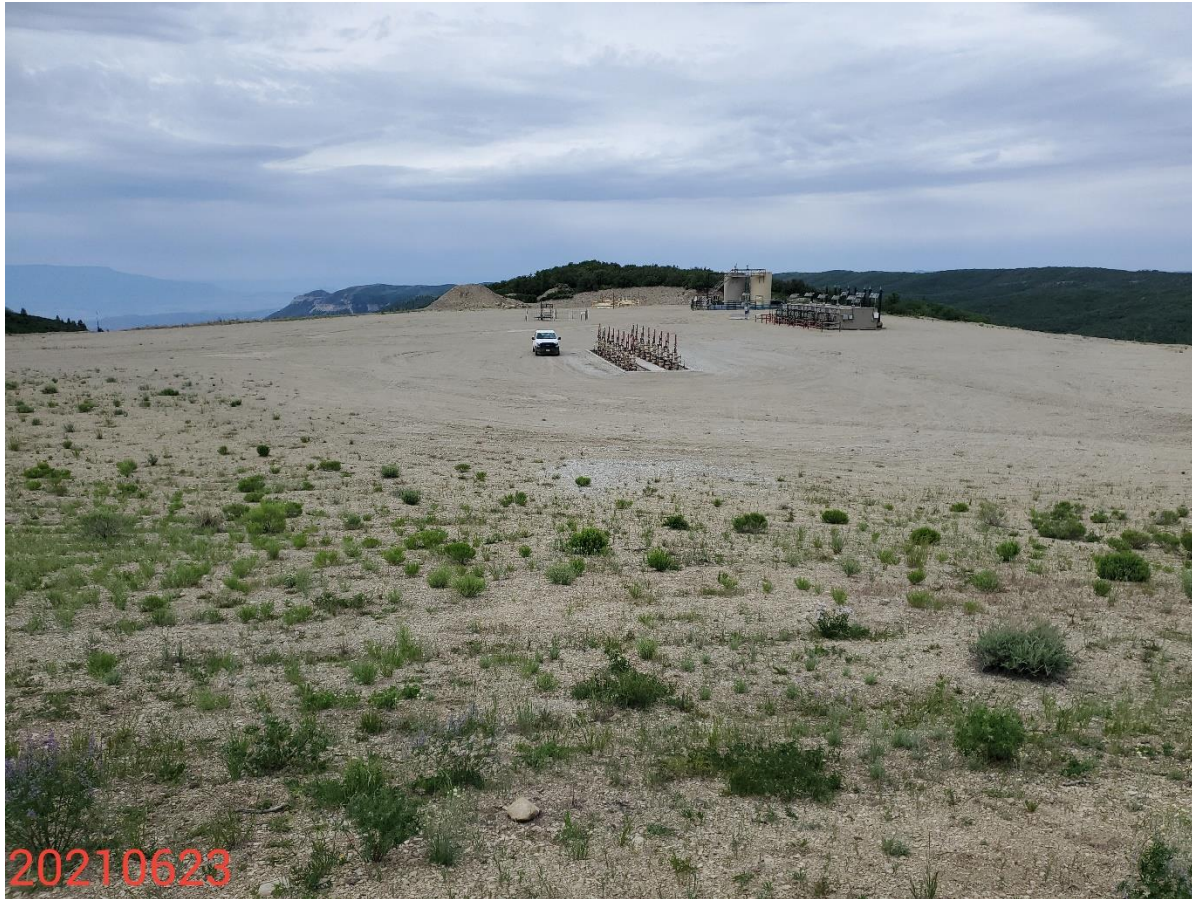
Photo 3: See comments under photo 2.

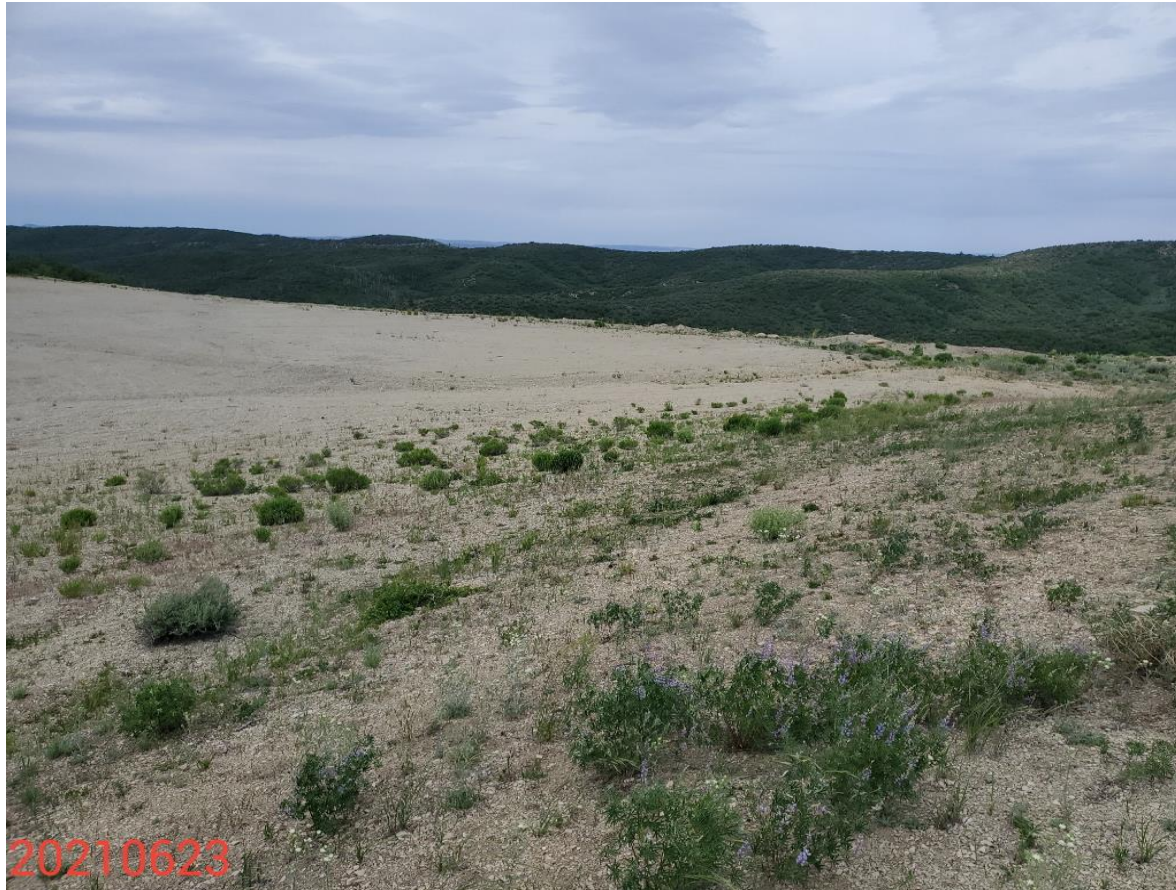
Photo 4: See comments under photo 2. .

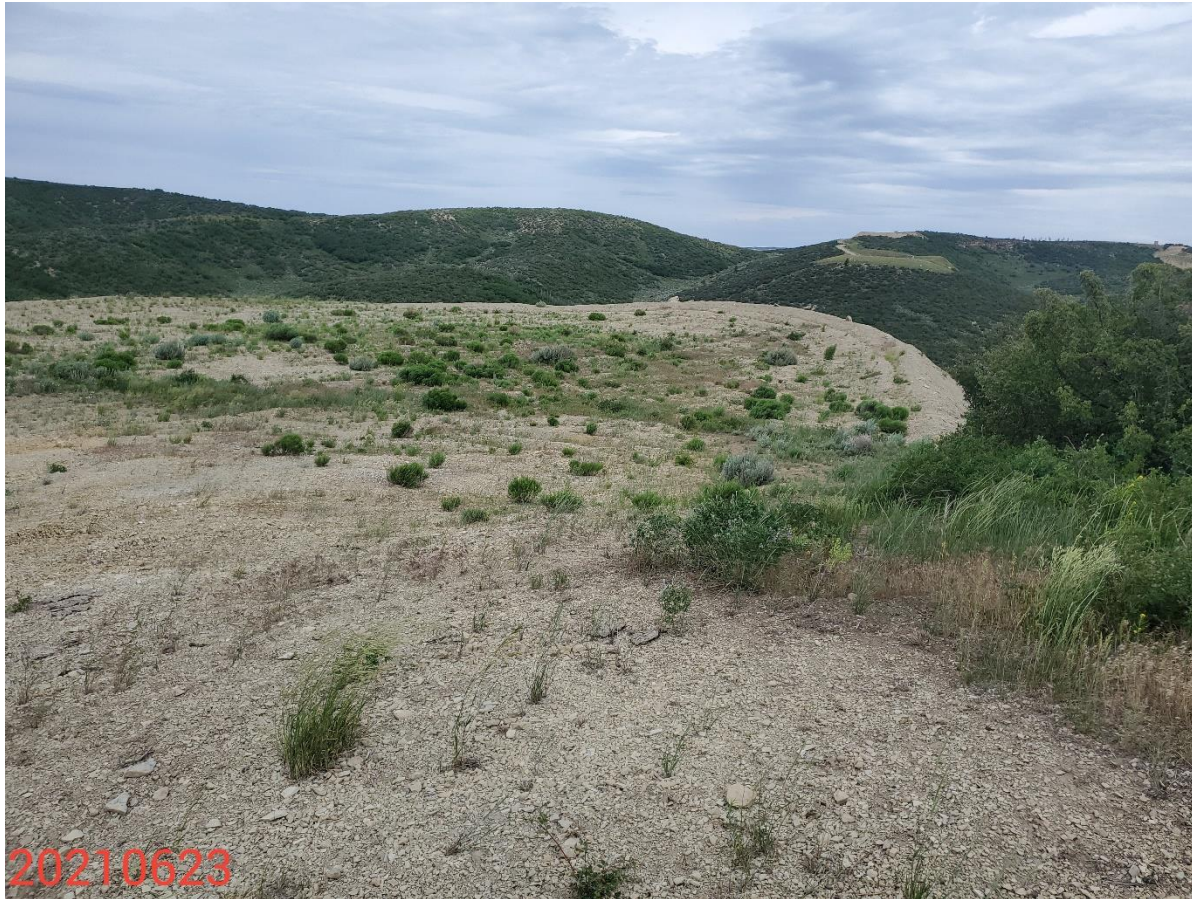
Photo 5: See comments under photo 2.

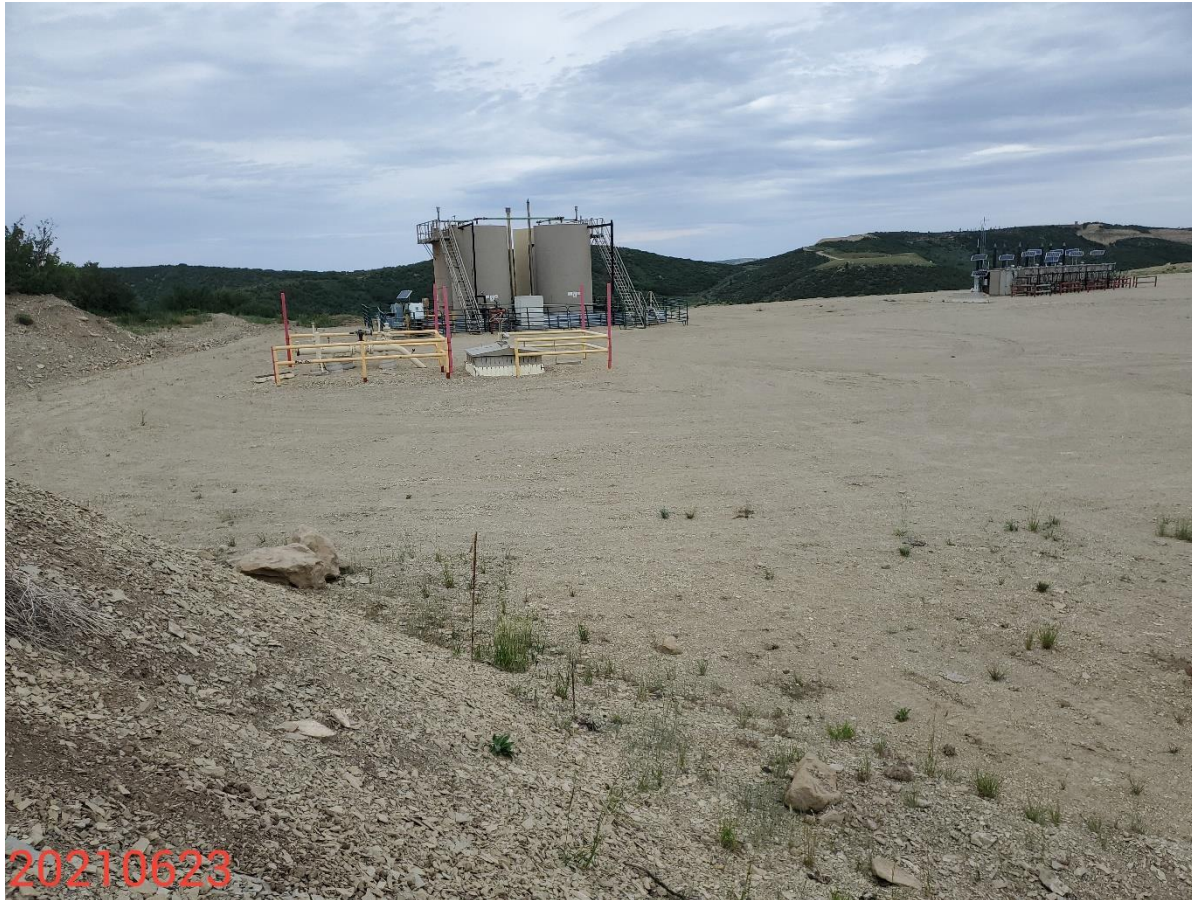
Photo 6: Photo taken from the southwest end of the Location, facing west. Photos 6-8 provide an overview of the Location from west, northwest to north. Photos show interim reclamation of areas not needed for production has not been performed in accordance with 1003 Rules and Corrective actions.

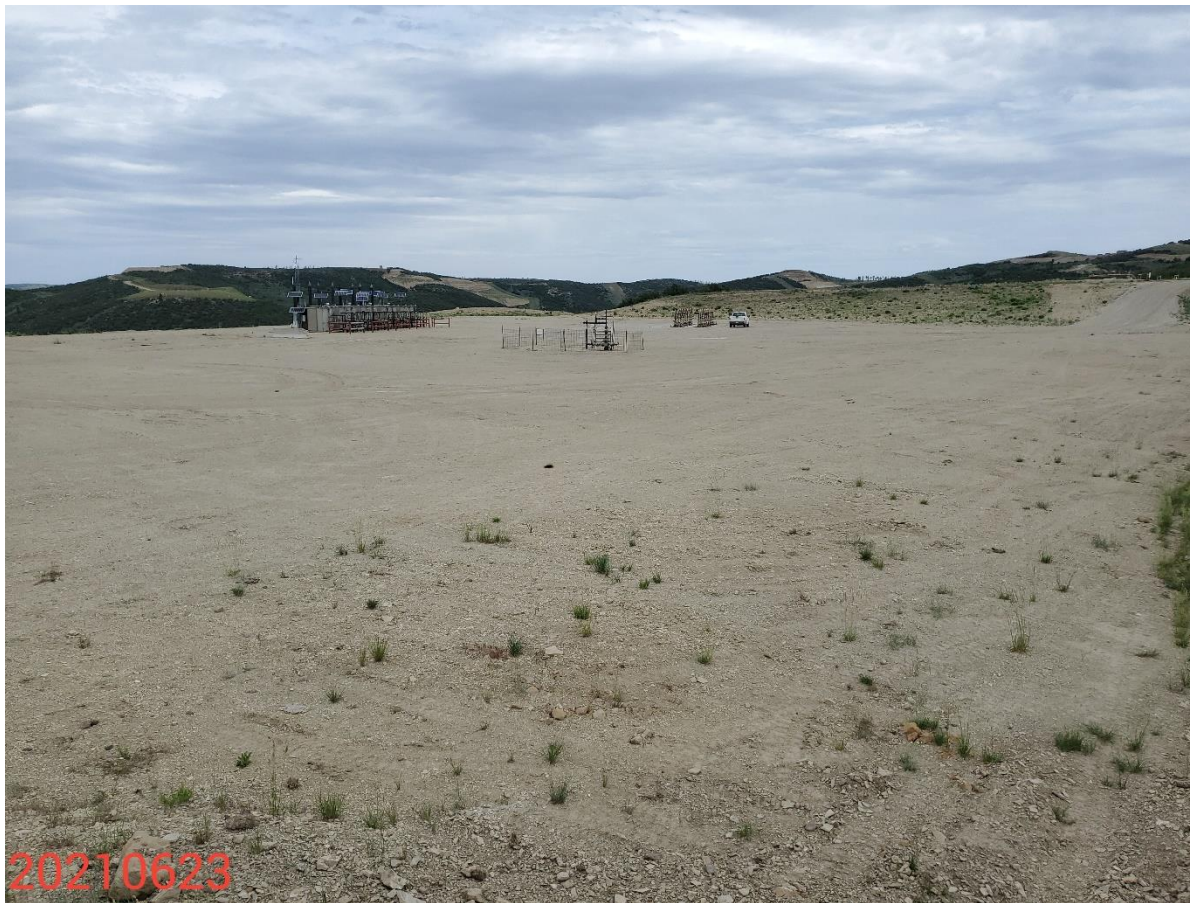
Photo 7: See comments under photo 6.

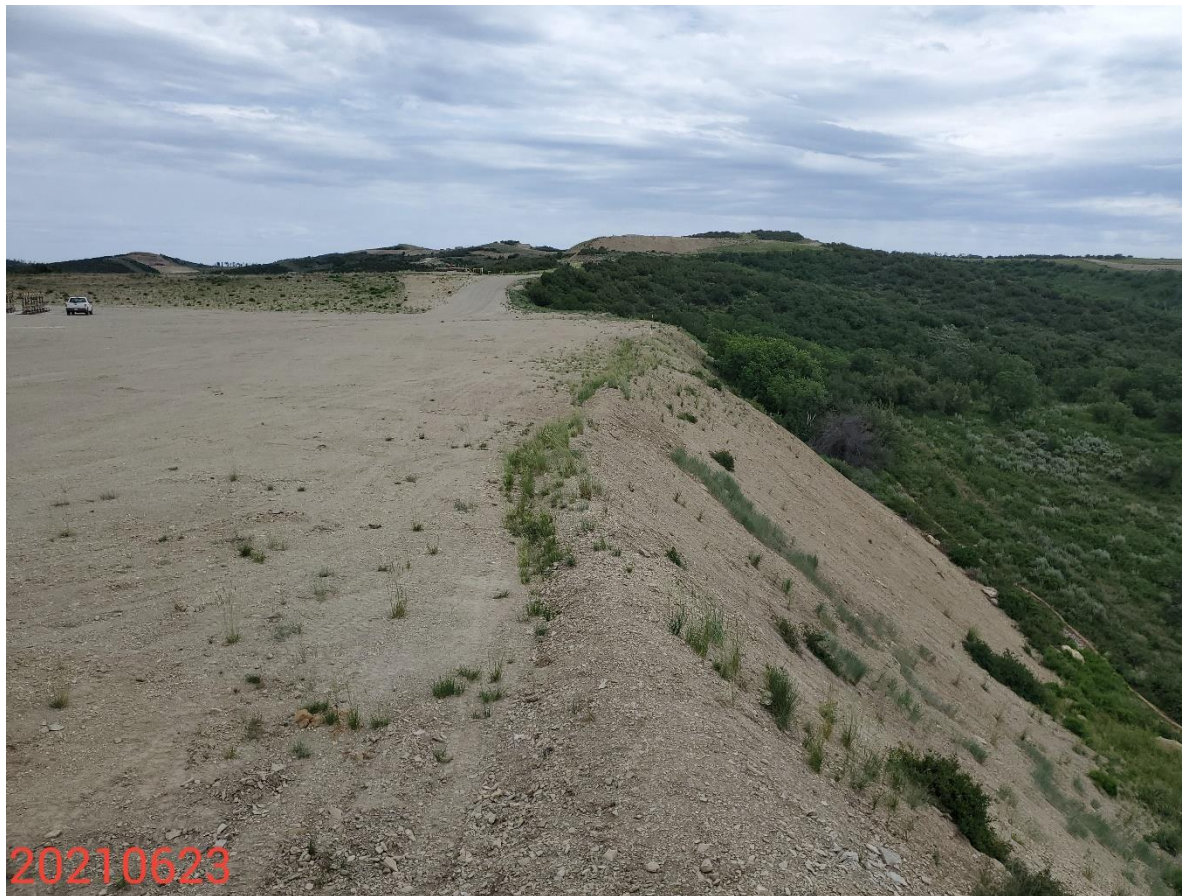
Photo 8: See comments under photo 6.

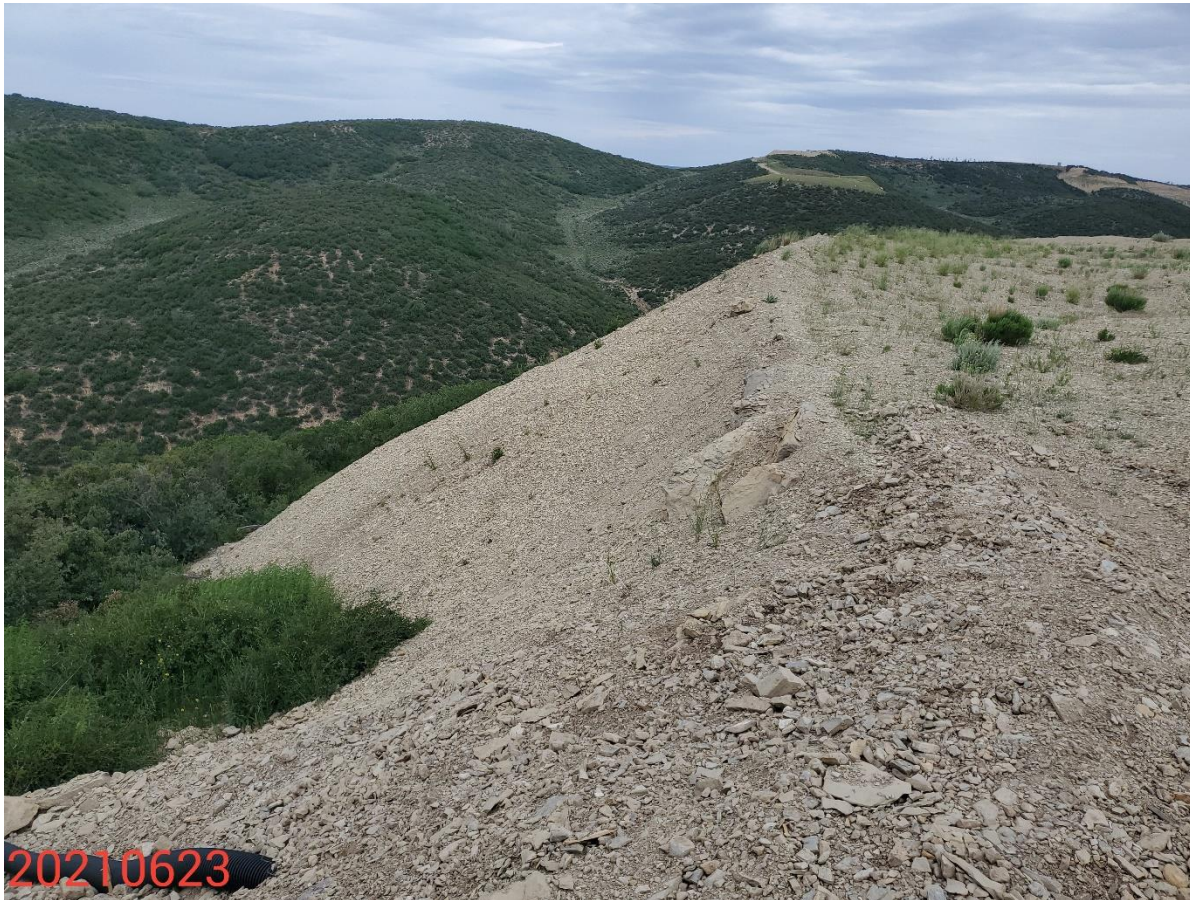
Photo 10: Photo taken from the west end of the Location, facing north. Photos show BMPs to protect and stabilize the slopes of the Location remain missing or insufficient/inadequate.

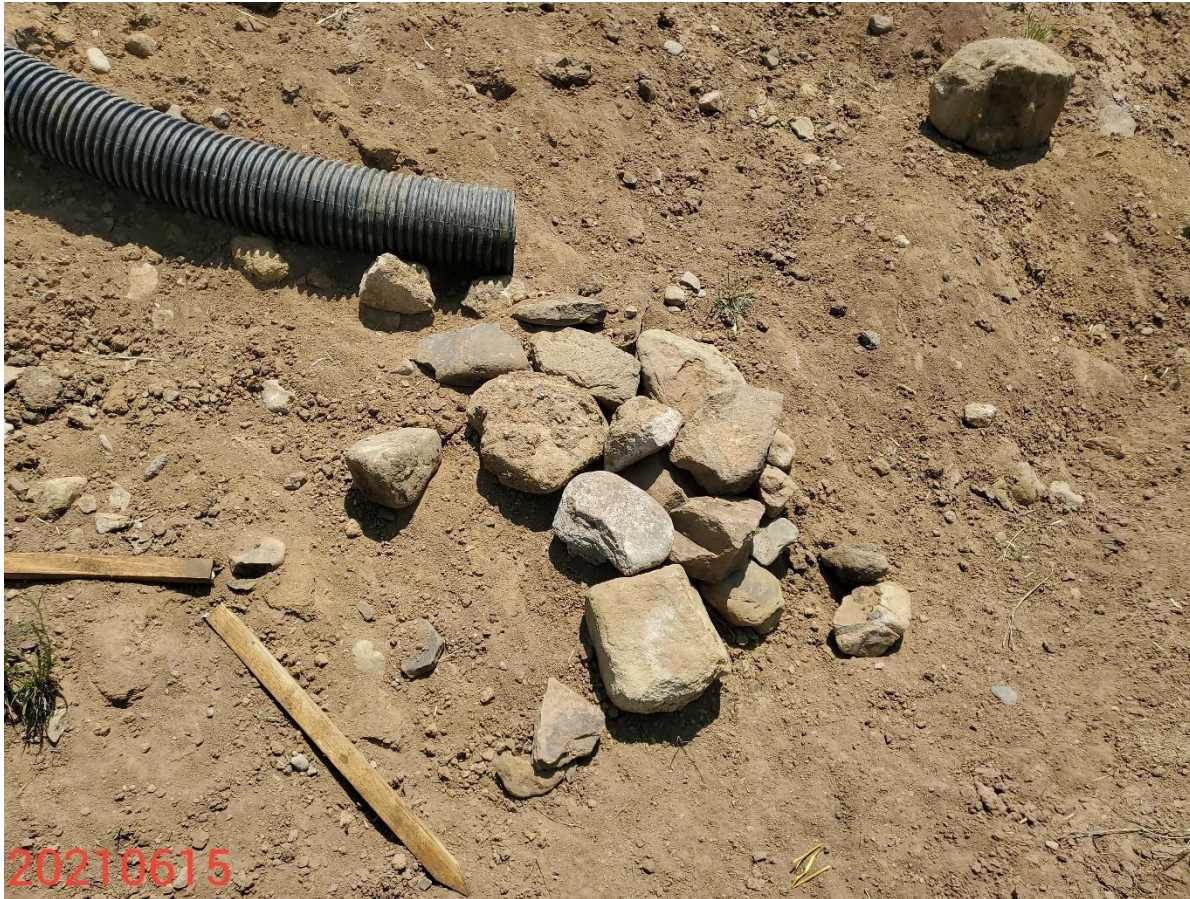
Photo 11: Continued from photo 10. Photo shows slope drain has not been properly secured, or constructed with an appropriate outlet in accordance with good engineering practice.

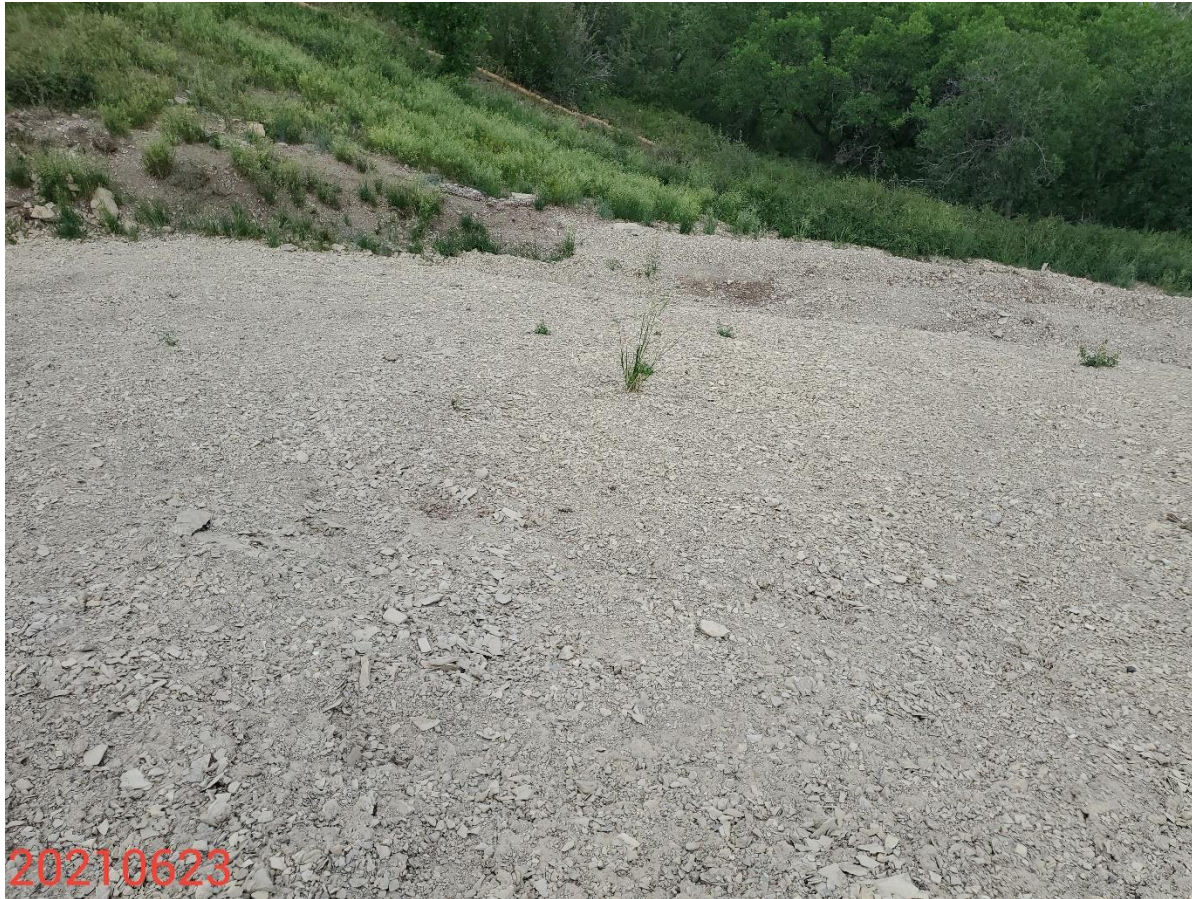
Photo 12: Photo taken from the west end of the Location, facing west. Photo shows BMPs to protect and stabilize the slopes of the Location remain missing or insufficient/inadequate.

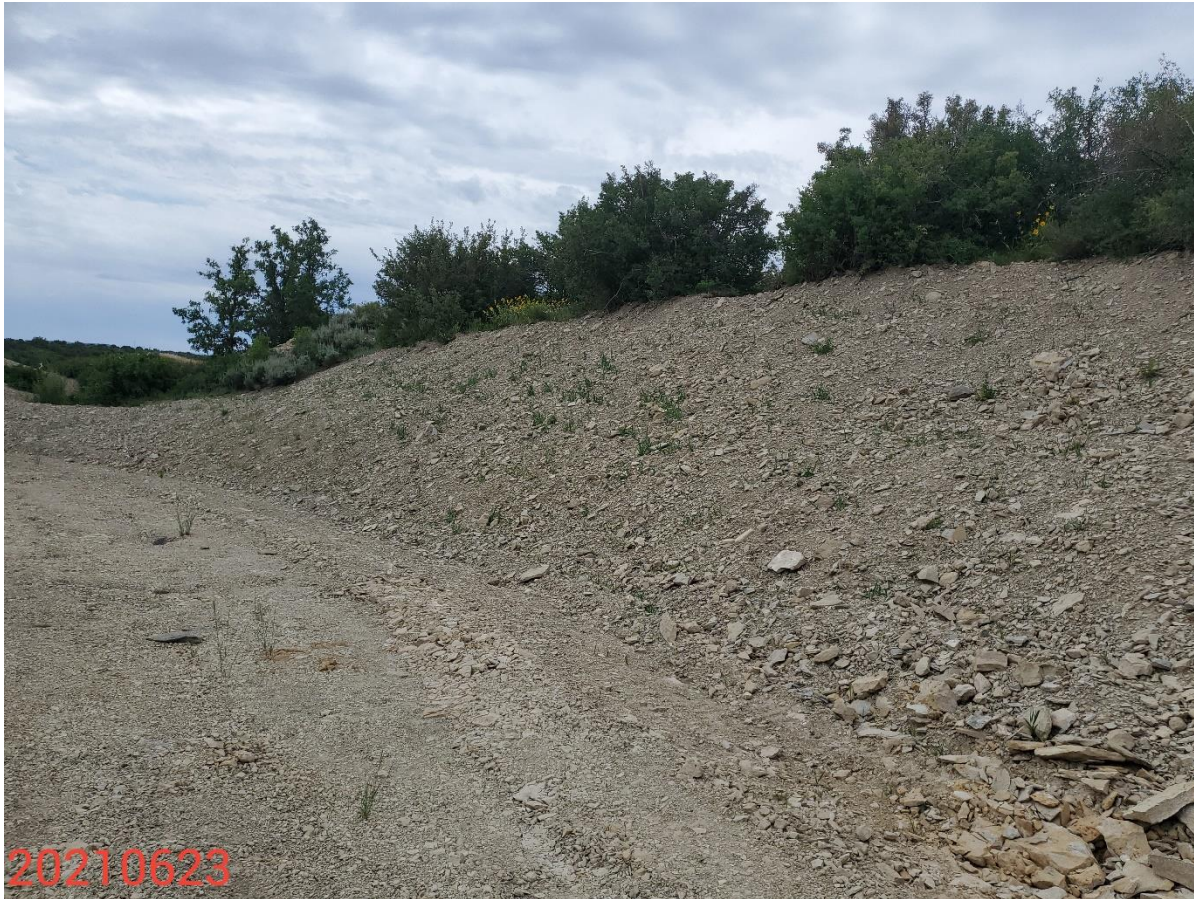
Photo 13: Photo taken from the south end of the Location, facing southeast. Photo shows BMPs to protect and stabilize the slopes of the Location remain missing or insufficient/inadequate.

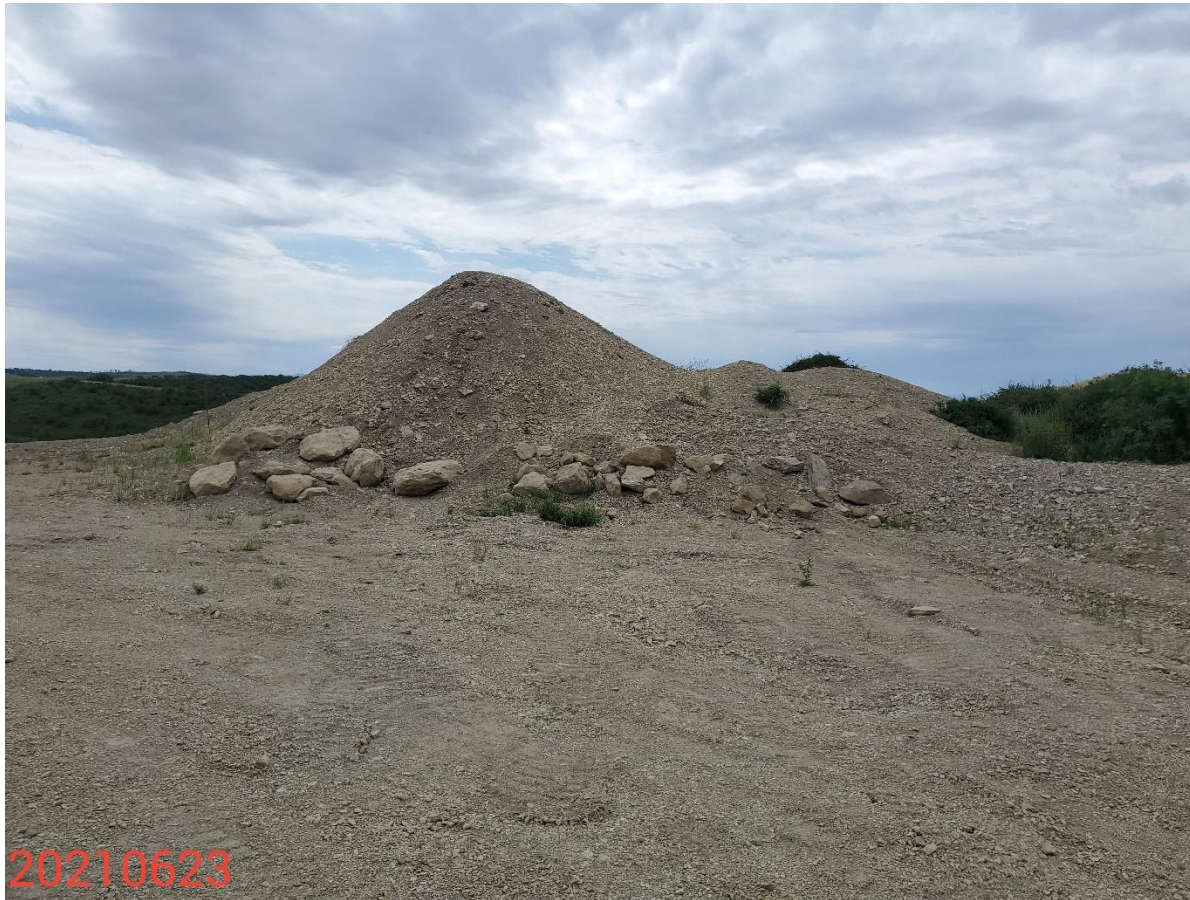
Photo 14: Photo taken from the southeast end of the Location, facing southeast. Photo shows soil stockpile. Photo also shows BMPs to protect and stabilize the slopes of the Location remain missing or insufficient/inadequate.

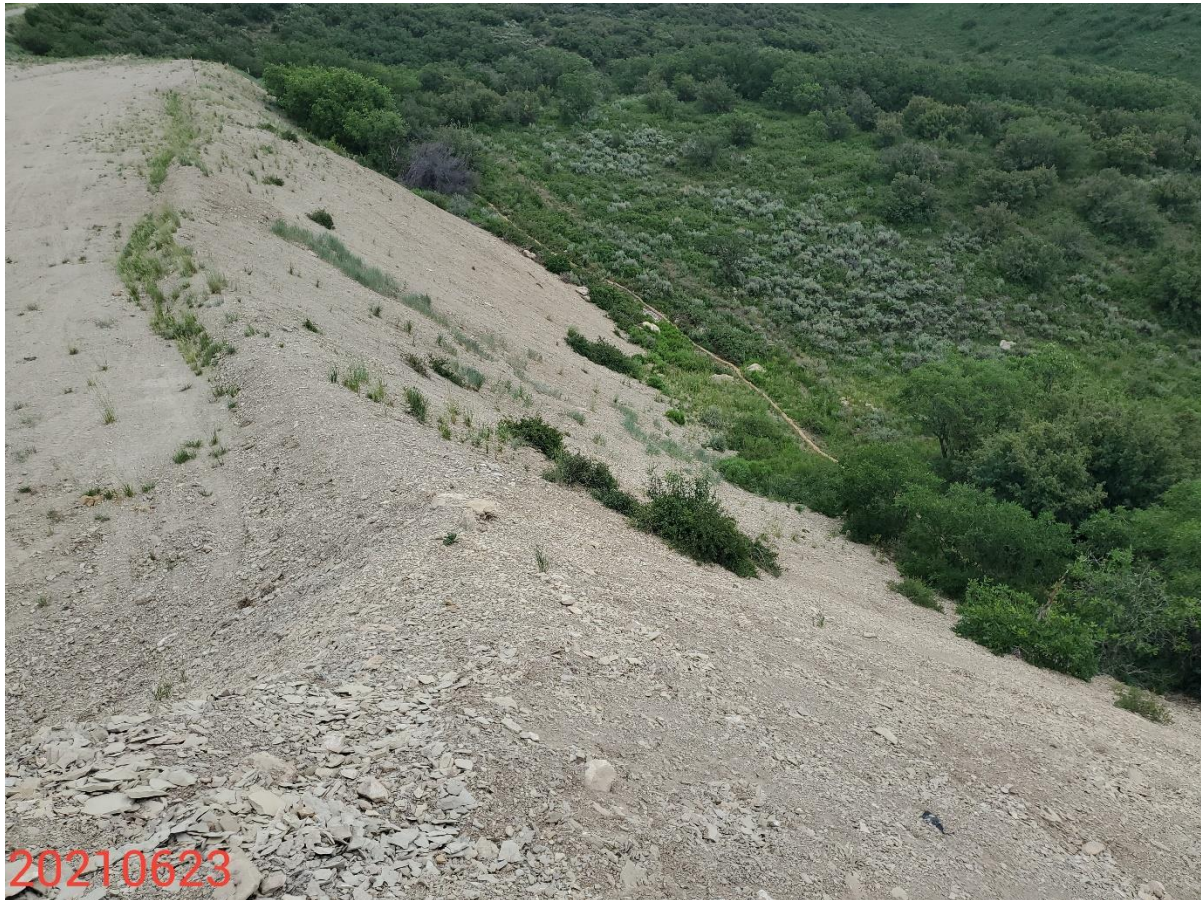
Photo 15: Photo taken from the east end of the Location, facing northeast. Photo shows BMPs to protect and stabilize the slopes of the Location remain missing or insufficient/inadequate.

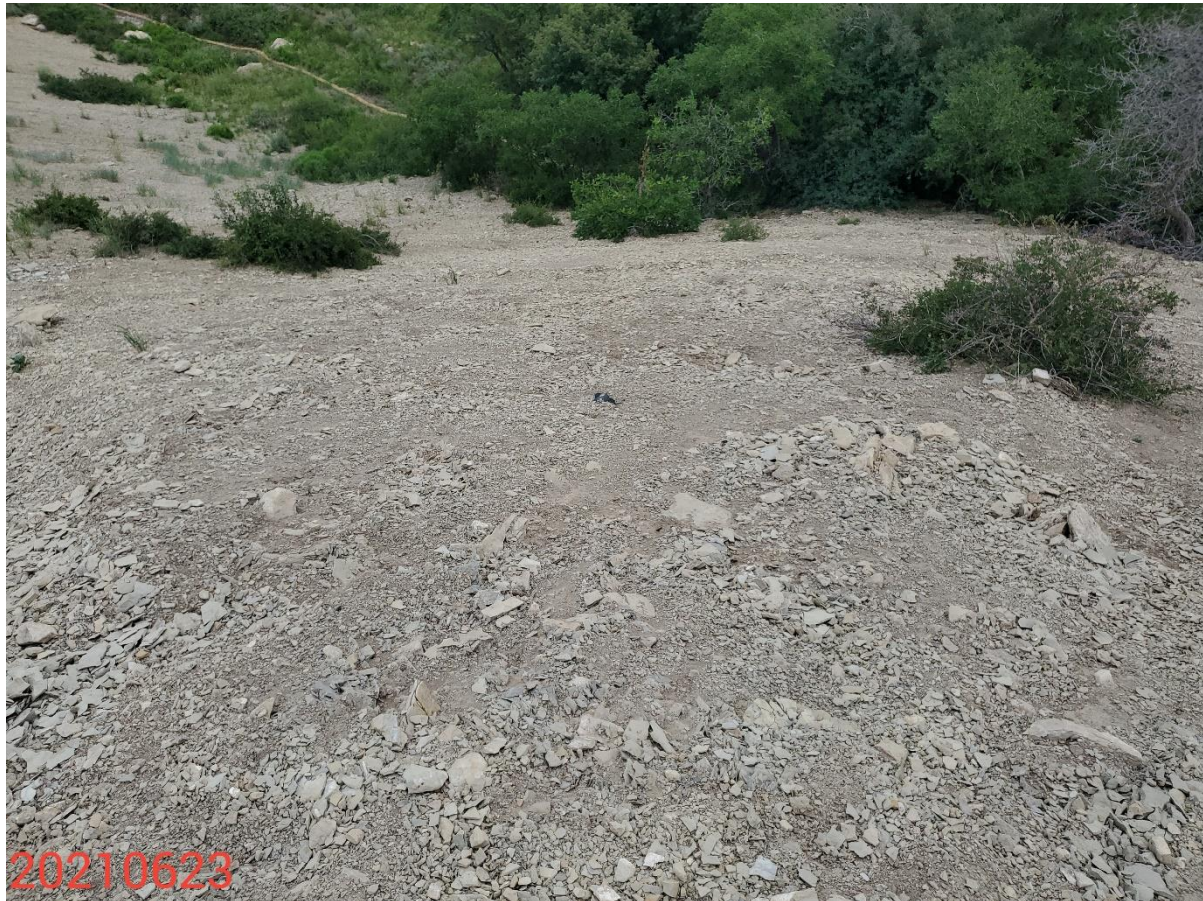
Photo 16: Photo taken from the east end of the Location, facing east. Photo shows BMPs to protect and stabilize the slopes of the Location remain missing or insufficient/inadequate.

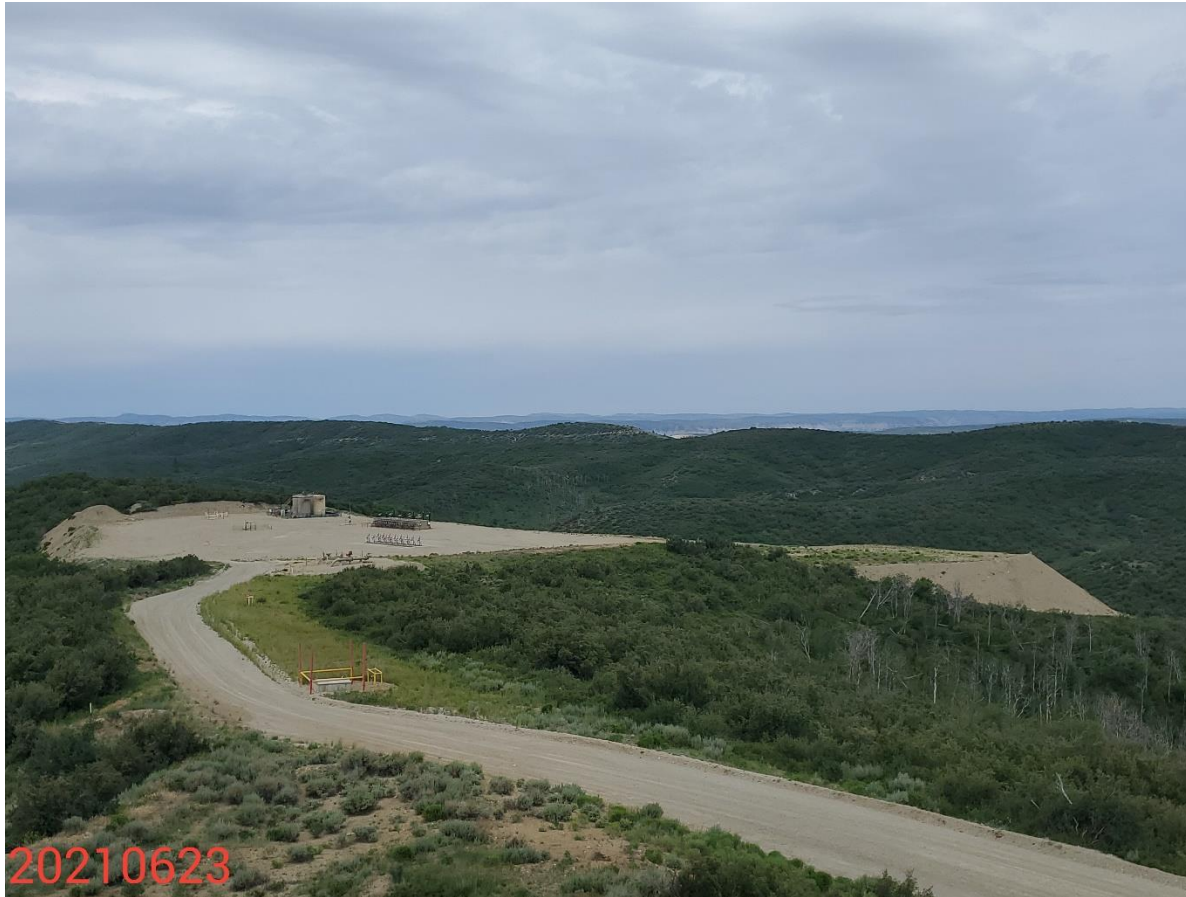
Photo 17: Photo taken northeast of the Location, facing southwest. Photo provides an overview of the Location, and shows that interim reclamation has not been performed in accordance with 1003 Rules. See photo 1 for aerial image of the Location.

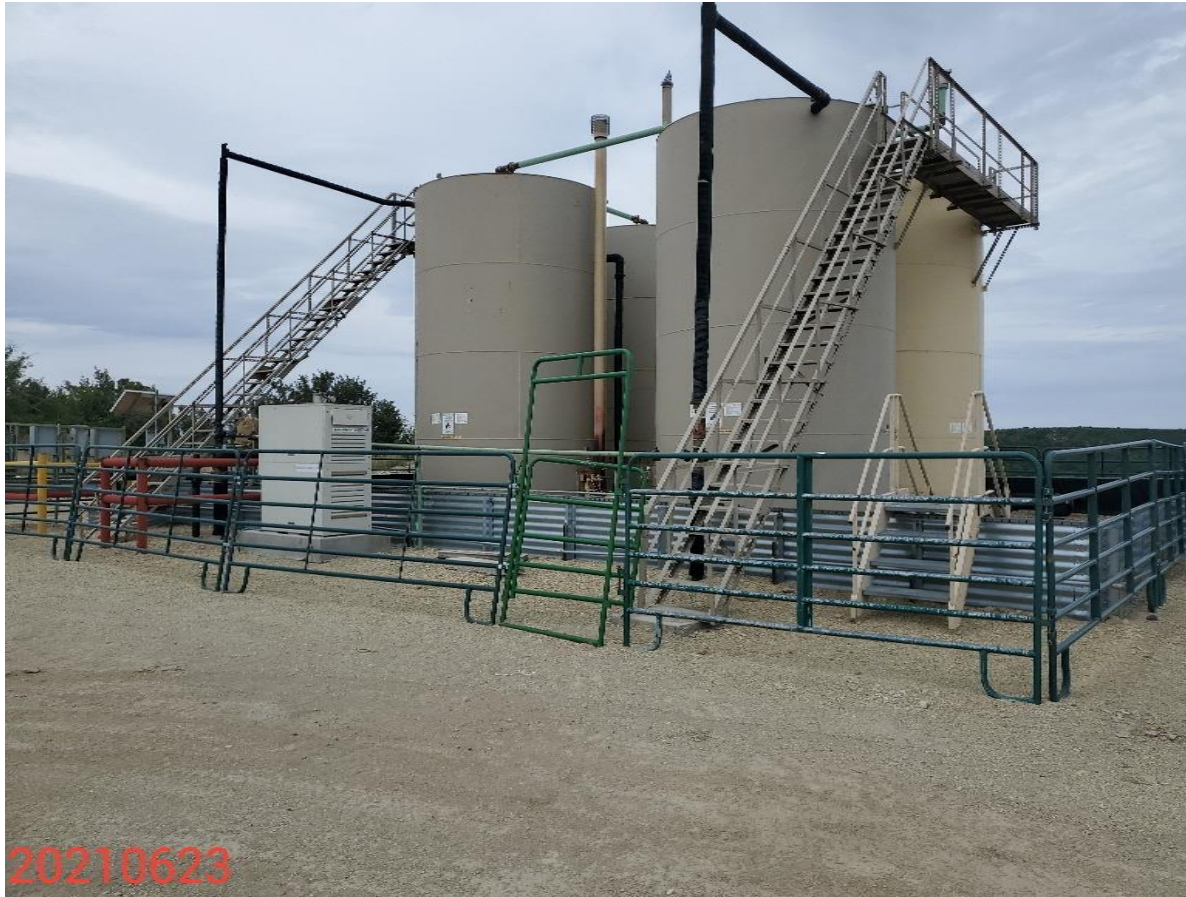
Photo 18: Photo of the tank battery on the southwest end of the Location. See inspection #701101419 for corrective actions regarding signage.
