Inspection Photos

6/23/2021

Operator: LARAMIE ENERGY LLC - 10433

Location ID: 383337

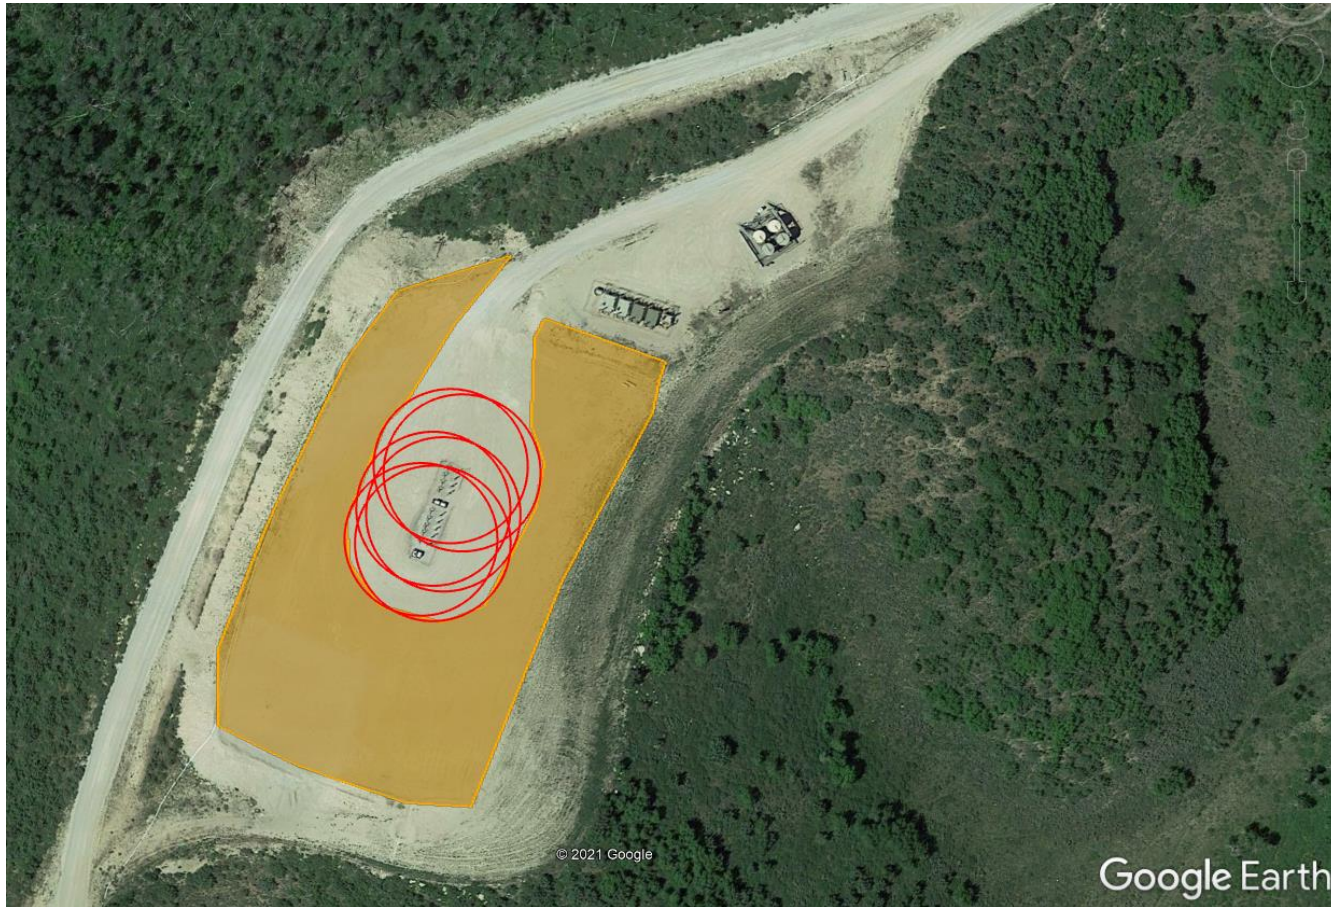
Photo 1: 2016 Google Earth aerial imagery. Orange polygon shows approximate areas of the pad not reasonably needed for production, that have not been recontoured/regraded and reclaimed in accordance with 1003 Rules. Red circles represent a 75 foot buffer around the wells.

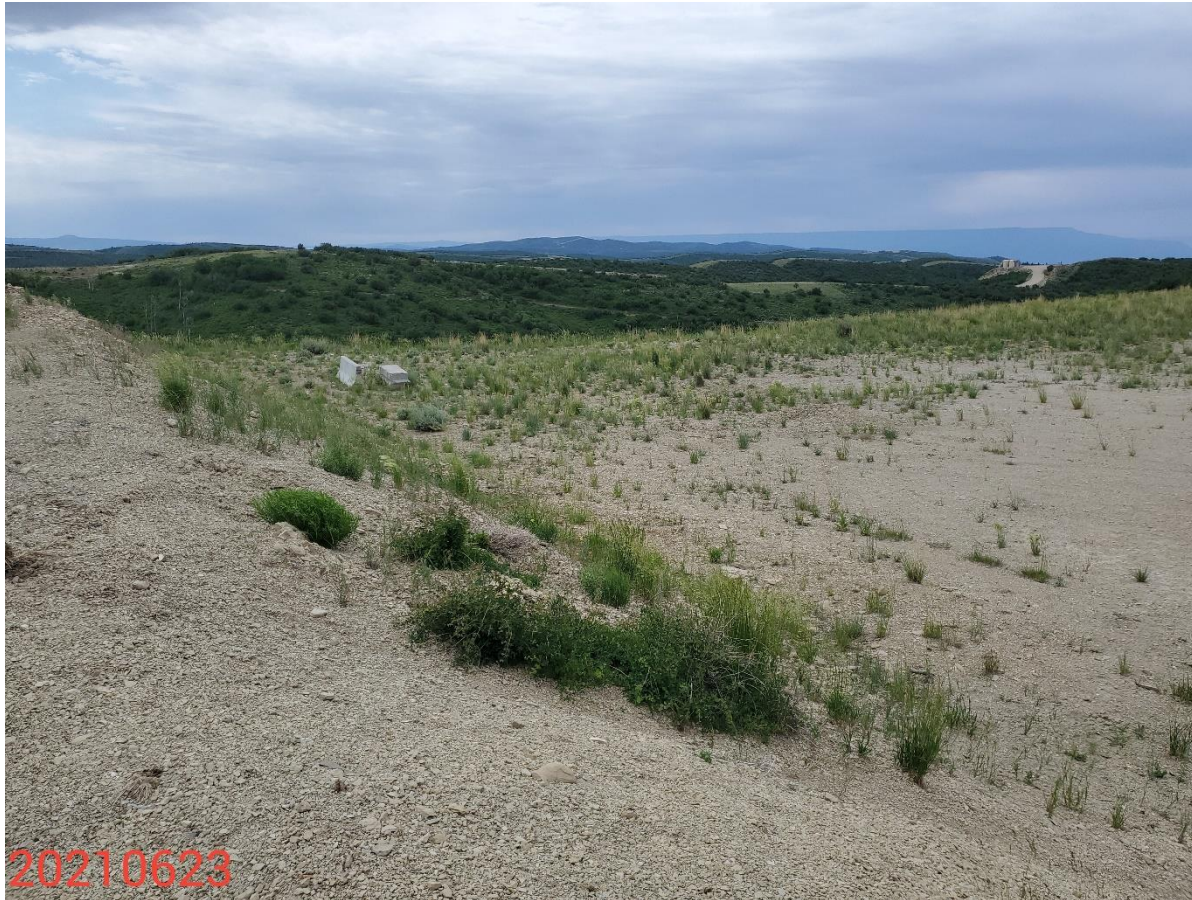
Photo 2: Photo taken from the North end of the Location facing southeast. Photos 2-5 provide an overview of the Location from southeast, south, southwest to west. Photos show interim reclamation of areas not needed for production has not been performed in accordance with 1003 Rules and Corrective actions.

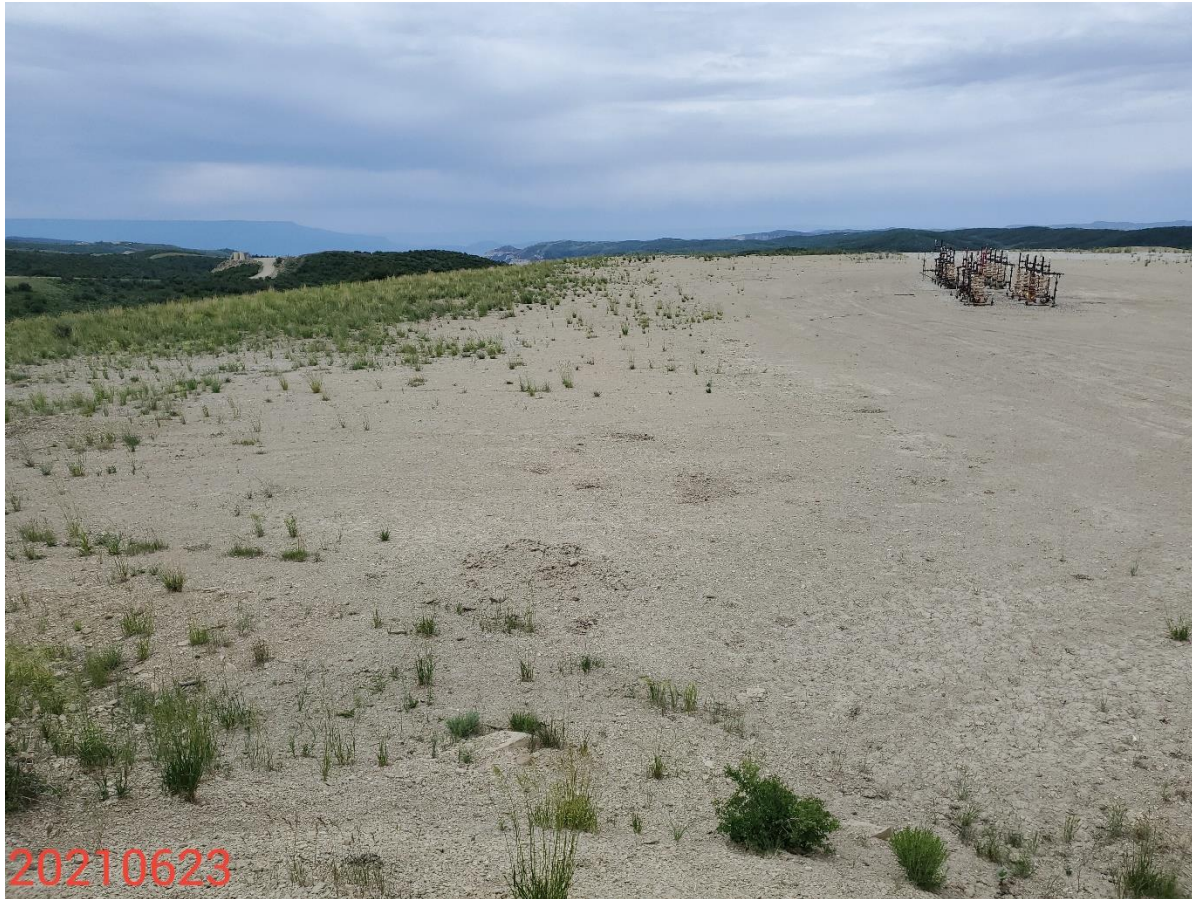
Photo 3: See comments under photo 2.

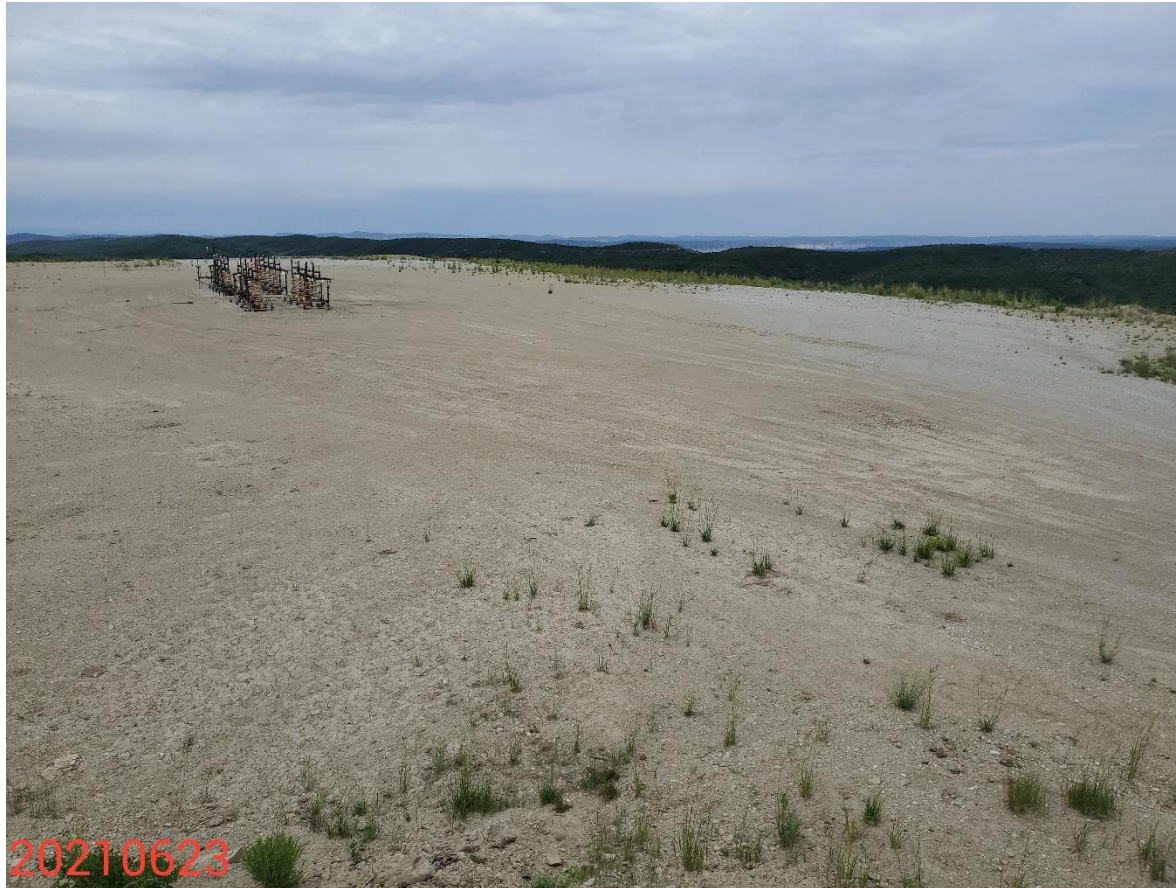
Photo 4: See comments under photo 2. .

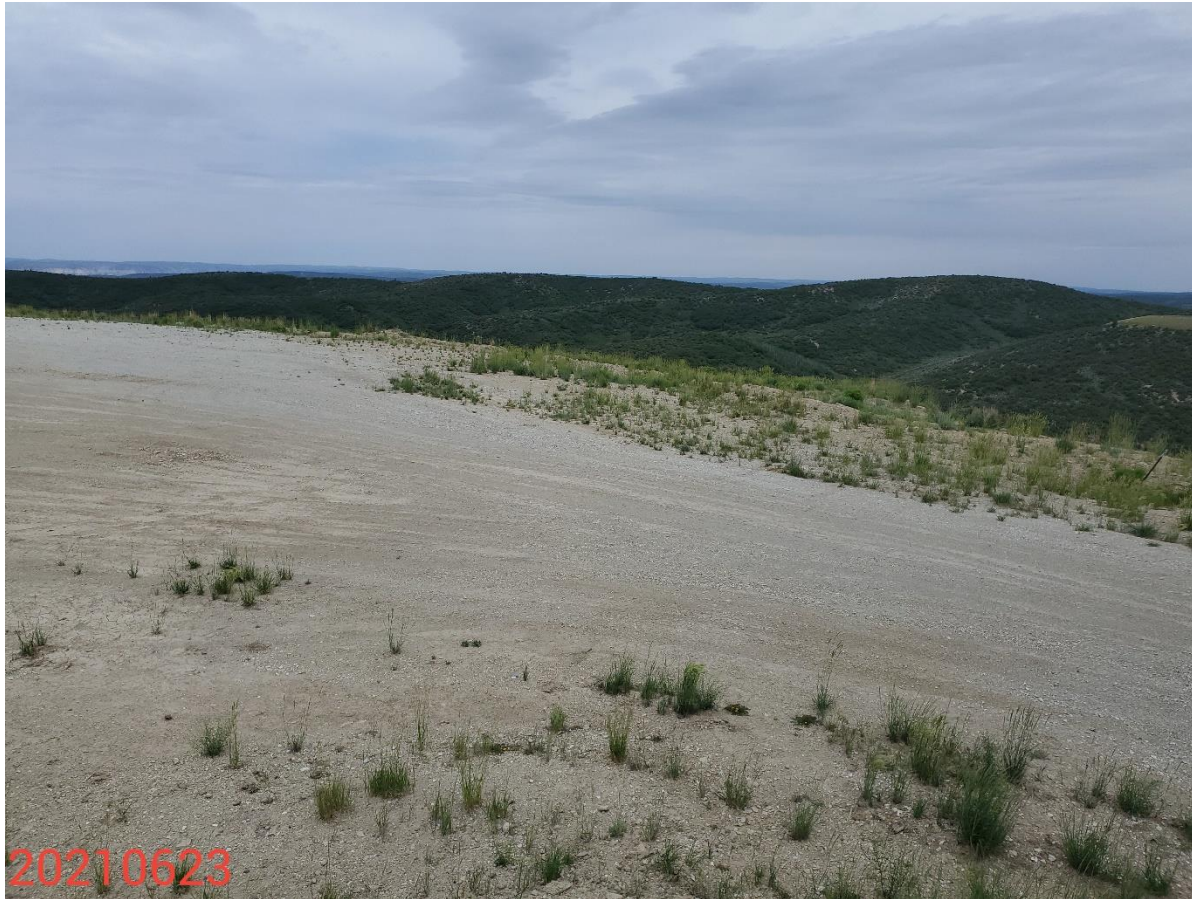
Photo 5: See comments under photo 2.

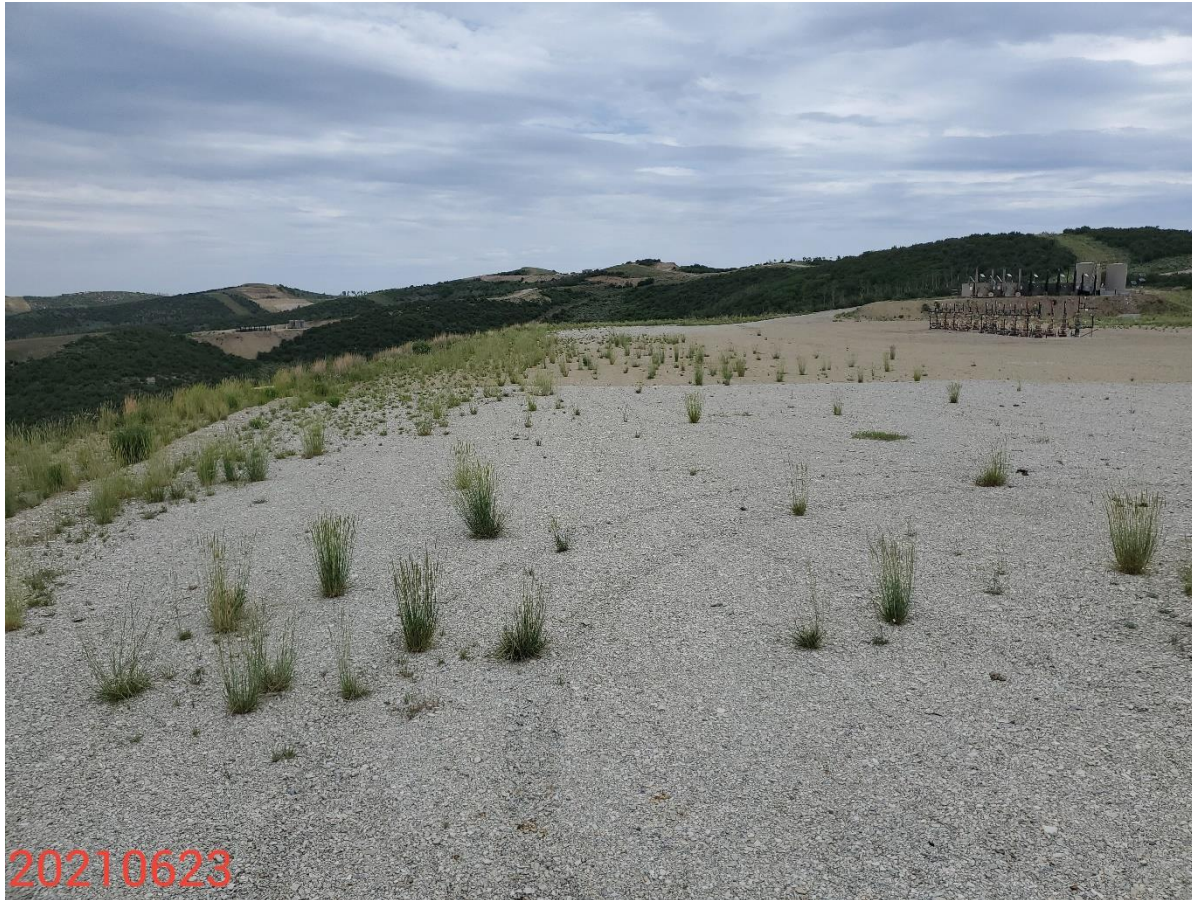
Photo 6: Photo taken from the southwest end of the Location, facing north. Photos 6-8 provide an overview of the Location from north, northeast to east. Photos show interim reclamation of areas not needed for production has not been performed in accordance with 1003 Rules and Corrective actions.

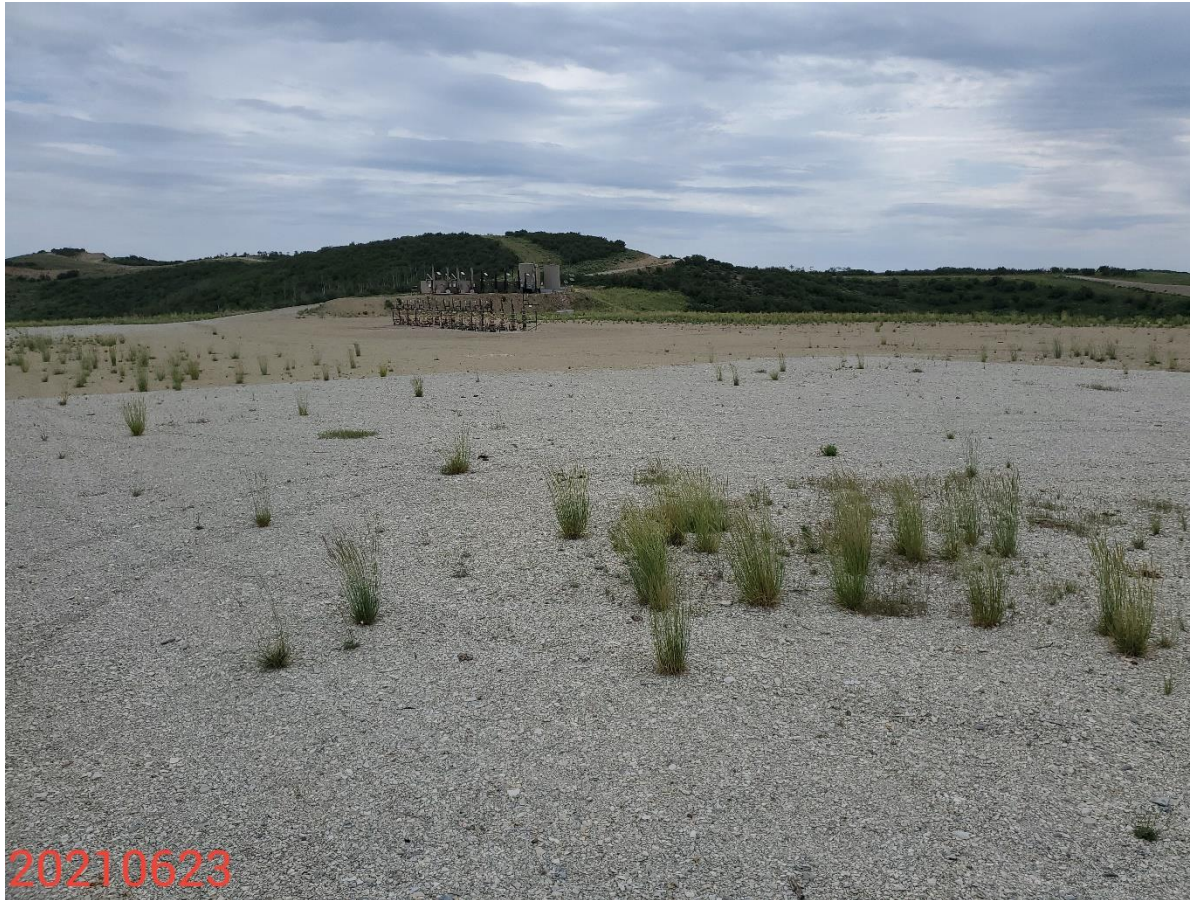
Photo 7: See comments under photo 6.

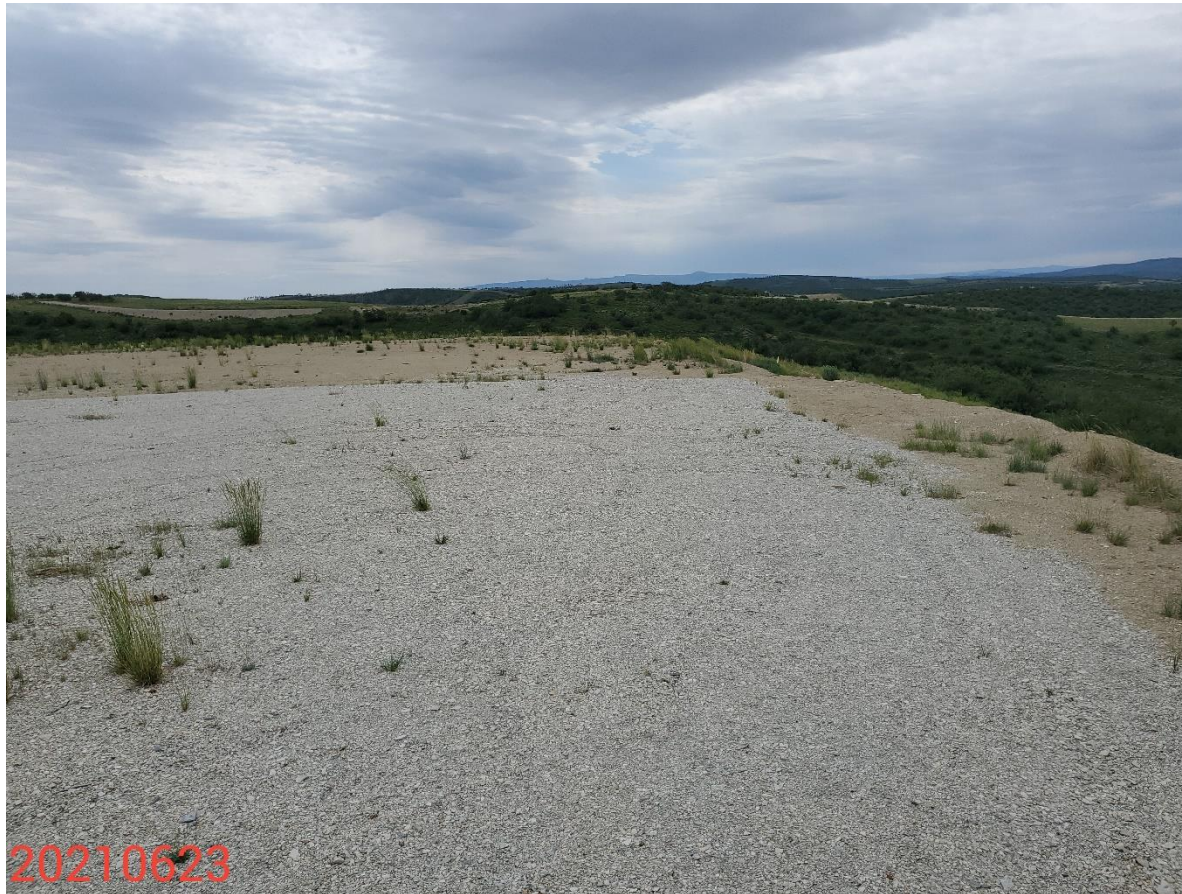
Photo 8: See comments under photo 6.

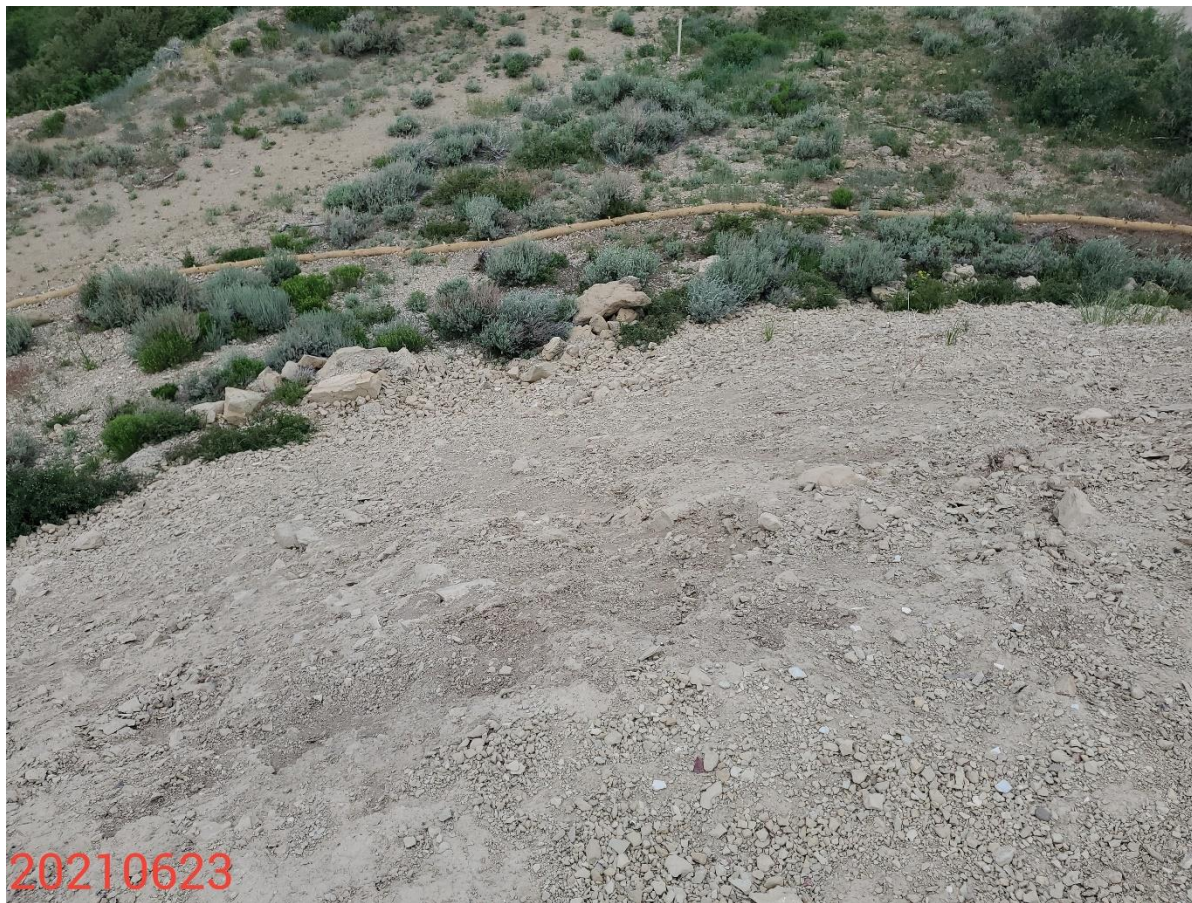
Photo 10: Photo taken from the south end of the Location, facing south. Photos shows example of slopes where BMPs remain missing or insufficient/inadequate to protect and stabilize the slopes of the Location.

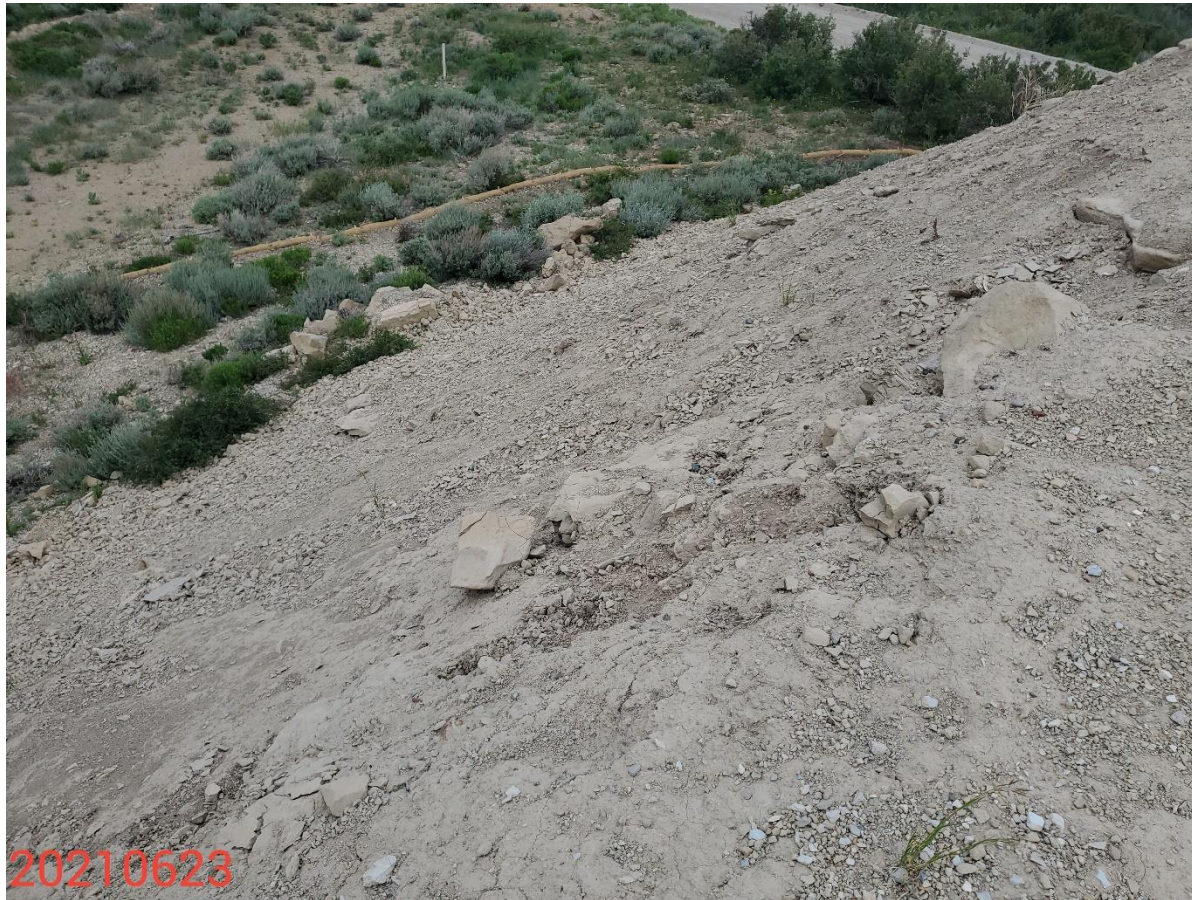
Photo 11: Photo taken from the south end of the Location, facing west. Photos shows example of slopes where BMPs remain missing or insufficient/inadequate to protect and stabilize the slopes of the Location.

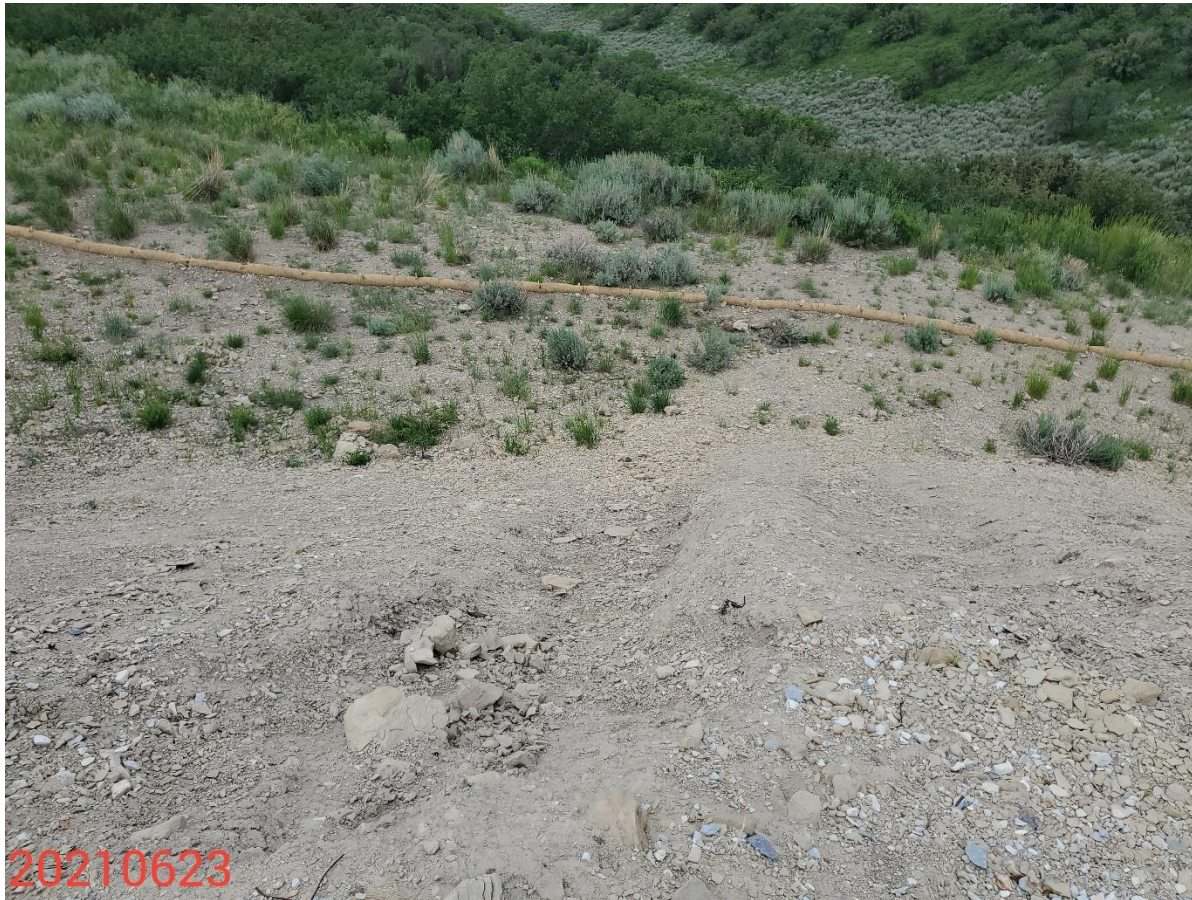
Photo 12: Photo taken from the south end of the Location, facing south. Photos shows example of slopes where BMPs remain missing or insufficient/inadequate to protect and stabilize the slopes of the Location.

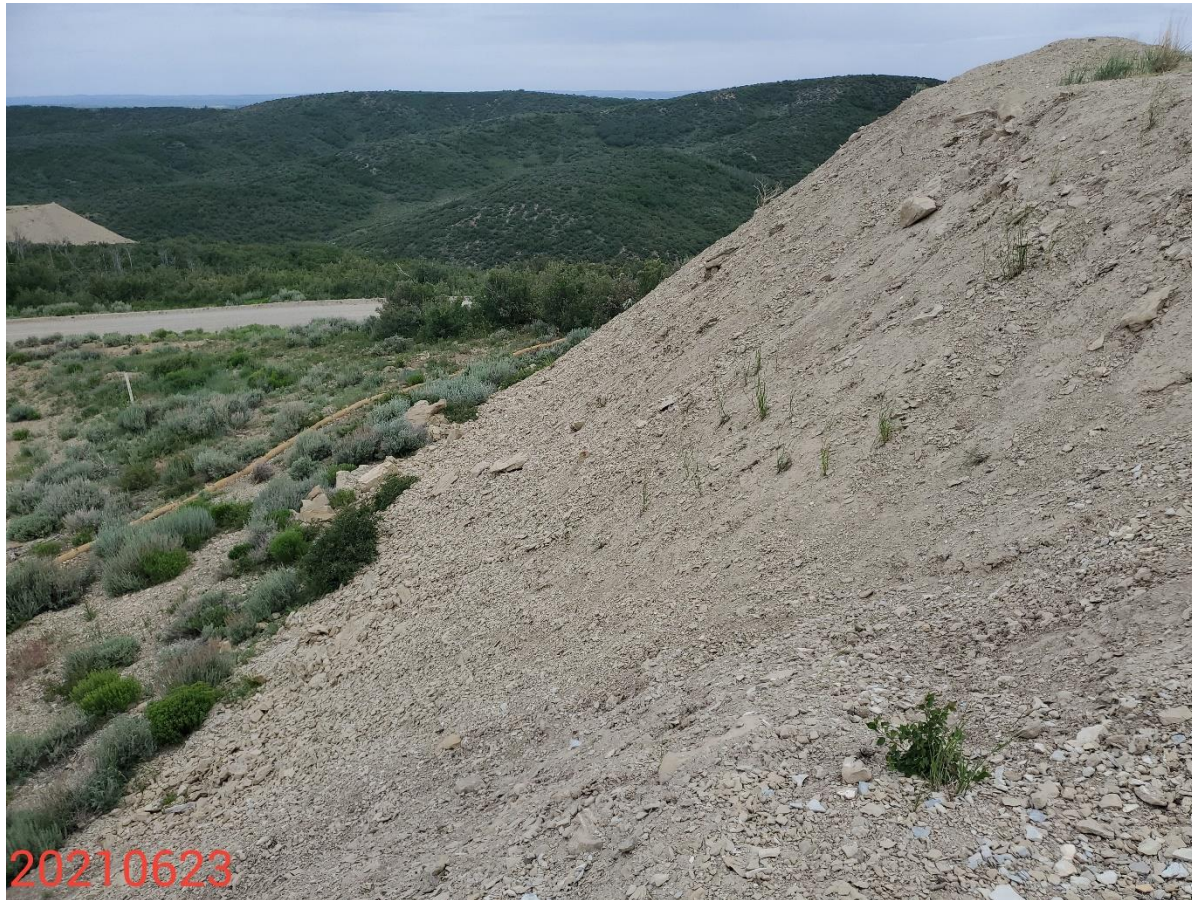
Photo 13: Photo taken from the south end of the Location, facing west. Photos shows example of slopes where BMPs remain missing or insufficient/inadequate to protect and stabilize the slopes of the Location.

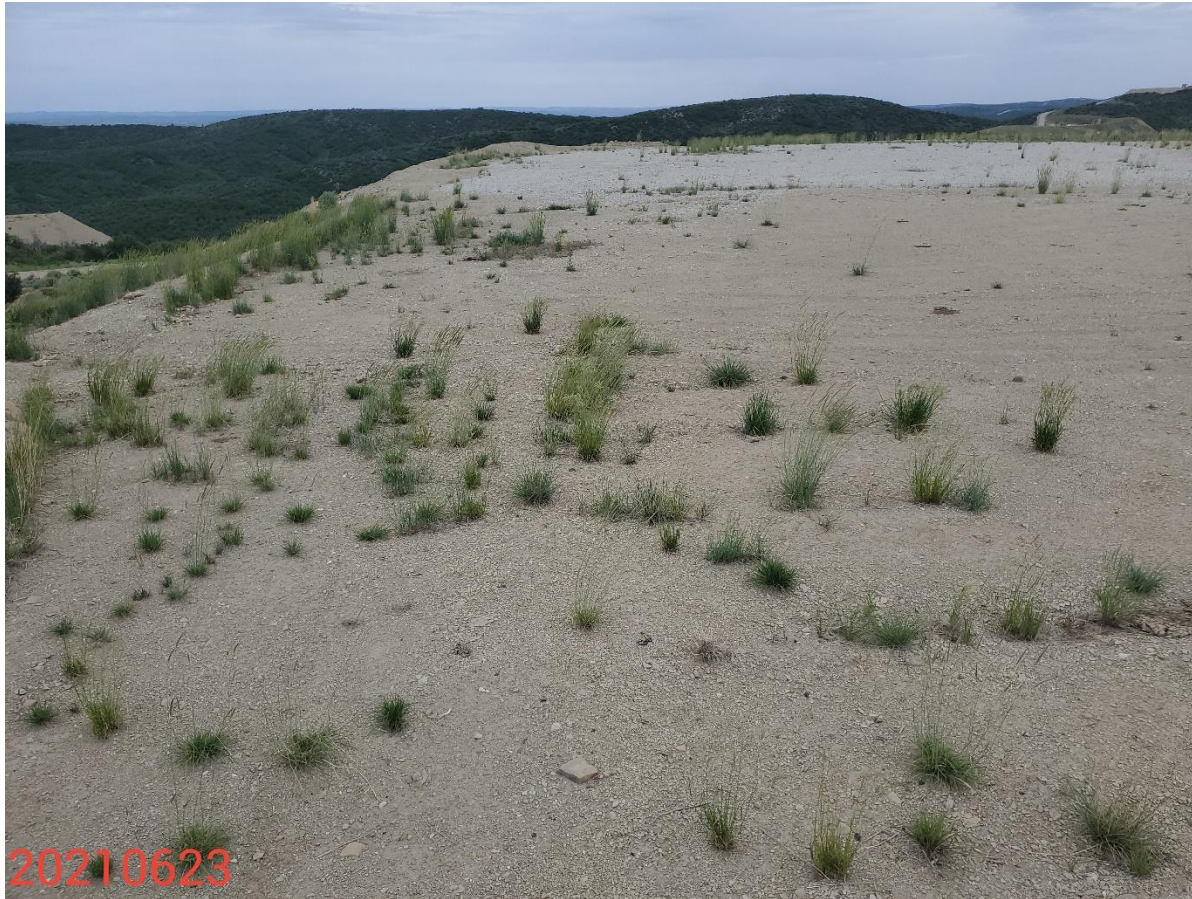
Photo 14: Photo taken from the southeast end of the Location, facing west. Photos 14-16 provide an overview of the Location from west, northwest to north. Photos show interim reclamation of areas not needed for production has not been performed in accordance with 1003 Rules and Corrective actions.

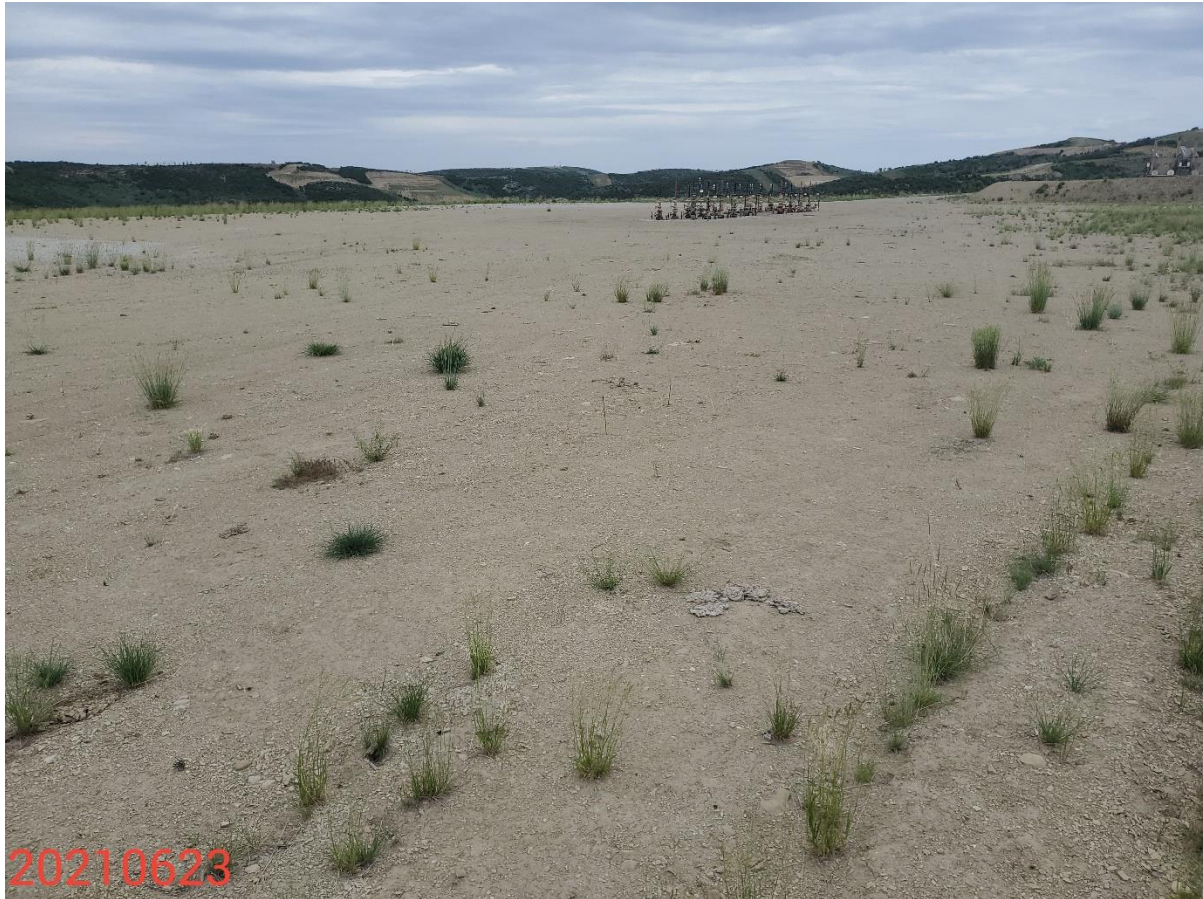
Photo 15: See comments under photo 14.

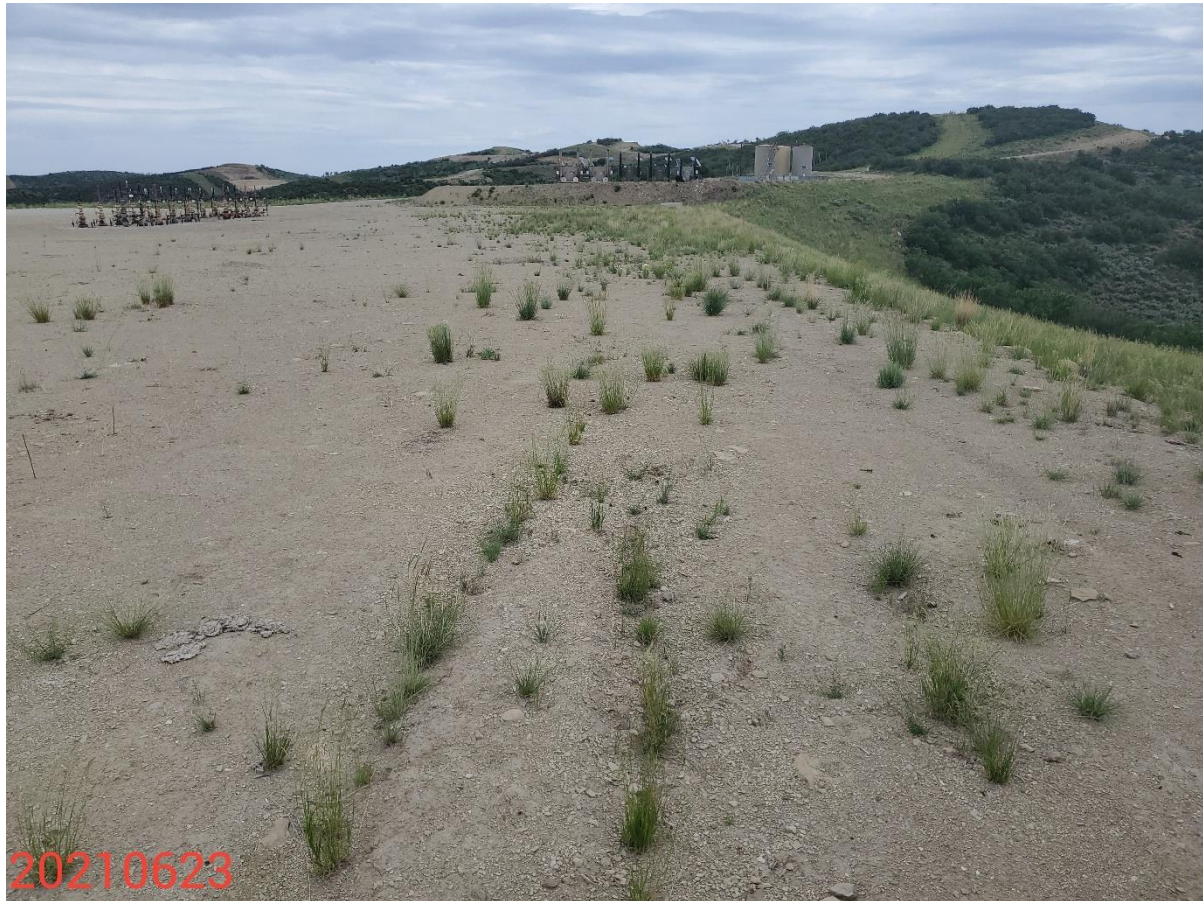
Photo 16: See comments under photo 14.

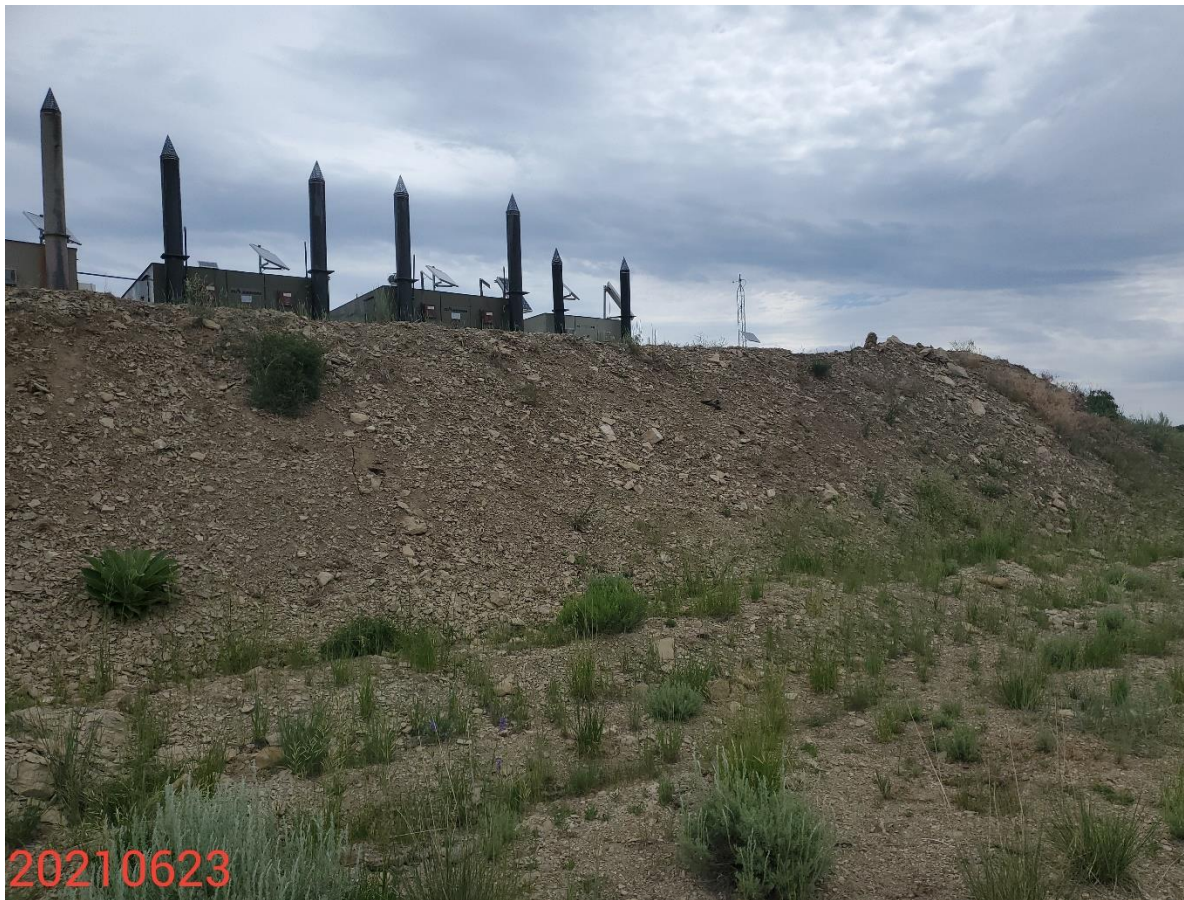
Photo 17: Photo taken from the north end of the Location, facing northeast. Photos shows example of slopes where BMPs remain missing or insufficient/inadequate to protect and stabilize the slopes of the Location.

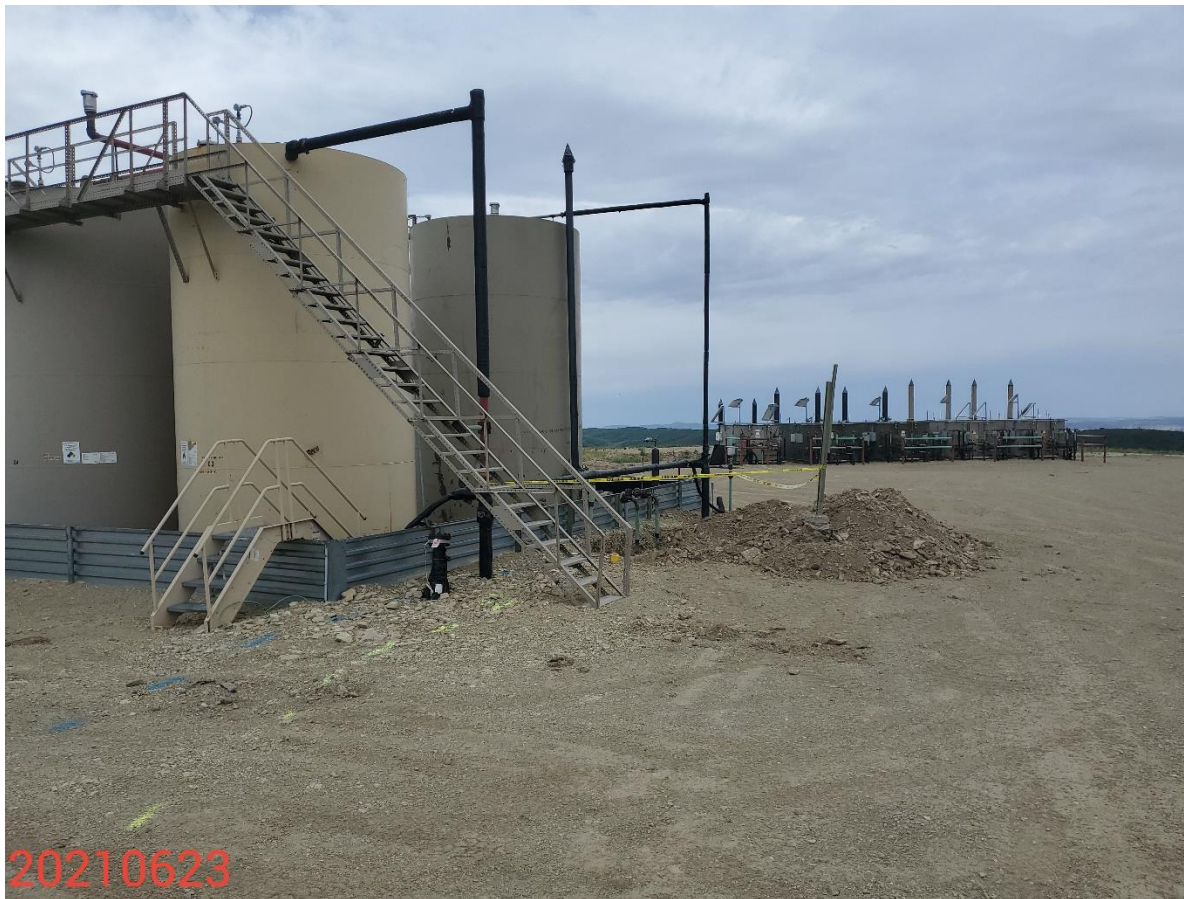
Photo 18: Photo of the tank battery on the southwest end of the Location. See inspection #701101420 for corrective actions regarding signage.
