Inspection Photos

6/23/2021

Operator: LARAMIE ENERGY LLC - 10433

Location ID: 323893

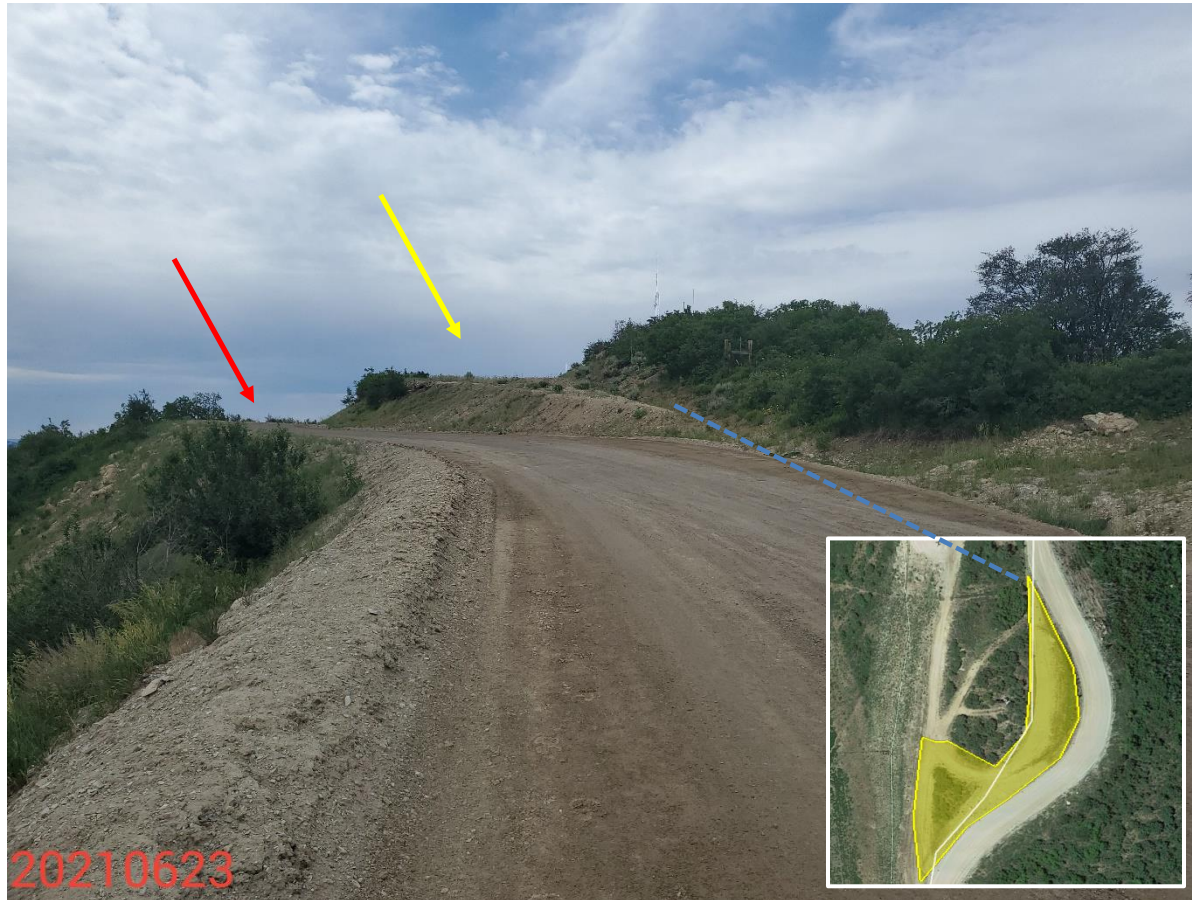
Photo 1: Photo taken from the east end of the Location (from the access road) facing south. Previous inspections documented that between 2011 and 2014, the access road in this area was further expanded east (red arrow). Previous inspections required Operator to reclaim the original access road (yellow) including, but not limited to, compaction alleviation, recontouring/regrading and revegetation. Photo shows that the original access road has not been reclaimed. Photo insert bottom right shows access road areas that were required to be reclaimed.

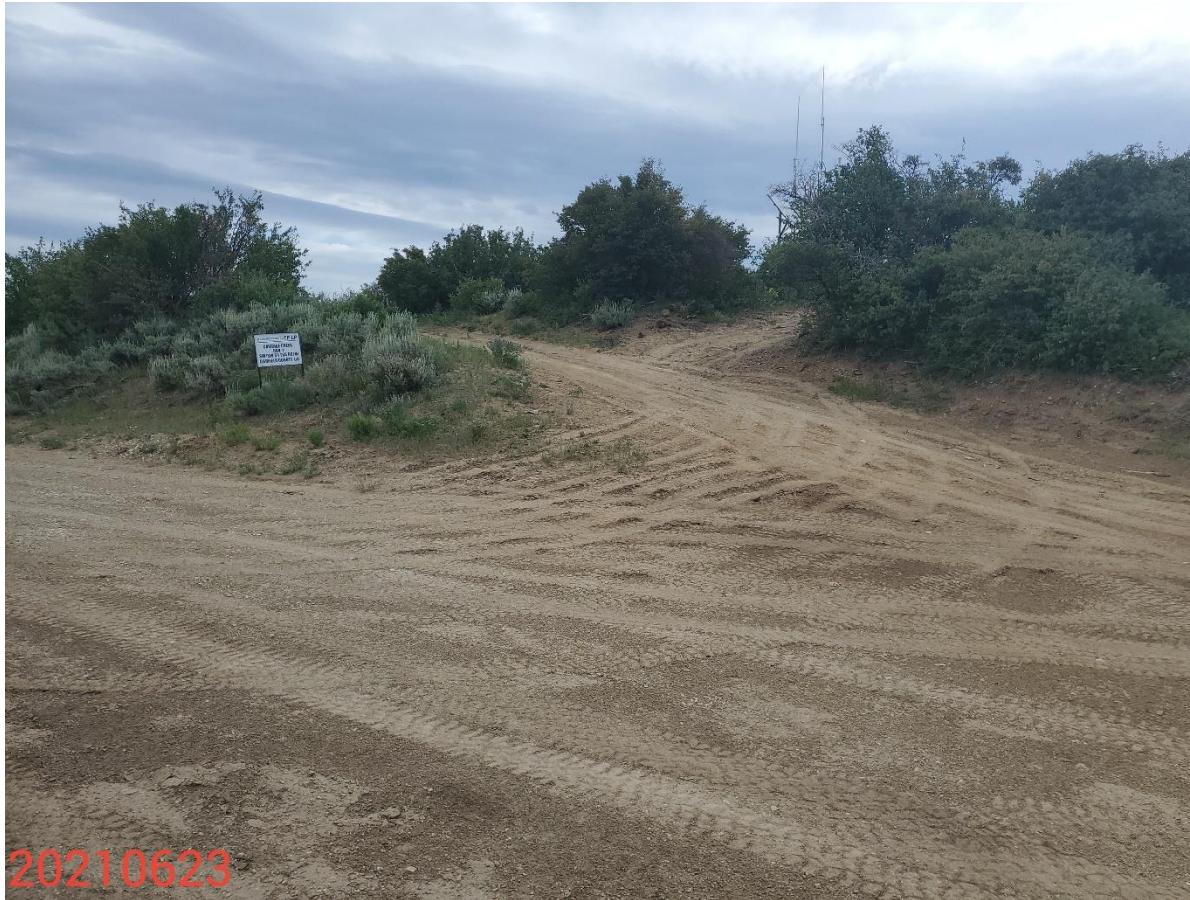
Photo 2: Photo taken from the access road southwest of the Location, facing northeast. Photo shows access area to a radio tower. This road is required to access facility; oil and gas access roads south and east require reclamation (photos 3-7).

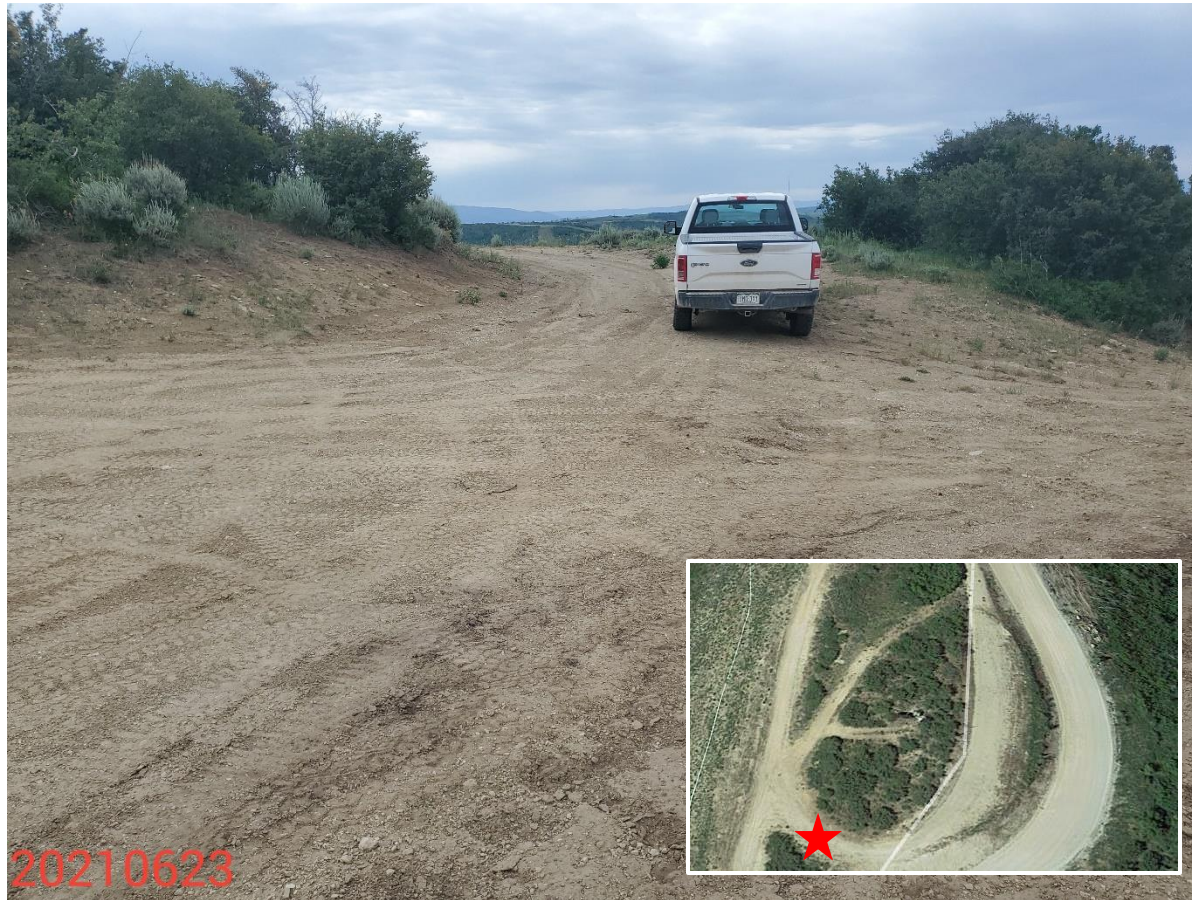
Photo 3: Photo taken from the access road that travels from the southwestern end of the Location, facing east. Photo shows a section of the original oil and gas access road, that accessed the Location from the south. Access road is not necessary and required reclamation. Photo shows Operator has not reclaimed the access road per the corrective actions.

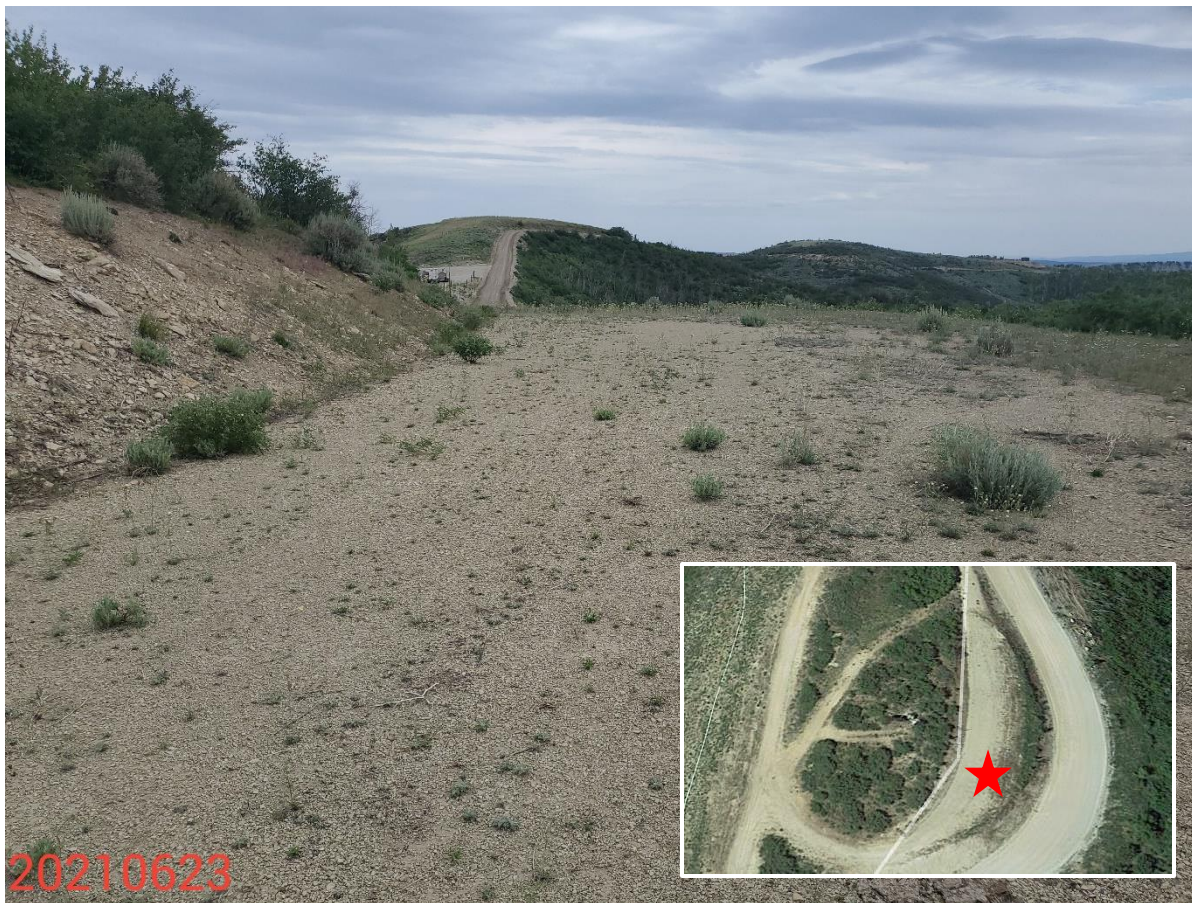
Photo 4: Photo taken from the former access road, southeast of the Location, facing north. Photo shows access road has not been reclaimed.

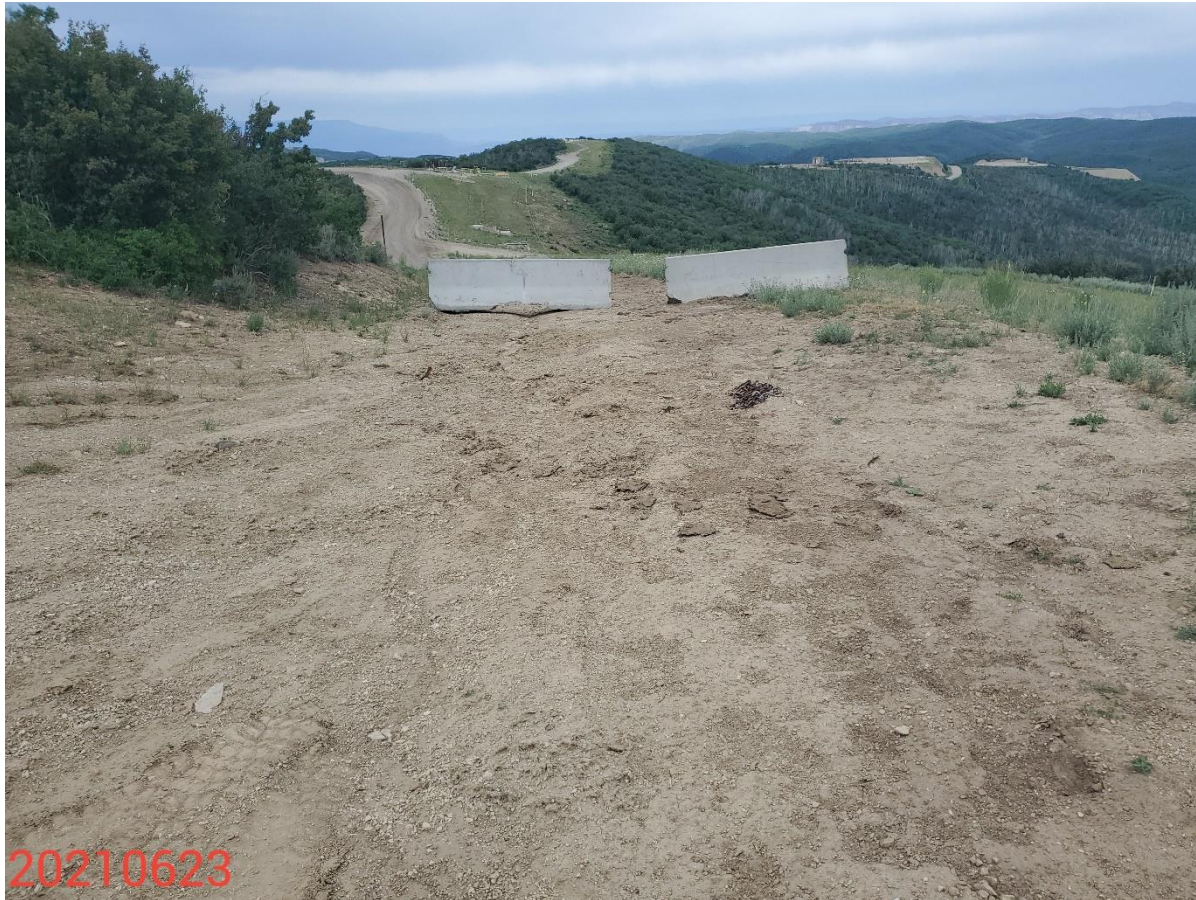
Photo 5: Photo taken from the access road that travels from the southwestern end of the Location, facing south. Photo shows Operator has not reclaimed the access road per the corrective actions.

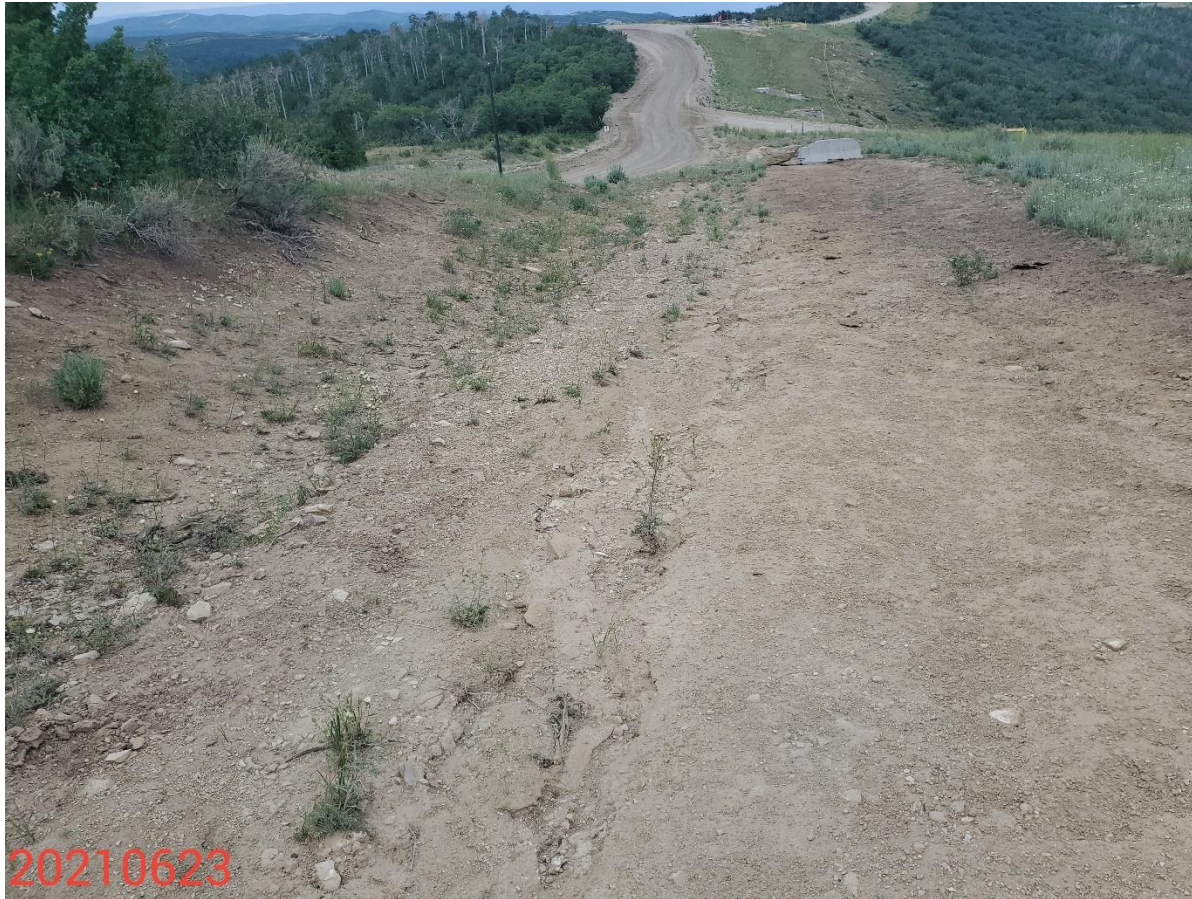
Photo 6: Continued from photo 3. Photo shows access road has not been reclaimed. Photo also shows stormwater erosion degradation observed on the road. Temporary stormwater BMPs required until reclamation has been performed, at which point control measures to stabilize the seeded soil are required.

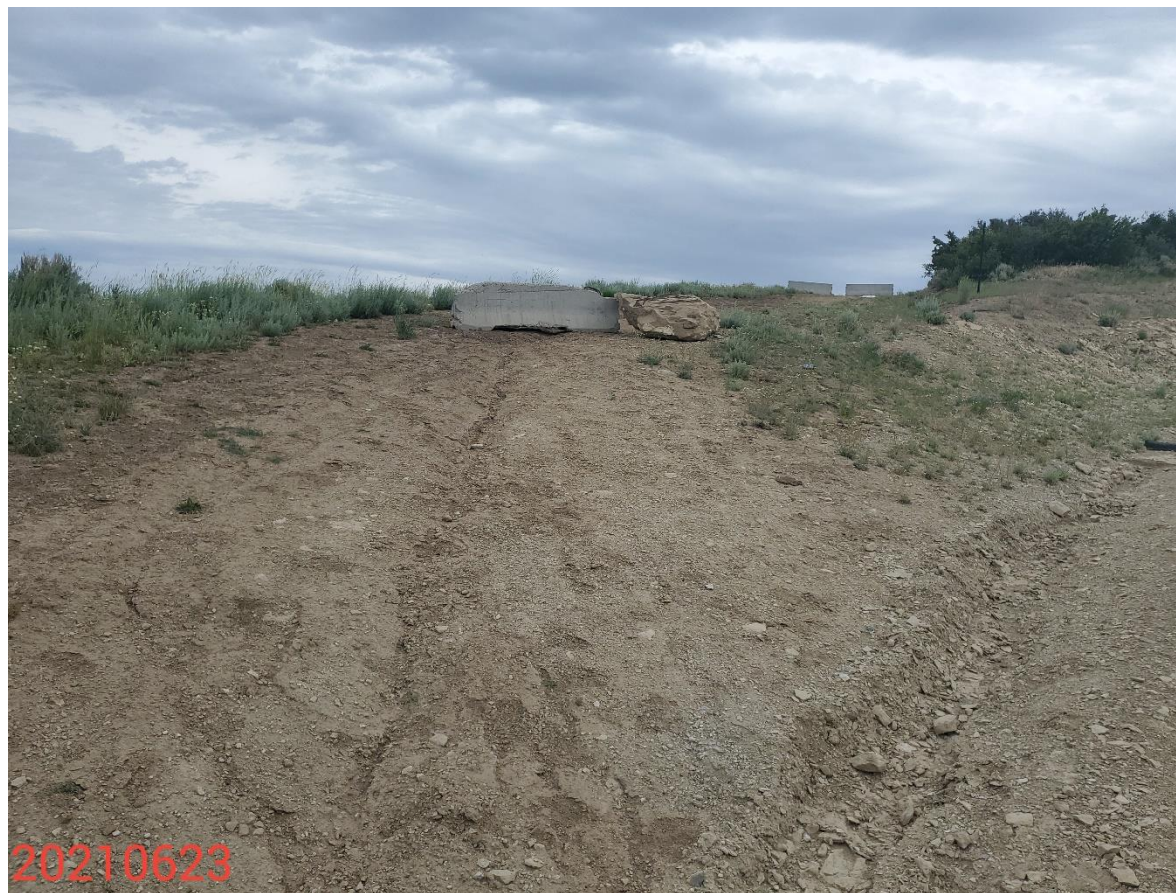
Photo 7: Continued from photo 4. Photo taken from the access road that travels from the southwestern end of the Location, facing north. Photo shows Operator has not reclaimed the access road per the corrective actions. Photo also shows stormwater erosion degradation.

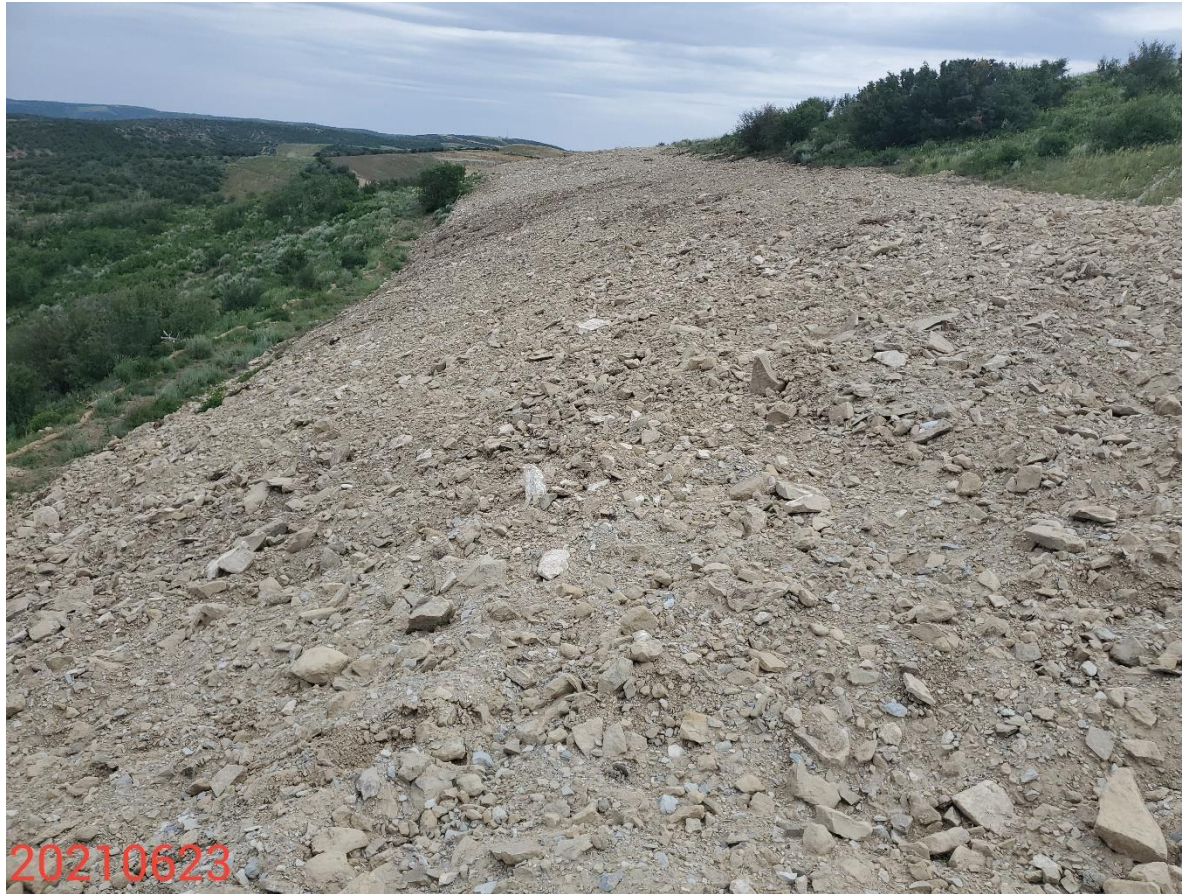
Photo 8: Photo taken from the access road that travels northwest of the Location, facing north. Photo shows reclamation activities have been performed. Corrective action required Operator to implement BMPs to stabilize the seeded soil. Photo shows BMPs to stabilize the seeded soil are missing or insufficient/inadequate; unable to find evidence that stabilization control measures have been installed.

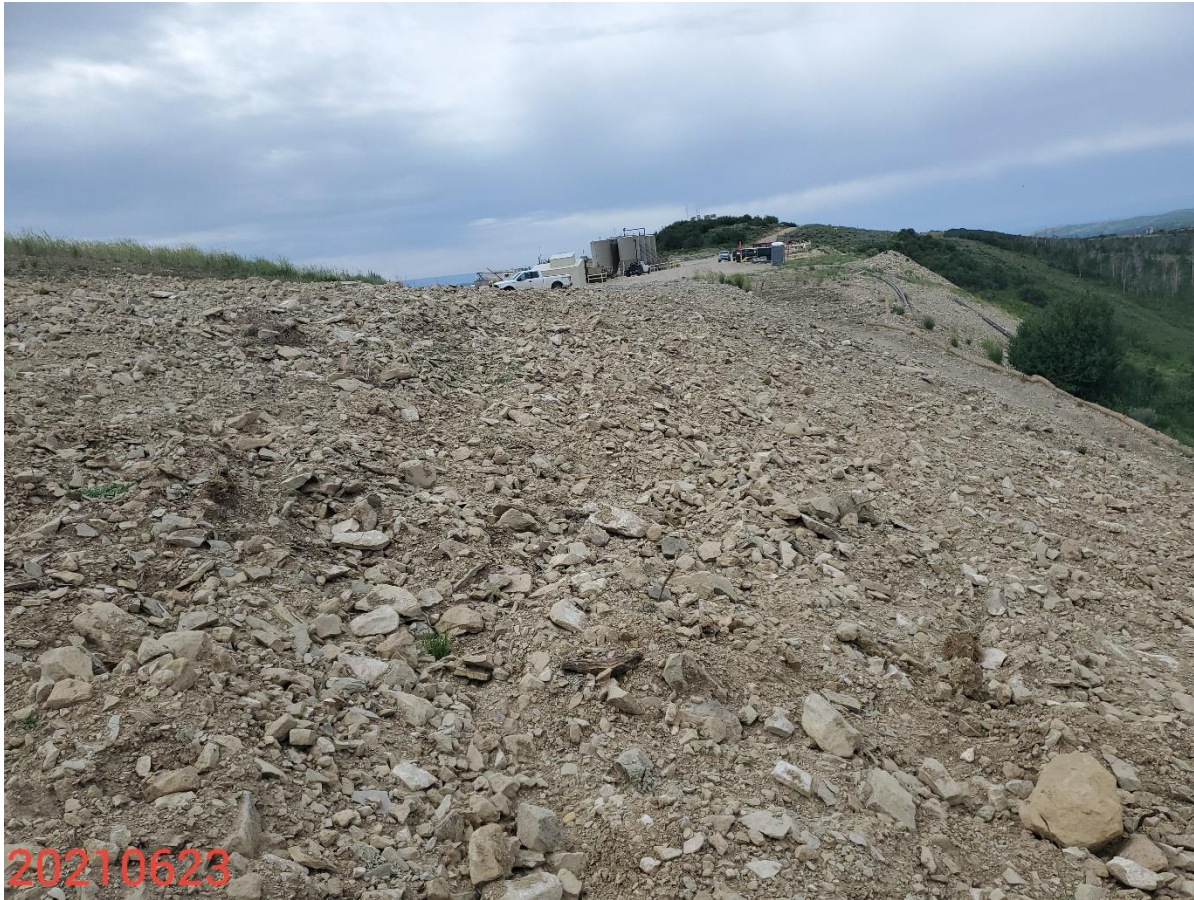
Photo 9: Photo taken from the access road that travels northwest of the Location, facing south. See comments under photo 8.

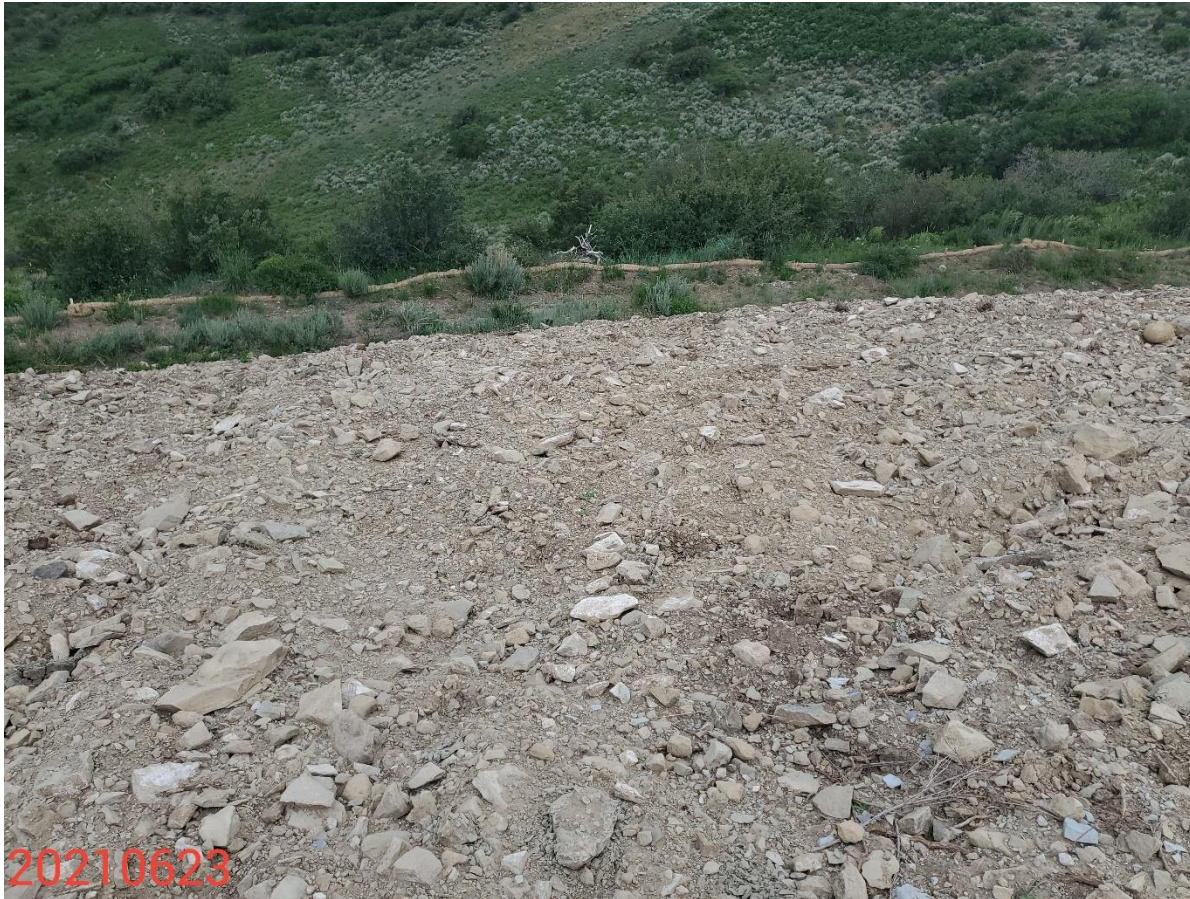
Photo 10: Photo taken from the access road that travels northwest of the Location, facing west. See comments under photo 8.
