Inspection Photos

6/23/2021

Operator: TEP ROCKY MOUNTAIN LLC #96850

Location ID: 324441

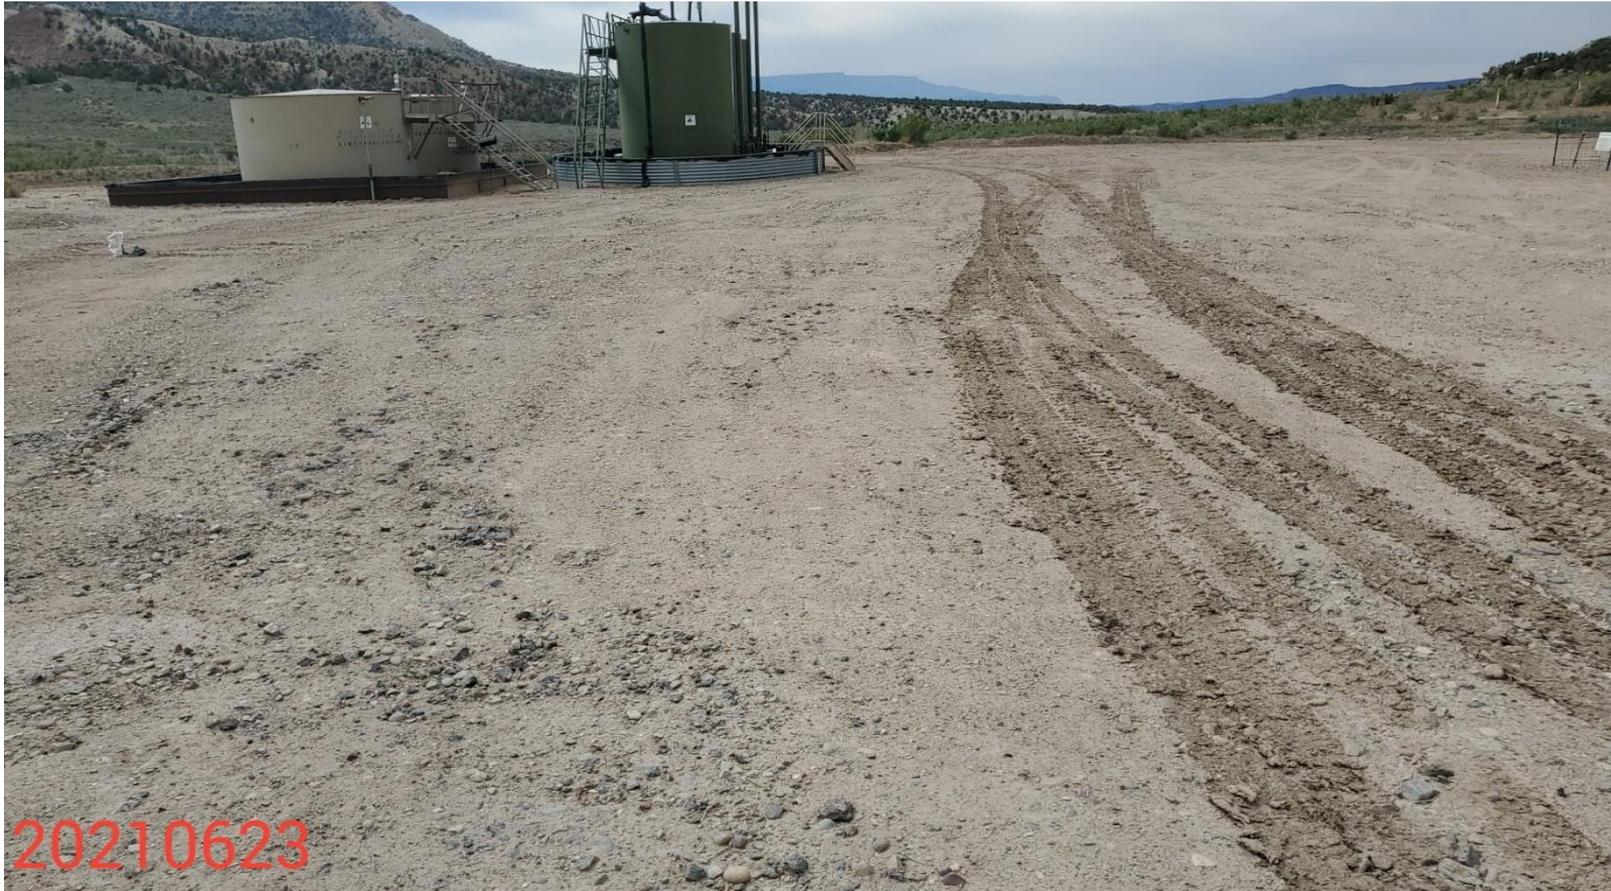
Photo 1: Photo taken from north end of the Location, facing south. Photos 1-3 provide and overview of the Location from south, southwest to west. Photo shows control measure to stabilize/protect the production areas, or to prevent off-site sediment transport and tacking remain missing or insufficient

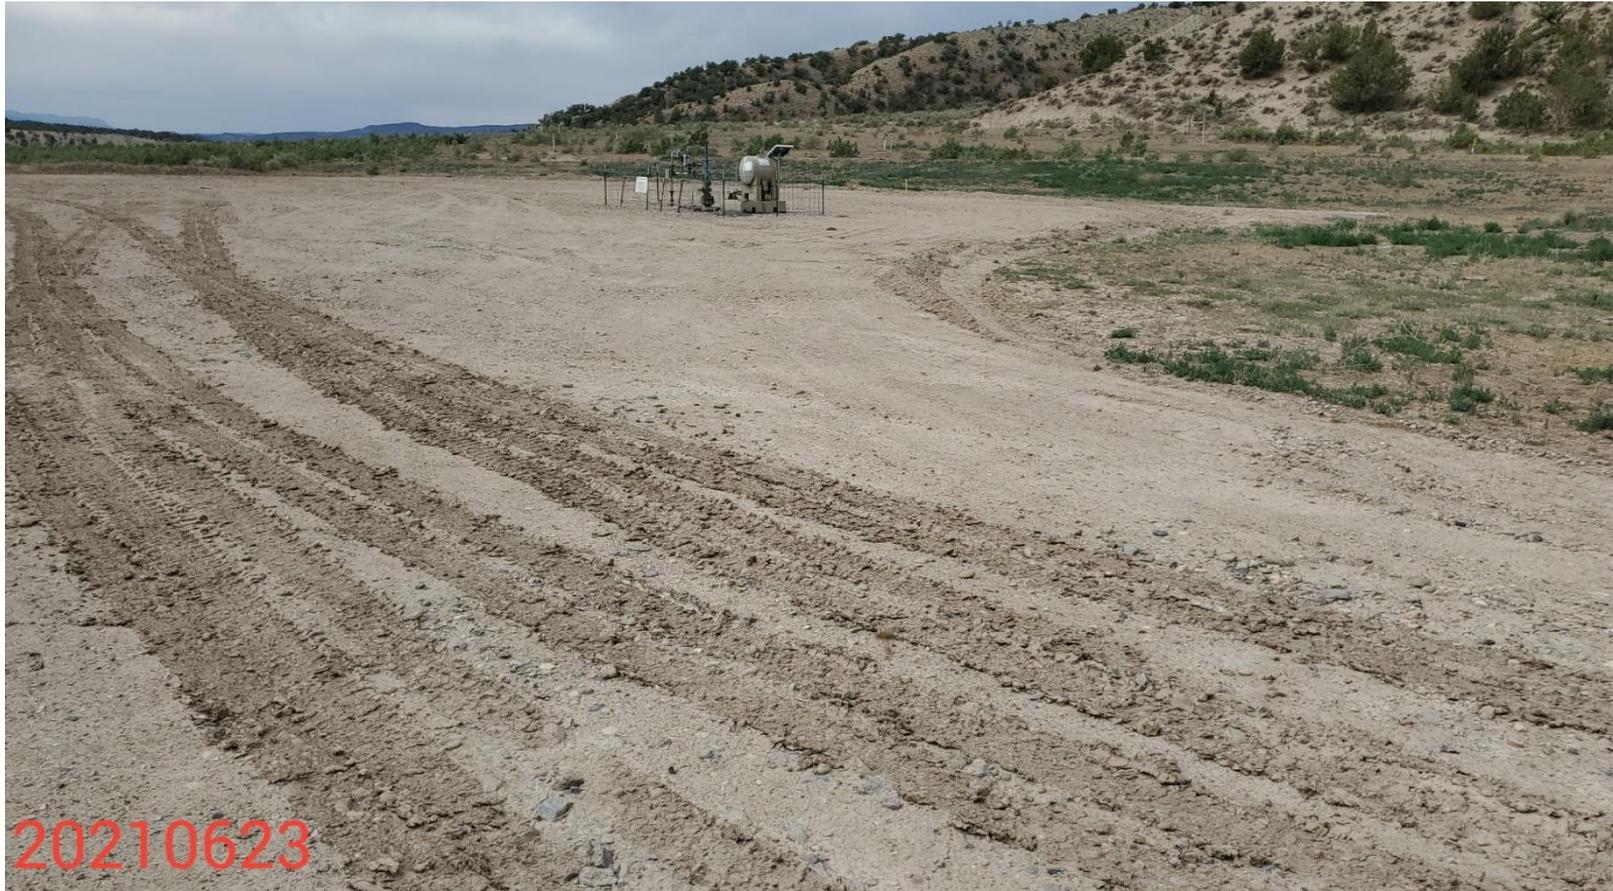
Photo 2: See comments under photo 1.

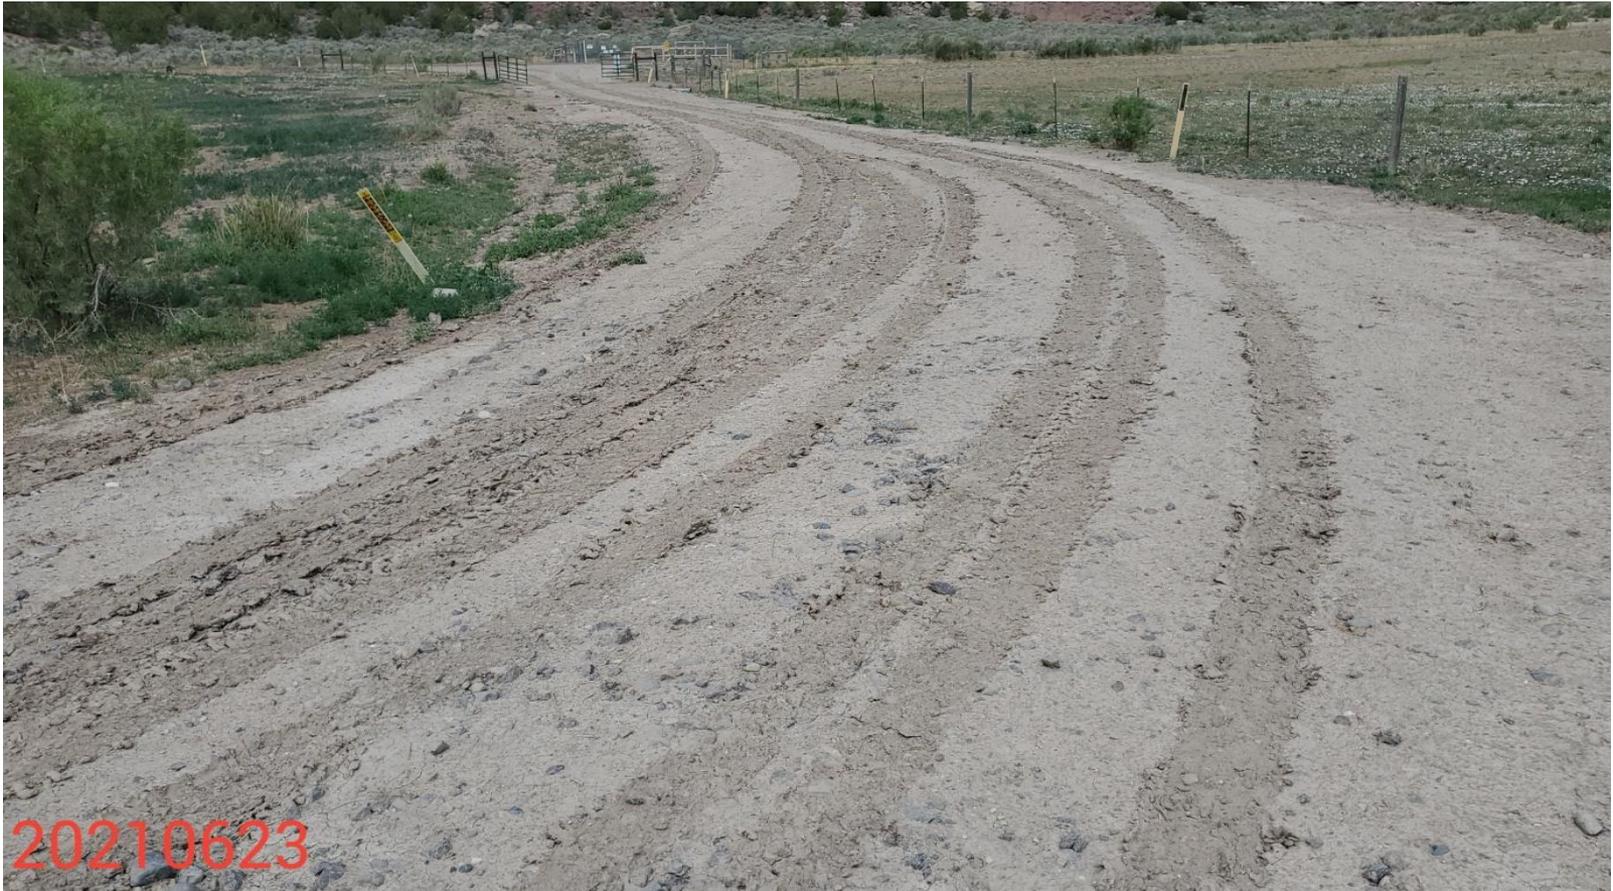
Photo 3: See comments under photo 1.

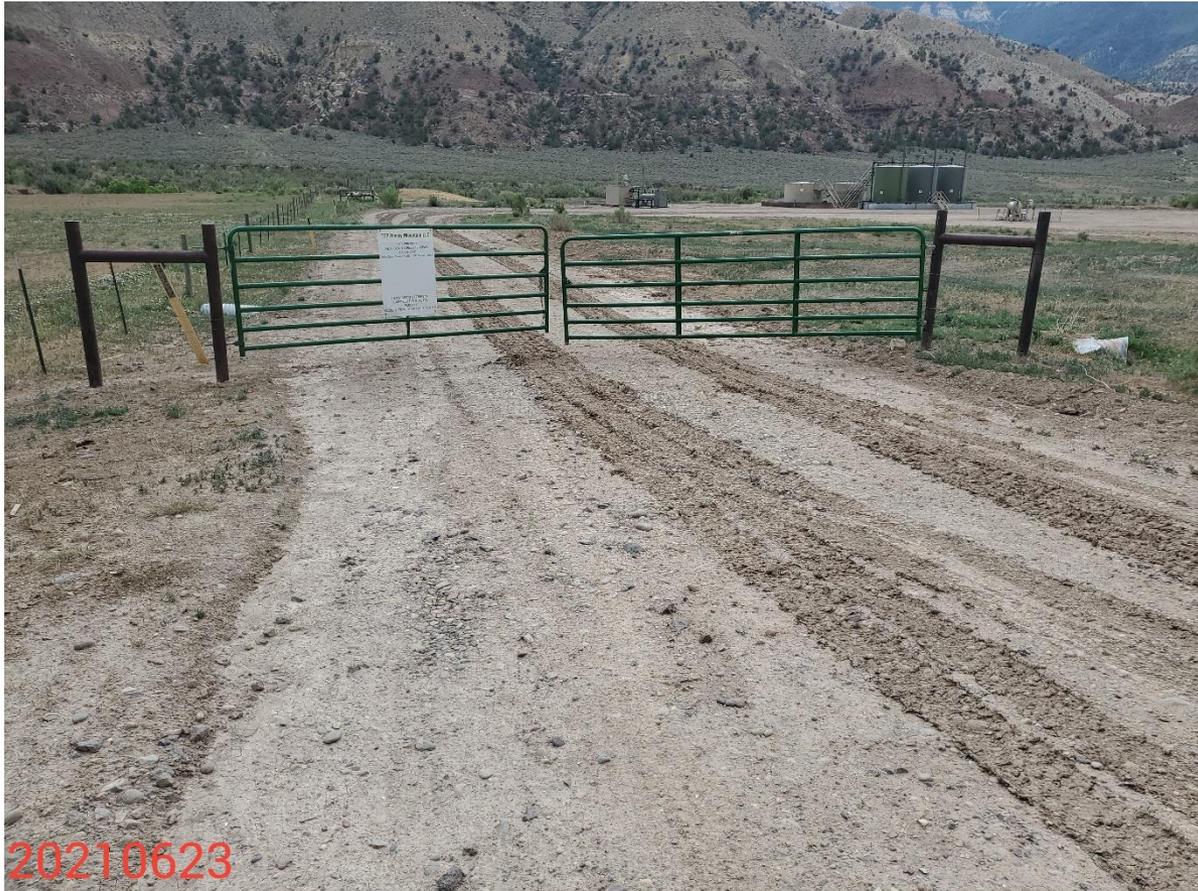
Photo 4: Photo taken from the Location entrance, facing east. Photo shows tracking and off-site sediment concerns remain evident; control measure to stabilize/protect the production areas and access road, or to prevent off-site sediment transport and tacking remain missing or insufficient

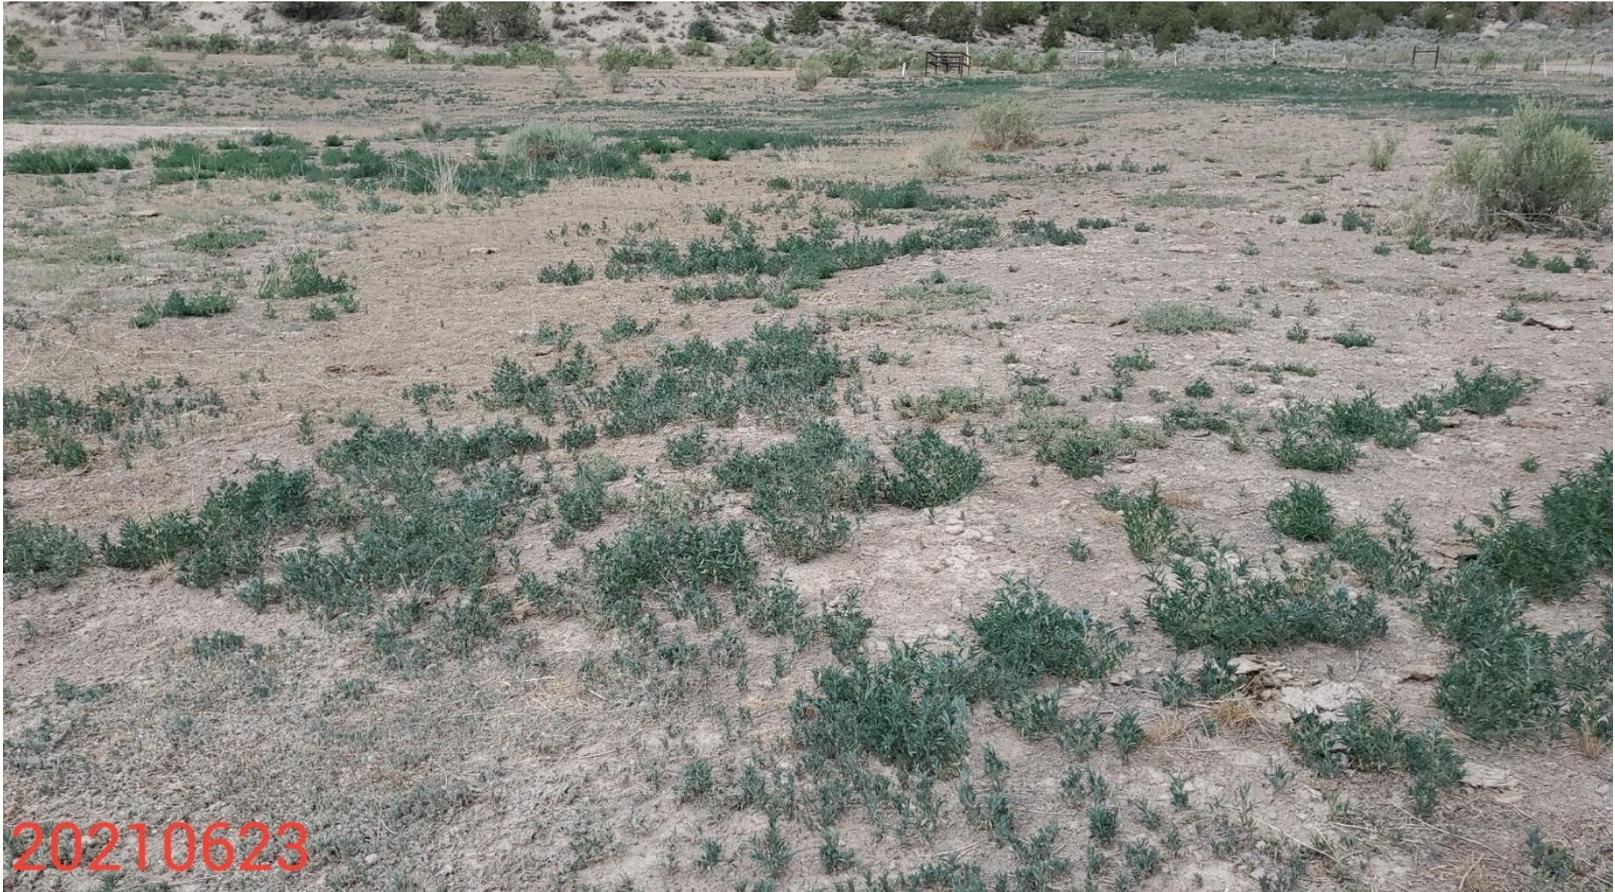
Photo 5: Photo taken from interim areas on the north end of the Location, facing west. Photo shows undesirable weedy plant establishment remains evident. Unable to find evidence that additional reclamation activities have been performed.

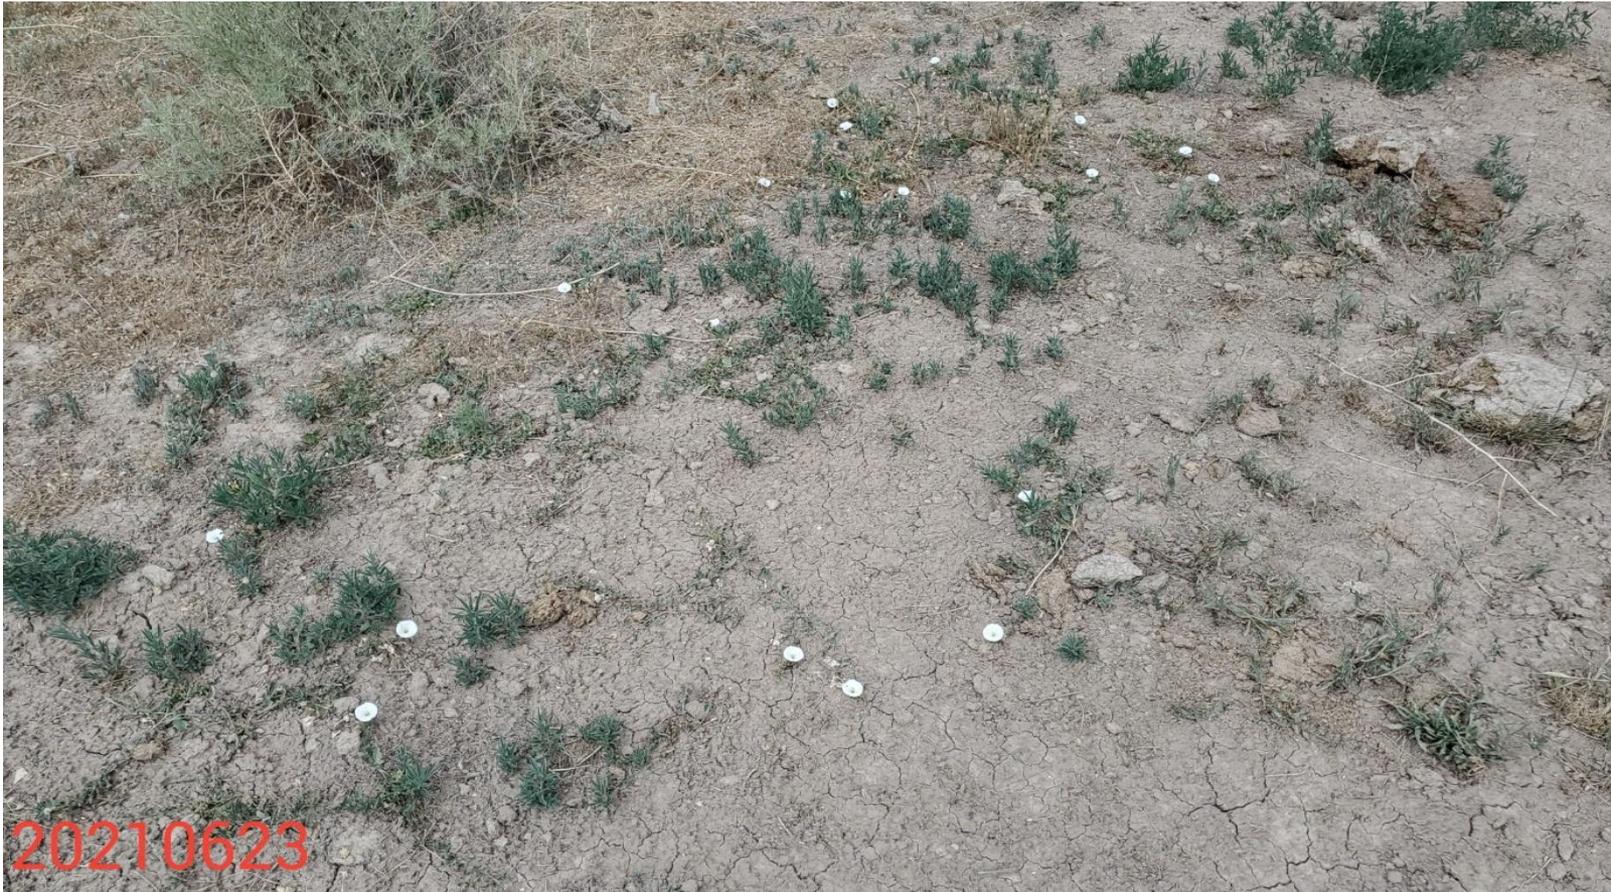
Photo 6: Continued from photo 5. Photo shows noxious weed (bindweed) establishment on the interim areas of the Location.

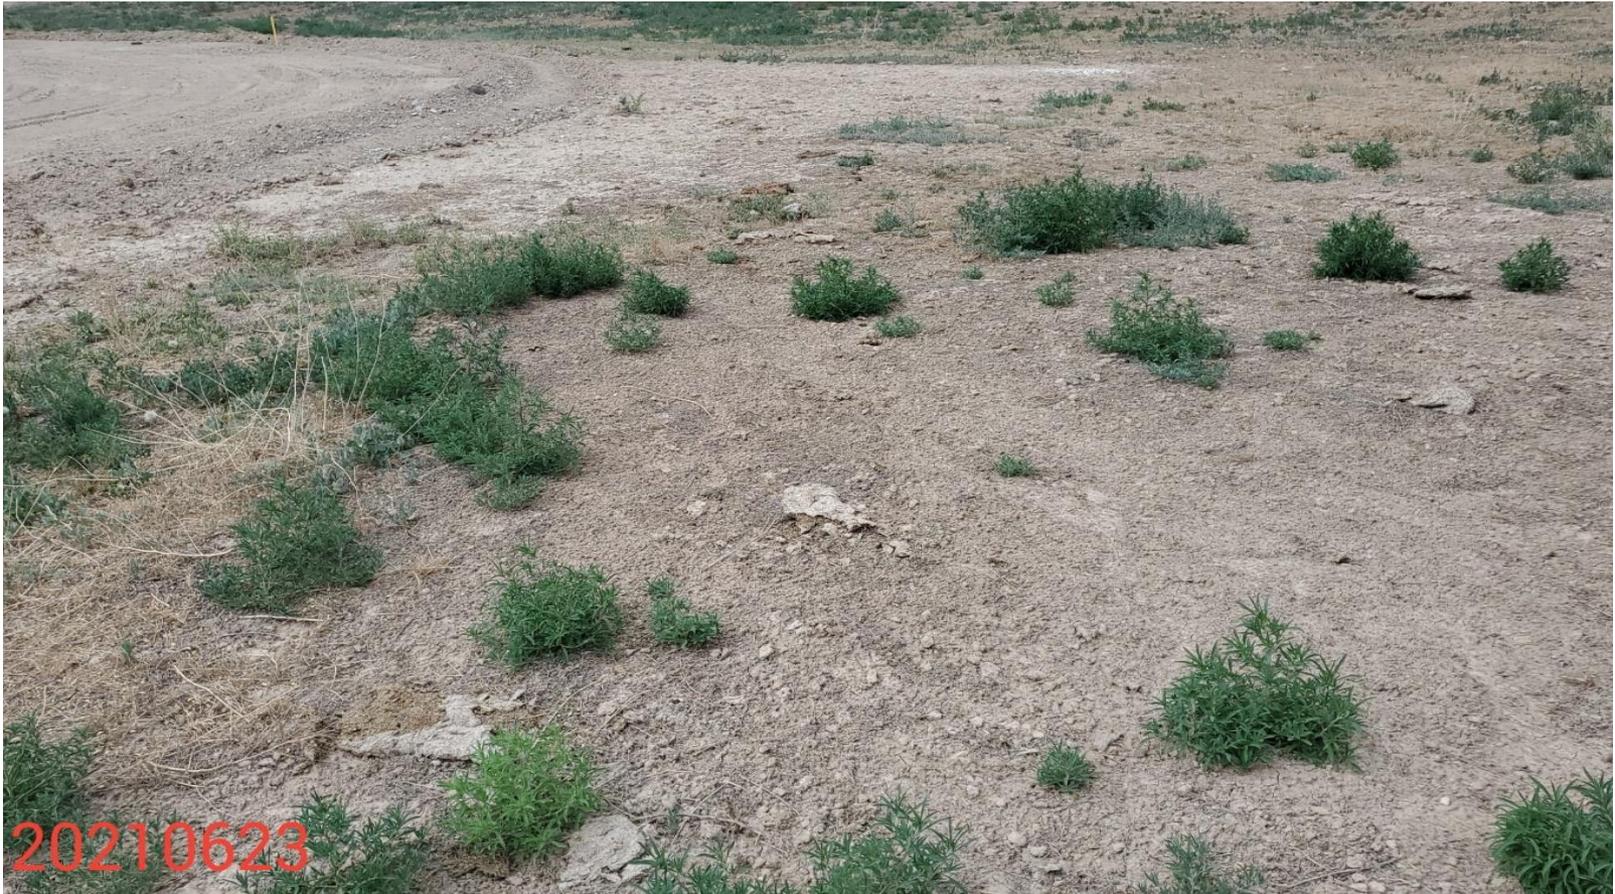
Photo 7: Photo taken from interim areas on the northwest end of the Location, facing southwest. Photo shows undesirable weedy plant establishment remains evident. Unable to find evidence that additional reclamation activities have been performed.

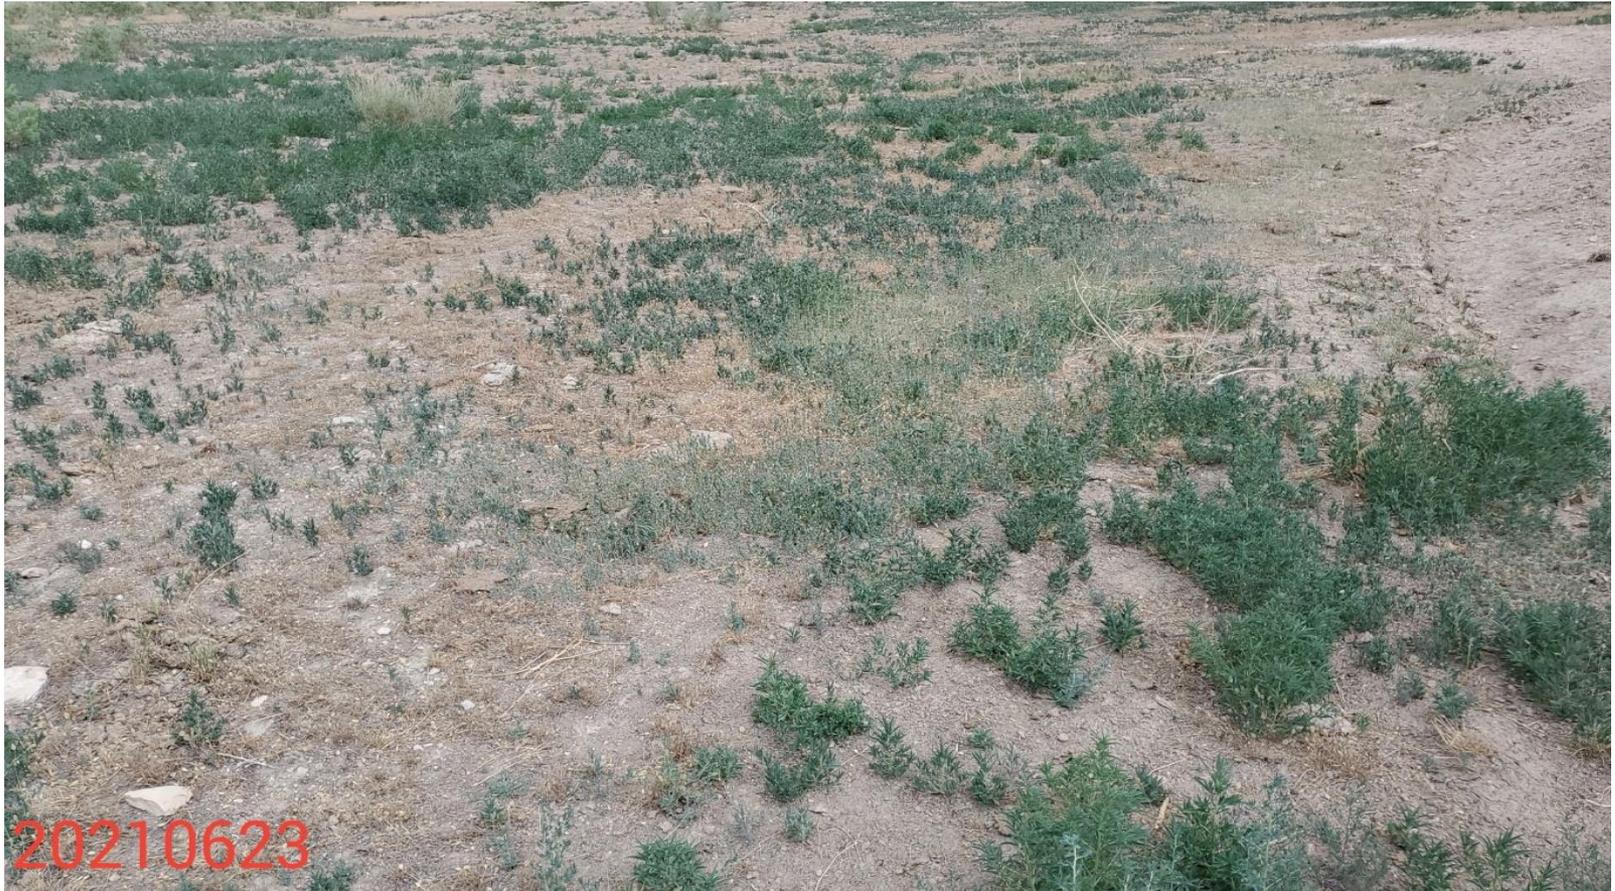
Photo 8: Photo taken from interim areas on the southwest end of the Location, facing north. Photo shows undesirable weedy plant establishment remains evident. Unable to find evidence that additional reclamation activities have been performed.

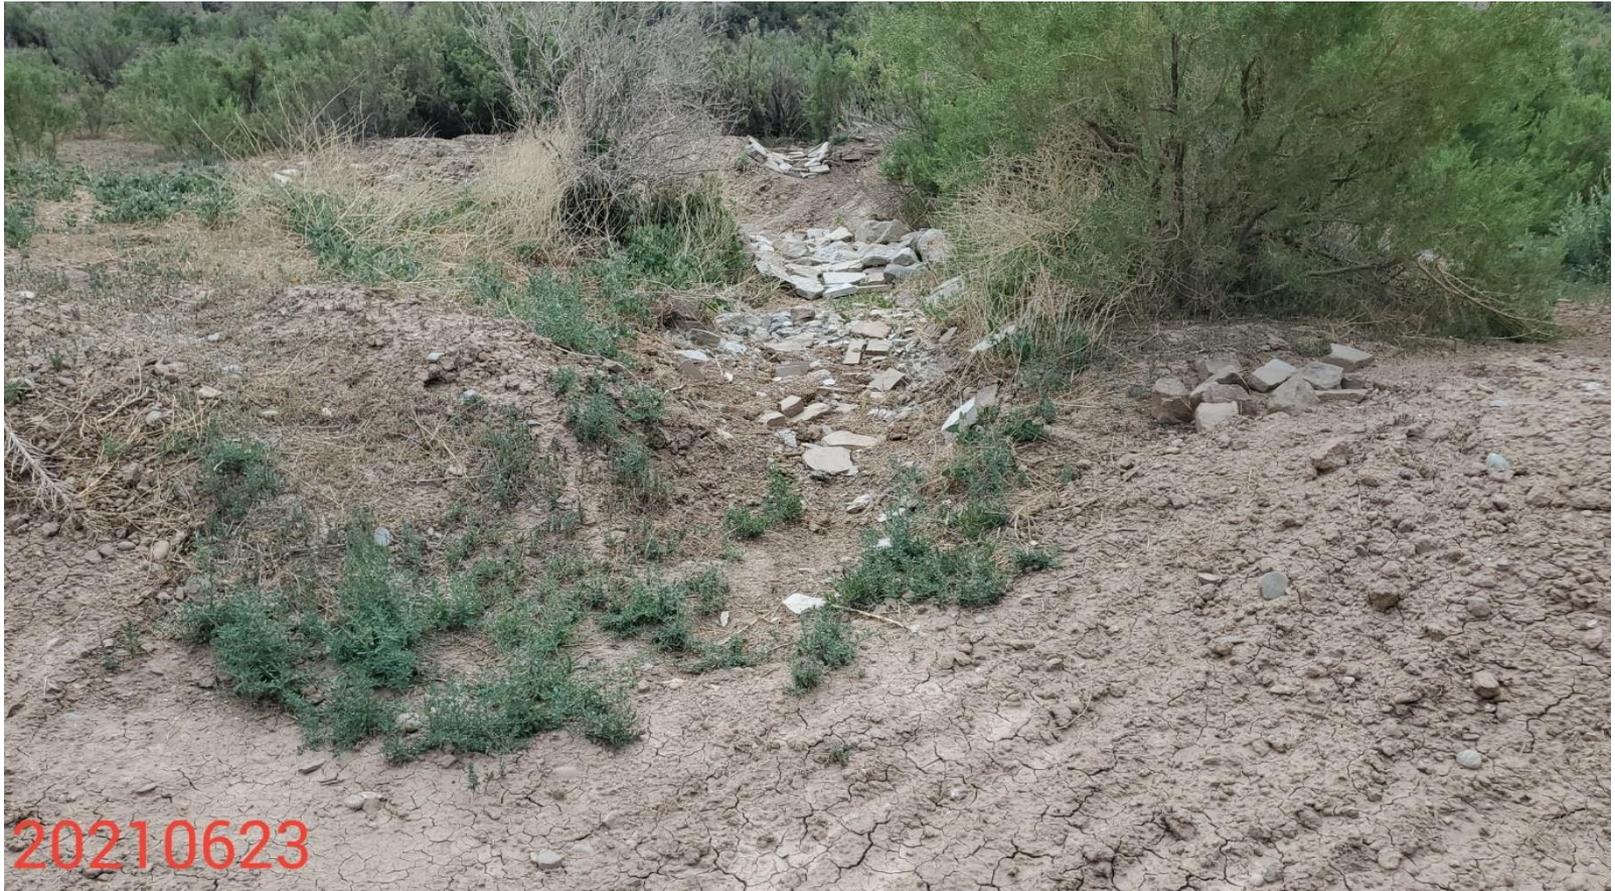
Photo 9: Photo taken from the southeast end of the Location, facing east. Photo shows sediment trap.

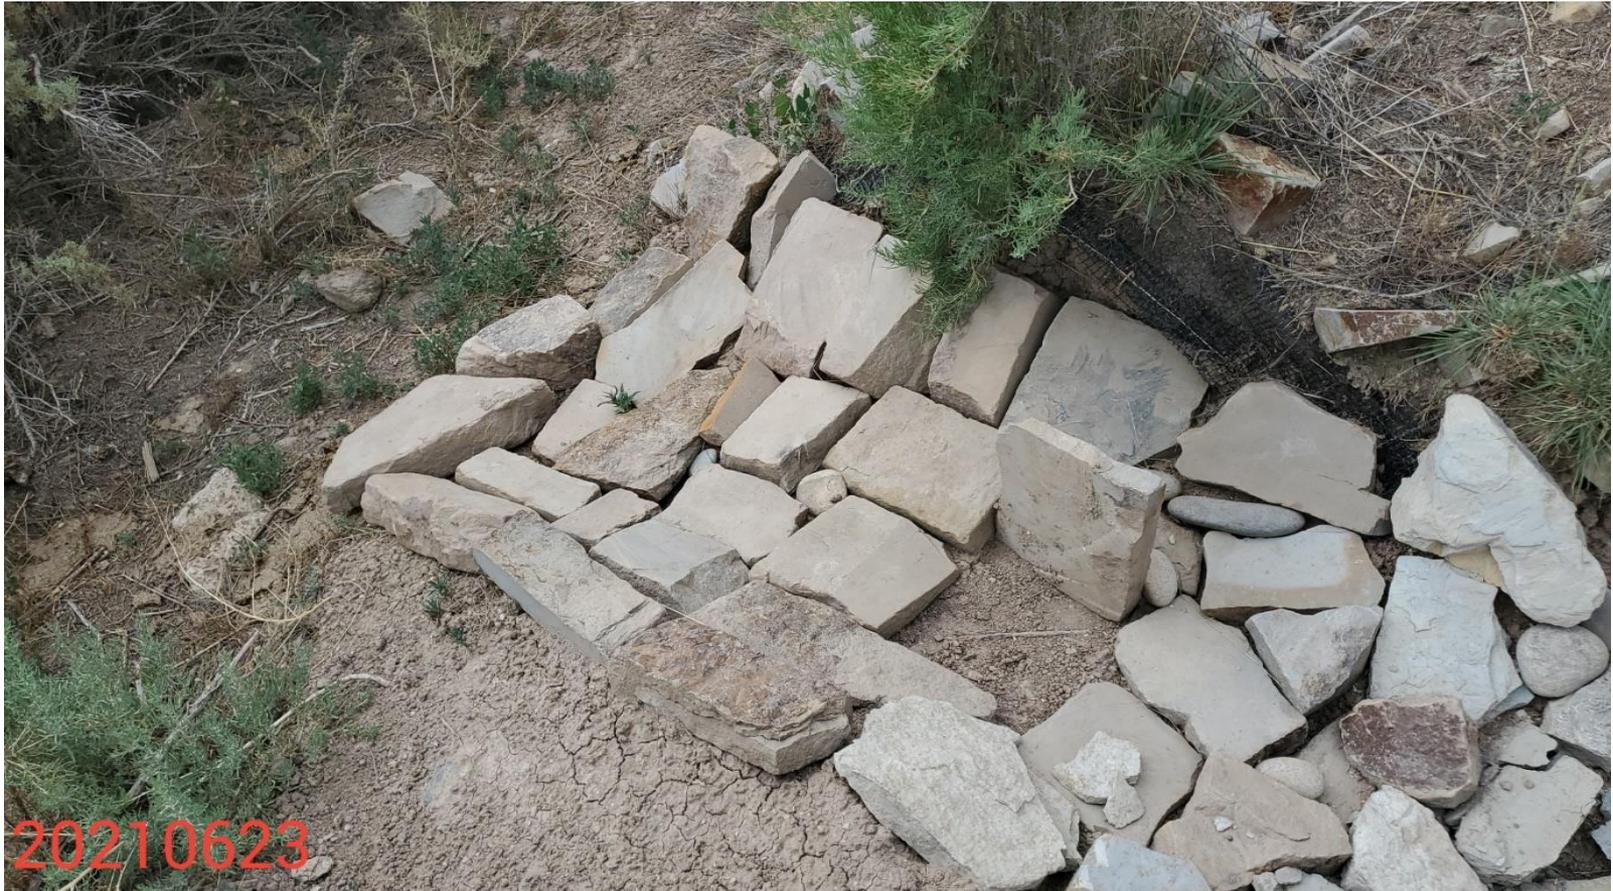
Photo 10: Continued from photo 9. Phot shows sediment trap has not been constructed with geotextile lining in accordance with good engineering practices

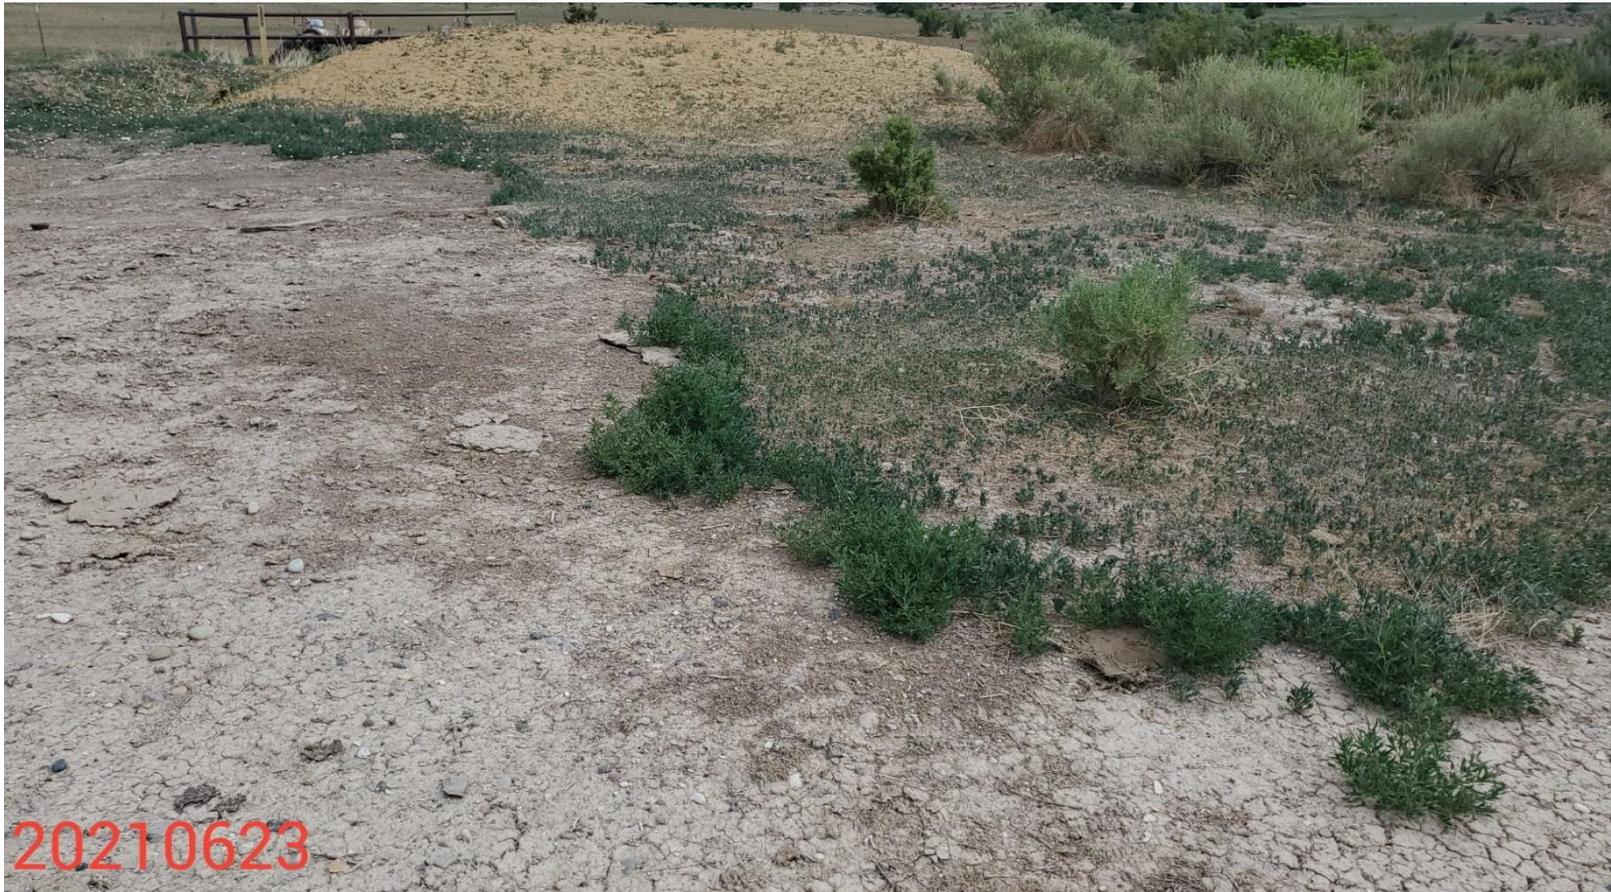
Photo 12: Photo taken from the northwest corner of the Location, facing north. Photo shows hydromulch has been applied to the soil stockpile. Photo also shows undesirable weedy plant establishment remains evident

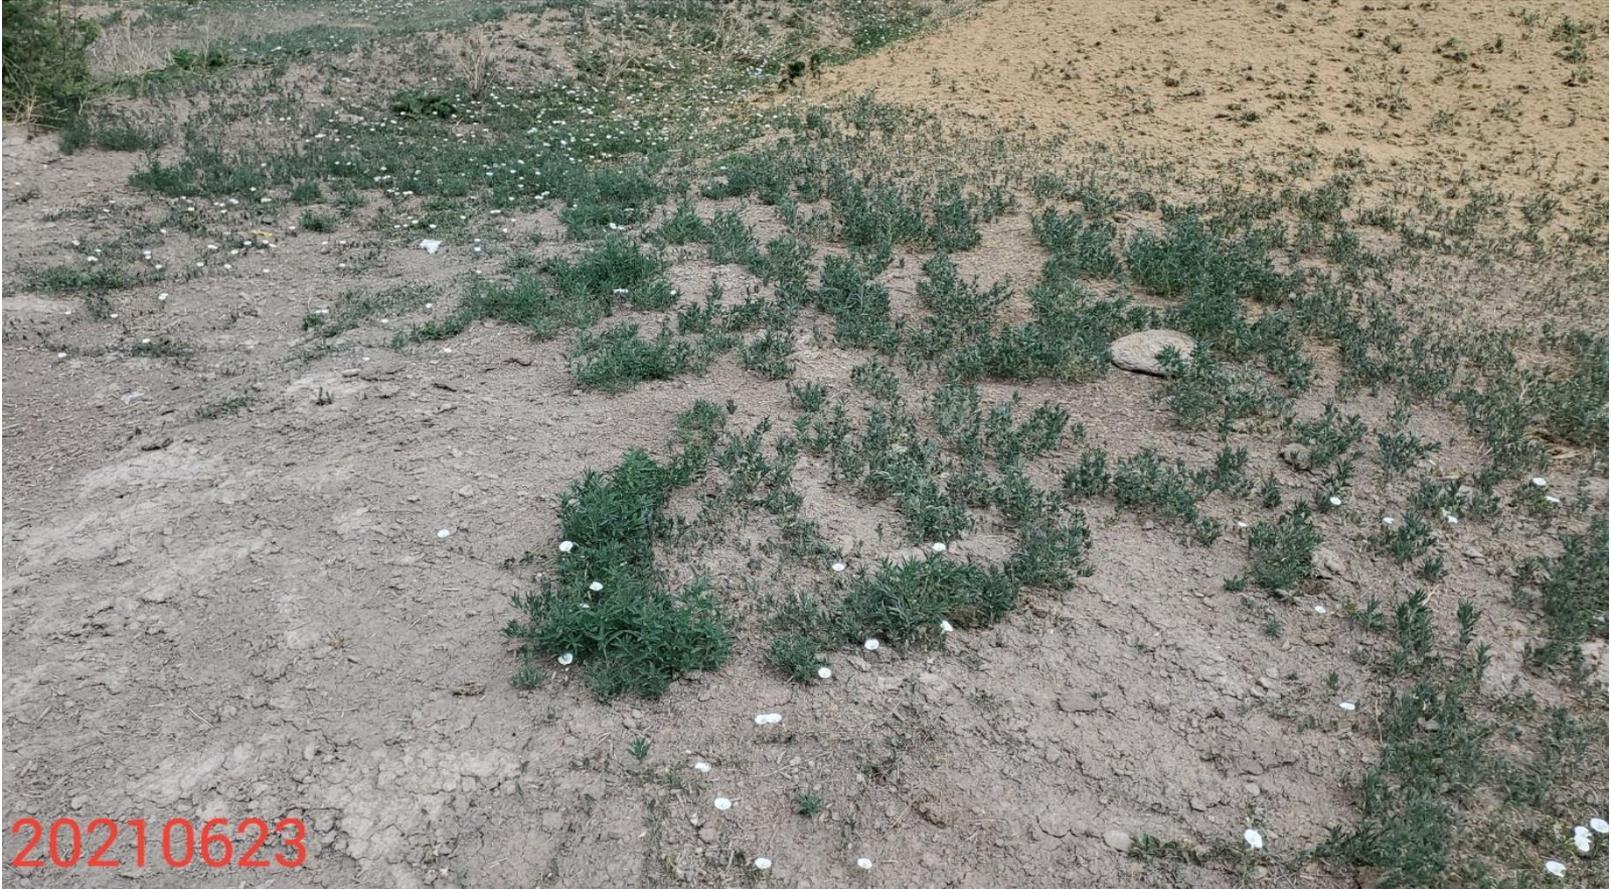
Photo 13: Continued from photo 12. Photo shows undesirable and noxious weed establishment at the soil stockpile.
