Inspection Photos
spill doc 402679961
Spill #479949

Inspection Date: 5/6/2021
All Photos taken by Kris Neidel

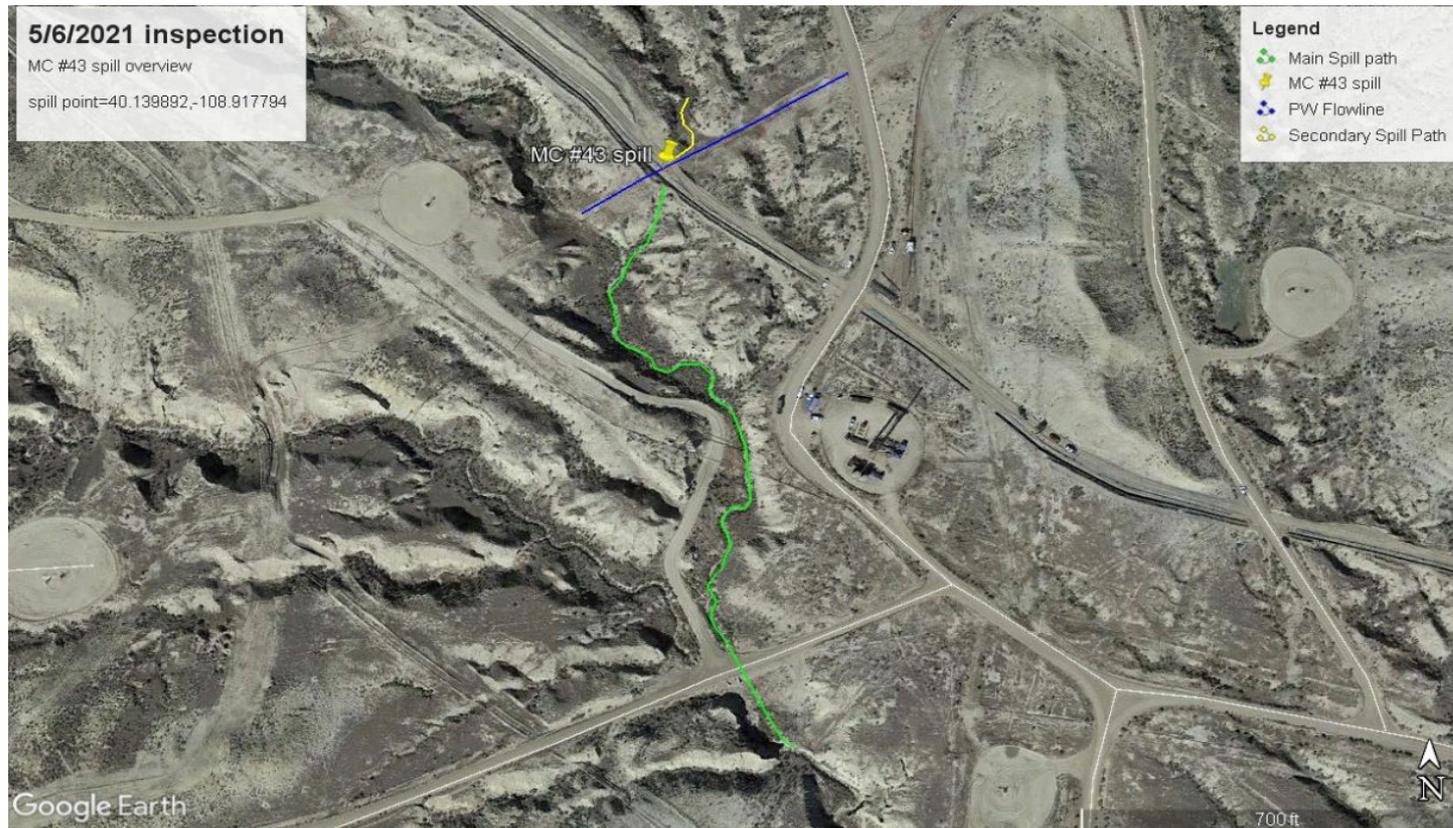
MC #43 spill overview

spill point=40.139892,-108.917794

NOTE: green line near spill point is where spill went back under ground.

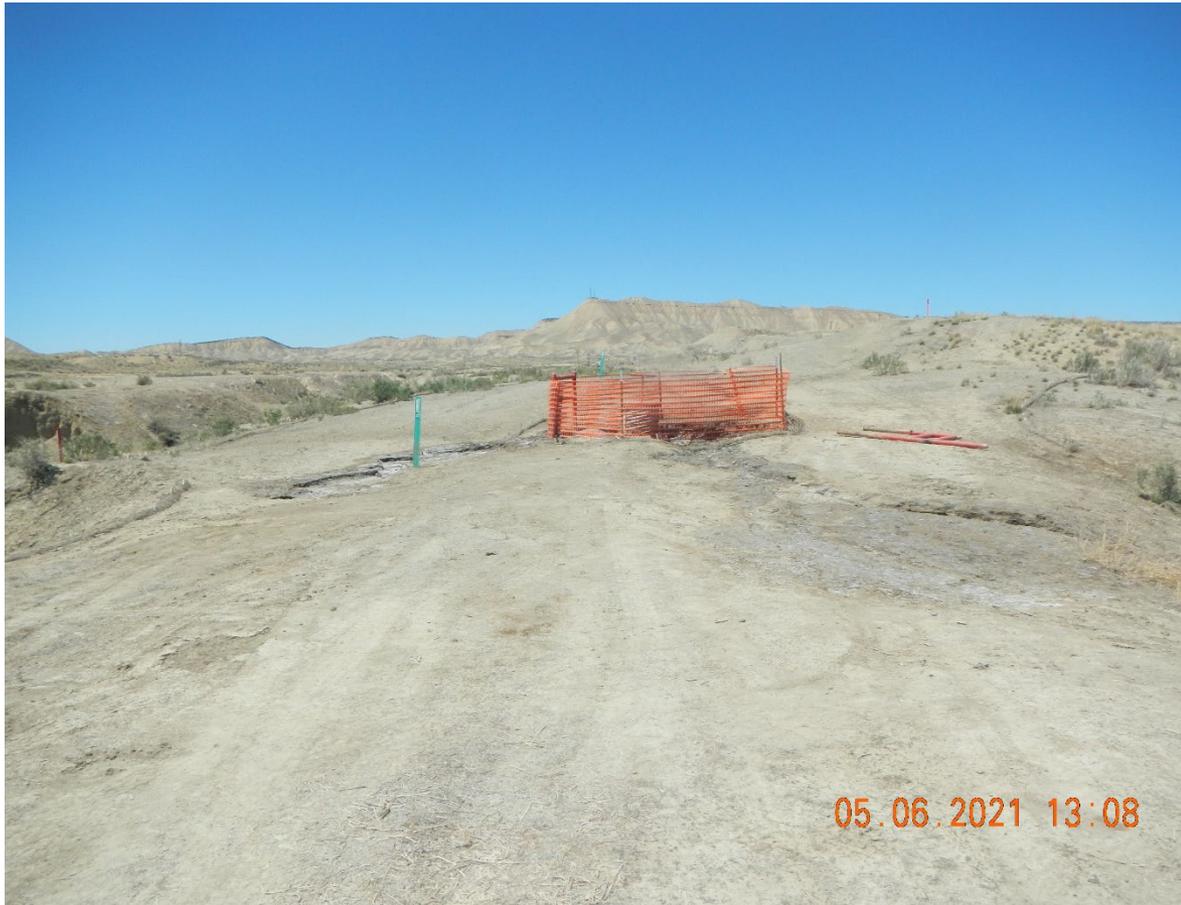
Photo #1 looking south west. Spill originated inside the orange fence. There is a valve box, flowline appeared to be ~7feet deep. Note the Two separate spill paths; the Main spill path flowed mostly south (left of photo), flowed approx. 1400ft. The Secondary spill path flowed to the north into an adjacent small basin, traveled approx. 170 feet.

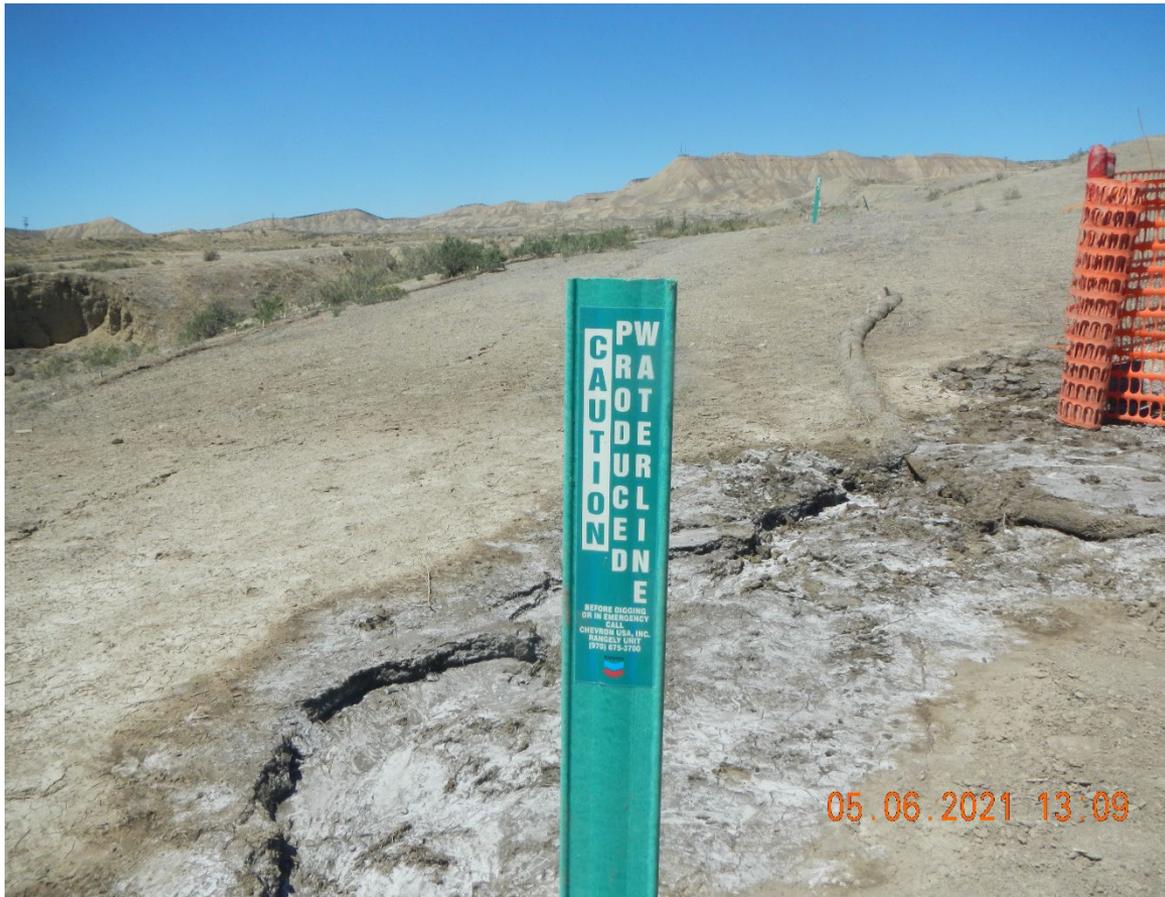
Photo #2 close up of photo#1 It appeared that the spill day-lighted near the valve box, and split into two flow paths. Photo taken looking to the southwest.

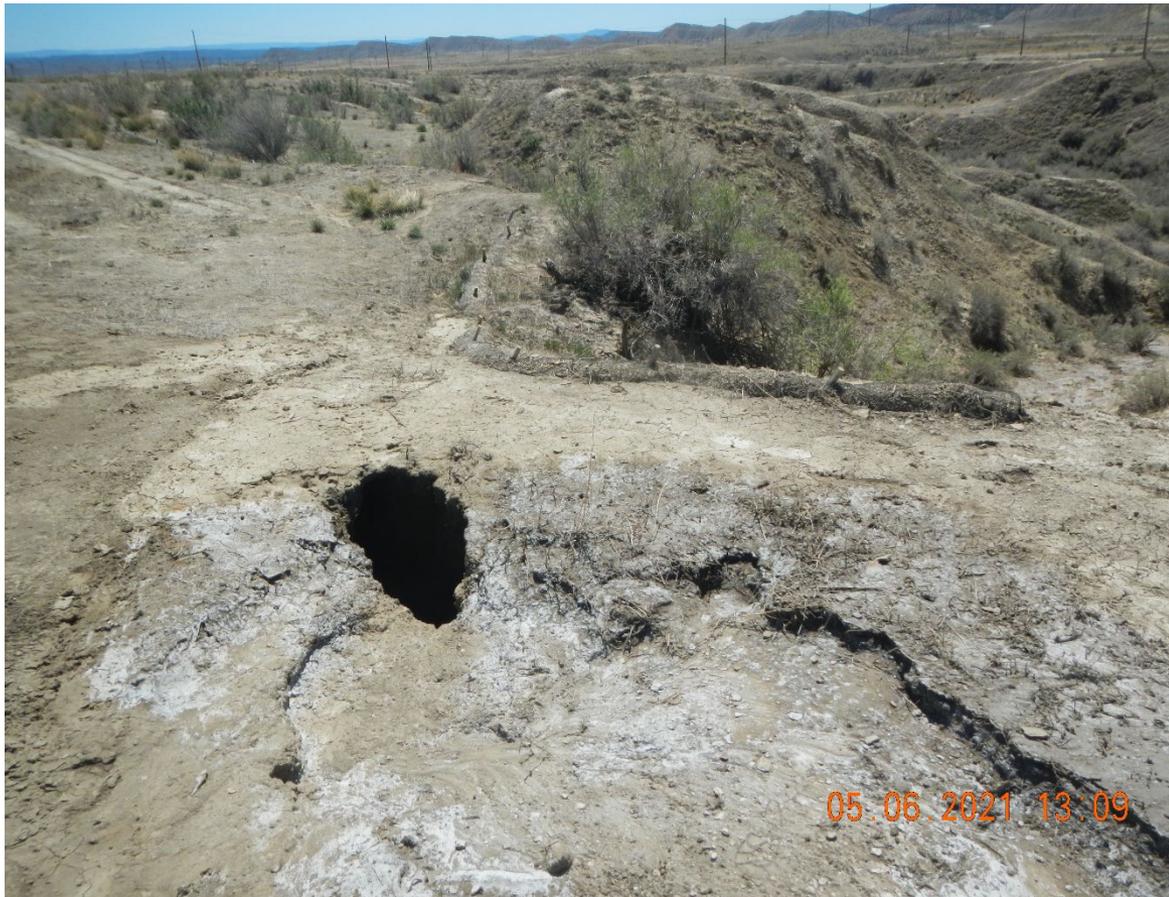
Photo #3 looking south-southwest. It appeared that produced water found a pathway through what appeared to be a Reclamation area. There was a “Notice of Reclamation” Sign nearby, implying this area.
Note: BMP’s

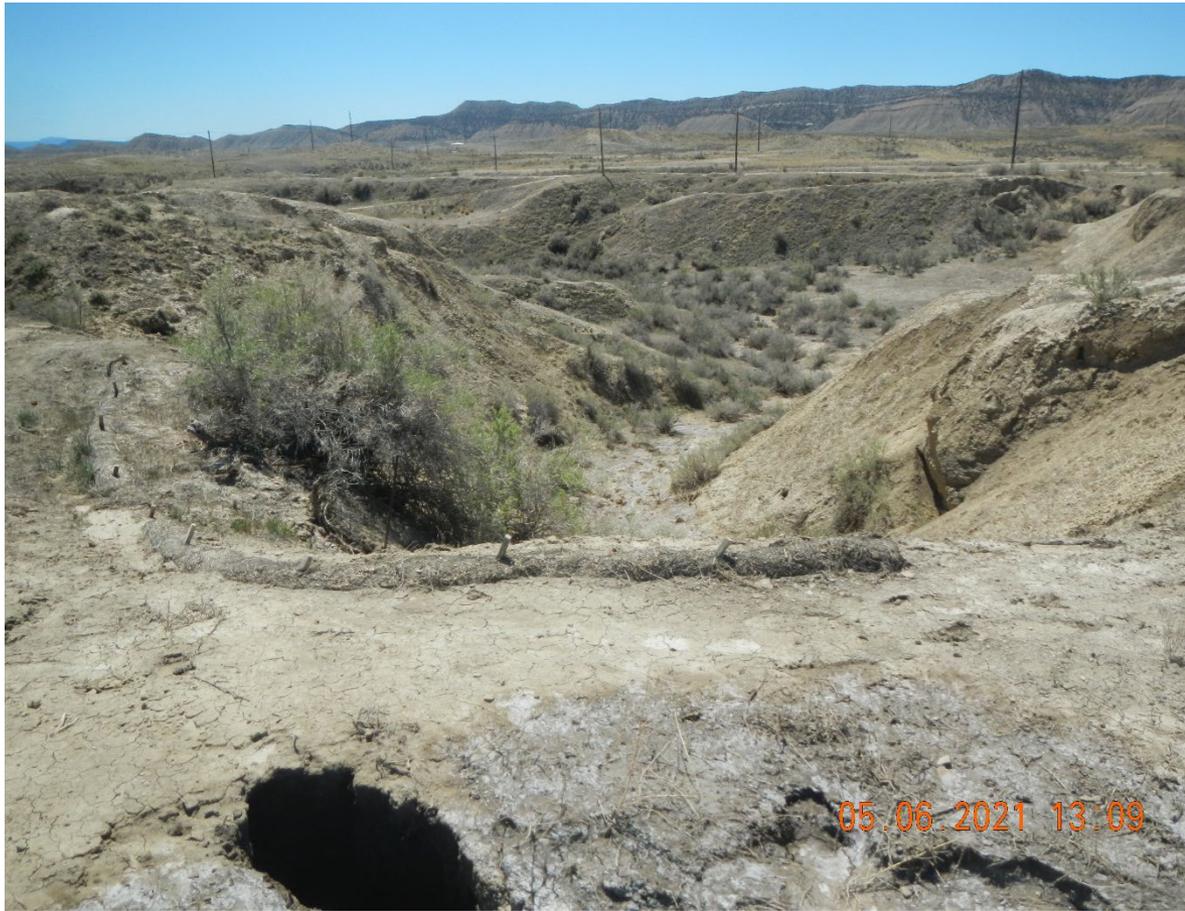
Photo #4 same as #3

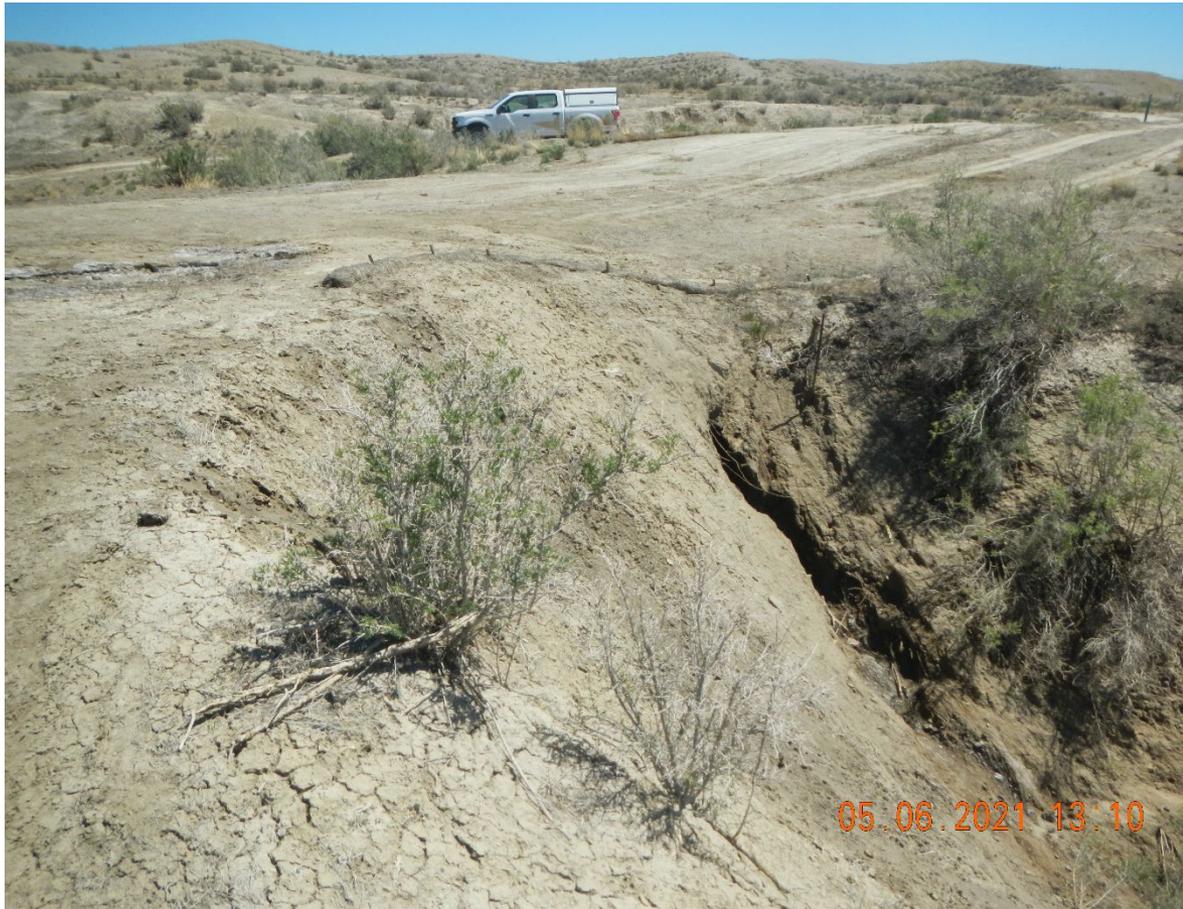
Photo #5 Looking to the Northeast vertical shadow to right of photo appears to be where spilled fluid day-lighted and made its way down grade.

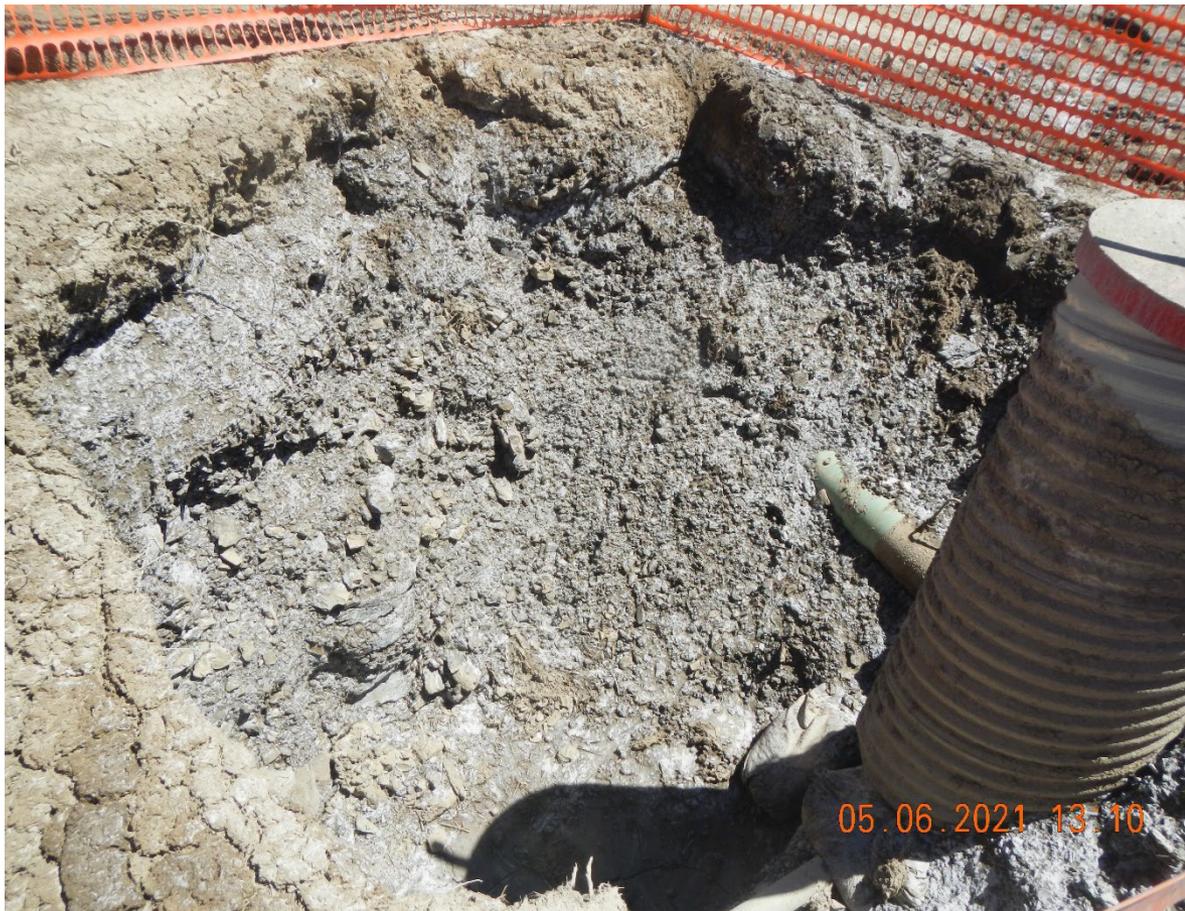
Photo #6 Spill release point.

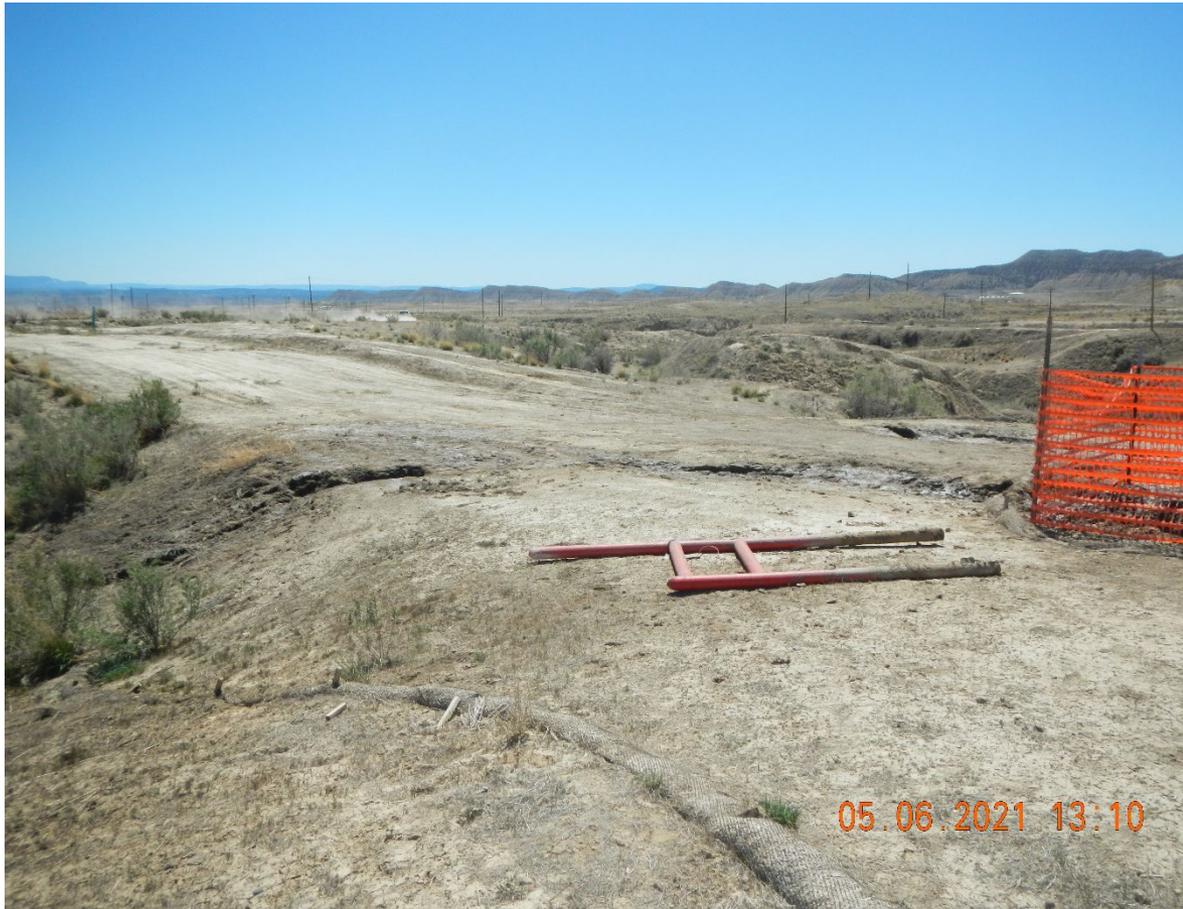
Photo #7 Spill path visible from release point (orange fence) is flowing to the North-northeast. This is the secondary flow path to the north.

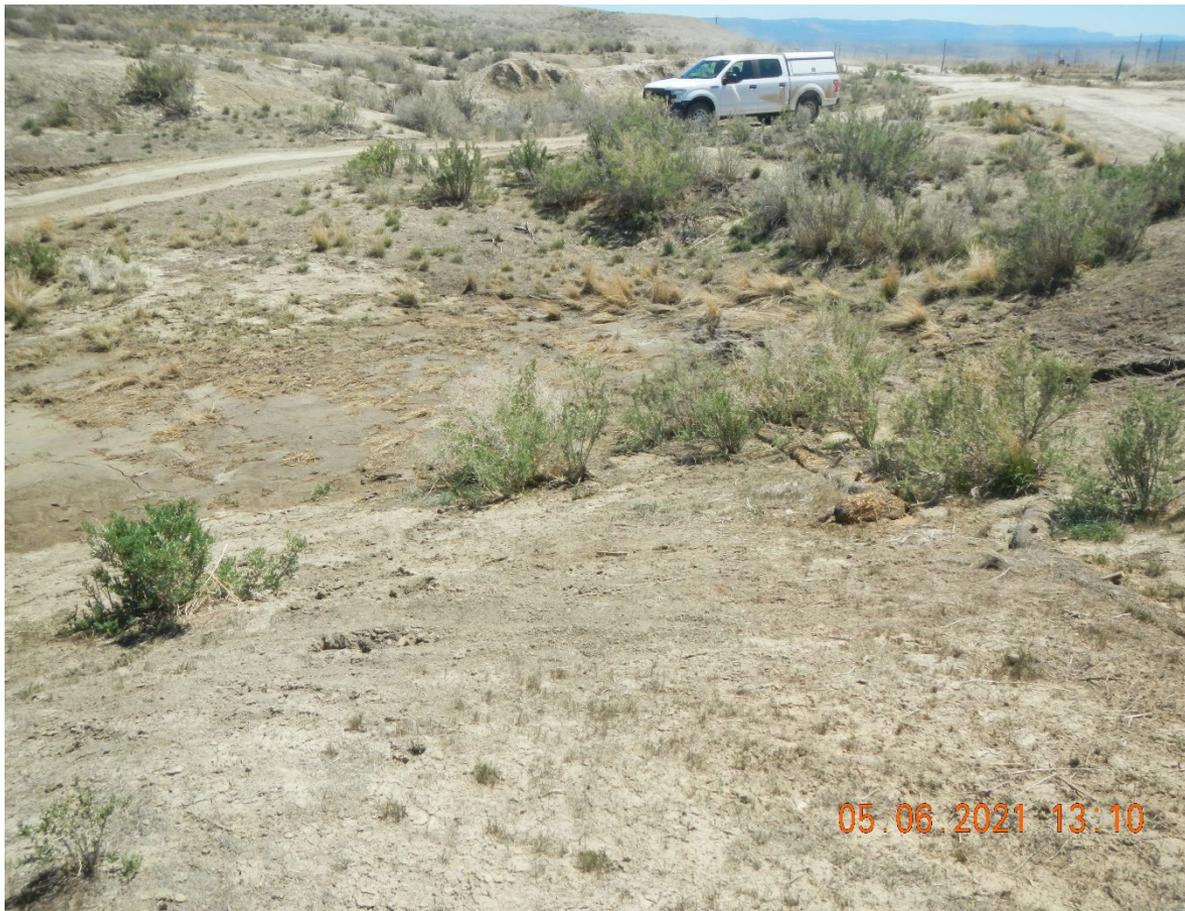
Photo #8 Looking northeast, spill point to right of photo, fluid flow observable in center of photo.

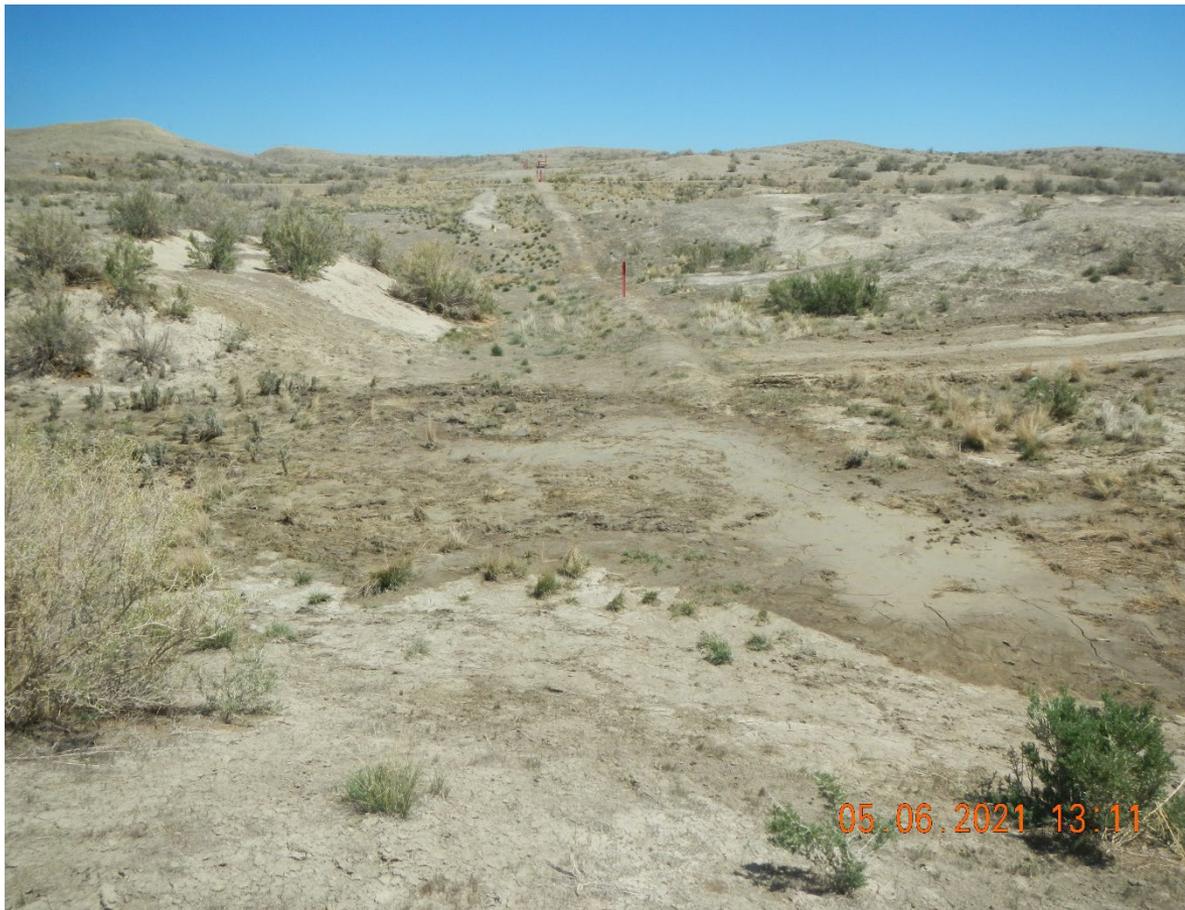
Photo #9 Secondary spill path

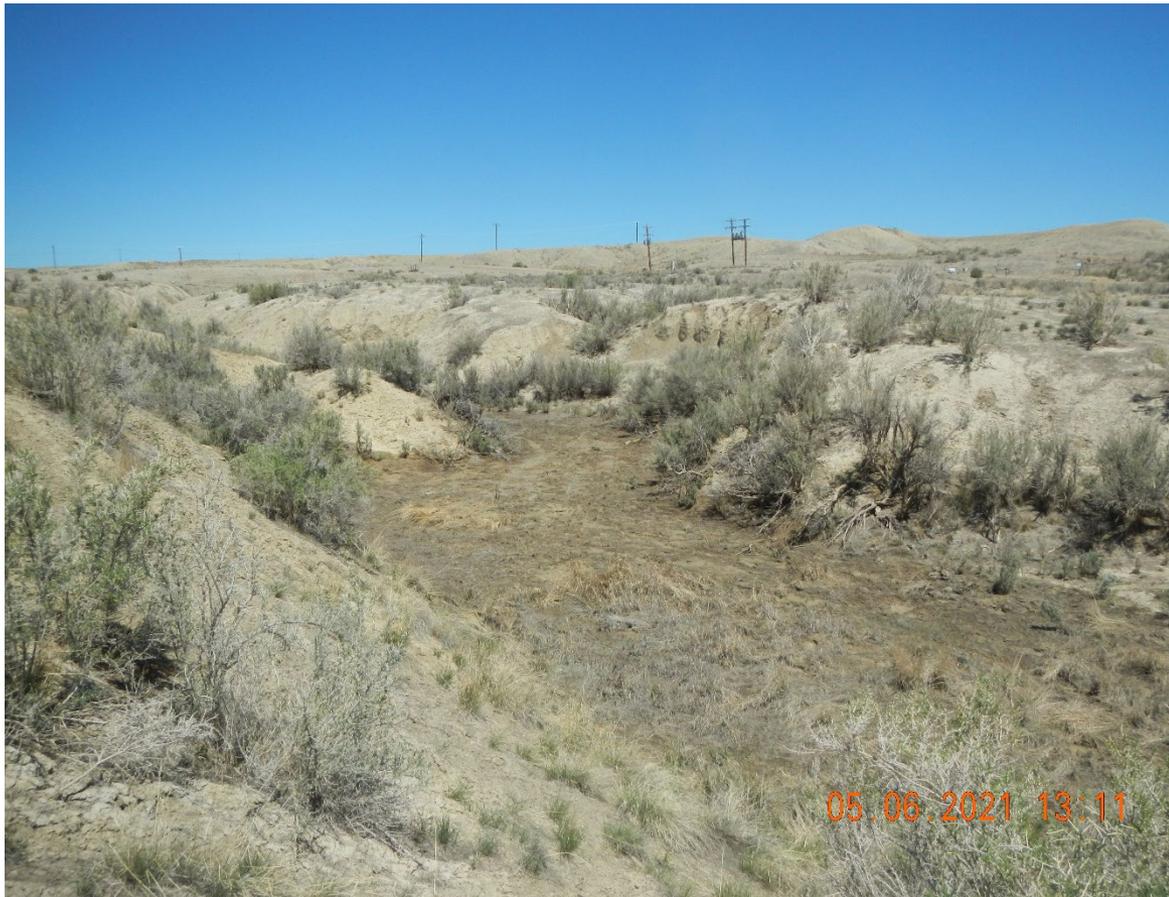
Photo #10 Termination of secondary spill path, approx. 170 feet from spill discharge point.

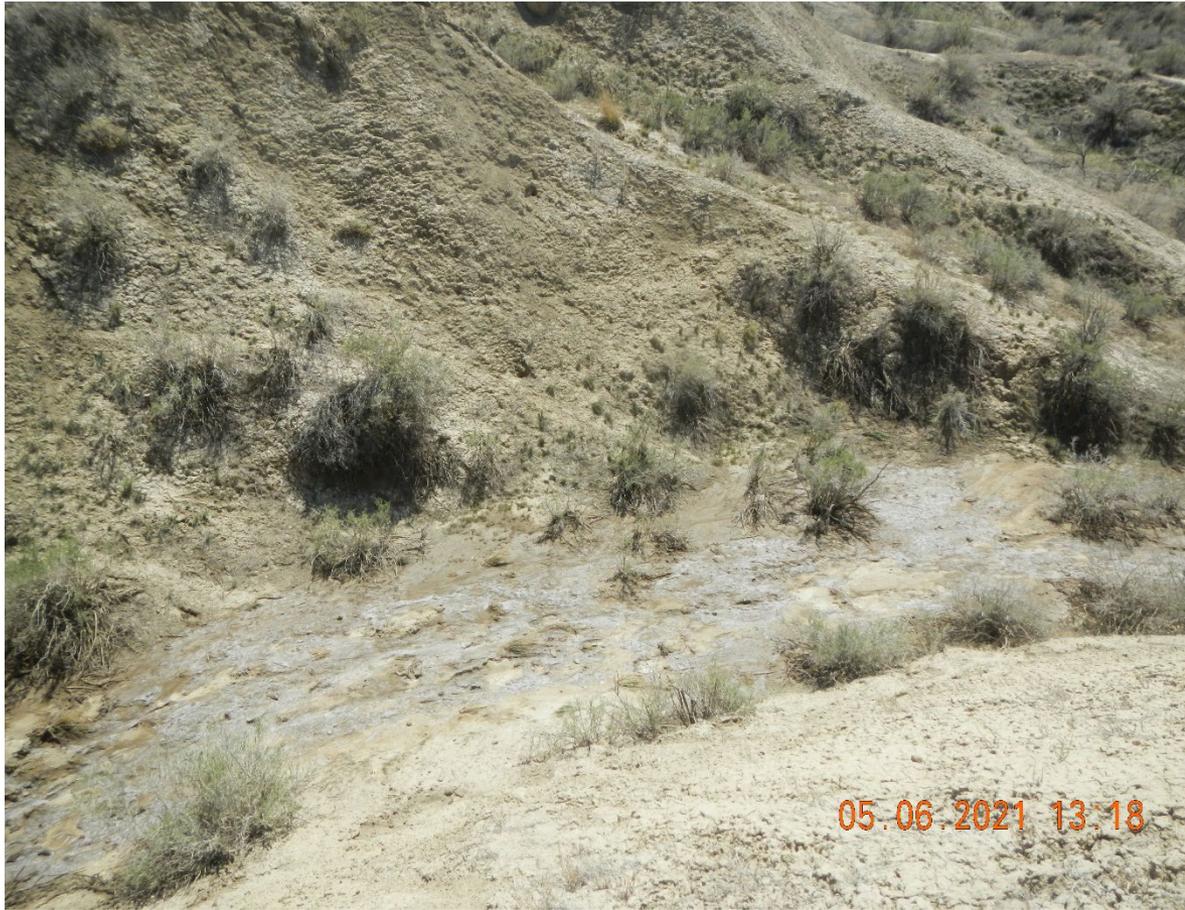
Photo #11 Main spill path in drainage to South of spill point.

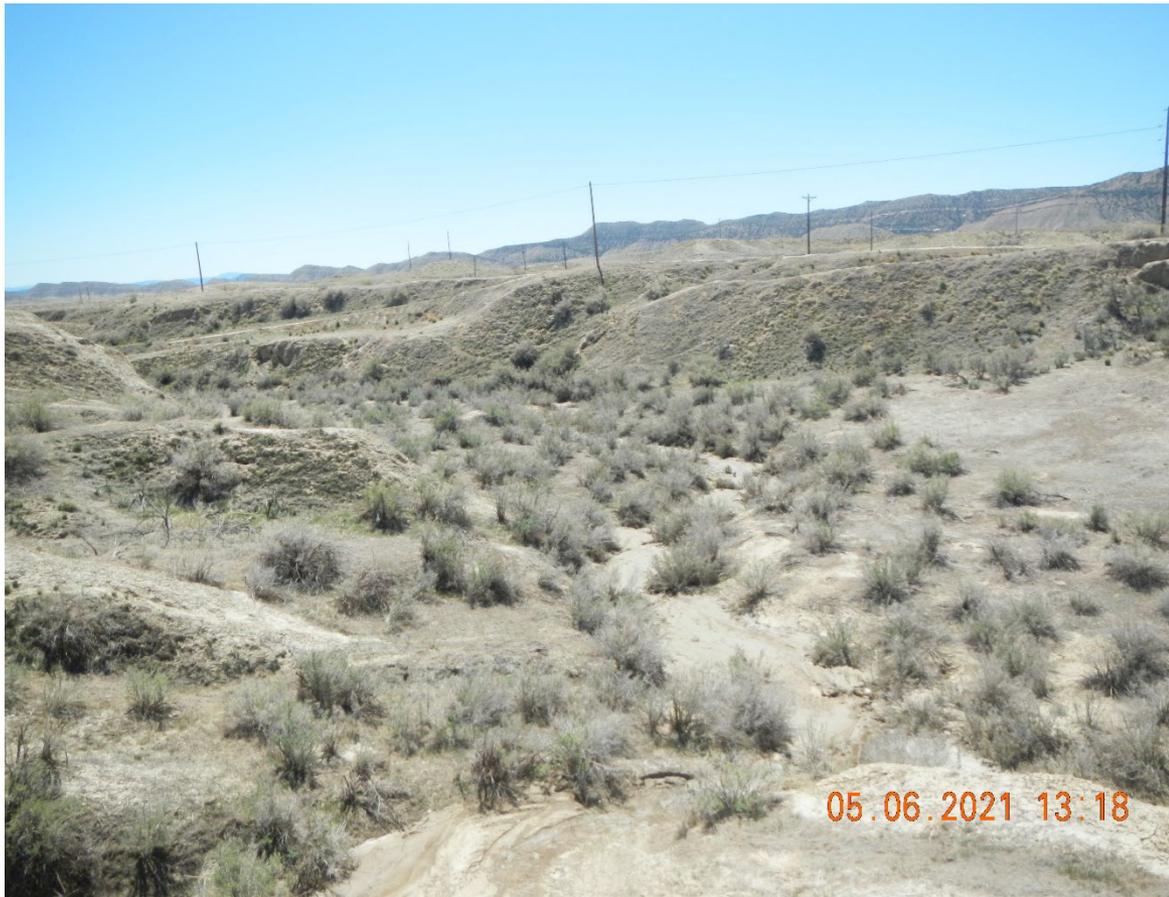
Photo #12 Along main spill path

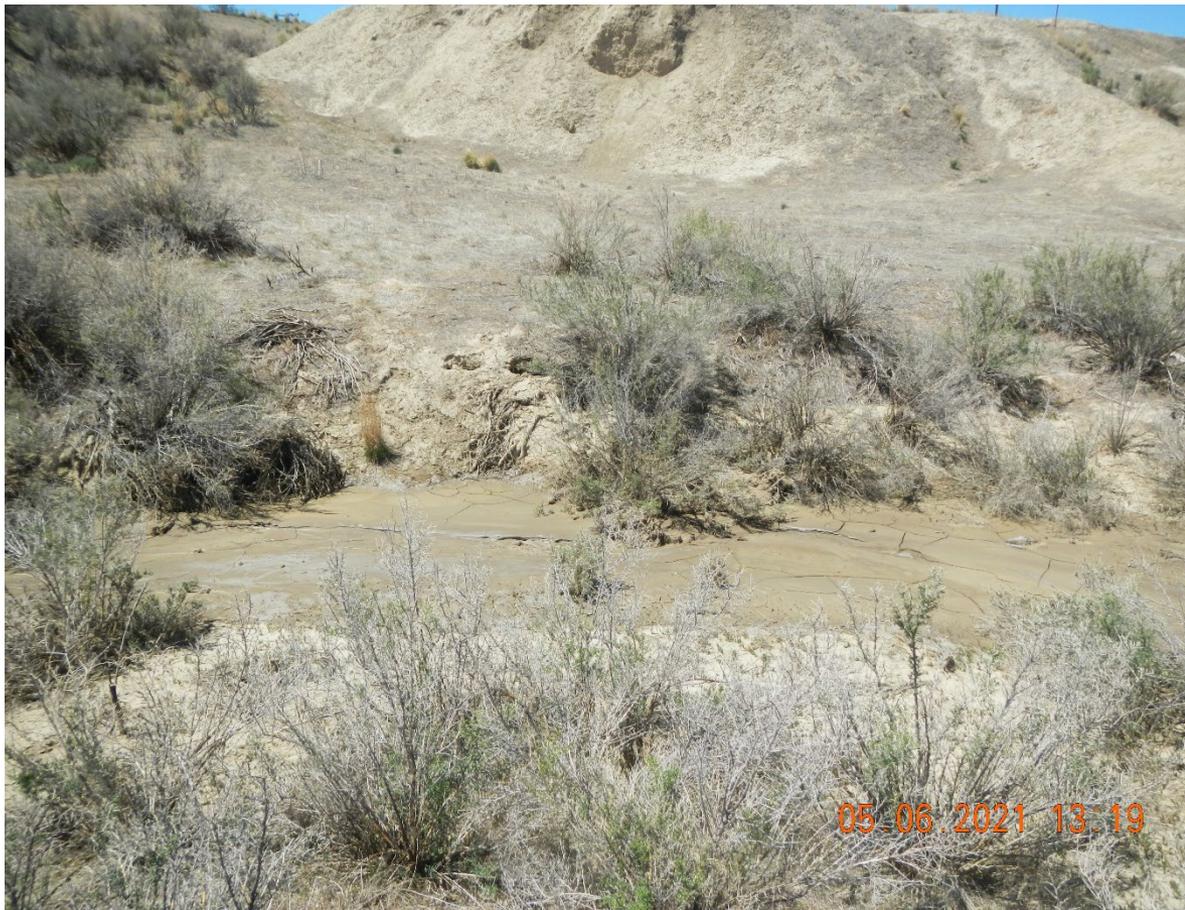
Photo #13 Main spill path

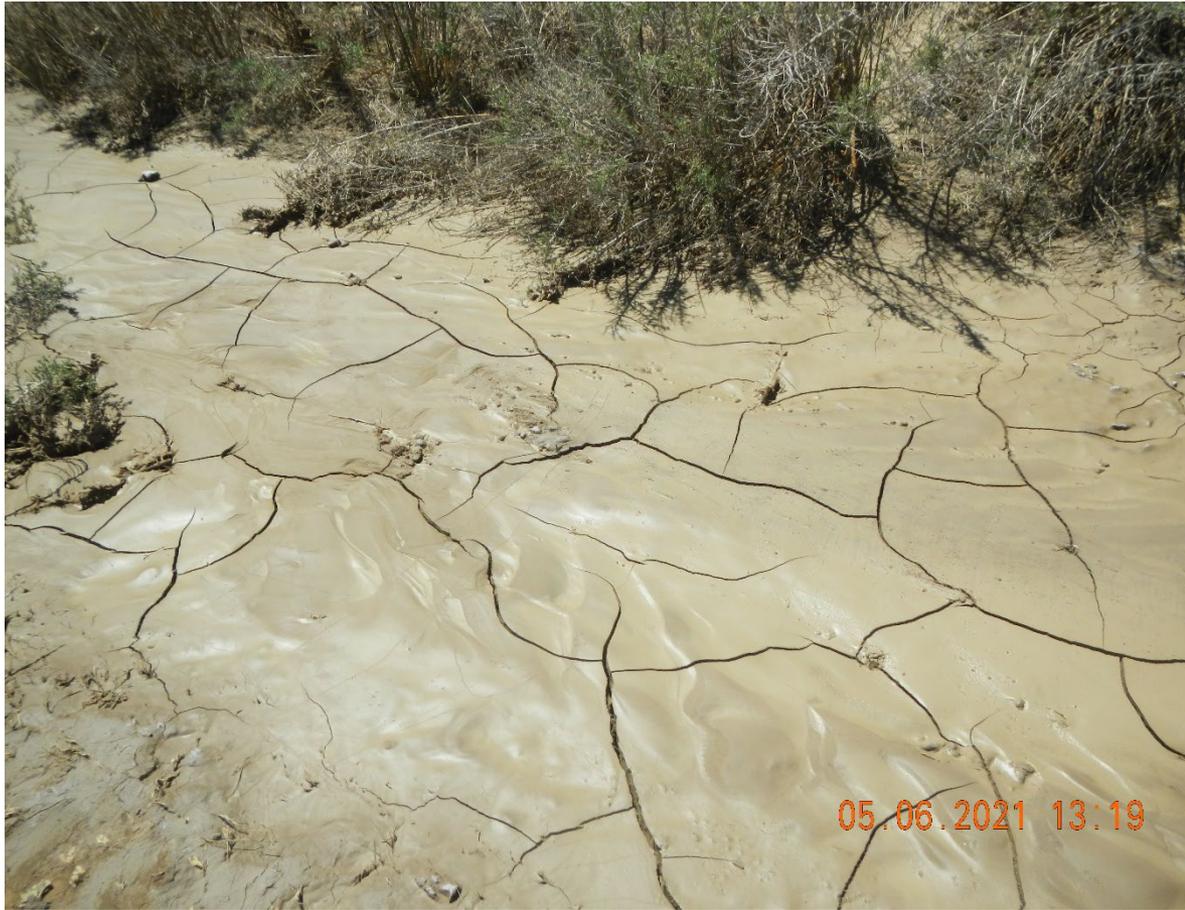
Photo #14 Main spill path

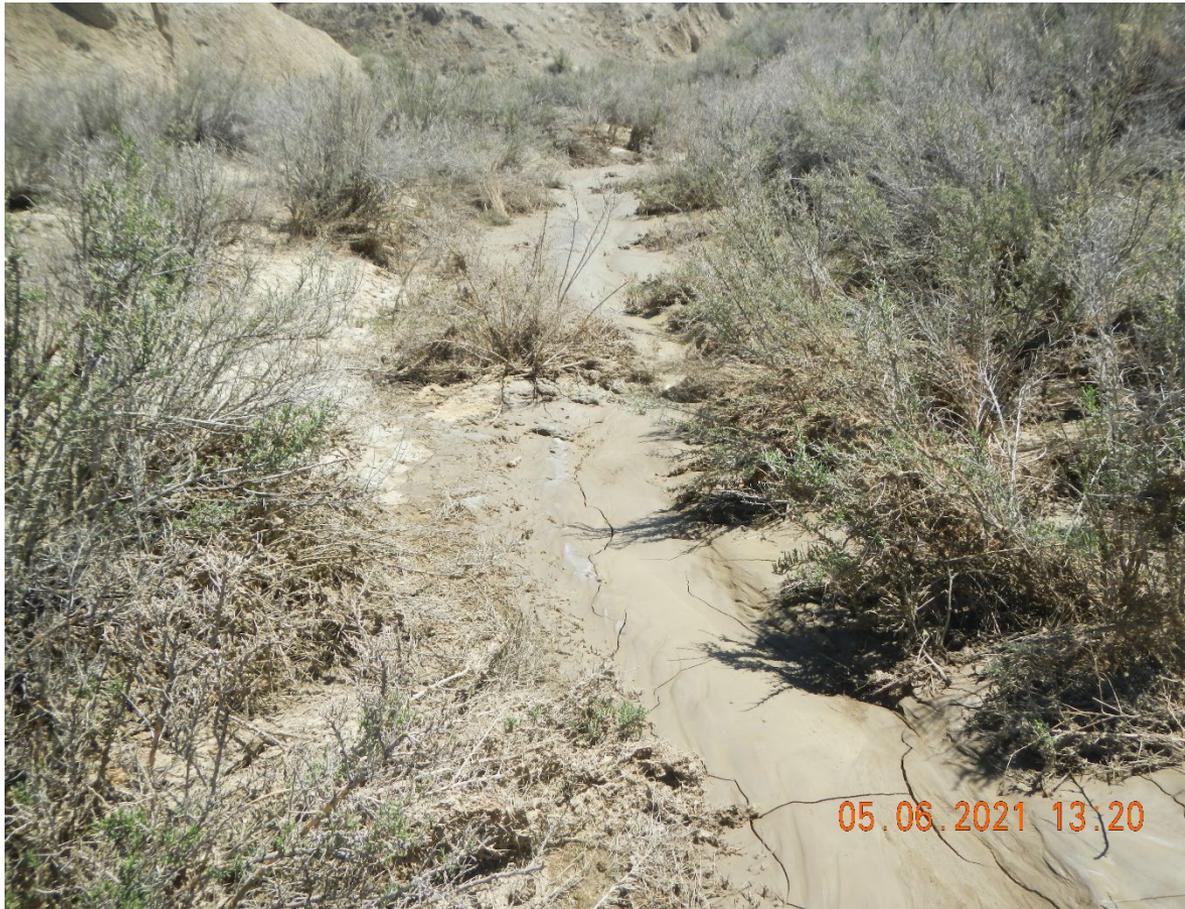
Photo #15 Main spill path

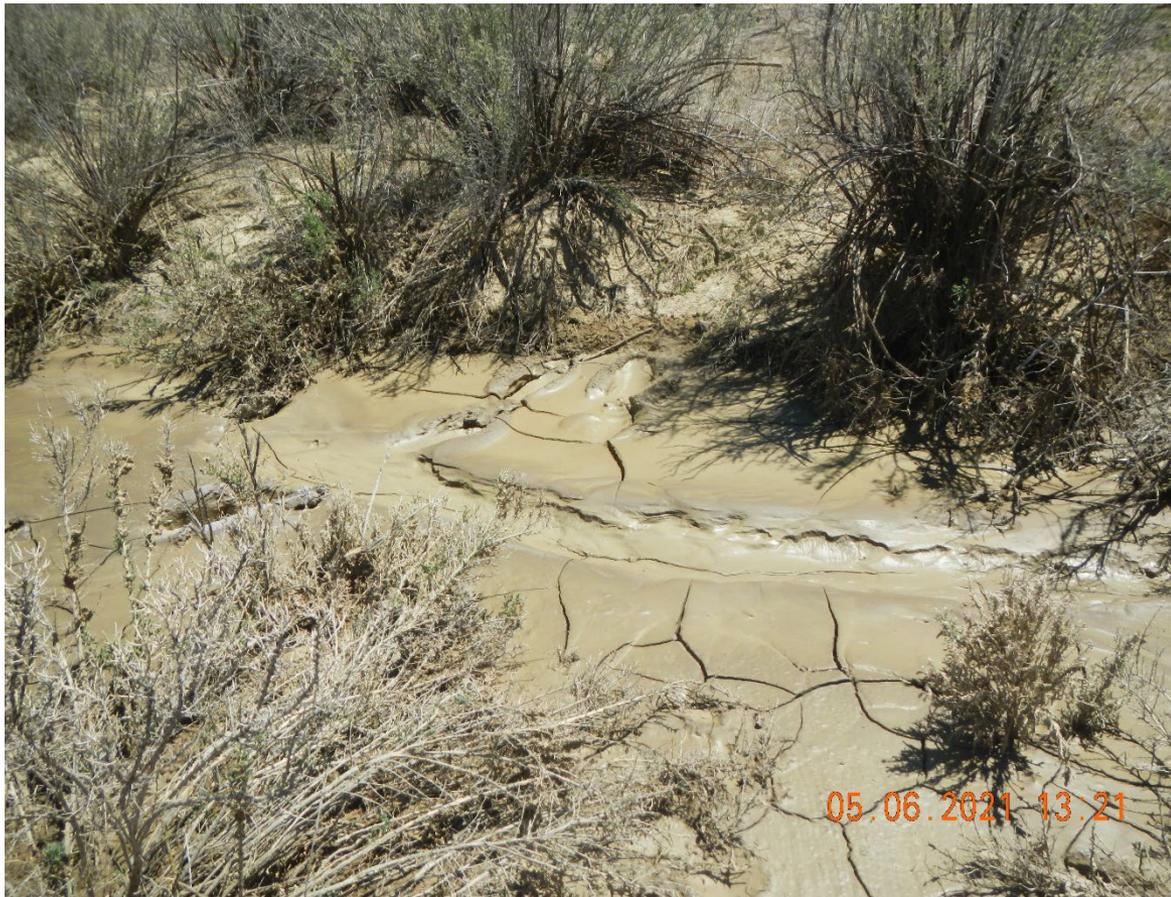
Photo #16 Main spill path

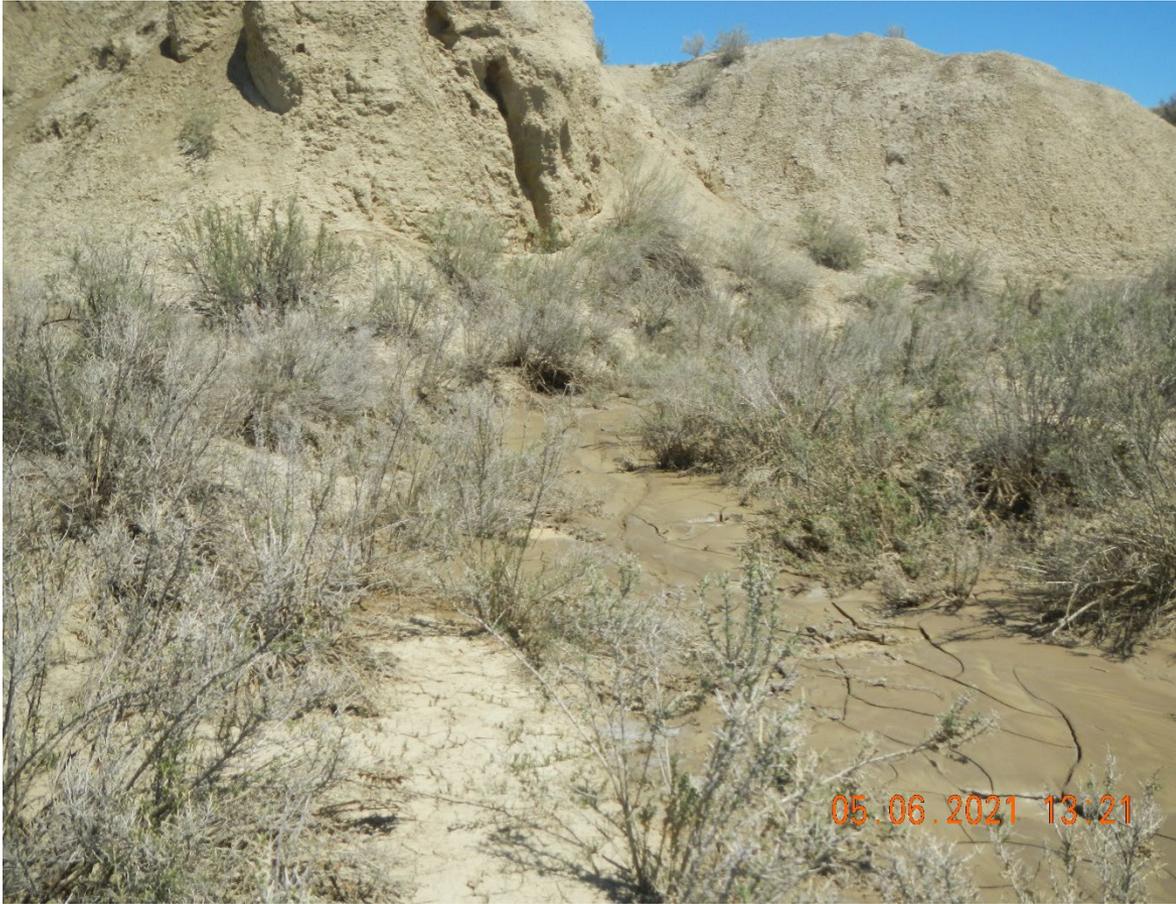
Photo #17 Main spill path

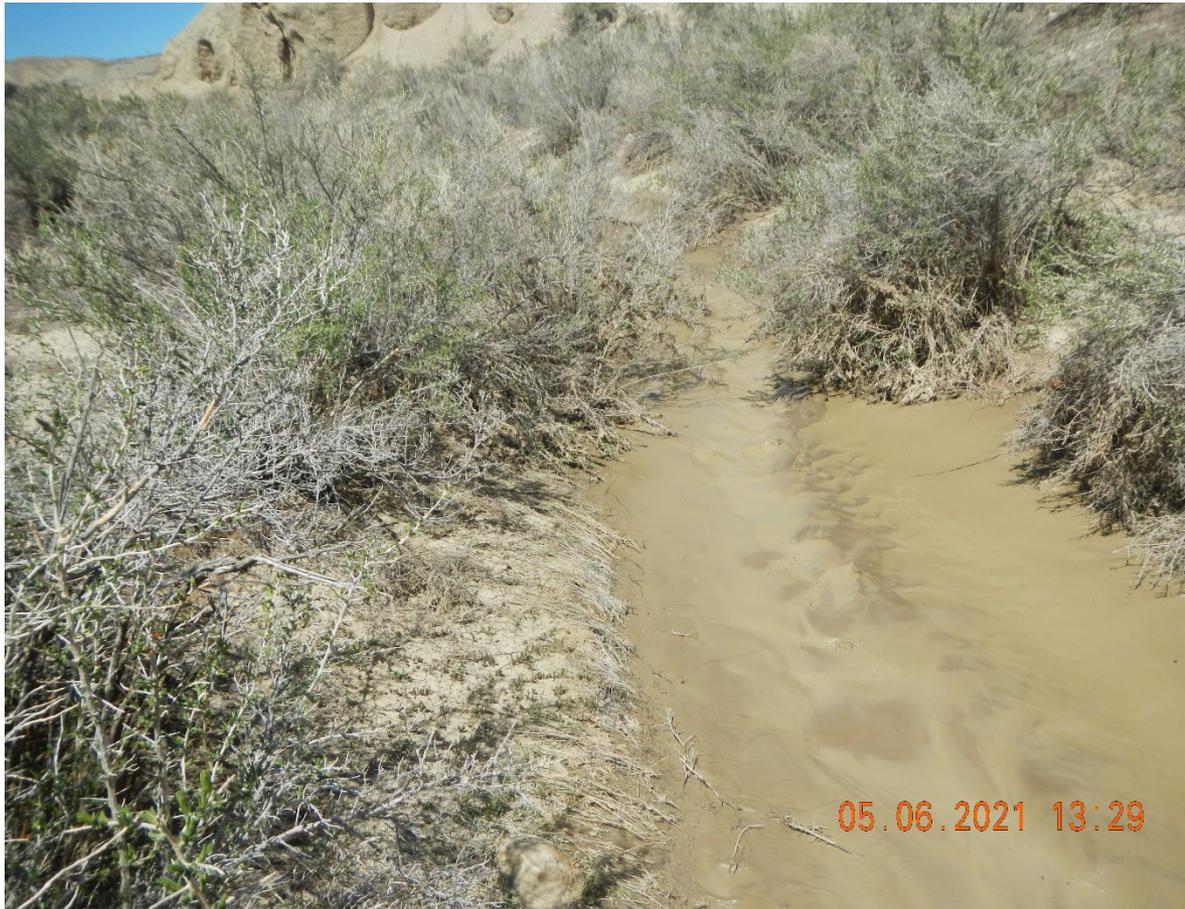
Photo #19 Main spill path

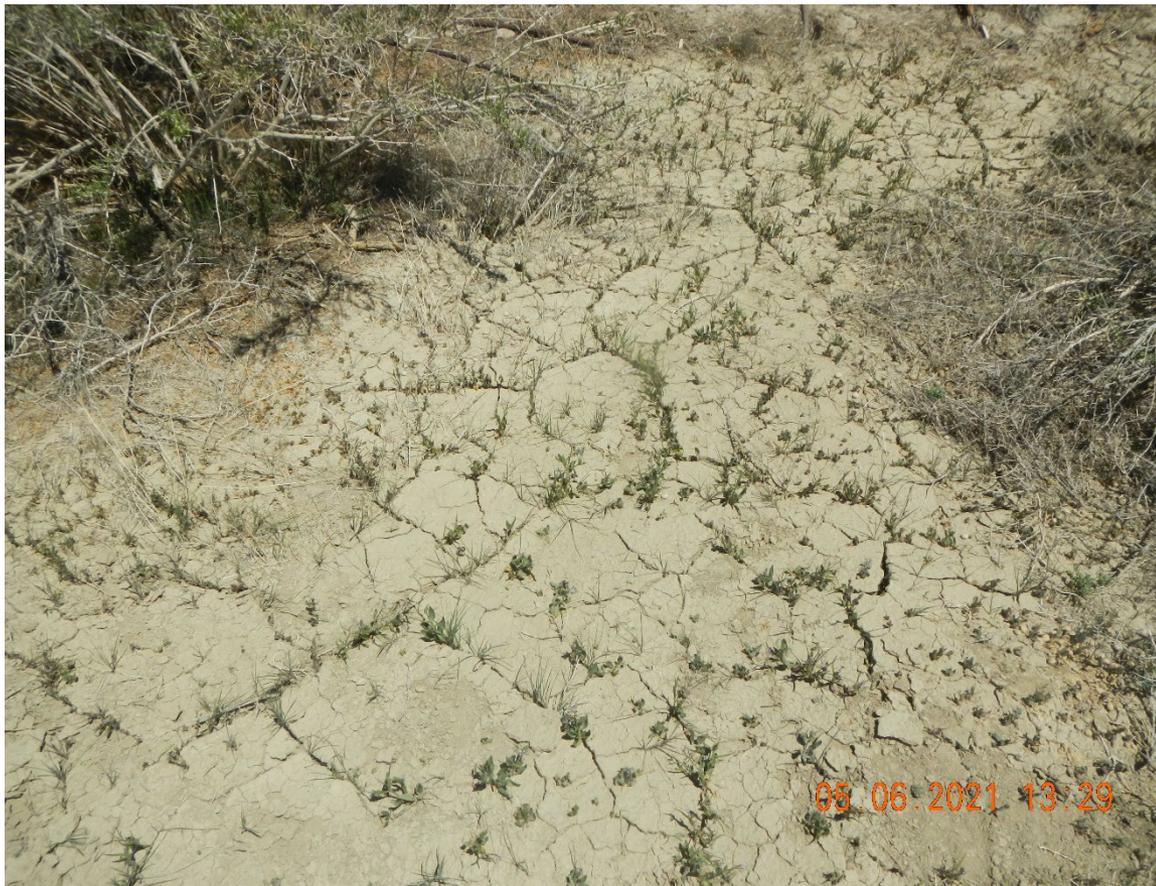
Photo #20 ground adjacent to spill path

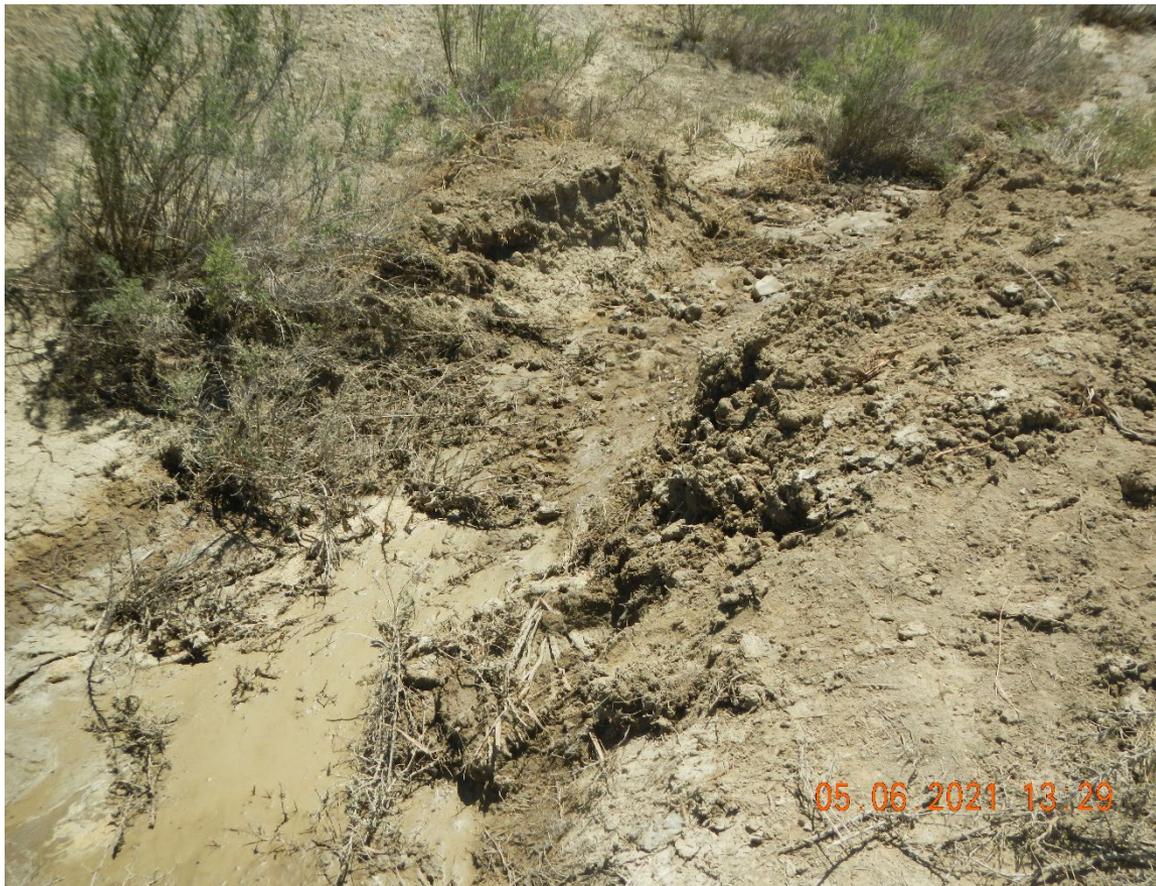
Photo #21 spill path, it was not obvious why the soil was disturbed.
