Inspection Photos

Spill #480059

Inspection Date: 5/25/2021

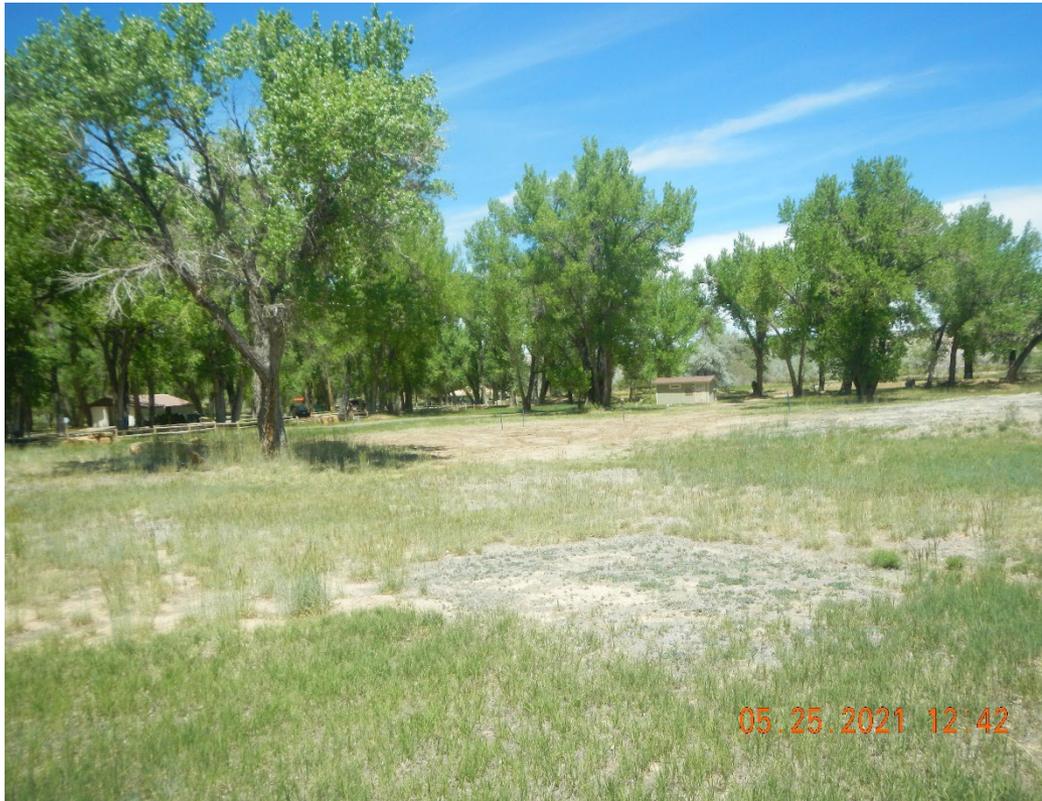
Photo #1 overview of spill area. The spill was reported as subsurface and occurred when an excavation clipped a line containing produced water and oil, the spill was reported as contained in the excavation. The area of impact is the disturbed soil near the tree shadow toward the back of photo.

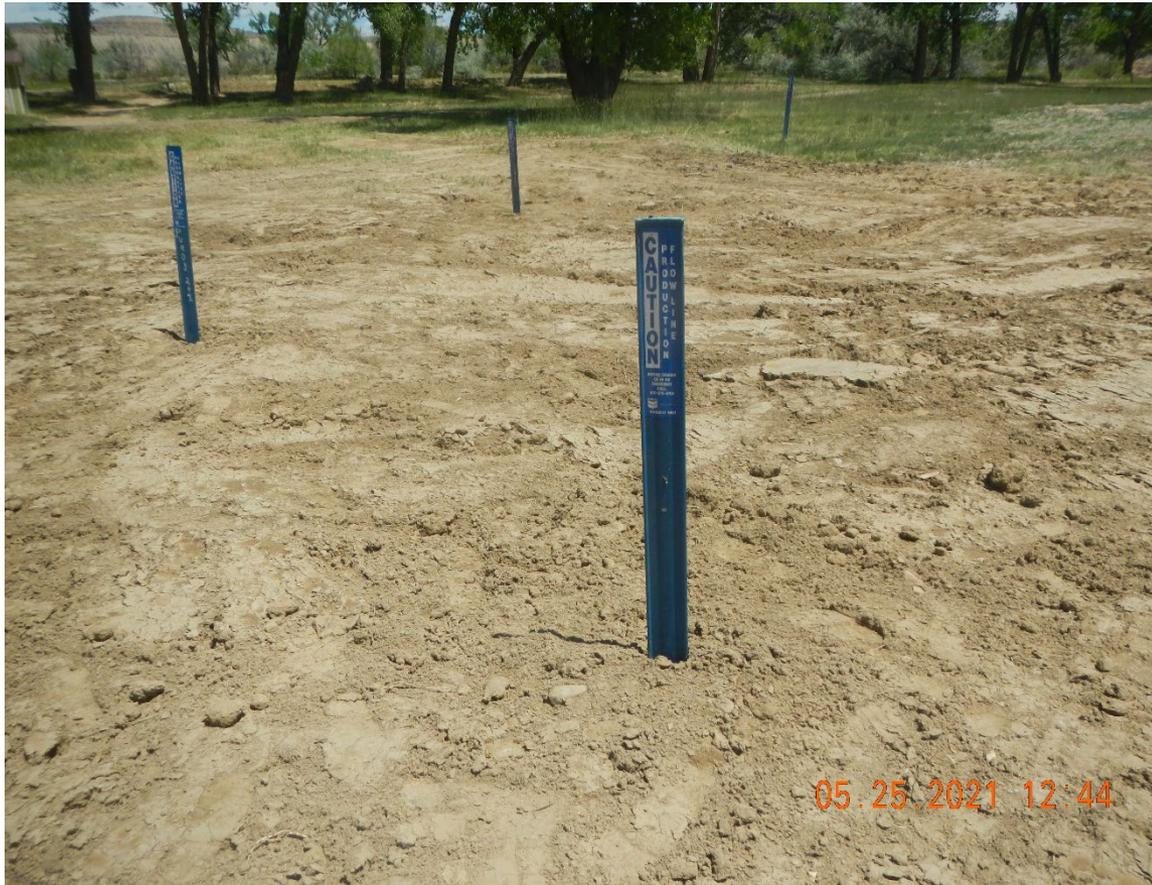
Photo #2 area of disturbed soil, it was not obvious where the failed flowline was

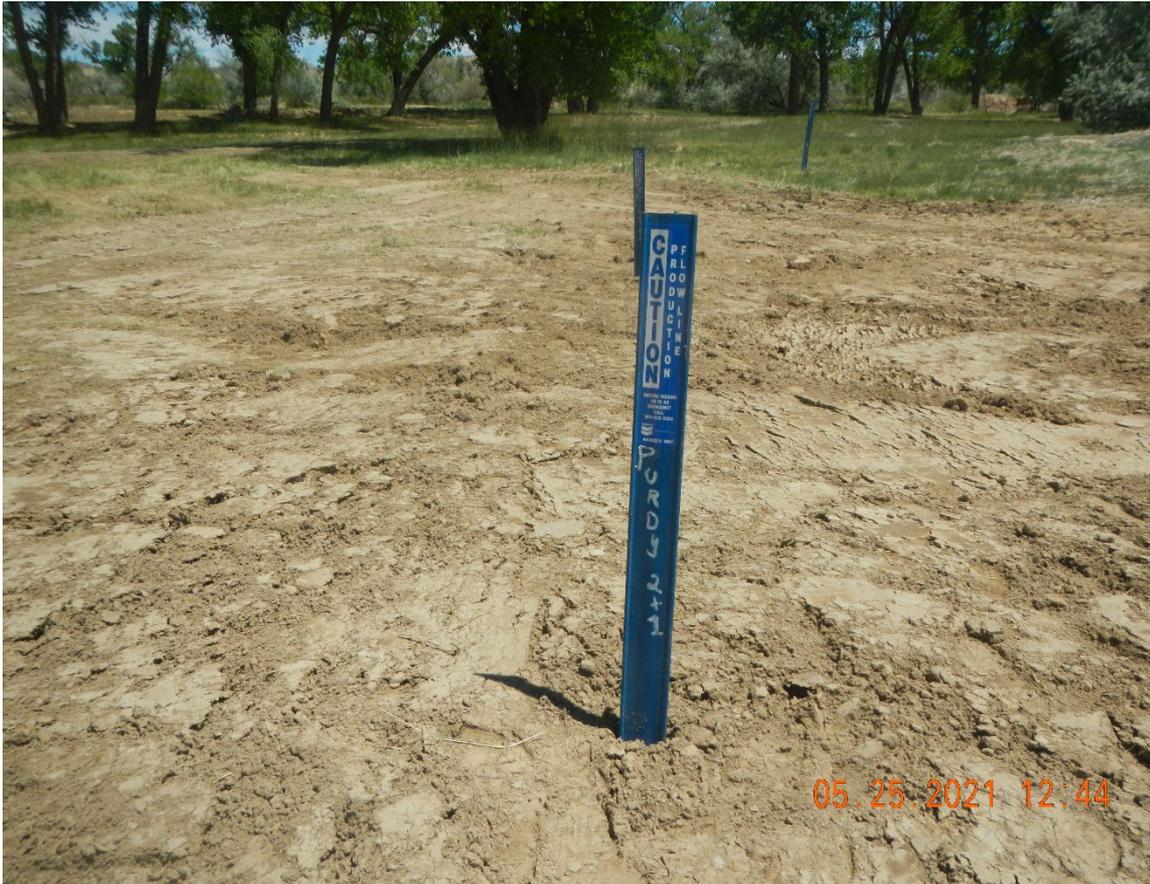
Photo #3 Area of disturbed soil, it was not obvious where the failed flowline was

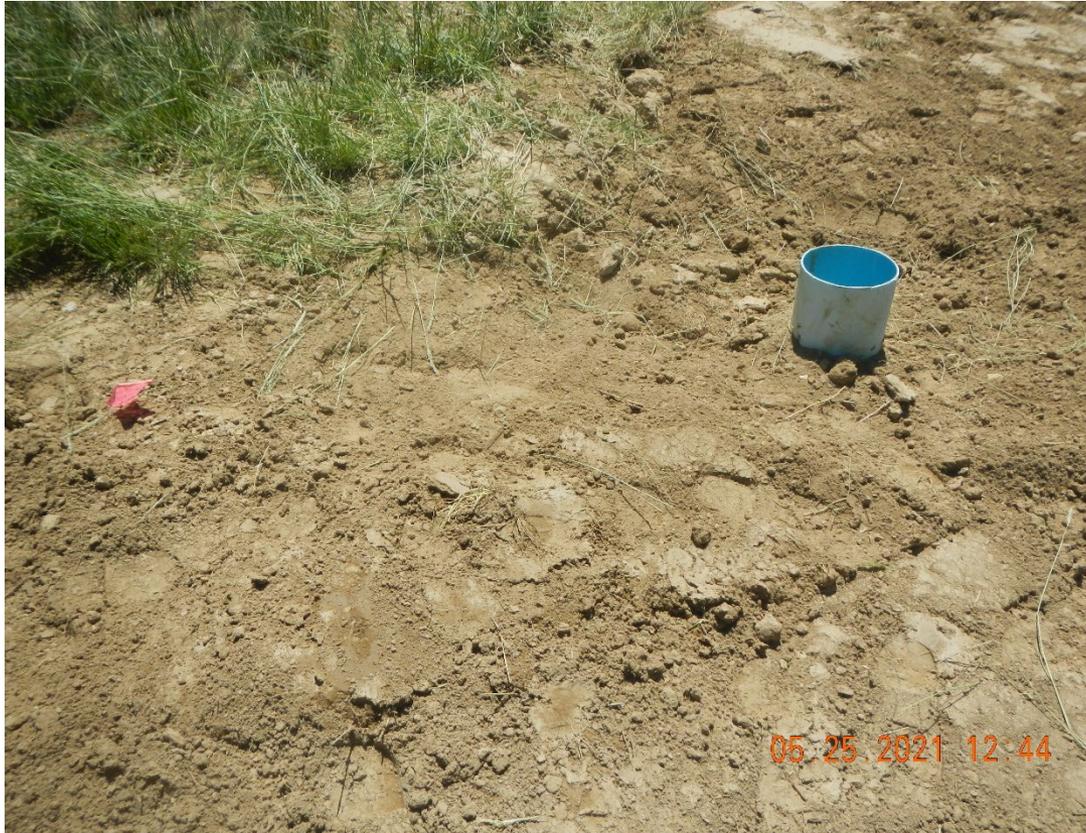
Photo #4 It was reported that when the spill occurred, City of Rangely crews were attempting to access a valve on a water line. The blue PVC pipe contained a valve.

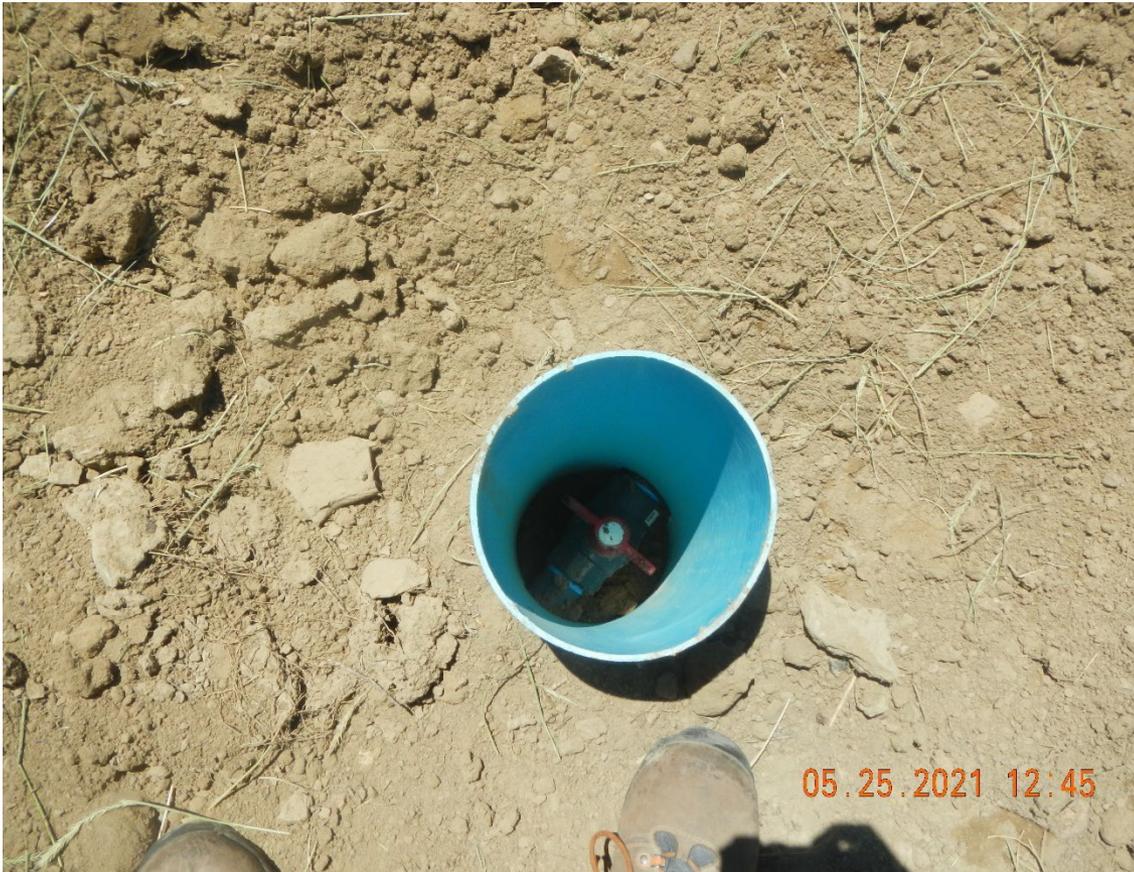
Photo #5 closed valve, assumed to be a water line.
