Inspection Photos

Spill #479949

Inspection Date: 5/25/2021

**COLORADO**  
Oil & Gas Conservation  
Commission  
Department of Natural Resources

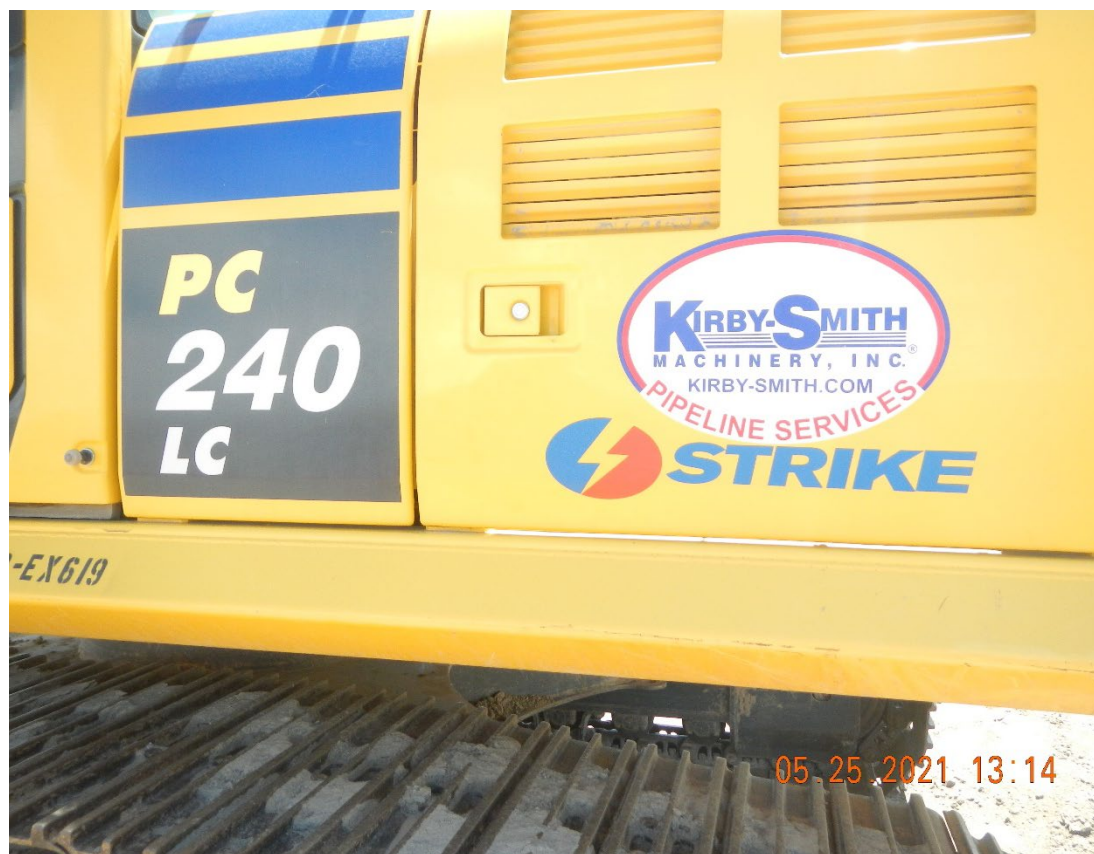
Photo #1 Trackhoe parked at spill 479949 spill point

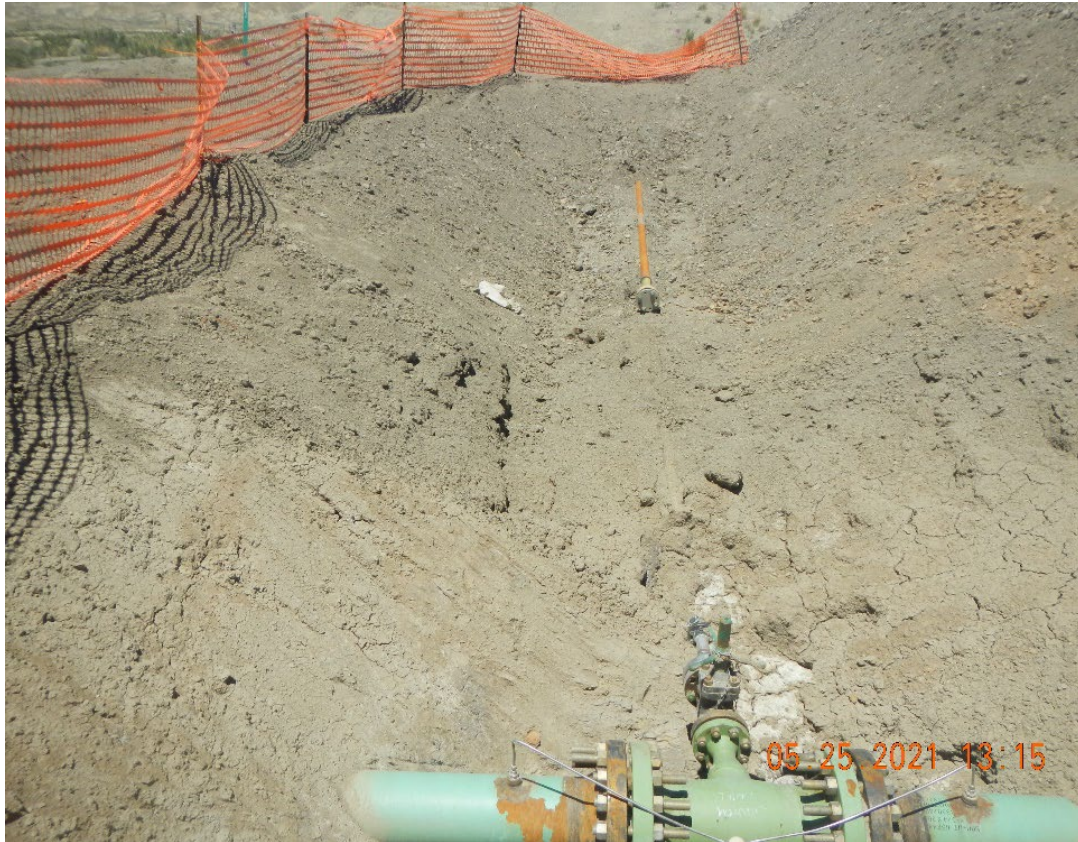
Photo #2 area at spill point had exposed flowlines and tees. Some salt staining was observed in excavation.

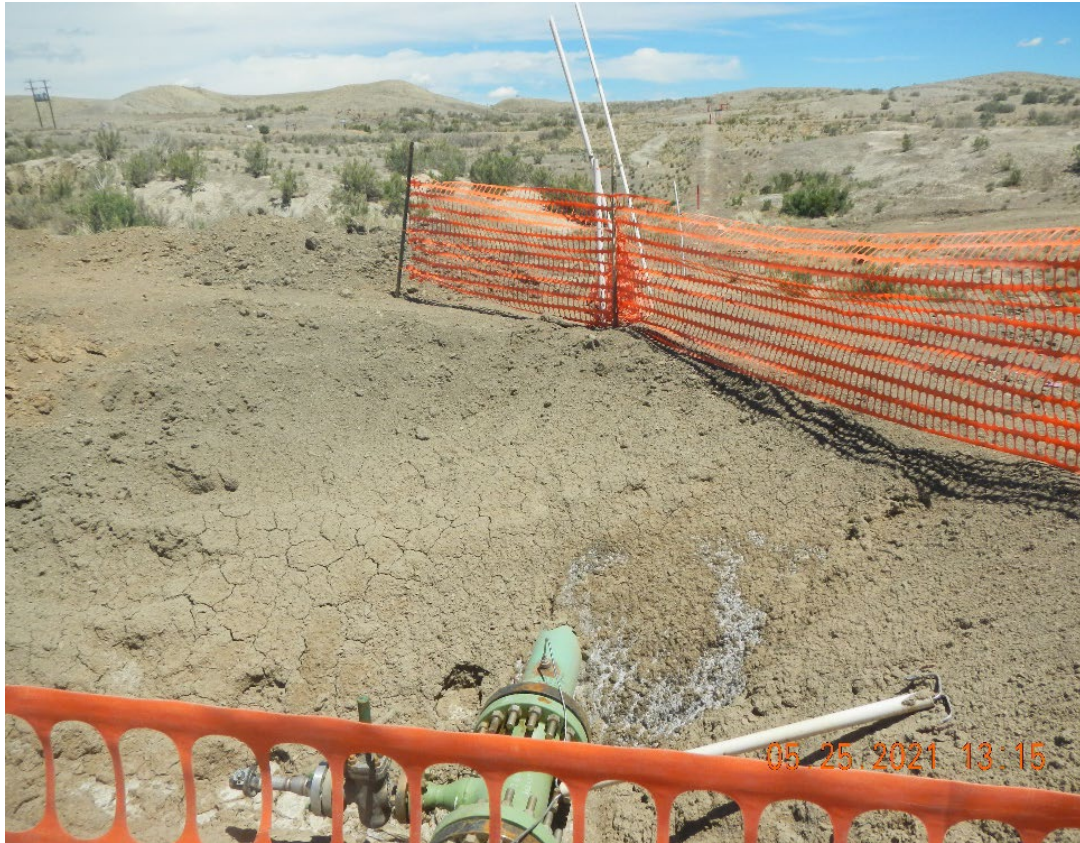
Photo #3 photos of spill point, had exposed flowlines and tees. Some salt staining was observed in excavation.

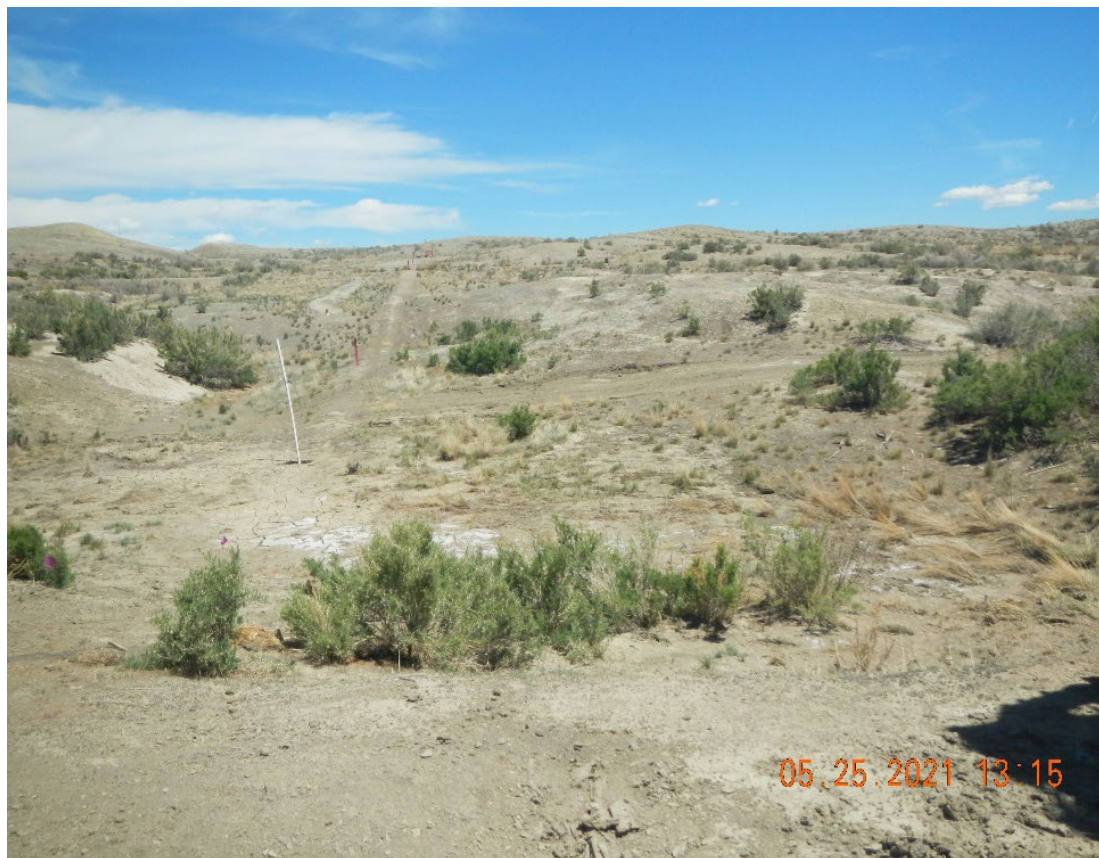
Photo #4 near spill point, looking north. Note PVC pipe in ground marking pothole.

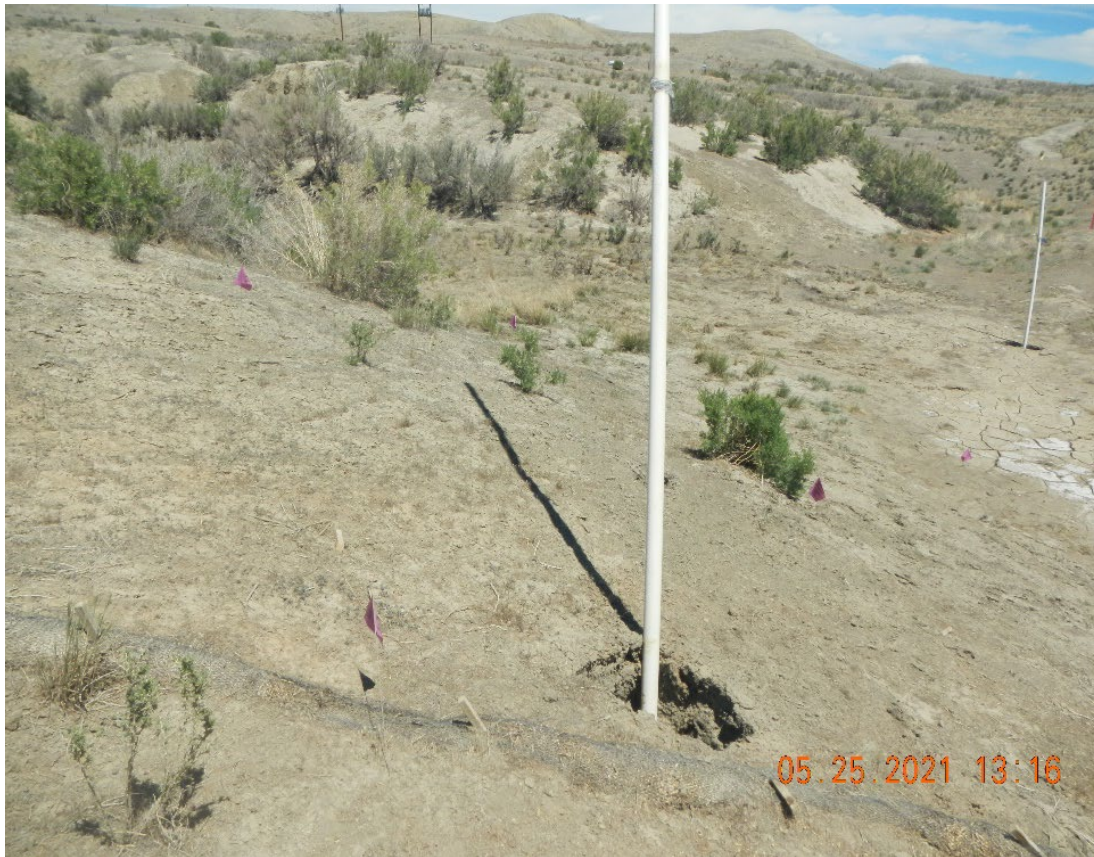
Photo #5 pot holes were observed, exposing flowline below. These potholes run from the spill point to the north.

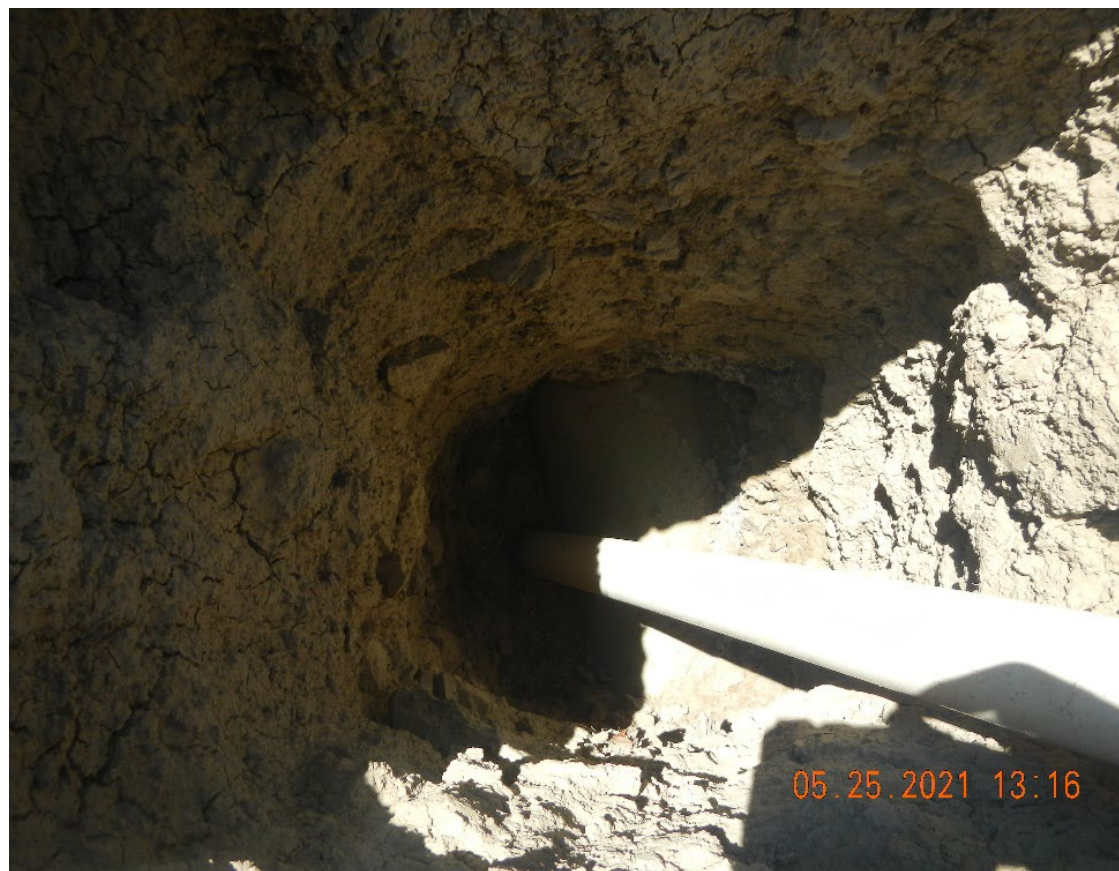
Photo #6 close up of the nearest pothole from Photo #5. A flowline was observable, not obvious in photo #5.

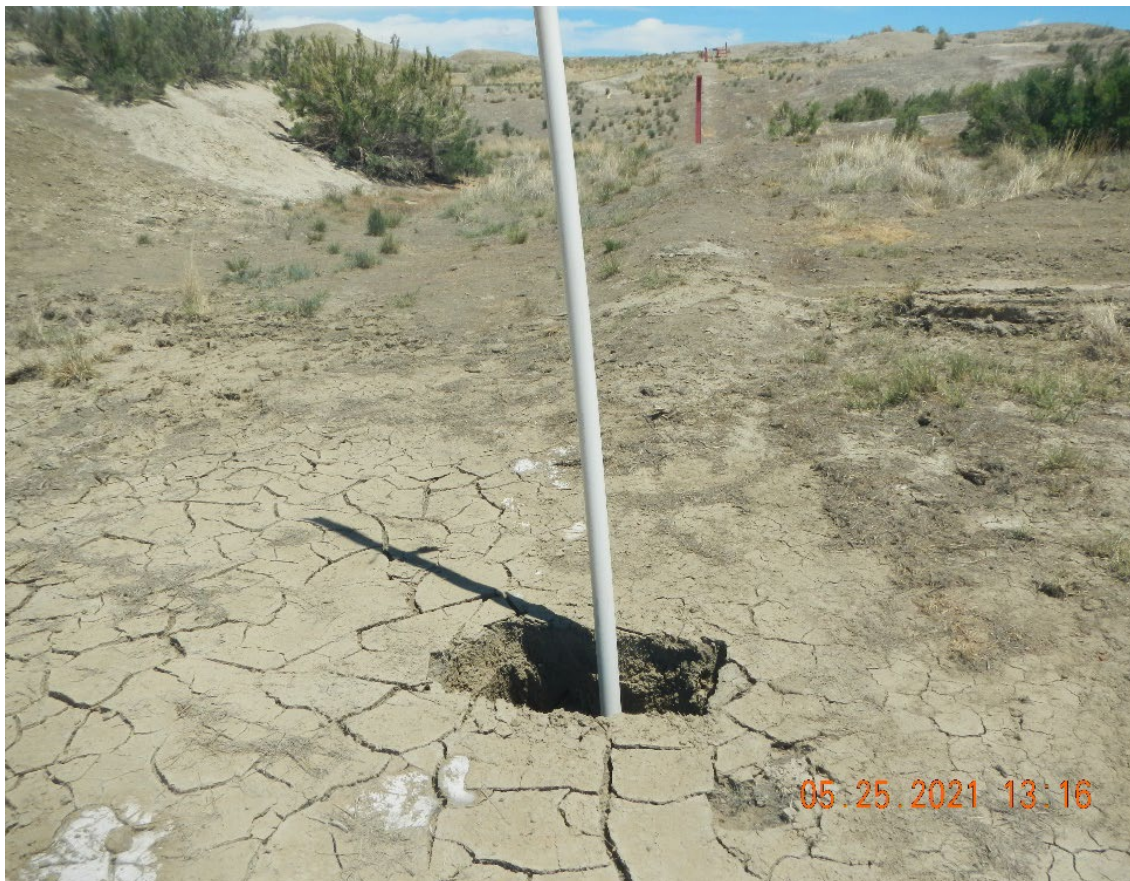
Photo #7 close up of the pothole seen in the background of Photo #4

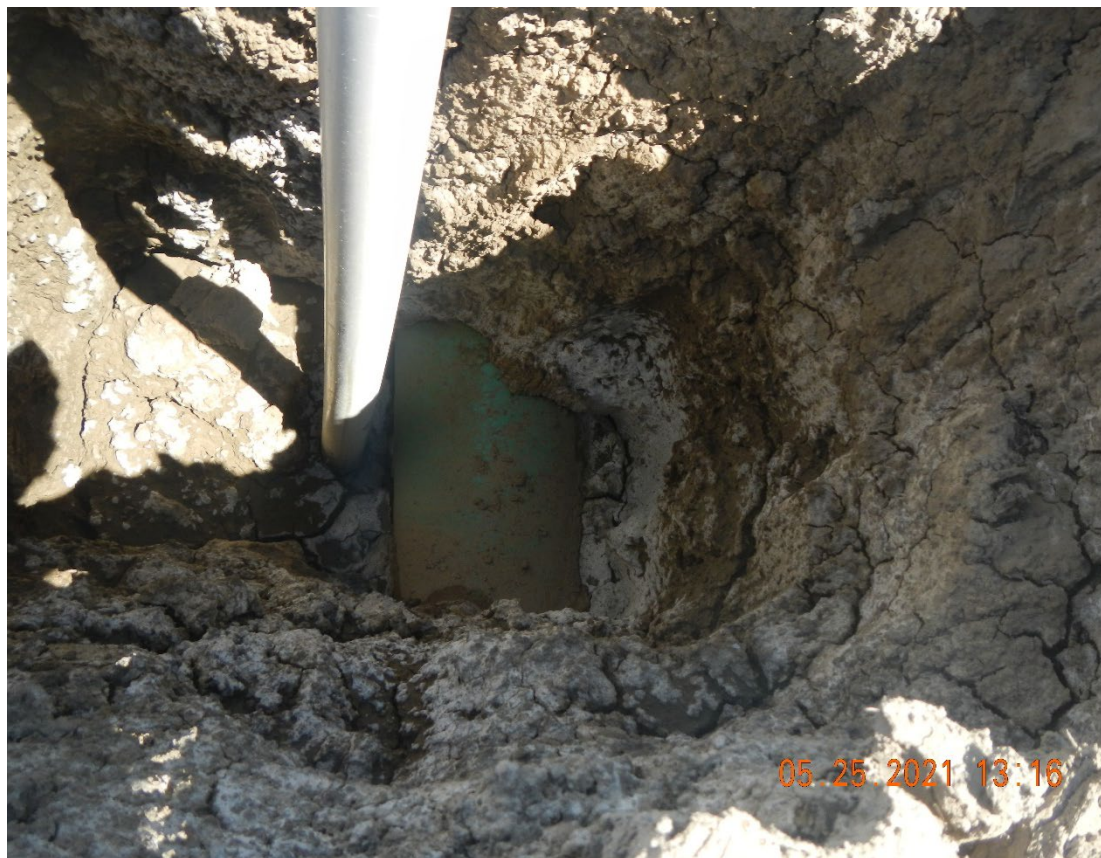
Photo #8 close-up of Photo #7, note flowline in pothole and salt staining.

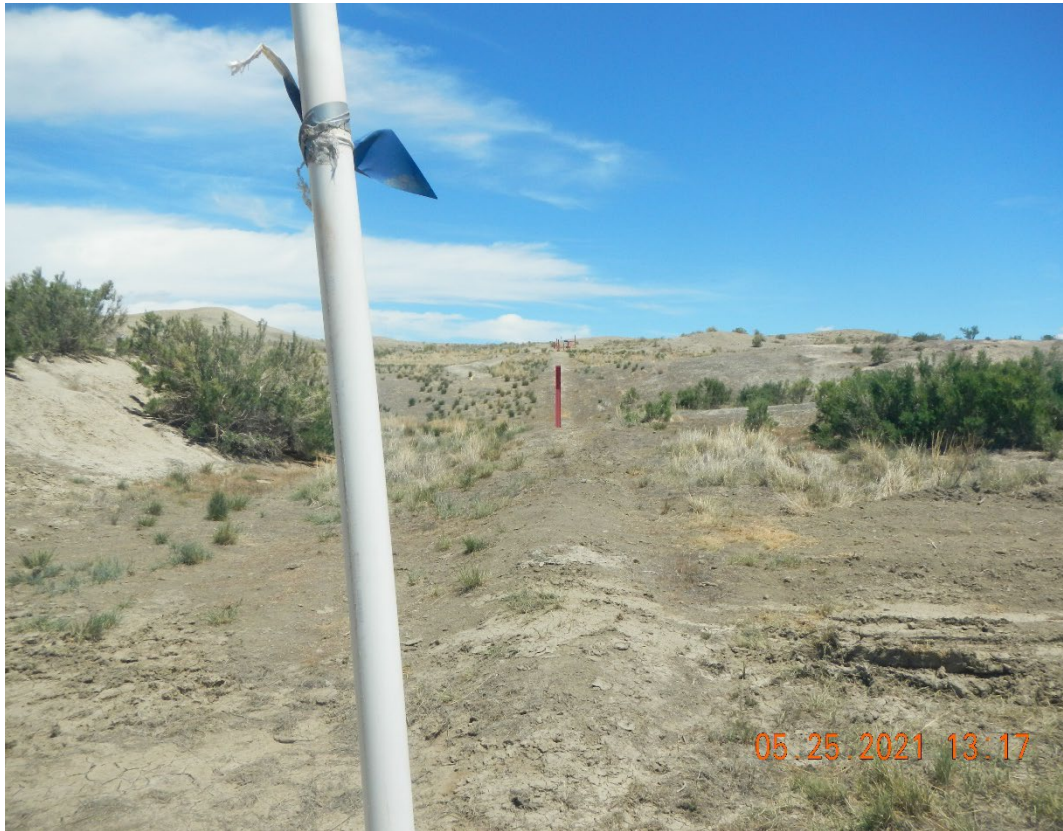
Photo #9, pothole marker seen in Photo #7 and Photo #8 looking north at flowline right-of-way marker.

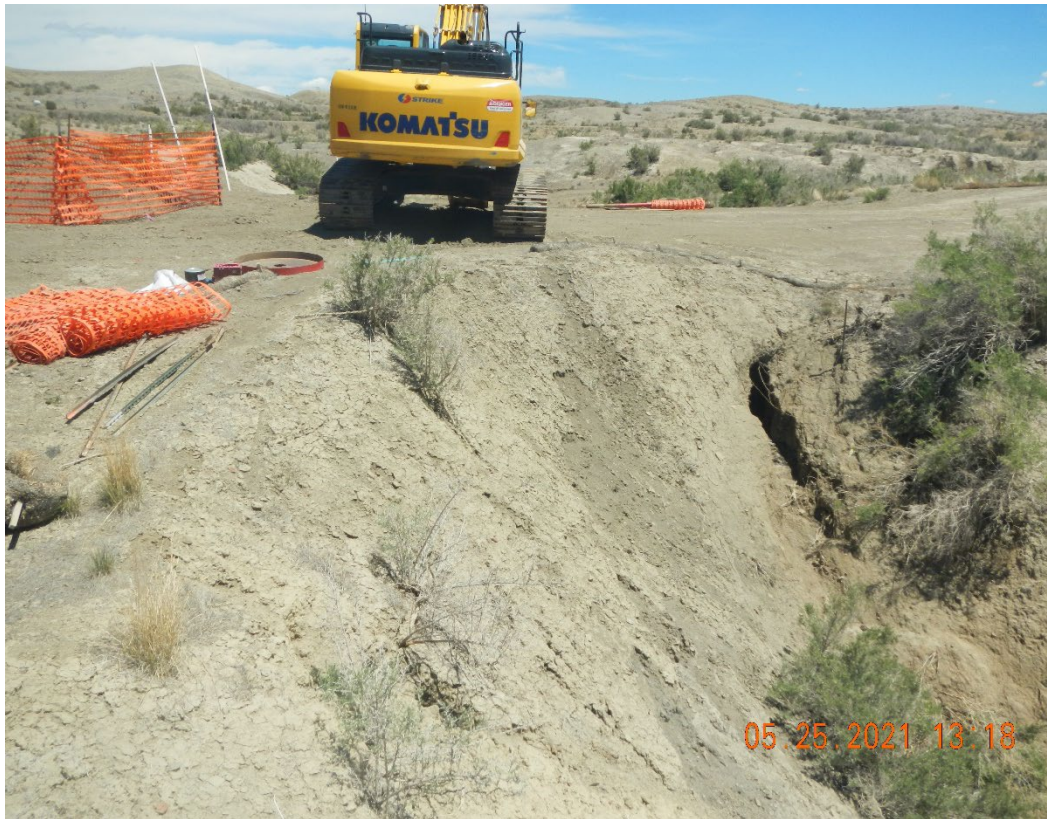
Photo #10, spill point is to the left of photo in orange fenced area. The area where the spill daylighted (second time) is observable to the right of photo below trackhoe. This was the main spill path.

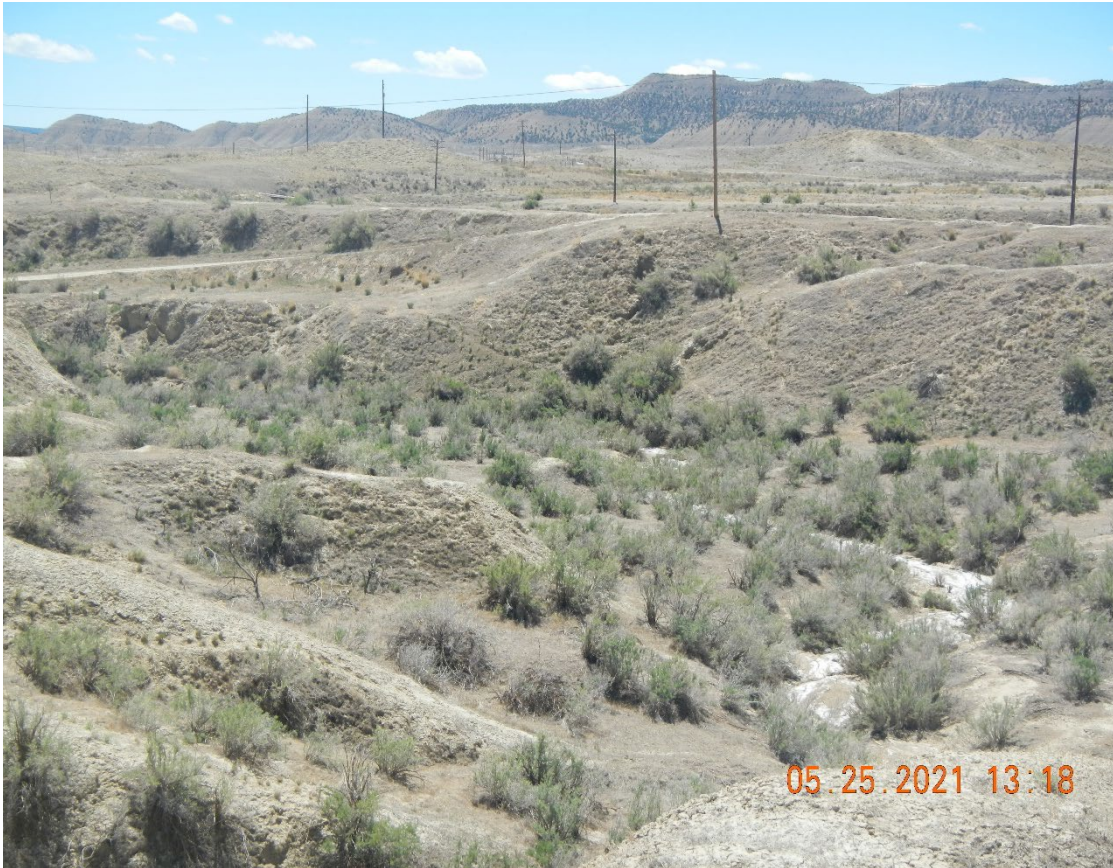
Photo #11 spill path observed downstream of spill point, note: salt staining. The spill path was documented by Chevron in spill documents and COGCC in inspection doc #694500337.

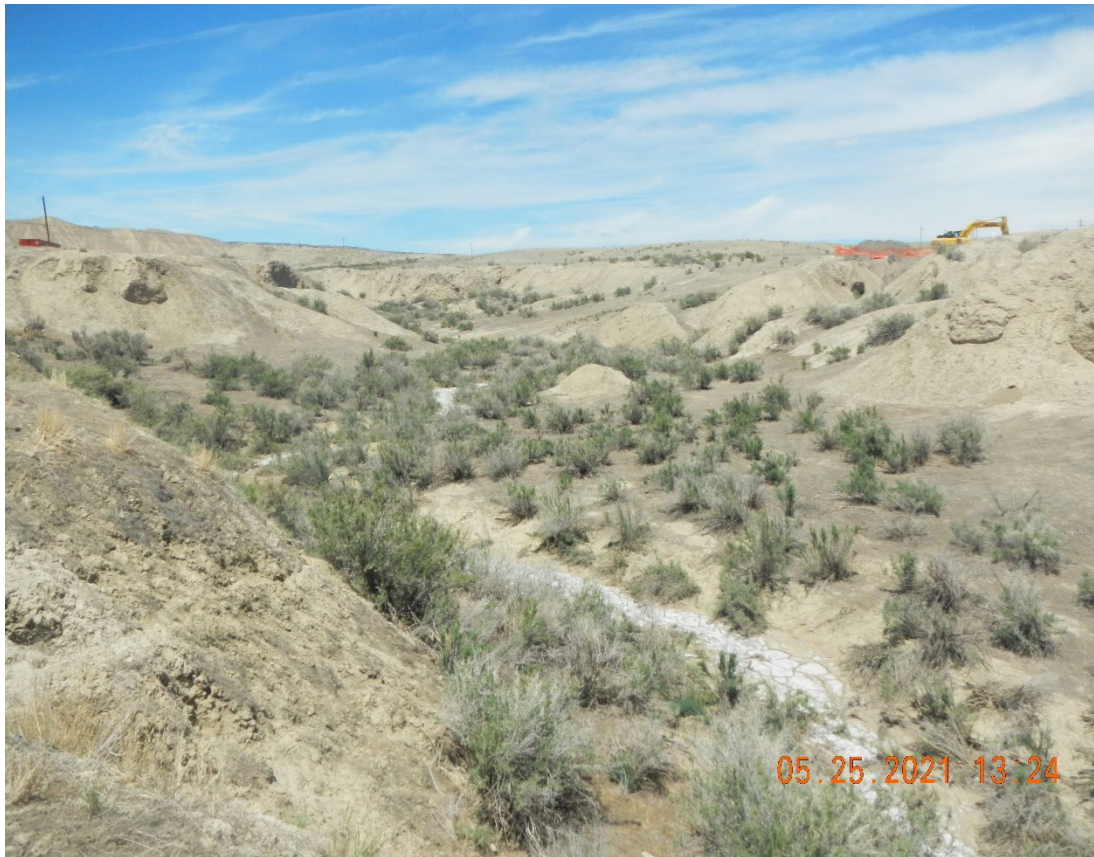
Photo #12 spill path observed downstream of spill point, note: salt staining. The spill path was documented by Chevron in spill documents and COGCC in inspection doc #694500337.

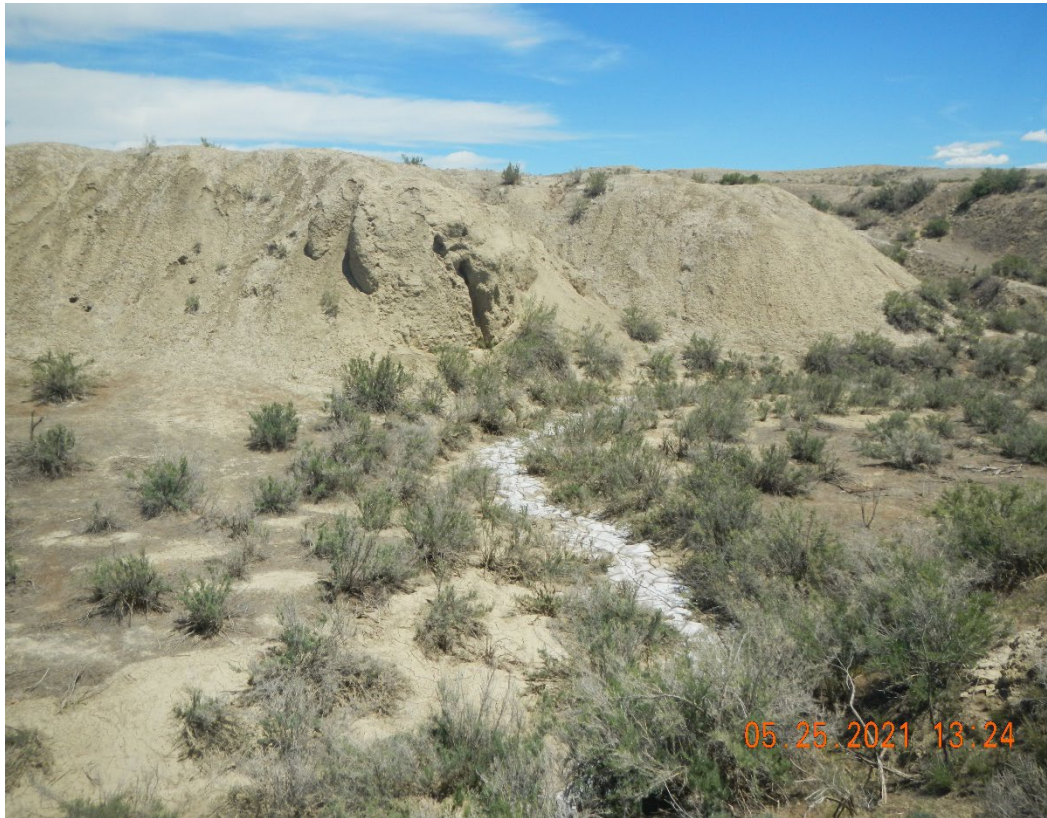
Photo #13 spill path observed downstream of spill point, note: salt staining. The spill path was documented by Chevron in spill documents and COGCC in inspection doc #694500337.
